Mitigation Assessment Team Report

# Hurricane Irma in Florida

Building Performance Observations,  
Recommendations, and Technical Guidance

FEMA P-2023 / December 2018

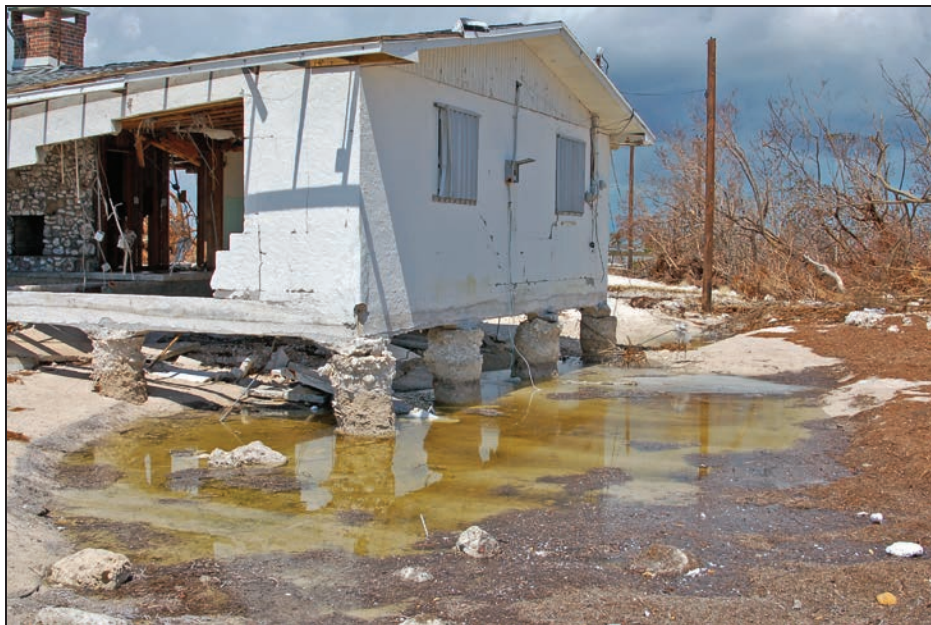
**Figure 3-15:**  
Scour was likely due to waves and high-velocity flow at this house on Long Beach Drive (same house is shown in Figure 3-6) (Big Pine Key, FL)

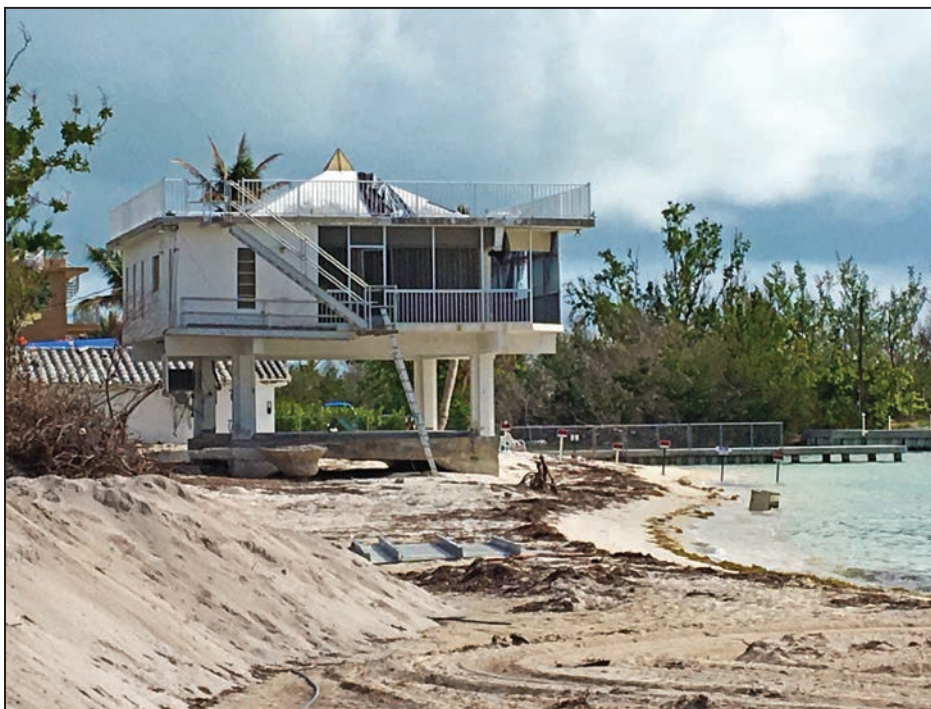
**Figure 3-16:**  
Erosion was likely due to wave attack around the foundation of this house on Sombrero Beach Road (Marathon, FL)

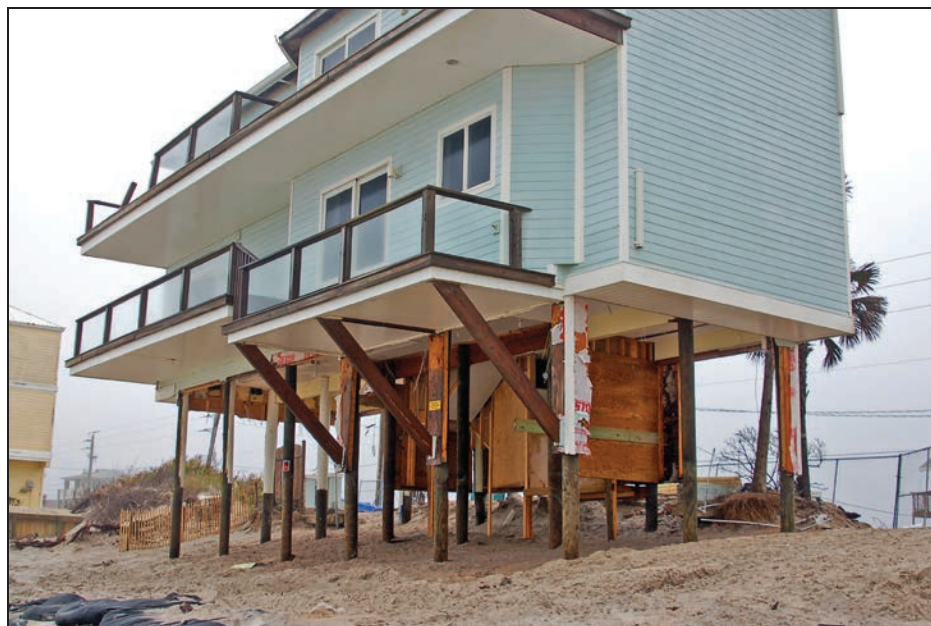
**Figure 3-18:**  
Undermined house on deep  
piles that survived erosion  
(Vilano Beach, FL)

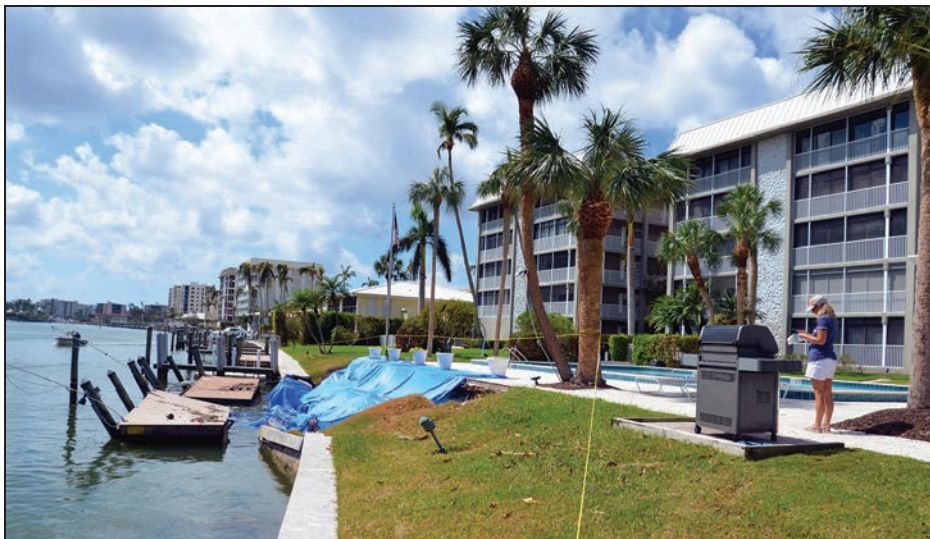
**Figure 3-27:**  
**Failure of bulkhead (anchor**  
**system) (Naples, FL)**

The failure of this bulkhead likely originated at its anchor system. This type of failure allows the top of a bulkhead to rotate toward the water.

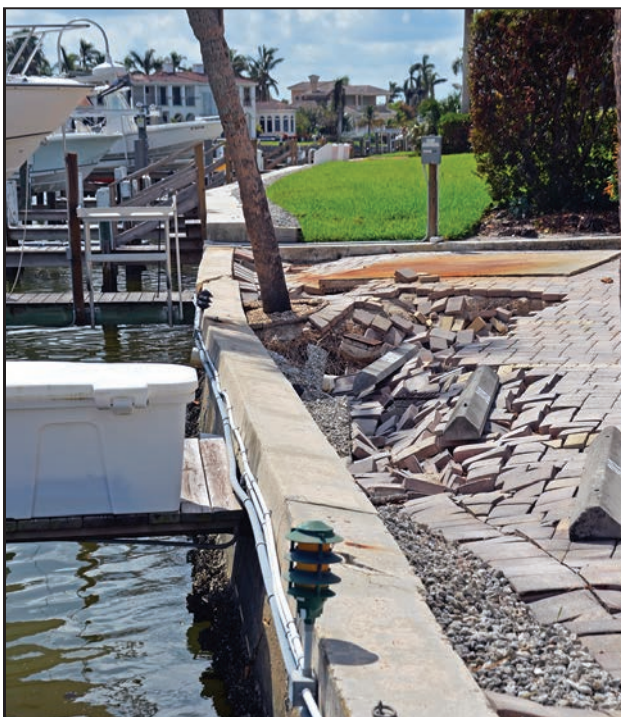
**Figure 3-28:**  
**Bulkhead toe failure**  
**(insufficient embedment)**  
**(Naples, FL)**

The failure of this bulkhead was likely due to insufficient embedment of the bulkhead toe into the ground. This type of failure allows the bottom of a bulkhead to rotate toward the water.

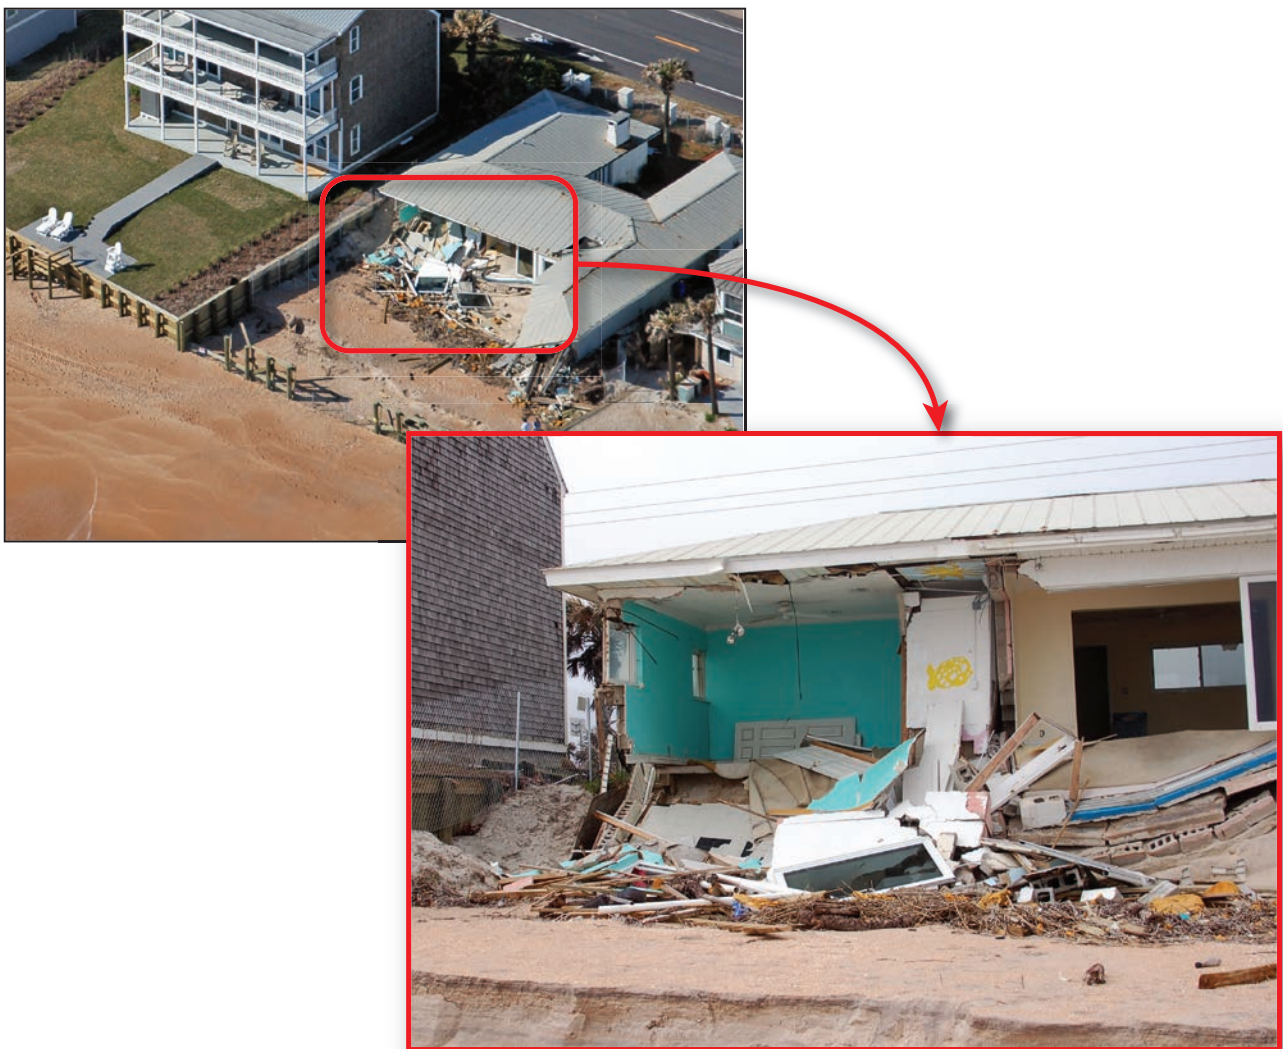
Figure 3-29: House on a shallow foundation that collapsed after it was undermined following failure of the bulkhead during Hurricane Irma (St. Johns County, FL)

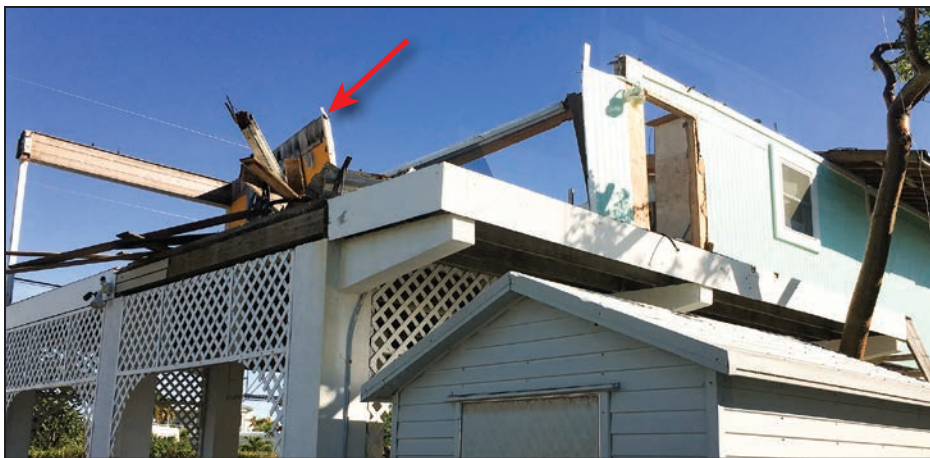
The screened porch and portion of the exterior wall, which is painted orange and indicated with the red arrow, remained standing. There is a missing wall section between it and the west-facing exterior wall. Same house as Figure 4-3.

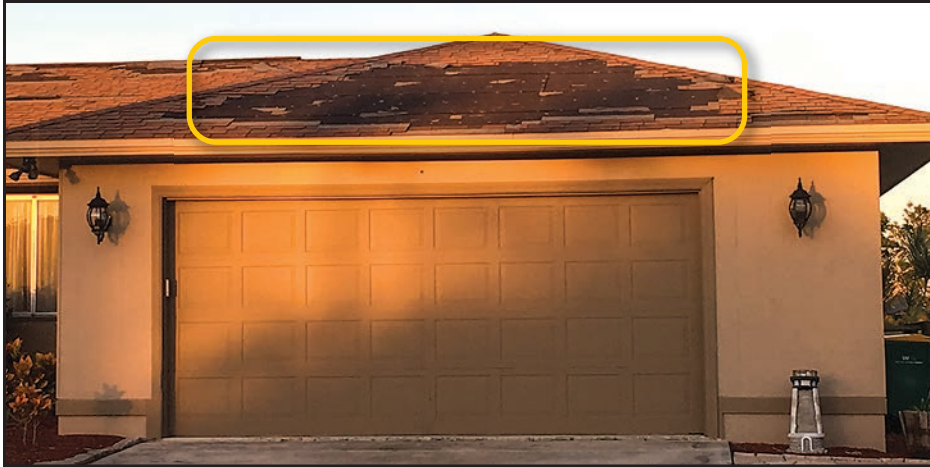
Figure 4-12:  
House with shingle loss  
near main ridge and  
between roof hips (yellow  
oval) (EWS = 109 mph;  
EDWS = 170 mph)  
(Marco Island)

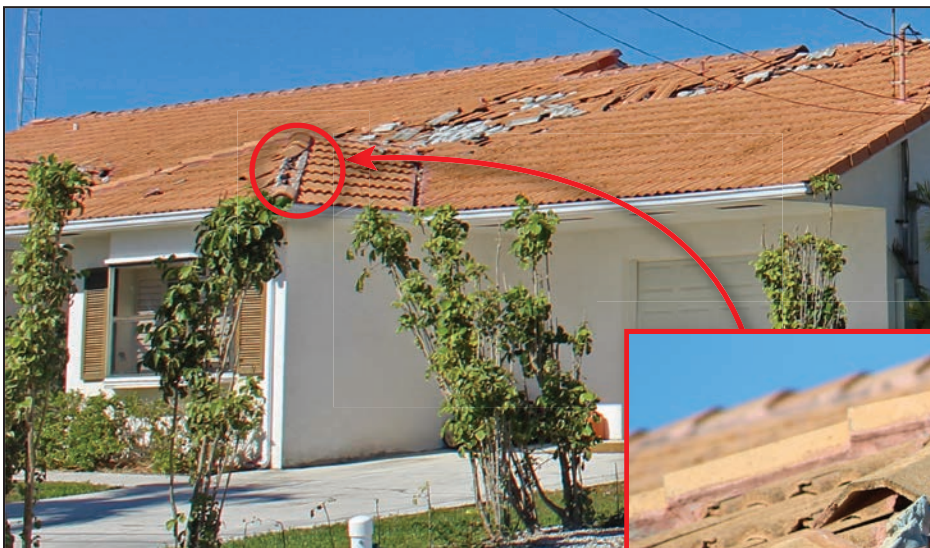
Figure 4-13:  
Roof tile failure (EWS = 113  
mph; EDWS = 180 mph)  
(Cudjoe Key)

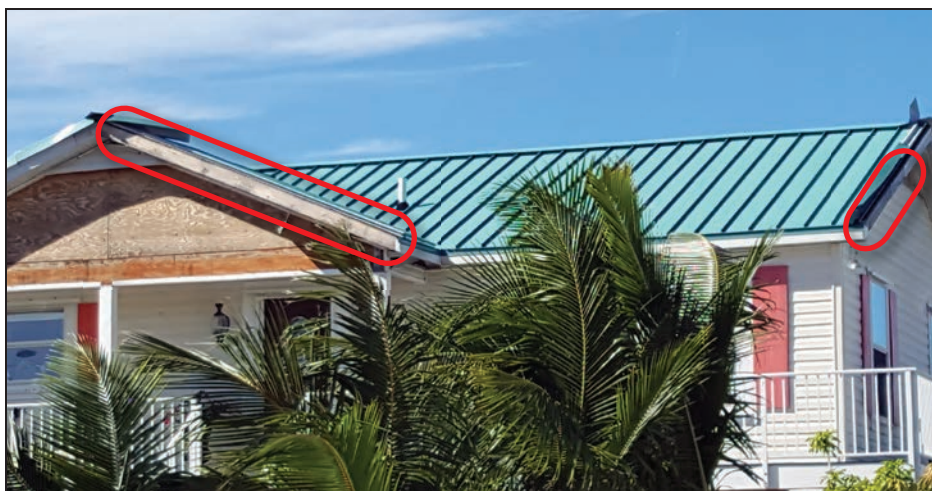
Figure 4-15:  
House with separated metal roof trim and missing fascia cover (red ovals) along gable end. (EWS = 113 mph; EDWS = 180 mph) (Sugarloaf Key)

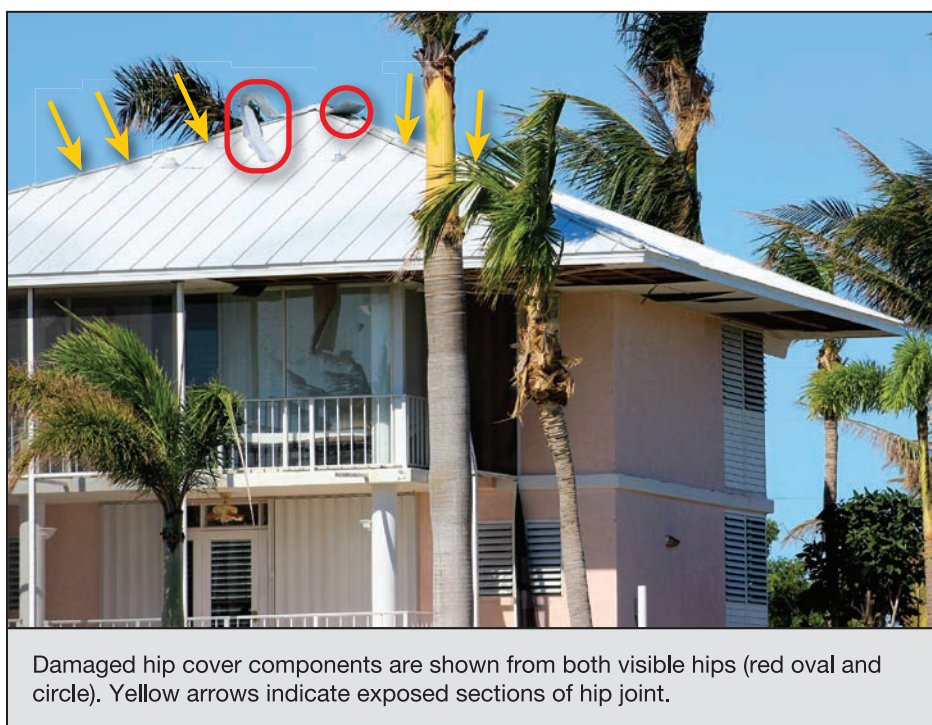
Figure 4-16:  
House with damaged metal roof system (EWS = 113 mph; EDWS = 180 mph) (Sugarloaf Key)

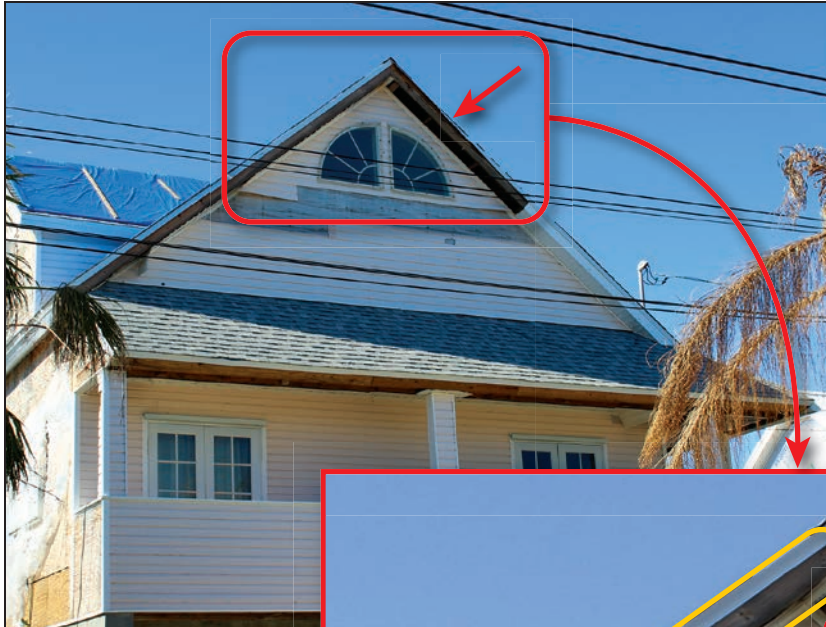
**Figure 4-18:**  
House that lost its soffit along the right side of the front-facing gable (EWS = 114 mph; EDWS = 180 mph) (Little Torch Key)

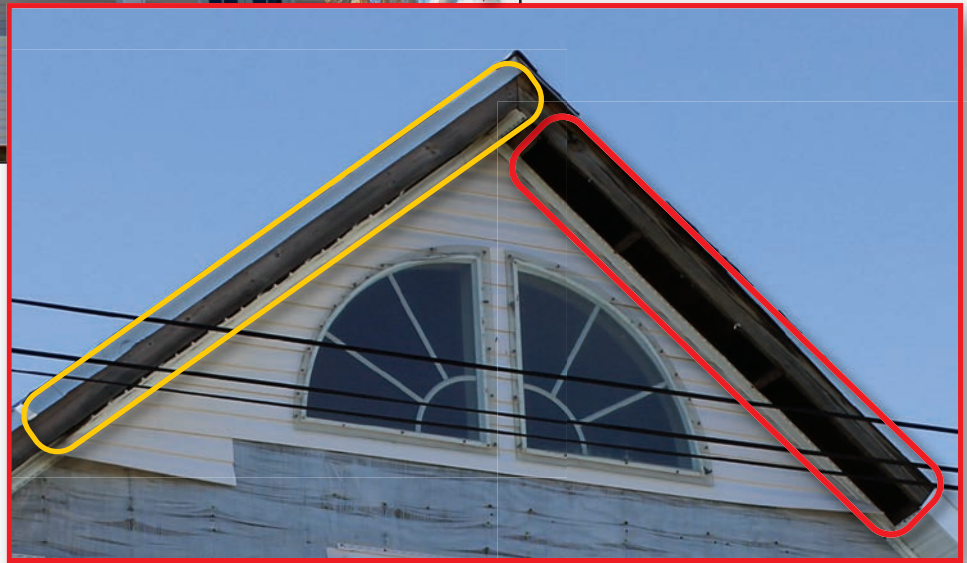
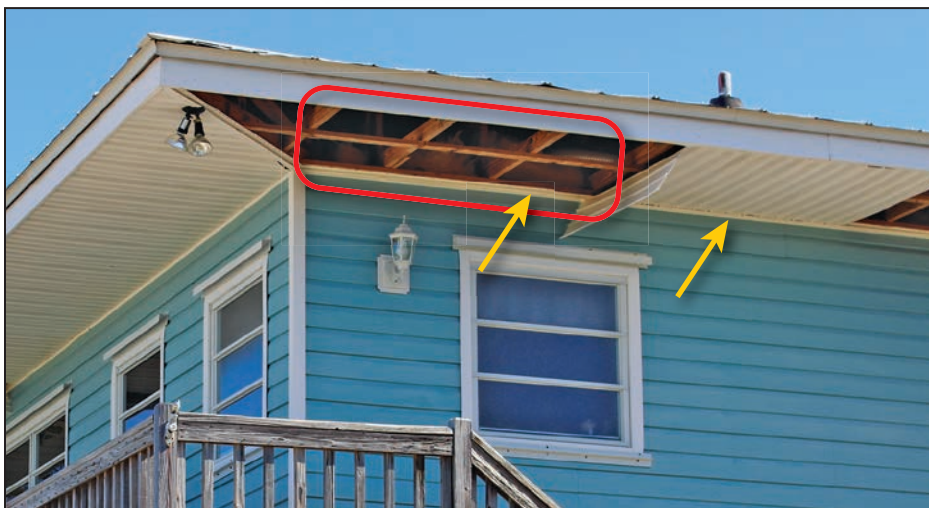
**Figure 4-19:**  
House with vinyl soffit damage not caused by fascia loss (EWS = 113 mph; EDWS = 180 mph) (Sugarloaf Key)

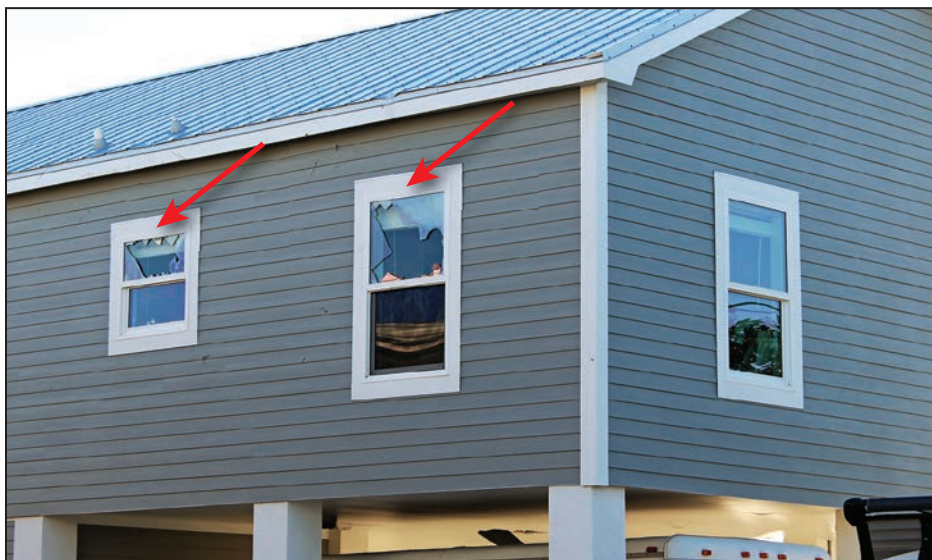
**Figure 4-32:**  
Residence with two windows where the outer panes were broken (see red arrows) but the inner panes stayed intact (EWS = 113 mph; EDWS = 180 mph) (Ramrod Key)

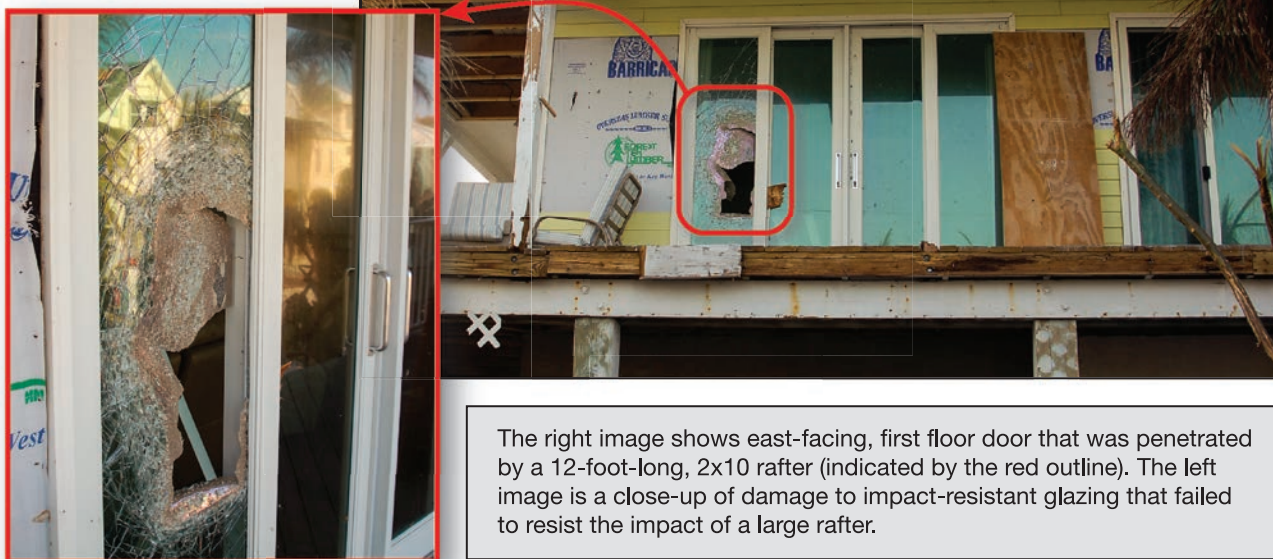
**Figure 4-34:**  
Wind-borne driven missile damaged second floor door at the same house as shown in Figure 4-33 (EWS = 114 mph; EDWS = 180 mph) (Little Torch Key)

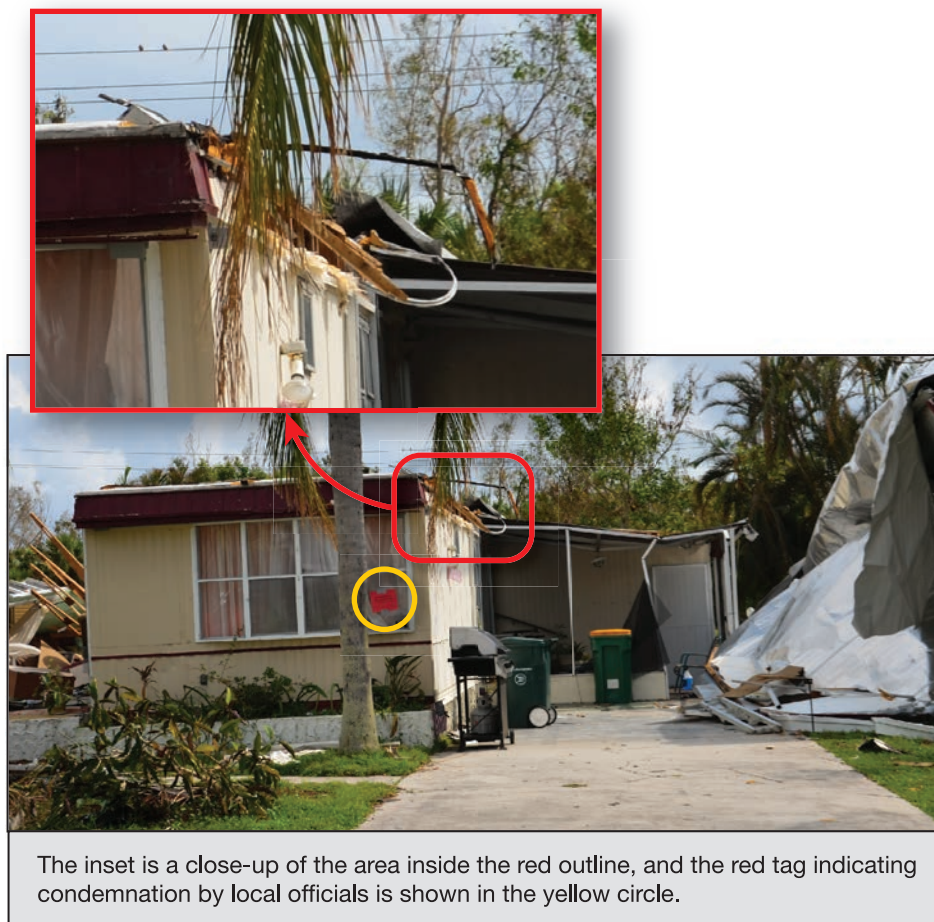
The inset is a close-up of the area inside the red outline, and the red tag indicating condemnation by local officials is shown in the yellow circle.
