Mitigation Assessment Team Compendium Report

2017 Hurricane Season

Building Performance Observations, Recommendations,
and Technical Guidance

FEMA P-2054 / September 2019

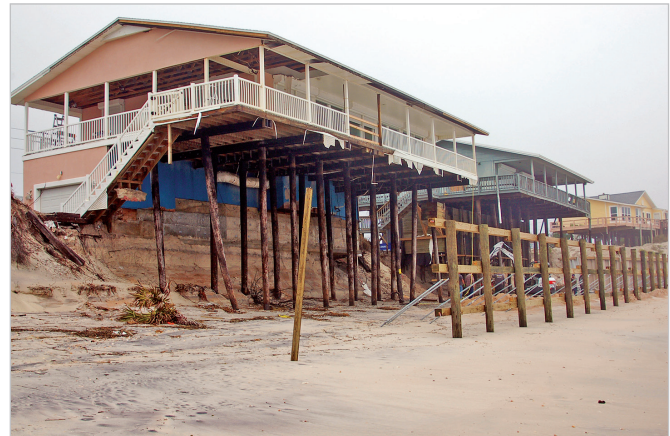
Figure 3-1: Undermined houses constructed on top of the dune in Vilano Beach, FL.

These houses survived the undermining, even though approximately 10 to 15 feet of dune height was lost beneath the houses. The pilings farther seaward are for a seawall under construction at the time of the MAT visit (February 2018).

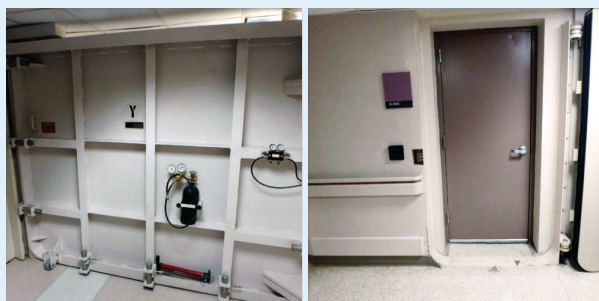
Flood doors in basement that subdivide basement areas within the main building.

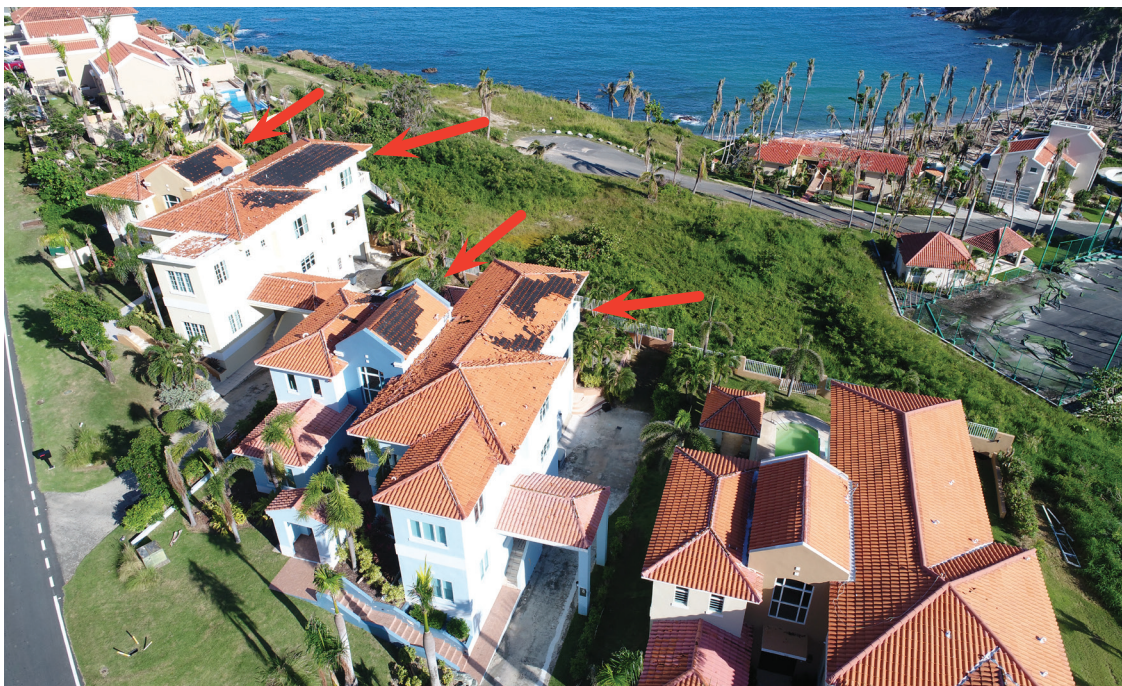
Figure 3-2: Roof damage from wind speed-up effects

These homes are located in Palmas del Mar in Humaco along the eastern coastline.

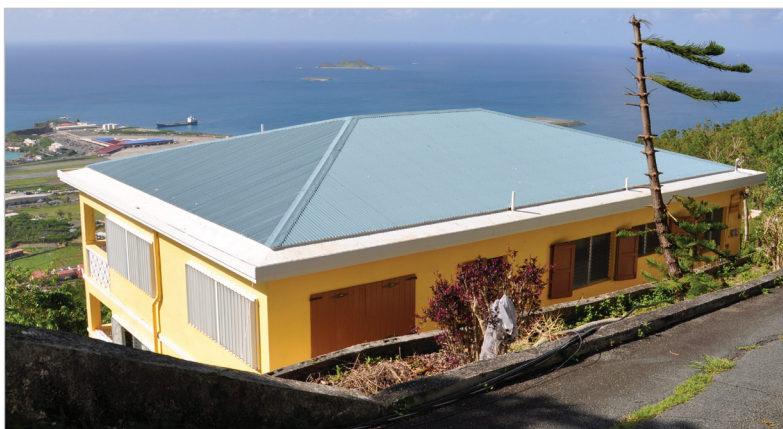
Figure 3-5: A liquid-applied membrane over plywood with wood battens roof system.

This roof system and integral gutter appeared to comply with the Stronger Home Guide.

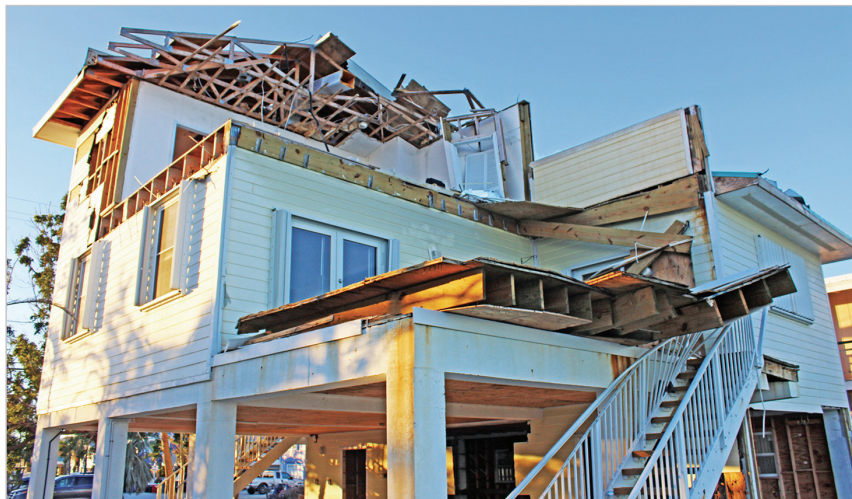
Figure 3-8: House with wind damage.

Roof structure loss and collapse of the second-floor exterior wall and adjacent deck.

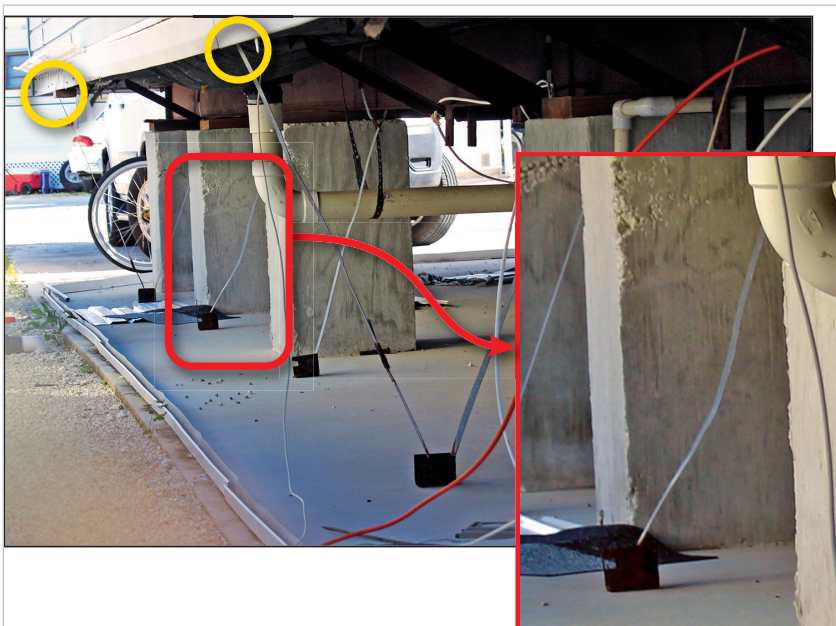
On this MHU installation, only the first and fourth straps are attached to the exterior wall base.

Yellow circles show where straps are attached to the base of the unit wall. The inset shows close-up of loose strap inside red outline.

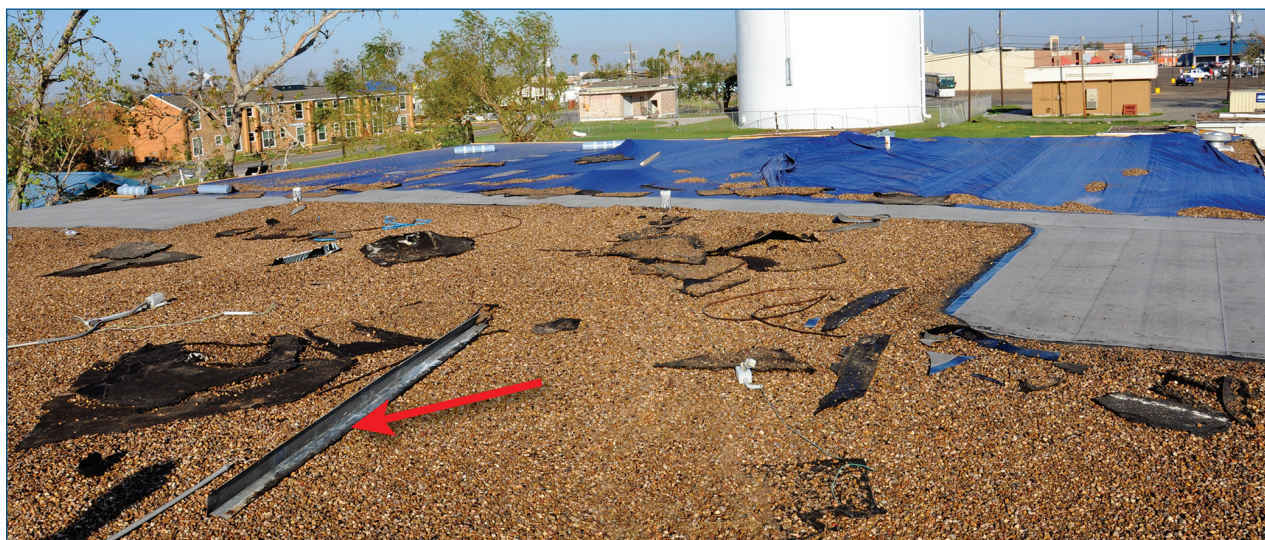
Figure 3-10: View of emergency repairs

At this older medical center, the roof above the emergency room area needed emergency repair work. The red arrow indicates a section of metal edge flashing that blew onto the roof.
