## **Evaluation of Wind Resistance of Vinyl Siding and Soffit Systems, and Performance during the 2017 Hurricane Irma**

Project #: P0103255

Report No. 01-19

21 June 2019

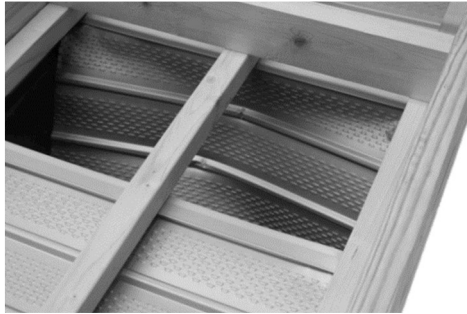
### Panel Disengagement

- Dominant failure mode
- The aluminum sections failed in the middle from panel disengagement.
- The vinyl sections failed in the end from panel disengagement.

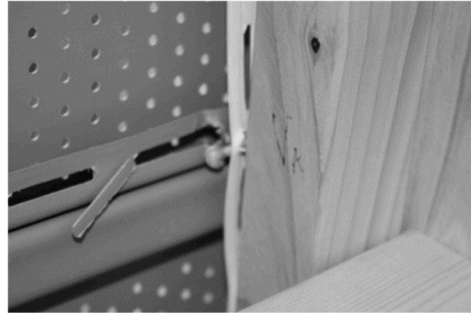
### Nail Pullover

- Dominant failure mode
- Nail pullover of the J-channel can cause the panels to disengage
- The sequence of nail pullover and panel unlocking could not easily be distinguished visually

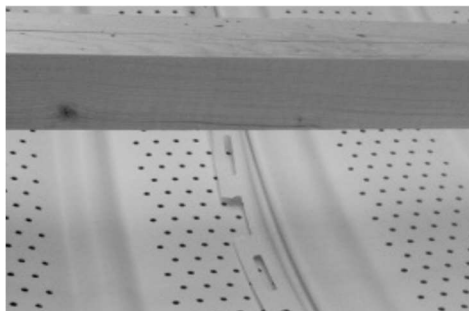
### Torn Nail Slot

Non-dominant failure mode

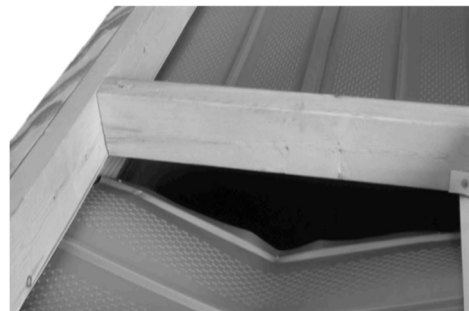
### Permanent Set

Non-dominant failure mode

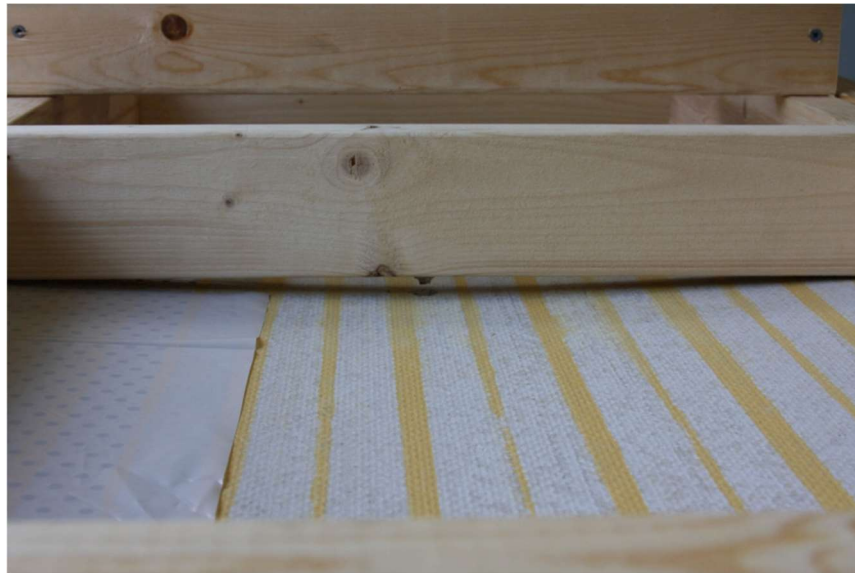
**Figure 4.** Predominant Failure Mode (Masters and Kiesling 2011)

- The most common mode of failure was pullout of the soffit around the fasteners in the intermediate nailing member (as the picture show)
- This failure was seen in each of the 610 mm (2 ft) fiber cement board soffit during both loading.
- The middle fastener should receive nominally twice the load the edge fasteners receive due to the difference in tributary area.

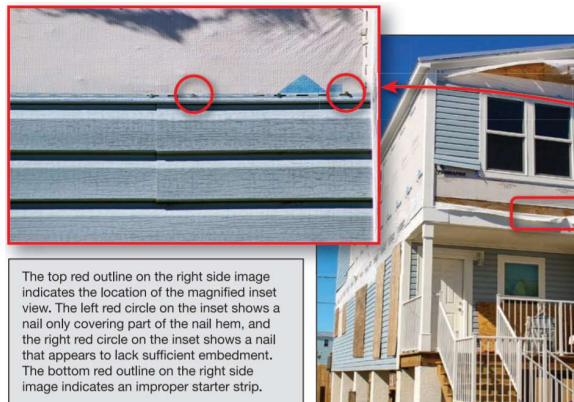
Failure of vinyl siding failure due to nail covering only part of the nail hem, and lack of nail embedment (Fema 2018)

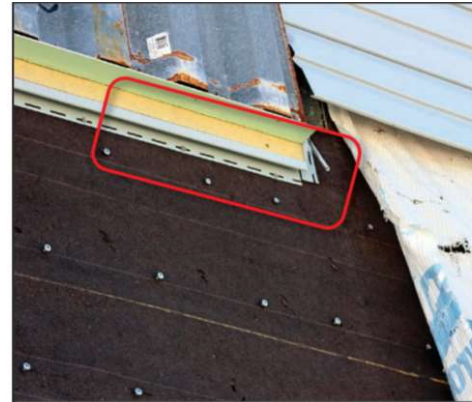
Vinyl siding failure because to lack utility trim under the windows (Fema 2018)

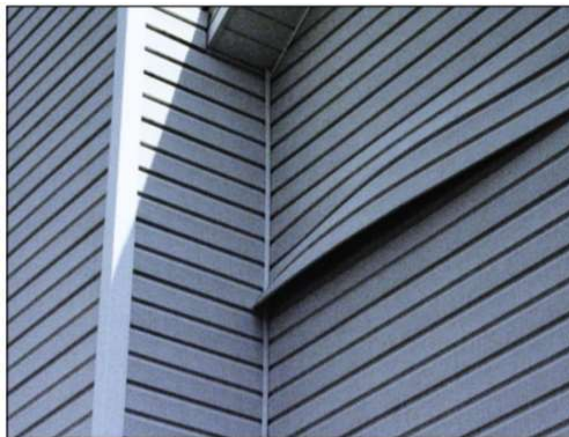
Unlatched vinyl siding panel susceptible to blow (FEMA 2005)

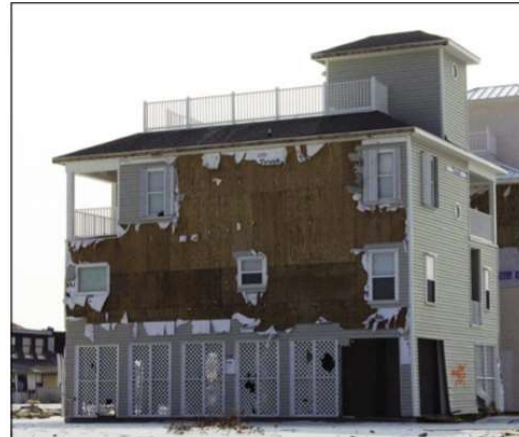
Extensive lost of vinyl siding and housewrap event though high wind panel was used (FEMA 2005)

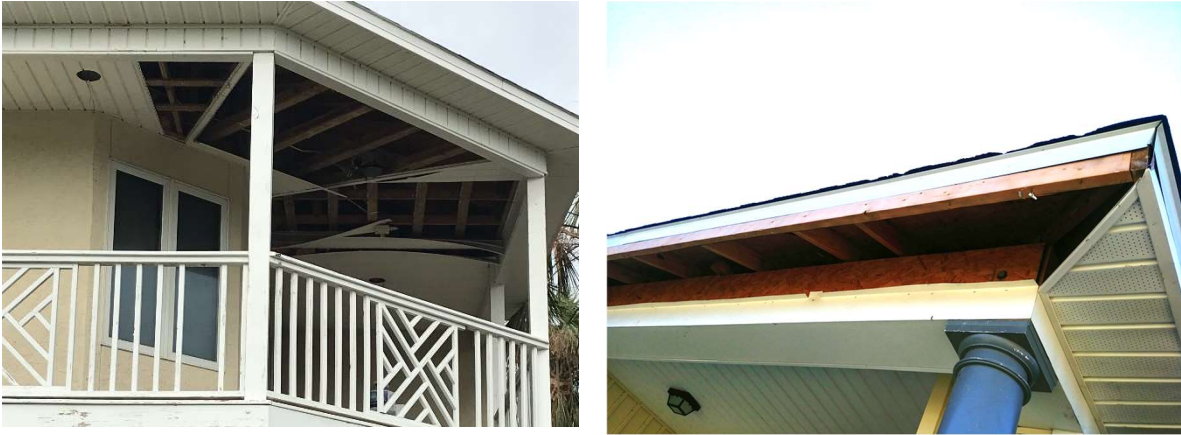
**Figure 15.** (Left) Failed vinyl soffit on the second story of a 1998 home in the Gulf Aire neighborhood due to Hurricane Michael; and (right) Failed fascia on a 2015 home in the Cedar's Crossing neighborhood due to Hurricane Michael.

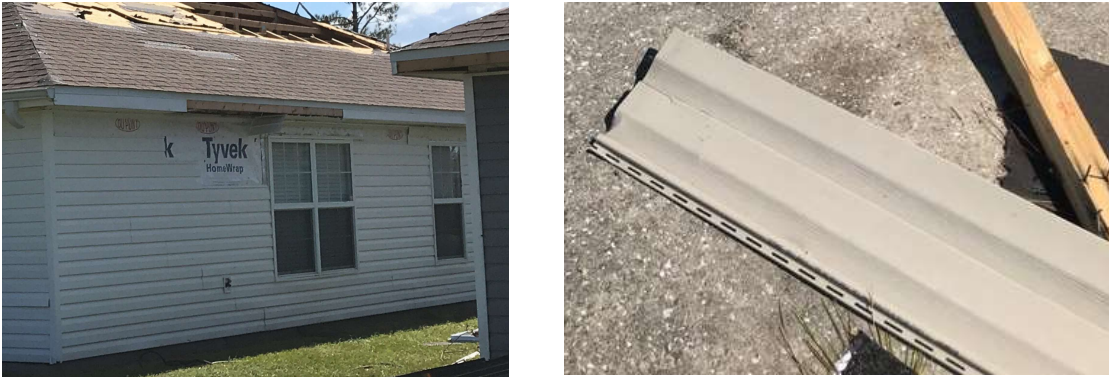
where  $K_z = 0.57$ ,  $K_{zt} = 1$ ,  $\hat{V}_{est} = 50$  m/s, and  $C_{p,ext}^- = -1.4$ , resulting in  $\hat{p}_{est} = -1.22$  kPa. The estimated wind loads were therefore nominally 55% of design, not accounting for any pressure equalization factors that are likely present with permeable cladding systems. The observed failure in this case was minor, and the reconnaissance team was unable to determine whether any deficiencies in installation were present. Given the similar layout and products used elsewhere in this subdivision, it is likely the same manufacturer and material that was used in all 2006/2007 homes in this same neighborhood, some of which had more significant vinyl siding failures.

**Figure 20.** Case Study #1: Minor failure of a vinyl siding system on a 2006 home in the Cedar's Crossing neighborhood for which the siding manufacturer and Miami-Dade Notice of Approval were able to be traced.

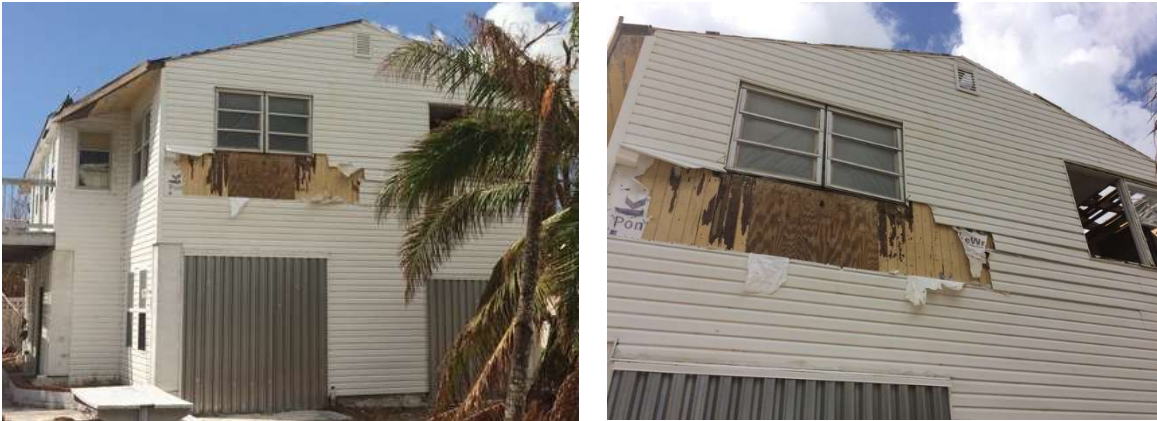
Case Study #2 is a single story, elevated, site-built home originally constructed in 1958. The original wall cladding system was replaced in 2004 with PVC vinyl siding (different manufacturer than that of Case Study #1). Per the Notice of Acceptance included in the permit file, the siding had a thickness of approximately 1 mm (0.04 inches), a single nailing hem, and a rated design pressure of +/-1.91 kPa (40 psf). The vinyl siding looks to have been installed directly atop the original exterior wood paneling. Approximately 40% of the siding was detached on the entire home. The failure of the vinyl siding in this home may have been exacerbated by the installation over existing cladding surface. The Structural Extreme Events Reconnaissance (StEER) Early Access Reconnaissance Report following Hurricane Florence also noted frequent vinyl siding failures when installed over existing cladding systems (Kijewski-Correa et al. 2018).

**Figure 21.** Case Study #2: Failure of a vinyl siding system on a 1958 home on Sugarloaf Key. The vinyl siding was installed in 2004 per the county permit records.

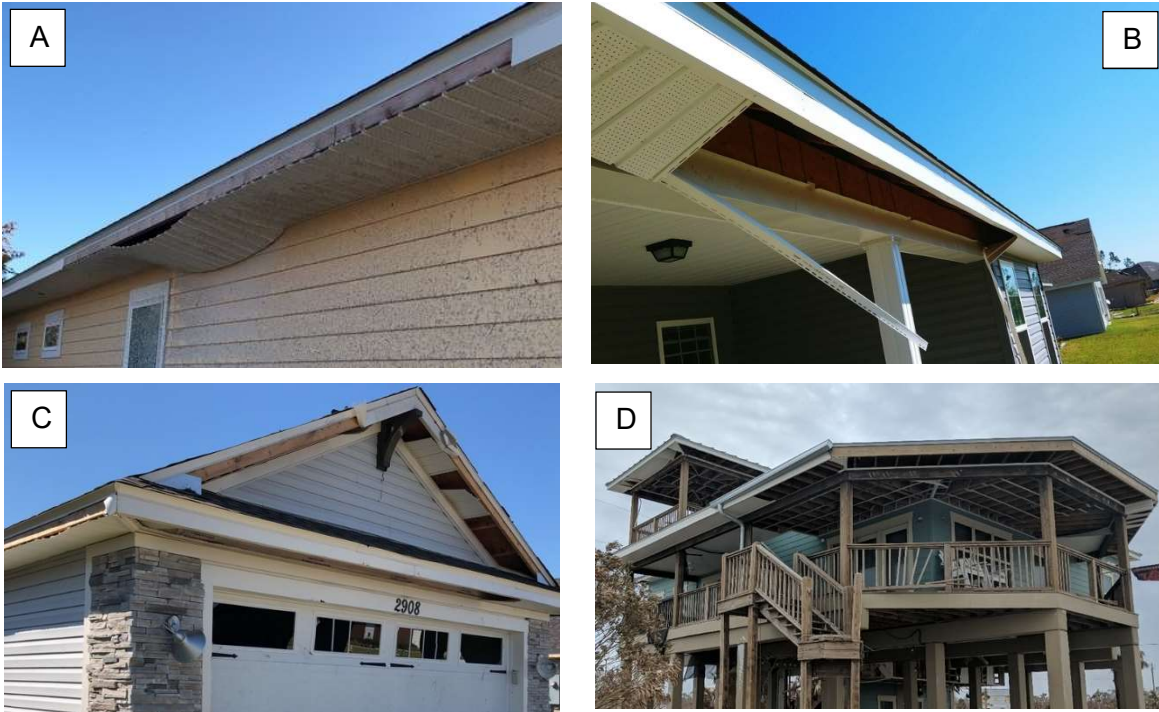
at the same locations. Anecdotally, the presence of gutters prevented fascia loss, which in turn mitigated soffit loss.

**Figure 25.** Soffit and fascia damage. (A) a 2017 home in Beacon Hill subdivision; (B) soffit damage without corresponding fascia damage to a 2015 home in Cedar's Crossing neighborhood; (C) extensive soffit and fascia damage to a 2016 home in Cedar's Crossing neighborhood; (D) extensive soffit and fascia damage to a 2012 home seaward of the Coastal Construction Control line in Mexico Beach, FL. Note the lack of fascia failure where the gutter is installed.
