Final Report:

Survey and Investigation of Buildings Damaged by Category II, III, IV and V Hurricanes in FY 2017-18 – Hurricane Irma 2017

Project #: P0058409

Report No. 06-18
22 June 2018

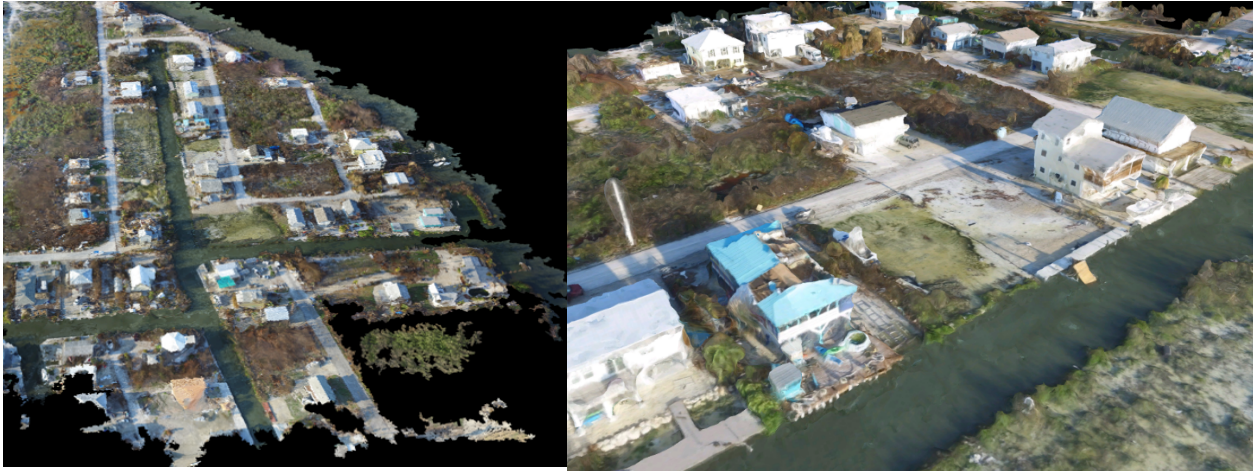
Figure 2. Two images extracted from 3D Point Cloud created for Little Torch Key North. Figure 2(a) shows the complete area created using still images captured by the UAV, and Figure 2(b) is a partial view showing damage to the metal roof Dutch-hipped roof house at 756 Jamaica LN.

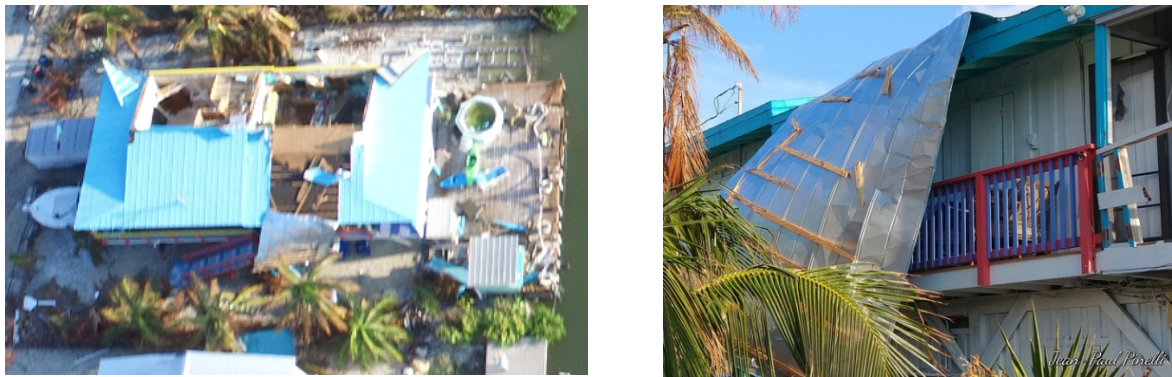
The 3D Point Clouds are a valuable tool enabling the surveyors to zero in on a structure and identify major damage on many surfaces. In Figure 3 it is obvious more than 50% of the roof structure has failed, and details of the failed structures can be observed in high-resolution still images.

Figure 3. Details of roof damage to structure at 756 Jamaica LN, Little Torch Key North. Figure 3(a) is a still-image taken from the drone overflight and Figure 3(b) is a photograph taken during the damage surveyor from the ground, showing the metal roofing blown over the north side of the building with some battens still attached.

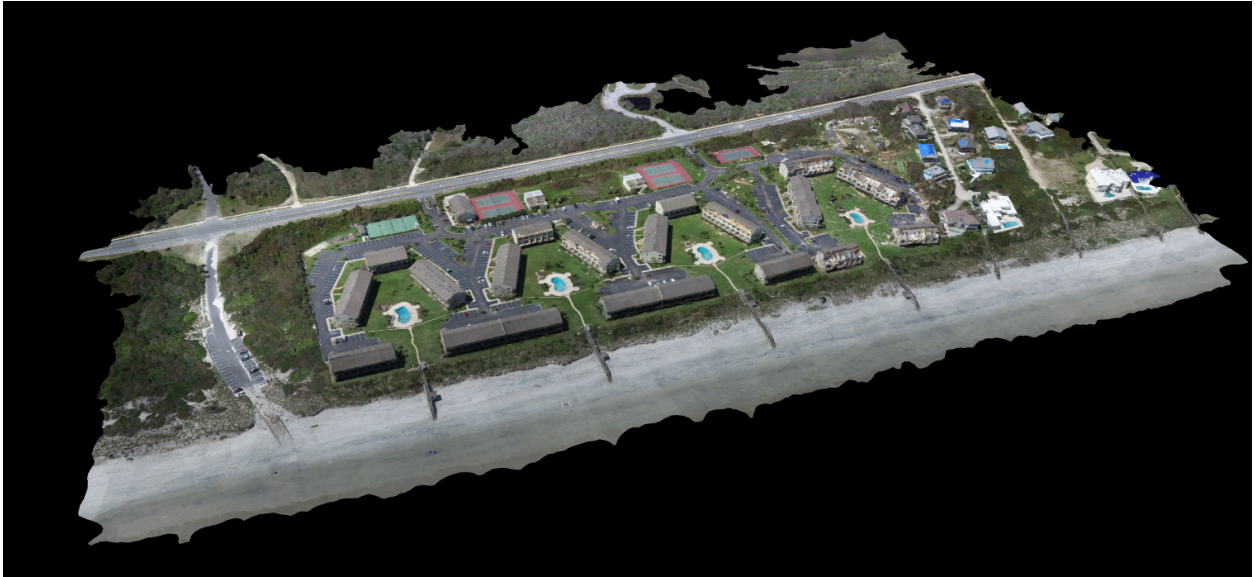
Figure 20. Townhouses in St. Augustine, FL damaged by a hurricane-induced tornado rated EF2 by the National Weather Service.

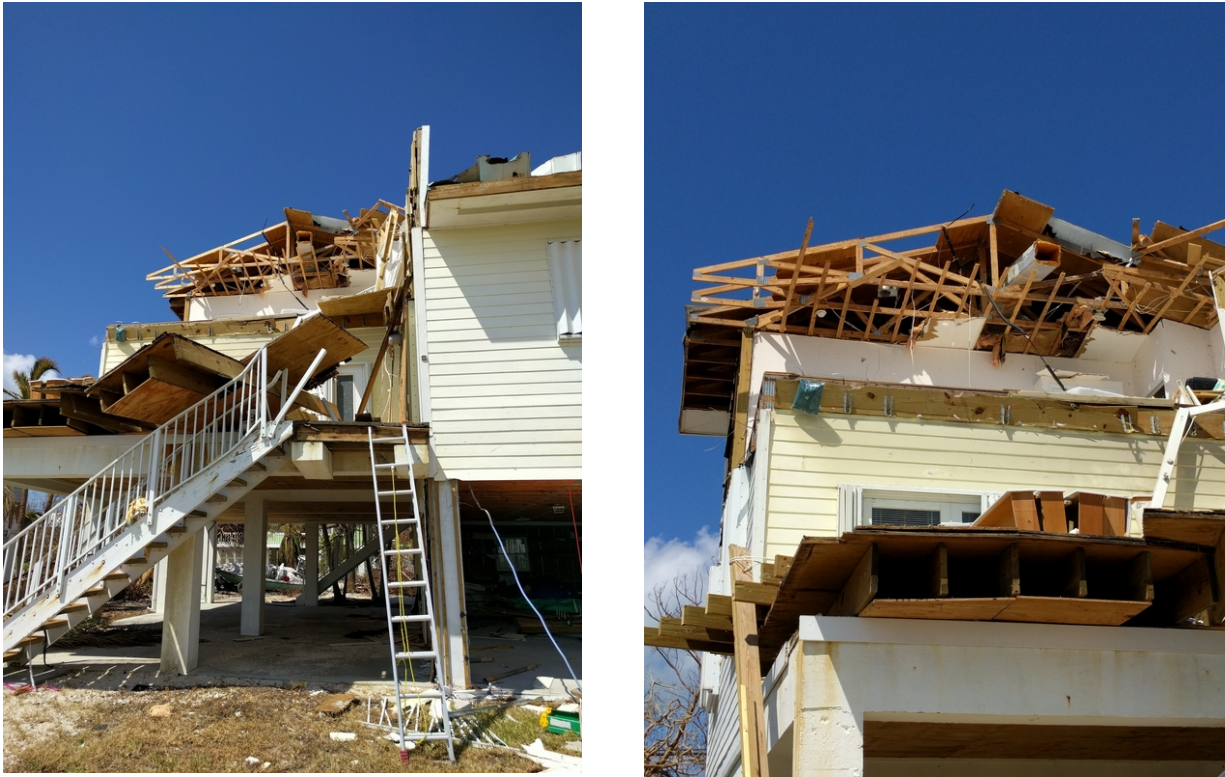
Figure 26. Wood-frame, two-story, elevated home located at 491 W Indies Drive in Ramrod Key, FL showing collapse of second story walls and portions of the roof structure.

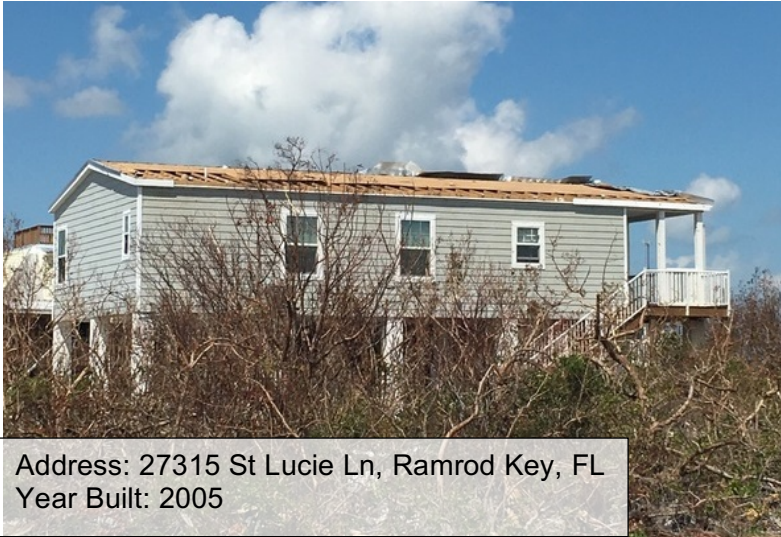
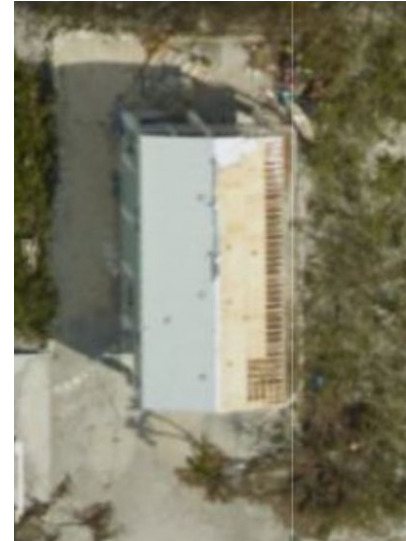
Figure 28. Roof sheathing failure in a post-2001 home (Year Built = 2005) on Ramrod Key, FL. Multiple sheathing panels along one eave and in a corner region of the roof uplifted.

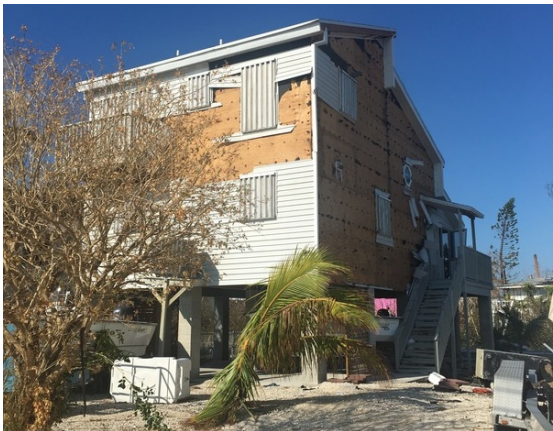
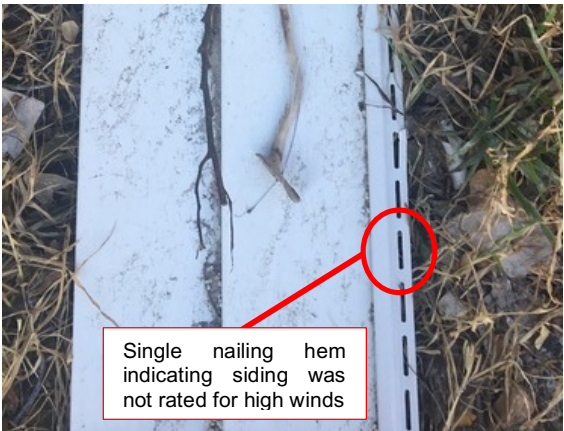
Figure 34. (Left) Damage to vinyl siding at 44 Pelican Ln in Big Pine Key, built in 1993 (estimated peak gust wind speeds of 114 mph at 33 ft height). (Right) Close-up of damaged siding indicating non high-wind rated siding was used.

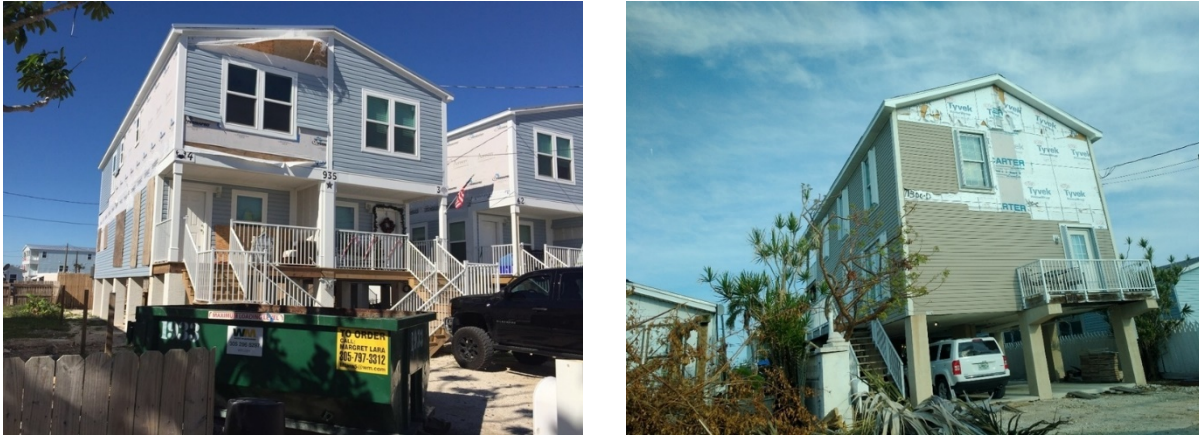
Figure 35. Vinyl siding damage to post-2002 homes. (Left) a 2017 home in Marathon, FL (estimated gust wind speed of 122 mph; ASCE 7-10 design wind speed of 180 mph); (right) A 2007 home on Stock Island (estimated gust wind speed of 109 mph at 33 ft from Hurricane Irma; ASCE 7-10 design wind speed of 180 mph).

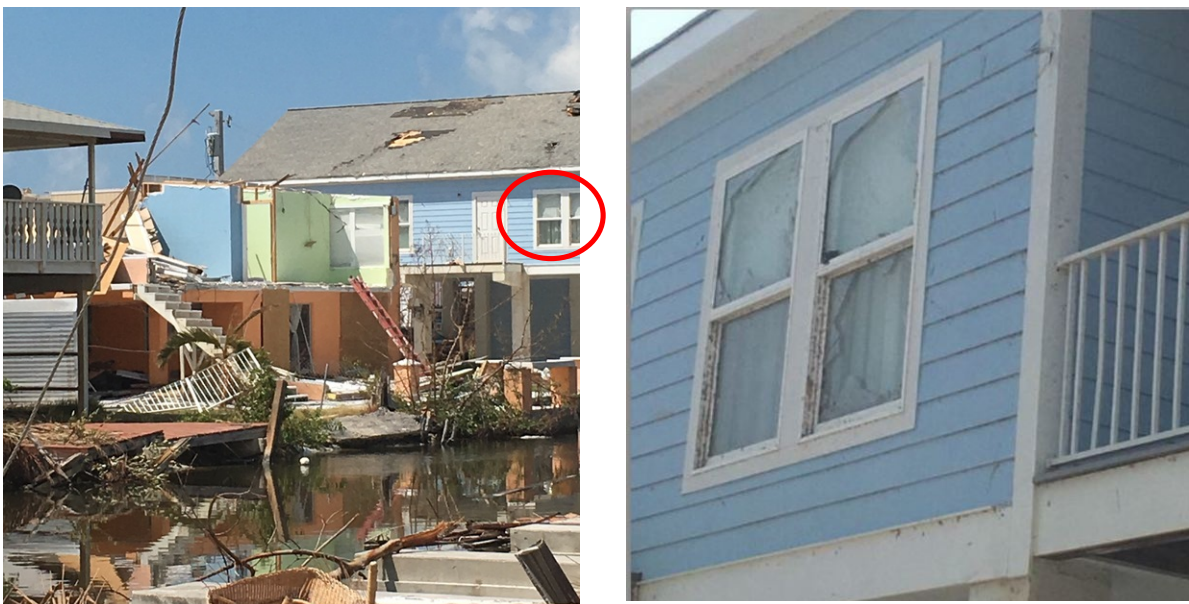
Figure 37. Shattered windows in a 2012 home on Ramrod Key (estimated peak gust wind speeds in Hurricane Irma of 117 mph). The windows were confirmed to be impact resistant during the field assessment. The left image shows the damaged windows (circled in red) in relation to a destroyed building adjacent to the house which was the likely source of the damaging debris.

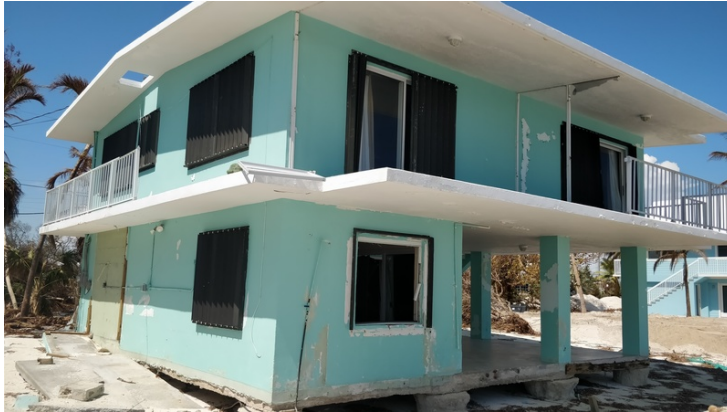
Figure 38. Home in Islamorada, FL (built in 1972) with damaged accordion-style hurricane shutters. Gust wind speeds at the home were estimated at 110 mph with approximately 1-2 ft of storm surge. No building permits are on file for this location.

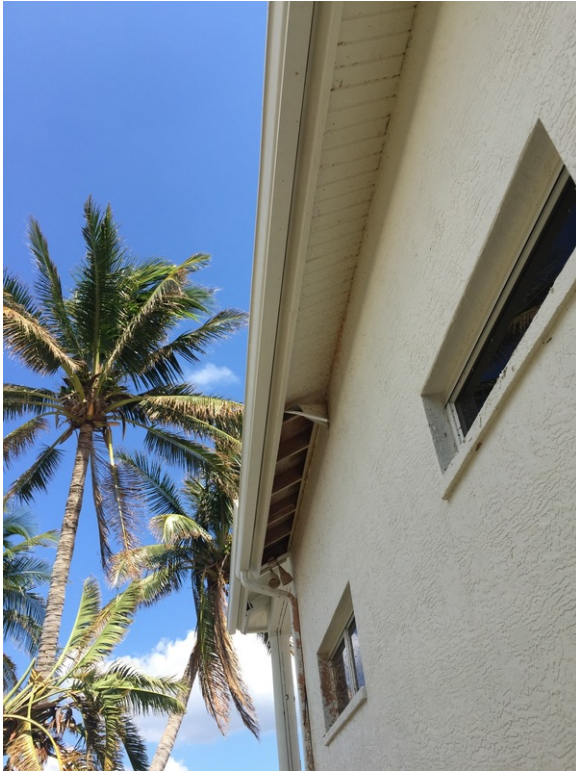
Figure 41. Soffit damage to a home in Marco Island (built in 2003).

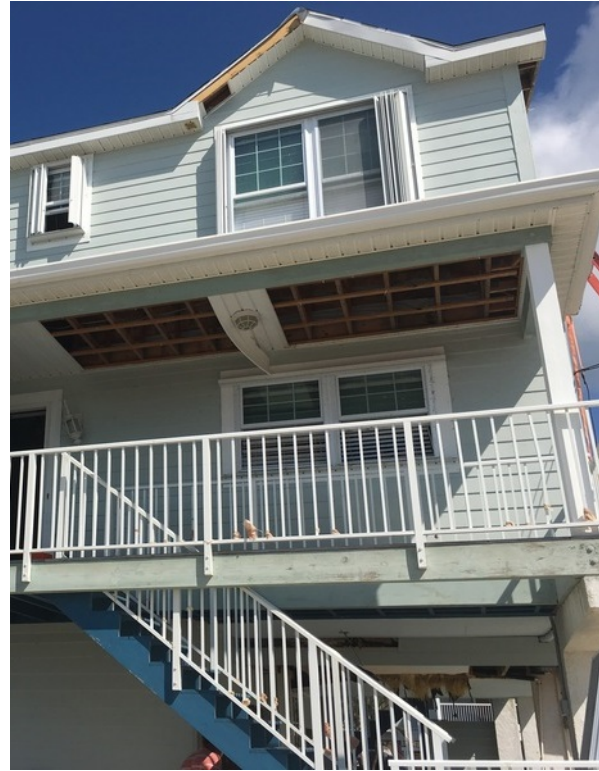
Figure 42. Soffit damage to a home on Little Torch Key (built in 2008).

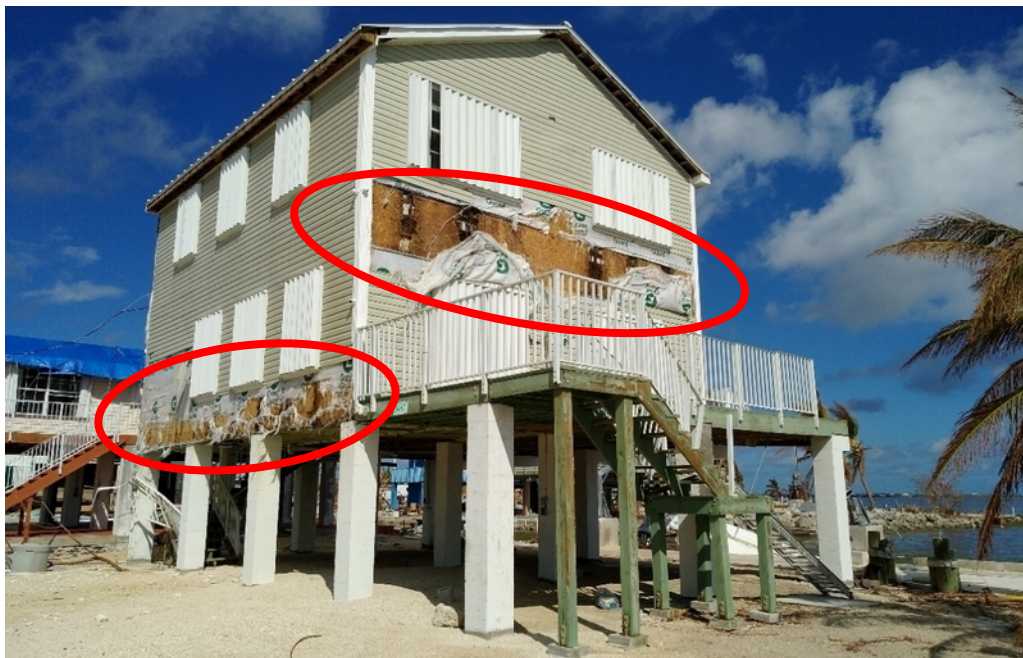
Figure 45. Possible surge-induced wall cladding failure to a home in Big Pine Key (built in 2004; current Base Flood Elevation of 10 ft) exposed to storm surge inundation. Actual surge inundation or waves may have reached higher than 10 ft based on scouring of porch posts and stairs and cladding damage, but some cladding damage may have been wind-induced.

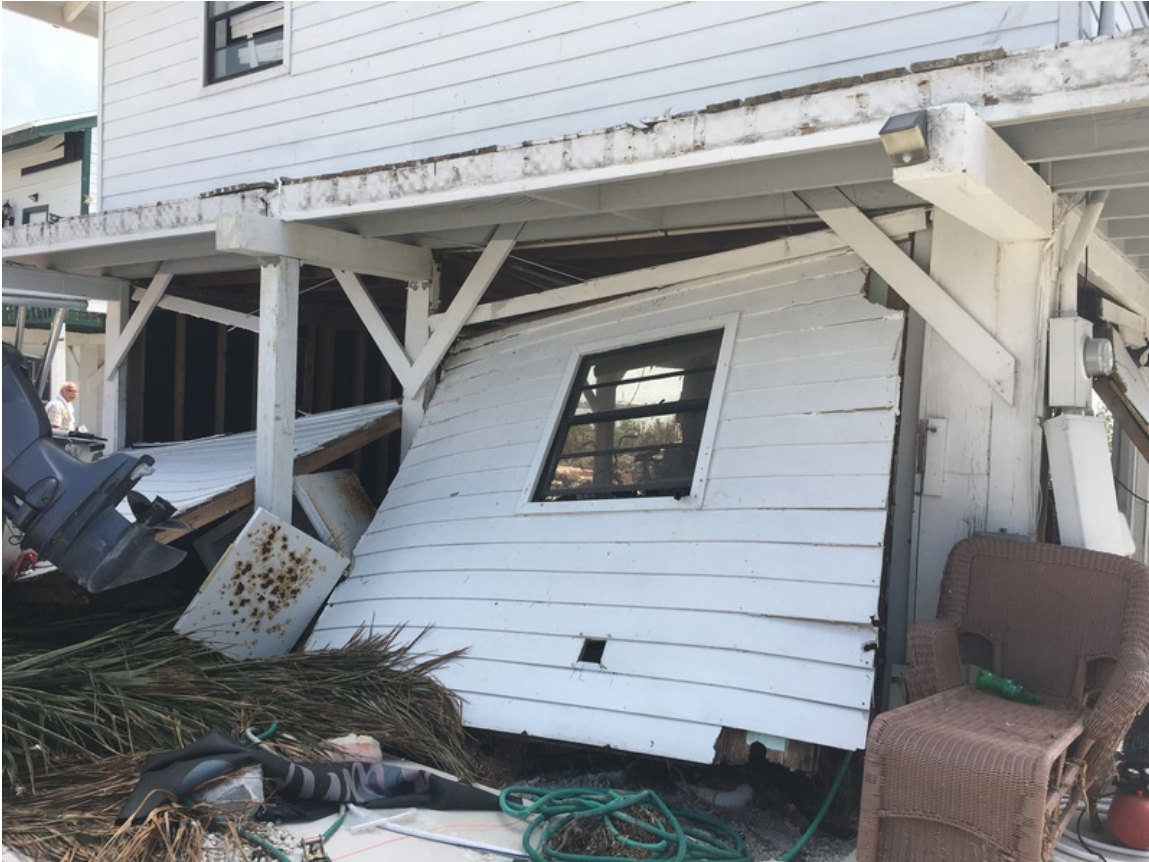
Figure 46. Surge-induced collapse of breakaway walls in lower level enclosure of a home in Cudjoe Key. Wind gusts of 114 mph were estimated at this location along with surge inundation of 45 inches.

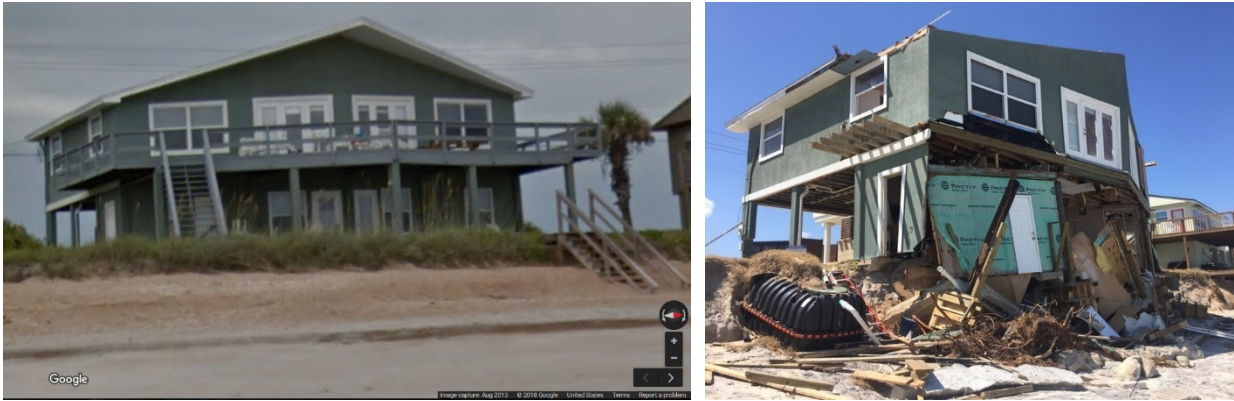
Figure 47. (Left) Seaward view of a home from 2013, courtesy of Google Streetview; (right) Seaward view of the same home after Hurricane Irma showing the collapsed foundation caused by washout of sand under slab foundation.

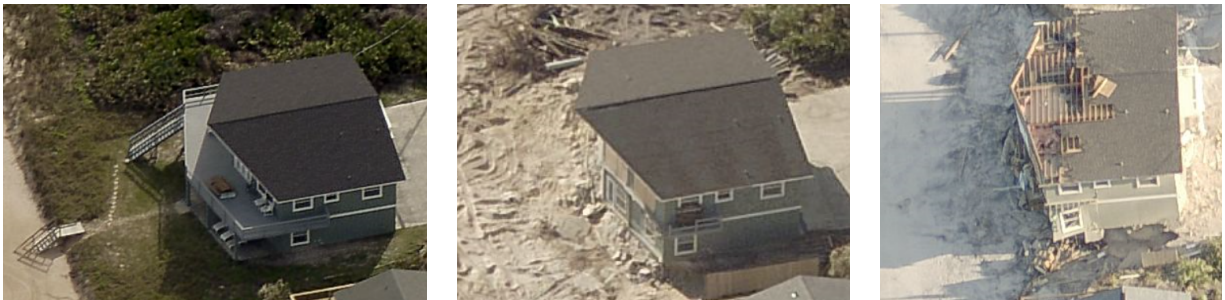
Figure 48. Views from (left) January 2014, (middle) January 2017, and (right) September 2017 of a home along S. Ponte Vedra Blvd in St. Johns County. In addition to the wind damage, surge inundation washed out the foundation causing collapse of the seaward exterior walls. Note the progression of the shoreline from 2014 to 2017. Hurricane Matthew impacted the same region in 2016. Imagery sourced from the St. Johns County property assessor.

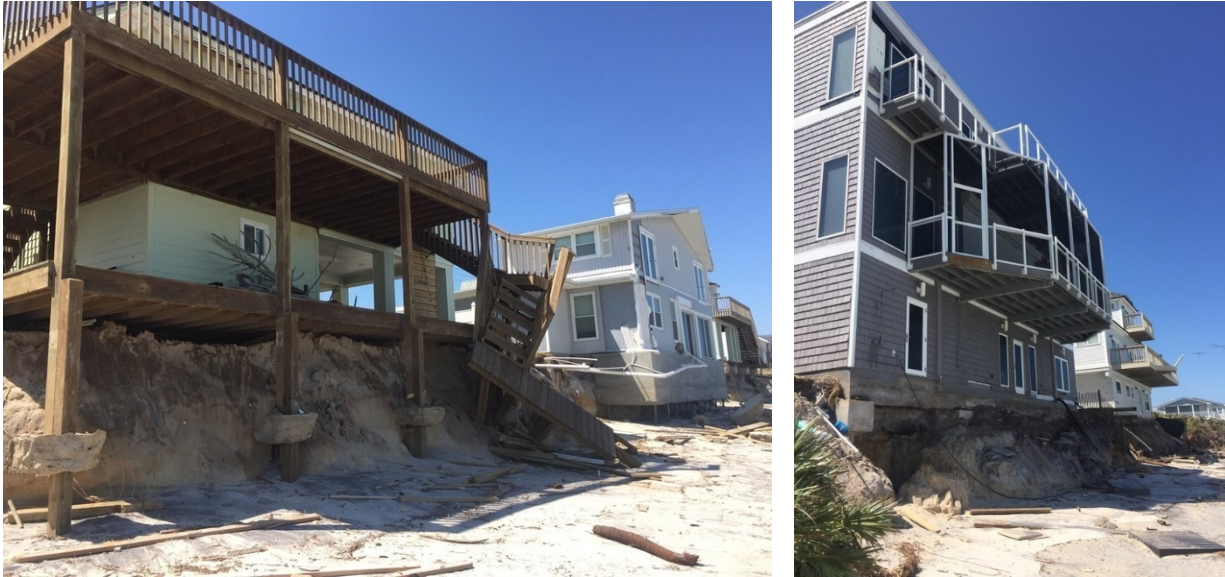
Figure 49. Surge washout inland to the foundations of several homes along Ponte Vedra Blvd in St. Johns County.
