# Hurricane Irma in Florida

Building Performance Observations,  
Recommendations, and Technical Guidance

FEMA P-2023 / December 2018

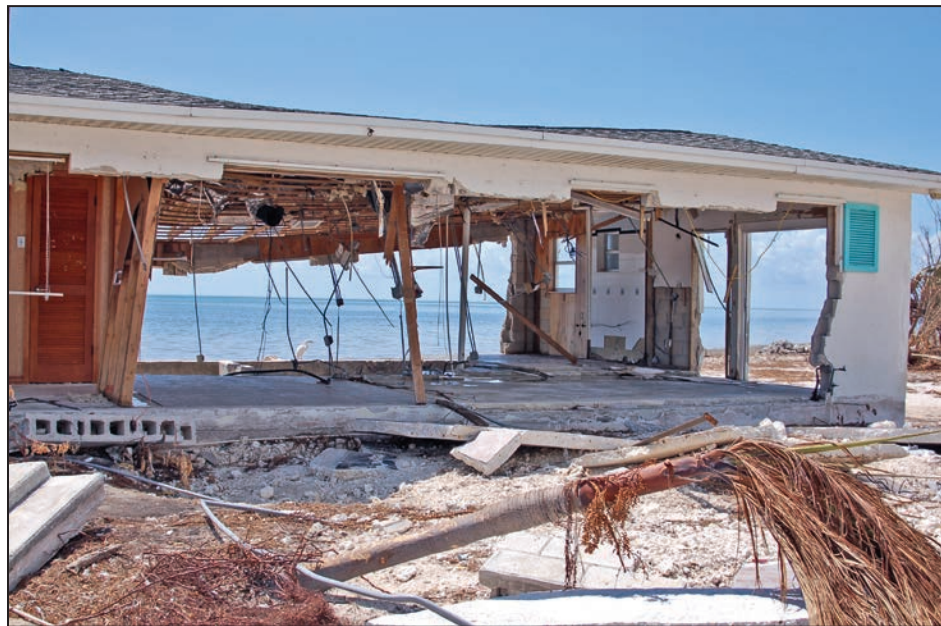
**Figure 3-6:**  
House constructed at grade  
where the masonry walls  
parallel to the shoreline  
were destroyed; this house  
was near the house shown  
in Figure 3-5  
(Big Pine Key, FL)

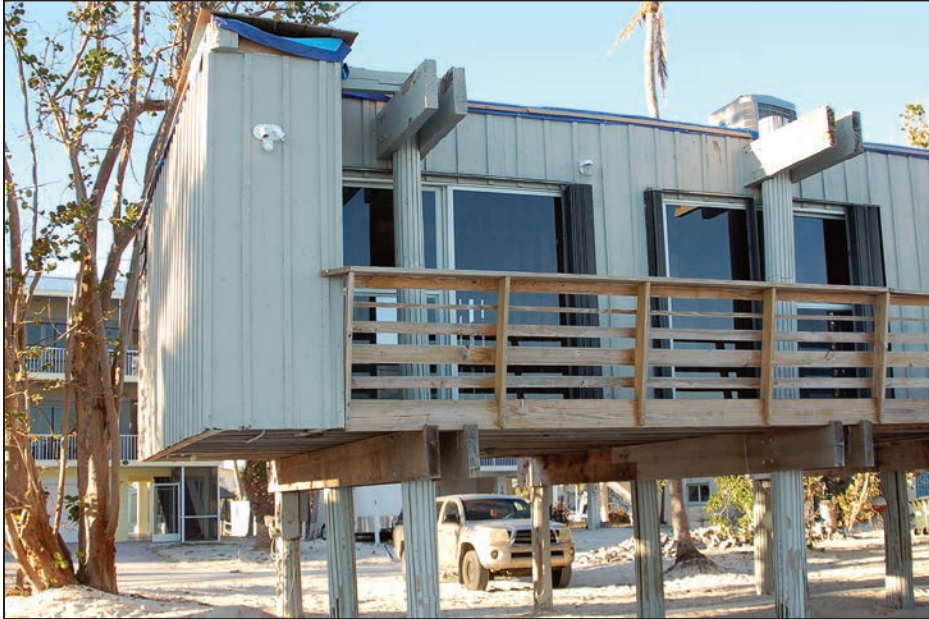
**Figure 3-7:**  
Example of a breakaway wall that was reported by a local code official to have performed as intended (Lower Matecumbe Key, FL)

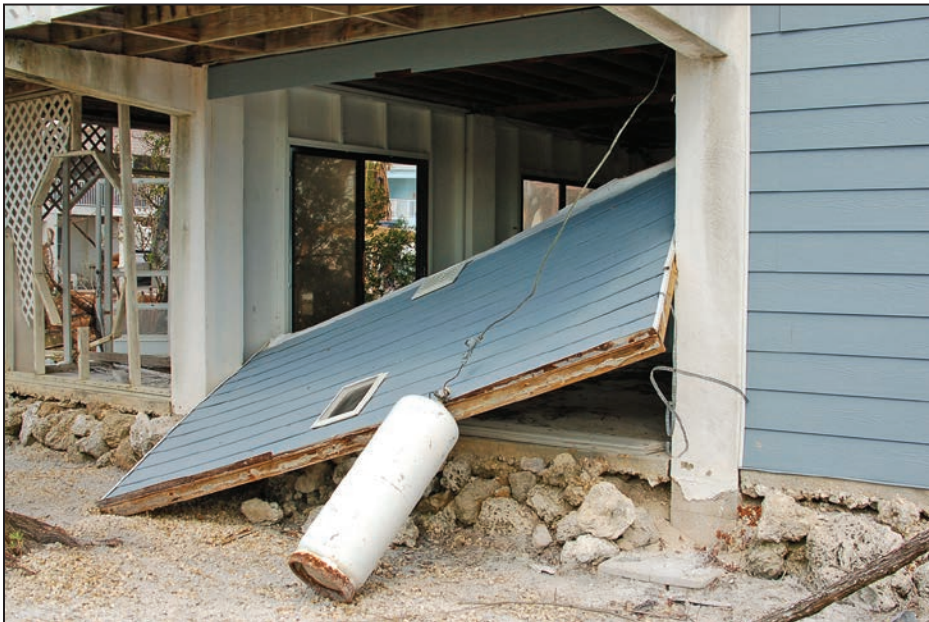
**Figure 3-8:**  
Example of partial failure of breakaway wall, with no associated damage to main structure observed (Cudjoe Key, FL)

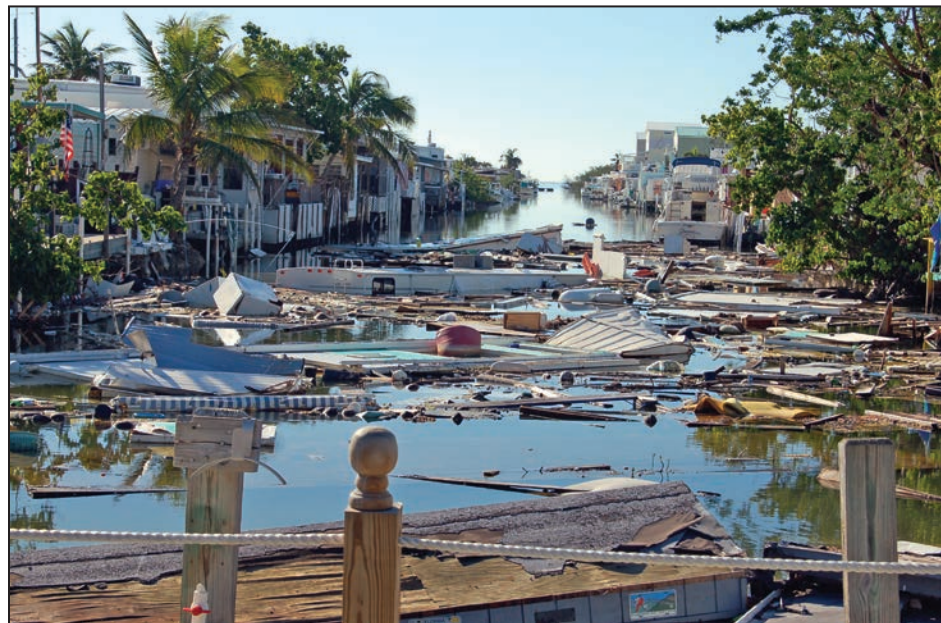
**Figure 3-11:**  
Boat and small debris that  
washed across a canal and  
onto houses  
(Big Pine Key, FL)

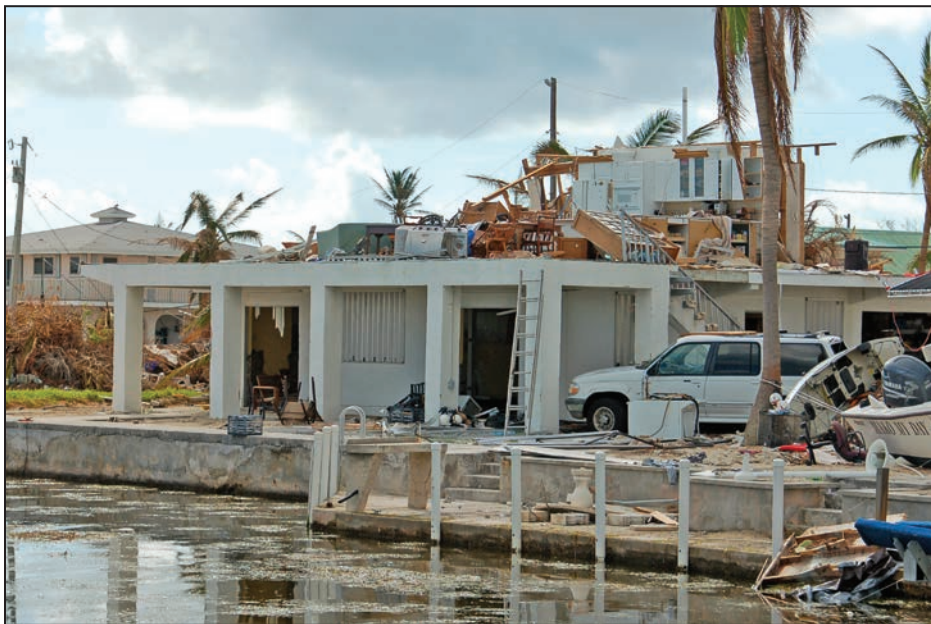
**Figure 3-12:**  
Car and debris that washed  
into a house  
(Big Pine Key, FL)

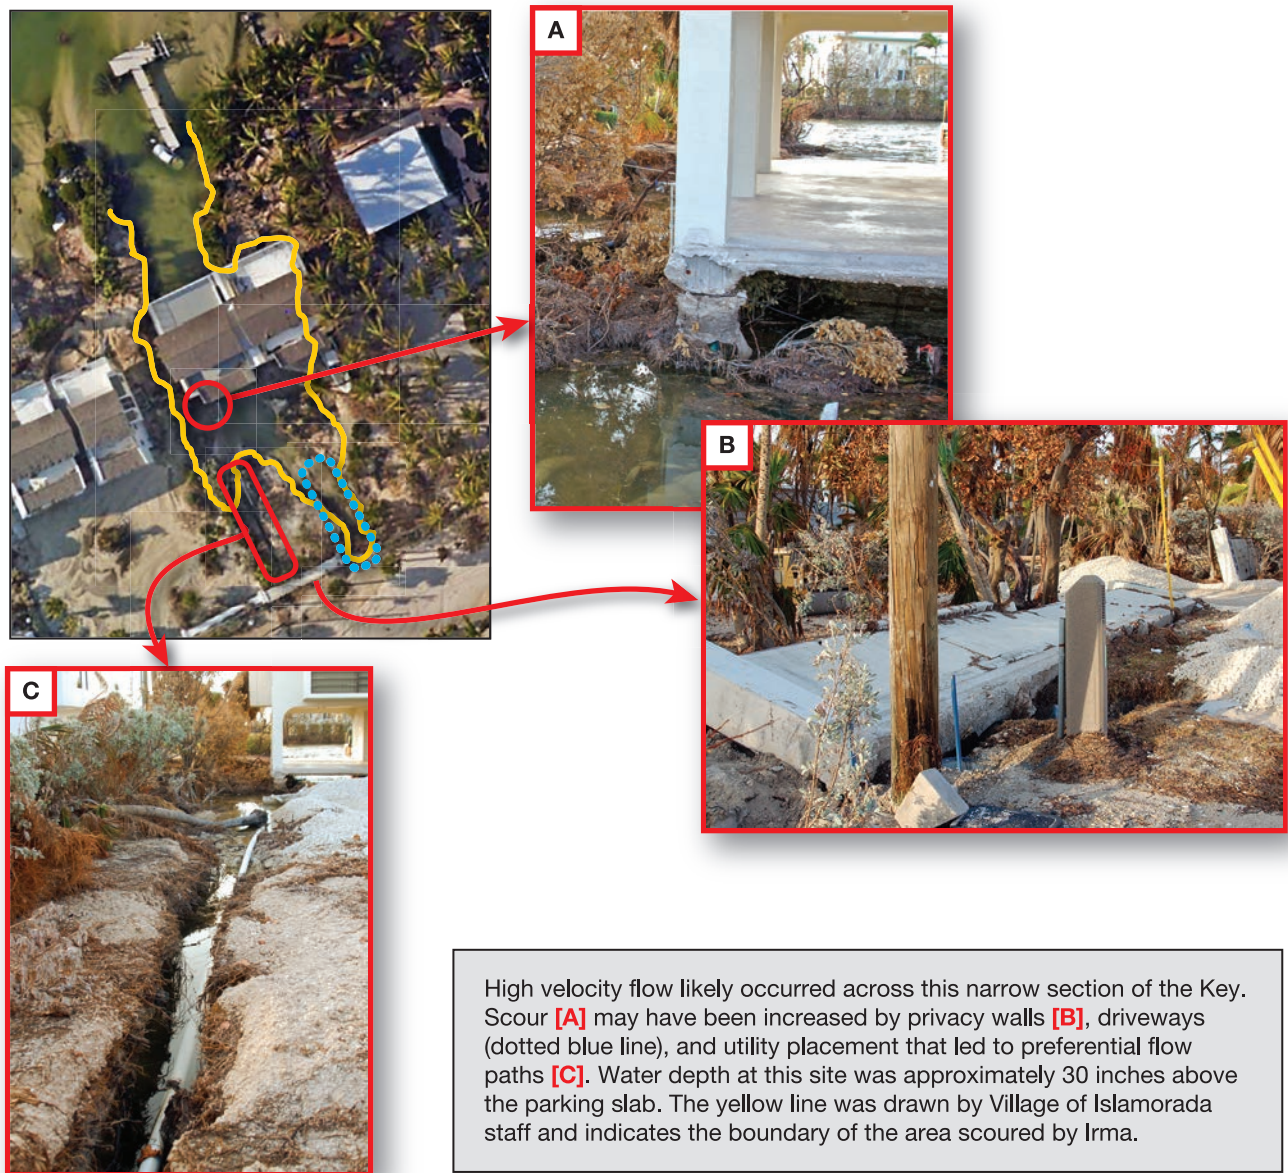
Figure 3-14: Scour near and around building foundation (Lower Matecumbe Key, FL)

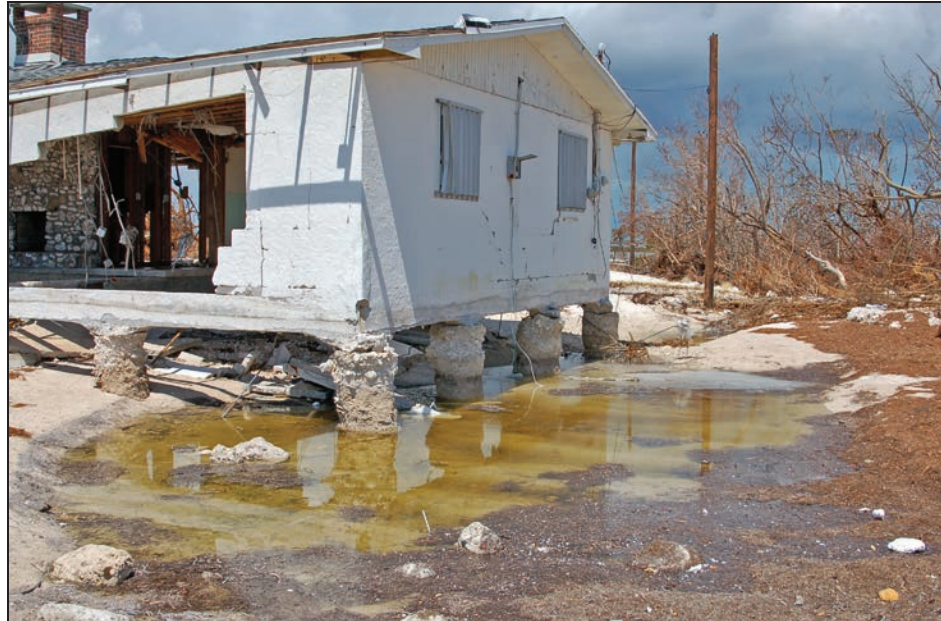
**Figure 3-15:**  
Scour was likely due to waves and high-velocity flow at this house on Long Beach Drive (same house is shown in Figure 3-6) (Big Pine Key, FL)

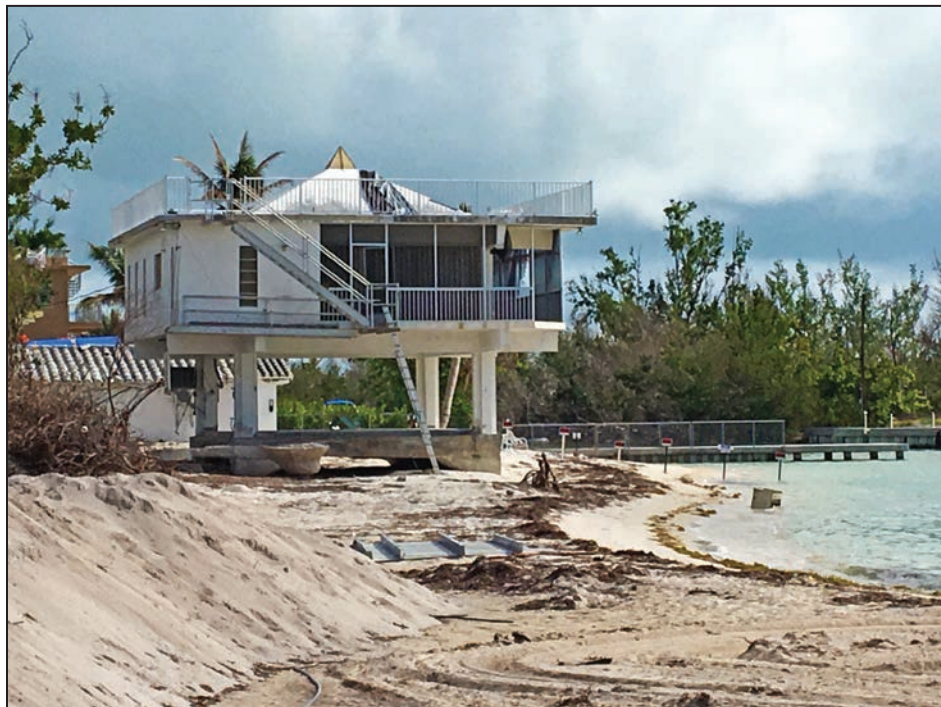
**Figure 3-16:**  
Erosion was likely due to wave attack around the foundation of this house on Sombrero Beach Road (Marathon, FL)

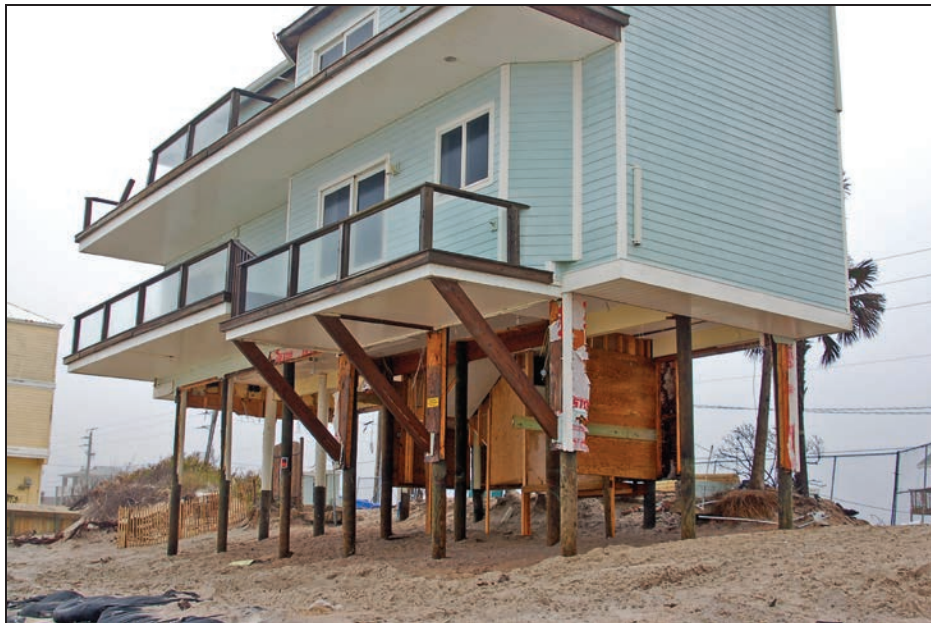
**Figure 3-18:**  
Undermined house on deep  
piles that survived erosion  
(Vilano Beach, FL)

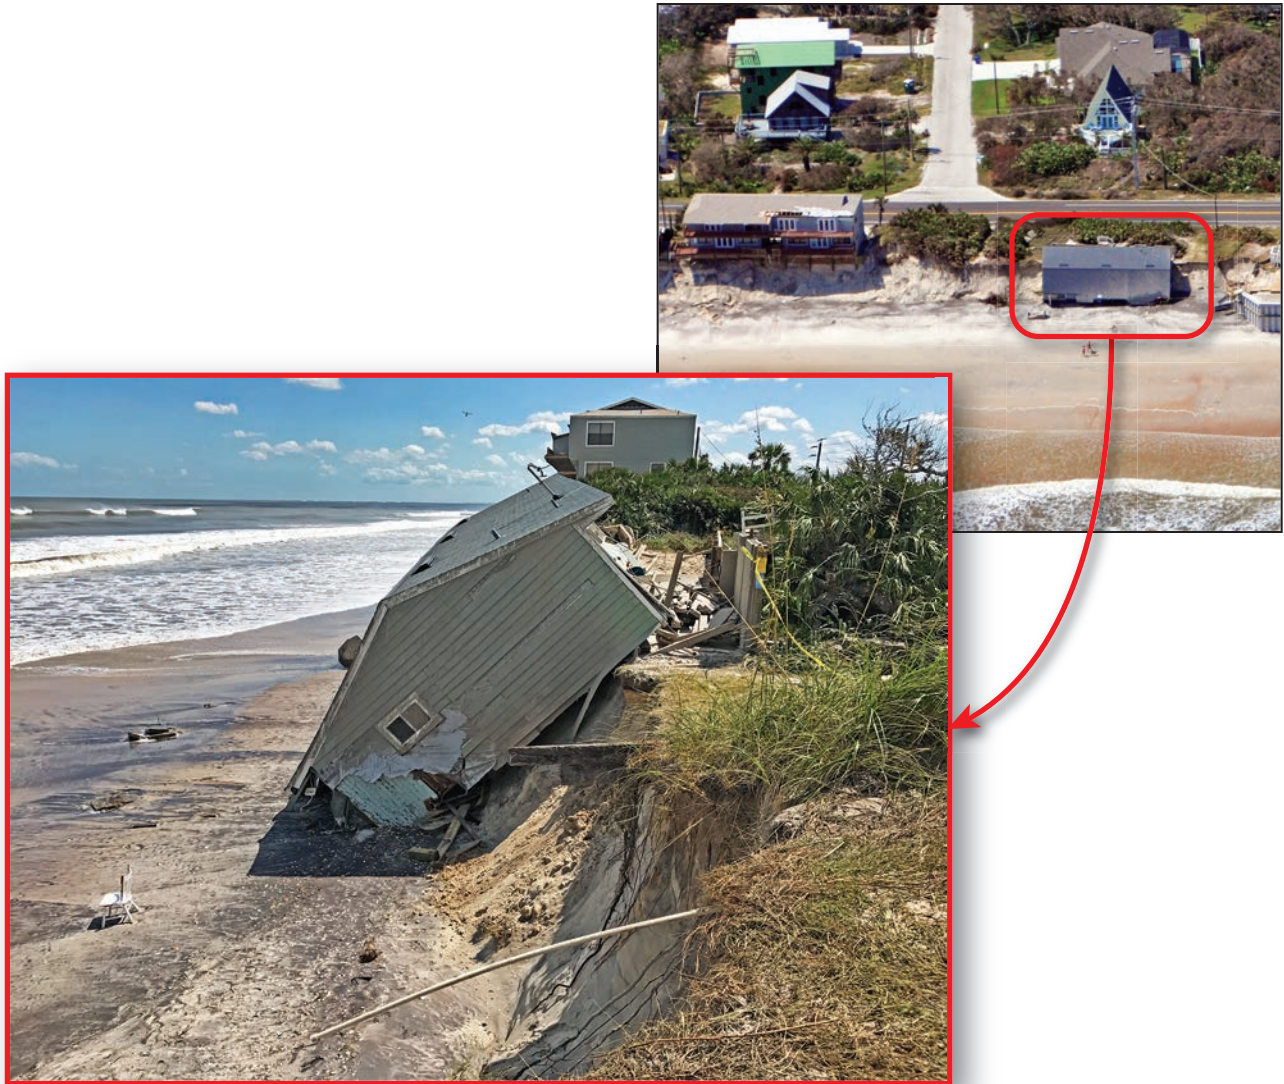
**Figure 3-20: Collapsed house on shallow foundation that was undermined by erosion induced by Hurricane Irma (Vilano Beach, FL)**

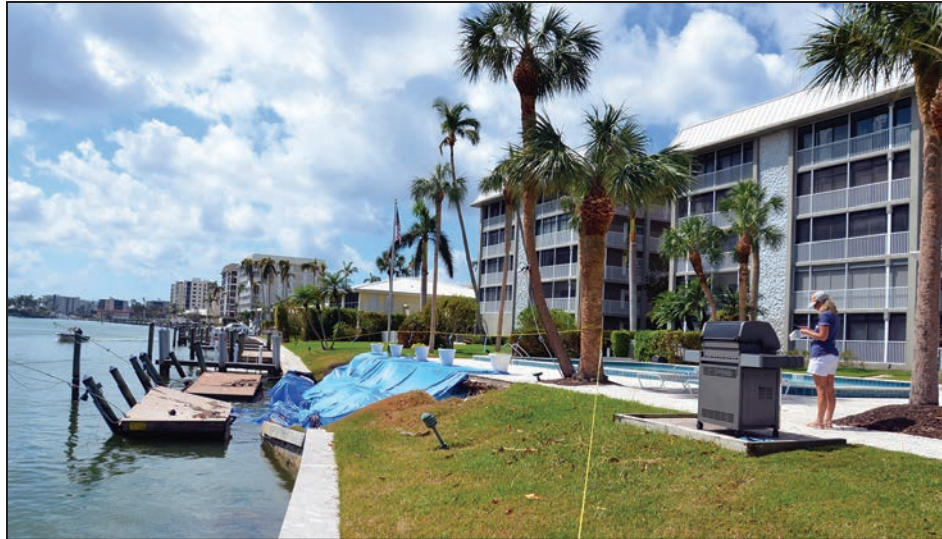
**Figure 3-27:**  
**Failure of bulkhead (anchor**  
**system) (Naples, FL)**

The failure of this bulkhead likely originated at its anchor system. This type of failure allows the top of a bulkhead to rotate toward the water.

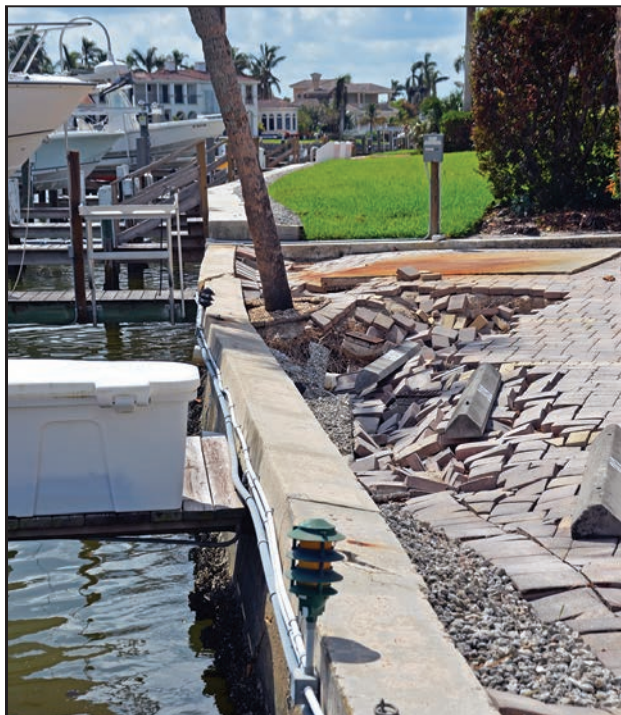
**Figure 3-28:**  
**Bulkhead toe failure**  
**(insufficient embedment)**  
**(Naples, FL)**

The failure of this bulkhead was likely due to insufficient embedment of the bulkhead toe into the ground. This type of failure allows the bottom of a bulkhead to rotate toward the water.

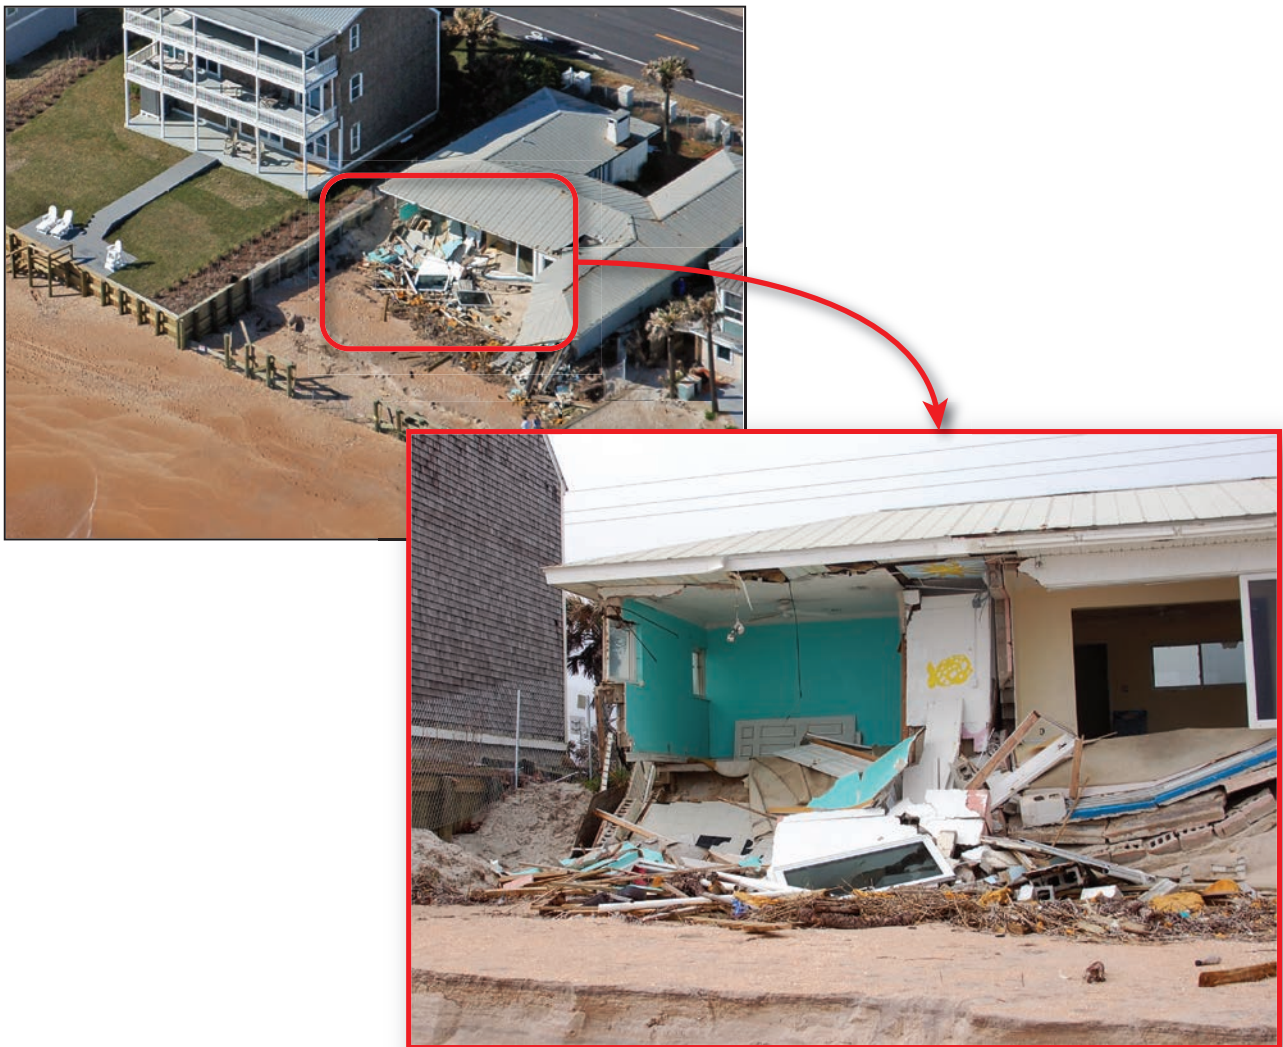
Figure 3-29: House on a shallow foundation that collapsed after it was undermined following failure of the bulkhead during Hurricane Irma (St. Johns County, FL)

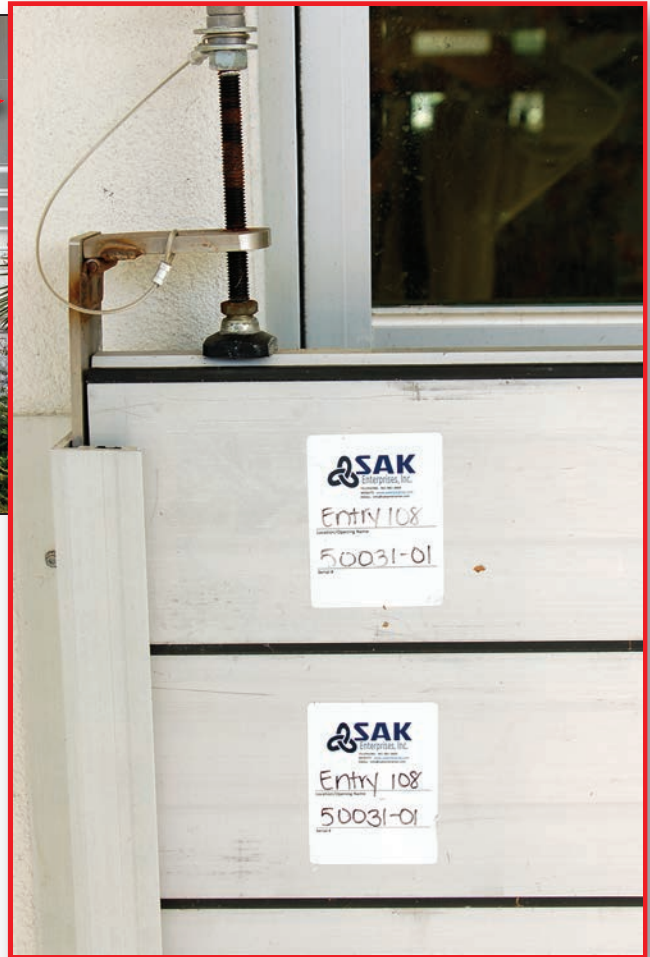
Figure 3-30: Flood plank system deployed at utility company building (Key West, FL)

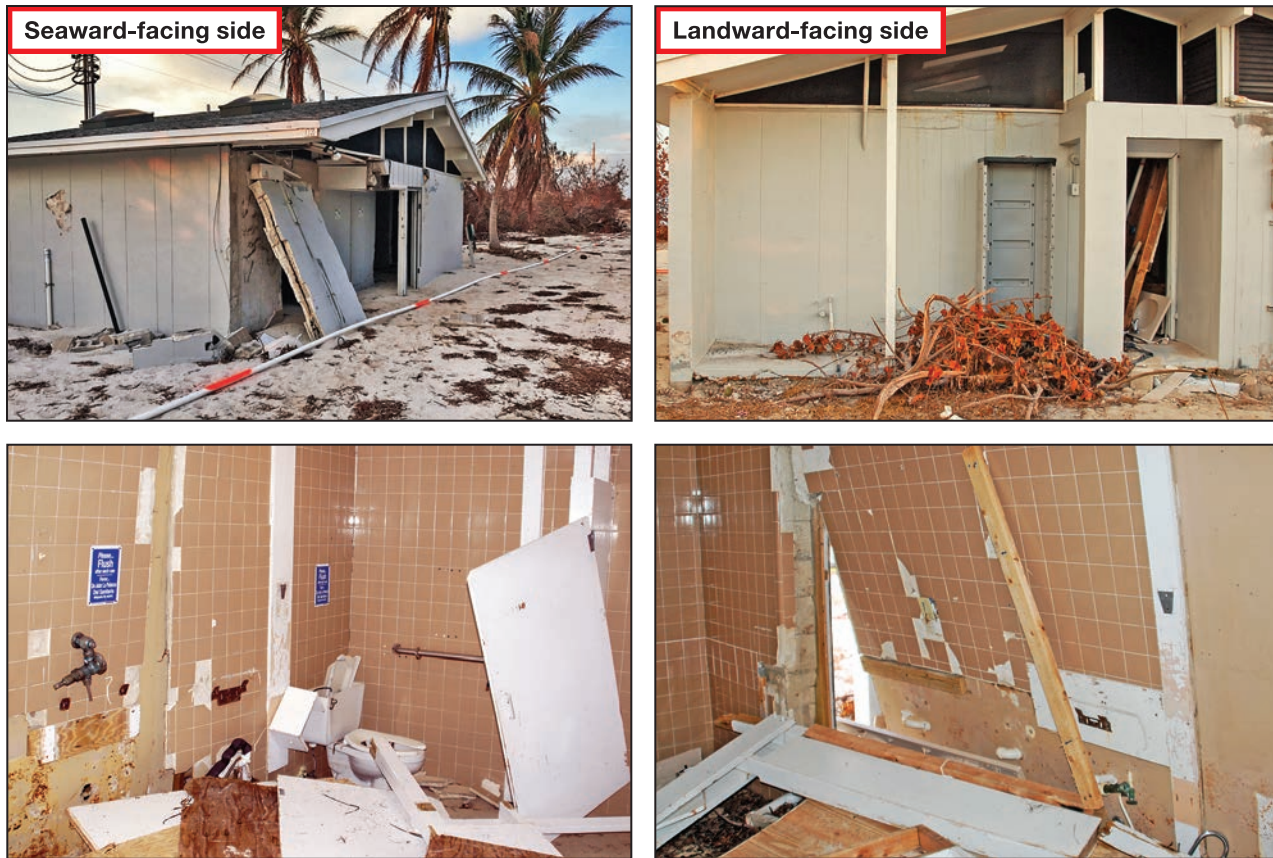
The bottom photos show damage to fixtures, partitions, and walls that was likely caused by waves and high-velocity flow. The restroom was demolished between the pre-MAT and MAT visits.

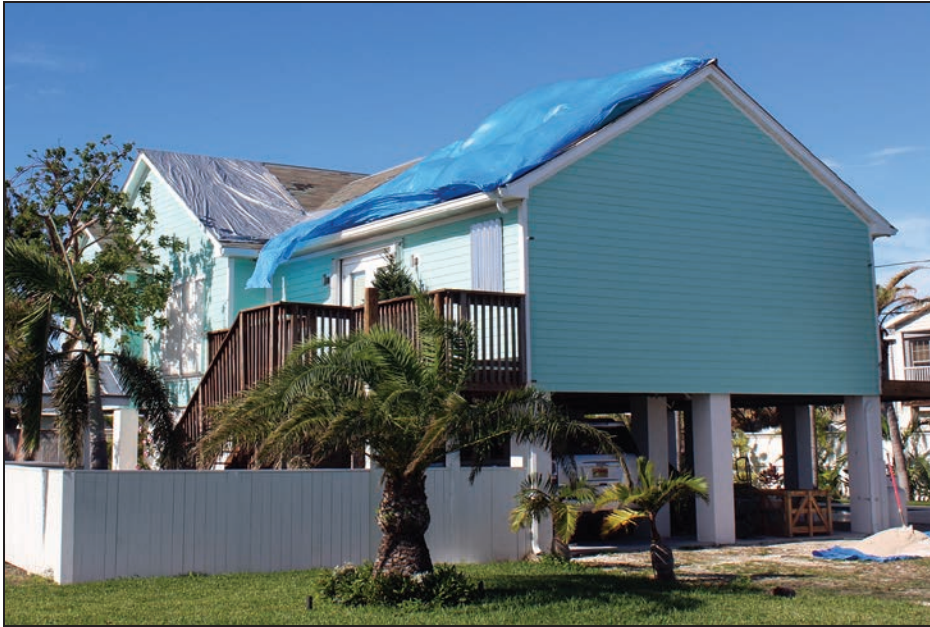
Figure 4-7:  
The MAT could not observe much of the asphalt roof damage on this house because it was covered by a tarp (EWS = 111 mph; EDWS = 180 mph) (Big Coppitt Key)

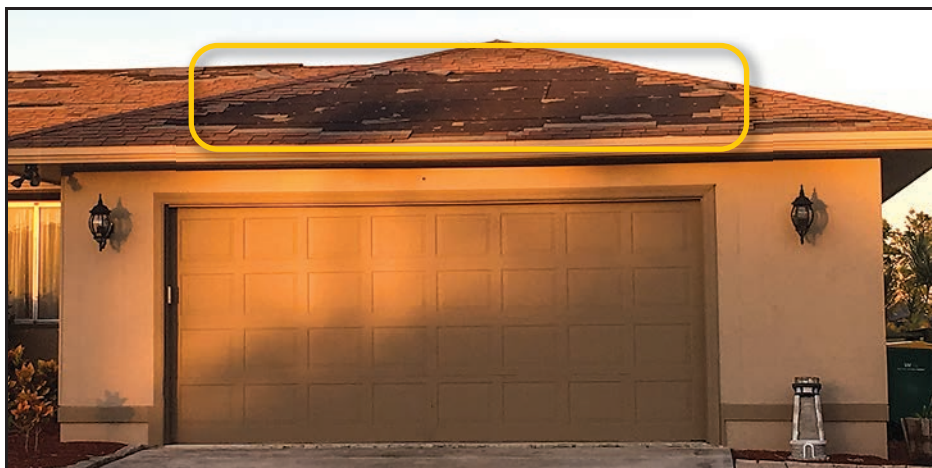
Figure 4-12:  
House with shingle loss  
near main ridge and  
between roof hips (yellow  
oval) (EWS = 109 mph;  
EDWS = 170 mph)  
(Marco Island)

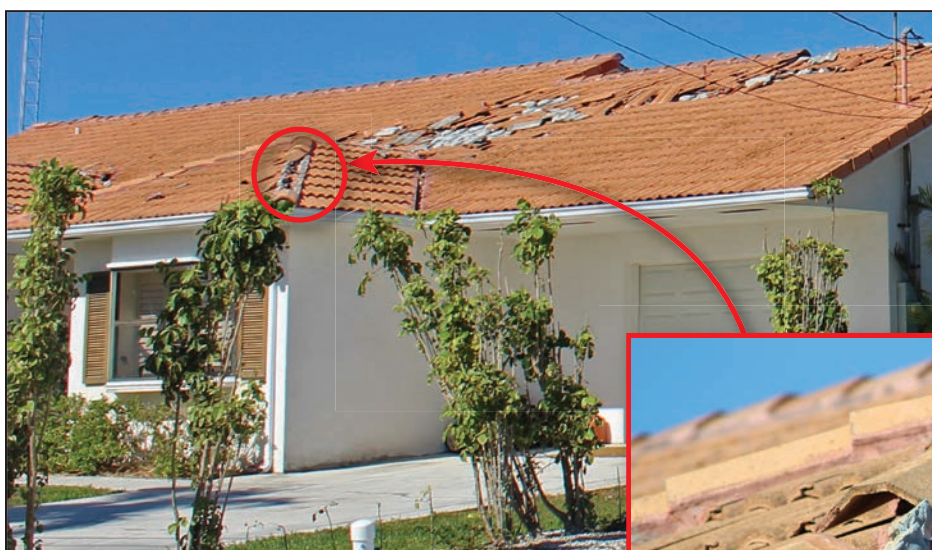
Figure 4-13:  
Roof tile failure (EWS = 113  
mph; EDWS = 180 mph)  
(Cudjoe Key)

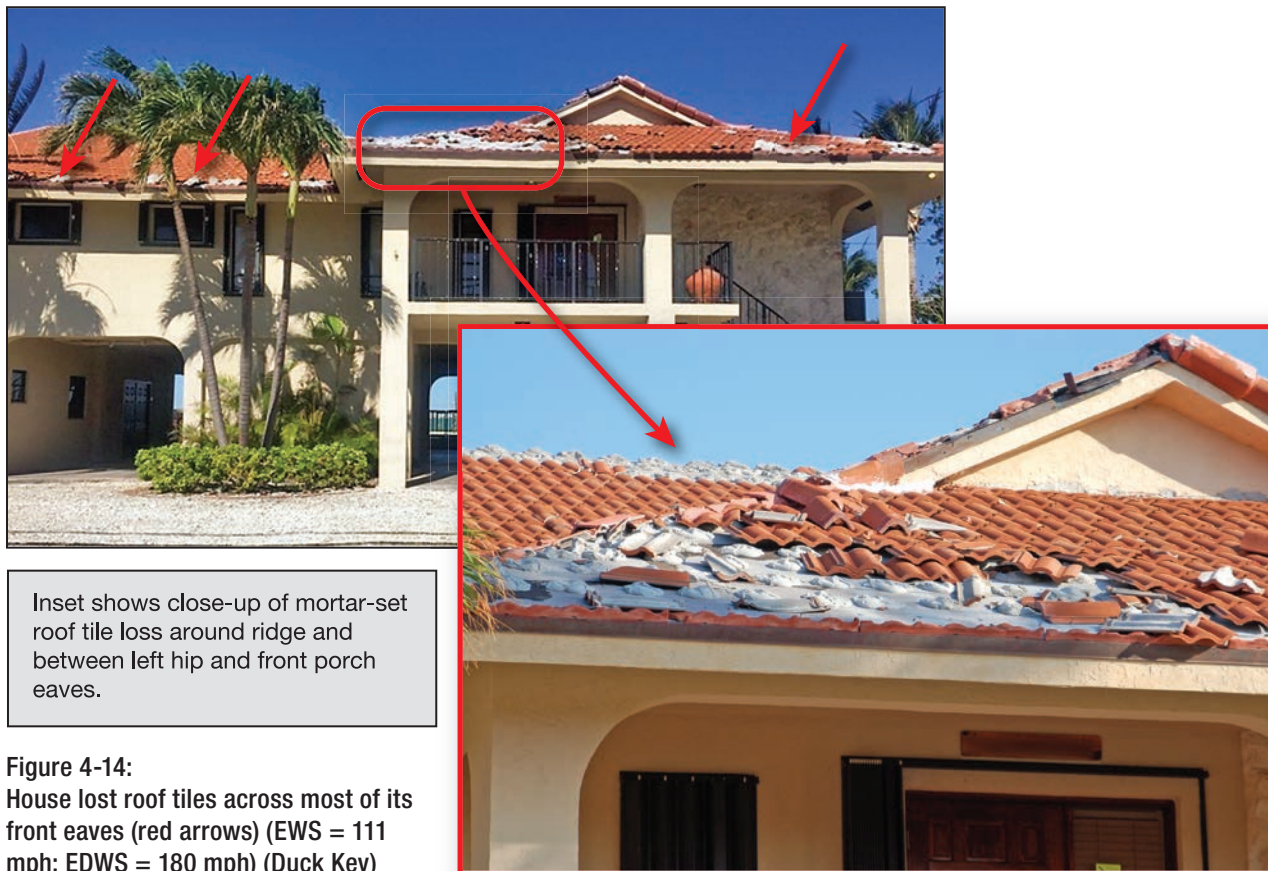
**Figure 4-14:**  
House lost roof tiles across most of its front eaves (red arrows) (EWS = 111 mph; EDWS = 180 mph) (Duck Key)

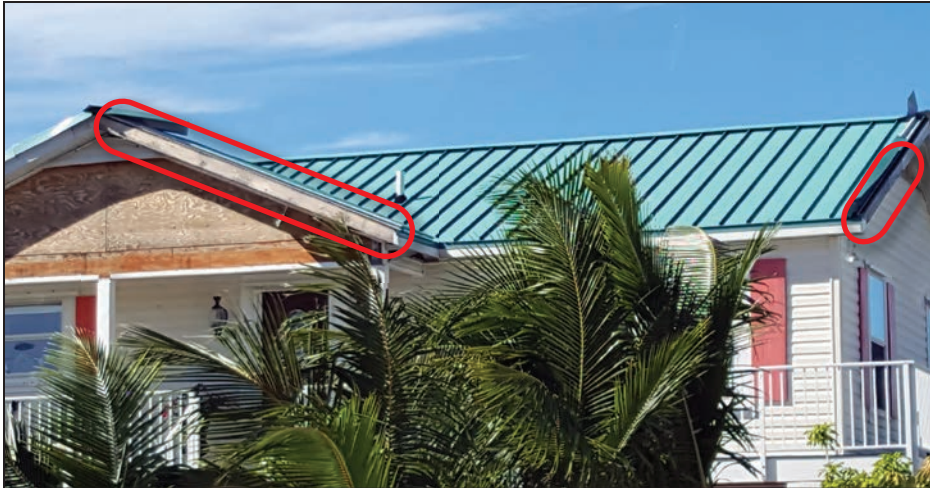
Figure 4-15:  
House with separated metal roof trim and missing fascia cover (red ovals) along gable end. (EWS = 113 mph; EDWS = 180 mph) (Sugarloaf Key)

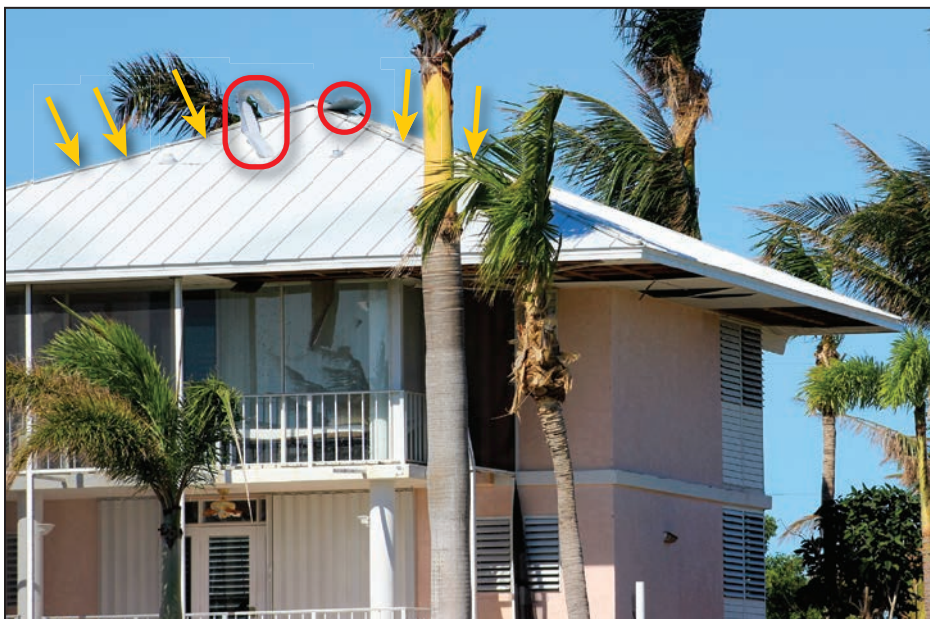
Figure 4-16:  
House with damaged metal roof system (EWS = 113 mph; EDWS = 180 mph) (Sugarloaf Key)

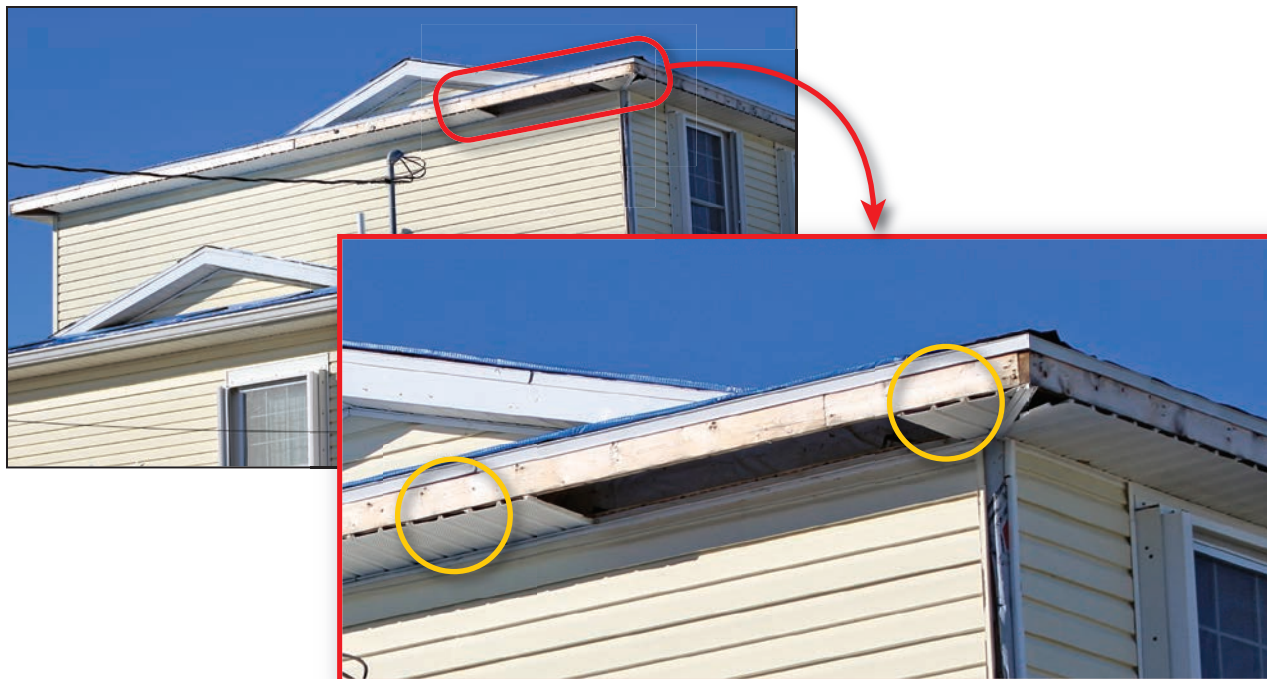
**Figure 4-17:**  
House that lost its vinyl  
soffit panel (EWS = 113  
mph; EDWS = 180 mph)  
(Summerland Key)

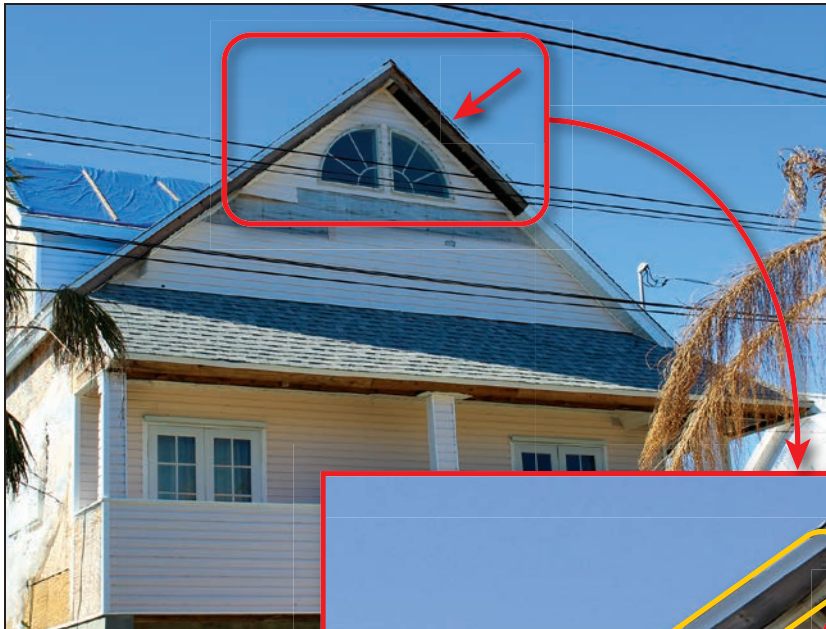
**Figure 4-18:**  
House that lost its soffit along the right side of the front-facing gable (EWS = 114 mph; EDWS = 180 mph) (Little Torch Key)

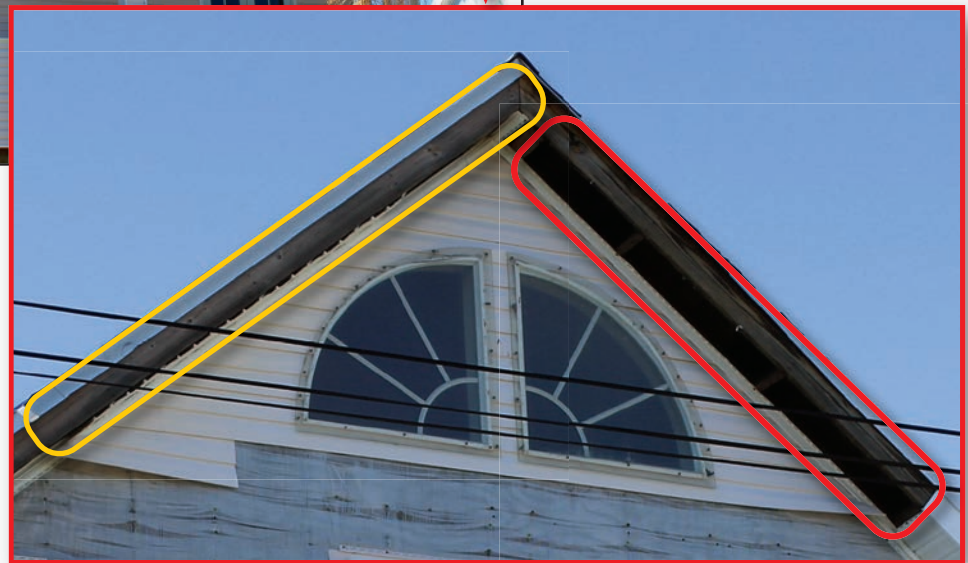
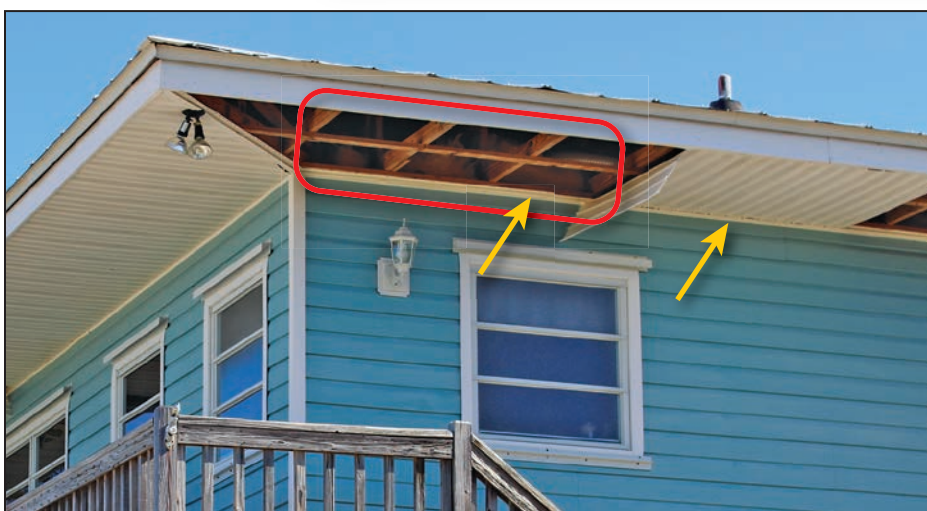
**Figure 4-19:**  
House with vinyl soffit damage not caused by fascia loss (EWS = 113 mph; EDWS = 180 mph) (Sugarloaf Key)

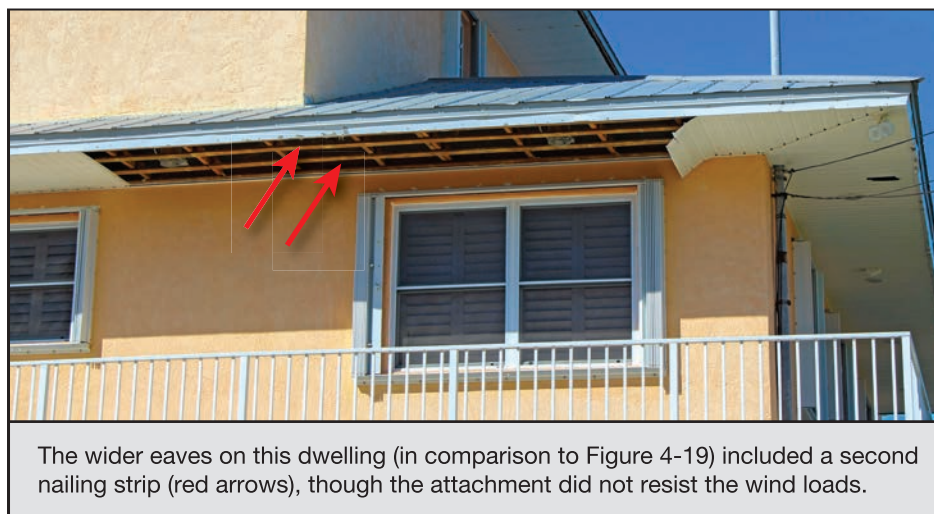
**Figure 4-21:**  
House with soffit loss (EWS = 110 mph;  
EDWS = 169 mph) (Goodland)

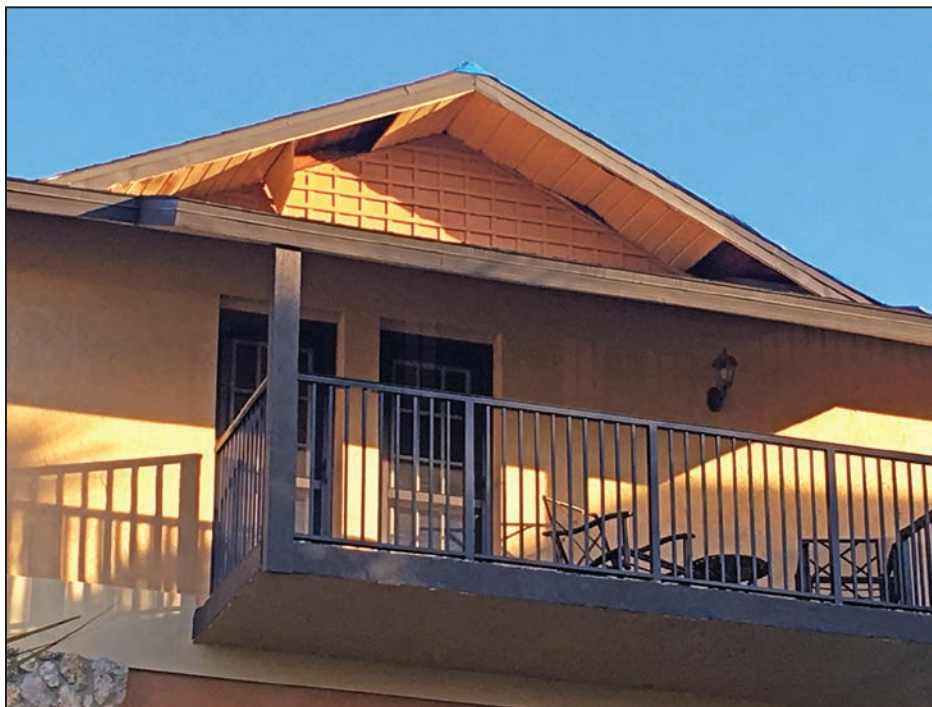
**Figure 4-25:**  
Metal soffit panel loss  
apartment gable end  
overhang (EWS = 104 mph;  
EDWS = 166 mph) (Naples)

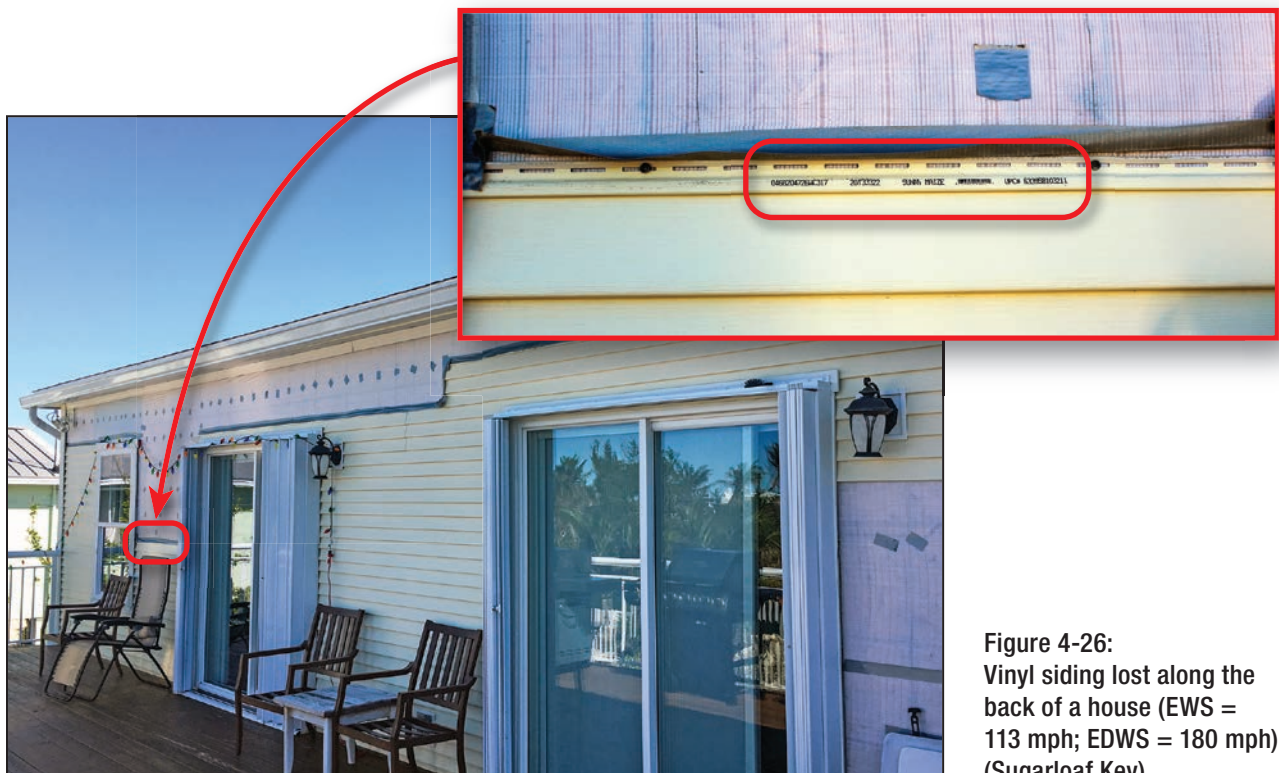
Figure 4-26:  
Vinyl siding lost along the  
back of a house (EWS =  
113 mph; EDWS = 180 mph)  
(Sugarloaf Key)

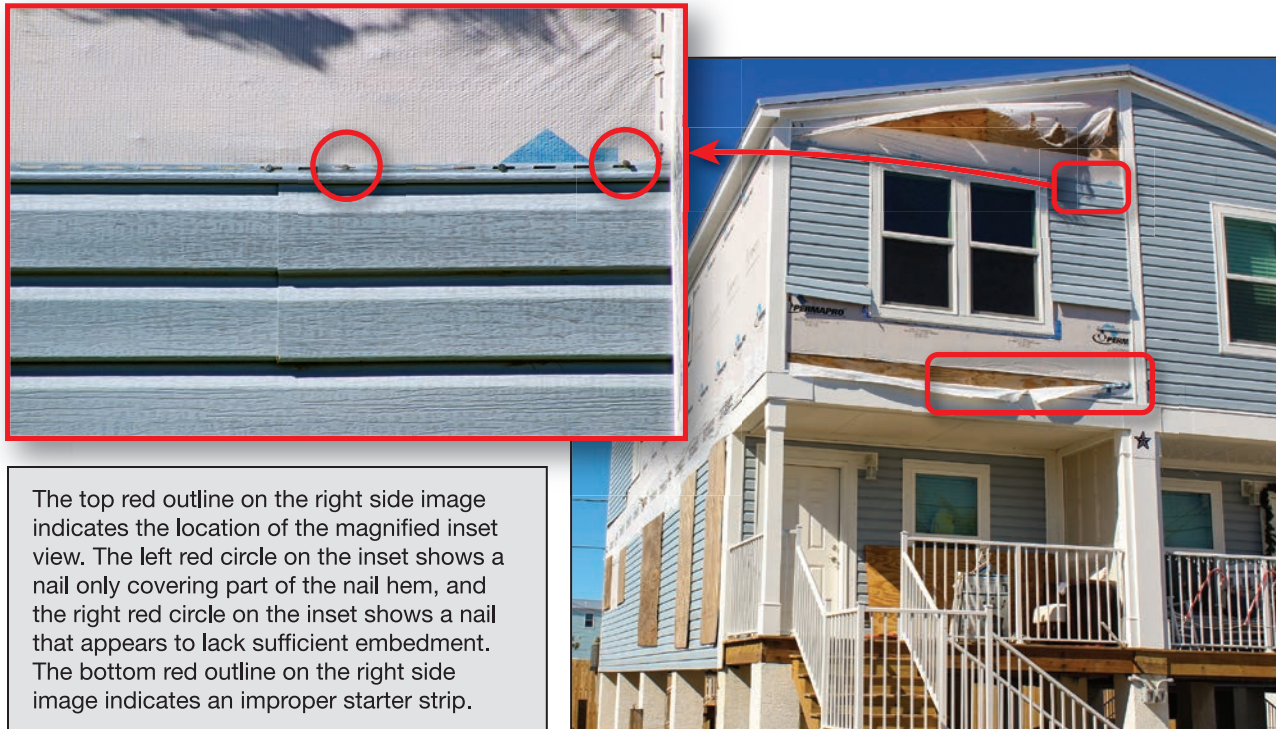
**Figure 4-28:** Duplex where vinyl siding above the front porch did not comply with manufacturer's installation instructions (EWS = 120 mph; EDWS = 180 mph) (Marathon Key)

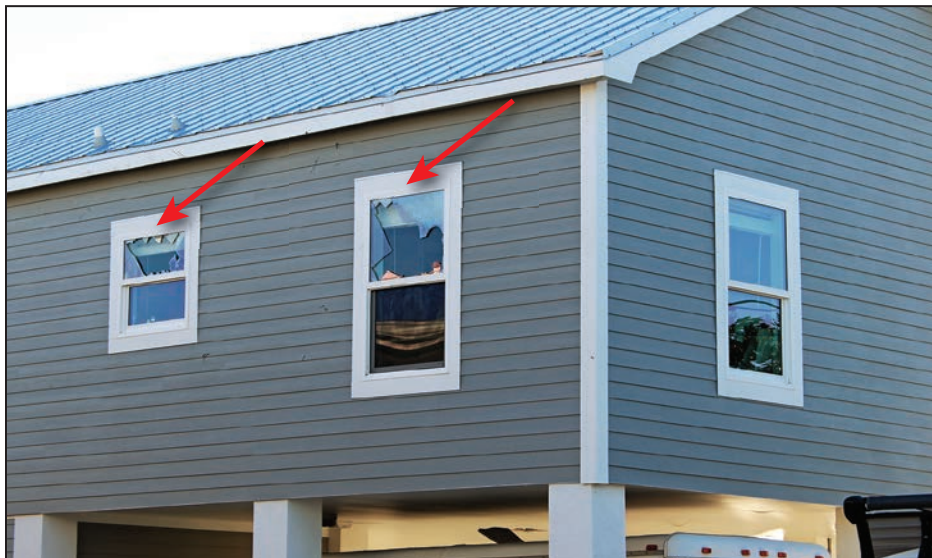
**Figure 4-32:** Residence with two windows where the outer panes were broken (see red arrows) but the inner panes stayed intact (EWS = 113 mph; EDWS = 180 mph) (Ramrod Key)
