# Hurricane Irma in Florida

Building Performance Observations,  
Recommendations, and Technical Guidance

FEMA P-2023 / December 2018

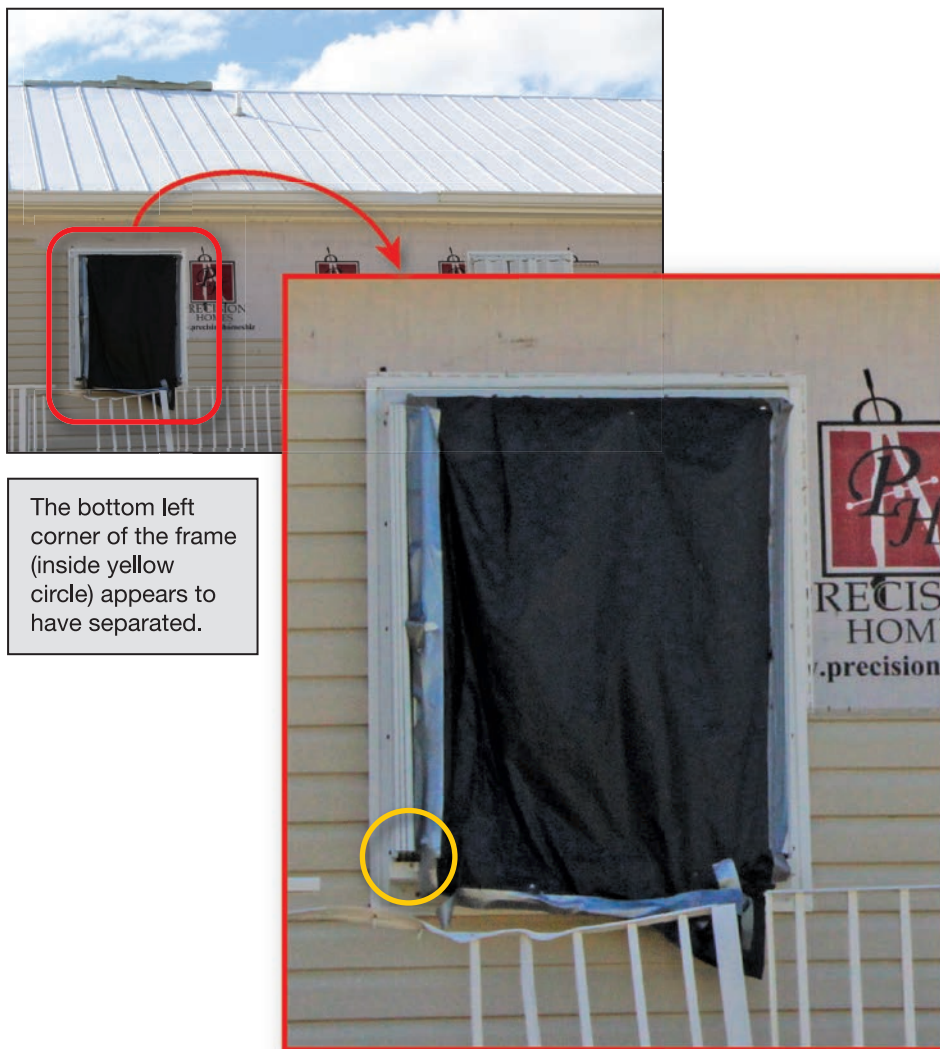
Figure 4-35: House with impact-resistant shutter system damaged by wind-borne debris; opening was covered at the time the MAT visited (EWS = 114 mph; EDWS = 180 mph) (Little Torch Key)

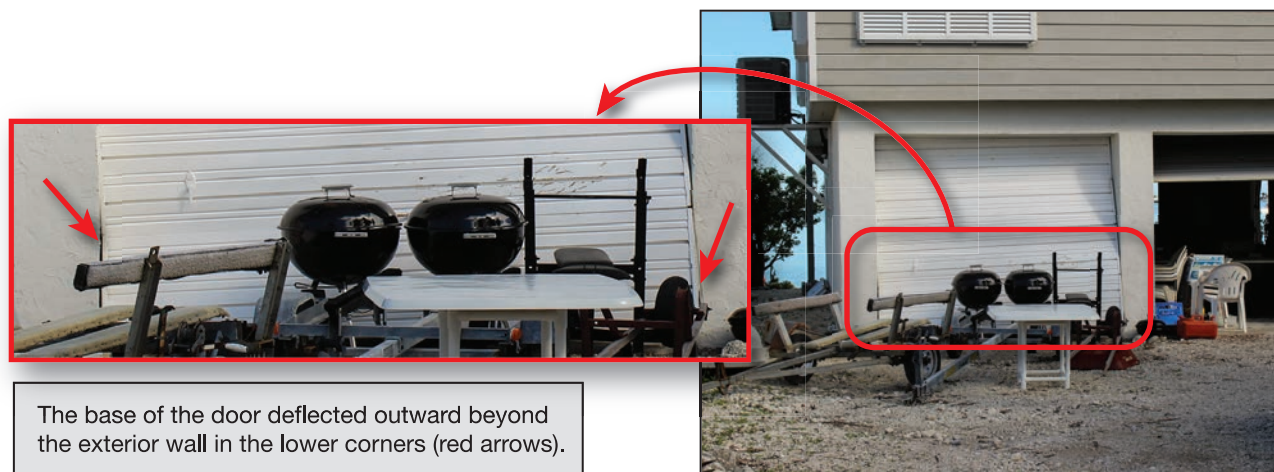
Figure 4-37: Damaged overhead garage doors (EWS = 114 mph; EDWS = 180 mph) (Little Torch Key)

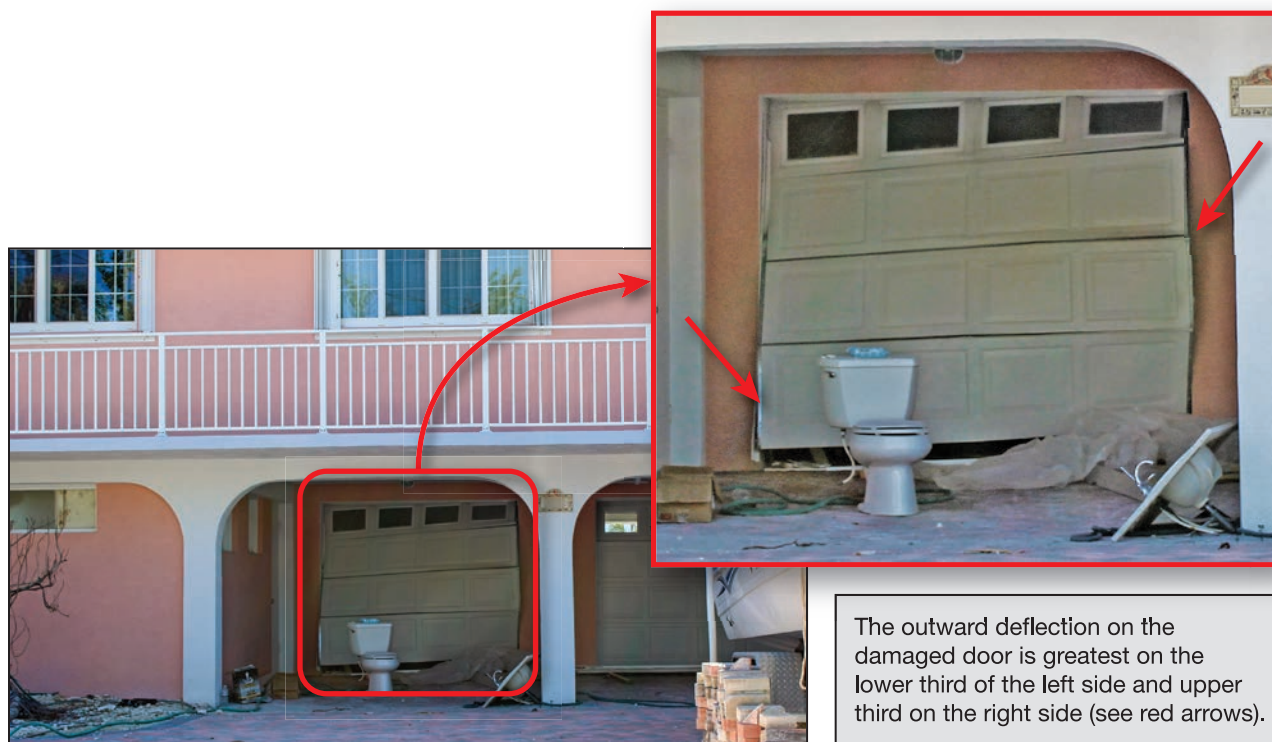
Figure 4-38: Damaged overhead garage door on a house (EWS = 111 mph; EDWS = 180 mph) (Duck Key)

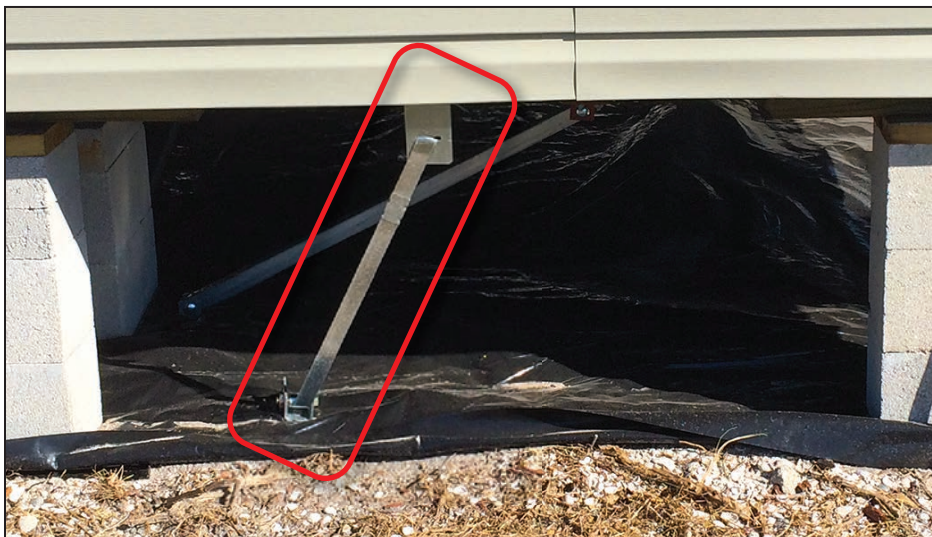
**Figure 4-41:**  
New MH unit installation with misaligned anchor strap installation (red outline) was otherwise anchored consistently with other post-Irma examples (EWS = 105 mph; EDWS = 164 mph) (Collier County)

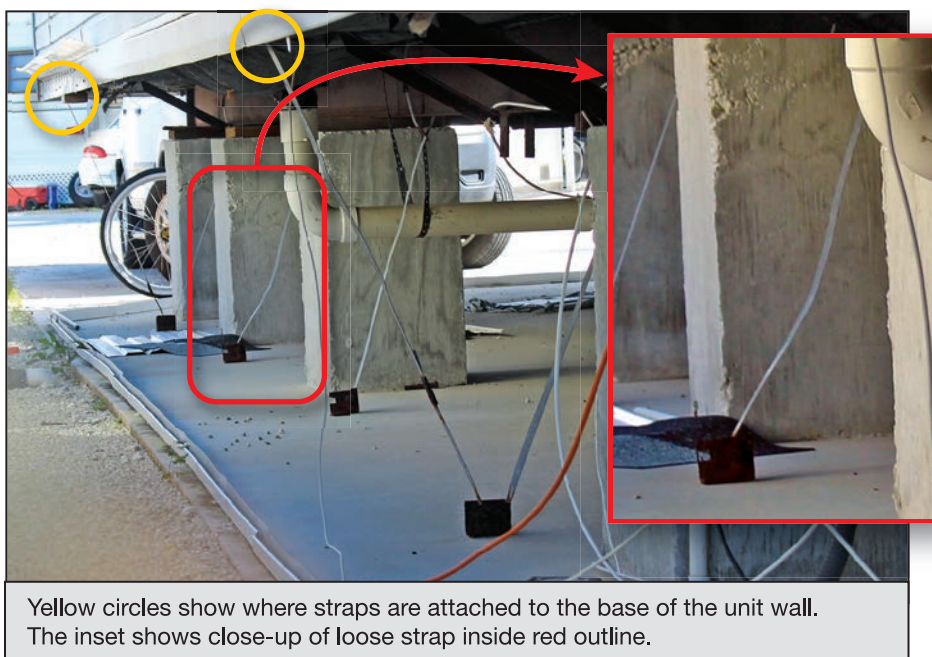
**Figure 4-42:**  
MH unit installation where only the first and fourth straps are attached to the exterior wall base (EWS = 111 mph; EDWS = 180 mph) (Big Coppitt Key)

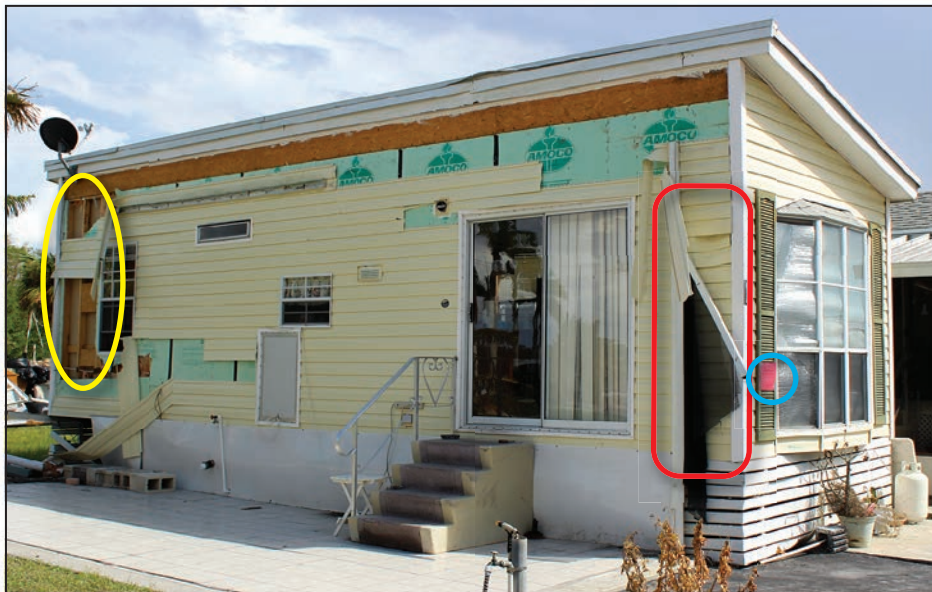
A remnant of the porch is shown in the red outline, and the red tag indicating condemnation by local officials is shown in the blue circle. The yellow oval shows missing sheathing and insulation characteristic of interior walls.

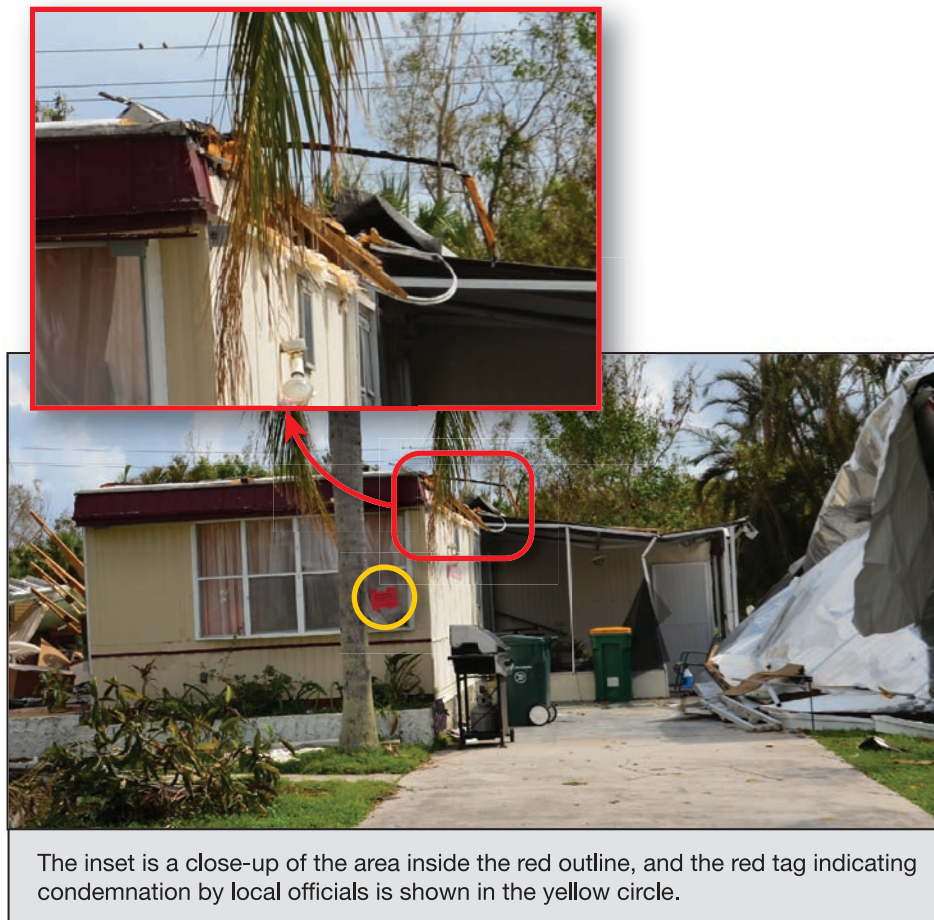
The inset is a close-up of the area inside the red outline, and the red tag indicating condemnation by local officials is shown in the yellow circle.
