REDUCING THE FIRE HAZARD

IN ALUMINUM-WIRED HOMES

Jesse Aronstein, PH.D., P.E.

Latest update: July 6, 2007

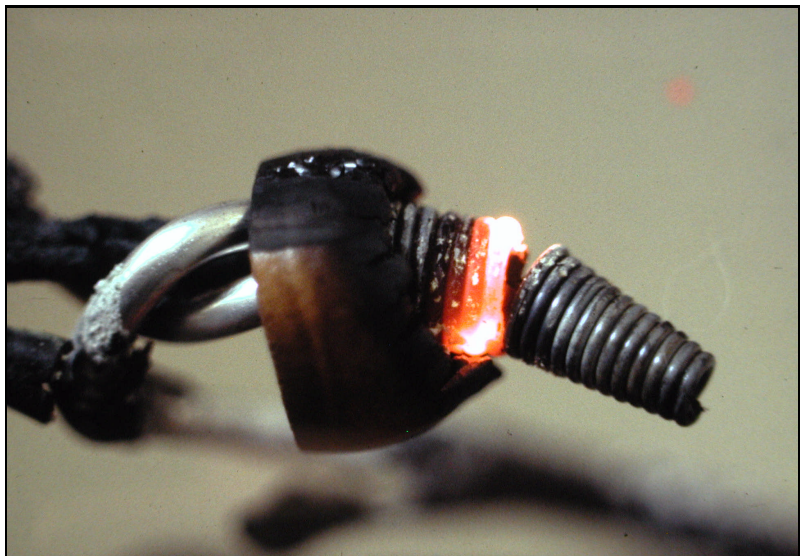
The most certain corrective action for all cases would be to rewire the home with copper wire. This is expensive and impractical in most cases. A practical approximation to rewiring can be achieved by a method known as "pigtailling", using a specially-selected connector and installation method to splice a short length of solid copper wire to each aluminum wire end. The copper wire "pigtail" is then connected to the circuit breaker, light fixture, receptacle, dishwasher, or other termination. This method is only effective if the connections between the aluminum wires and the copper pigtails are extremely reliable. Pigtailling with some types of connectors, even though they might be presently listed by UL or certified by CSA for the application, can lead to increasing the hazard.[5][6] (See Figure 1.)

FIGURE 1 - ALUMINUM WIRE SPLICES MADE WITH TWIST-ON CONNECTORS CAN BE DANGEROUS. The use of most types of twist-on connectors with aluminum wire can lead to hazardous results. This twist-on pigtail connection (two #10 aluminum wires with one #12 copper wire, in a 20-amp circuit), made with a twist-on connector that was UL listed for use with aluminum wire at the time, remains electrically functional in the circuit, but it becomes extremely hot whenever a significant amount of current flows. The heat has deteriorated the insulation on both the connector and the wires. In this photo, a portion of the connector's spring is red hot, at current well below the circuit rating.

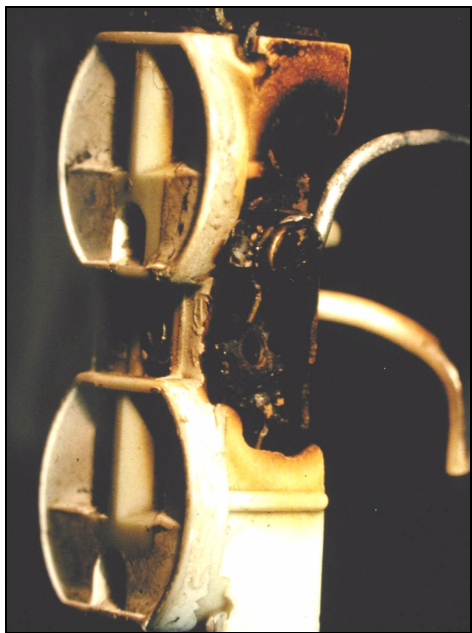
FIGURE 2 - EXAMPLE OF OVERHEATING OF ALUMINUM-WIRED TERMINALS ON A RECEPTACLE. Enough heat was generated by current flowing through the aluminum wire connections to cause charring of the receptacle body and disintegration of the insulation that was on the wire. Note that the face of the receptacle, as the homeowner or an inspector would have seen it, with the cover plate on, would look normal.

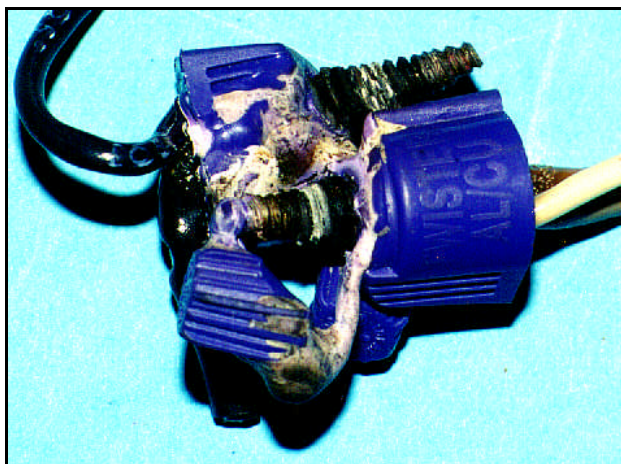
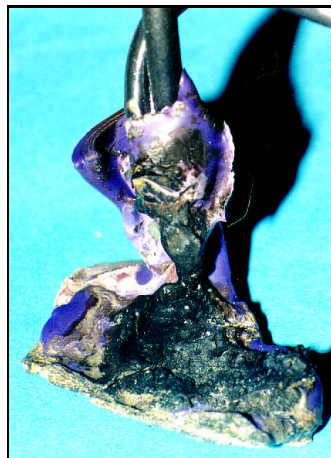
**FIGURE 5 - FIELD FAILURES OF ALUMINUM TO COPPER
SPLICES MADE WITH IDEAL #65 CONNECTORS [12]**

Additionally, field burnouts have now been reported with the Ideal #65 connectors in their rated applications. With CPSC skeptical (and requesting that UL withdraw its listing), the manufacturer initially agreeing that the connector is not for the pigtailling retrofit application, independent tests clearly demonstrating poor performance, and field failures reported, the use of the Ideal #65 "Twister" connector for the pigtailling application is definitely not recommended. If the COPALUM repair is not available, use the AlumiConn connector (See Section 1C).

A. THESE TWO FAILED SPLICES ARE ADHERED

PLASTIC SHELLS SHELL MELTED AND CHARRED.
THE CHARRING INDICATES THAT

B. SEVERE FAILURE, PLASTIC

TOGETHER BY THE MELTED
IT HAD PROBABLY IGNITED.

3. IDEAL #65: came on the market in the mid-1990's. Within three years of its introduction, the first report of field failure surfaced. There have been additional failures reported since then.
