Investigation of Potential Benefits of
Revising Exception 1 under
FLORIDA BUILDING CODE,
ENERGY CONSERVATION,
Section 101.4.7.1.1
Duct Sealing upon Equipment Replacement

FSEC-CR-1979-14
June 2014

Authors
Janet McIlvaine
David Beal

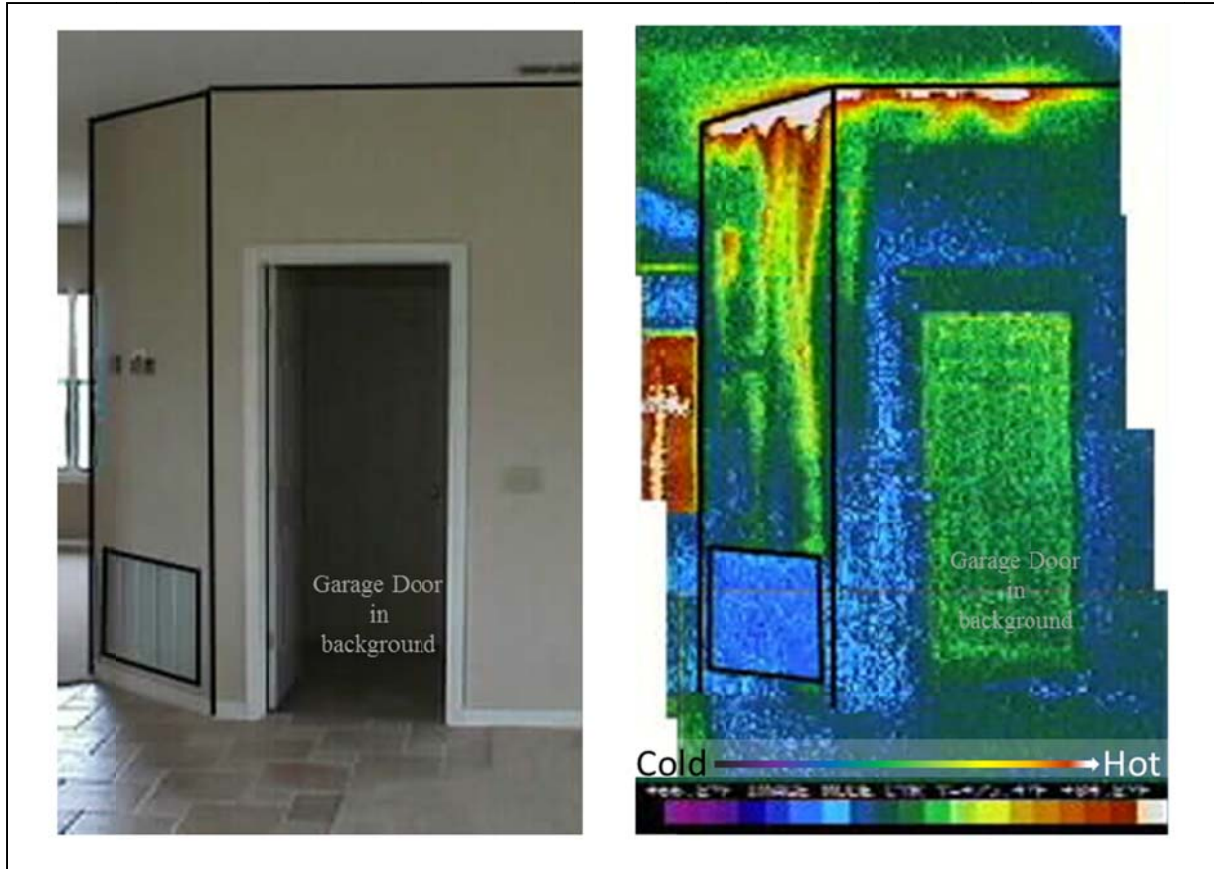
Air handler closets typically house a central return plenum, and are usually formed by the walls of the closet. If these walls are unfinished, open wall cavities, it results in a return plenum that pulls air from those wall cavities and the attic above as shown in the infrared image in Figure 2 (Parker et al. 1998). The infrared image shows the wall between the utility room and the main body of the house. The return air path is unintentionally connected to the wall cavity and consequently the attic as evidenced by the signature of hot air being pulled down the wall during air handler operation.

Figure 2. Left: A return plenum formed by unfinished framing under an air handler support platform is on the other side of this wall mounted return air grille in a utility room. Right: Infrared image showing hot attic air (see color scale at bottom of image) being pulled down the interior wall cavity during air handler run time (Parker, et al. 1998).

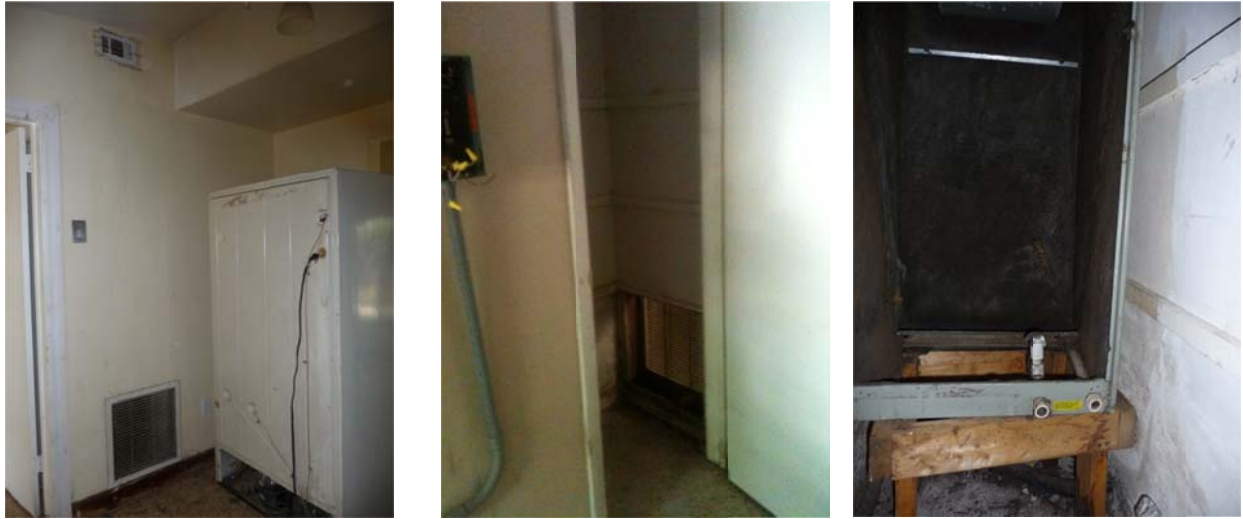
As seen in **Figure 5** the supply register for the kitchen is located directly above the return opening. This register was merely stuck in the wall, the supply duct feeding it was not attached to a boot, providing conditioned air to the wall cavity that is directly connected to the return (Figure 7). As configured the air handler and the kitchen supply, sources of positively pressurized leakage points, are in the return, a negative pressure area. This in effect is “turbocharged” duct leakage.

Figure 5. The entire air handler closet serves as the return plenum. Left: Central (only) return air grille mounted in wall between kitchen and air handler closet. Center: Air handler closet showing back of return air grille. Right: Inside the air handler closet, to the left of the door, showing air handler mounted on free-standing wooden supports.

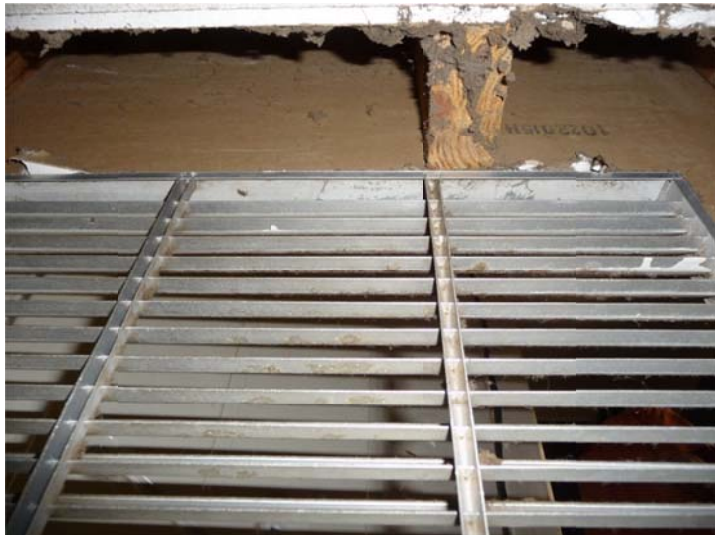
As found, the home had a retrofitted HVAC system with an air handler installed in a former pantry (note “A/C” in Figure 4). The Air handler unit was installed on a platform in the pantry with a filter at its bottom. The pantry door was solid, requiring a through-the-wall return. This return was accomplished by cutting a hole in the pantry/kitchen wall, directly behind the refrigerator (Figure 5). This hole was completely unsealed from the wall (Figure 6).

Figure 6. Looking up into the wall cavity from the wall-mounted return air grille. This wall cavity is part of the return air plenum because there is no air barrier separating it from the return air flow path.

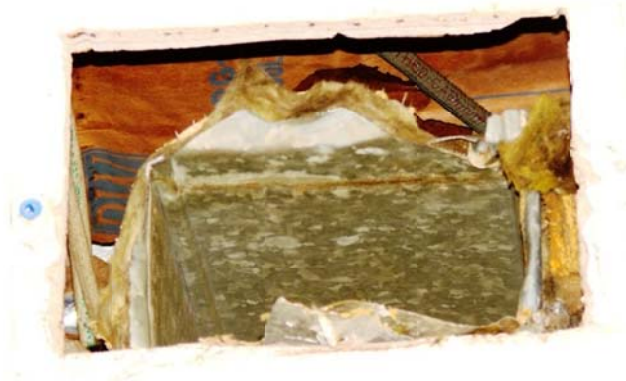
Figure 7. Disconnected supply duct

In this house the contractor also addressed the obvious failures in the supply duct work, sealing the open supply in the kitchen, re-installing the supply boots found disturbed in the attic portion of the house, and sealing all supply boots with mastic on their inside surfaces. The improvement from these repairs is apparent in the leakage reduction for the entire system shown in Table 2 and Figure 10.

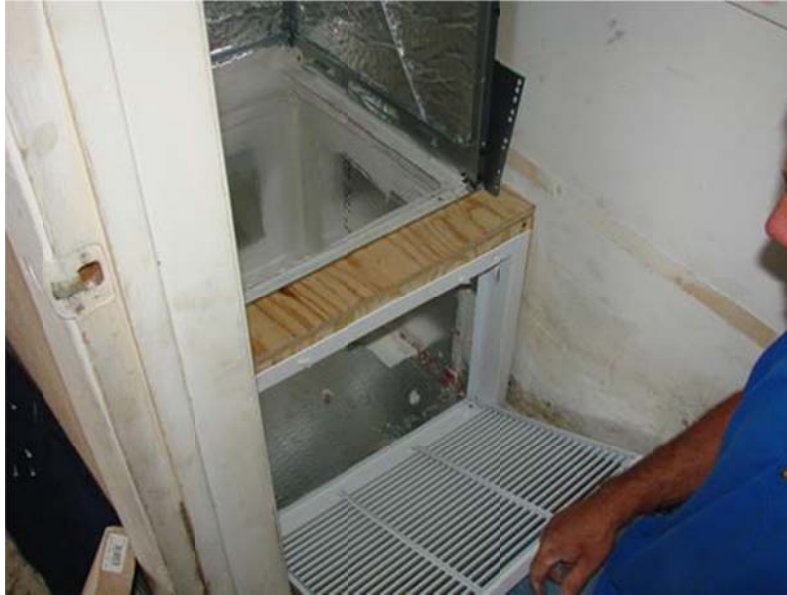
Figure 9. Filter-back return grille installed on new platform return in existing air handler closet.

The HVAC contractor removed the existing air handler unit (AHU) and stand. The contractor built a new platform in the same location as the old AHU. The stand was built to allow for the

installation of a filter-backed grill under the AHU. The platform was lined with foil-faced fiberglass “duct board” to seal the entire cavity from the area outside the platform (Figure 9).

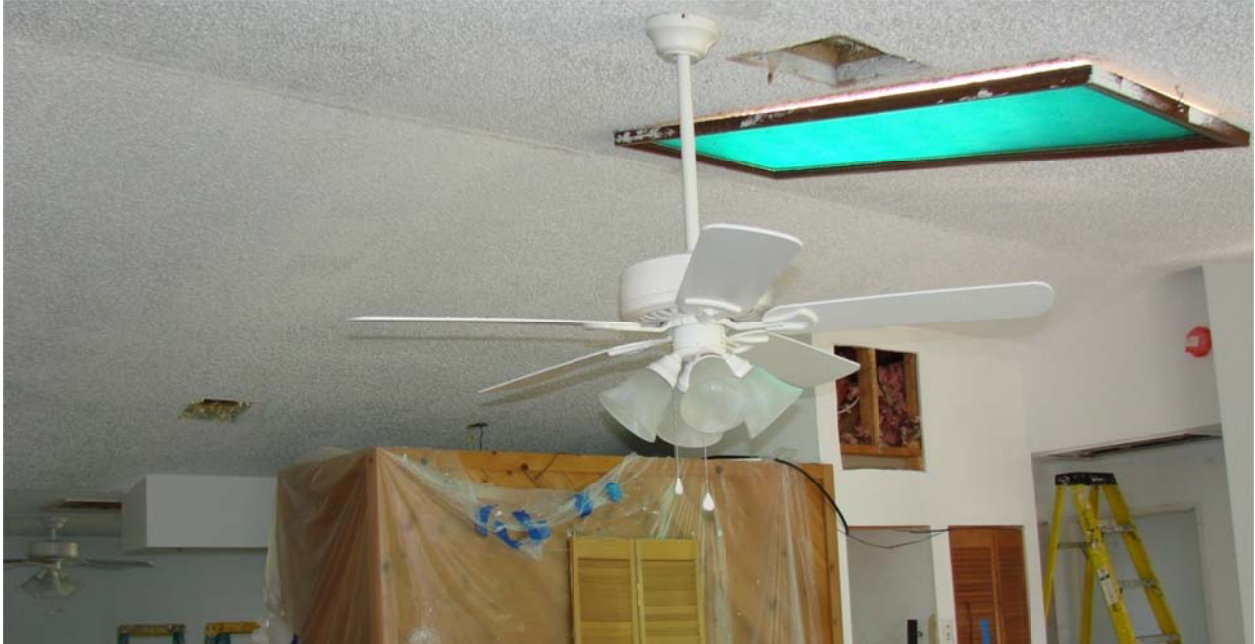
Figure 13. The hole in the wall over the air handler closet was cut to facilitate supply plenum installation. Also note the living room supply, to be relocated during repair.

There was significant repair to the supply duct system, both through the wall over the air handler and in the attic. The living room supply run was relocated and re-run (Figure 13)

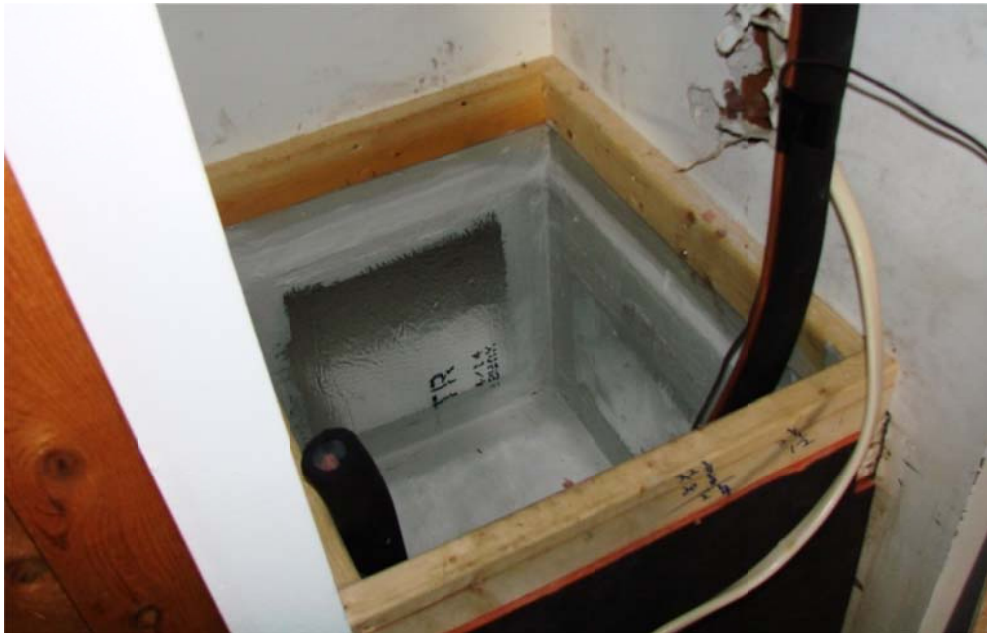
Figure 14 New duct board lining provides an air barrier to separate the return air stream from adjacent open wall cavities.

The existing return platform was removed and replaced with new wood. The walls and floor of the plenum was lined with duct board and sealed with mastic. The front of the plenum was prepped for the future installation of a filter-back grill (Figure 14). The finished air handler platform is designed with a filter-back grill under the platform. The air handler is to be enclosed with a half-door closet (Figure 15).

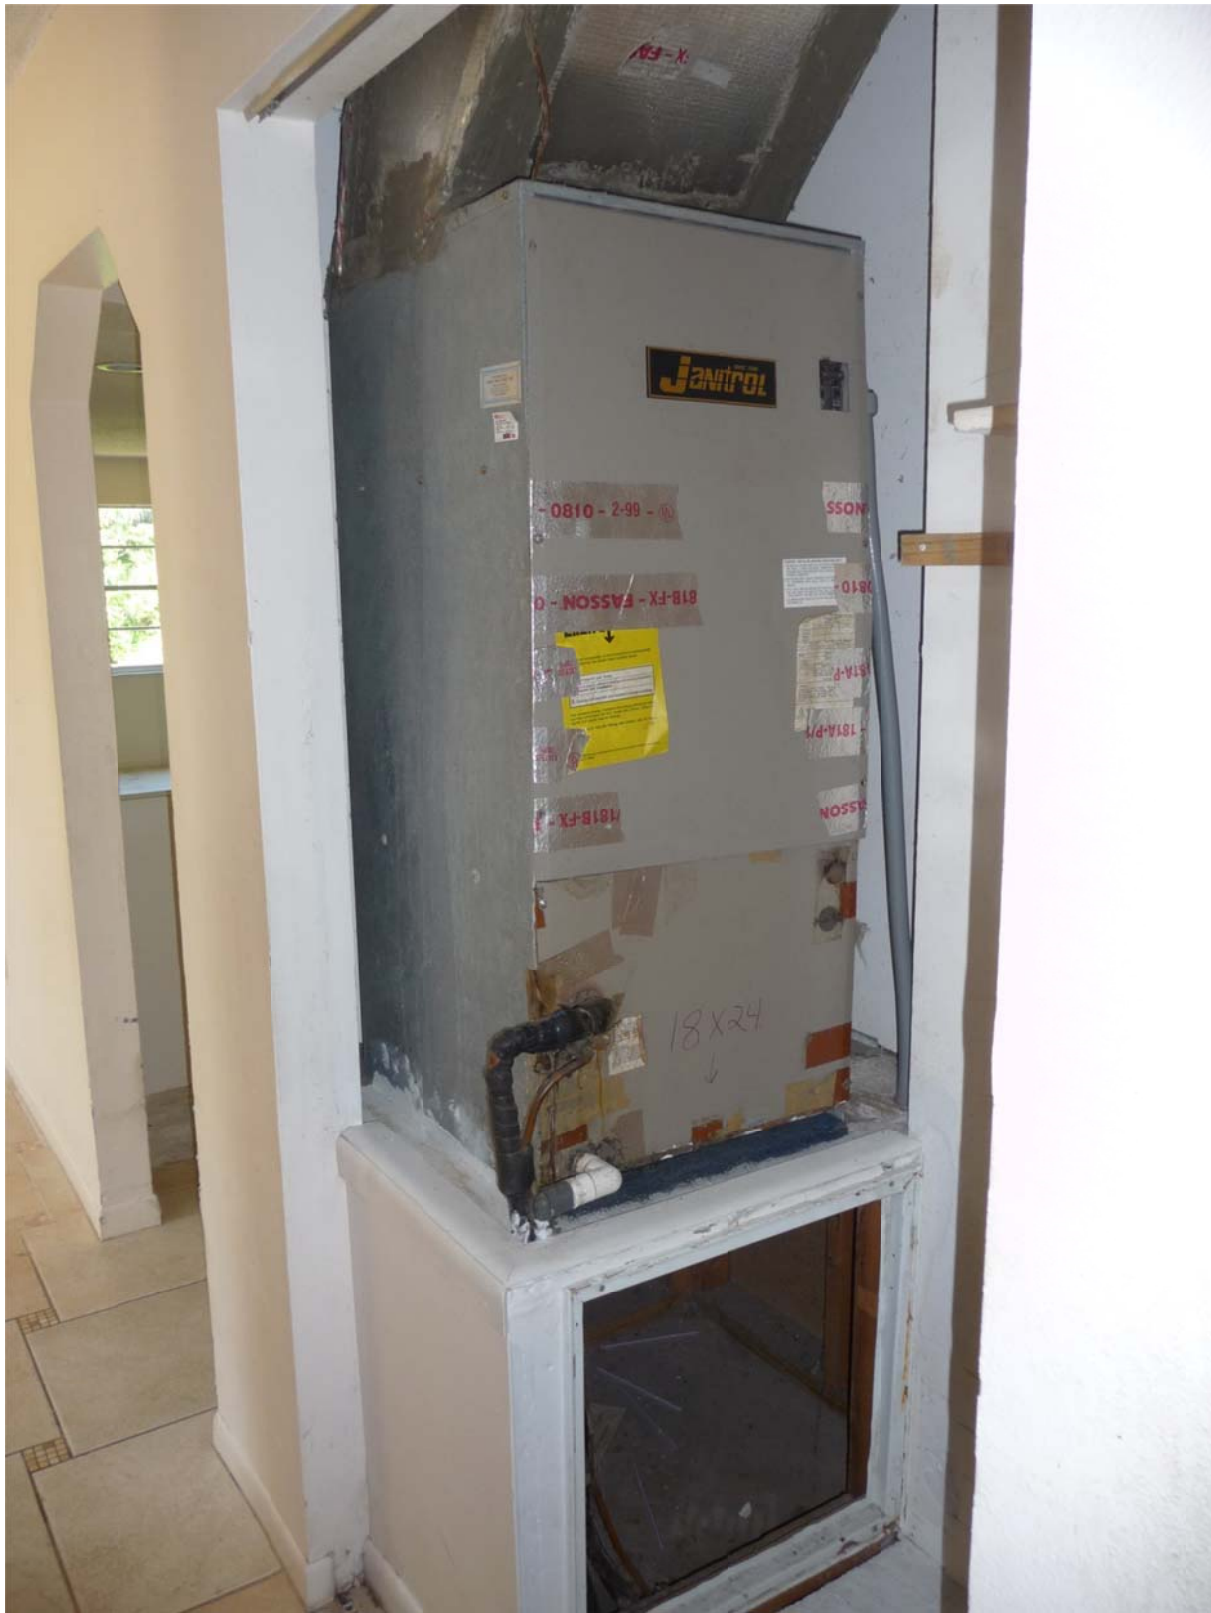
House 261 is a 1369 ft² slab-on-grade frame house (Figure 17). It has three bedrooms, two baths and an attached garage. The air handler is installed in a hall closet on a platform with a filter back grill in the closet. The closet has large, 6' wide, louvered bi-fold doors (Figure 18). There was a raised plywood floor in the closet. The return plenum was open to the wall cavities and the floor cavity (Figure 19). There was a filter installed under the air handler that was completely blocked with insulation and other dust and debris.

Figure 18. Note the open wall cavities in the return plenum and the raised plywood floor in the closet (in the lower right corner of the image)

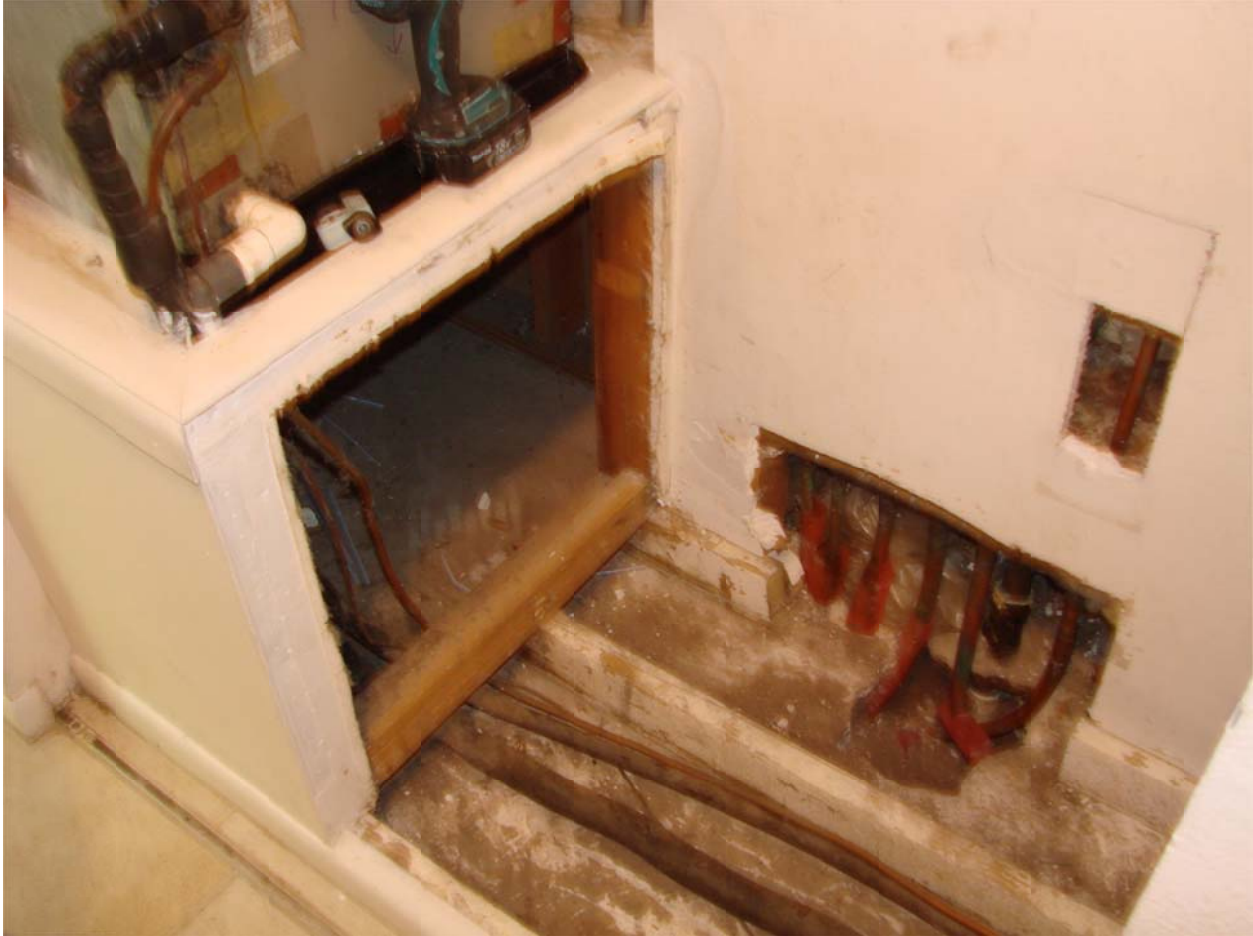
Figure 19. Raised closet floor created a plumbing chase for refrigerant line, condensate drain line and other plumbing run. Chase is fully connected to return air plenum at pipe penetrations.

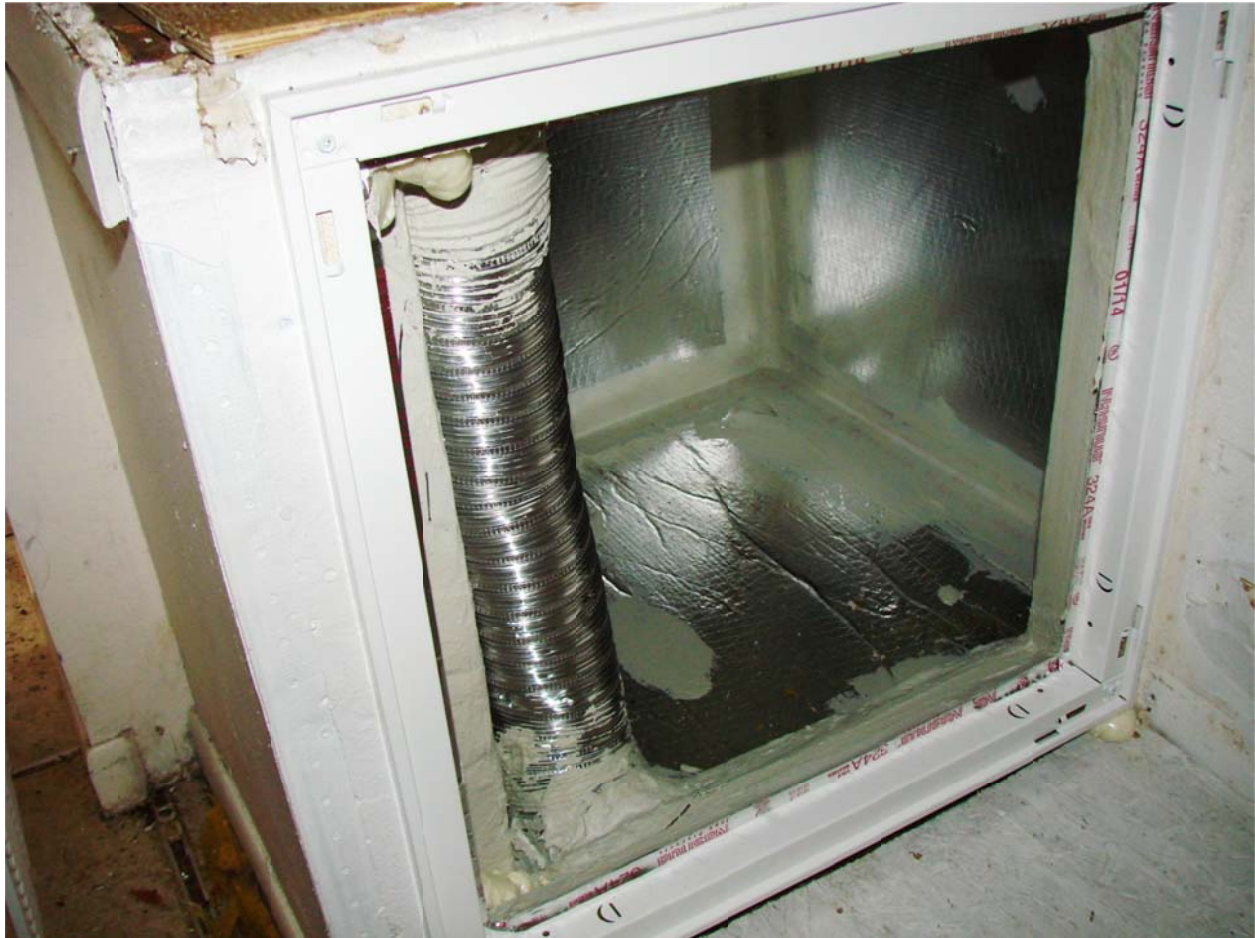
Figure 22. Repaired return plenum lined with duct board air barrier sealed with mastic at all edges.

Significant effort was expended on sealing and rebuilding the air handler platform in this house. When the air handler was removed the platform top was found to be rotten. The platform top removal was complicated by the fact that the platform was original installed before the house was drywalled. When the plenum was exposed it was sealed with duct board and mastic at the wall cavities and the raised floor (Figure 22). The new air handler was installed on the new platform and sealed with a combination of tape, mastic and caulk(Figure 23).

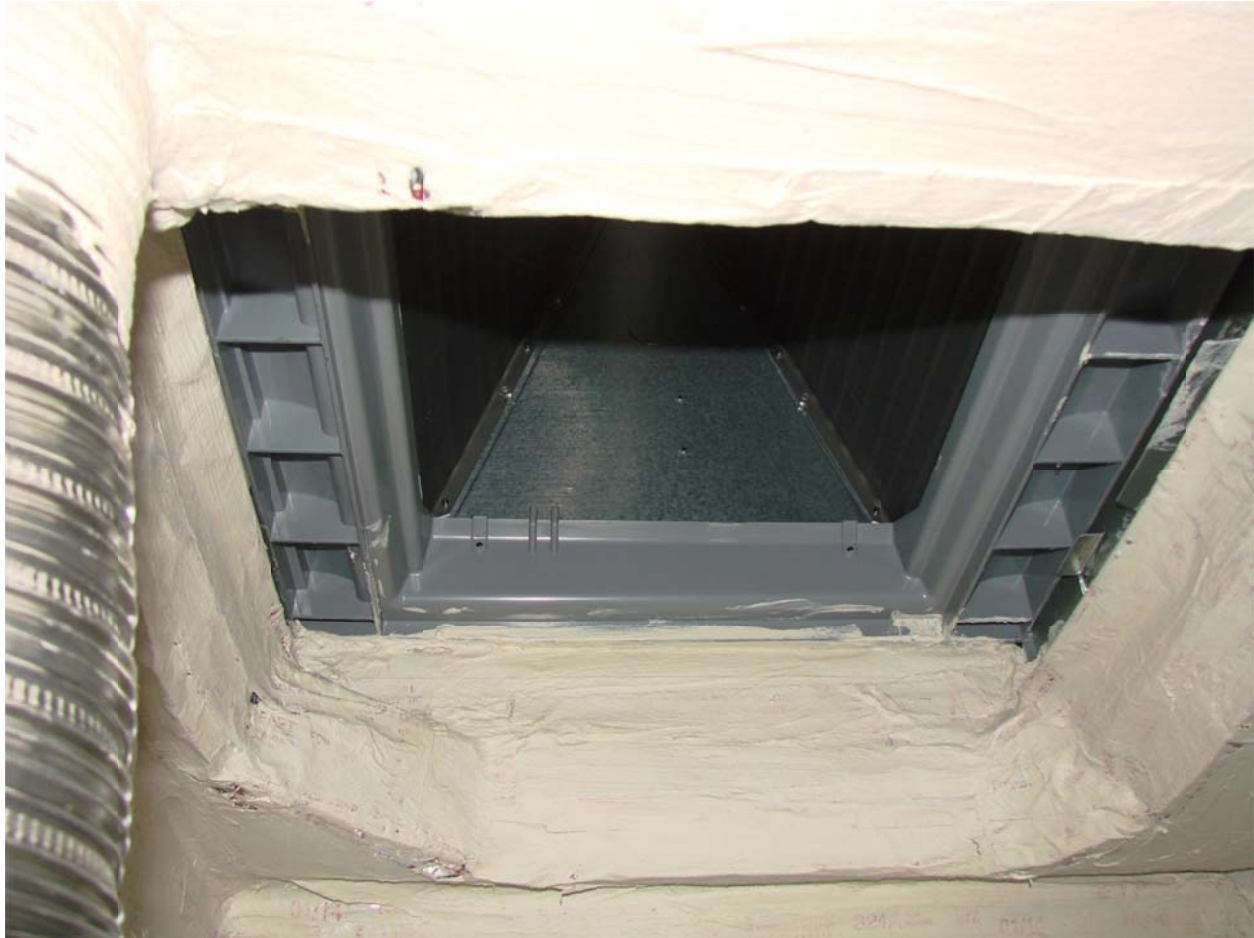
Figure 123. Return air entry to air handler seen from inside the return plenum. Joint between plenum, platform, and air handler is thoroughly sealed with mastic.

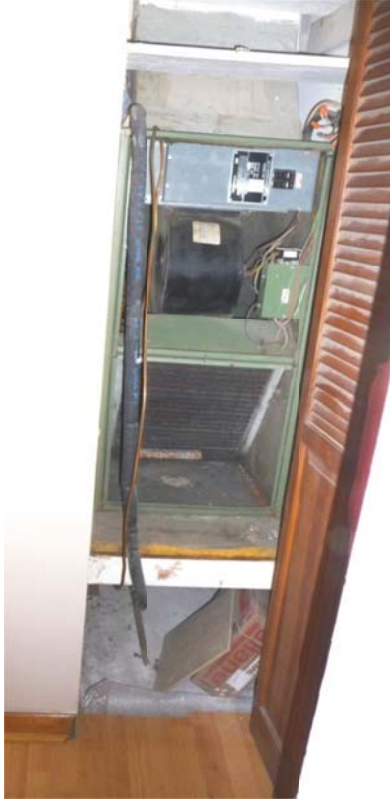
This 900 ft² slab-on-grade CBS house was built in 1981 (Figure 25). It has two bedrooms, one bath and an attached garage. The air handler is located on a stand in a hall closet behind a bi-fold half-louvered door (Figure 26). The return plenum formed under the air handler is un-drywalled, resulting in open wall cavities in the air handler return path (Figure 27).

Figure 26. Air handler closet with open frame platform return plenum.

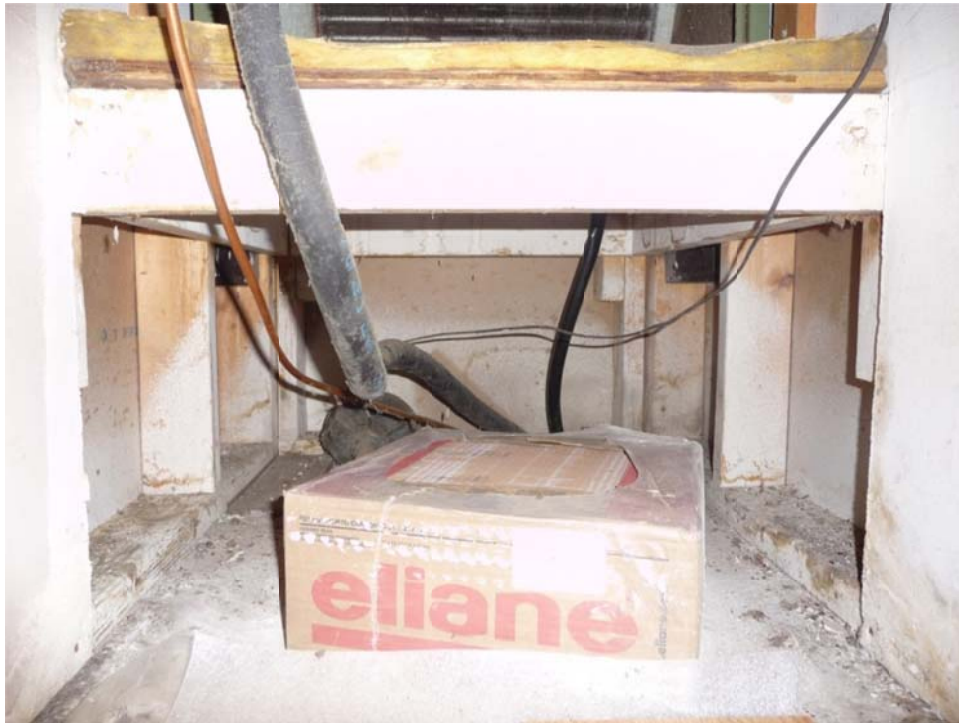
Figure 27. Open frame platform return.

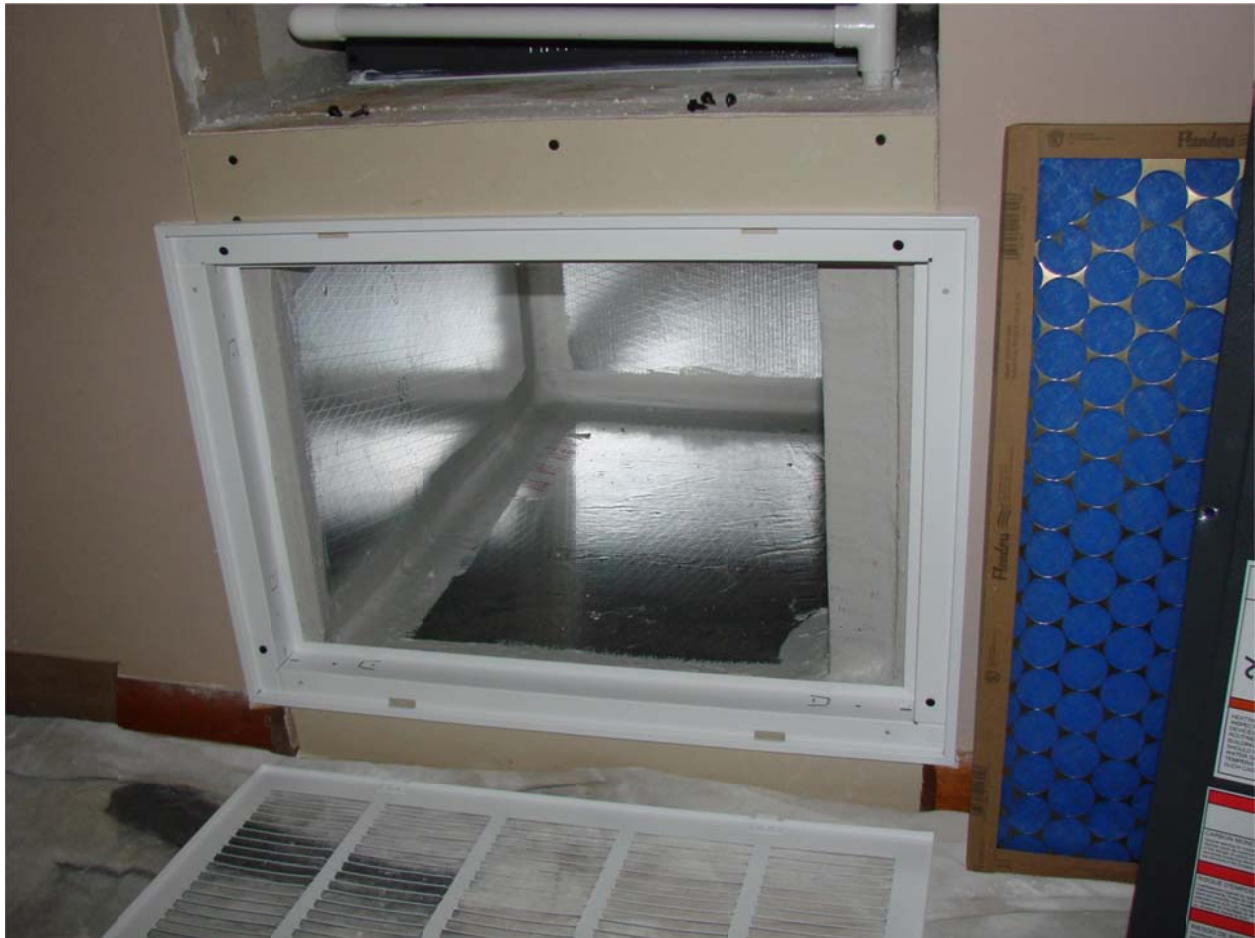
Figure 28. Repaired platform return plenum with duct board air barrier sealed at edges.

This contractor did significant work in the attic of the house sealing the supply system. The entire return configuration was changed to a platform with a filter-back grill installed in a well-sealed plenum (Figure 28). Additional time was spent while sealing the plenum to keep the condensate and Freon pipes isolated from the return plenum. The air handler closet will be completed with the installation of a half door to hide the air handler.

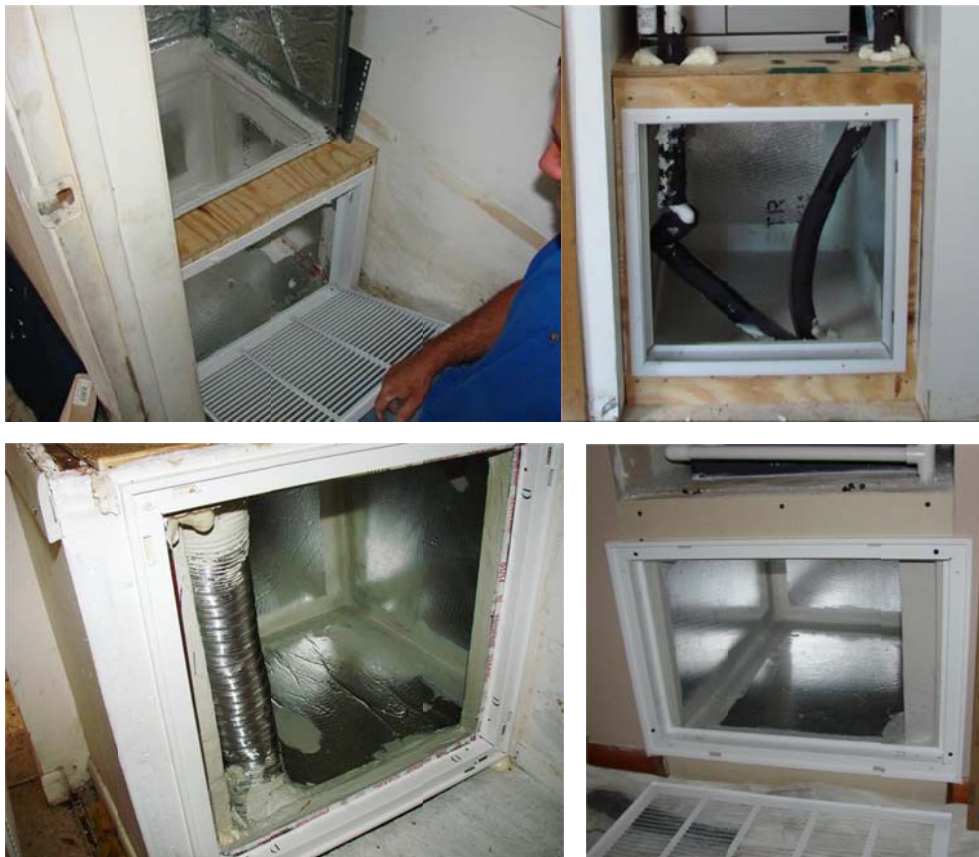
Although field data from previous studies backs up the findings in this small sample, it would be premature to draw any conclusions about feasibility of sealing building cavities used for return air in the general Florida existing housing stock. However, it is clear that the HVAC contractors in this study all had the same approach: build a platform return lined with duct board sealed at the edges and seams (Figure . An approach that is consistent with HVAC requirements and practices in Florida new construction. In essence, these return plenums are “as good as new”.

Figure 33. Air barrier lined return plenums in Test Houses (left to right) 1962, 194, 261, and 223.
