Final Report for Project Entitled:

**Full Scale Wind Load Testing of Aluminum Screen Enclosures
PO Number A95F33**

Florida Building Commission
State of Florida Department of Business and Professional Regulation

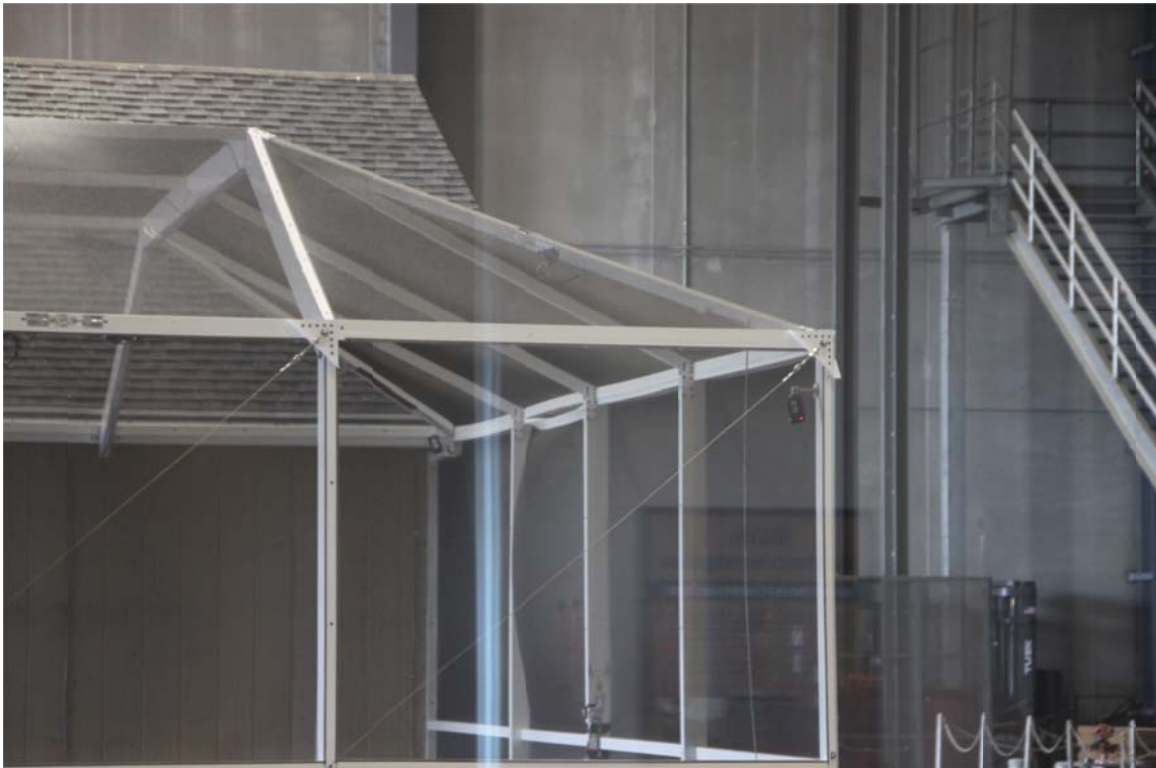
The generic specimen did not show any significant damage until Run 27 (80 mph). During Run 27, one 2X1 screen attachment failed and caused large movement of the attached screen as shown in Figure 16. The failed member was inspected after Run 27, which showed that the failure was due to the pullout of inner screws (Figure 17). The attachment had permanent distortion but it was still attached to the adjacent structural member.

Figure 16. Partial failure of the screen attachment during Run 27 (maximum wind speed = 80 mph)

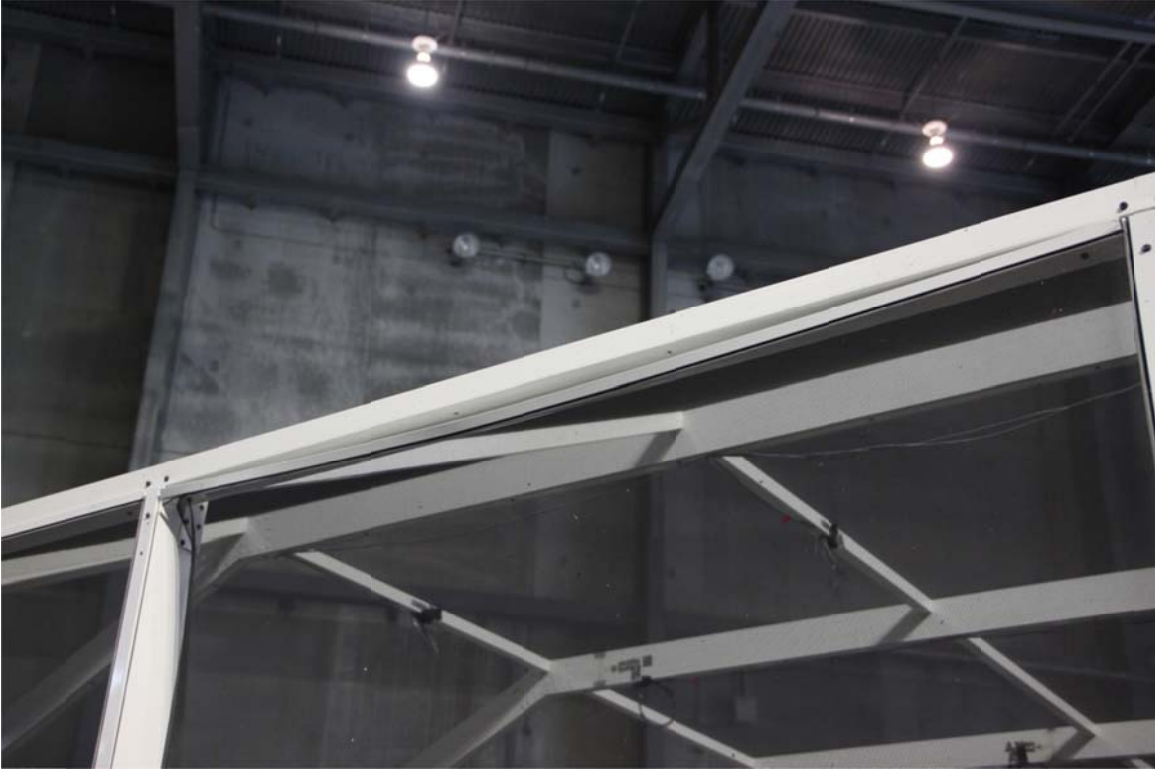
Figure 17. Partial failure of the screen attachment due to the pullout of screws (after Run 27)

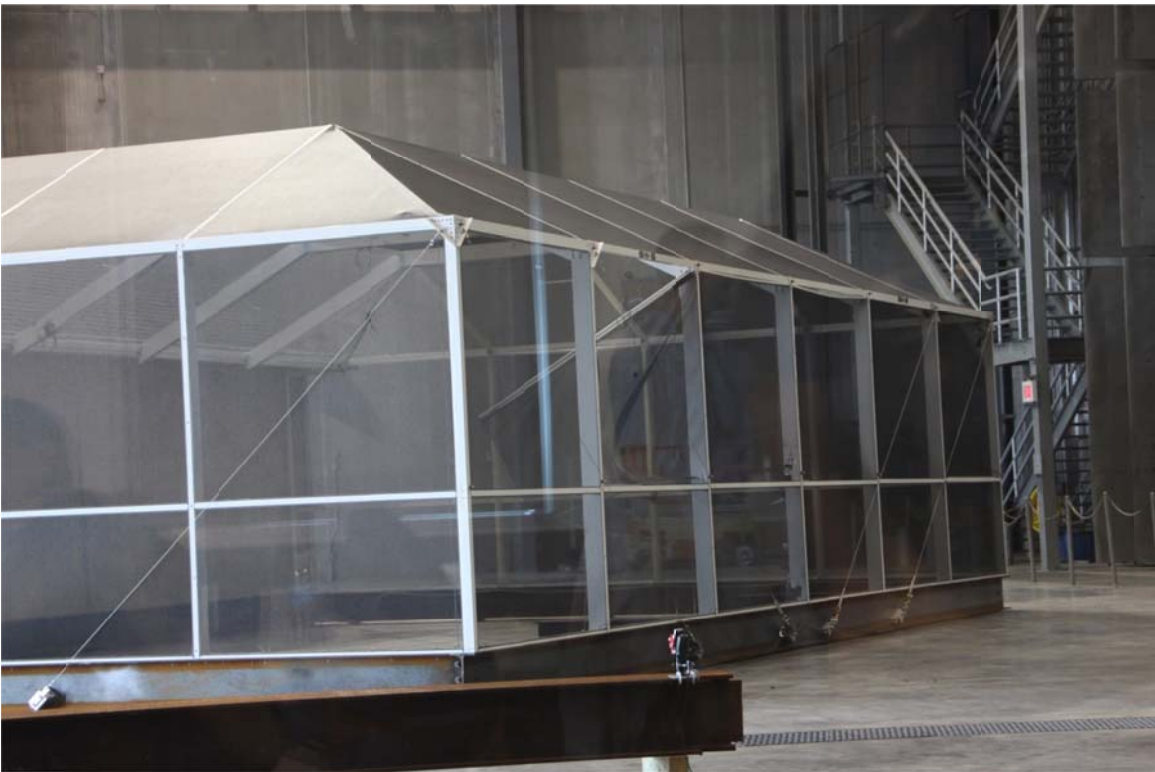
Run 28, the same maximum wind speed but applied at the wind angle of 0 degree, showed very similar behavior. Two 2X1 screen attachments at the upper center part of the windward wall failed in a similar way. When the maximum wind speed increased to 90 mph at Run 29, one 2X1 member further detached from the structure as shown in Figure 18. This particular stayed attached at one corner without causing failure of the main structural member.

Figure 18. Failure of the screen attachment during Run 29 (maximum wind speed = 90 mph)

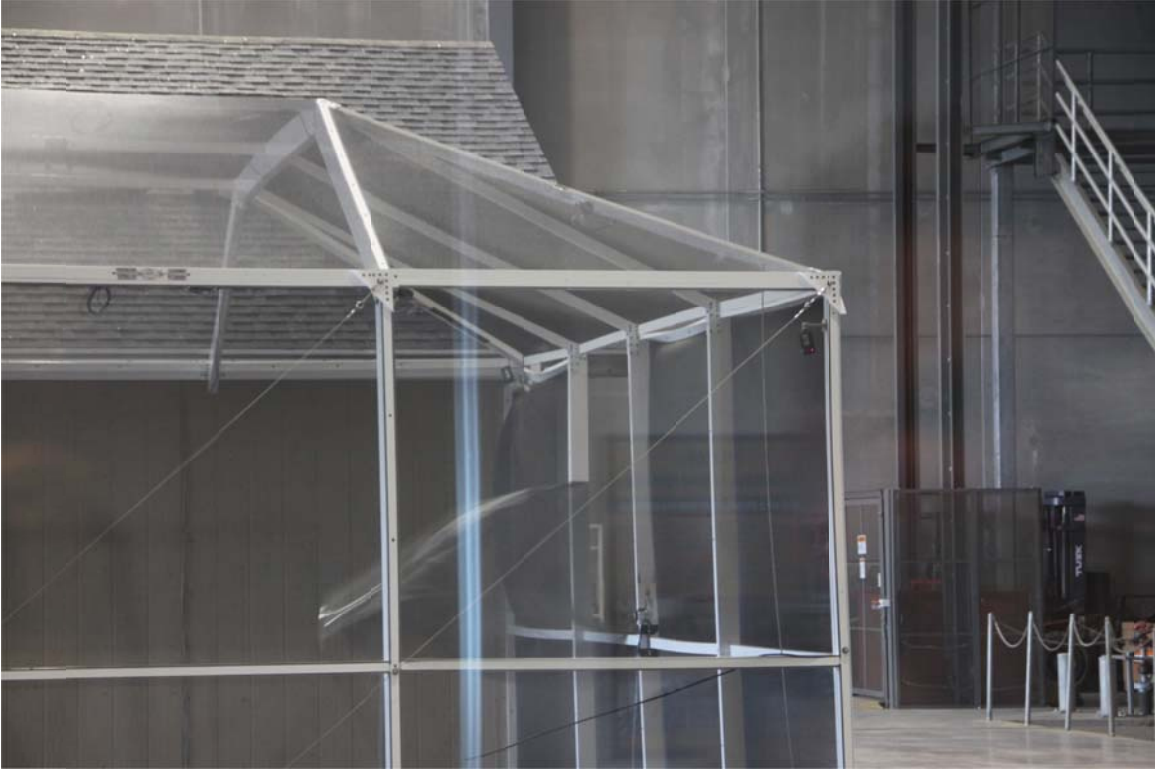
The next load case was Run 30, with the maximum wind speed of 90 mph applied at the wind angle of 90 degrees. One 2X1 member detached from the structure as shown in Figure 19. Similar failure occurred to one additional 2X1 member next to the host structure, which fluttered while staying attached to the structural member. The failed members were visually inspected after the Run 30. As shown in Figure 20, unlike the cases so far, failure of the 2X1 member caused failure of structural members. The failed structural members were the vertical post attached to the host structure and the member below the eave.

Figure 19. Failure of the screen attachment during Run 30 (maximum wind speed = 90 mph)

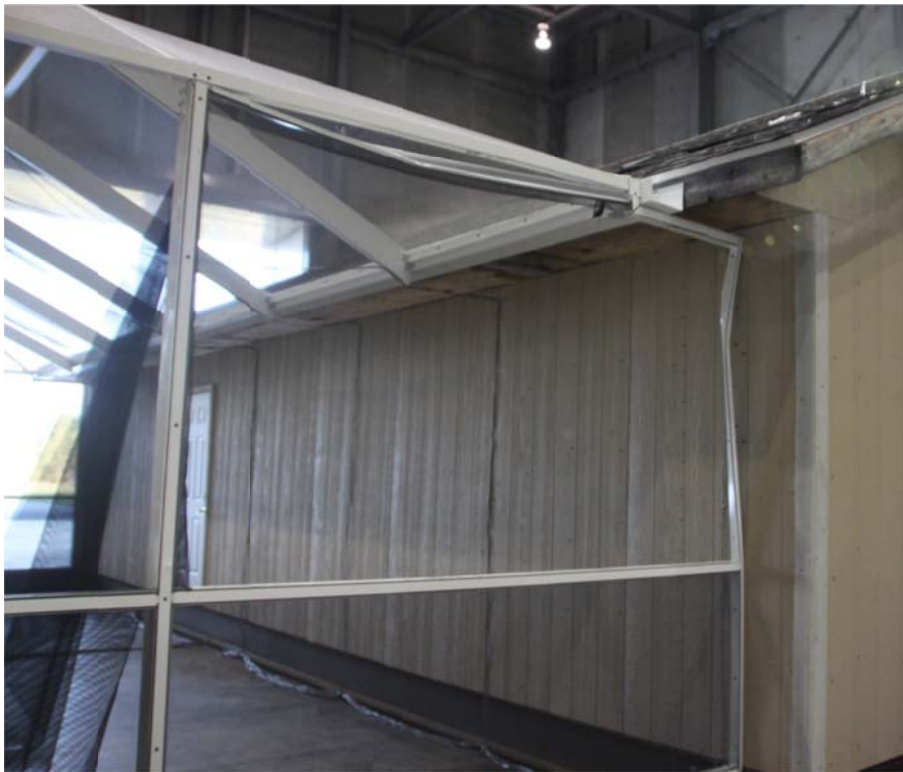
Due to the unexpected failure of the screens in both 0 degree wind angle and 90 degree wind angle, we were not able to fully load the generic specimen. The maximum wind speed that the structural members experienced was 80 mph, because at 90 mph screens began to fail. After completing Run 30, these failed screens were re-installed, with the exception of the corner shown in Figure 20 where re-installation was

Figure 20. Failure of the structural members after Run 30

not possible. It was decided to add additional screws (in between the installed screws) to prevent failure of the screens. The goal was to apply larger forces to structural members without premature failure of the screens.

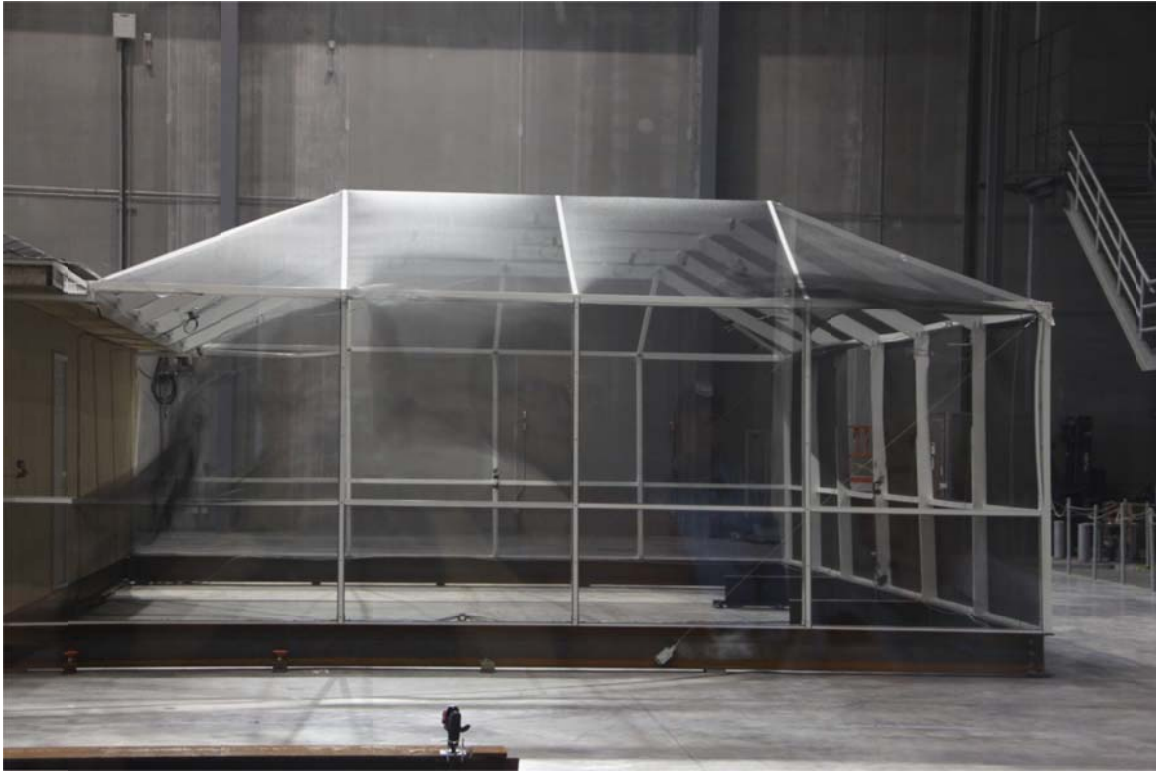
The wind angle was adjusted to 270 degrees (instead of 90 degrees) in Run 31 to utilize fully intact windward screens on that side. The maximum wind speed was increased to 100 mph. Run 32 also had the maximum wind speed of 100 mph, but applied at 0 degree wind angle. In both tests there were no visible failure of structural members. Only some 2X1 screen attachment continued to fail as shown in Figure 21.

Figure 21. Failure of the screen attachment during Run 32 (maximum wind speed = 100 mph)

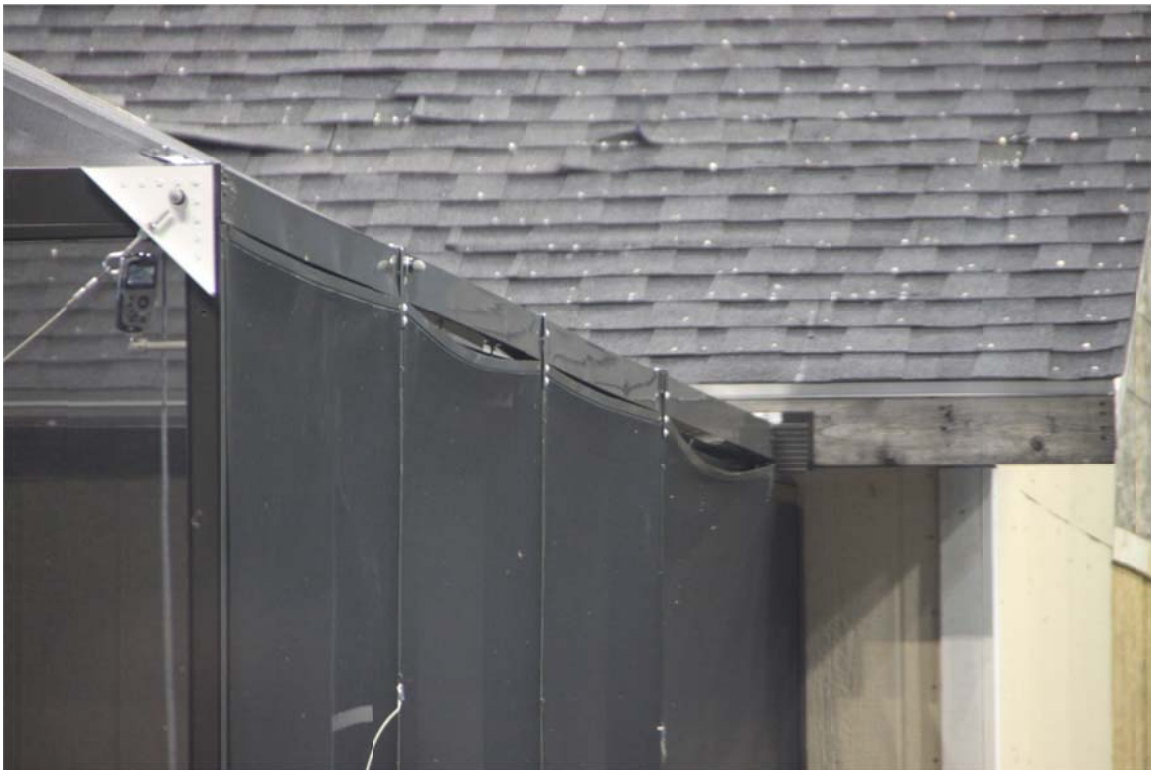
Overall, the AAF specimen responded similar to the generic specimen. No significant damage was observed until 80 mph, when some screen attachments began to fail partially as shown in Figure 22. At 90 mph 0 degree wind angle (Run 29), the second screen panel from the far end failed as shown in Figure 23. At 90 mph 90 degree wind angle (Run 30), the first screen panel from the far end failed in a similar fashion. Figure 24 compares failed screen attachments between the generic specimen and the AAF specimen after completing the Run 30.

Figure 22. Partial failure of the screen attachment during Run 27 (maximum wind speed = 80 mph)

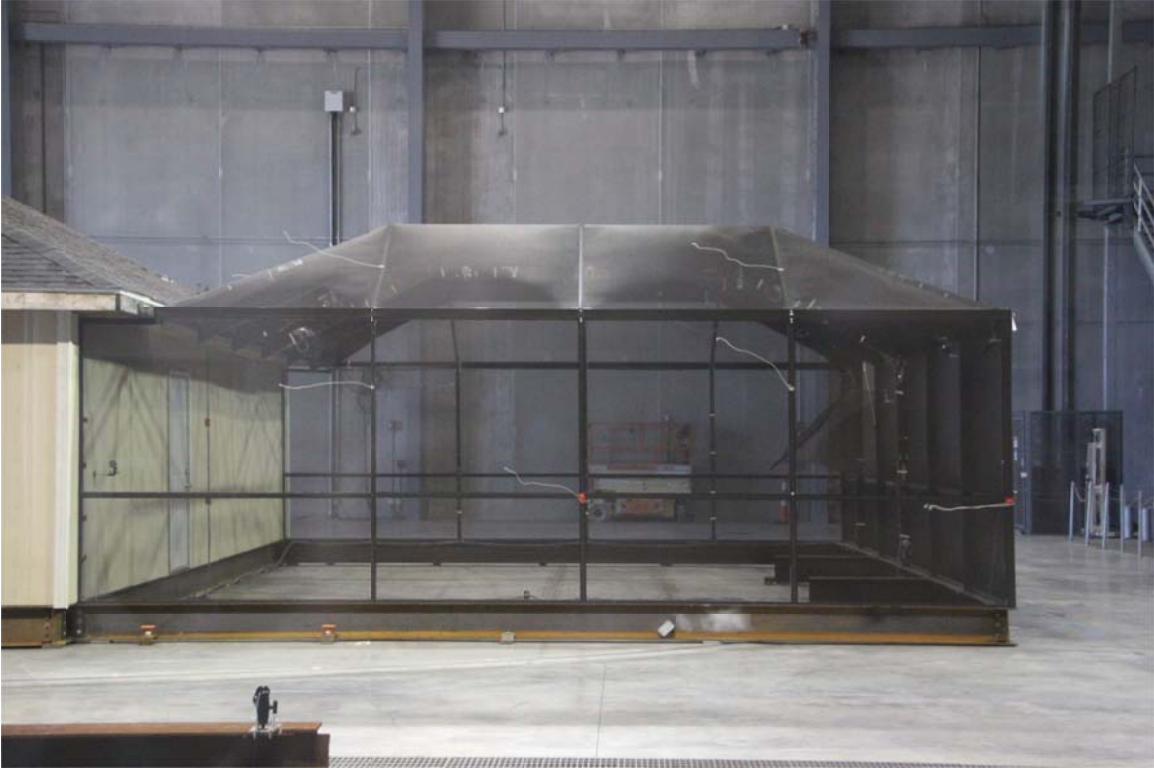
Figure 23. Failure of the screen attachment during Run 29 (maximum wind speed = 90 mph)

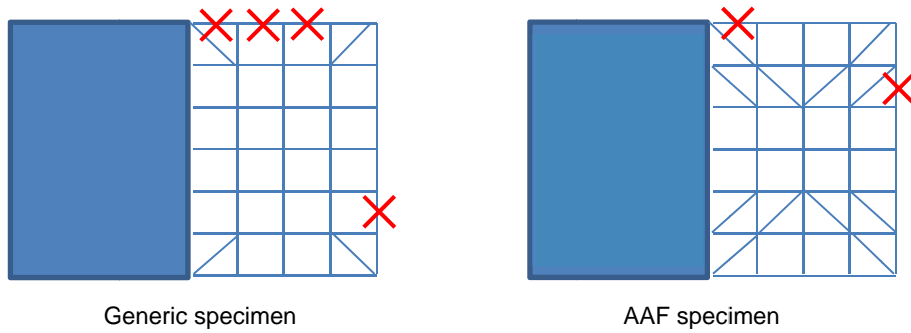
Figure 24. Comparison of failed screens and/or screen attachments (fully failed ones only) between the generic specimen and the AAF specimen after Run 30 (maximum wind speed = 90 mph)

When we compare high moment locations (M-17, M-18) with the location that lost the screen attachment (see Figure 24), we can hypothesize that high moment contributed to the failure of the screen attachment. We can also hypothesize that overall higher moments in the Generic specimen led to greater loss of screen attachments compared to the AAF specimen. With the available data, it is not possible to prove or disprove these points, but these can be further investigated in the future study.

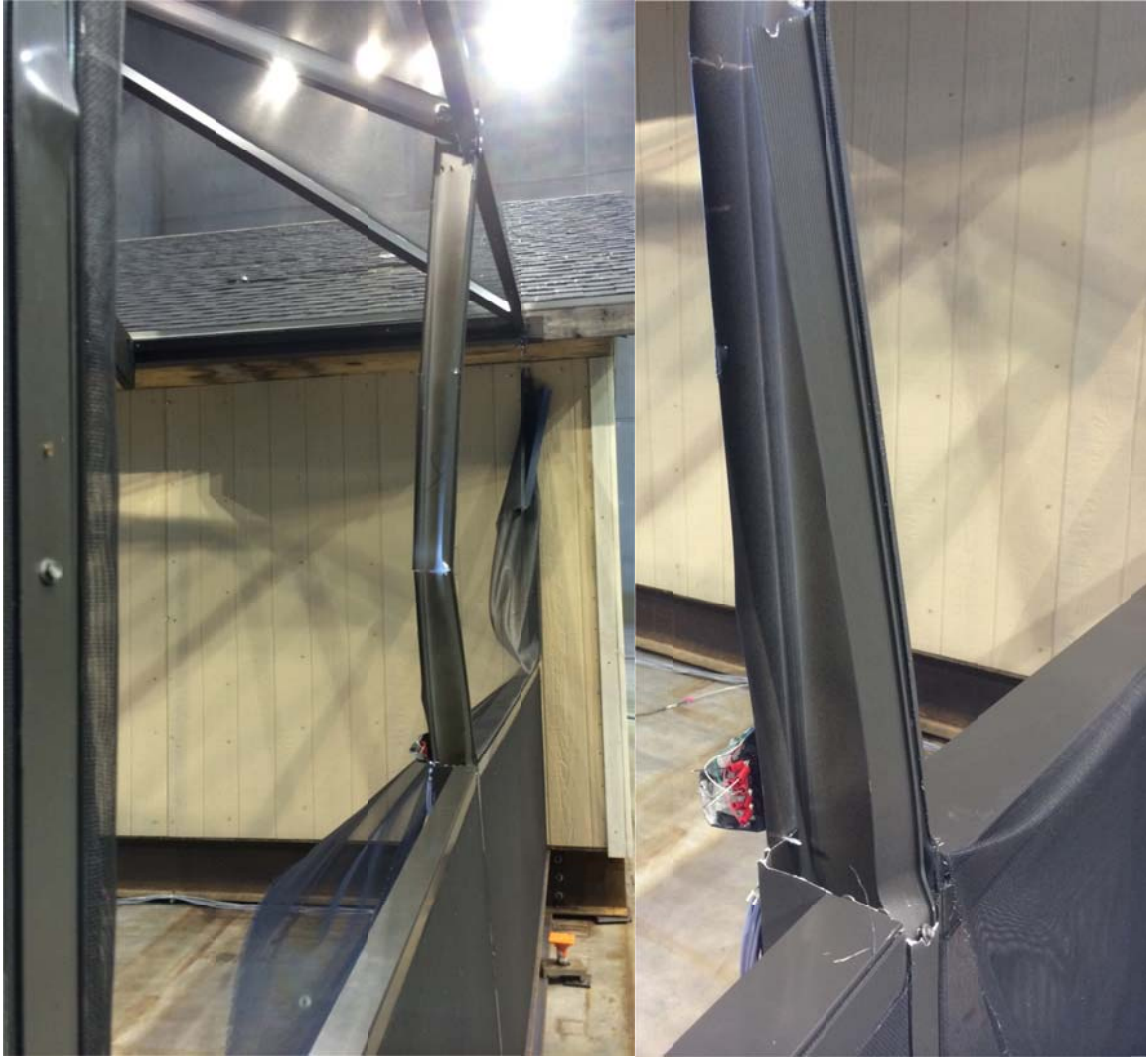
While the generic specimen had to undergo re-screening due to the loss of three (out of four) upper windows as well as change of loading direction in Run 31, the AAF specimen was subjected to 100 mph wind speed immediately after the Run 30. During Run 31, the screen attachment of the second window from the far failed, but the failed member dangled in the corner and fluttered. Therefore, the upper column was continuously subjected to the large force even after the failure of the screen. The upper column was significantly damaged in the process as shown in Figure 25. While investigating the failure, the thickness of this column was compared between the generic specimen and the AAF specimen. For the generic specimen, the thickness of the flat part and the grooved part were 0.045 inch and 0.061 inch. For the AAF specimen, the thickness of the flat part and the grooved part were 0.042 inch (-6%) and 0.059 inch (-3%). It is possible that slightly less thickness of the AAF member contributed to the failure, but given the small difference the fluttering of the dangled screen attachment was likely cause of the failure of this column.

Figure 25. Failure of structural members after Run 31 (maximum wind speed = 100 mph)

We decided to further investigate why the column has failed. The windward wall (at 90 degrees wind angle) was retrofitted by replacing the two interior posts with intact members from the generic specimen. All failed screens were repaired with new screens. Additional screws were added to the screen attachments to prevent the failure of the screen attachment, and to fully load the specimen. Run 32 then was conducted, which was identical to Run 31. Turbulence was added at Run 33. Wind angle was changed from 90 degrees to 0 degree in Run 34. The corner screen was cut in Run 35 to introduce unbalanced loading to the column. Extra screws in the screen attachment were removed in Run 36.

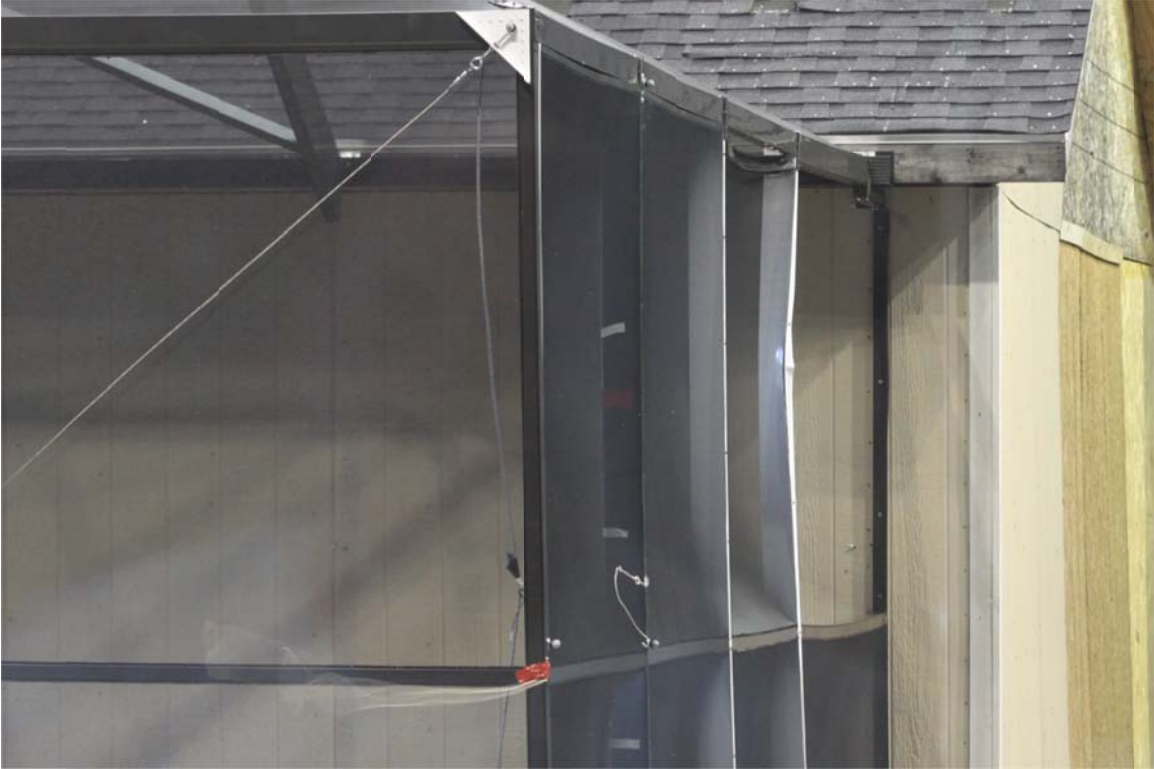
Additional screws from the second window attachment were removed in Run 37, so that the attachment would fail similar to what happened in Run 31. Under these conditions, i.e., wind loading from only one of the two sides and failed screen attachment, the column failed again as shown in Figure 26.

Figure 26. Reproduction of failure of the column in Run 37: unbalanced loading with the failed screen attachment led to the failure of the column

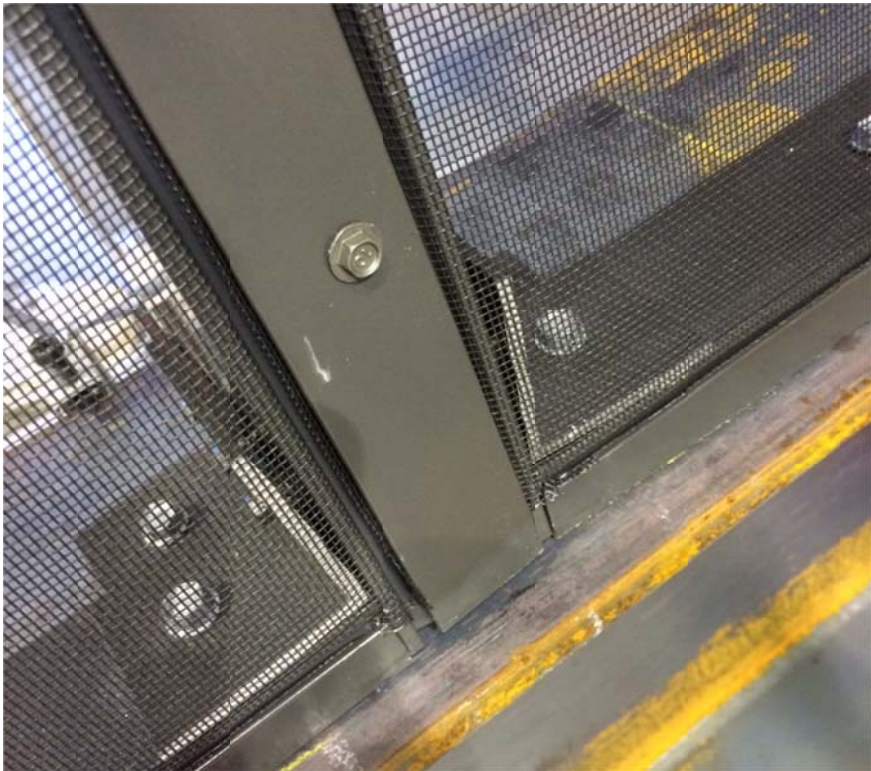
While the specimen was retrofitted after Run 31, we visually checked failure at other locations. It appeared that cables lost tensions significantly (but not completely) during the series of runs. We also found out that brackets at the base of the post (windward wall for 0 degree wind angle, third post from the left) had local failure as shown in Figure 27. It was unclear if the failure was from a specific load case, or repeated high moment at the base during the series of runs.

Figure 27. Local failure of brackets at the base of the post (windward wall for 0 degree wind angle, third post from the left)

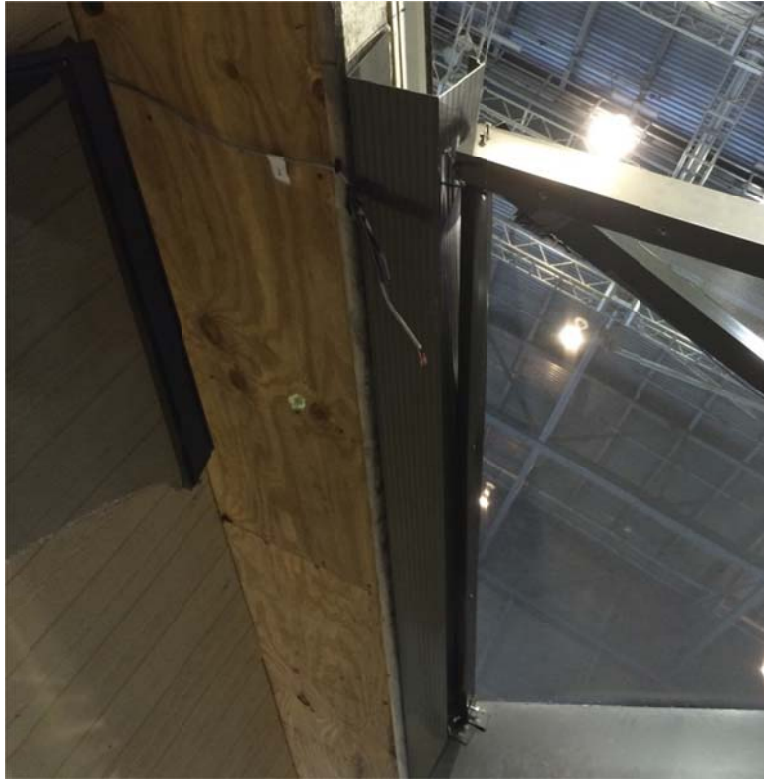
Run 38 was an attempt to investigate the effect of the additionally installed screws to the screen attachments. Extra screws in windward wall of 0 degree wind angle were removed in Run 38. Runs 39 and 40 were attempts to investigate poorly constructed cables. Poorly constructed cables can be pulled out from the ground or the mount during the hurricanes. In these tests tension cables were removed from the specimen. When the wind loading was applied greater moment was applied to the screen-to-host connections and one of these connections failed as shown in Figure 28.

Figure 28. Failure of a screen-to-host connection after Run 39 (removed tension cables, wind angle = 270 degrees, maximum wind speed = 100 mph)
