FINAL Report:

Hurricane Michael Data Enhancement (Phase II), Performance of Modular Houses and FEMA Recovery Advisory Reviews

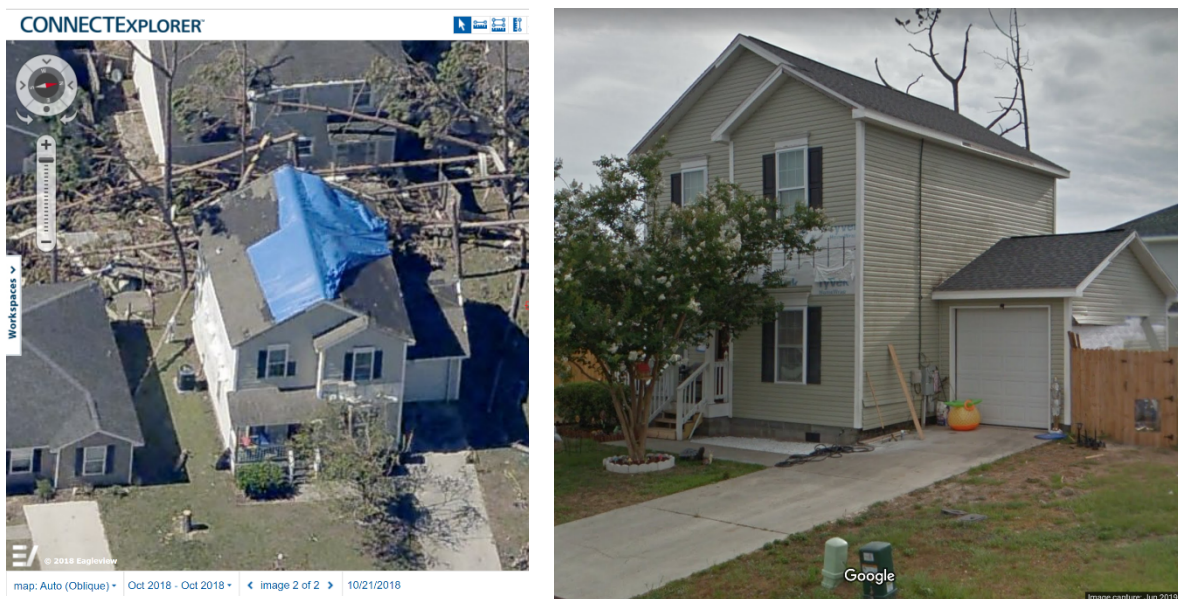
Figure 1. Supplemental data sources for identifying hurricane damage to modular homes. (Left) Eagleview ConnectExplorer platform (imagery collected 10/21/2018), and (right) Google Streetview (imagery collected June 2019).

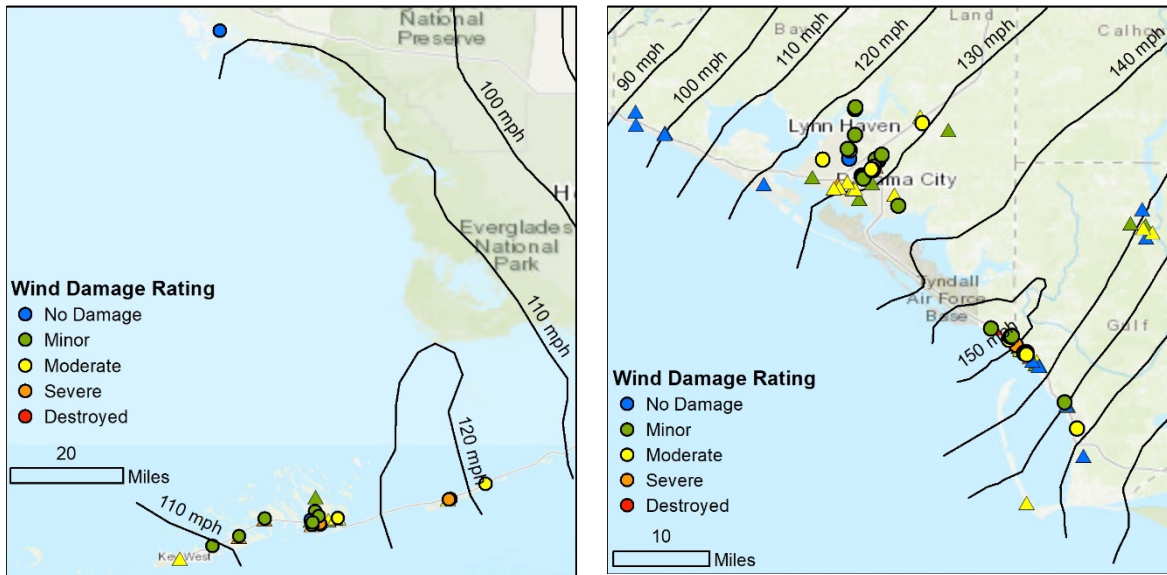
Figure 2. Locations of modular and site-built homes used to evaluate relative wind performance during (left) Hurricane Irma (2017); and (right) Hurricane Michael (2018). Circles indicate site-built homes and triangles indicate modular homes.

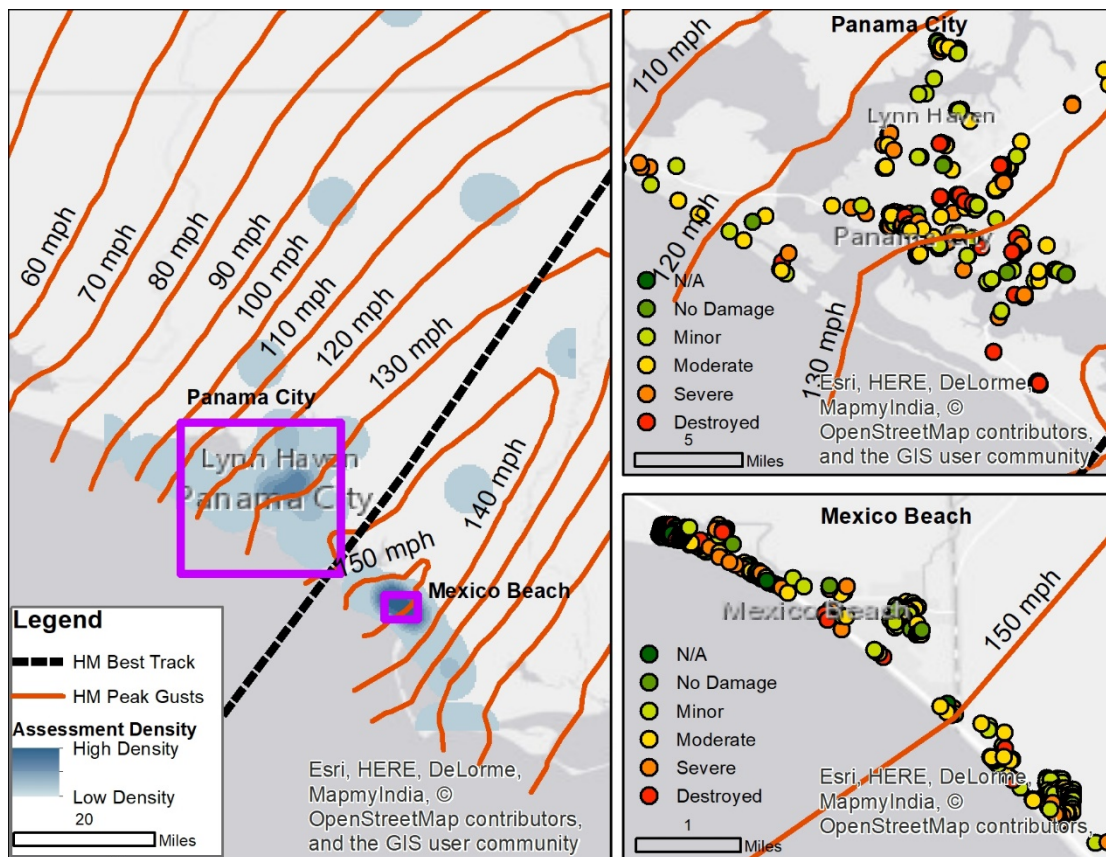
Figure 3. Assessment locations in Florida relative to estimated peak gust wind speeds (Vickery Peter et al. 2018) and best hurricane track (Beven et al. 2019). Wind damage rating are provided in the two inset figure for Panama City and Mexico Beach.

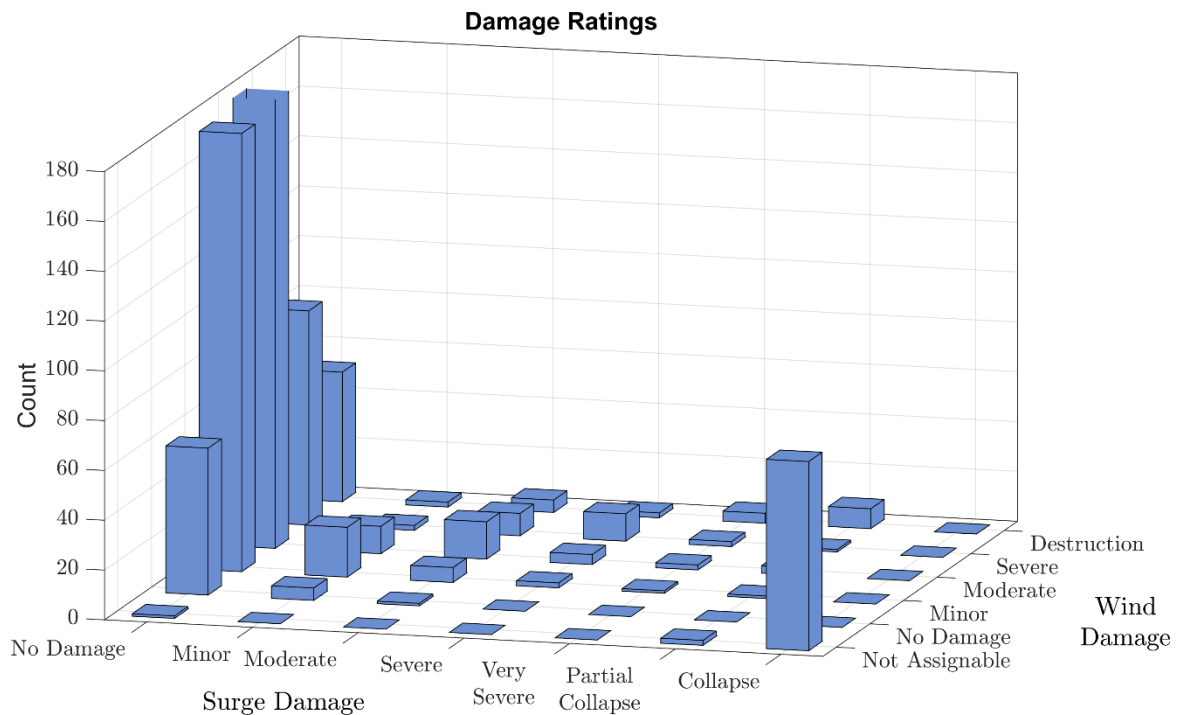
Figure 4. Distribution of wind and surge damage ratings.

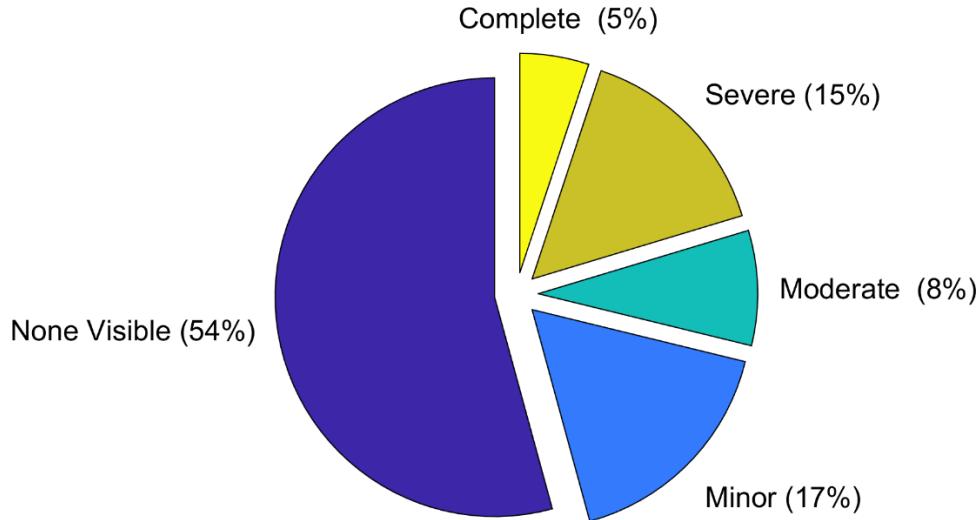
Figure 5. Distribution of rainwater ingress damage ratings (N = 59).

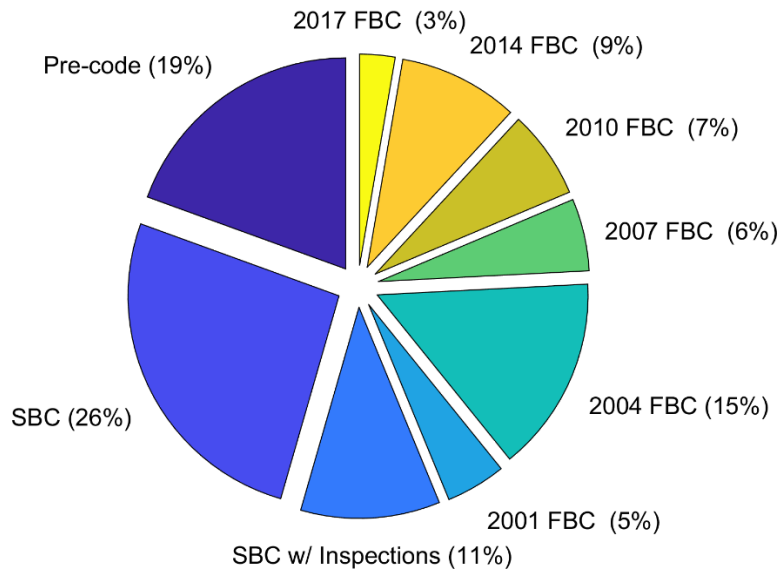
Figure 7. Distribution of buildings in the dataset by building code edition (N = 751).

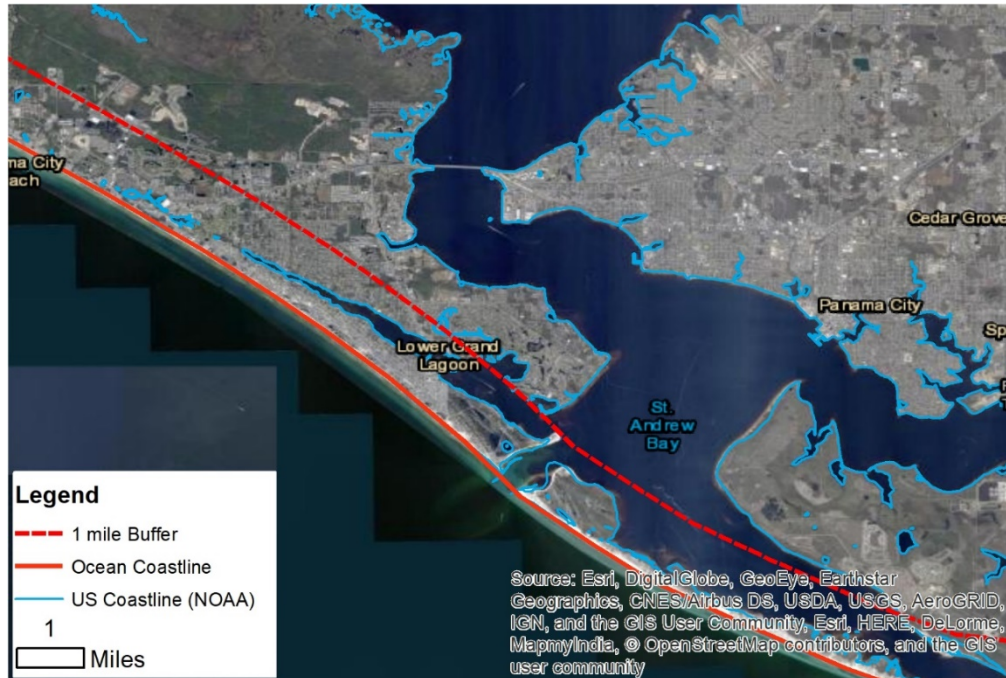
Figure 8. Approximate delineation of the wind-borne debris region based on 1 mile from mean high water line, subjectively shown here as the coastline bordering the Gulf of Mexico.

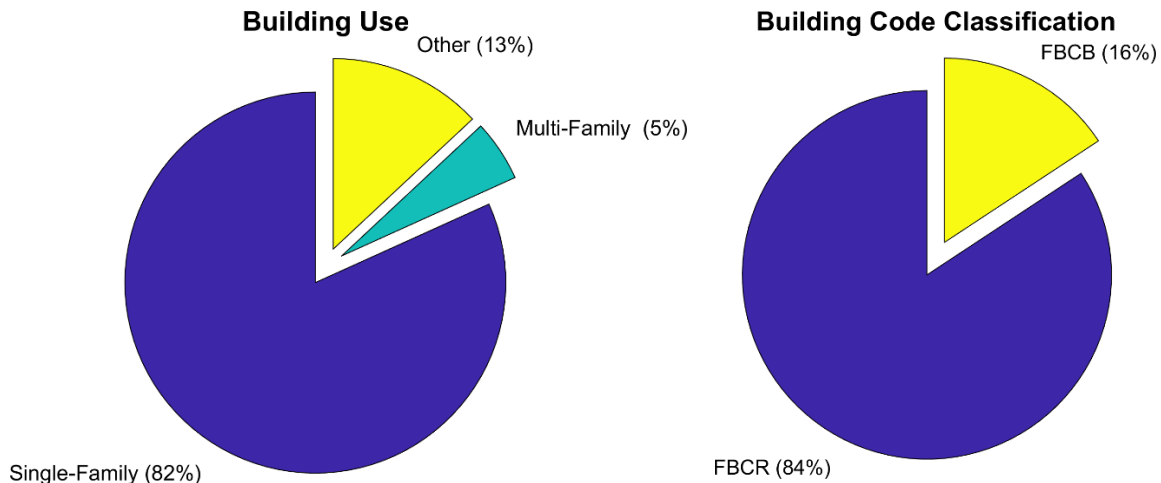
Figure 9. Distribution of buildings by (left) building use, and (right) building code classification.

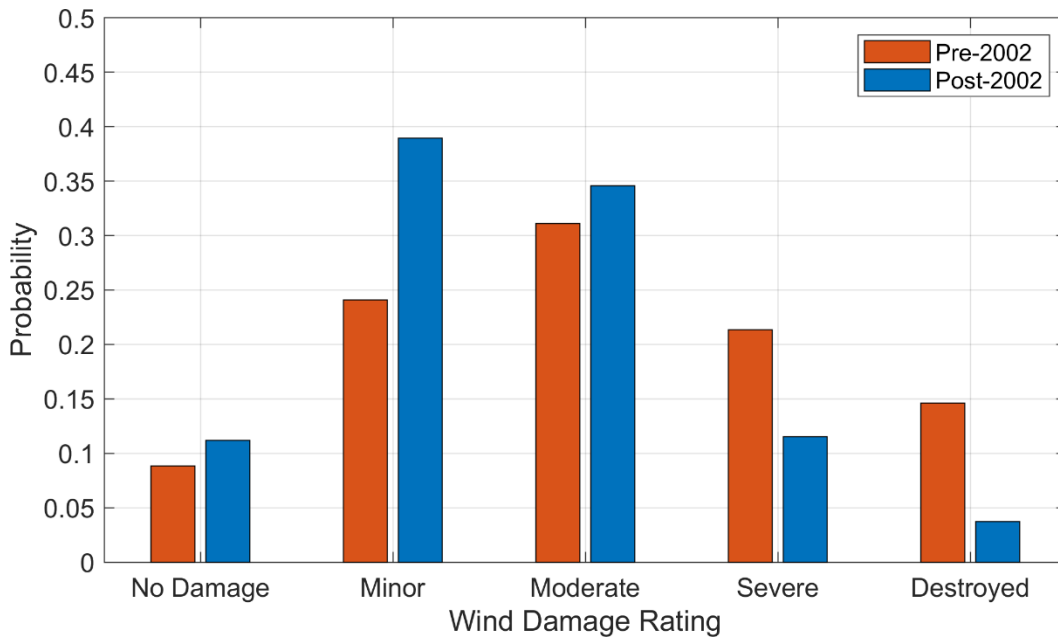
Figure 10. Relative distribution of wind damage ratings in pre-2002 (prior to 2001 FBC) and post-2002 (after 2001 FBC) buildings.

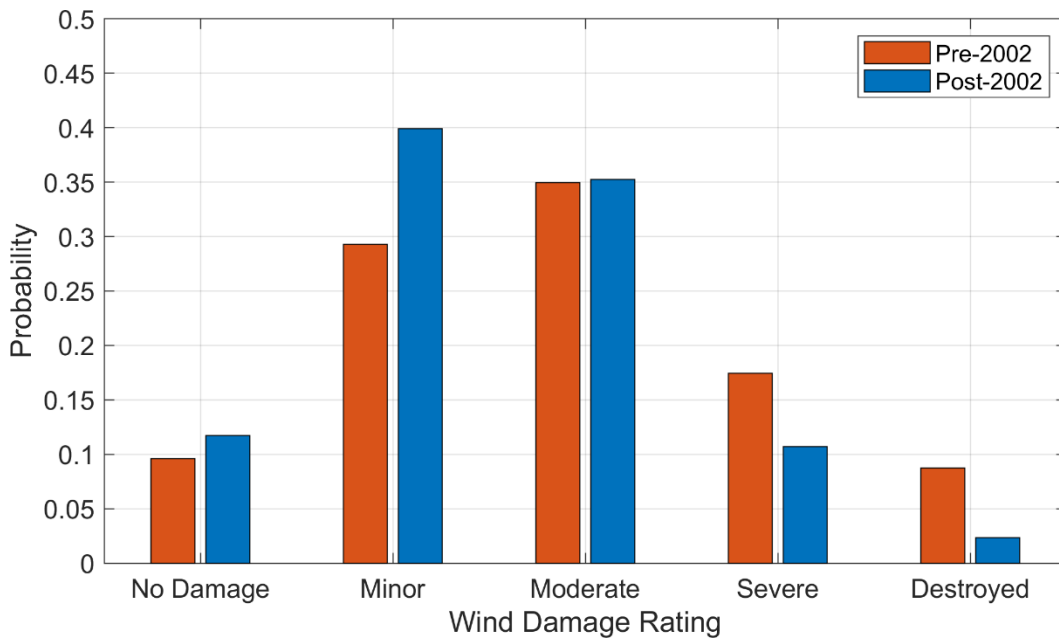
Figure 11. Relative distribution of wind damage ratings in pre-2002 (prior to 2001 FBC) and post-2002 (after 2001 FBC) Single-Family Residential buildings.

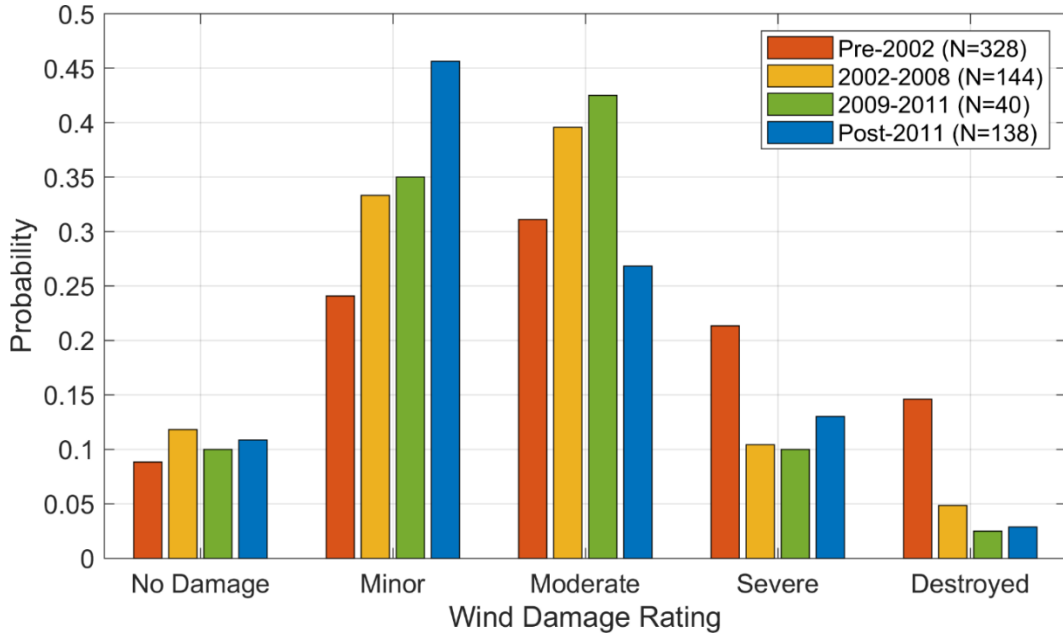
Figure 12. Distribution of wind damage ratings for all buildings by major era.

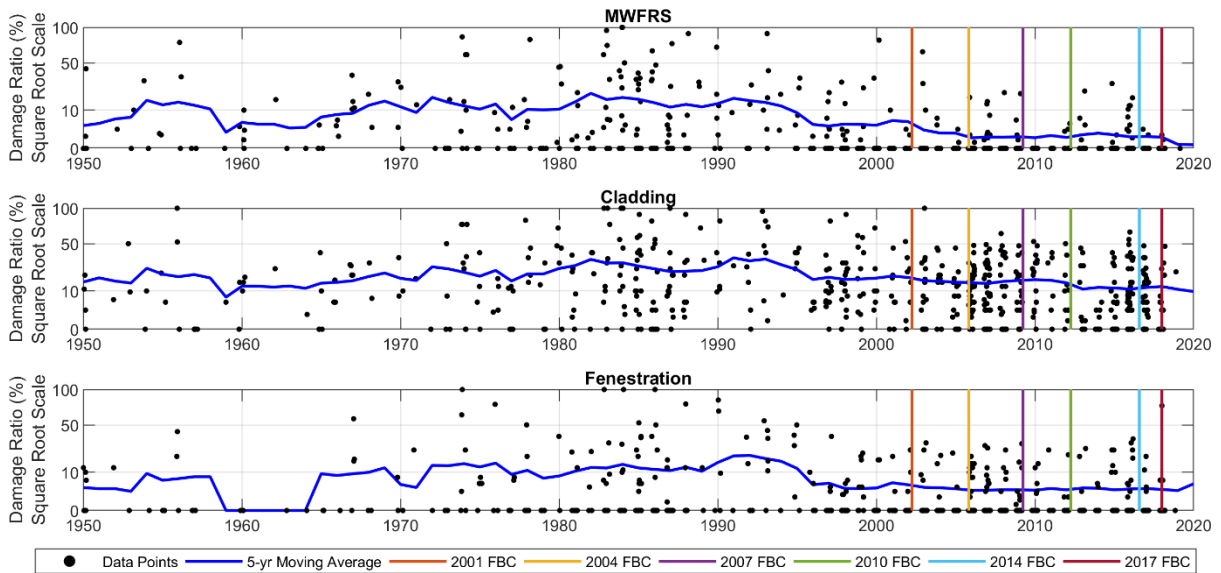
Figure 13. Changes in MWFRS, Cladding and Fenestration damage ratios with respect to year built and Florida Building Code editions. Damage ratios exclude any damage caused by storm surge.

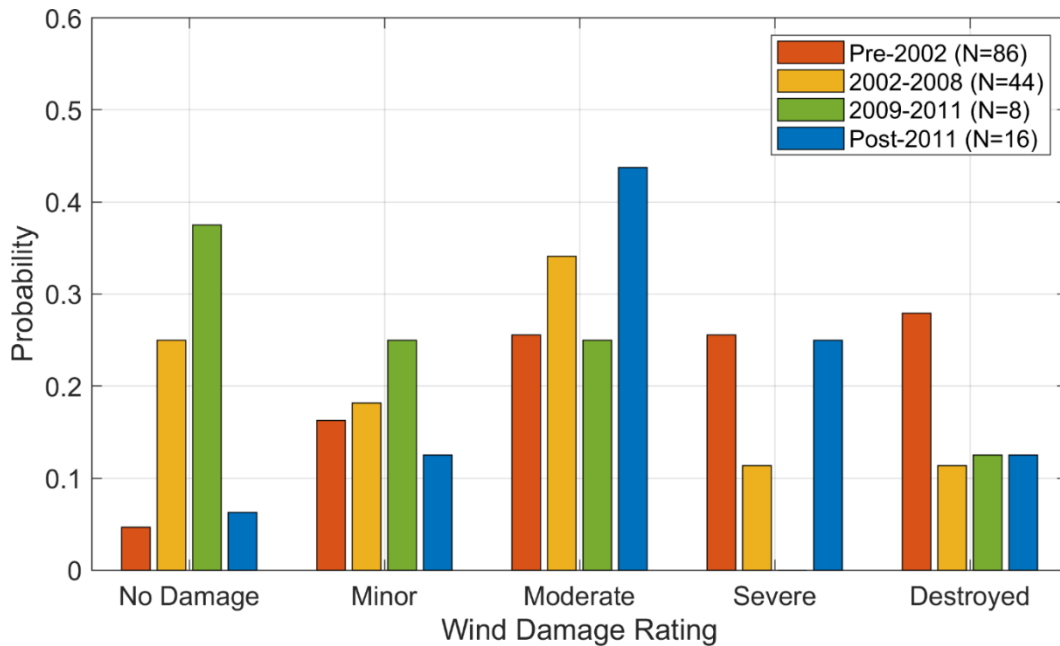
Figure 14. Distribution of wind damage ratings for all buildings excluded from using the Florida Building Code Residential, by major era.

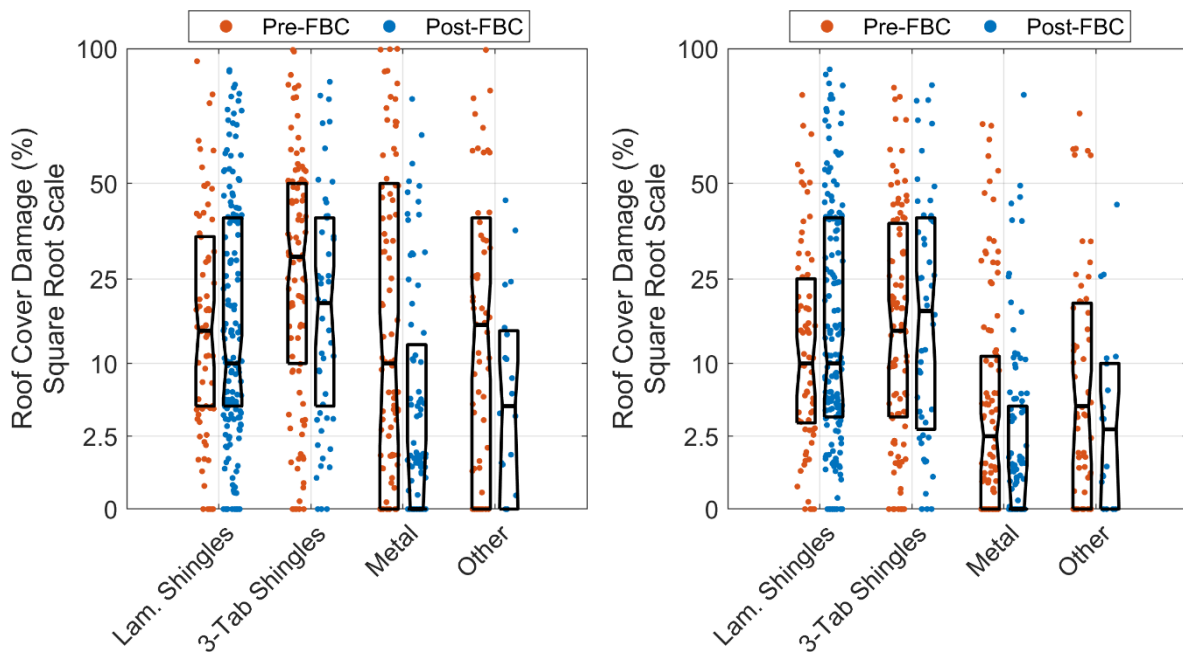
Figure 15. Roof cover damage ratios in pre- and post-FBC buildings by roof cover type (left) assuming 100% roof cover located on damaged roof substrate is also damaged; (right) assuming 0% of roof cover located on damaged roof substrate is also damaged.

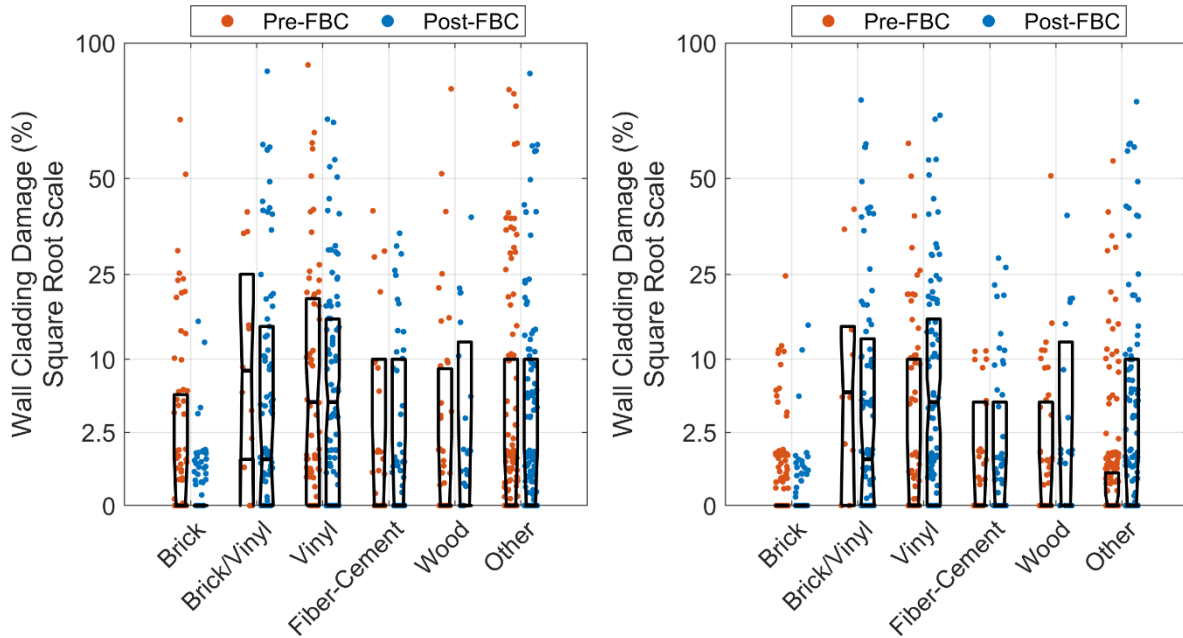
Figure 16. Wall cladding damage ratios in pre- and post-FBC buildings by cladding material; (left) assuming 1000% of wall cladding located on damaged wall substrate is also damaged; (right) assuming 0% of wall cladding located on damaged wall substrate is also damaged.

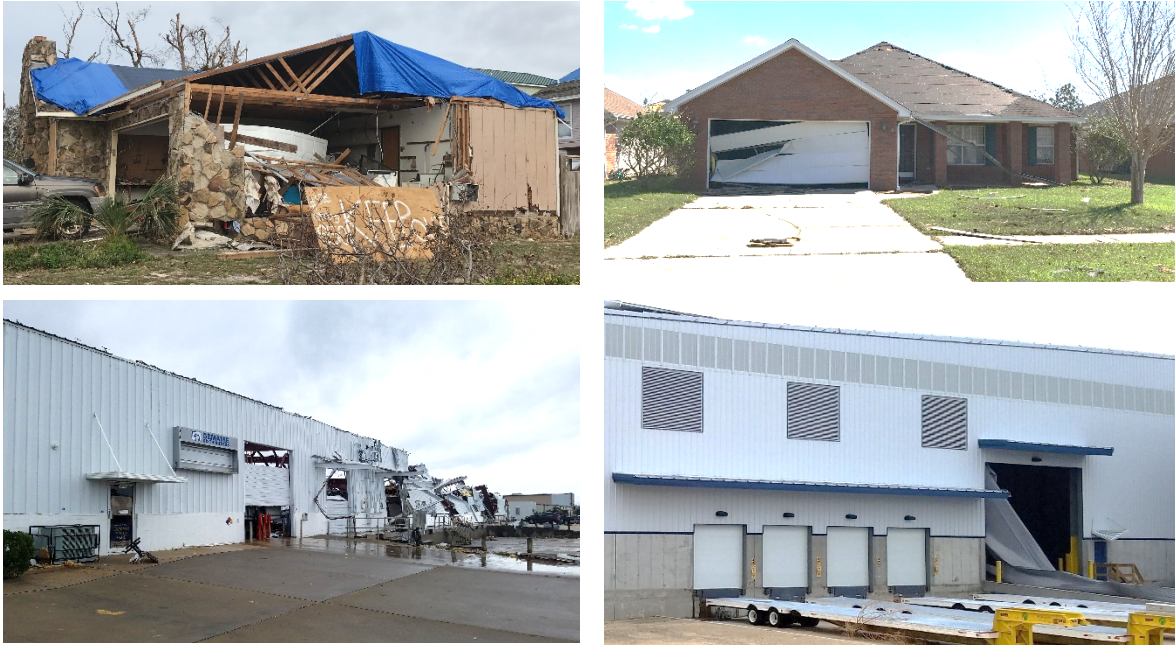
Figure 17. Illustrative large door failures; (top left) pre-FBC residential building in Mexico Beach area, (top right) post-FBC building in Panama City, (bottom left) pre-FBC commercial building in Panama City, (bottom right) post-FBC commercial building in Panama City.

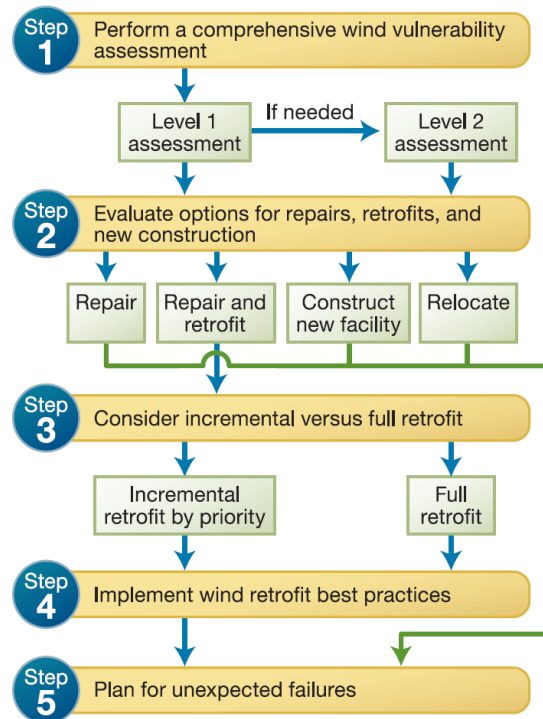
Figure 18. RA 1 flowchart showing five-step approach to improving wind resistance (FEMA, 2019a)

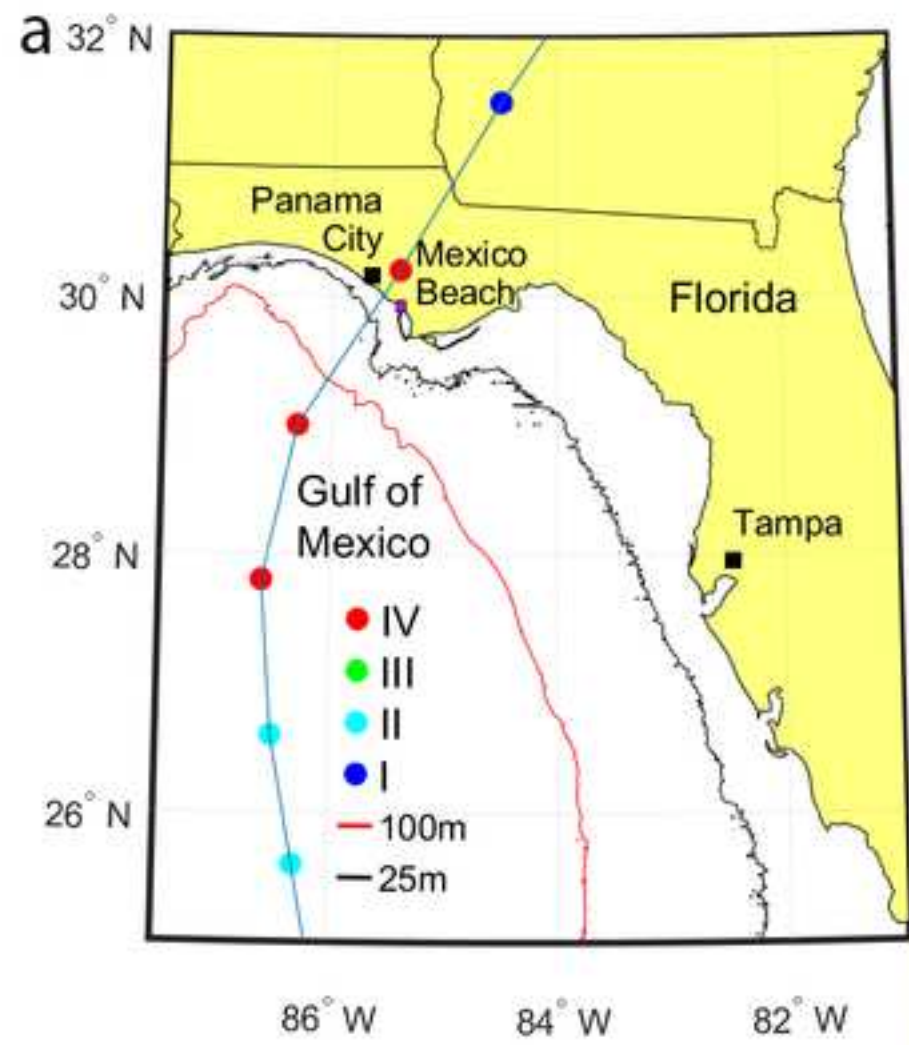
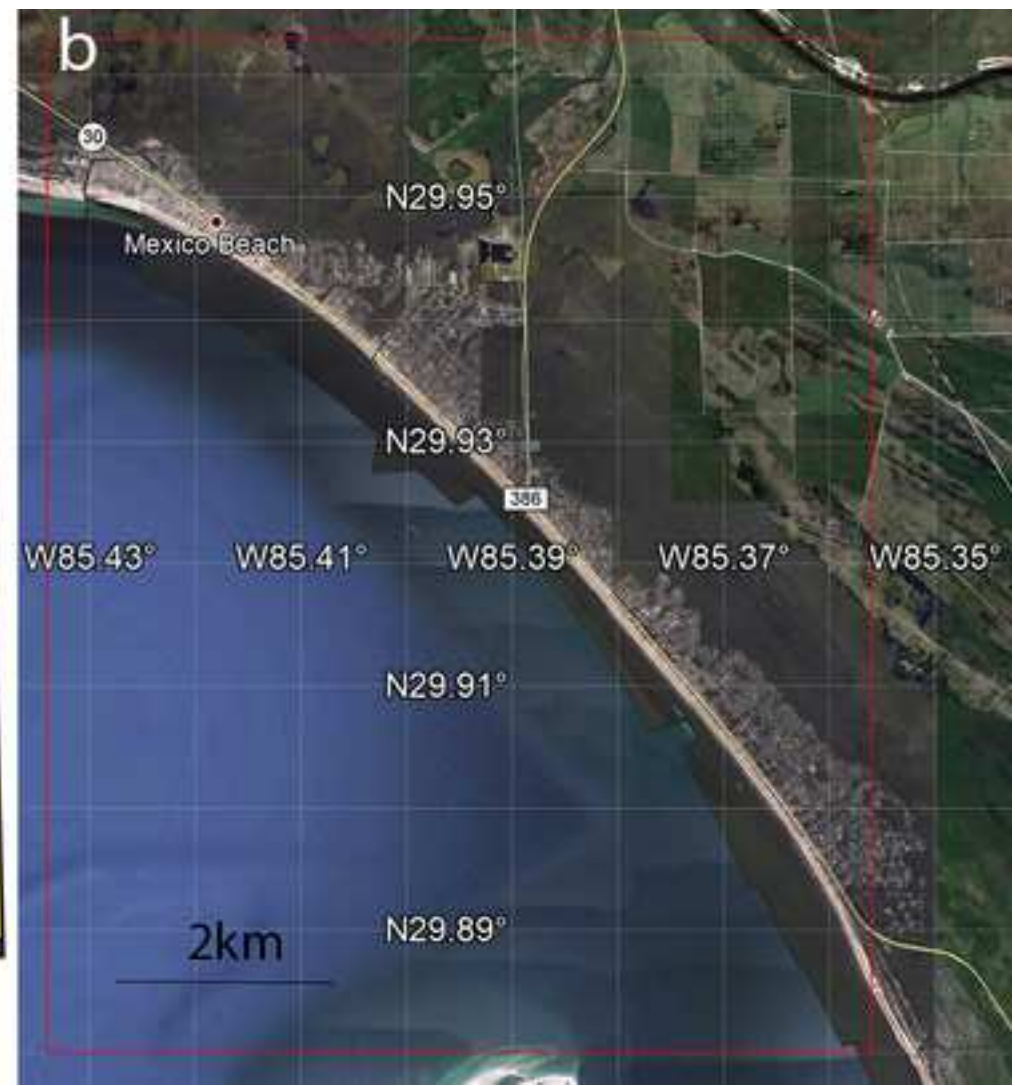
Table 2: Damage State Component Classification Methodology from Tomiczek et al. (2017).
