Residential Roofing And Hurricanes

**June 2005
Version 1.0**

**Florida Building Commission
2555 Shumard Oak Boulevard
Tallahassee, Florida 32399-2100
(850) 487-1824**

Residential Roofing and Hurricanes

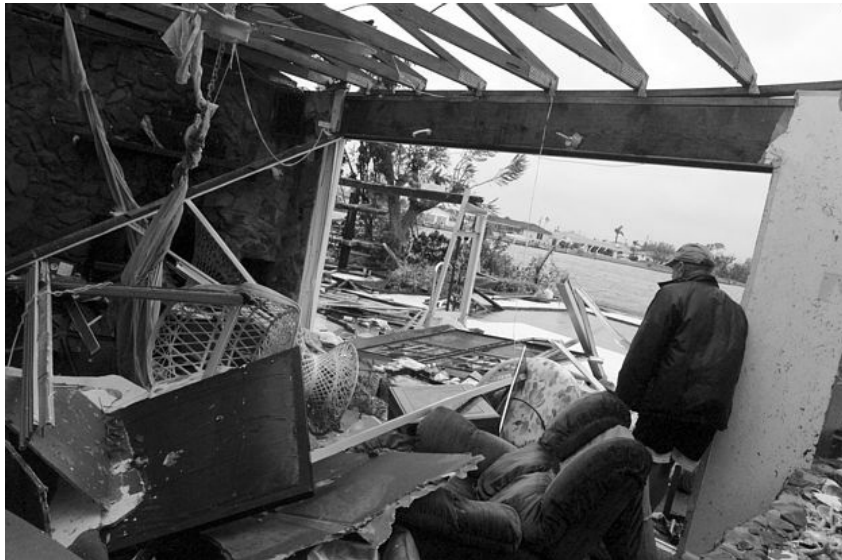
...this kind of failure due to wind pressure was not investigated. At least it appears the hurricane clips worked...but that's little consolation to the homeowner.

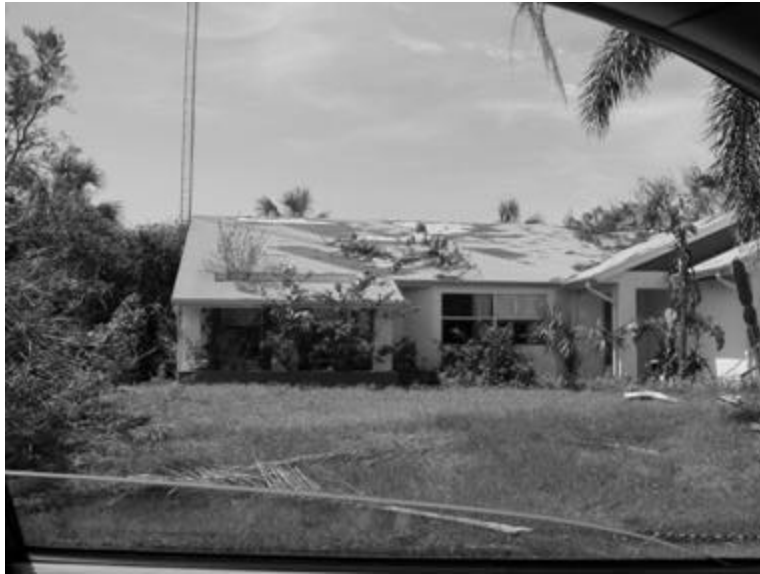
An example of gable roof damage

Wood-frame gable ends of roofs can be failure-prone, except when properly braced. In many instances gable-end failure seems primarily attributable to poor or non-existent bracing between gable-ends and the rest of the structure. The use of structural outlookers rather than ladder-type framing can also help. These generally cantilevered 2×4s oriented edge-wise at roof sheathing joints extend outward from the first interior trusses or rafter over "dropped" gable-end wall framing. Secondary bracing installed between trusses can also increase lateral support.

In addition, the nailing pattern used on roof sheathing needs to be designed for both shear and uplift loads.

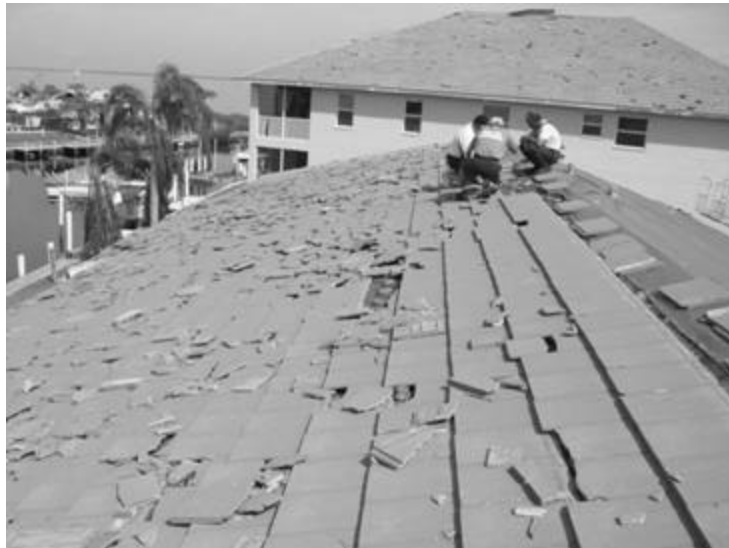
An example of damage to flat roofs

Many flat and low-slope roof systems show damage primarily at roof corners.

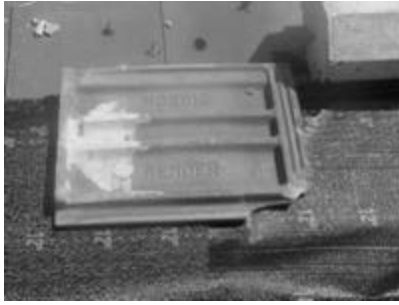
Mortar—wrong location

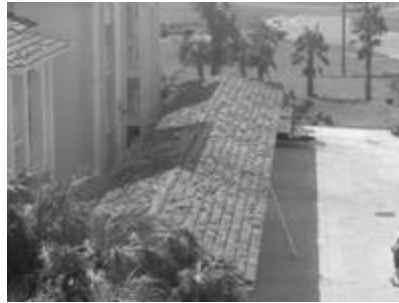
Tiles on this project created damage on lower parking area. Unable to determine if the damage was caused by the storm or from the clean-up.

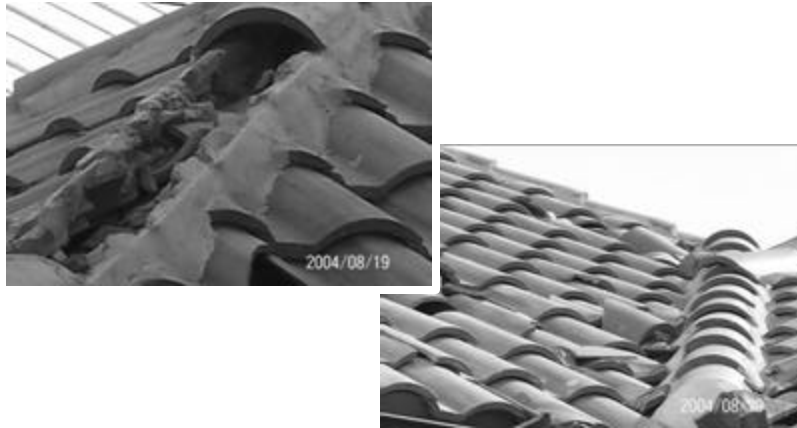
Some hip barrels lost from mortar;
debris damaged some field pieces.

Concrete hip/ridge pieces loosened from cement.
Field damage from hip/ridge debris.

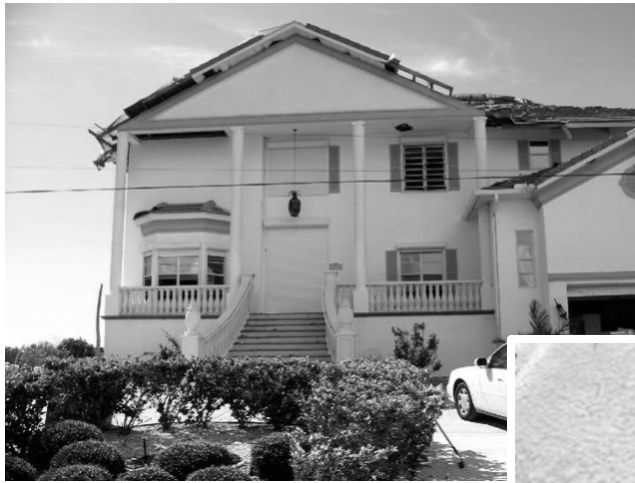
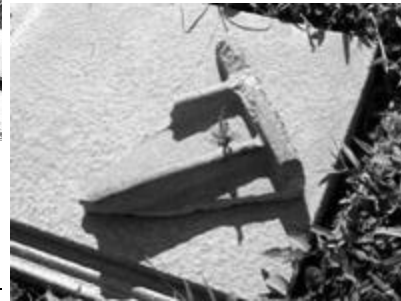
Soffit and
framing damage

Flat tiles nailed with 0 to 1 nails

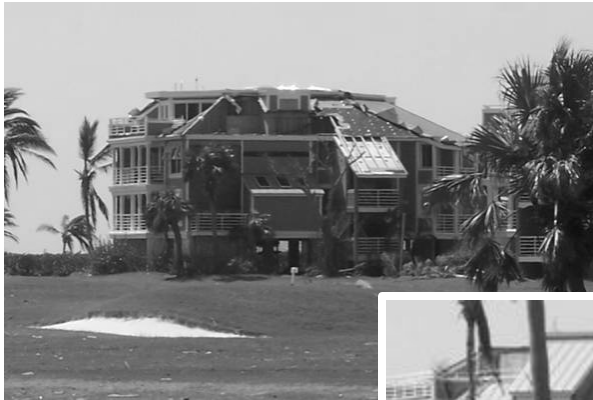
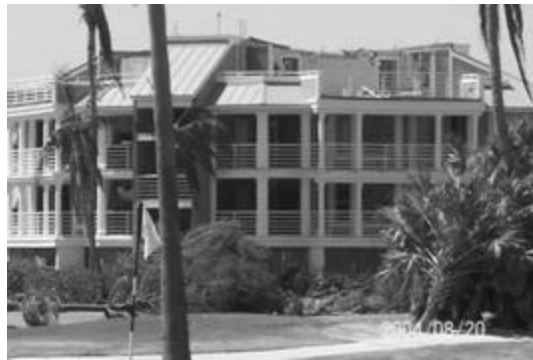
Standing seam metal came off from screwed clips, which pulled and tore loose from stapled plywood.

Structural damage

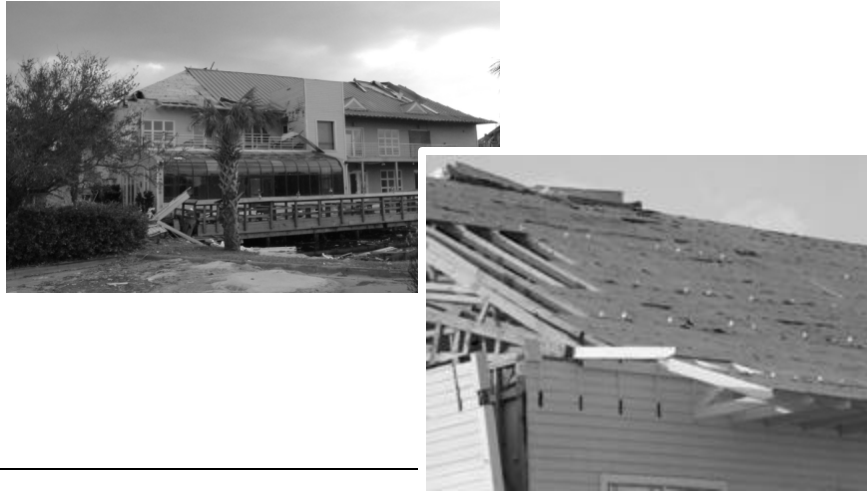
Overhanging deck and truss failure initiated release of standing seam roof.

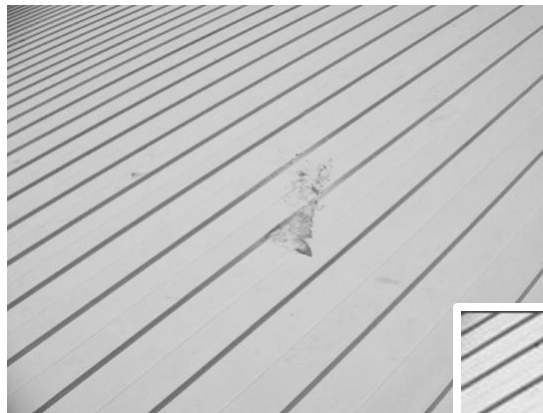
Impact damage to
standing seam
metal roof

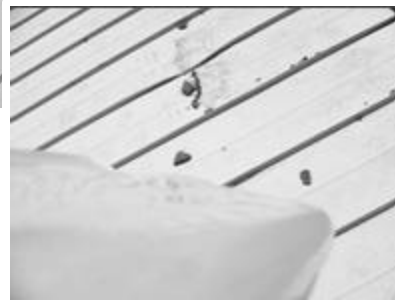
Scattered debris
from adjacent roof

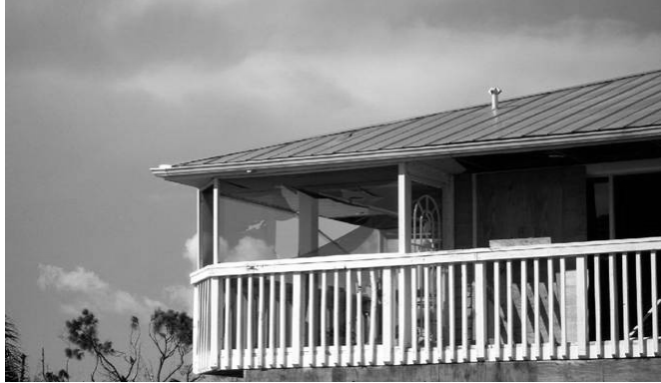
Thru-fastened metal roof principally damaged by debris, not by wind.

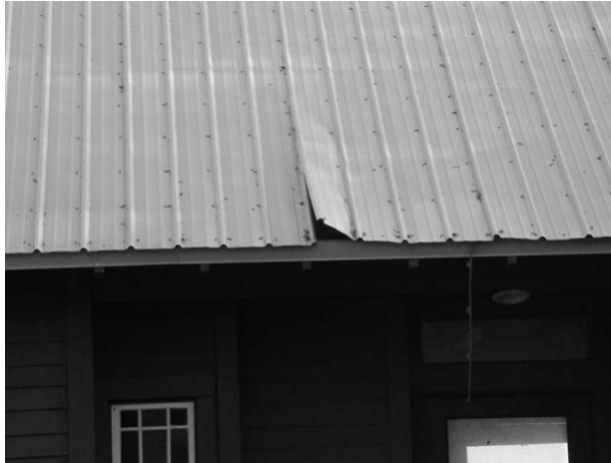
Typical to see soffit damage.

Damaged wind screens gave indication of how much wind.

Thru-fastened panel lifted and detached at seam but remained on roof.

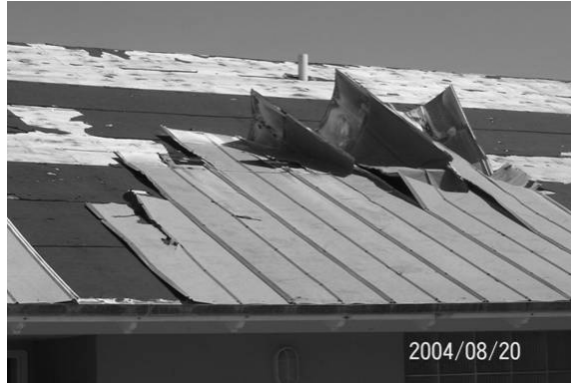
Old 5V crimp

- Insufficient number of fasteners (18 in. o.c.) in rusting metal
- Applied to inadequate framing/construction

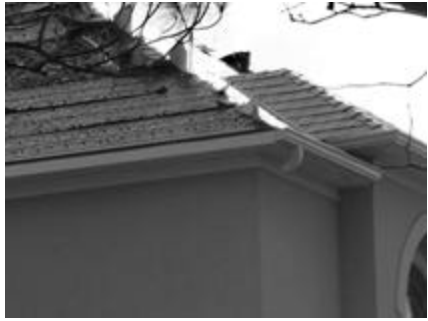
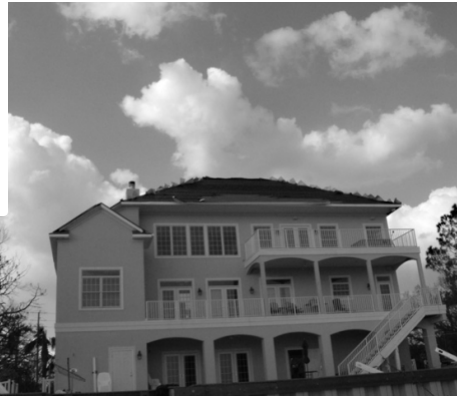
- Lap from the front
- Lock mechanism did not hold
- Fascia metal sometimes deformed—gave way, which then precipitated failure

Interlocking steel shingle that unlocked from edge metal and clips.

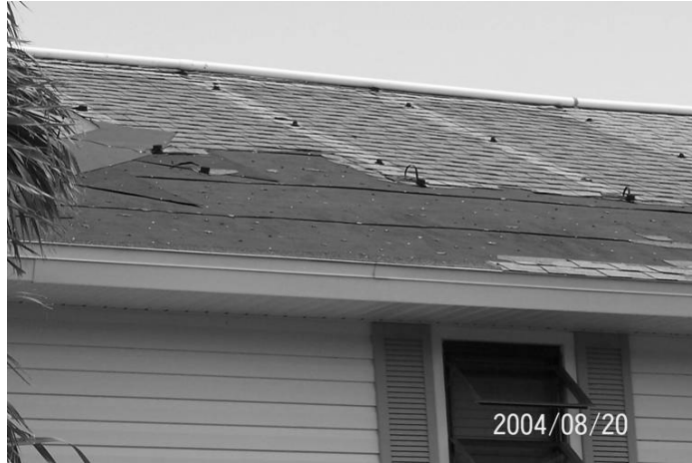
Asphalt shingles installed under solar system,
and attached with 4 nails, came loose.

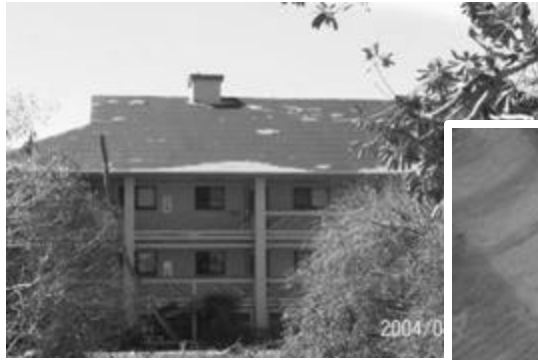
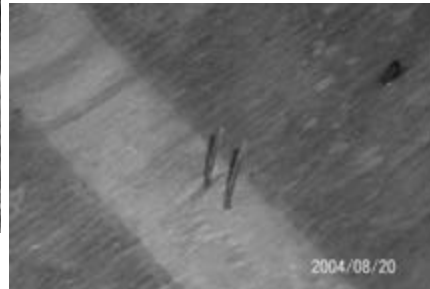
- Some shingles, even with 6 nails, tore loose.
- However, some of these nails were in the seal strip.
- There was evidence of attic pressurization.
- Plywood stapled to the trusses didn't improve the situation.

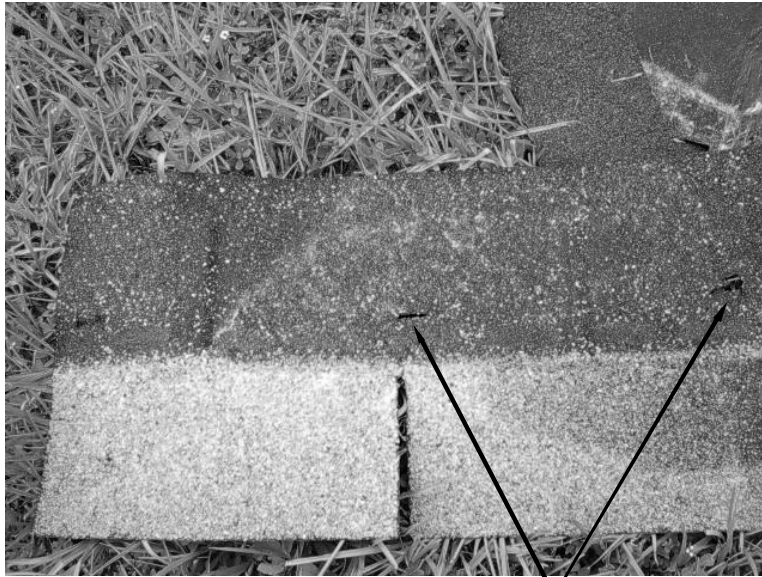
- Rusty nails
- A lot of nails still in place
- Shingles pulled off

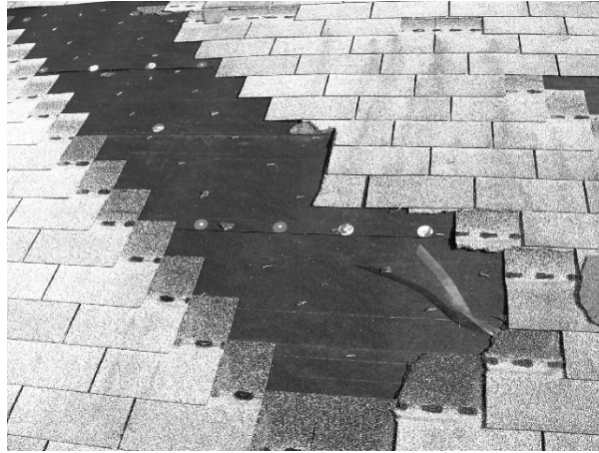
12-year-old 3-tab shingles tore loose from 4 staples per piece.

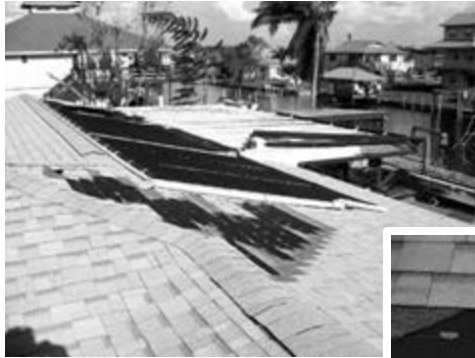
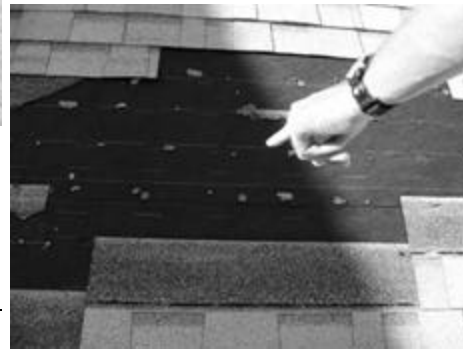
Shingles tore loose from 6 nails placed in seal strip.

Placing the nails in the seal strip is a less-than-optimal location. All dimensional shingles have nail lines.

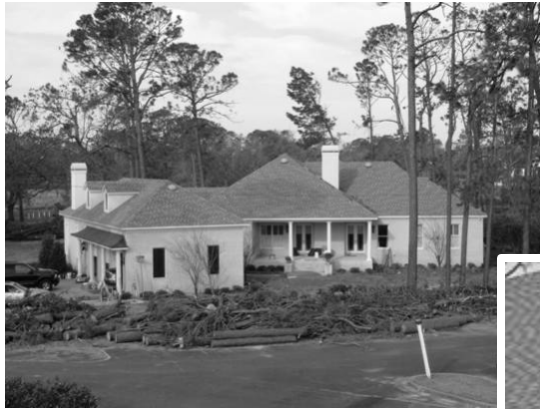
Hip and ridge loss on home protected by wooded areas.

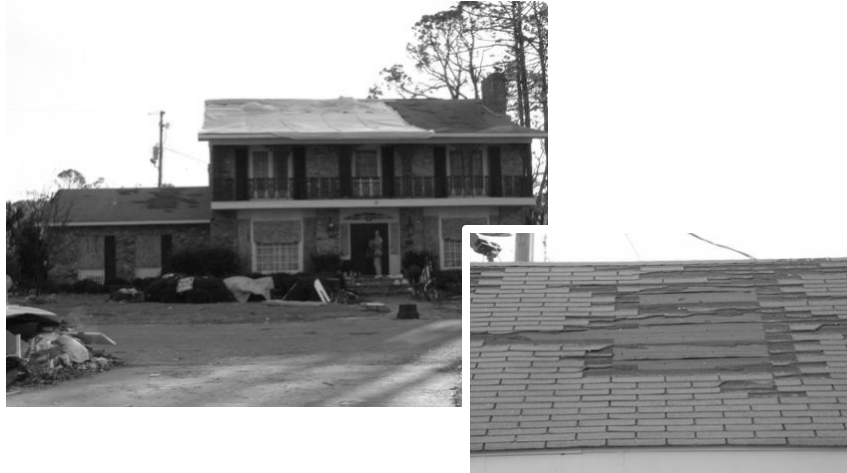
4 nails per 3-tab shingles. Not sealing at tabs.

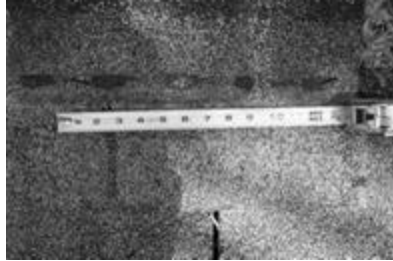
Only hip loss with 6 nails

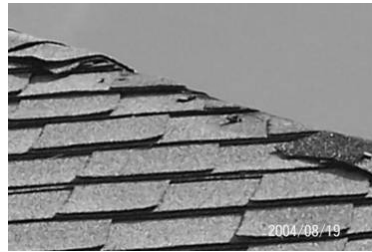
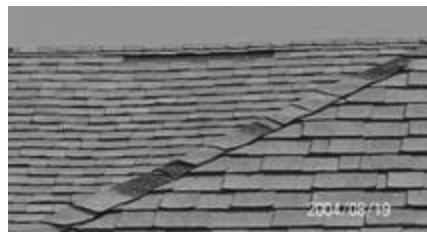
Using 4 to 6 staples—and placing them in seal strip—caused loss

- Hip/ridge and field loss from inconsistent nailing
- 4 to 6 nails and location

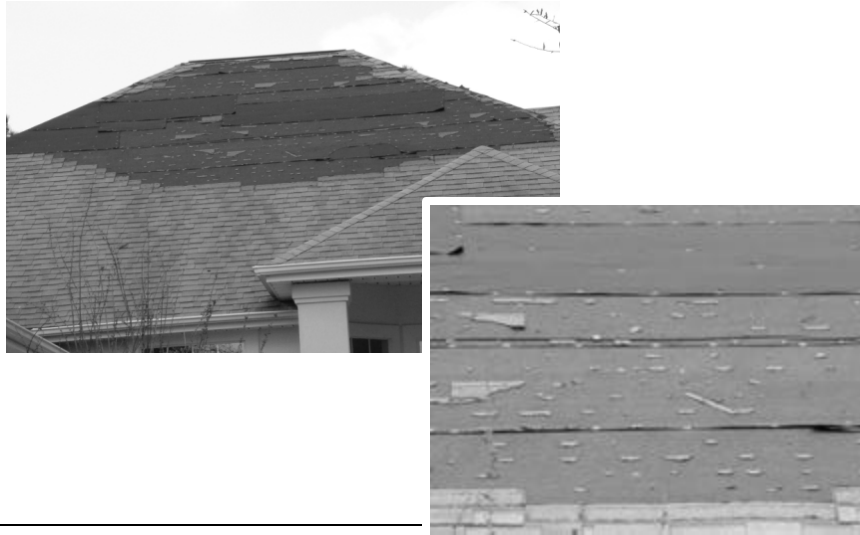
Shingle tabs lifted and tore from 6 nails per piece.

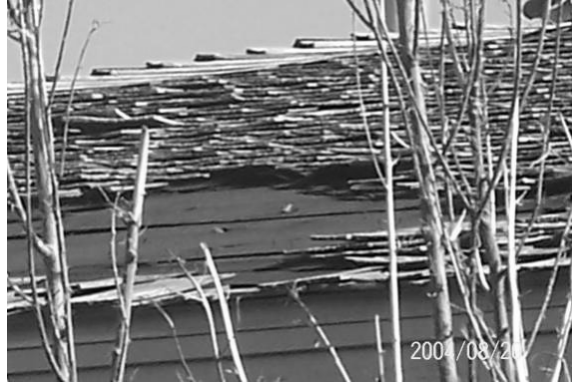
Wood

Shake either pulled nails loose, tore from nails, or caused rusted nails to break.

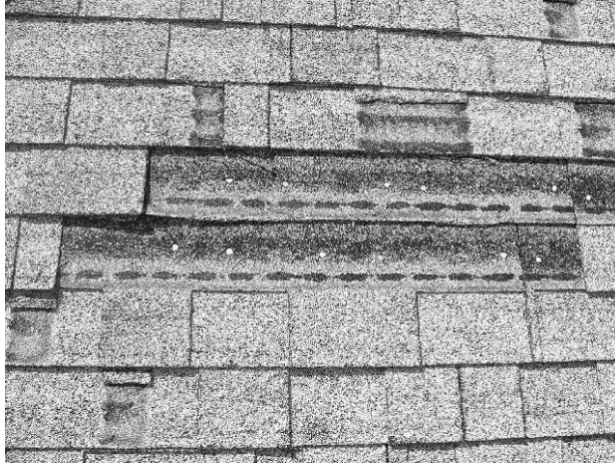
Mechanisms of failure: age

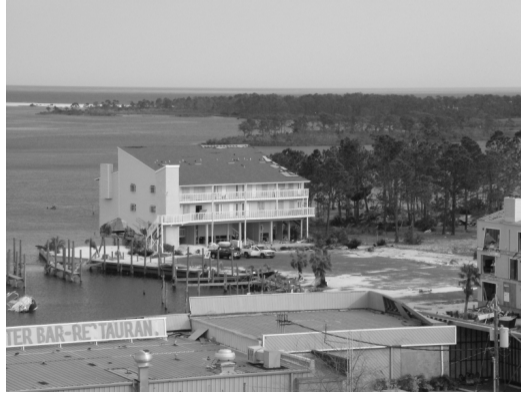
Mechanisms of failure:
winds exceeding roof/structure design

Roof basically intact, but substrate lost at eave and ridge.

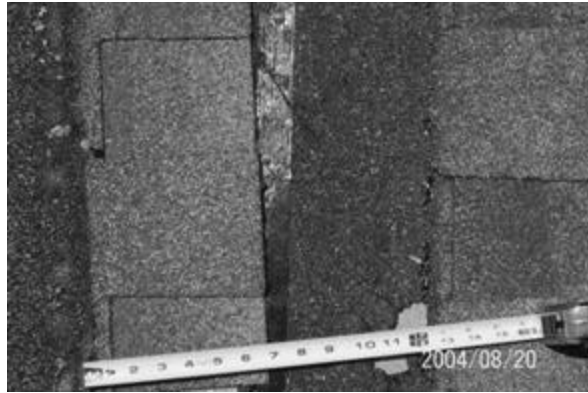
Mechanisms of failure: improper materials selection

Asphalt shingle “seconds”

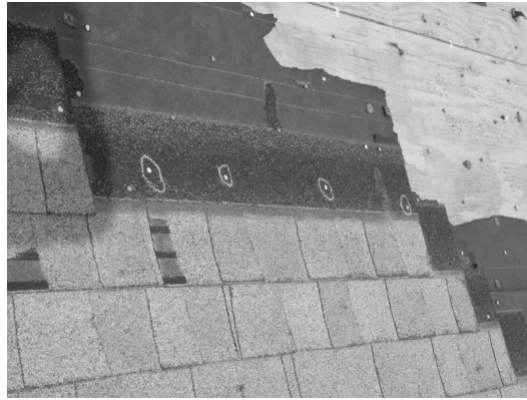
Mechanisms of failure: insufficient attachments

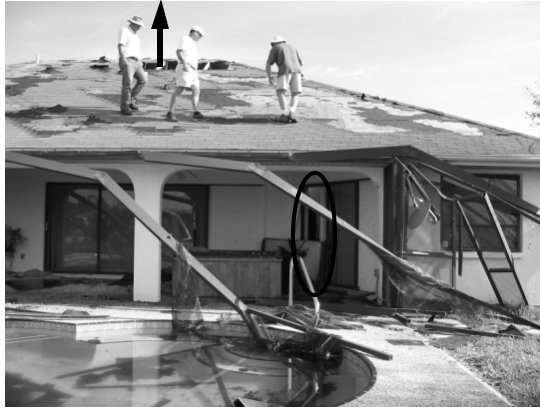
Mechanisms of failure: structural failure

Internal Pressurization

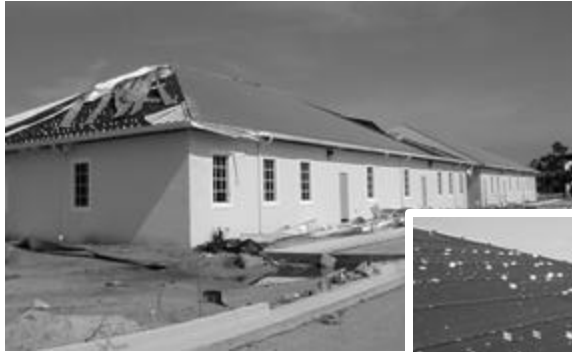
Mechanisms of failure: workmanship

Poor installation
and performance
