Final Report:
Damage Assessment of Residential Infrastructure
Impacted by Hurricanes Harvey and Irma

Submitted to: National Association of Home Builders
(NAHB) – Project sponsor

March 4, 2019

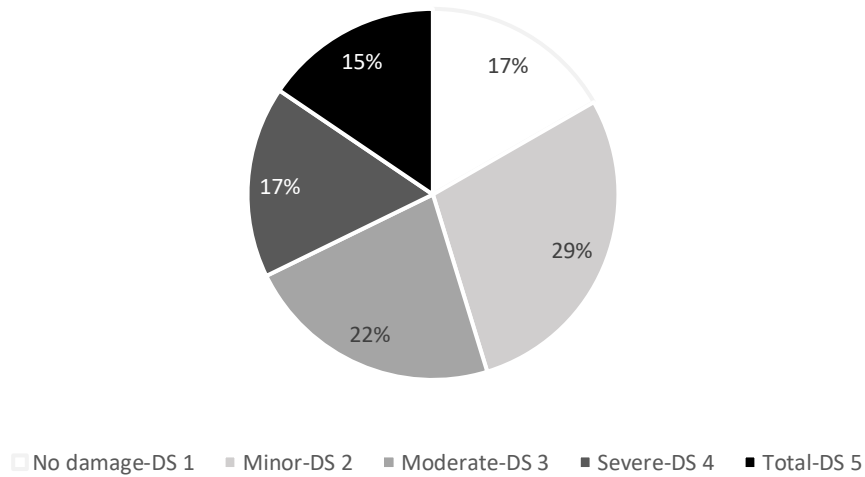
Figure 7: Distribution of overall damage in the Texas dataset after Hurricane Harvey.

The distribution of the observed overall damage in Texas after Hurricane Harvey is presented in Figure 7. This figure shows that the dataset has a good portion of each damage state. In addition, this figure indicates that a large percentage of the buildings within the community experienced overall damage over damage state 1 (associated with no damage). Furthermore, a considerable portion of the buildings (15%) have experienced the highest level of damage, damage state 5 (total-complete collapse). Hence, this figure implies a high level of overall damage throughout the community.

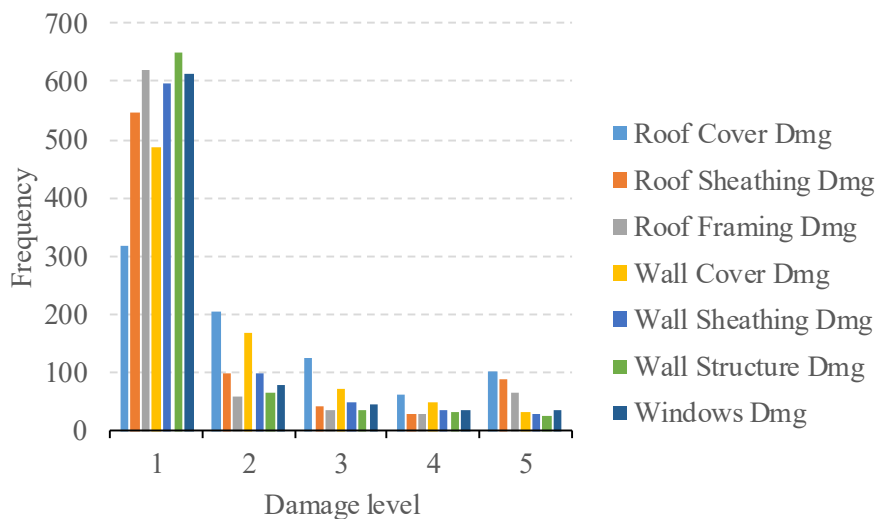
Figure 8: Histogram of damage in building components in the damage dataset of Texas after Hurricane Harvey.

The frequency of damage observed in the inspected buildings is shown in the histogram plot of Figure 8. Damage levels are defined based on the percentage of damage observed at each component. Five component damage levels are defined based on the damage percentage in increments of 20% from 0% to 100% damage. This figure shows that in the most severe damage level, damage level 5, the highest frequency is for roof cover damage. In addition, based on the associated frequencies in damage level 1, it can be observed that wall structure damage, roof framing damage, window damage, and wall sheathing damage are rarely observed or are minor.

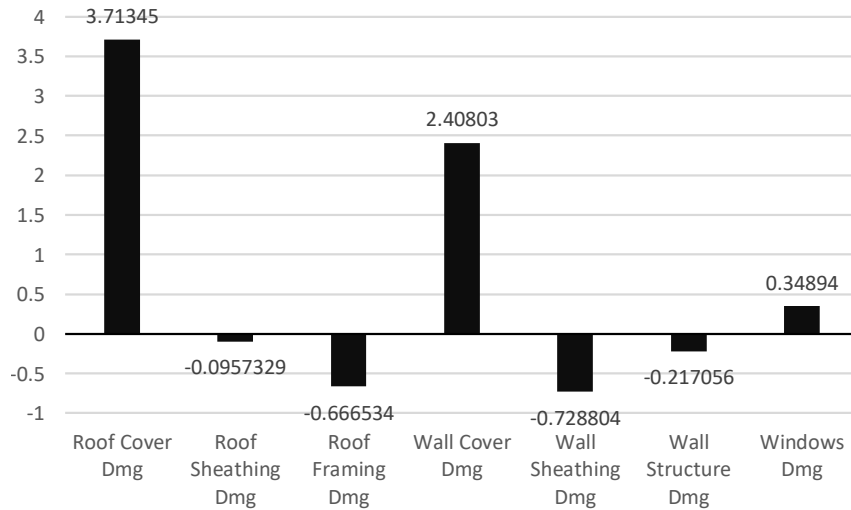
Figure 9: mean values of the model parameters.

The posterior statistics of the Bayesian Linear regression analysis are presented in Table 1. As this table indicates, since Coefficient of Variations (CoV) of θ_2 and θ_6 are very large, they are not significant and hence not informative in this equation. This indicates that the components associated with these parameters are not significant in the overall damage status of the building. These components are roof sheathing and wall structure. The mean values for the model parameters are illustrated in Figure 9. This figure shows that three components which are directly related to the overall damage of the building are roof cover, wall cover, and windows, respectively based on their importance. Since, the values for these parameters in the regression are all in percentages, they are in the same order and there is no need to standardize them, and hence, the values shown in Figure 9 directly compare the influence of each component to the overall damage. The values for the other four components are negative which does not have a physical meaning. As mentioned previously, two of them, roof sheathing and wall structure, are insignificant due to high CoV of model parameters, and hence their mean value is out of value to interpret. In addition, θ_2 and θ_3 and also θ_5 and θ_6 are highly negatively correlated which means that they cancel the effect of one another on the overall damage. This indicates that the main contributing source of high damage to the buildings impacted by Hurricane Harvey in the TX building stock evaluated in this study is damage to the envelope of the building, including the wall and roof covers as well as windows. It does not mean that damage to the structure of the walls or roofs is not important. Rather, it means that damage to the envelope of the building causes high overall damage even if the structure is not damaged at all.

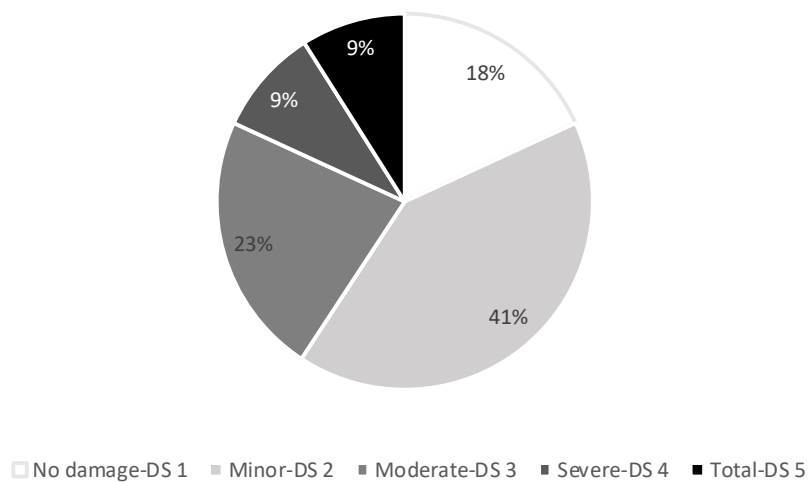
Figure 15: Distribution of overall damage in the Florida dataset after Hurricane Irma.

The distribution of the state of the observed overall damage in Florida after Hurricane Irma is presented in Figure 15. This figure indicates that a large percentage of the buildings within the community experienced overall damage over damage state 1 (associated with no damage). A large portion of the buildings have experienced damage state 2, which is not very severe (minor damage). However, it is still very important in terms of restoration and recovery, and the socio-economic impacts of long duration of recovery.

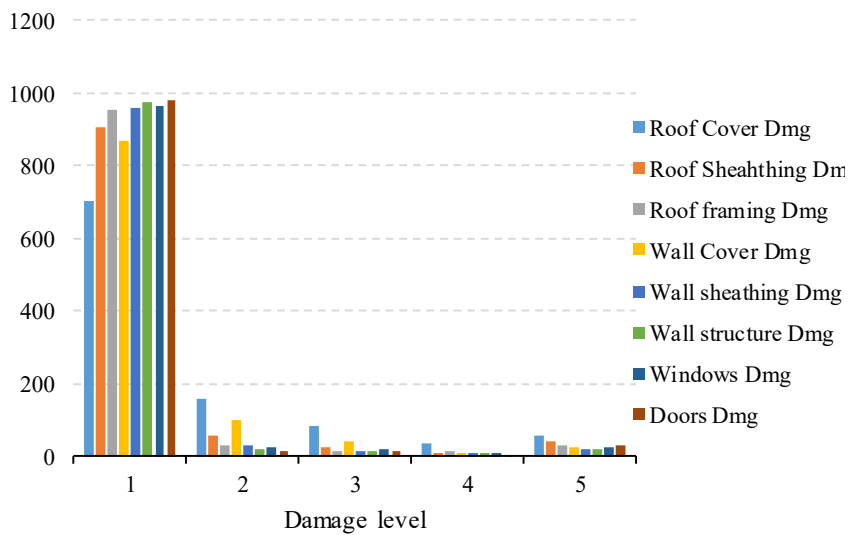
Figure 16: Histogram of damage in building components in the damage dataset of Florida after Hurricane Irma.

The frequency of damage observed in the inspected buildings is shown in the histogram plot of Figure 16. Damage levels are defined based on the percentage of damage observed at each component. Five damage levels are defined based on the damage percentage in increments of 20% from 0% to 100% damage. This figure shows that in the most severe damage level (damage level 5), the highest frequency is for roof cover damage. In addition, based on the associated frequencies in damage level 1, it can be observed that door damage, wall structure damage, window damage, wall sheathing damage, and roof framing damage are rarely observed or are minor.

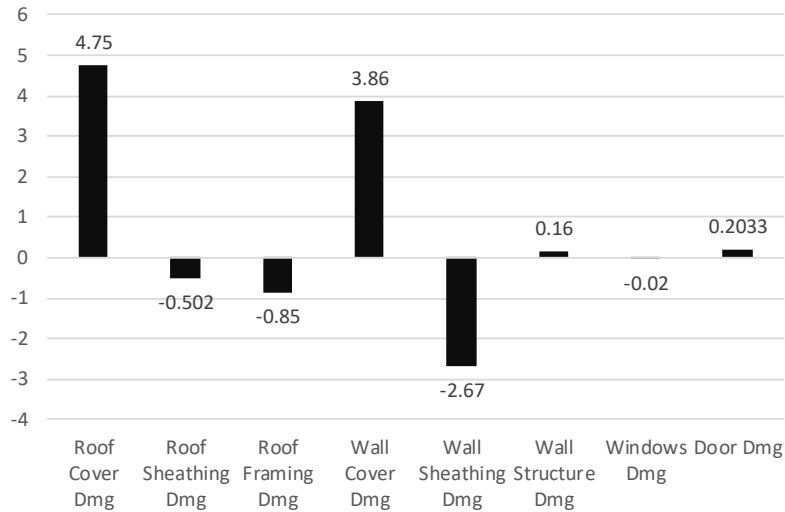
Figure 17: mean values of the model parameters.

The posterior statistics are as presented in Table 2. As this table indicates, since CoV of θ_2 , θ_3 , θ_6 , θ_7 , and θ_8 are very large, they are not significant and hence not informative in this equation.

This indicates that the components associated with these parameters are not significant in the overall damage status of the building. These components are roof sheathing, roof framing, wall structure, windows, and doors. The mean values for the model parameters are illustrated in Figure 17. Among the remaining informative parameters, θ_1 , θ_4 , and θ_5 , the mean value of θ_5 is negative meaning that the overall damage decreases as the wall sheathing damage increases, which does not have a physical meaning, hence, there is no direct conclusion drawn out of this parameter. In contrast, this figure shows that two components which are directly related to the overall damage of the building are roof cover and wall cover, respectively based on their importance. Since the values for these parameters in the regression are all percentages, they are in the same order and there is no need to standardize them, and hence the values shown in Figure 17 directly compare the influence of each component to the overall damage. In summary, the results indicate that the main reason for high damage to the buildings in the inspected building stock in Florida impacted by Hurricane Irma is damage to the covering of the roof and walls. It does not mean that damage to the structure of the walls or roofs is not important. Rather, it means that damage to the envelope of the building causes high overall damage even if the structure is not damaged at all.

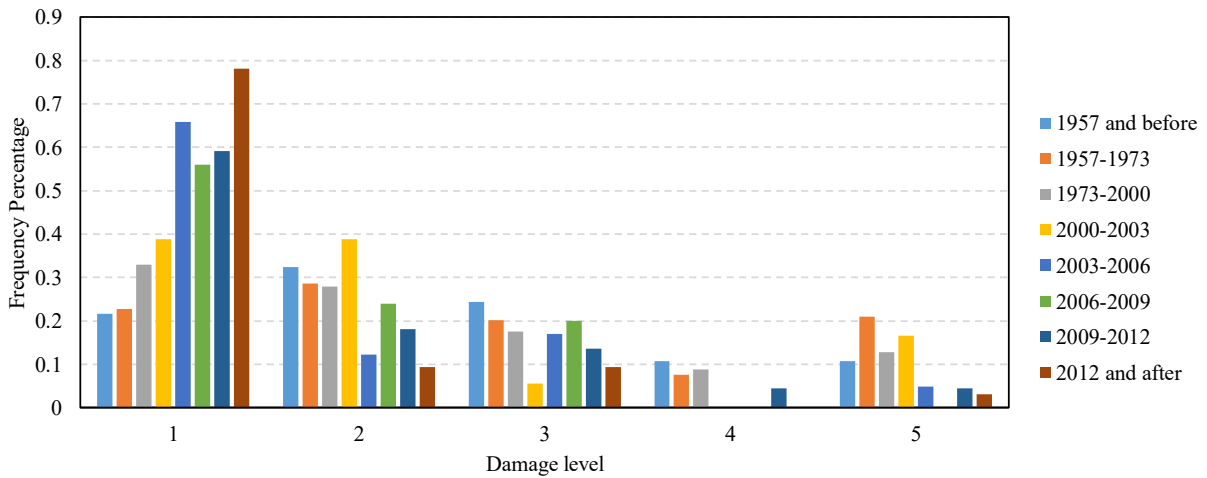
Figure 18: Histogram of damage to roof cover for different year subsets.

The histogram plots of damage to roof covering of buildings in the eight aforementioned subsets of years are presented at the same time in Figure 18. This figure indicates that the damage of the roof cover in most of the buildings which are built recently (for instance, consider 2012 and after) is classified as level 1. In contrast, the roof cover of the older buildings (consider 1957 and before) experienced a wide range of damage levels, and only a few of them (around 20% for the pre-1957 built buildings) were classified as damage level 1 (associated with no significant damage). In addition, according to the frequency percentages of the buildings classified as damage level 5, this figure indicates that more aged buildings are classified as damage level 5 compared to the less aged buildings. It should be noted that the buildings constructed between 2003 and 2006 have experienced considerably less damage to their roof cover in comparison to the two subsets of

buildings constructed in previous years (2006-2009 and 2009-2012), which might be because of the code updates.

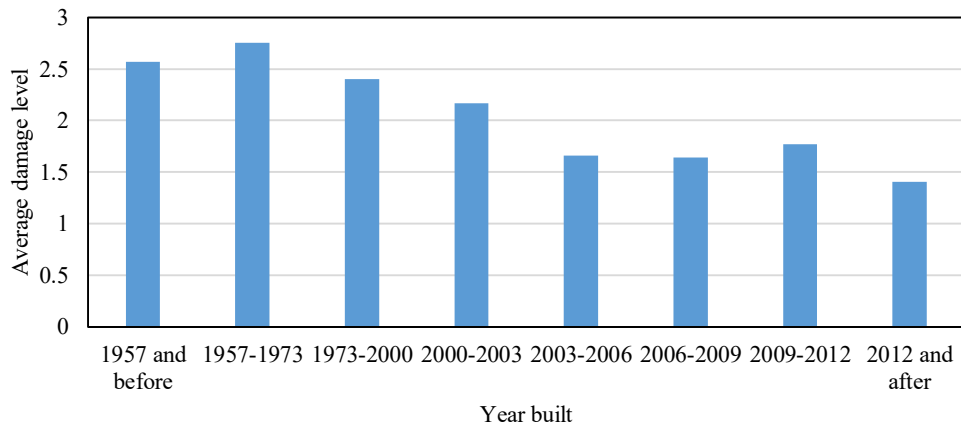
Figure 19: The average damage level of roof cover for each year bracket.

In addition, the average damage level of each built year subset is computed and shown in Figure 19. This figure shows that the average damage in the roof cover decreased significantly for subsets after 2003.

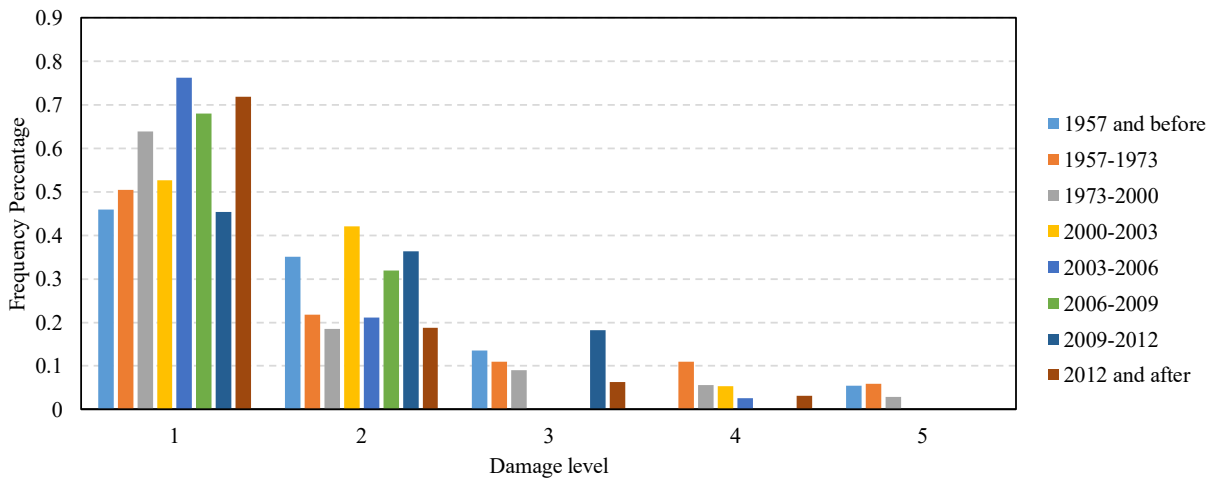
Figure 20: Histogram of damage to wall cover for different year subsets.

The damage level vs. frequency for the various time frames associated with code updates for the wall cover is presented in Figure 20. The results regarding the relationship between damage and the year of construction are similar to the roof cover with one exception. The buildings constructed between 2009 and 2012 surprisingly experienced more damage to wall cover compared to a number of the subsets of years before it. The reason for this phenomena should be investigated through the code update. It should be mentioned that it may be due to some bias in the dataset, since the data points for this subset might be not be large enough to be reliable.

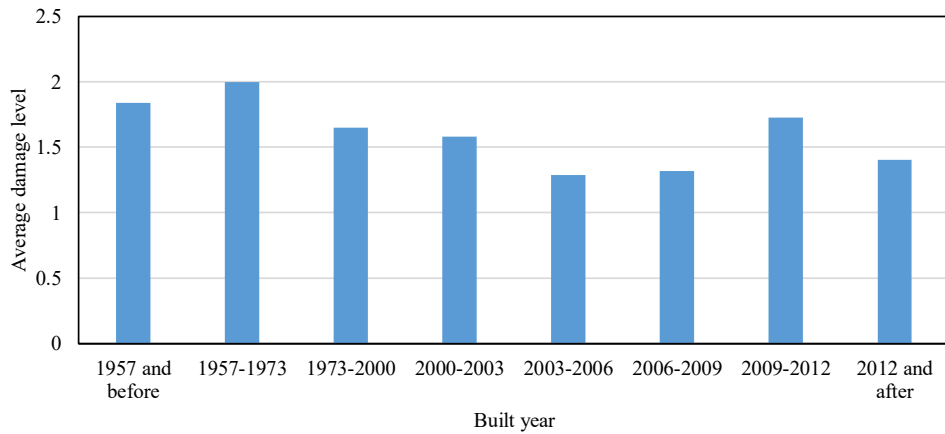
Figure 21: The average damage level of wall cover for each year bracket.

In addition, the average damage level of each construction year subset is computed and shown in Figure 21. This figure shows that the average damage in wall cover decreased significantly for subsets after 2003, with the exception of 2009-2012.

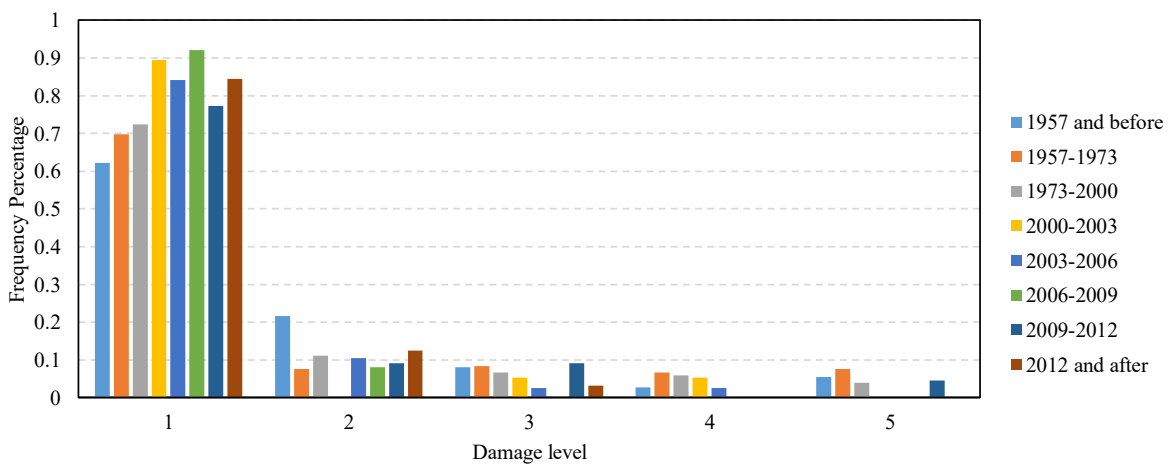
Figure 22: Histogram of damage to windows for different year subsets.

The damage level vs. frequency for the various time frames associated with code updates for window damage is presented in Figure 22. The results regarding the relationship between damage and the year of construction are similar to those presented for roof cover. This figure shows that in the thresholds of years 1957 and 2000 the damage levels changed more significantly. For instance, by observation of damage level 1, the frequency increases with a bigger step in these two year thresholds compared to the years before these thresholds. Considering damage level 1 is the least damage of windows, this figure shows that the windows in buildings constructed after 2000 experienced the least level of damage in comparison to those ones constructed prior to 2000.

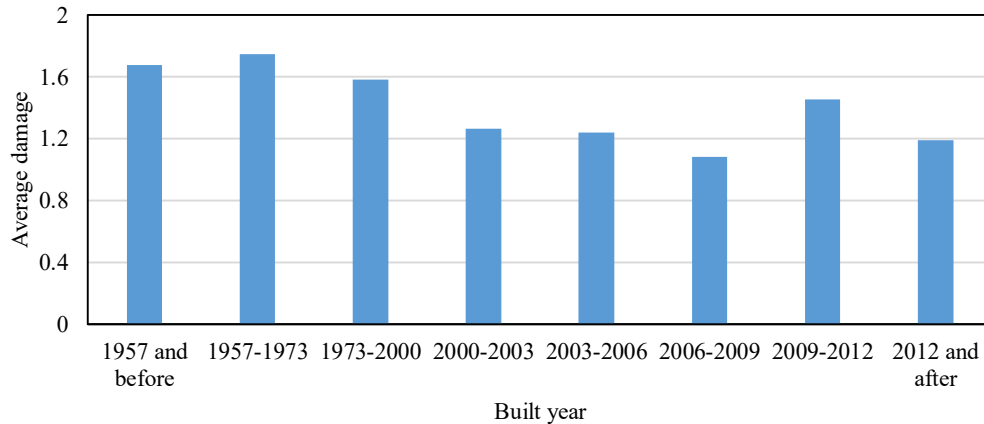
Figure 23: The average damage level of windows for each year bracket.

In addition, the average damage level of each construction year subset is computed and shown in Figure 23. This figure shows that the average damage in wall cover decreased significantly for subsets after 2000, with the exception of 2009-2012.

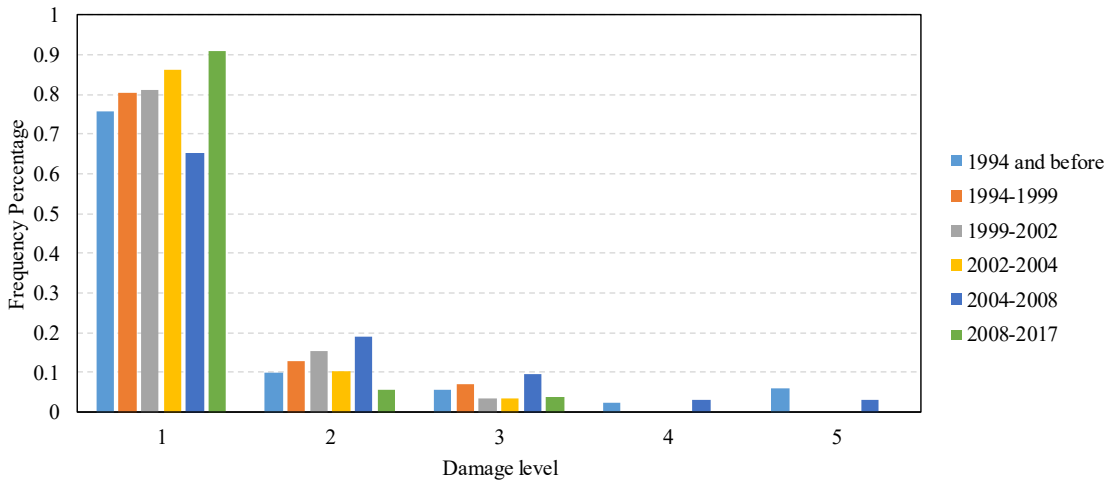
Figure 24: Histogram of damage to roof cover for different year subsets.

The histogram plots of damage to roof cover of buildings in the six aforementioned subsets of years are presented at the same time in Figure 24. This figure indicates that less than 10% of buildings constructed between 2008 and 2017 have experienced damage greater than level 1 (associated with no significant damage). A surprising observation in this diagram is that roof cover of buildings constructed between 2004 and 2008 experienced a wide range of damage compared

to other year brackets. Approximately 63% of the buildings constructed in this period experienced damage level 1 and below. This is even worse than the oldest buildings constructed prior to 1994.

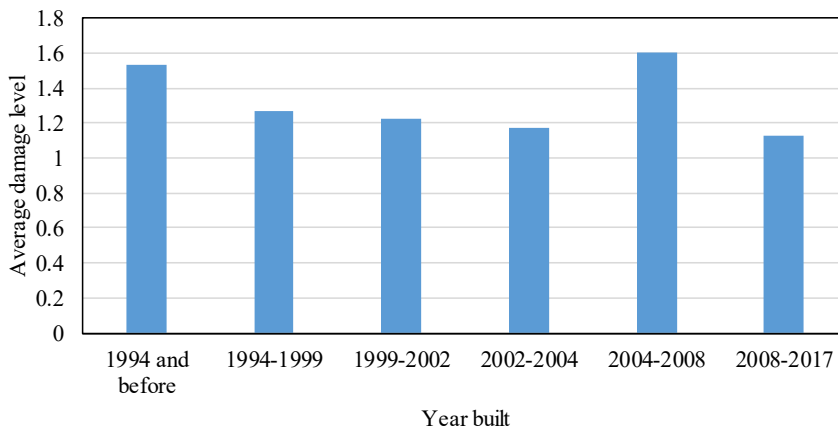
Figure 25: The average damage level of roof cover for each year bracket.

In addition, the average damage level of each construction year subset is computed and shown in Figure 25. This figure shows that the average damage in the roof cover decreased significantly after 1994, when the first state-wide code/standard was introduced. In addition, the results of this plot confirm the previous claim on the 2004-2008 year bracket. A sudden increase is present in the average damage level for this bracket compared to the others.

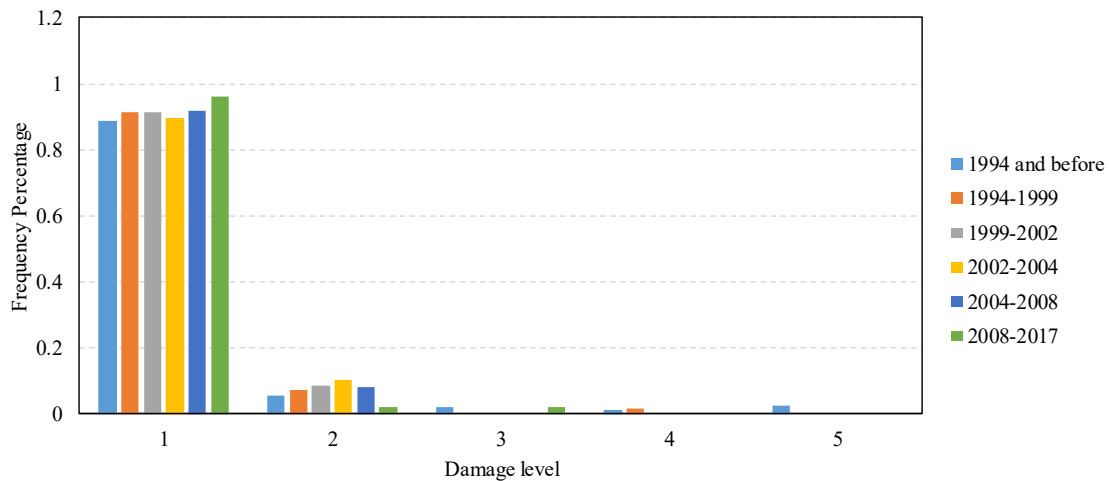
Figure 26: Histogram of damage to wall cover for different year subsets.

The damage level vs. frequency for the various time frames associated with code updates for wall cover is presented in Figure 26. The highest frequency in damage level 1 is observed for the 2008-2017 bracket and the lowest is for those buildings constructed before 1994. In addition, the only bracket with damage level 5 is the bracket associated with construction before 1994.

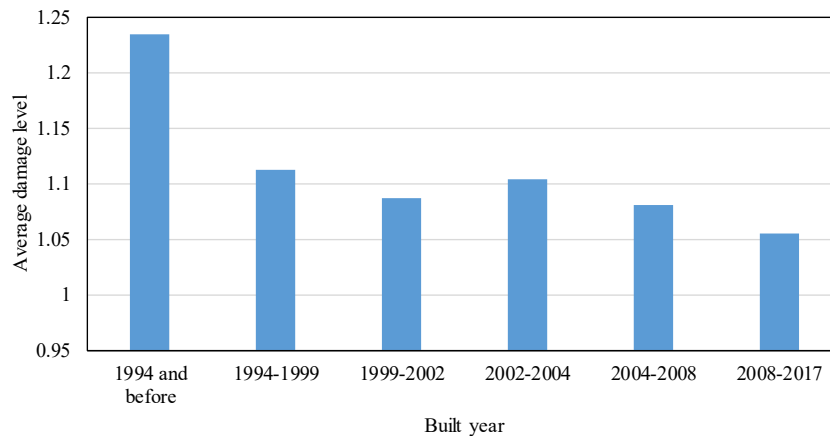
Figure 27: The average damage level of wall cover for each year bracket.

In addition, the average damage level of each construction year subset is computed and shown in Figure 27. This figure shows that the average damage in the wall cover decreased significantly for the subsets after 1994. There is a slight increase in the average damage of 2002-2004 compared to its previous bracket. However, since it is a slight (not significant) increase, it can be due to the nature of the dataset.
