Investigation of Potential Benefits of
Revising Exception 1 under
FLORIDA BUILDING CODE,
ENERGY CONSERVATION,
Section 101.4.7.1.1
Duct Sealing upon Equipment Replacement

FSEC-CR-1979-14
June 15, 2014
Revised June 30, 2014

Authors
Janet McIlvaine
David Beal

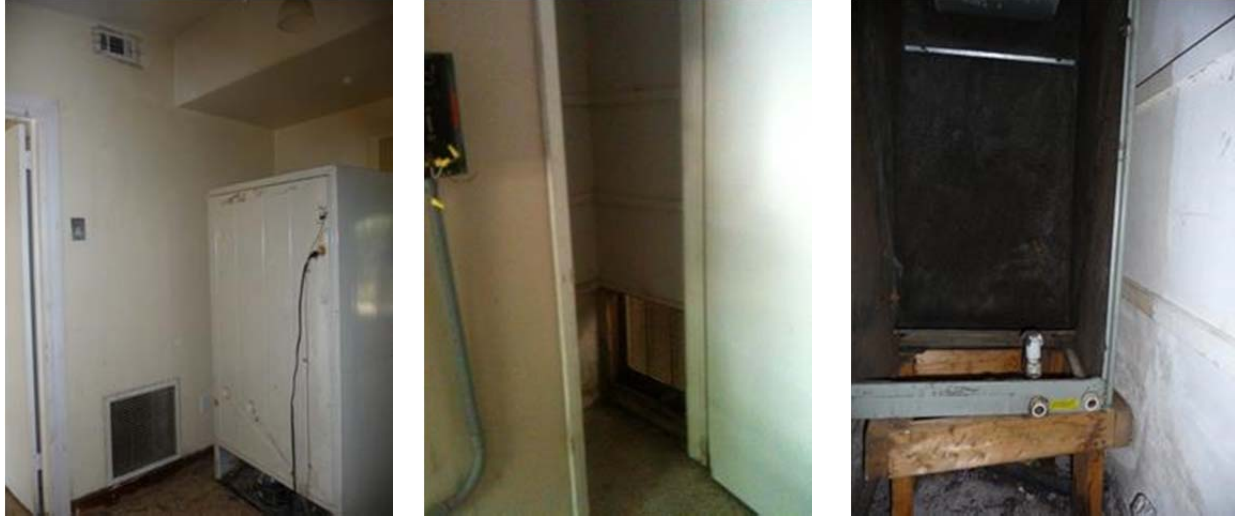
As found, the home had a retrofitted HVAC system with an air handler installed in a former pantry (note “A/C” in Figure 4). The Air handler unit was installed on a stand in the pantry with a filter at its bottom. The pantry door was solid, requiring a through-the-wall return. This return was accomplished by cutting a hole in the pantry/kitchen wall, directly behind the refrigerator (Figure 5). This hole was completely unsealed from the wall (Figure 6).

As seen in Figure 5 the supply register for the kitchen is located directly above the return opening. This register was merely stuck in the wall, the supply duct feeding it was not attached to a boot, providing conditioned air to the wall cavity that is directly connected to the return (Figure 7). As configured the air handler and the kitchen supply, sources of positively pressurized leakage points, are in the return, a negative pressure area. This in effect is “turbocharged” duct leakage.

Figure 5. The entire air handler closet serves as the return plenum. Left: Central (only) return air grille mounted in wall between kitchen and air handler closet. Center: Air handler closet showing back of return air grille. Right: Inside the air handler closet, to the left of the door, showing air handler mounted on free-standing wooden supports.

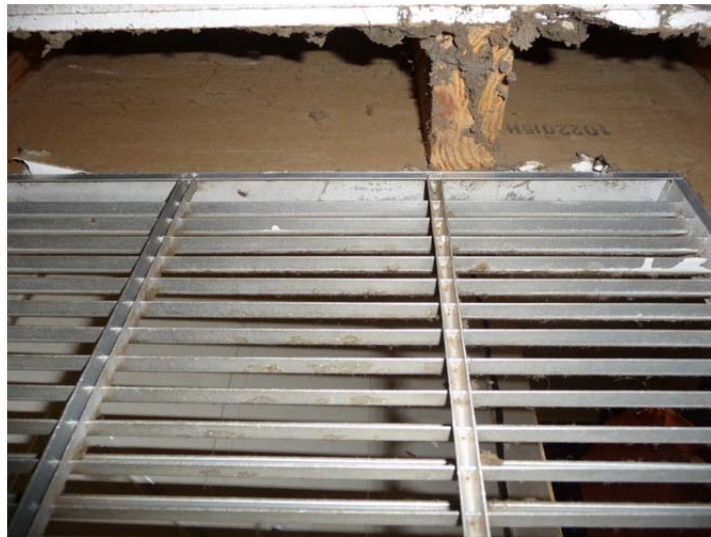
Figure 6. Looking up into the wall cavity from the wall-mounted return air grille. This wall cavity is part of the return air plenum because there is no air barrier separating it from the return air flow path.

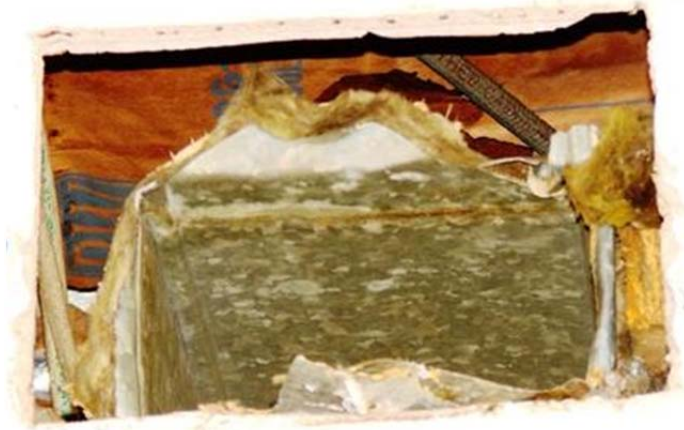
Figure 7. Disconnected supply duct

In this house the contractor also addressed the obvious failures in the supply duct work, sealing the open supply in the kitchen, re-installing the supply boots found disturbed in the attic portion of the house, and sealing all supply boots with mastic on their inside surfaces. The improvement from these repairs is apparent in the leakage reduction for the entire system shown in Table 2 and Figure 10.

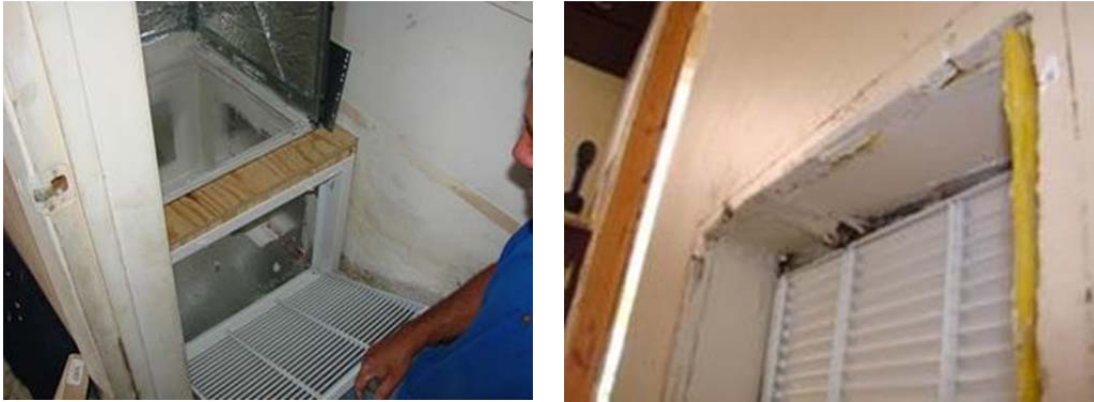
Figure 9. Filter-back return grille installed on new platform return in existing air handler closet (left). Air barrier blocking air flow down common wall (right).

The HVAC contractor removed the existing air handler unit (AHU) and stand. The contractor built a new platform in the same location as the old AHU. The stand was built to allow for the installation of a filter-backed grill under the AHU. The platform was lined with foil-faced fiberglass “duct board” to seal the entire cavity from the area outside the platform (Figure 9).

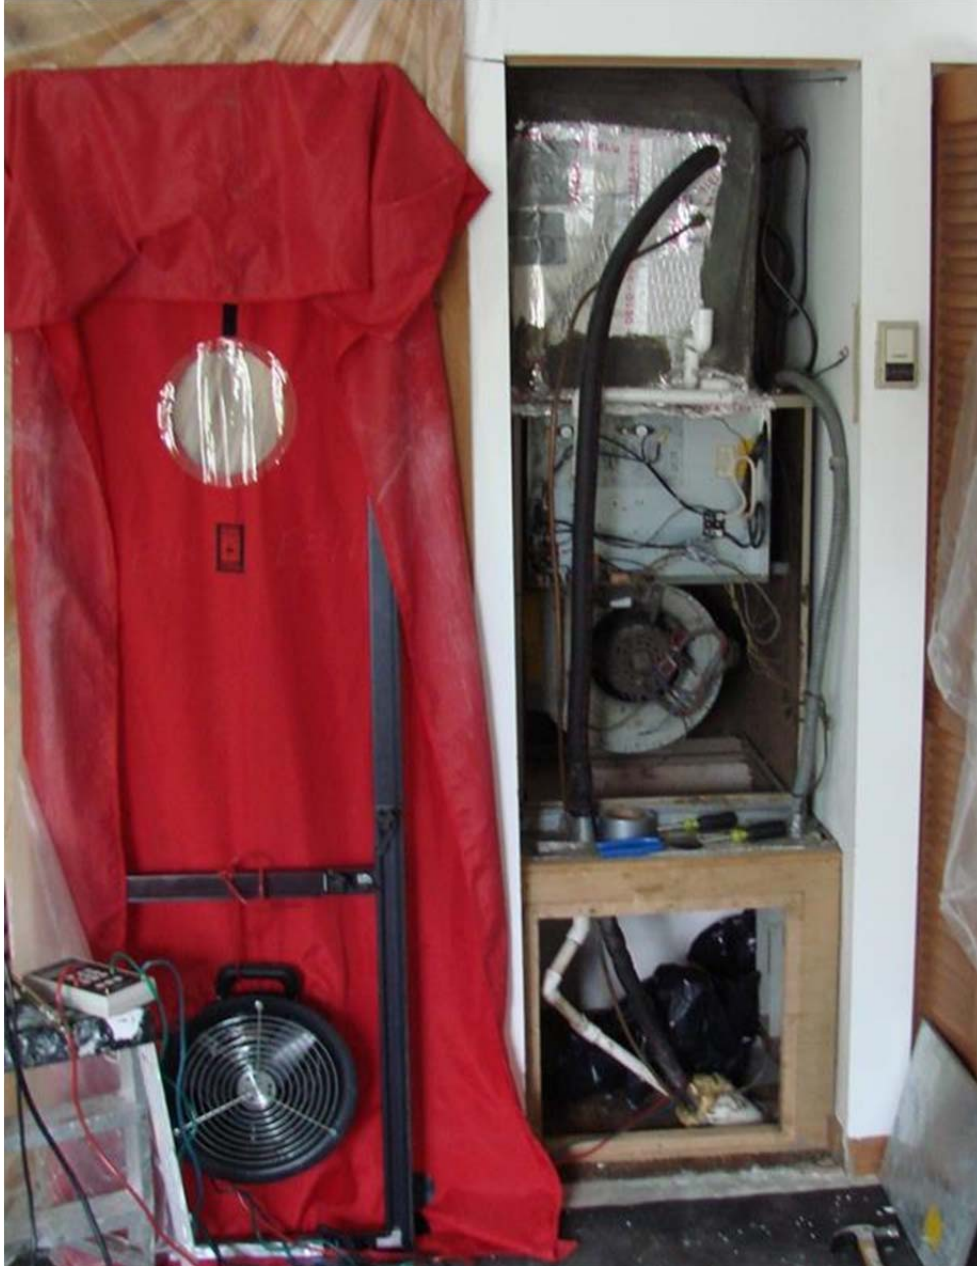
Figure 12. Air handler mounted on an open frame platform

As found the air handler had no filter, and no apparent place to install a filter. Although there was a return platform in the closet the return was open to the entire closet, which includes the air handler cabinet itself. To simulate operating conditions (louvered door closed, return open to closet) testing was done using a duct blaster curtain in place of the louvered door (Seen in Figure 12).

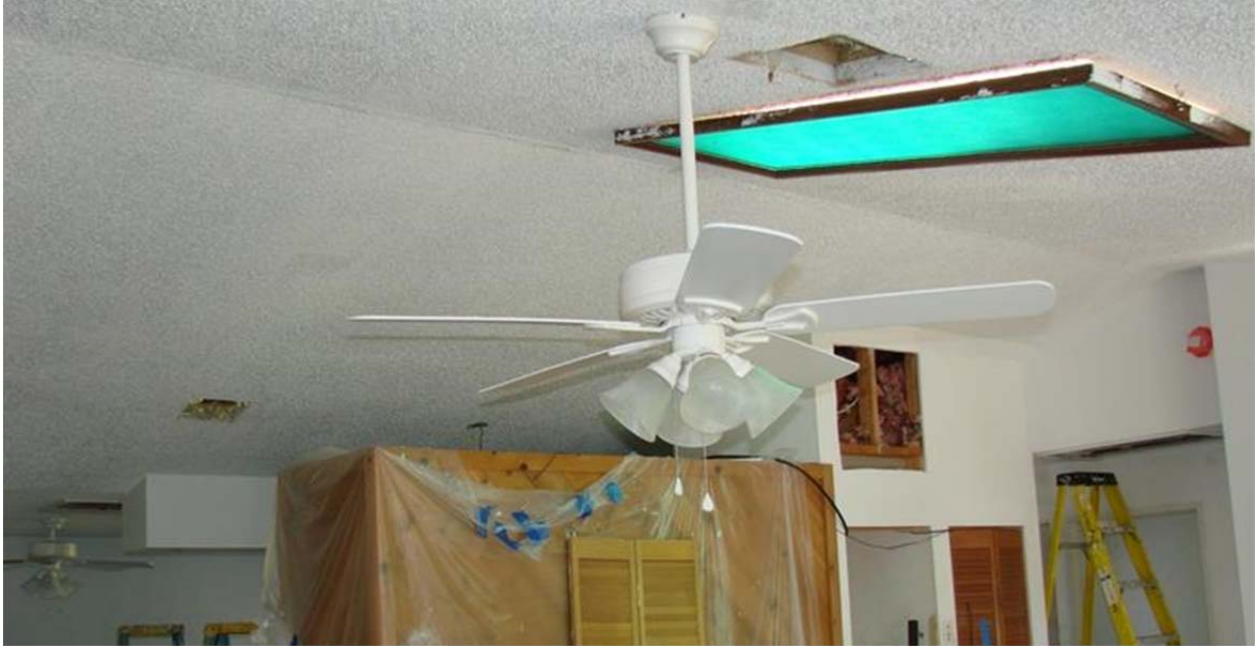
Figure 13. The hole in the wall over the air handler closet was cut to facilitate supply plenum installation. Also note the living room supply, to be relocated during repair.

There was significant repair to the supply duct system, both through the wall over the air handler and in the attic. The living room supply run was relocated and re-run (Figure 13)

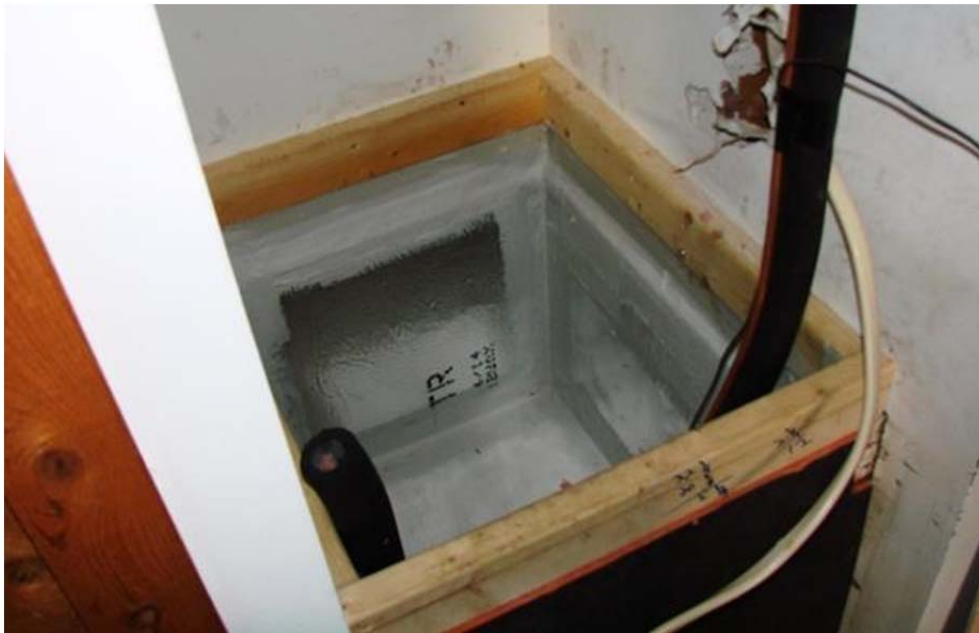
Figure 14 New duct board lining provides an air barrier to separate the return air stream from adjacent open wall cavities.

The existing return platform was removed and replaced with new wood. The walls and floor of the plenum was lined with duct board and sealed with mastic. The front of the plenum was prepped for the future installation of a filter-back grill (Figure 14). The finished air handler platform is designed with a filter-back grill under the platform. The air handler is to be enclosed with a half-door closet (Figure 15).

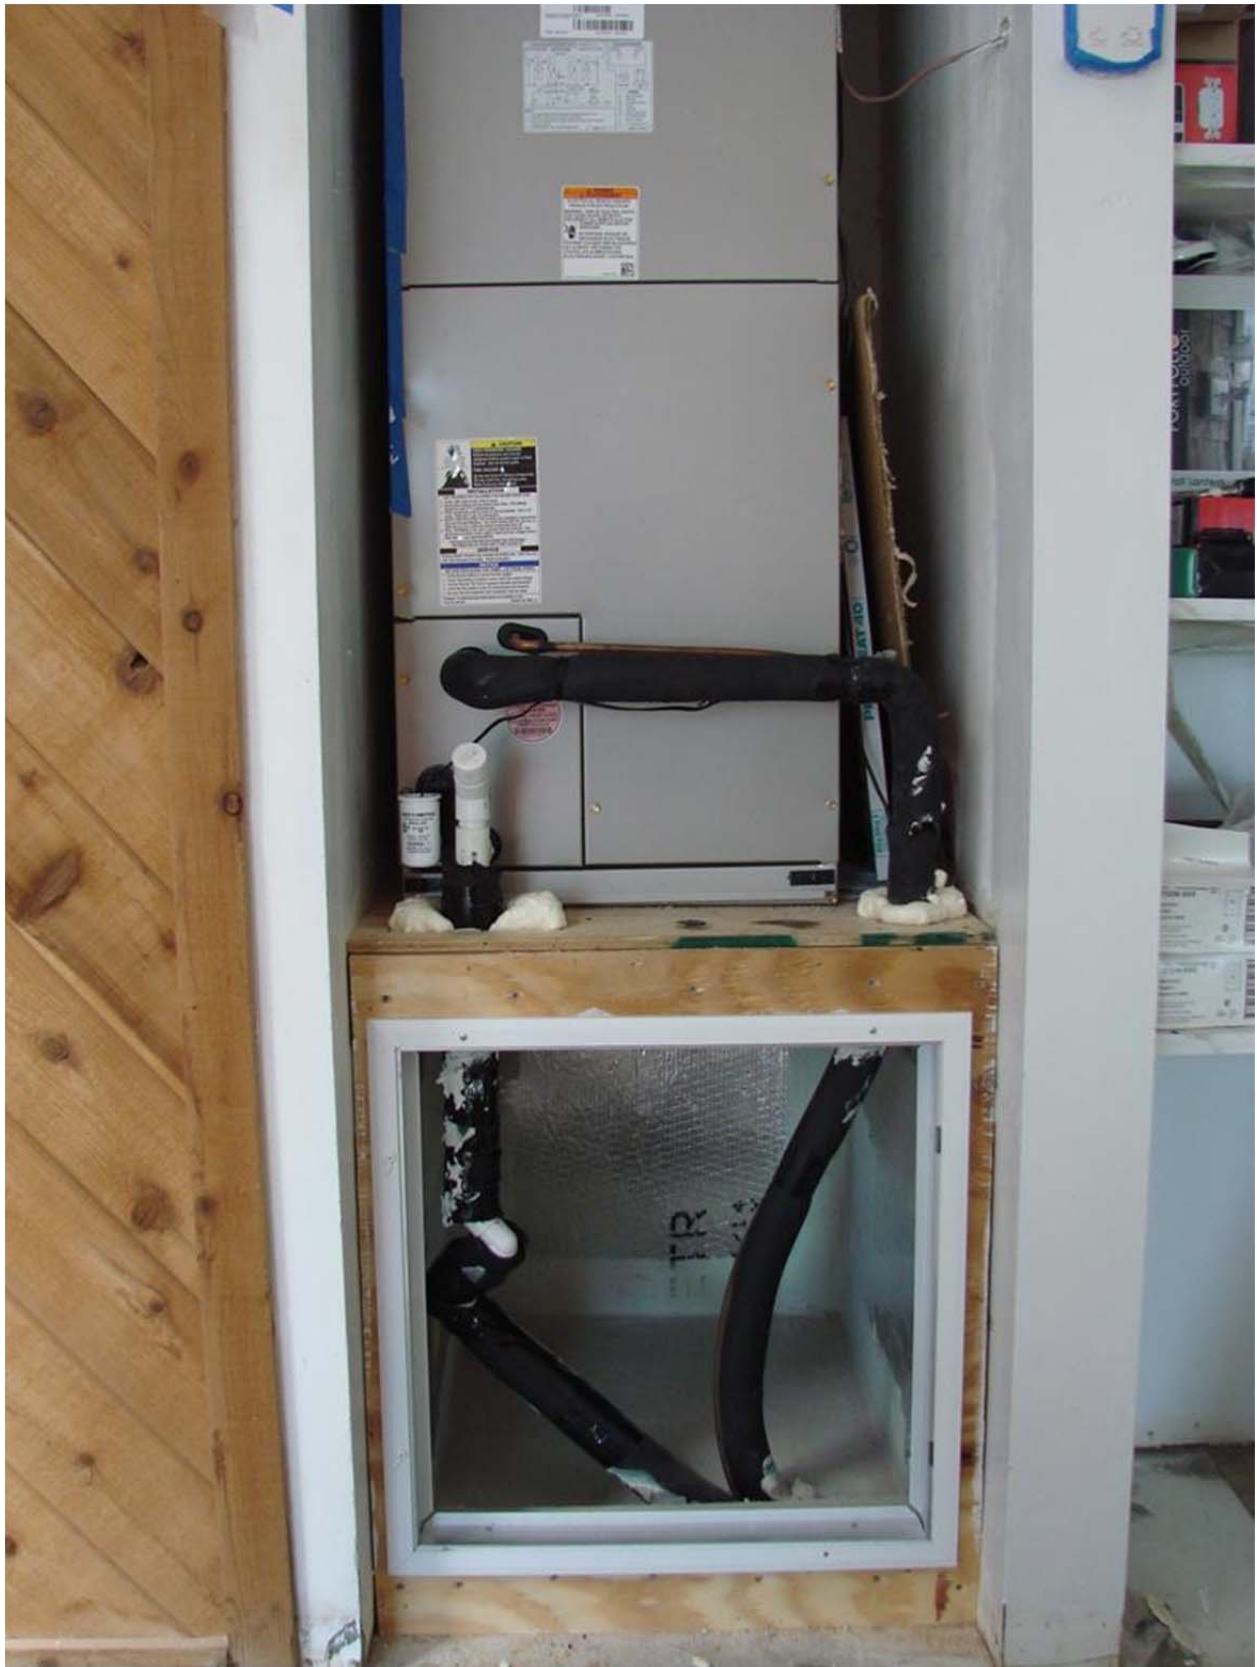
Figure 15 Completed repaired return air plenum. Note mastic at duct board seams.

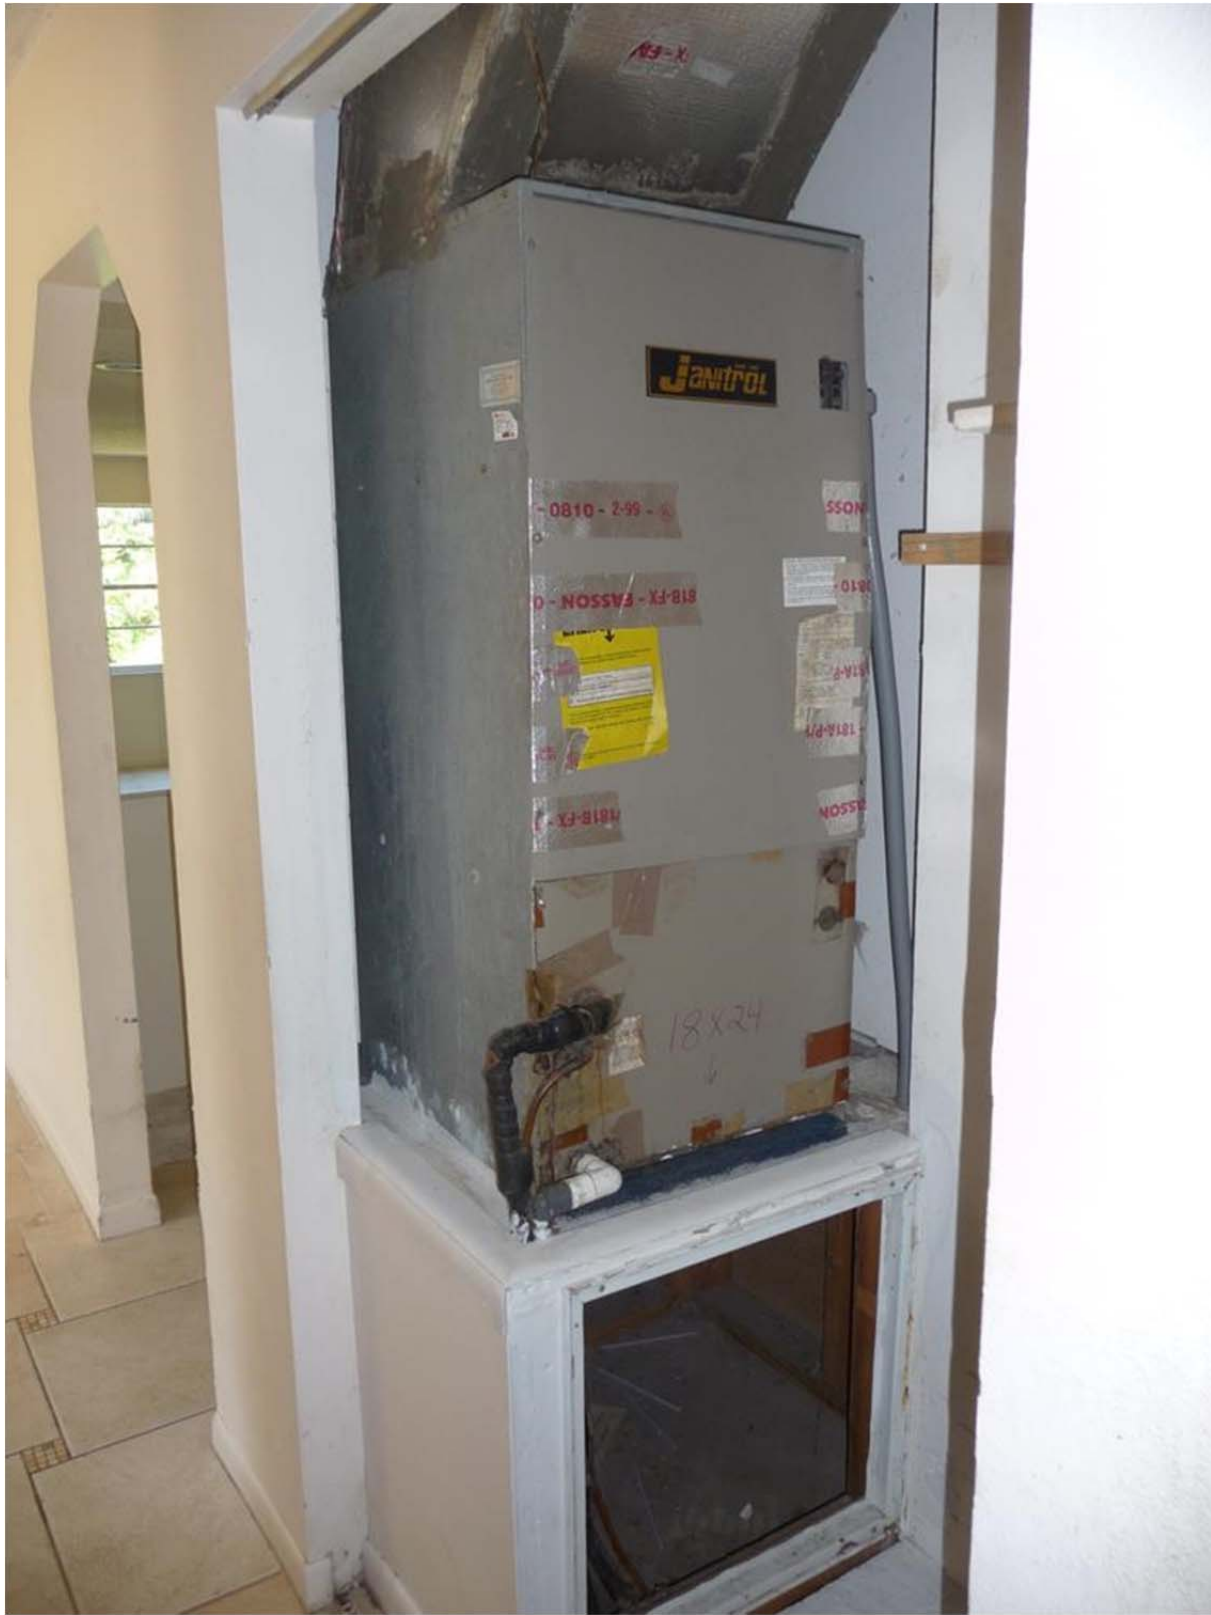
House 261 is a 1369 ft² slab-on-grade frame house (Figure 17). It has three bedrooms, two baths and an attached garage. The air handler is installed in a hall closet on a platform with a filter back grill in the closet. The closet has large, 6' wide, louvered bi-fold doors (Figure 18). There was a raised plywood floor in the closet. The return plenum was open to the wall cavities and the floor cavity (Figure 19). There was a filter installed under the air handler that was completely blocked with insulation and other dust and debris.

Figure 18. Note the open wall cavities in the return plenum and the raised plywood floor in the closet (in the lower right corner of the image)

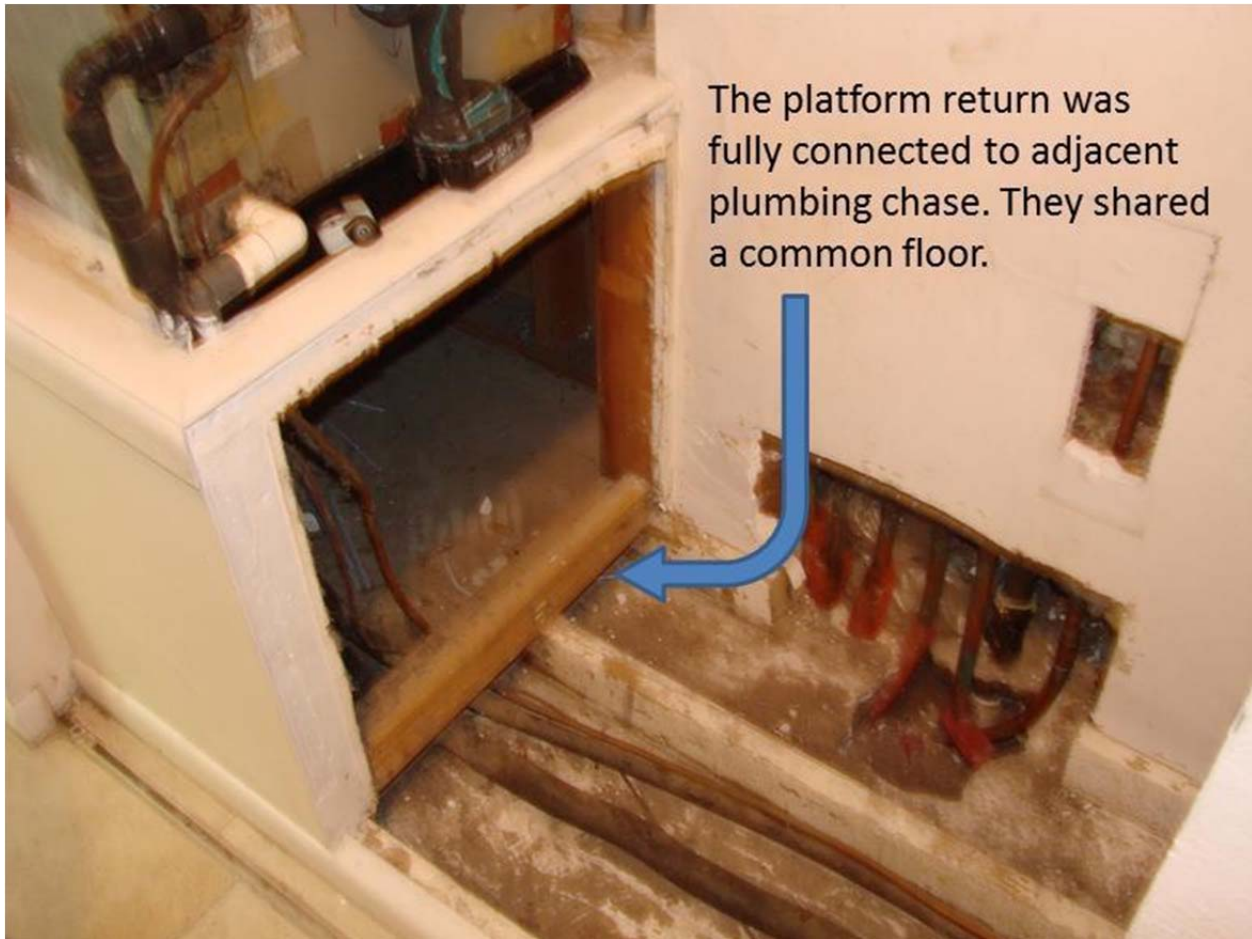
Figure 19. Raised closet floor created a plumbing chase for refrigerant line, condensate drain line and other plumbing runs. Chase is fully connected to return air plenum at pipe penetrations.

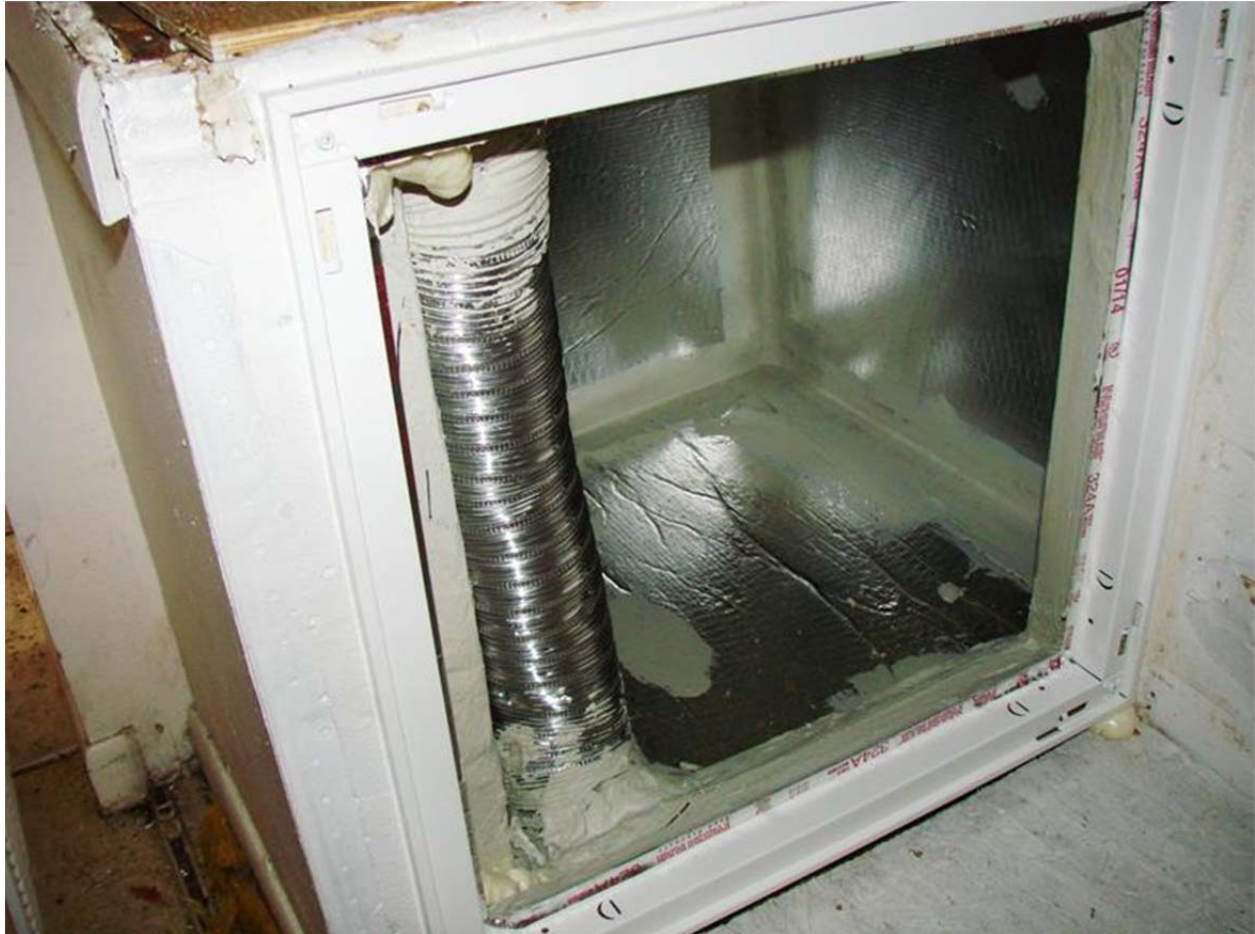
Figure 22. Repaired return plenum lined with duct board air barrier sealed with mastic at all edges.

Significant effort was expended on sealing and rebuilding the air handler platform in this house. When the air handler was removed the platform top was found to be rotten. The platform top removal was complicated by the fact that the platform was original installed before the house was drywalled. When the plenum was exposed it was sealed with duct board and mastic at the wall cavities and the raised floor (Figure 22). The new air handler was installed on the new platform and sealed with a combination of tape, mastic and caulk(Figure 23).

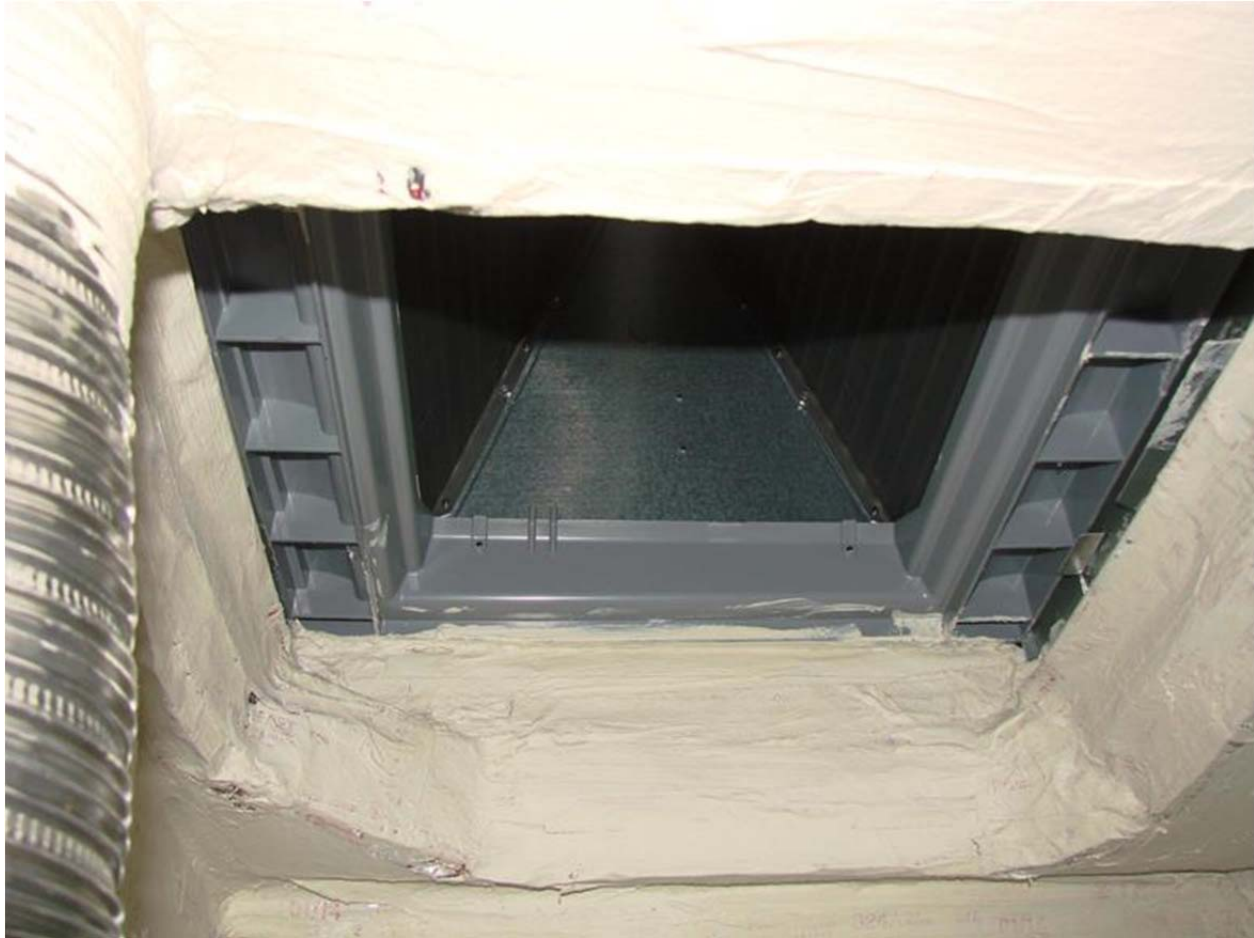
Figure 123. Return air entry to air handler seen from inside the return plenum. Joint between plenum, platform, and air handler is thoroughly sealed with mastic.

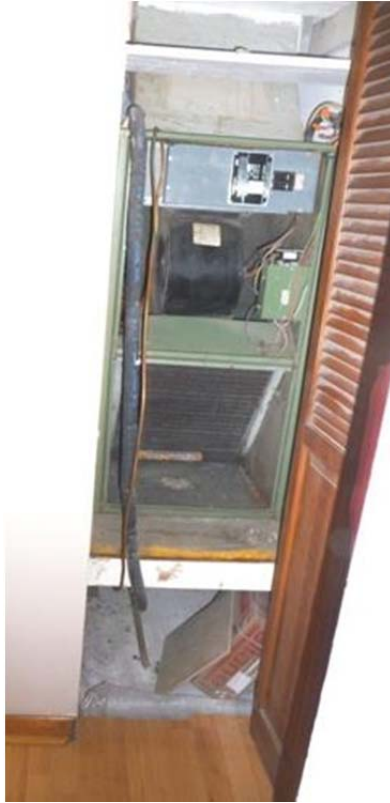
This 900 ft² slab-on-grade CBS house was built in 1981 (Figure 25). It has two bedrooms, one bath and an attached garage. The air handler is located on a stand in a hall closet behind a bi-fold half-louvered door (Figure 26). The return plenum formed under the air handler is un-drywalled, resulting in open wall cavities in the air handler return path (Figure 27).

Figure 26. Air handler closet with open frame platform return plenum.

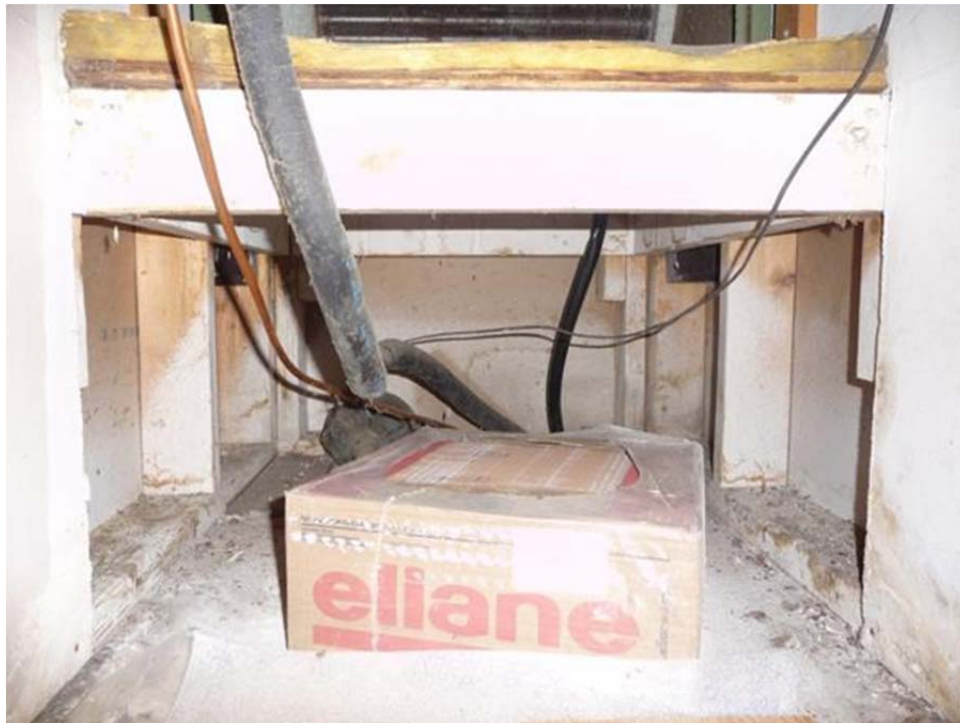
Figure 27. Open frame platform return.

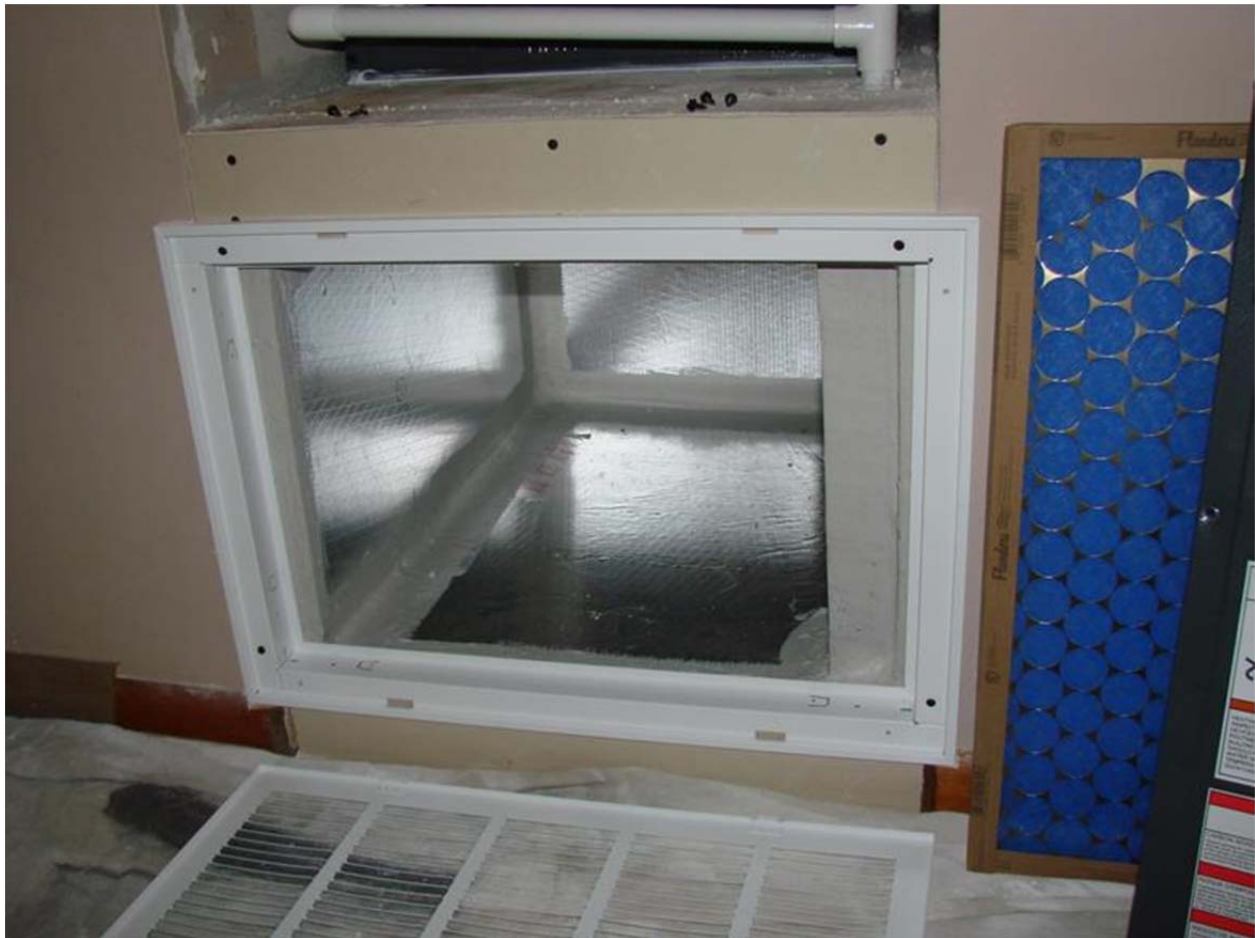
Figure 28. Repaired platform return plenum with duct board air barrier sealed at edges.

This contractor did significant work in the attic of the house sealing the supply system. The entire return configuration was changed to a platform with a filter-back grill installed in a well-sealed plenum (Figure 28). Additional time was spent while sealing the plenum to keep the condensate and Freon pipes isolated from the return plenum. The air handler closet will be completed with the installation of a half door to hide the air handler.

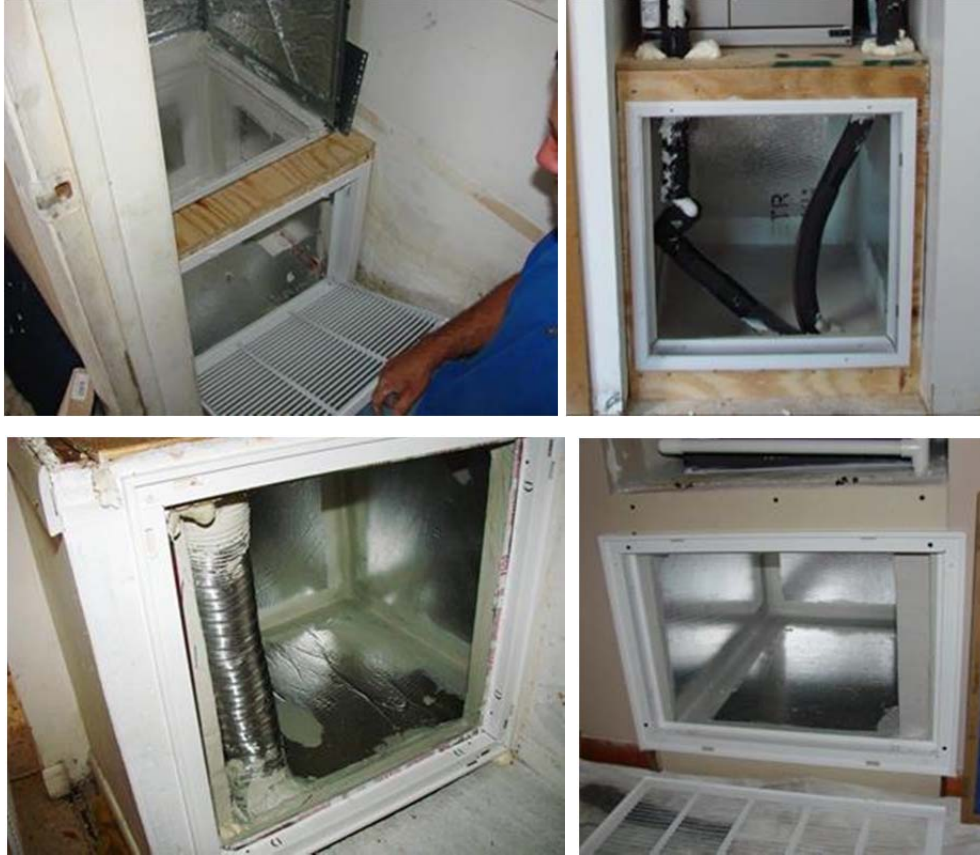
air in the general Florida existing housing stock. However, it is clear that the HVAC contractors in this study all had the same approach: build a platform return lined with duct board sealed at the edges and seams (Figure 33) . An approach that is consistent with HVAC requirements and practices in Florida new construction. In essence, these return plenums are “as good as new”.

Figure 33. Air barrier lined return plenums in Test Houses (left to right) 1962, 194, 261, and 223.
