Final Report for Project Entitled:
Full Scale Wind Load Testing of Aluminum Screen Enclosures
PO Number A95F33

Performance Period: 1/6/2014 – 6/30/2014

Presented to the
Florida Building Commission
State of Florida Department of Business and Professional Regulation

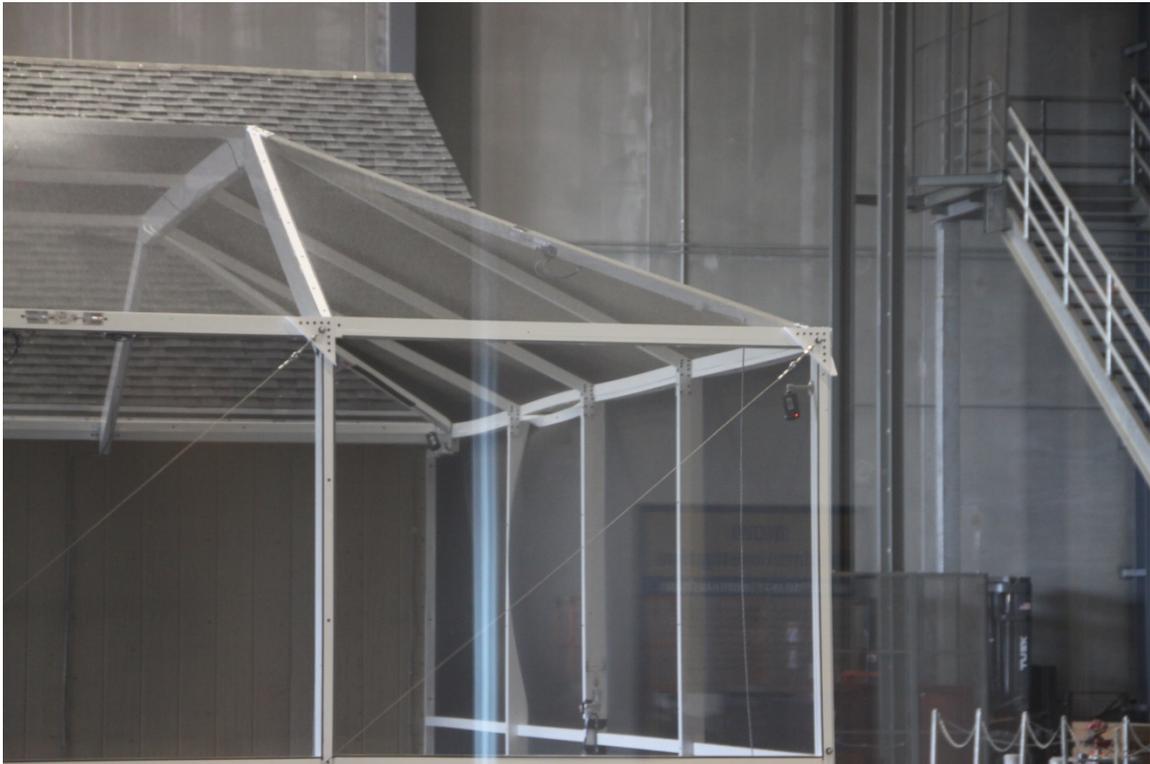
The generic specimen did not show any significant damage until Run 27 (80 mph). During Run 27, one 2X1 screen attachment failed and caused large movement of the attached screen as shown in Figure 16. The failed member was inspected after Run 27, which showed that the failure was due to the pullout of inner screws (Figure 17). The attachment had permanent distortion but it was still attached to the adjacent structural member.

Figure 16. Partial failure of the screen attachment during Run 27 (maximum wind speed = 80 mph)

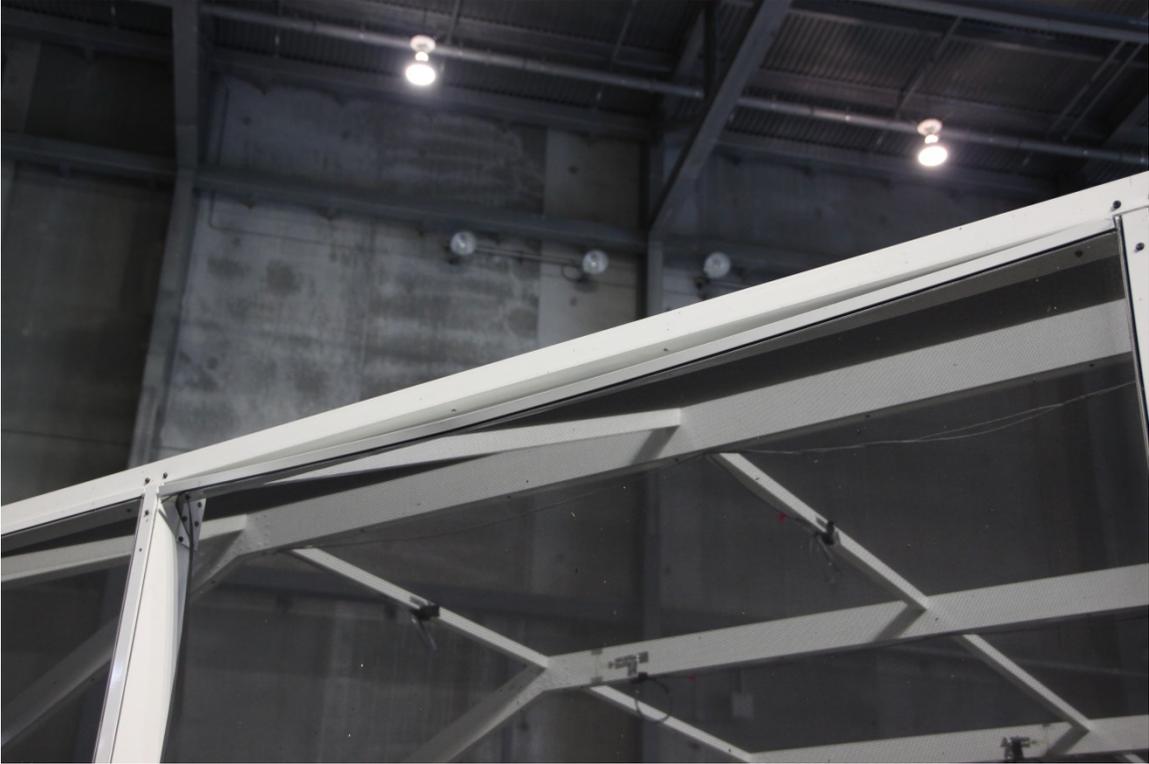
Figure 17. Partial failure of the screen attachment due to the pullout of screws (after Run 27)

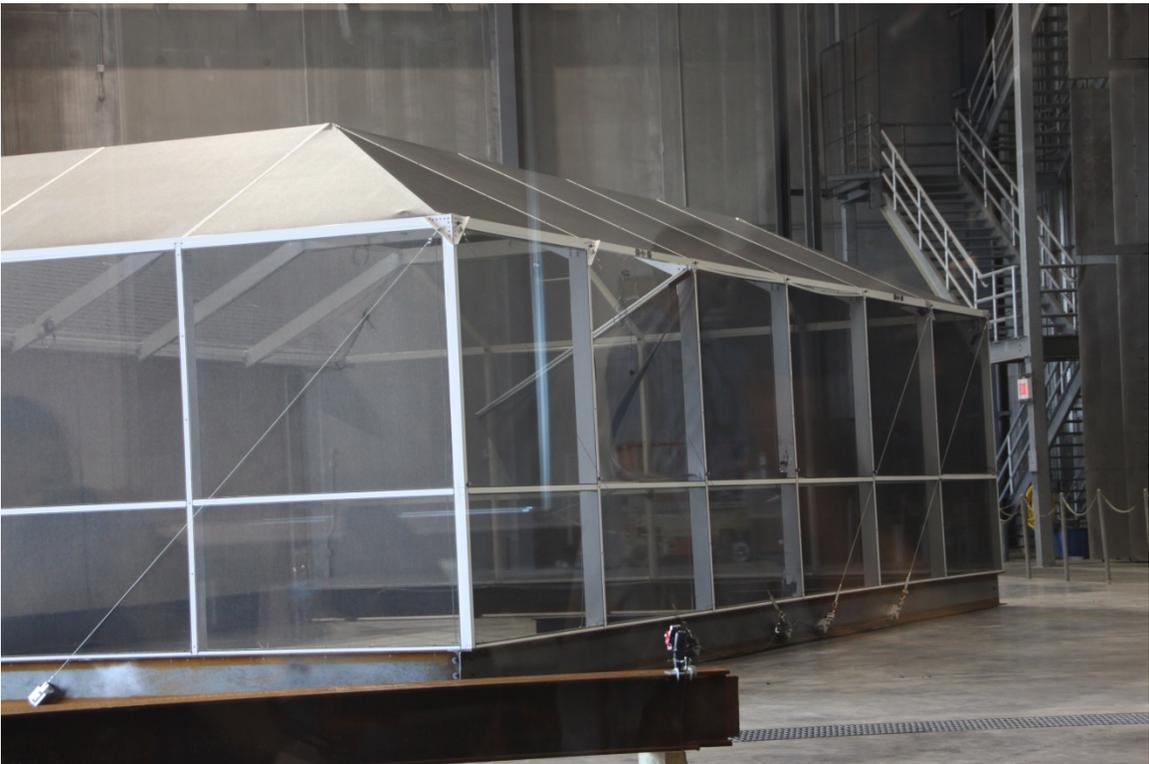
Run 28, the same maximum wind speed but applied at the wind angle of 0 degree, showed very similar behavior. Two 2X1 screen attachments at the upper center part of the windward wall failed in a similar way. When the maximum wind speed increased to 90 mph at Run 29, one 2X1 member further detached from the structure as shown in Figure 18. This particular stayed attached at one corner without causing failure of the main structural member.

Figure 18. Failure of the screen attachment during Run 29 (maximum wind speed = 90 mph)

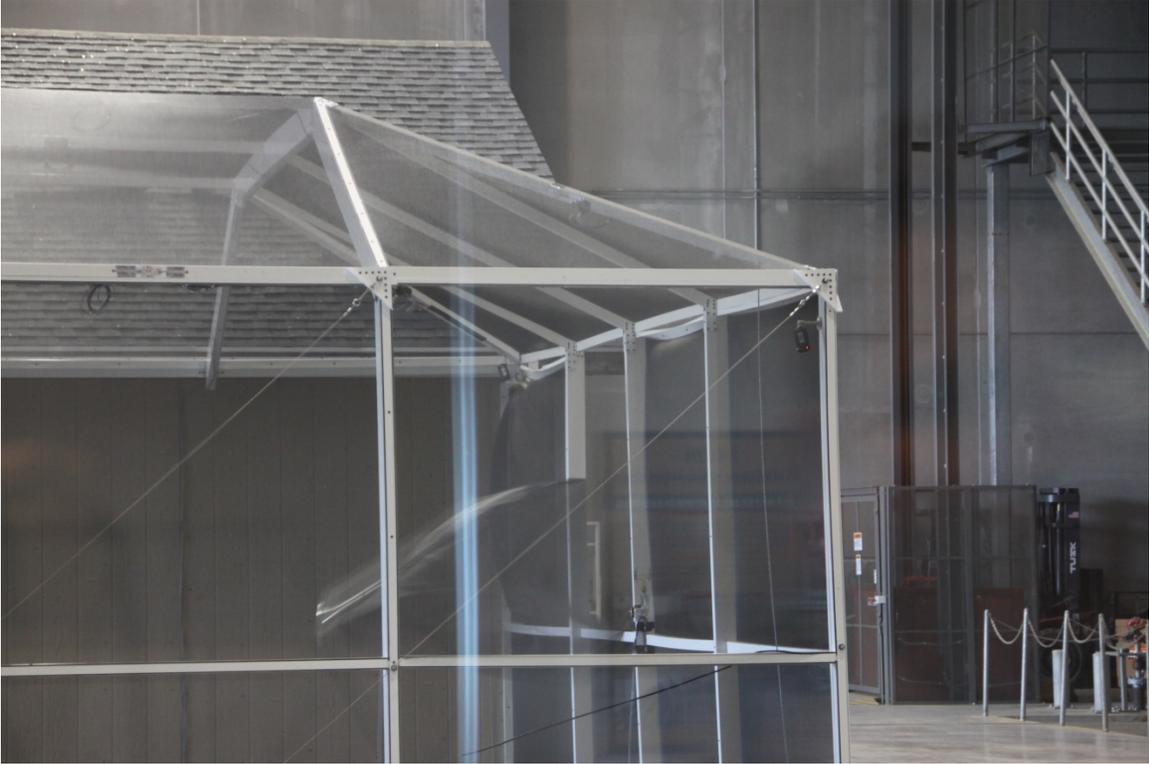
The next load case was Run 30, with the maximum wind speed of 90 mph applied at the wind angle of 90 degrees. One 2X1 member detached from the structure as shown in Figure 19. Similar failure occurred to one additional 2X1 member next to the host structure, which fluttered while staying attached to the structural member. The failed members were visually inspected after the Run 30. As shown in Figure 20, unlike the cases so far, failure of the 2X1 member caused failure of structural members. The failed structural members were the vertical post attached to the host structure and the member below the eave.

Figure 19. Failure of the screen attachment during Run 30 (maximum wind speed = 90 mph)

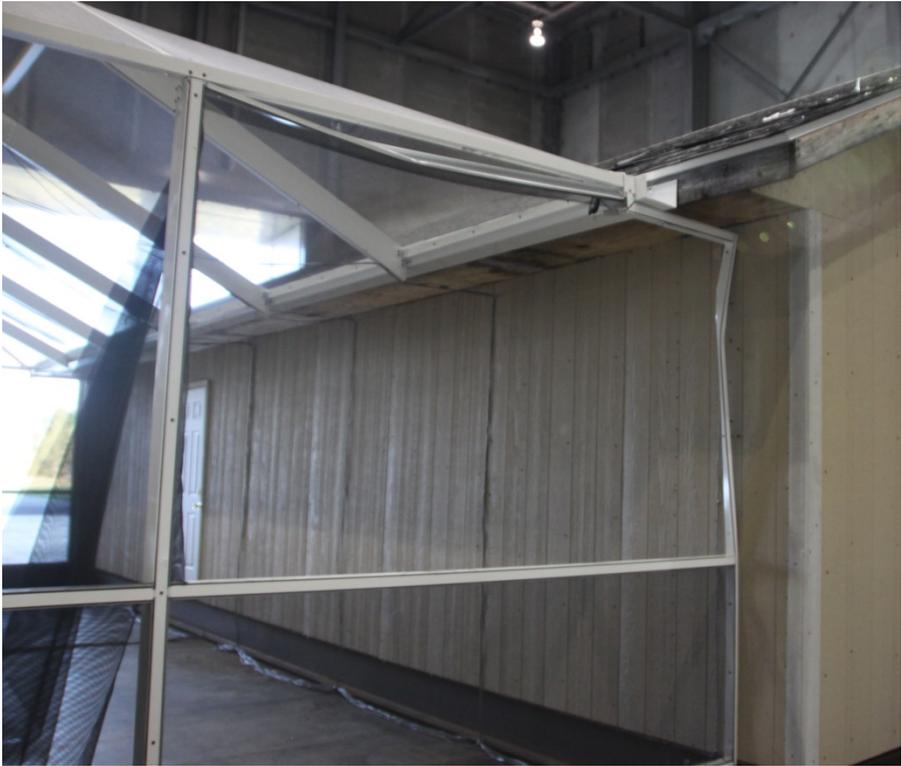
Due to the unexpected failure of the screens in both 0 degree wind angle and 90 degree wind angle, we were not able to fully load the generic specimen. The maximum wind speed that the structural members experienced was 80 mph, because at 90 mph screens began to fail. After completing Run 30, these failed screens were re-installed, with the exception of the corner shown in Figure 20 where re-installation was

Figure 20. Failure of the structural members after Run 30

not possible. It was decided to add additional screws (in between the installed screws) to prevent failure of the screens. The goal was to apply larger forces to structural members without premature failure of the screens.

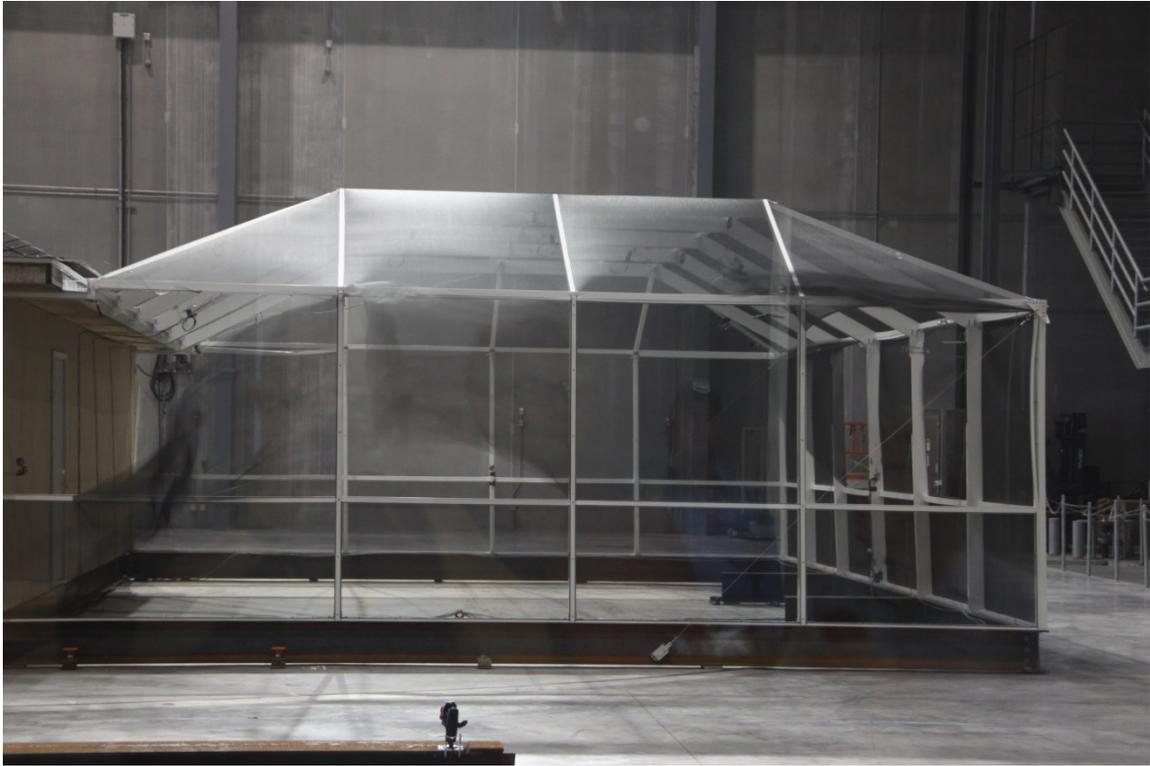
The wind angle was adjusted to 270 degrees (instead of 90 degrees) in Run 31 to utilize fully intact windward screens on that side. The maximum wind speed was increased to 100 mph. Run 32 also had the maximum wind speed of 100 mph, but applied at 0 degree wind angle. In both tests there were no visible failure of structural members. Only some 2X1 screen attachment continued to fail as shown in Figure 21.

Figure 21. Failure of the screen attachment during Run 32 (maximum wind speed = 100 mph)

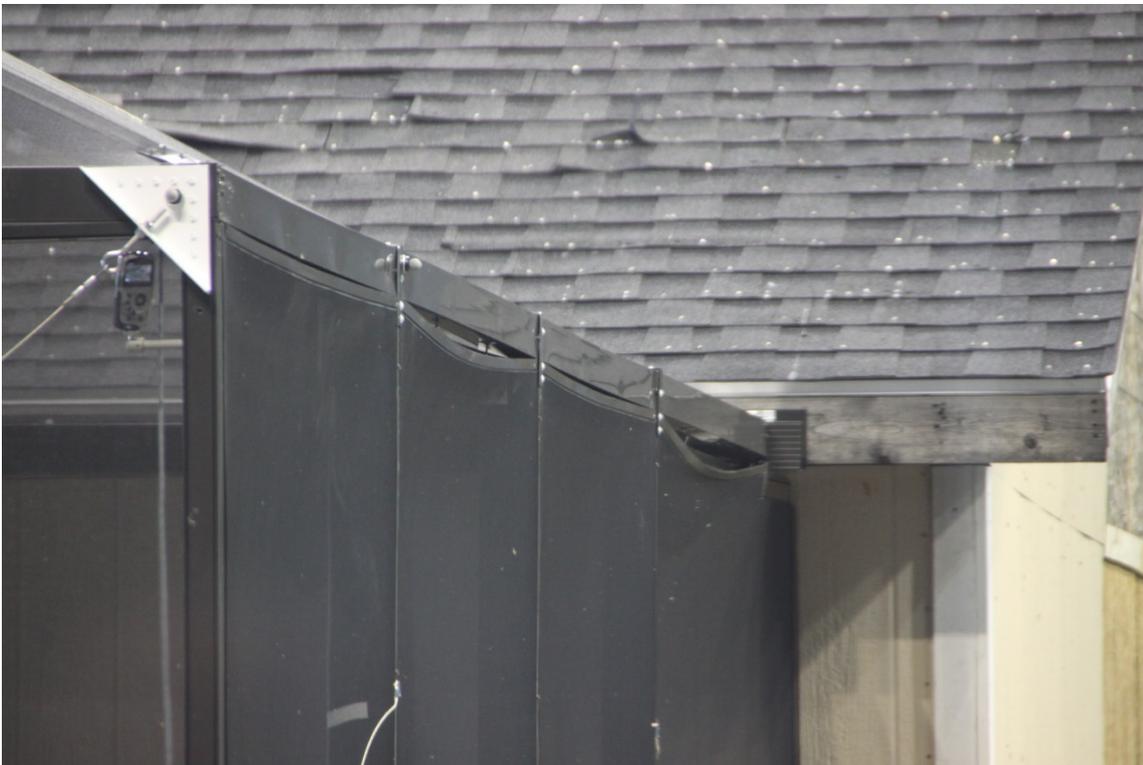
Overall, the AAF specimen responded similar to the generic specimen. No significant damage was observed until 80 mph, when some screen attachments began to fail partially as shown in Figure 22. At 90 mph 0 degree wind angle (Run 29), the second screen panel from the far end failed as shown in Figure 23. At 90 mph 90 degree wind angle (Run 30), the first screen panel from the far end failed in a similar fashion. Figure 24 compares failed screen attachments between the generic specimen and the AAF specimen after completing the Run 30.

Figure 22. Partial failure of the screen attachment during Run 27 (maximum wind speed = 80 mph)

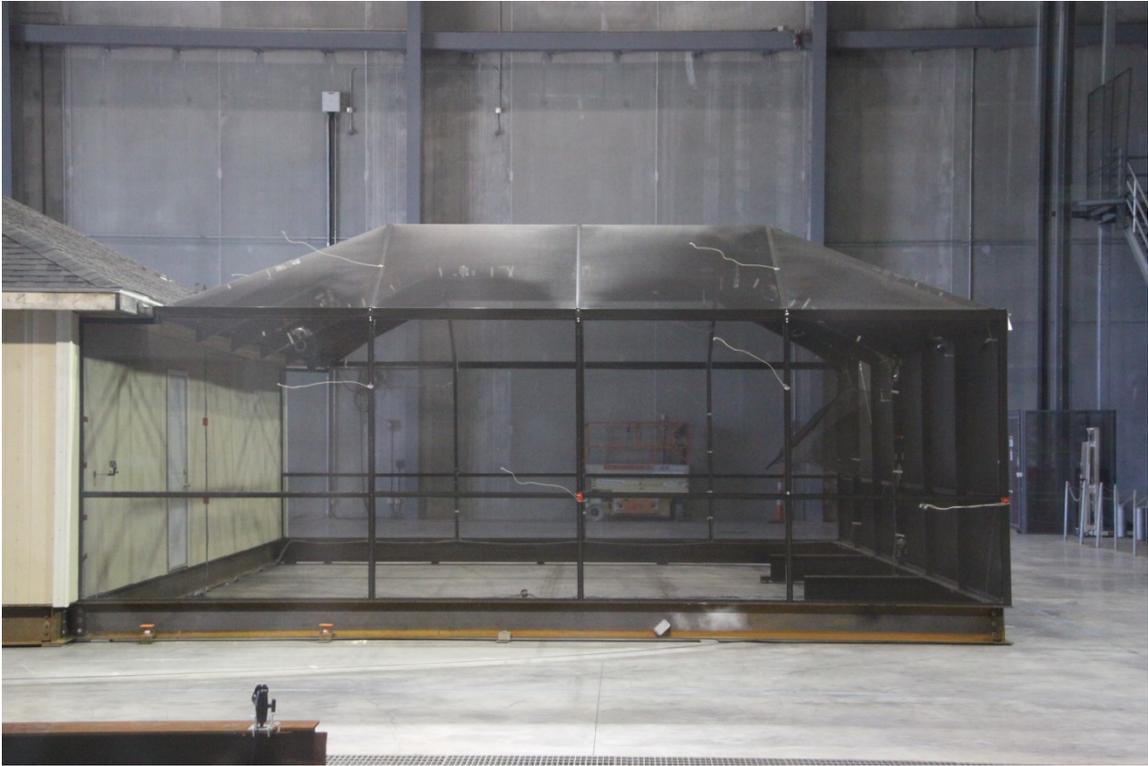
Figure 23. Failure of the screen attachment during Run 29 (maximum wind speed = 90 mph)

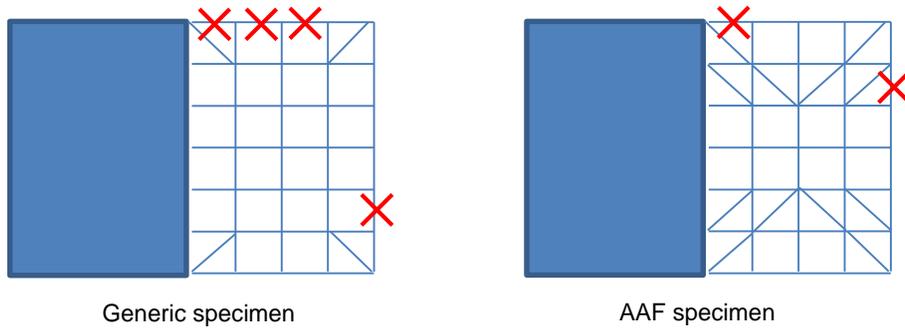
Figure 24. Comparison of failed screens and/or screen attachments (fully failed ones only) between the generic specimen and the AAF specimen after Run 30 (maximum wind speed = 90 mph)

When we compare high moment locations (M-17, M-18) with the location that lost the screen attachment (see Figure 24), we can hypothesize that high moment contributed to the failure of the screen attachment. We can also hypothesize that overall higher moments in the Generic specimen led to greater loss of screen attachments compared to the AAF specimen. With the available data, it is not possible to prove or disprove these points, but these can be further investigated in the future study.

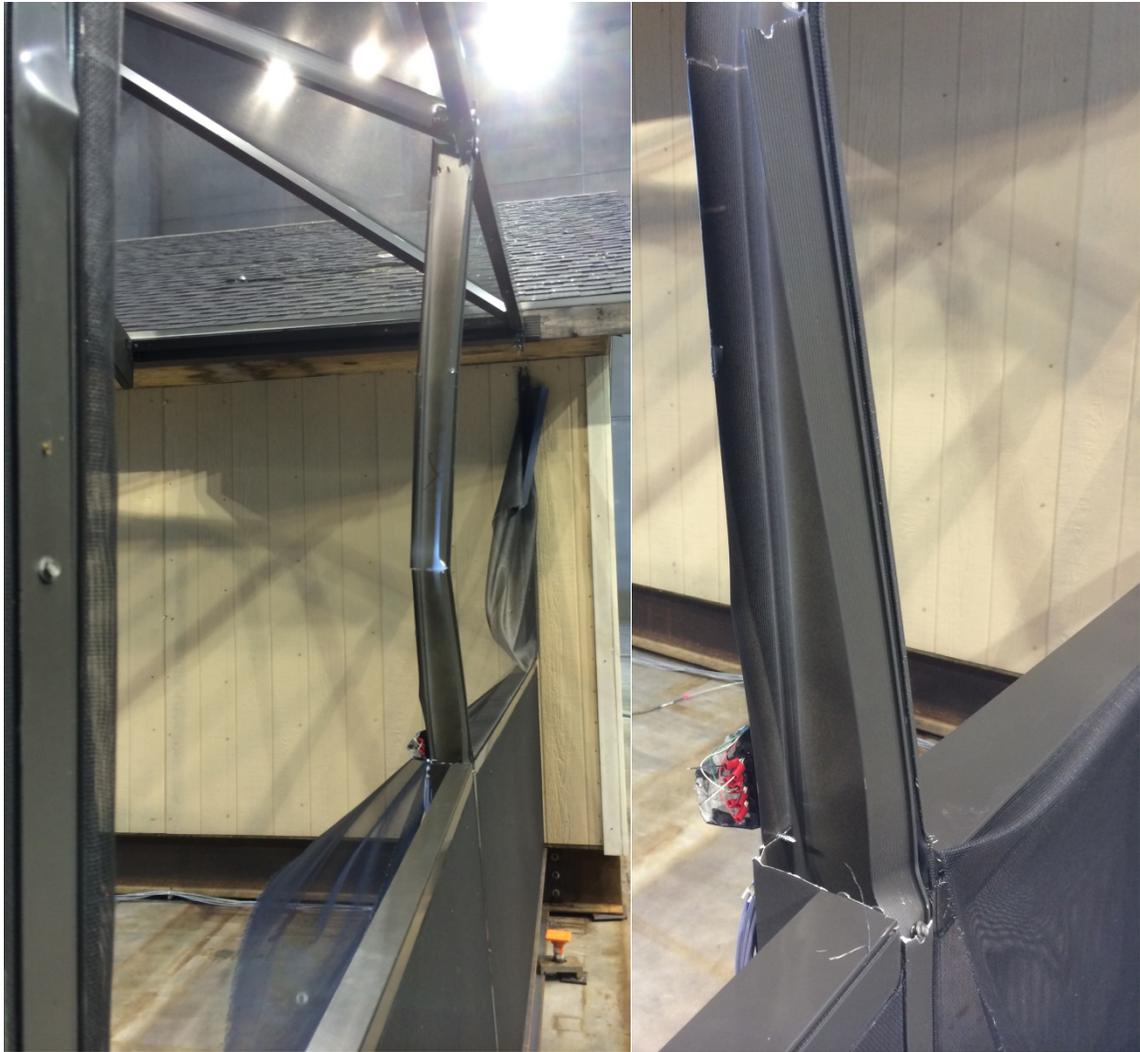
While the generic specimen had to undergo re-screening due to the loss of three (out of four) upper windows as well as change of loading direction in Run 31, the AAF specimen was subjected to 100 mph wind speed immediately after the Run 30. During Run 31, the screen attachment of the second window from the far failed, but the failed member dangled in the corner and fluttered. Therefore, the upper column was continuously subjected to the large force even after the failure of the screen. The upper column was significantly damaged in the process as shown in Figure 25. While investigating the failure, the thickness of this column was compared between the generic specimen and the AAF specimen. For the generic specimen, the thickness of the flat part and the grooved part were 0.045 inch and 0.061 inch. For the AAF specimen, the thickness of the flat part and the grooved part were 0.042 inch (-6%) and 0.059 inch (-3%). It is possible that slightly less thickness of the AAF member contributed to the failure, but given the small difference the fluttering of the dangled screen attachment was likely cause of the failure of this column.

Figure 25. Failure of structural members after Run 31 (maximum wind speed = 100 mph)

We decided to further investigate why the column has failed. The windward wall (at 90 degrees wind angle) was retrofitted by replacing the two interior posts with intact members from the generic specimen. All failed screens were repaired with new screens. Additional screws were added to the screen attachments to prevent the failure of the screen attachment, and to fully load the specimen. Run 32 then was conducted, which was identical to Run 31. Turbulence was added at Run 33. Wind angle was changed from 90 degrees to 0 degree in Run 34. The corner screen was cut in Run 35 to introduce unbalanced loading to the column. Extra screws in the screen attachment were removed in Run 36.

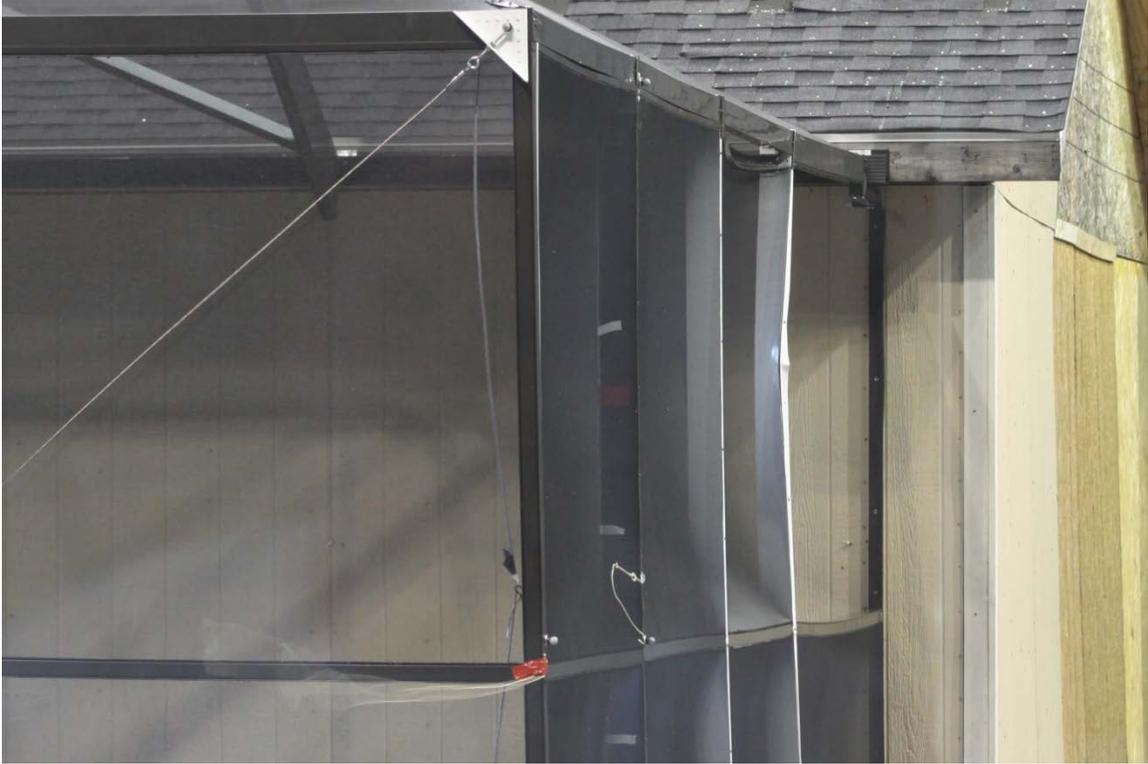
Additional screws from the second window attachment were removed in Run 37, so that the attachment would fail similar to what happened in Run 31. Under these conditions, i.e., wind loading from only one of the two sides and failed screen attachment, the column failed again as shown in Figure 26.

Figure 26. Reproduction of failure of the column in Run 37: unbalanced loading with the failed screen attachment led to the failure of the column

The wind loading applied during the full-scale tests did not exceed the design loading. In principle, no members should have failed. However, one vertical post failed due to the unbalanced loading. One side of the failed post had the screen (and therefore wind loading) whereas the other side did not have the screen.

The unbalanced loading has direct implications on the rule on removing the screen (Rule 61G20-1.002). If some screens are cut but not others, unbalanced loading may accelerate the failure of the post. Code changes should be considered to require removal of all screens above the chair rail if we were to allow the removal of the screen.

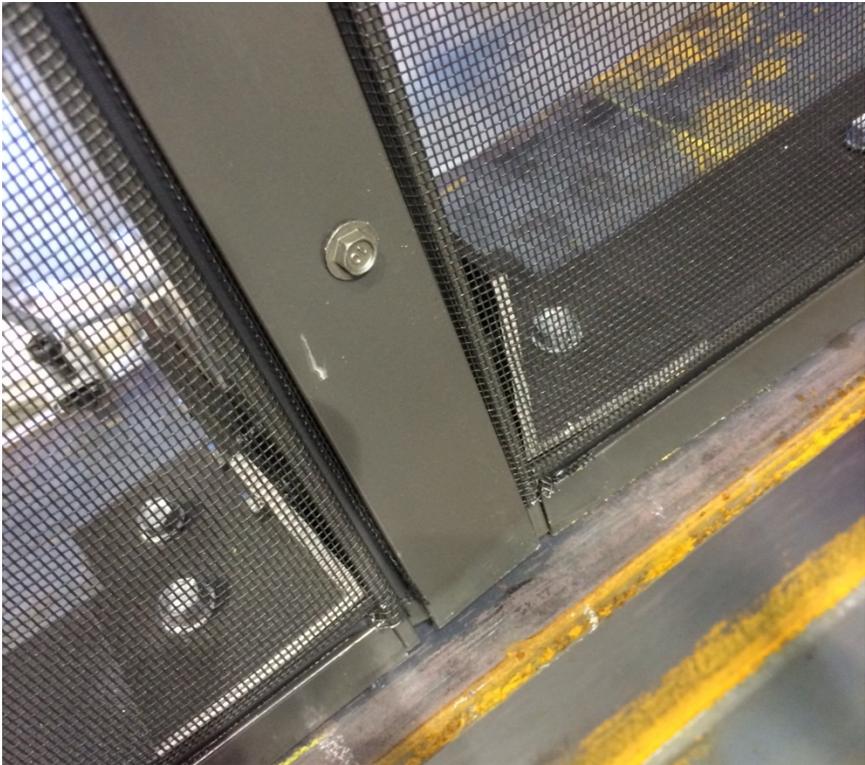
While the specimen was retrofitted after Run 31, we visually checked failure at other locations. It appeared that cables lost tensions significantly (but not completely) during the series of runs. We also found out that brackets at the base of the post (windward wall for 0 degree wind angle, third post from the left) had local failure as shown in Figure 27. It was unclear if the failure was from a specific load case, or repeated high moment at the base during the series of runs.

Figure 27. Local failure of brackets at the base of the post (windward wall for 0 degree wind angle, third post from the left)

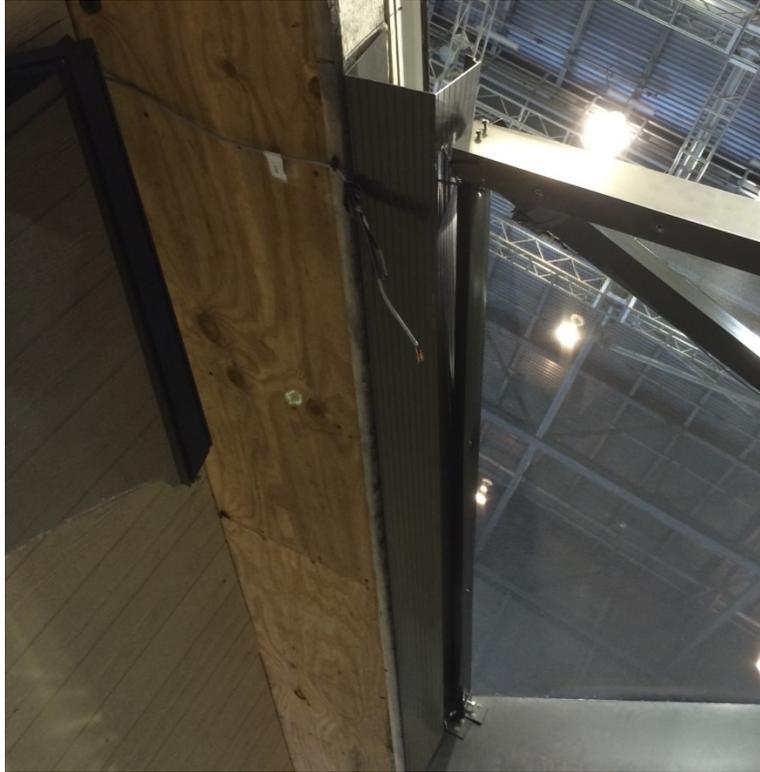
Run 38 was an attempt to investigate the effect of the additionally installed screws to the screen attachments. Extra screws in windward wall of 0 degree wind angle were removed in Run 38. Runs 39 and 40 were attempts to investigate poorly constructed cables. Poorly constructed cables can be pulled out from the ground or the mount during the hurricanes. In these tests tension cables were removed from the specimen. When the wind loading was applied greater moment was applied to the screen-to-host connections and one of these connections failed as shown in Figure 28.

Figure 28. Failure of a screen-to-host connection after Run 39 (removed tension cables, wind angle = 270 degrees, maximum wind speed = 100 mph)
