BUILDING CODE TRIAGE TEAM AFTER ACTION REPORT: HURRICANE DENNIS

Michael Ashworth, Building Code Triage Team Leader (850-922-6075):

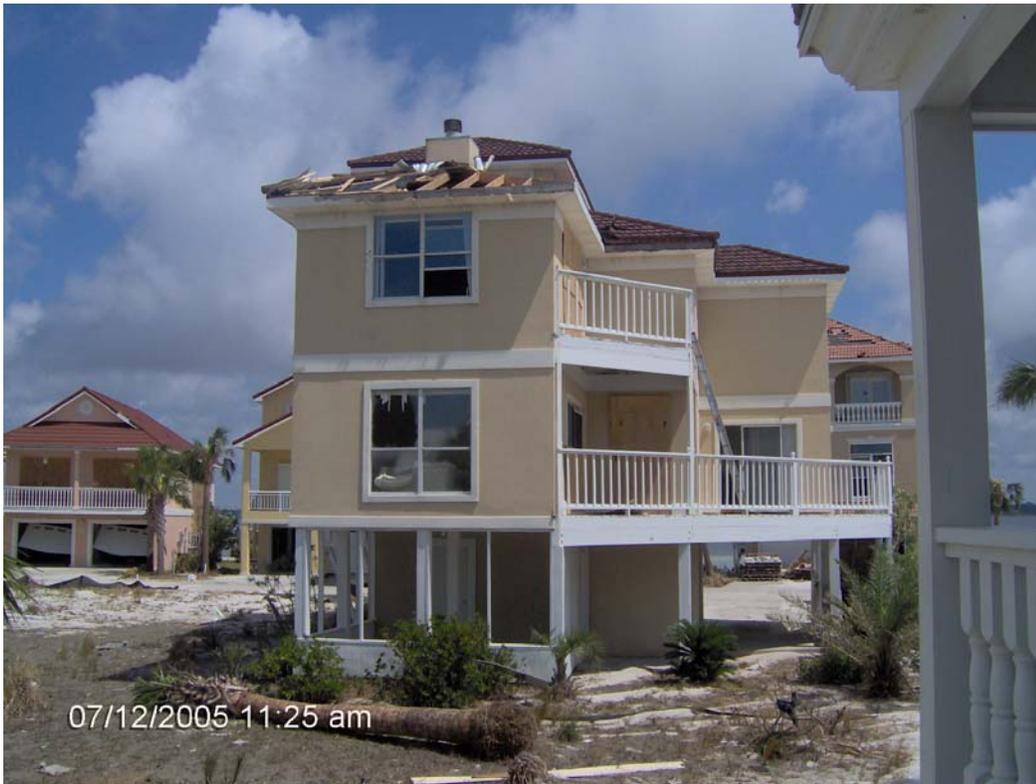
somewhat lower. These winds were at the threshold of where the building codes require windborne debris protection and the following photos show the criticality of that protection.

The residence above was about 12 years old and located in Navarre Beach. This community has covenants for architectural appearance that require a tile roof appearance, and many roof tiles were evident on the ground, decks, and porches. The duration of winds above 110 mph is not known, but evidently it was enough to begin removing the roof. Some of the homeowners had replaced their roofs, post Ivan, with metal roofs, but some had retiled. Perhaps the third time will be the charm!

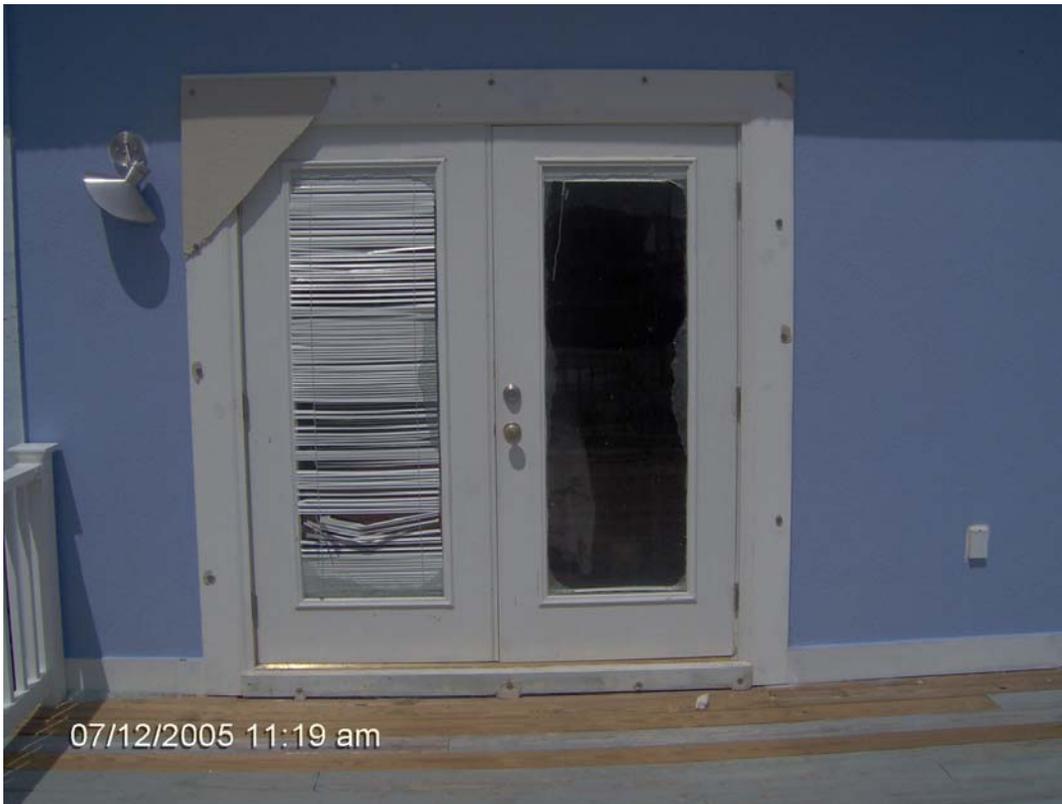
My second observation is that windborne debris windows are working, although their use is not yet commonplace and finding them among the affected homes is still rare. The following picture shows an impact resistant door with the outer tempered lites impacted, but the inner lites maintaining the opening. This was within 100 yards of the first picture and no doubt would have threatened the integrity of the roof if non impact product had been used.

The above picture also depicts a futile effort to use siding panels as a shutter, which perhaps implies that the owner was unaware that the home had impact resistant doors. The deck was strewn with roof tiles and tile fragments.

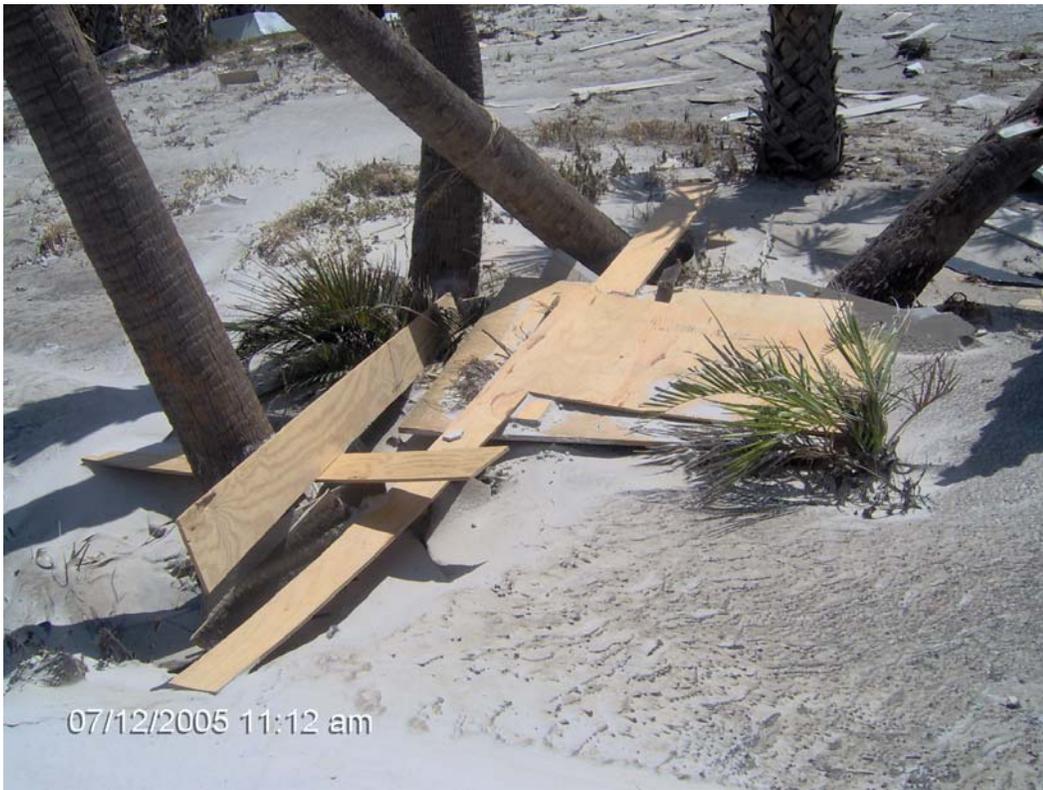
A third observation is that we consistently see elements that are meant to be windborne debris protection actually becoming the windborne debris. It is very commonplace to wade through and across debris piles that include plywood, OSB, and corrugated panels that were intended to save openings but instead inflicted damage as they became projectiles. The following picture shows one such piece of protection/projectile. Perhaps tested windborne debris protection should be the only permissible protection allowed on barrier islands?

- Find a way to restrict protective panels being allowed that become debris after they leave the opening
- Restrict the use of EIFS over wood framing in windborne debris (WBD) areas unless some protective layer is used and perhaps require some stringent licensing exam to insure qualification of the installers.

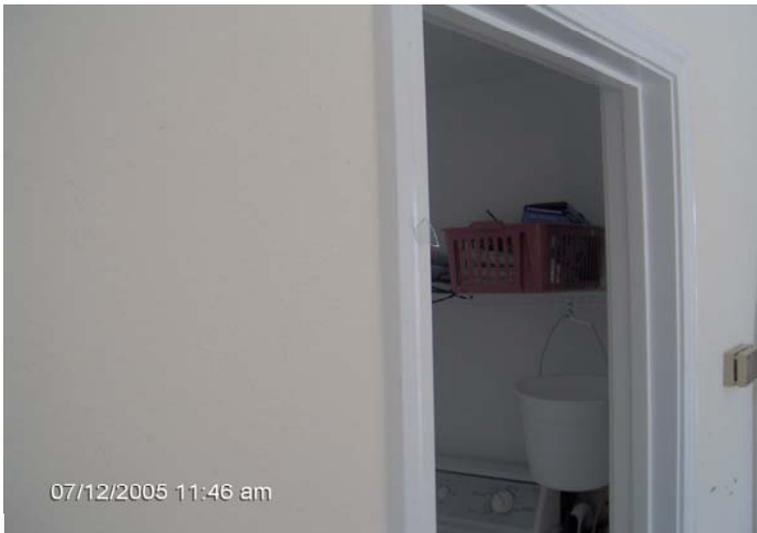
A fourth observation is that there have been some manufacturers selling doors with annealed glass. Tempered glass has been required in doors for some time yet the picture below shows a fragment of annealed glass that was embedded in the left door casing after failure of the patio door.

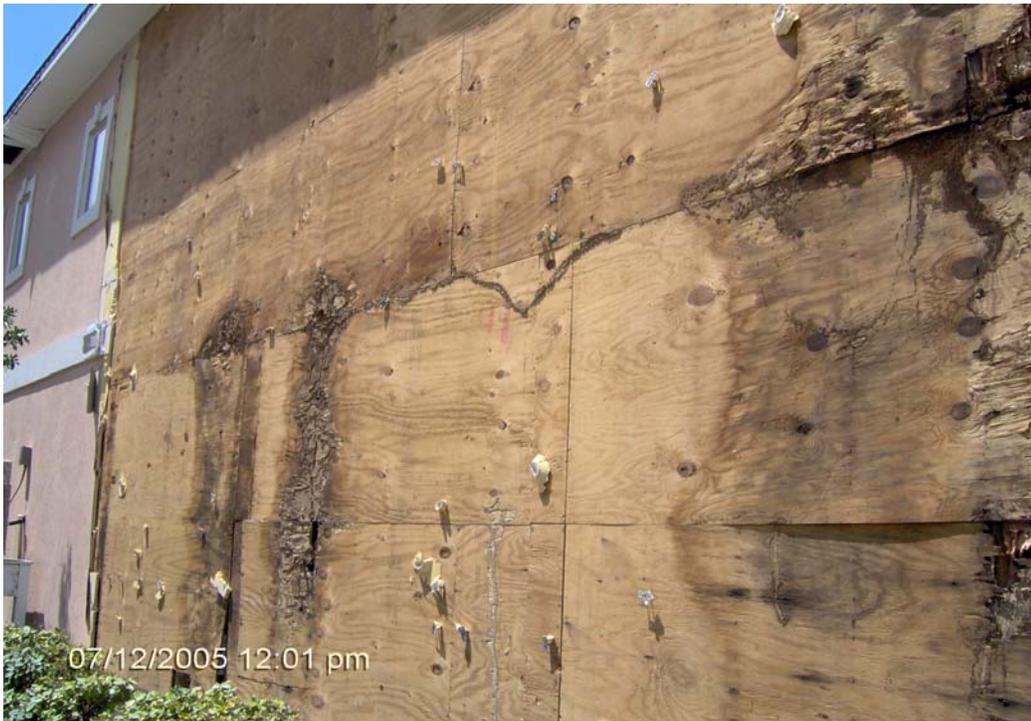
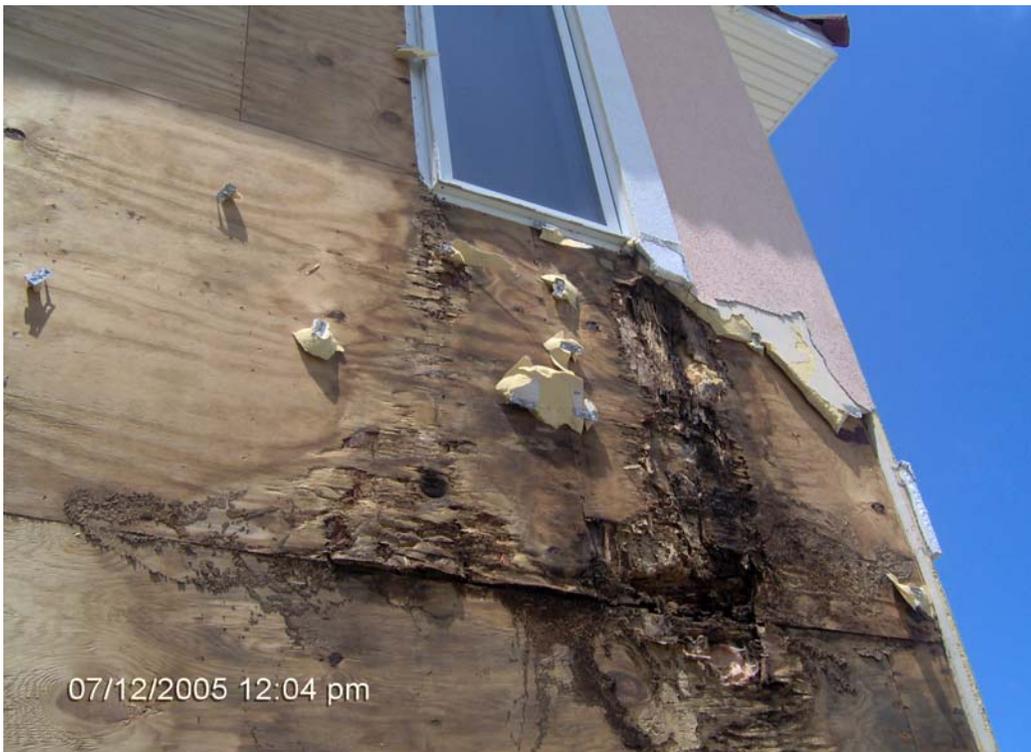
impressive damage were observed on a barrier island. The next two pictures shows the termite tracks after the wind removed the EIFS (note the lack of water control barrier, flashing?).

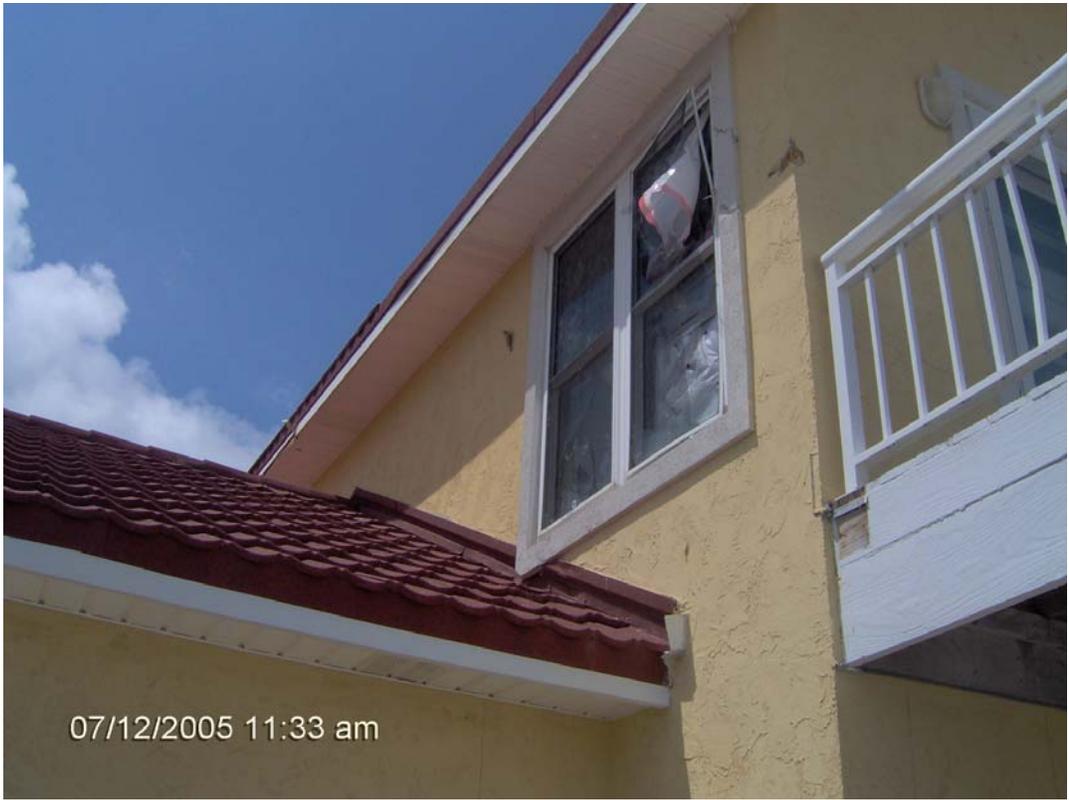
EIFS, Exterior Insulated Finish System, does not seem to remain adhered to wood sheathing and is easily penetrated by projectiles such as roof tiles. It would seem extremely dangerous to try and weather a windstorm in such a structure. Though it's difficult to see, the following photo shows an entry wound for a roof tile that passed through an exterior wall, an interior wall, and was imbedded in the opposite exterior wall.

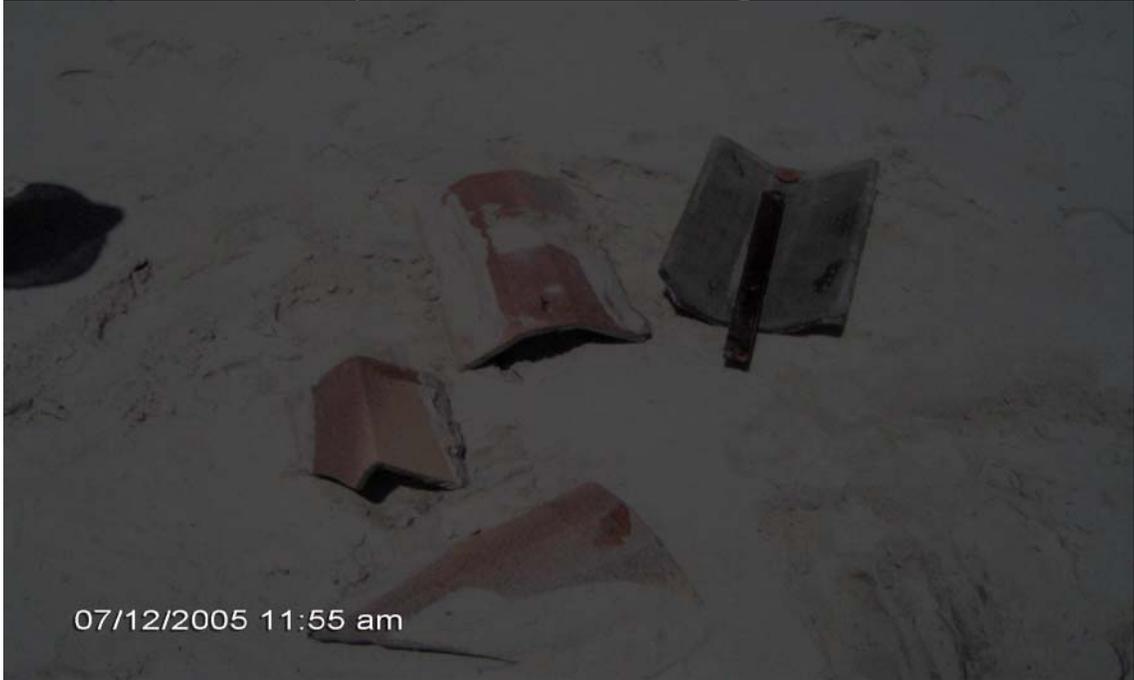
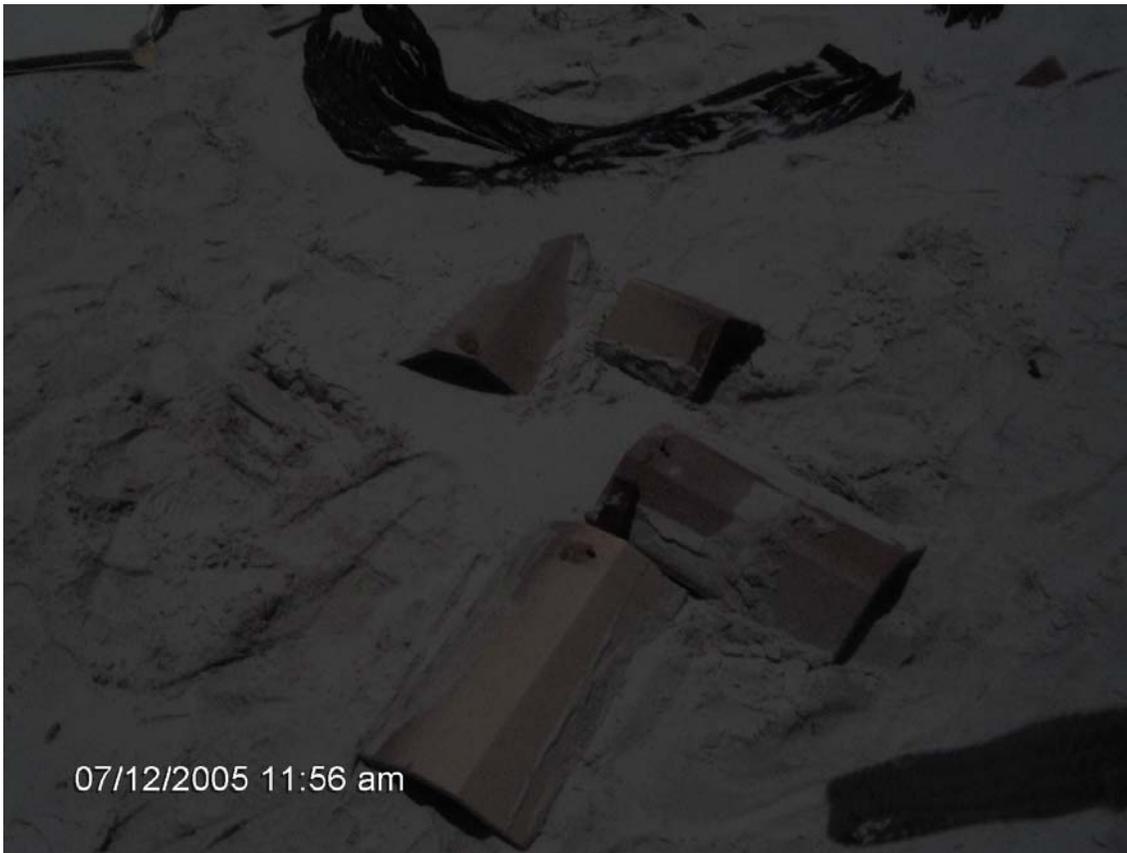
Roof tiles have been under scrutiny for some time now and Hurricane Dennis with its marginal winds removed tiles from roofs that had been replaced since Hurricane Ivan. The following photos show the minimal contact of adhesive present and the removal of a ridge board.

- Restrict the use of roof tiles in WBD areas and/or perhaps require a more stringent exam to insure that installers are qualified.
- Commercial signs should be a fabric material over a skeleton so that they can disintegrate and not damage anything else.
