Final Report:

Survey and Investigation of Buildings Damaged by Category-III, IV & V Hurricanes in FY 2018-2019 – Hurricane Michael

Project #: P0091032

Report No. 01-19

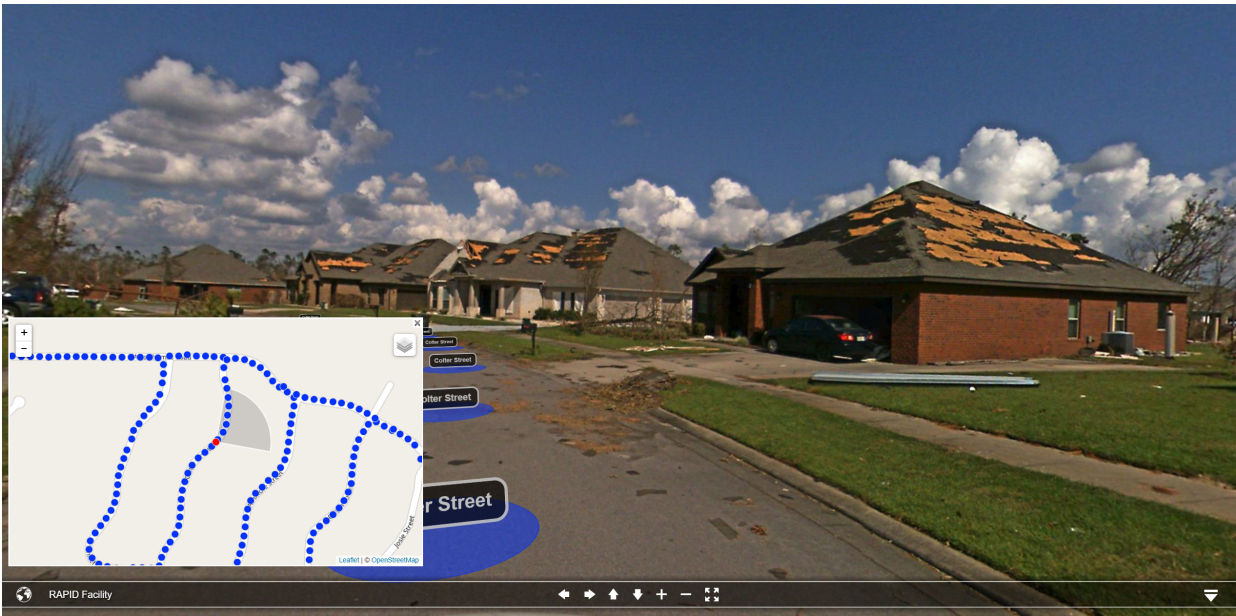
Figure 6. StreetView imagery of homes damaged by Hurricane Michael in Panama City, FL.

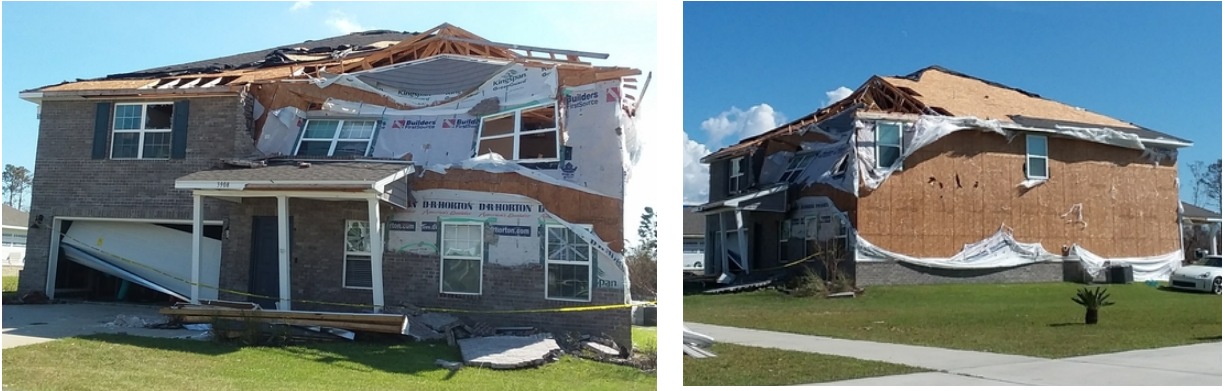
Figure 22. Damage to a 2016 home in the Magnolia Hills subdivision in Panama City, FL. The estimated peak gust wind speed here was 57 m/s, with an ASCE 7-10 design wind speed of 59 m/s.

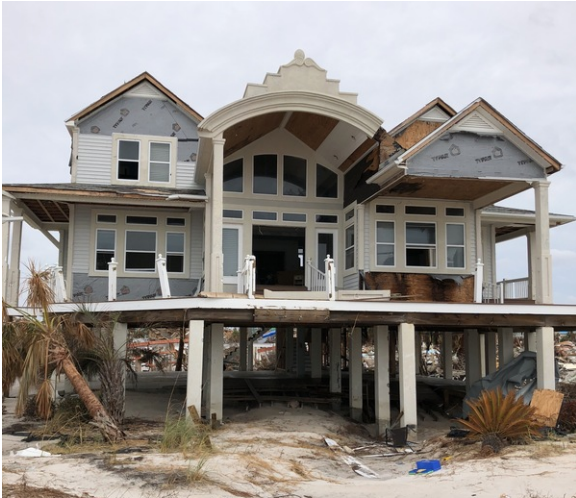
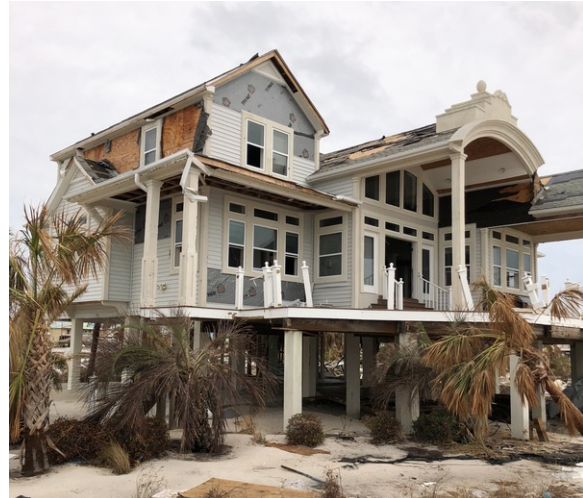
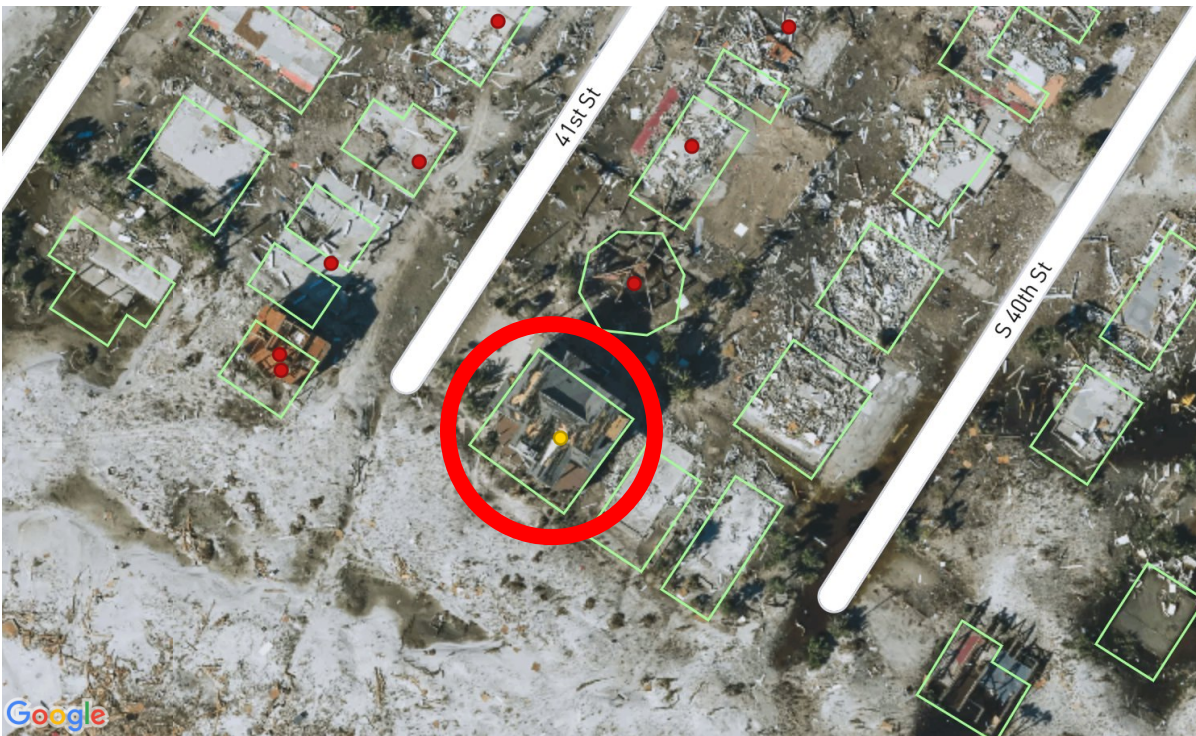
Figure 26. Performance of a pre-FBC home (Year Built = 1997) on Mexico Beach (Latitude: 29.950607, Longitude: -85.426983). CERA estimated the maximum surge inundation above ground level was 1.27 m (4.2 ft) while the first floor elevation was estimated at 3.5 m. The bottom image shows the home surrounded by other homes with slabs swept clean. Green rectangles indicate the outlines of where homes used to be.

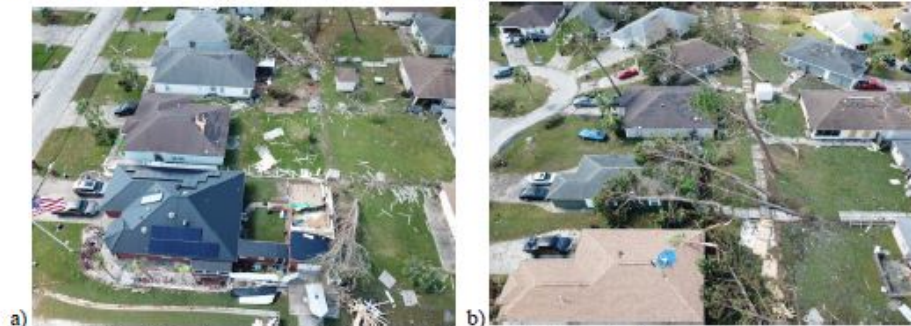
Figure 1: Post Hurricane Michael Damage to Residential Houses in Cedar's Crossing, Panama City, FL
