# Final Report

## Evaluation of Concrete Pile Foundations During Hurricane Michael

Raphael Crowley, Ph.D., P.E.  
Principal Investigator  
Associate Professor (Coastal and Port Engineering)

Taylor Engineering Research Institute  
School of Engineering  
University of North Florida  
1 UNF Drive  
Building 4, Room 1501  
Jacksonville, FL 32224

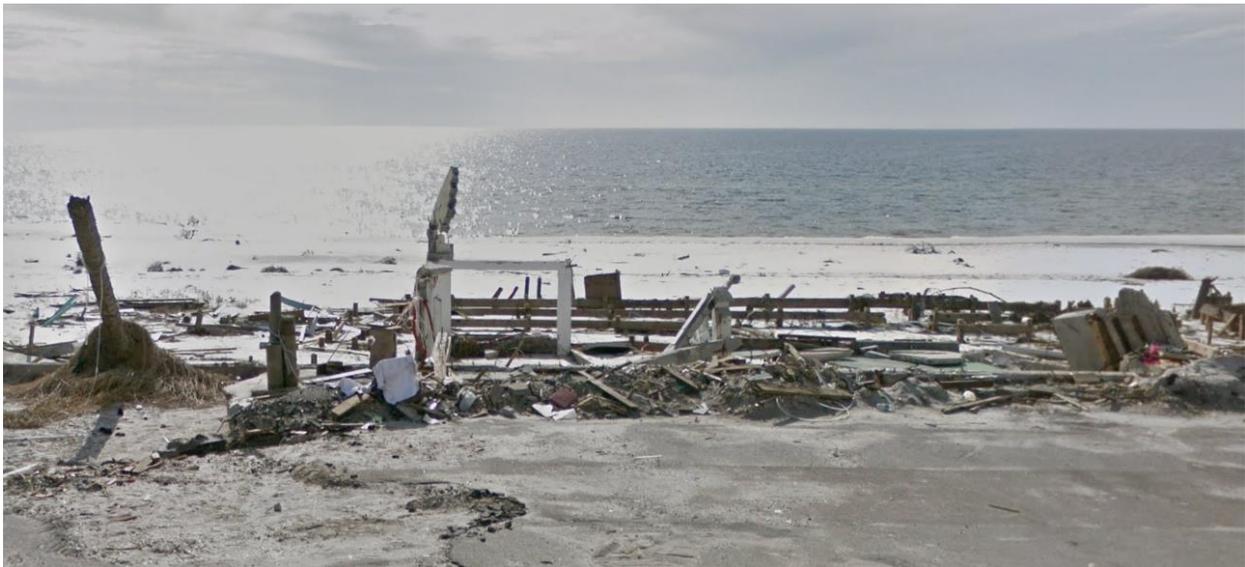
Figure 2-2. Evidence of structure with concrete foundations that failed during Hurricane Michael located at 719 FL-30/US-98 (former site of Toucan's of Mexico Beach)

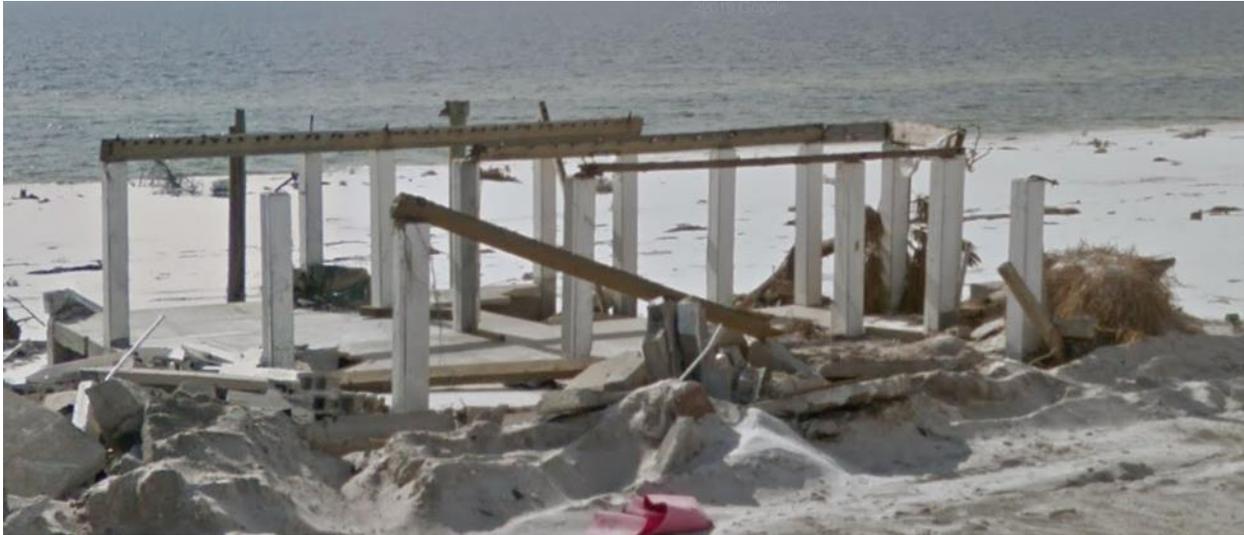
Figure 2-3. Evidence of a structure with structural failure but little to no concrete foundation failure after Hurricane Michael located at 903 FL-30/US-98

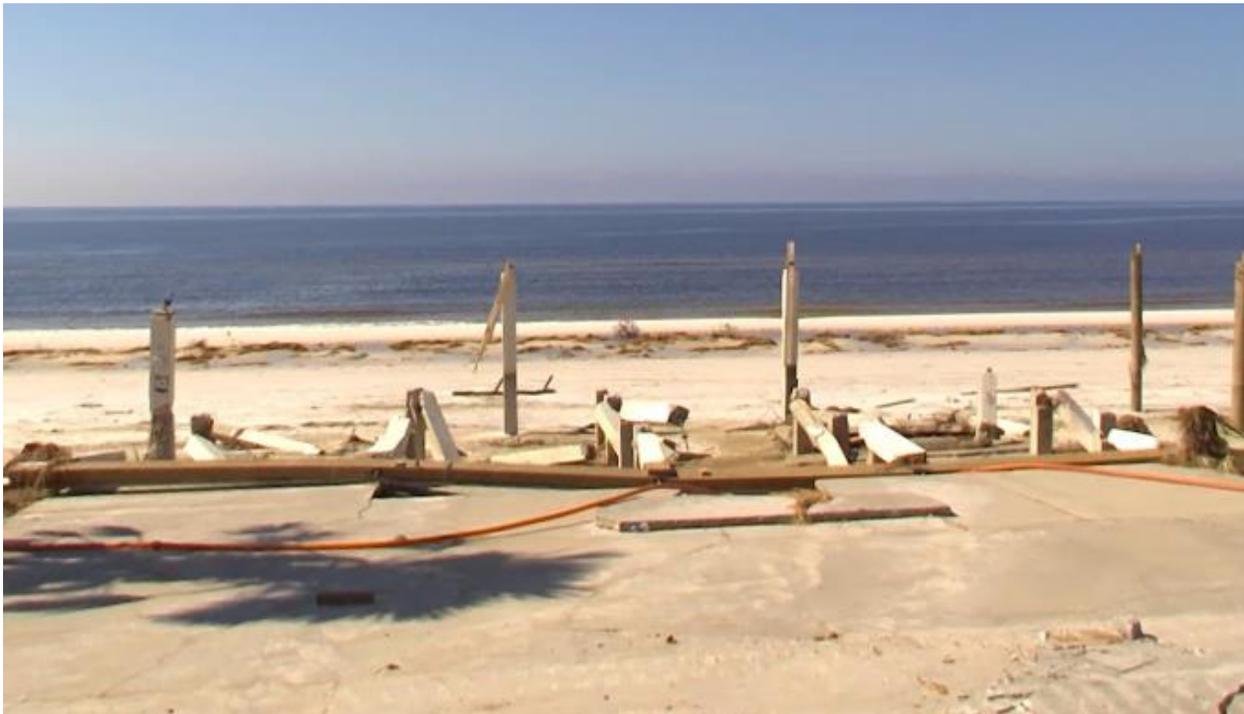
Figure 2-4. Evidence of a structure with concrete foundations that failed during Hurricane Michael located at 1101 FL-30/US-98

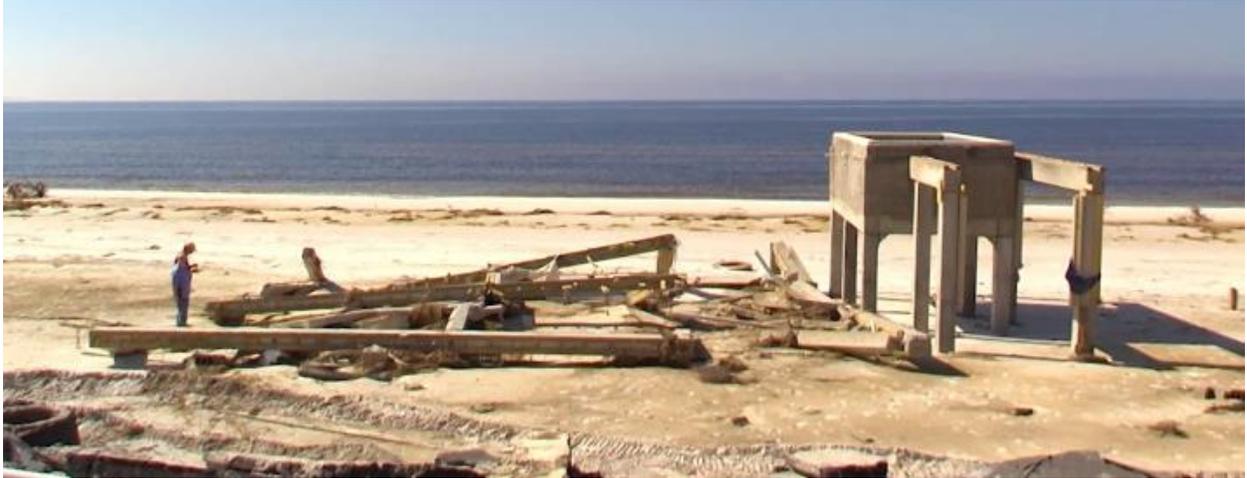
Figure 2-5. Evidence of a structure with concrete foundations that partially failed during Hurricane Michael located at 1207 FL-30/US-98

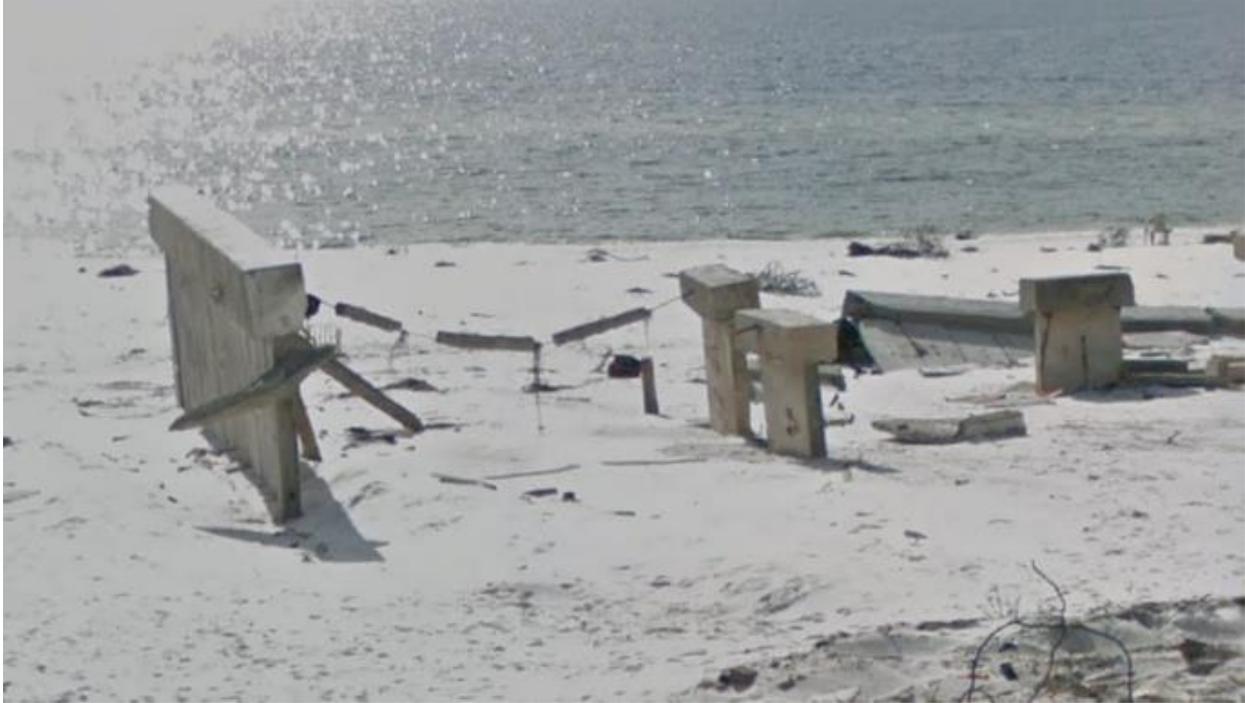
Figure 2-7. Evidence of a structure with structural failure and partial concrete foundation failure after Hurricane Michael located at 1603 FL-30/US-98

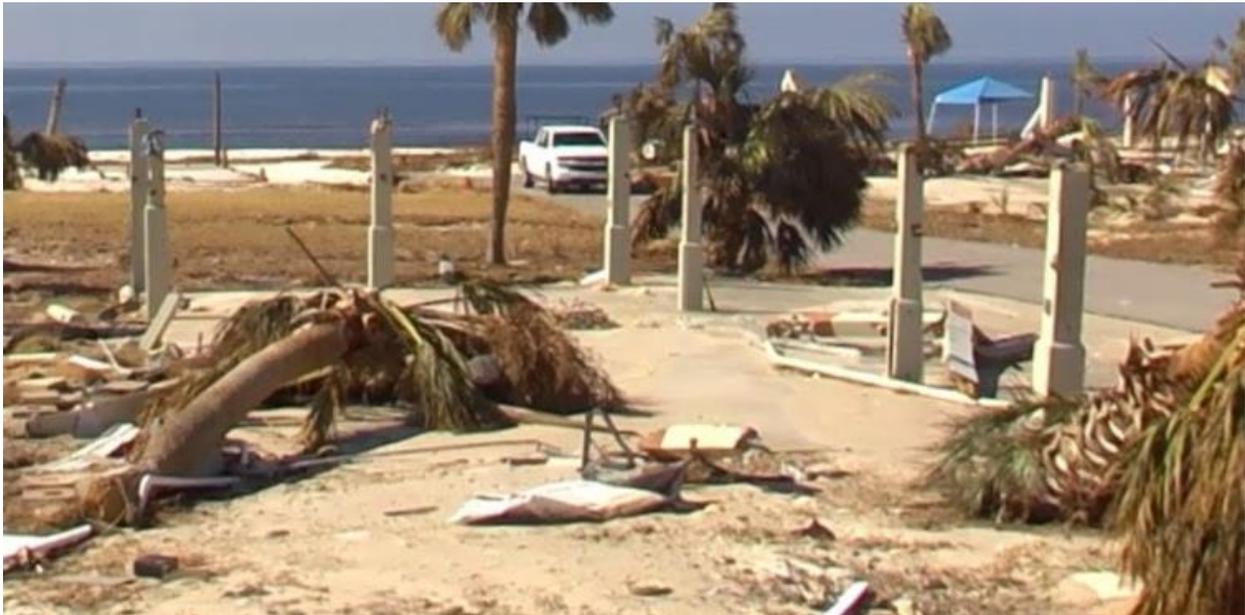
Figure 2-8. Evidence of a structure with concrete foundations with structural failure but no foundation failure during Hurricane Michael located at 101 S 25<sup>th</sup> Street

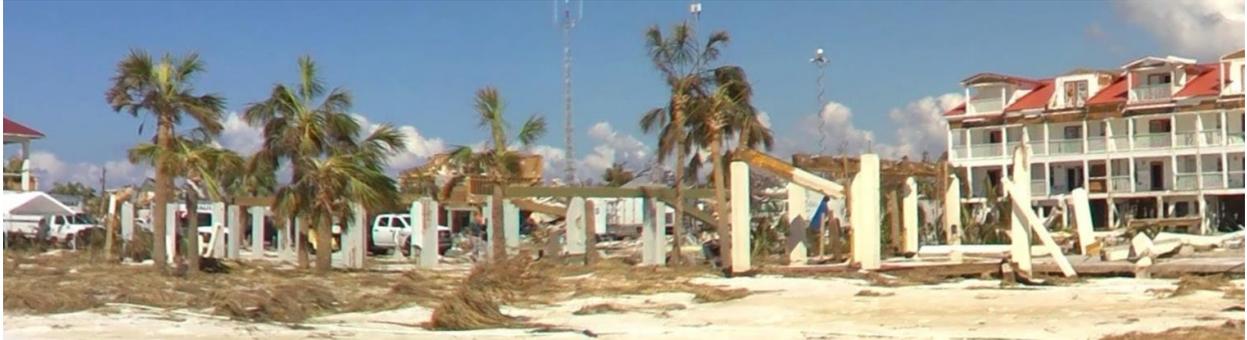
Figure 2-9. Evidence of concrete foundation failure located at 106 S 25<sup>th</sup> Street and 107 S 27<sup>th</sup> Street

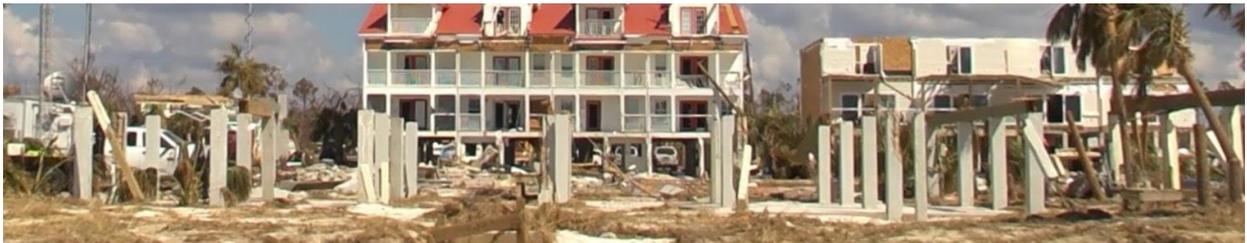
Figure 2-10. Evidence of concrete foundation failure located at 106 S 25<sup>th</sup> Street and 107 S 27<sup>th</sup> Street (different angle)

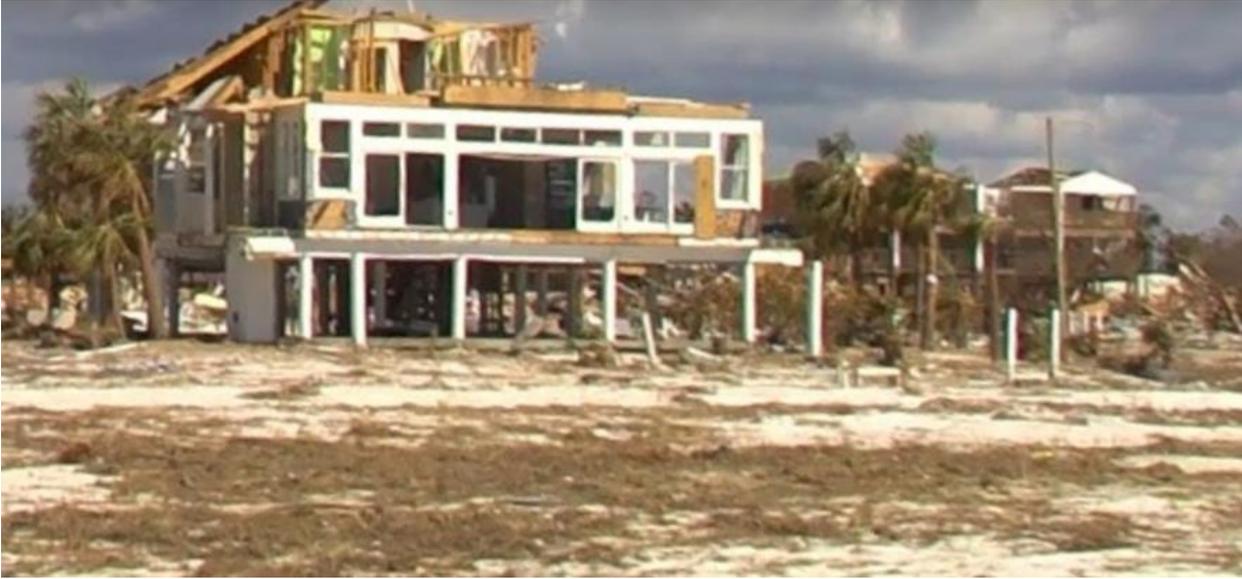
Figure 2-12. Evidence of a structure with partial concrete foundation failure located at 108 S 29<sup>th</sup> Street

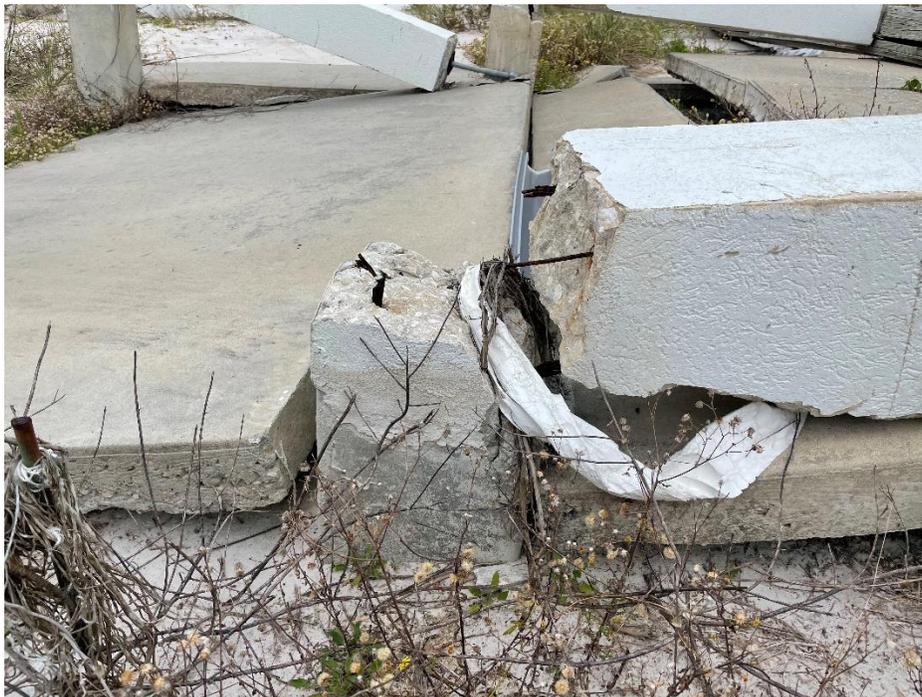
Figure 2-18. Close-up of failed concrete pile at 1101 FL-30/US-98

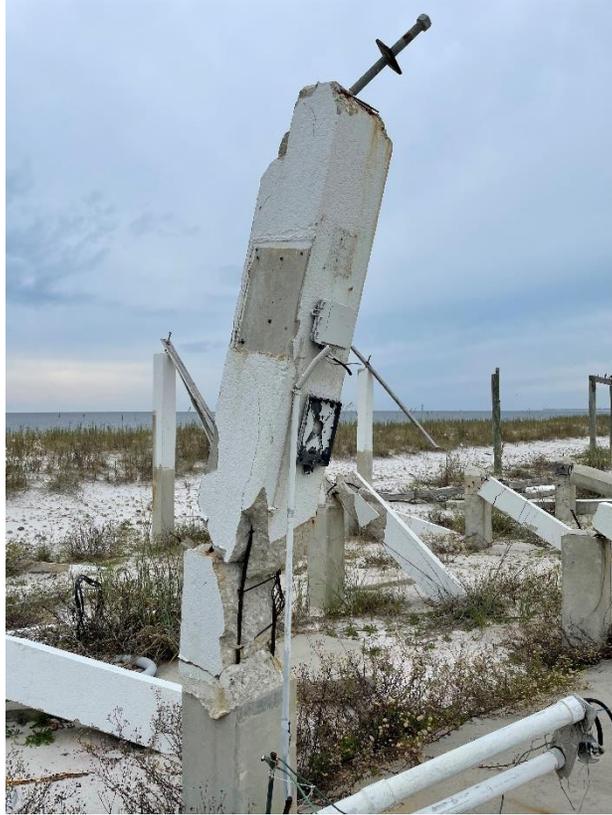
Figure 2-19. Close-up of another failed concrete pile at 1101 FL-30/US-98

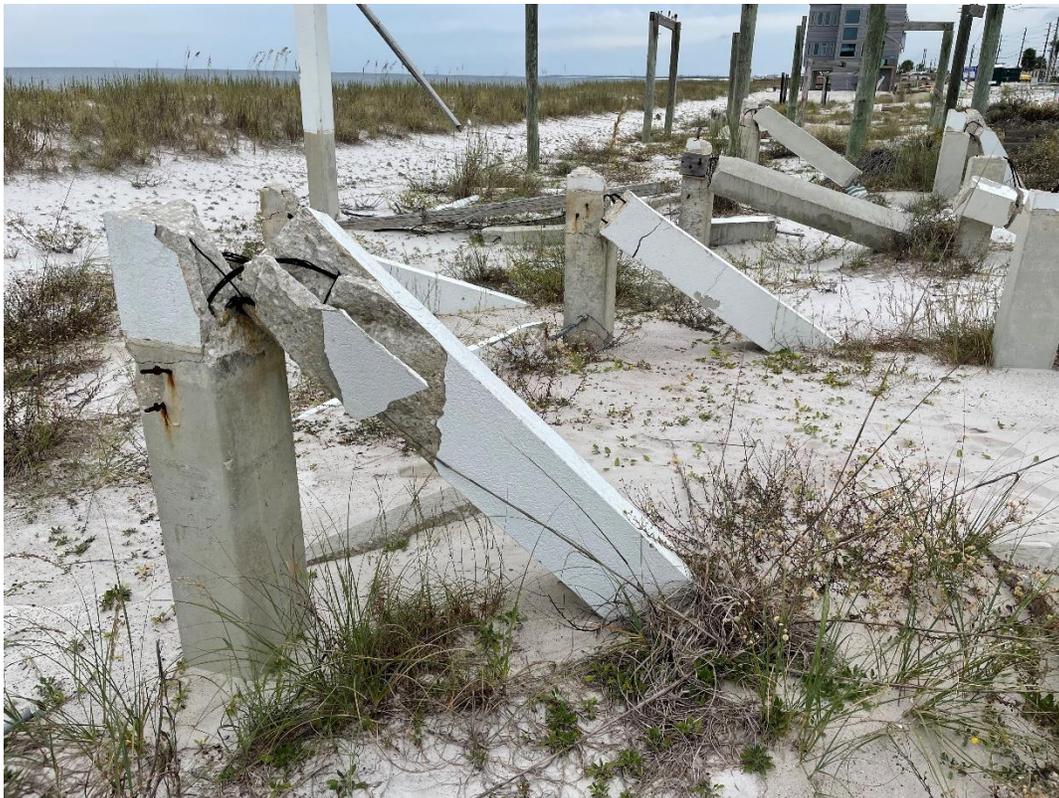
Figure 2-20. Close-up of second row of failed concrete piles at 1101 FL-30/US-98

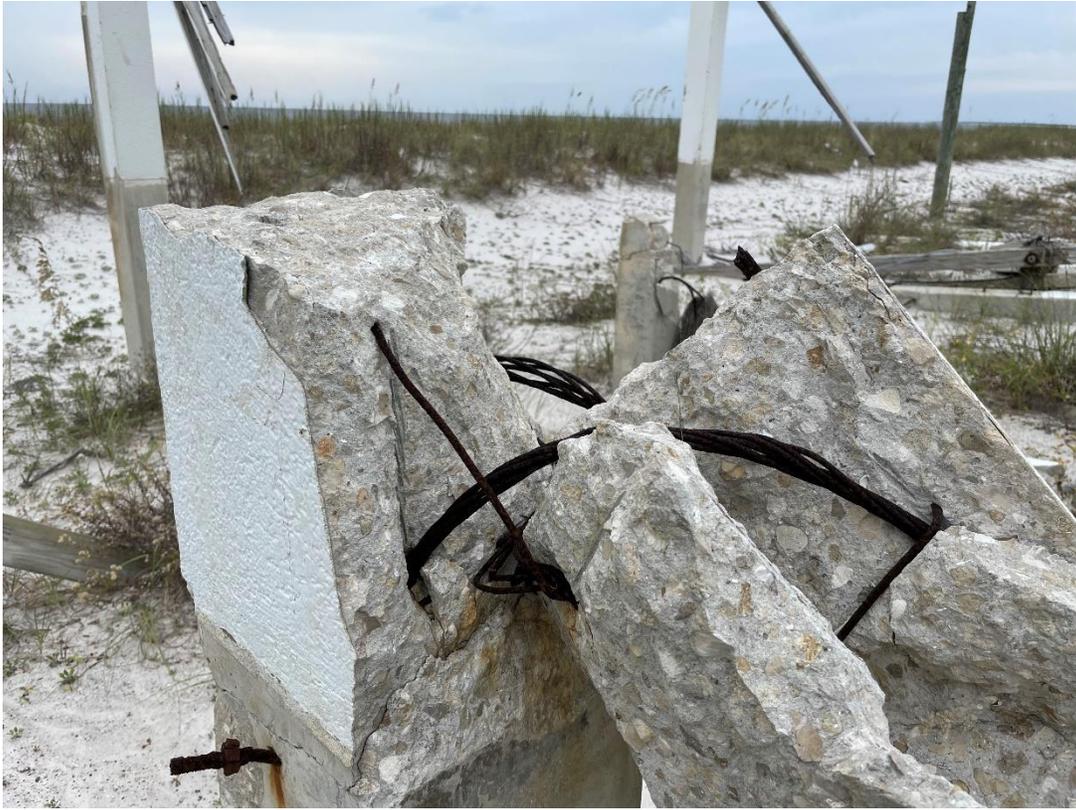
Figure 2-21. Close-up of prestressing strands in far-left pile shown in Fig. 2-19

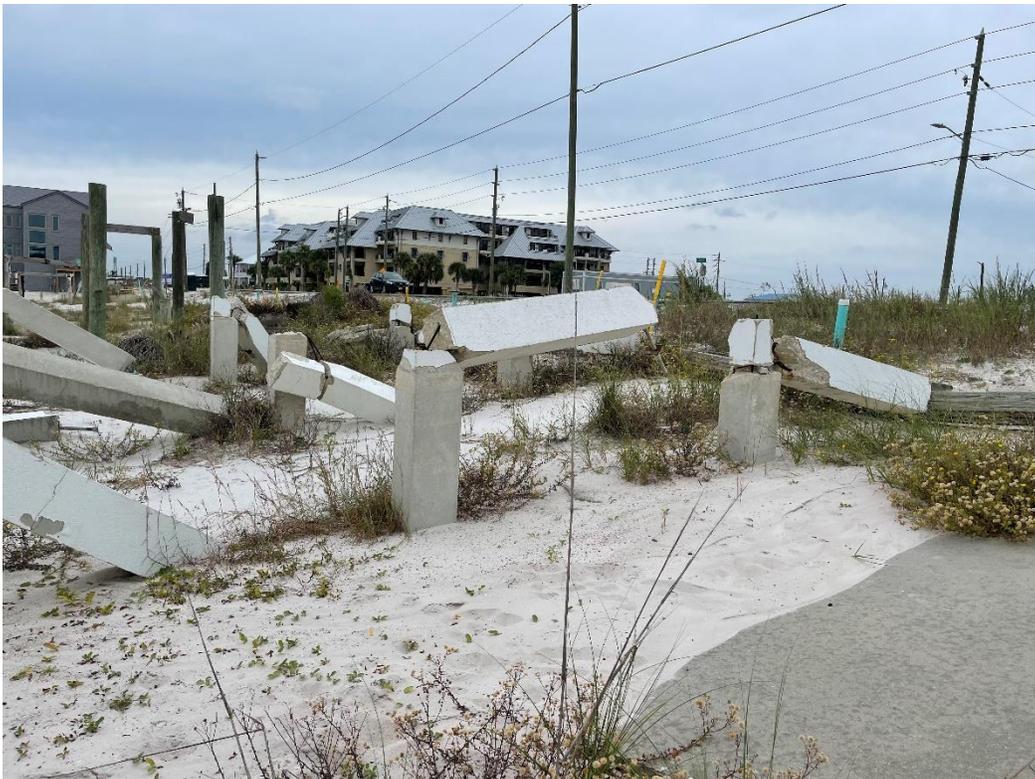
Figure 2-22. Another close-up of failed concrete piles at 1101 FL-30/US-98

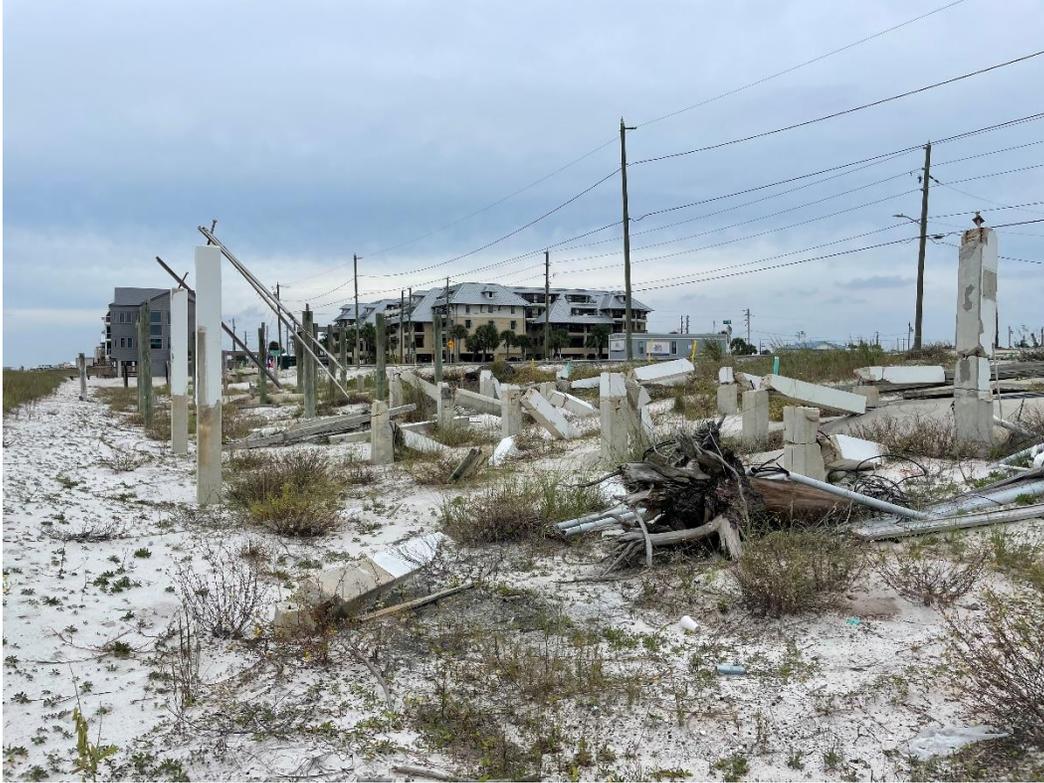
Figure 2-23. Beach-side overview of failed concrete piles at 1101 FL-30/US-98

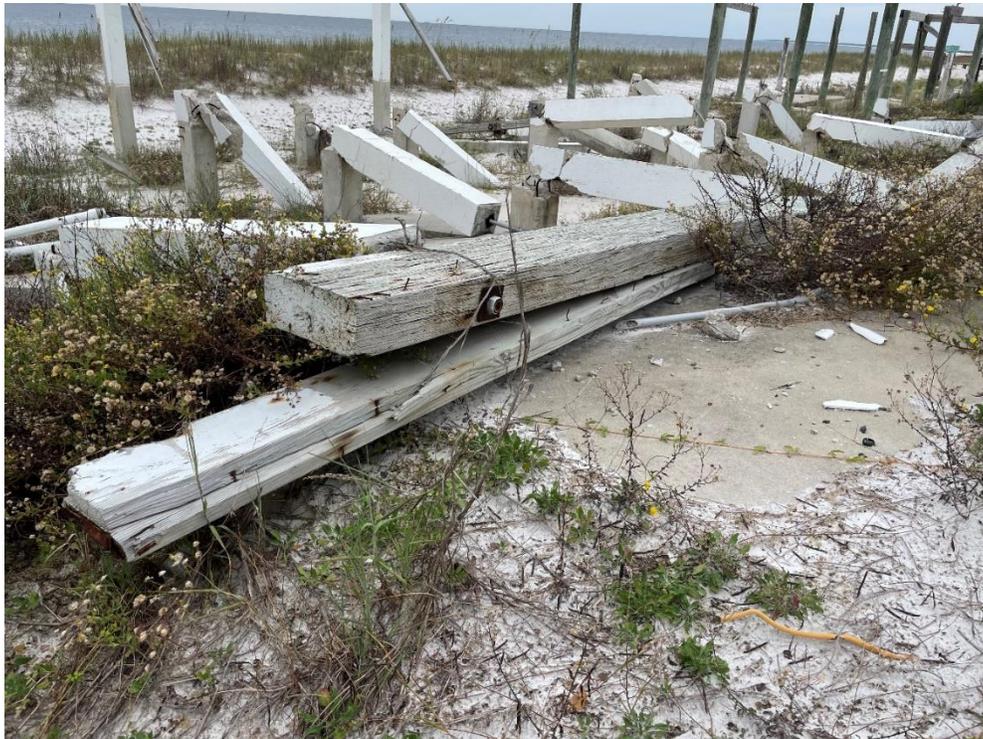
Figure 2-24. Close-up of timber pile cap that ran along the tops of the piles at 1101 FL-30/US-98. Also shown are anchor bolts that anchored the piles to the cap. Note that the anchor bolts are mostly intact

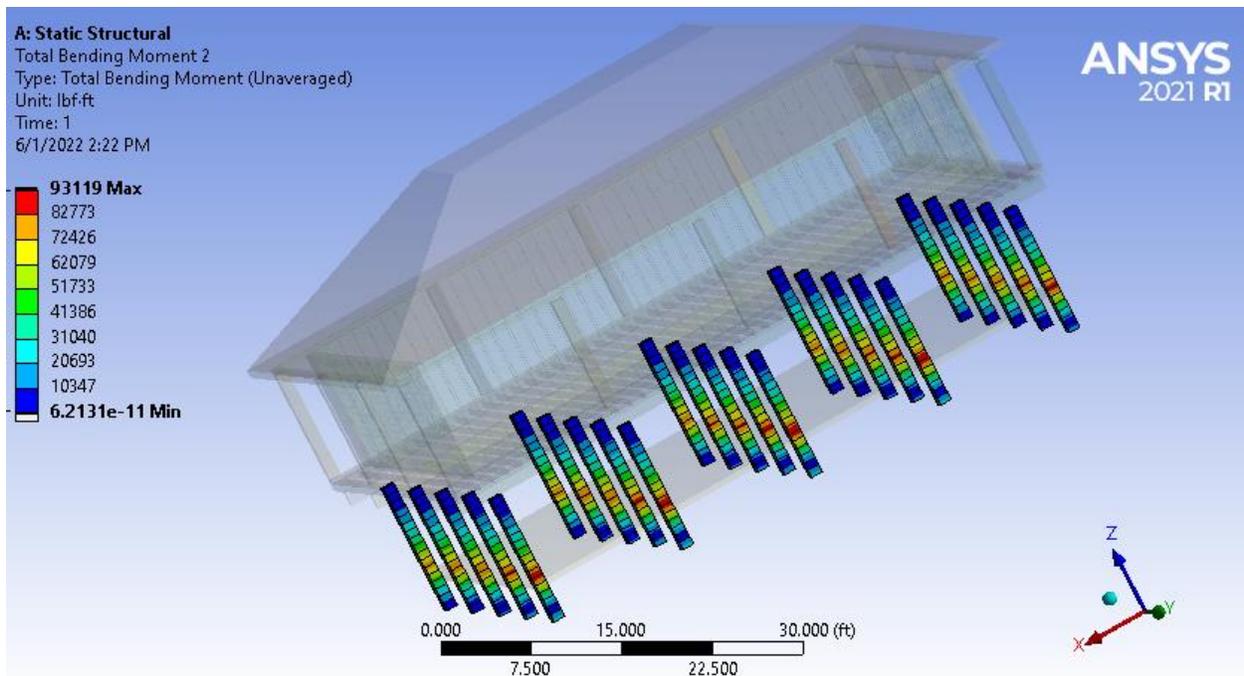
Figure 5-3. Results from ANSYS model at 1101 FL-30/US-98 with 3-ft of scour, attached grade-level slab, and initial water elevation of +18.9 ft NAVD
