Testing 21053 4831 SW 168 Ave Southwest

F+E | LC#18-0524.01 - ASTM E1105 Field Water Infiltration Test

Description Test Report Number S001-T001

Specimen Name	S001-T001
Product Description	Series "Barcelona" Model "TSL30I" Triple Horizontal Window
Product Manufacturer	Soft-Lite Windows
Configuration	X/O/X
Overall Dimensions	73" L x 49" H
Location Within Building	1st Floor East Elevation , Living Room
Approximate Age of Specimen	New
General Physical Conditions	Good

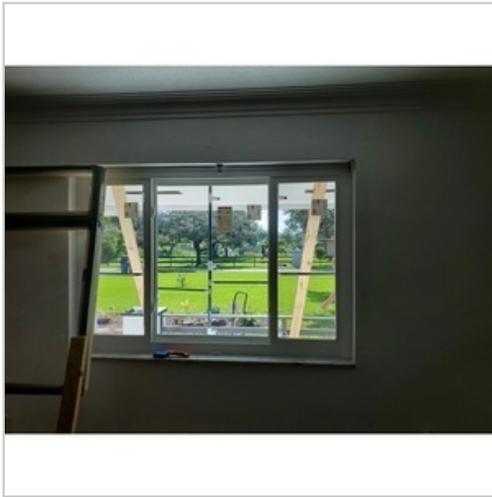
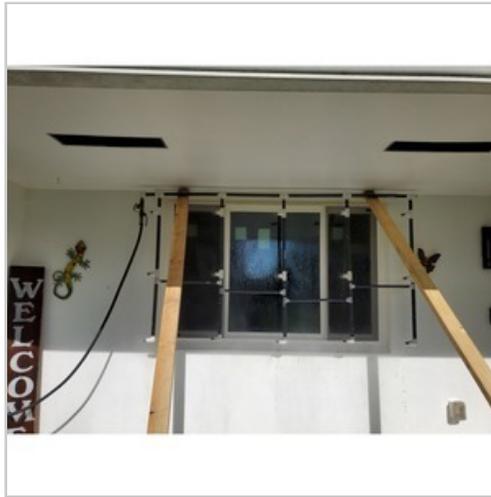
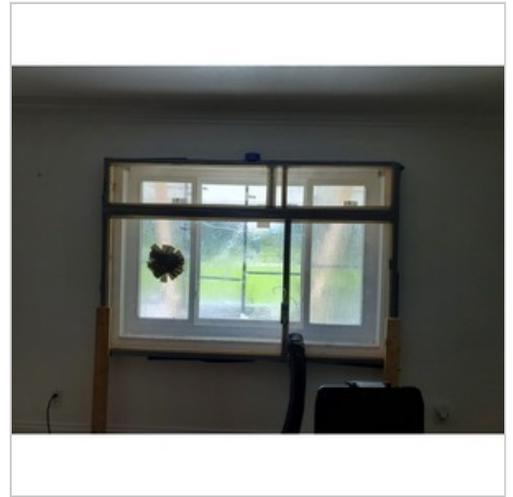
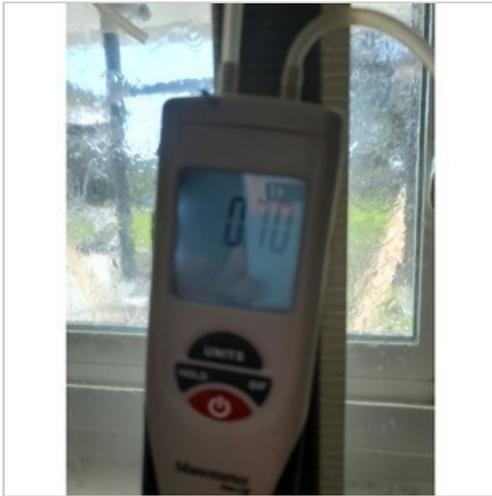
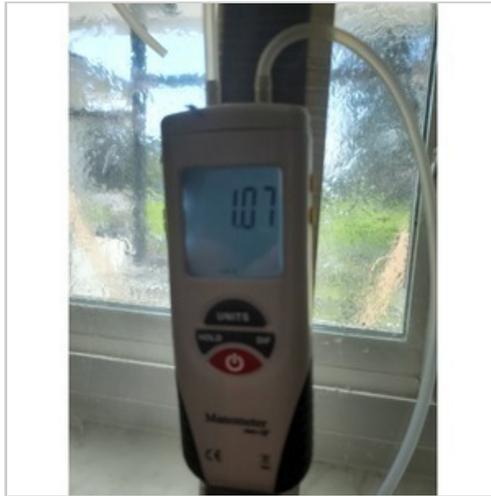
Item #	Description
01	Interior finish was not removed prior to the water test.

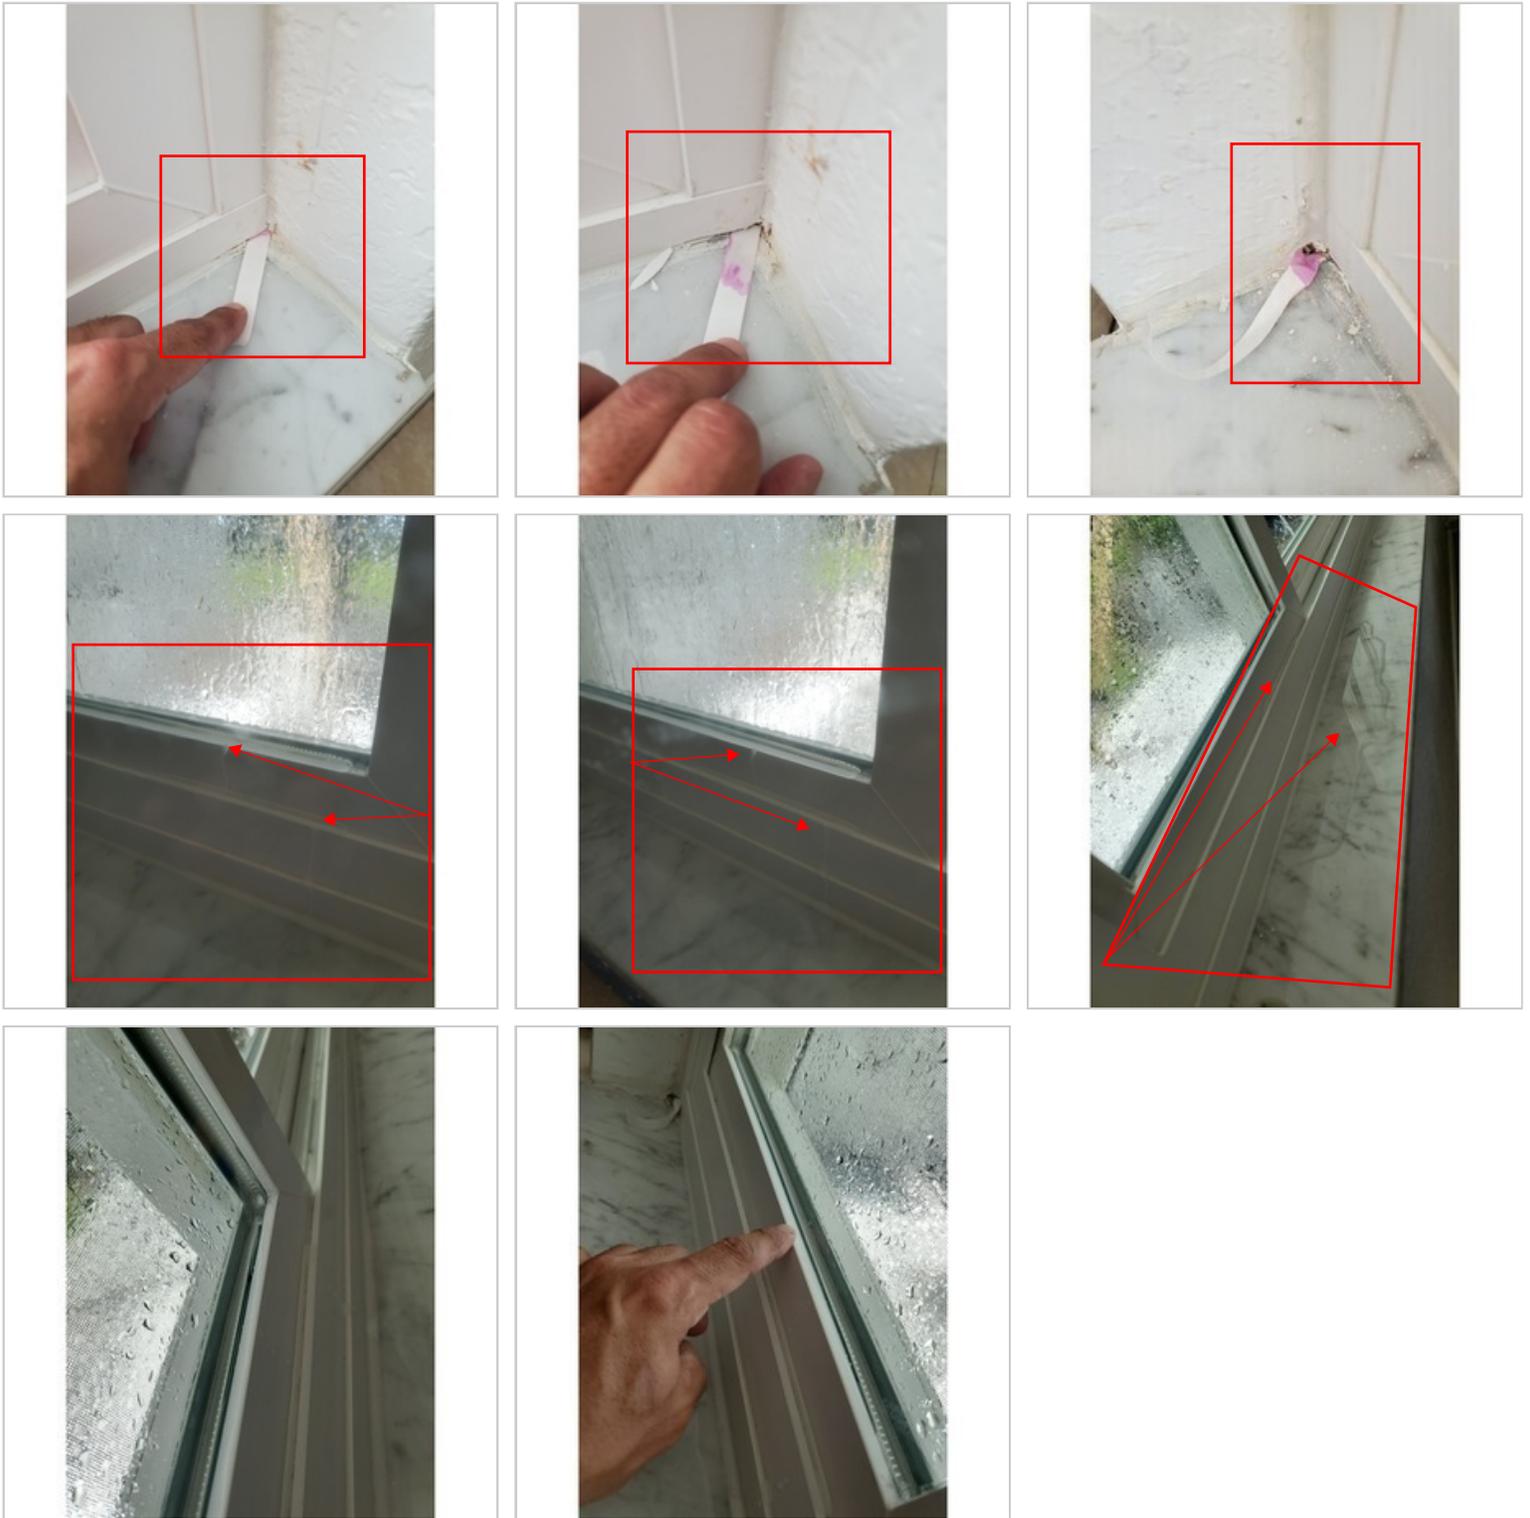
FAIL

Item	Description
A	During test T001A, water infiltration was observed entering under the frame sill bottom right corner approximately one (1) minute into test.
B	During test T001B, water infiltration was observed entering under the frame sill bottom right and left corners approximately three (3) minutes into test
C	During test T001C, water infiltration was observed entering through the glazing pocket of the left operable vent approximately one (1) minute into test.
D	During test T001C, water infiltration was observed overflowing the frame sill at the bottom left corner approximately two (2) minutes into test.
