**From:** Soto, Rolando <ROSOTO@broward.org>  
**Sent:** Thursday, April 20, 2023 2:55 PM  
**To:** Madani, Mo  
**Cc:** Parks, Bryan; mbeck@coconutcreek.net; Ryan Banyas - Coconut Creek FCO  
**Subject:** Toilet exhaust fan fires.  
**Attachments:** Bathroom fan code amendment.docx; FW: Ventilation Bathroom Fan Fires; Eutectic-TCO-Report-6b6-cleared-cleaned-January-2018-version (1).pdf; google search.docx

Bathroom fan code amendment.

# CPSC Staff Assessment on Eutectic-Type Thermal-Cutoff Fuse Failures in Shaded-Pole Motors Used in Exhaust Fans

December 2017

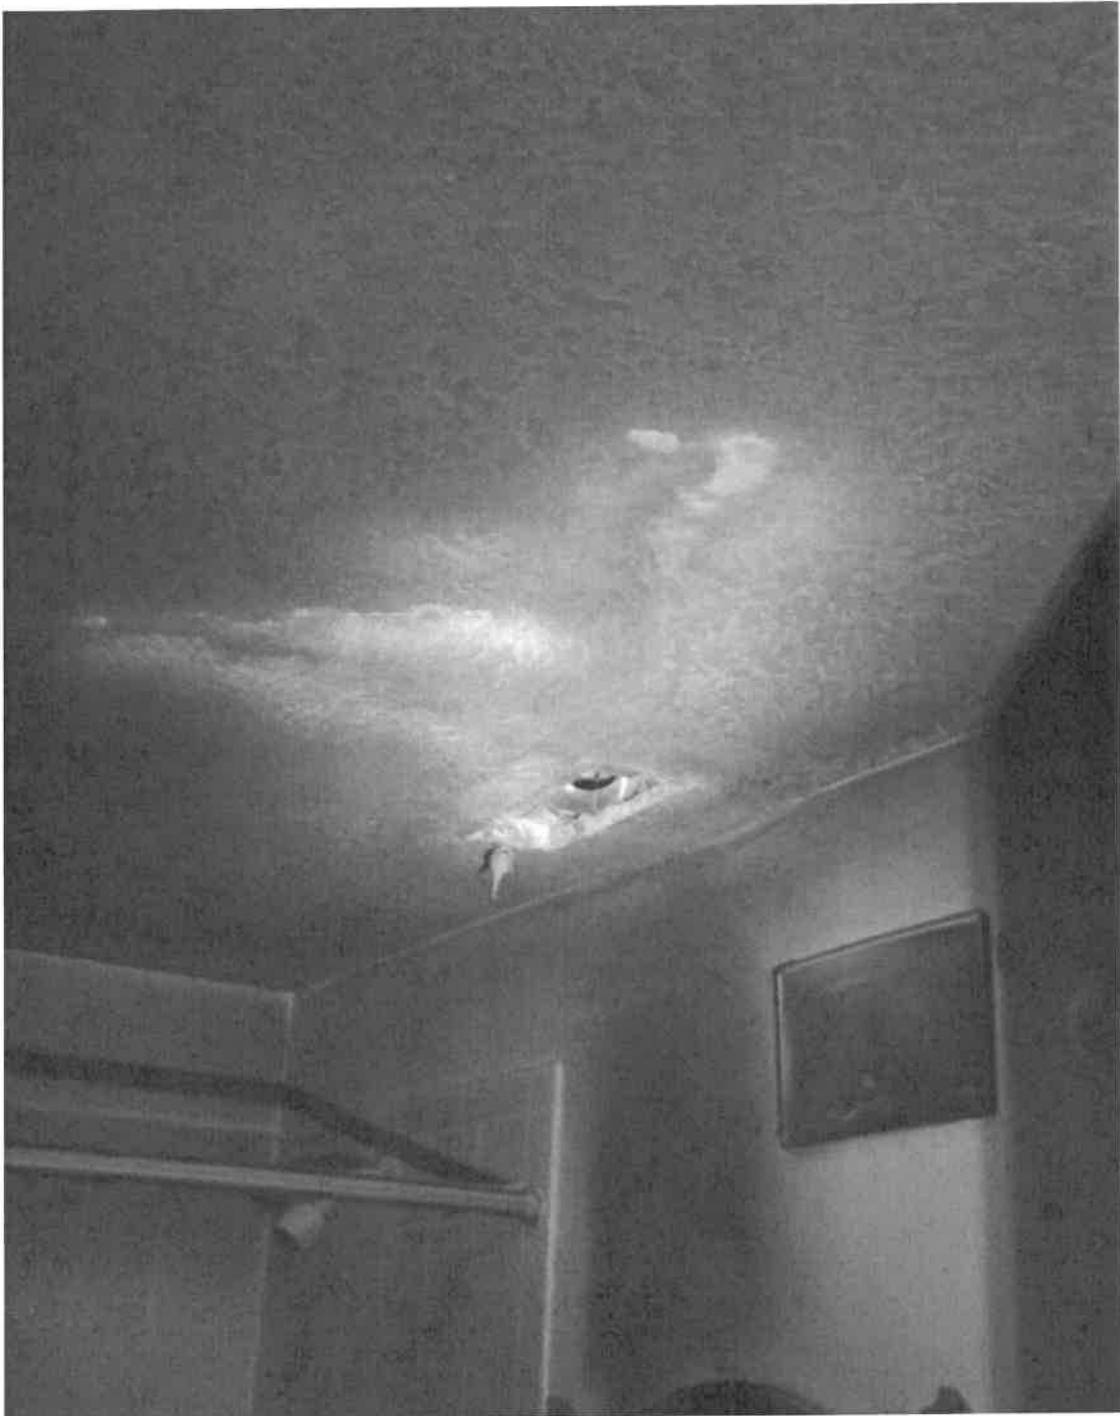
Barbershop 02/2013

Please see the 5 fires located in bathroom ventilation fans in Coconut Creek that I am aware of. There were two other fires that were undetermined fires that I did not include because the fire damage was too extreme to determine the cause to be the fan. It would be great to see all new fan installations requiring thermal couplings.

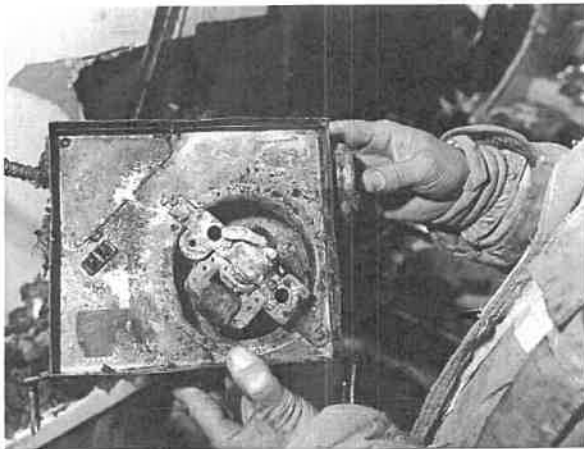
In March 2001, at about 6:50 a.m. the fire department responded to an apartment structure fire. Firefighters discovered fire in the walls and the attic above the bathroom where the incident exhaust fan was located. Fire had spread into the common bathroom wall between apartment units and in the adjacent bedroom walls. The fire department determined that the fire started from a 30-year-old exhaust fan located in the bathroom of the apartment.

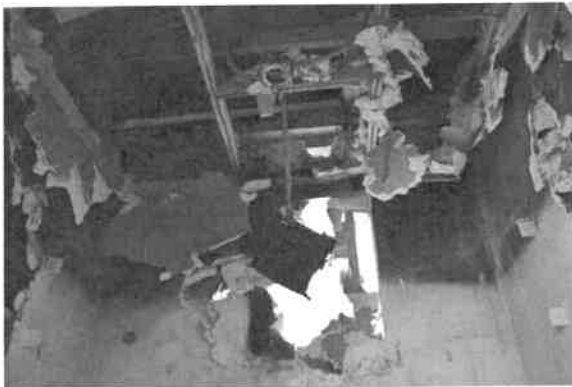
The incident occurred at a daycare facility. The building was built in 1995, and has been used as a daycare facility since its construction. The fans were original when the building was constructed. The lights and fans were controlled by a single switch. Five days a week, the switch was turned on at approximately 6:30 a.m. and turned off at about 7:00 p.m. The incident occurred in March 2011. After the daycare lights and fans were switched on, the daycare heat was also turned on. Approximately 1 hour later, a teacher and her assistant smelled something burning and assumed it was related to the heating system. Even though after the heating system was turned off, the burning smell persisted. The director went to the infant room and localized the burning smell to the changing room/bathroom. The director notified the owner of the daycare and was advised to disconnect the exhaust fans because they were old. The director was unplugging the exhaust fan when a “large fireball shot out” of the exhaust fan. The daycare was evacuated and the fire department was summoned to extinguish the fire.

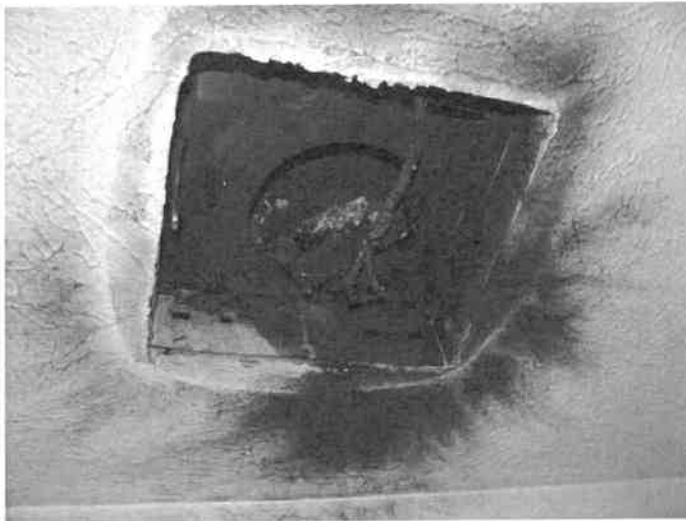
The June 12 incident occurred in a half bath in a single-family home. The Fort Riley Fire Department was dispatched to a structure fire at the residence. Upon arrival, the fire responders did not witness any signs of fire outside the home. Fire personnel entered the home to investigate and found water pouring from the first floor bathroom exhaust fan on the ceiling. The fire had been extinguished before fire fighters entered the home. The report identified that the plastic inside the fan had ignited, which then ignited the plastic vent hose. A plastic water line located above the fan had melted, which extinguished the fire. The cause of the incident was an overheated exhaust fan.

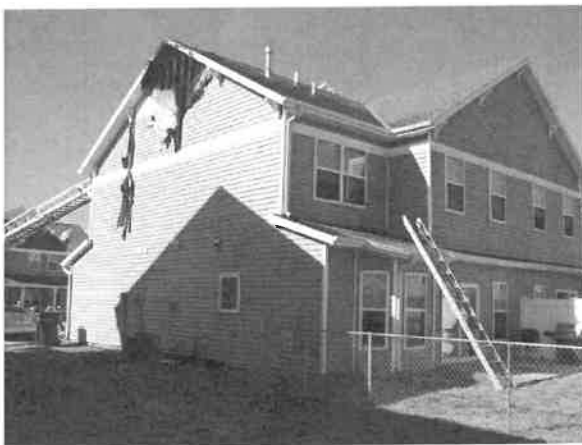
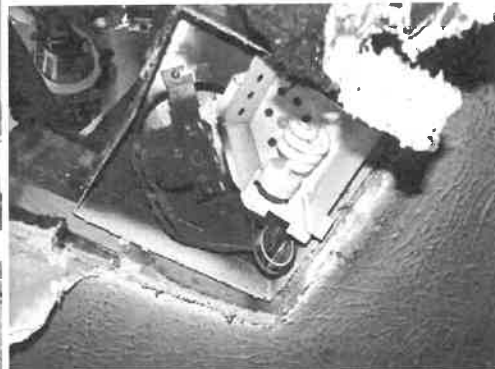
The February 5 incident occurred in a full bath on the second floor of a single-family home. There was extensive damage to the attic above the bathroom. The field investigator noted that the incident fan switch was in the “up” position, suggesting that the fan was on when the incident occurred. When the fire department arrived at the scene, fire personnel determined that the fire had spread into the attic area. An overheated exhaust fan caused the incident.

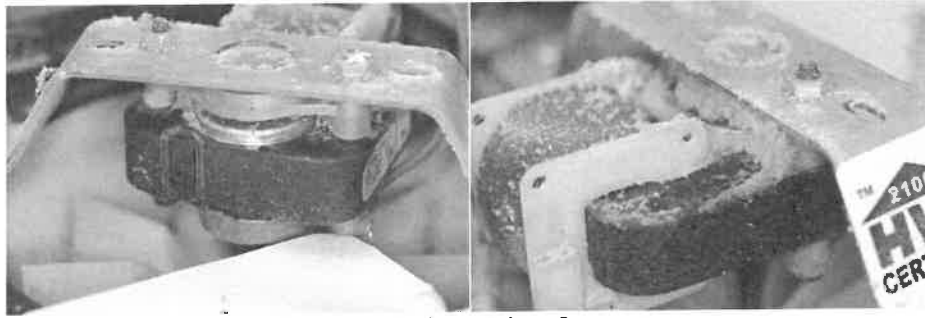
Figure 12. Sub 45 with dust and surface rust on core

Fan sub 45 rotor did not turn freely in the condition in which it was received because of what appears to be dust and grime build-up at the bearings. When the sample was energized, the impeller/rotor did not spin; thus, it was in “locked-rotor” condition. Figure 12 shows sub 45 before any testing.

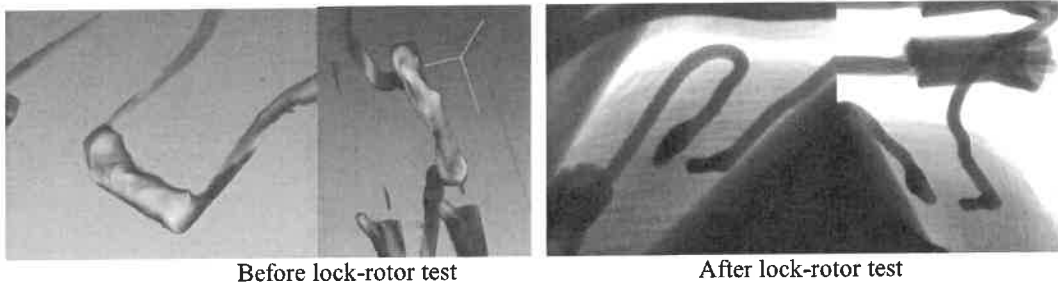
Figure 14. Radiograph and CT scans of the TCO before and after lock-rotor testing (Sub 45)

The fan was tested in its as-received condition, *i.e.*, locked-rotor condition. A single thermocouple was placed on the side of the winding, on the outside of the wrap, adjacent to the TCO location. After being energized, the TCO activated after 22 minutes, as shown by the temperature traces in Figure 13. For the location of this thermocouple, the temperature shows a maximum of 120°C, but this location is about 20°C cooler than the actual TCO or at the top of the winding. The actual TCO functioning temperature ( $T_f$ ) was calculated to be about 140°C ( $120^\circ\text{C} + 20^\circ\text{C}$ ), which corresponds closely to the  $T_f$  of 136°C. This testing in lock-rotor condition also verified that the side thermocouple measurements on the paper wrap were about 20°C lower than the actual TCO or the top of the windings. Figure 14 shows the radiographs of the TCO’s fusible link after lock-rotor testing, which shows the thermal linkage melted or open.

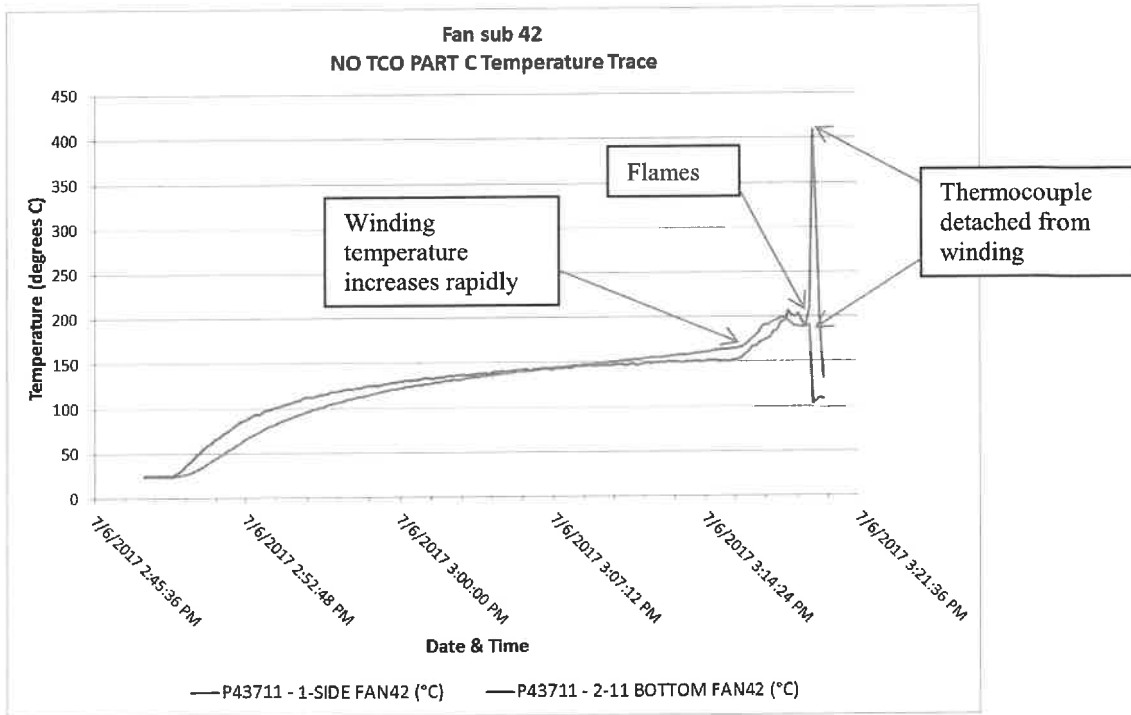
Figure 18. Sub 42 third test period Lock-Rotor Test with no TCO

For the third test period, the fan was energized in the lock-rotor condition, and after about 30 minutes, the temperature increased rapidly, which resulted in smoke and flames. The thermocouple temperature traces are shown in Figure 18. The motor winding ignited, which then ignited the plastic impeller, as shown in Figure 19. The plastic impeller resulted in dripping, flaming plastic. The total lock-rotor test time was about 4.5 hours (period 1 + period 2 + period 3).

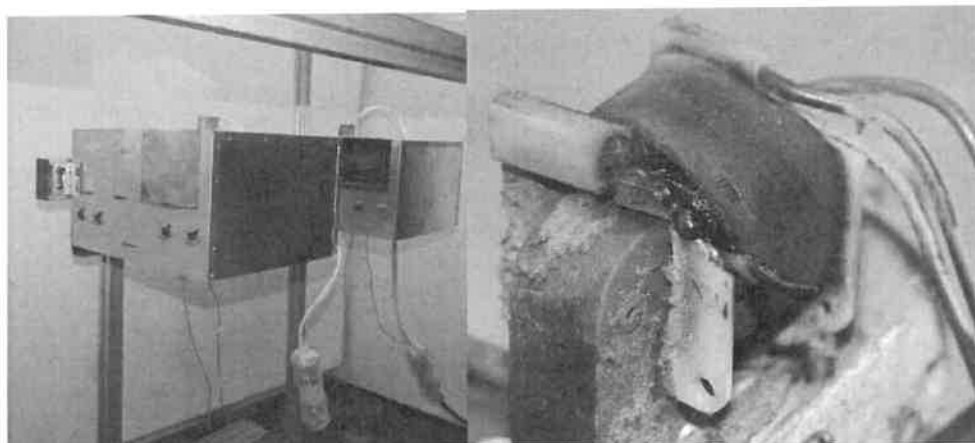
Figure 27. Sub 41 Test Group 3 - Lock-Rotor Test producing smoke and post examination

Figure 27 shows the fan producing significant smoke during the second lock-rotor testing. There were no visible flames during the testing. Examination of the motor shows localized overheating and arcing in the winding. The full elapsed time for the first and second lock-rotor tests was about 2 hours 40 minutes.

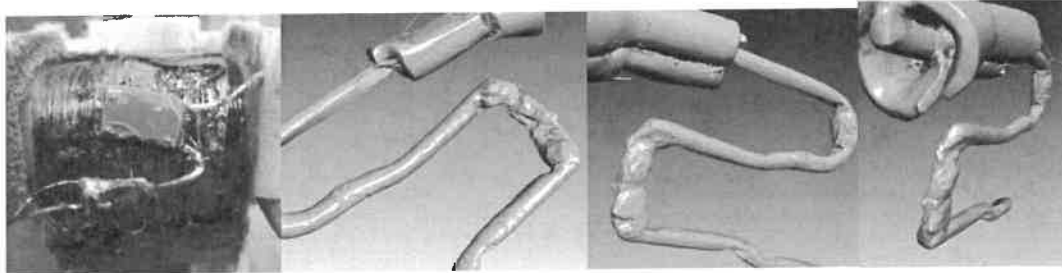
Figure 28. TCO from Sub 41 after Lock-Rotor Test

Post examination shows the TCO's fusible link to be intact, as shown by CT scans in Figure 28. During lock-rotor testing, the TCO failed to activate, but the event ended because the motor winding opened, thus de-energizing the motor.

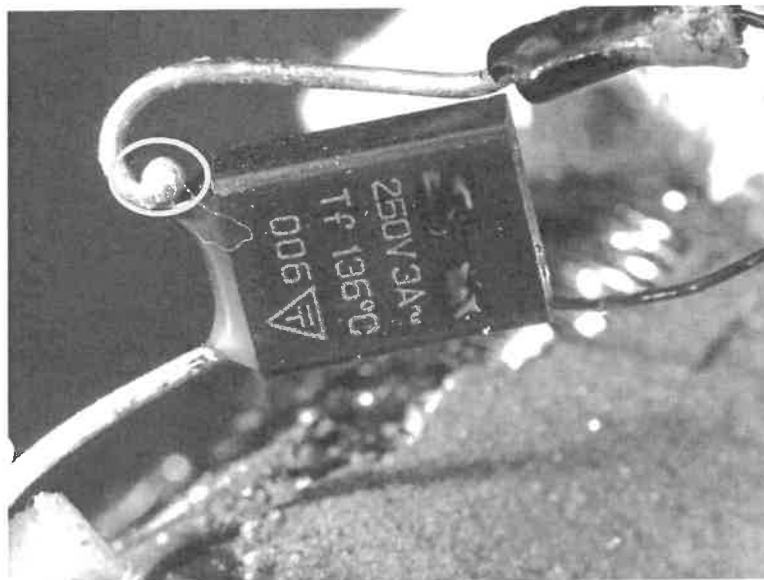
Figure 30. Solder bead on TCO lead from Sub 64 after second Lock-Rotor Test

Post examination revealed a solder bead external to the TCO casing, as highlighted by the yellow circle shown in Figure 30. Microscopic images of the TCO show that the solder bead originated from inside the TCO because solder was located in cracks between the epoxy seal and the lead wire, as shown in Figure 31. Figure 32 shows the CT scans with the partially melted fusible link after the testing, thus, indicating the TCO did activate, but abnormally. Visible in the CT scan is the solder bead, highlighted by the yellow circles.

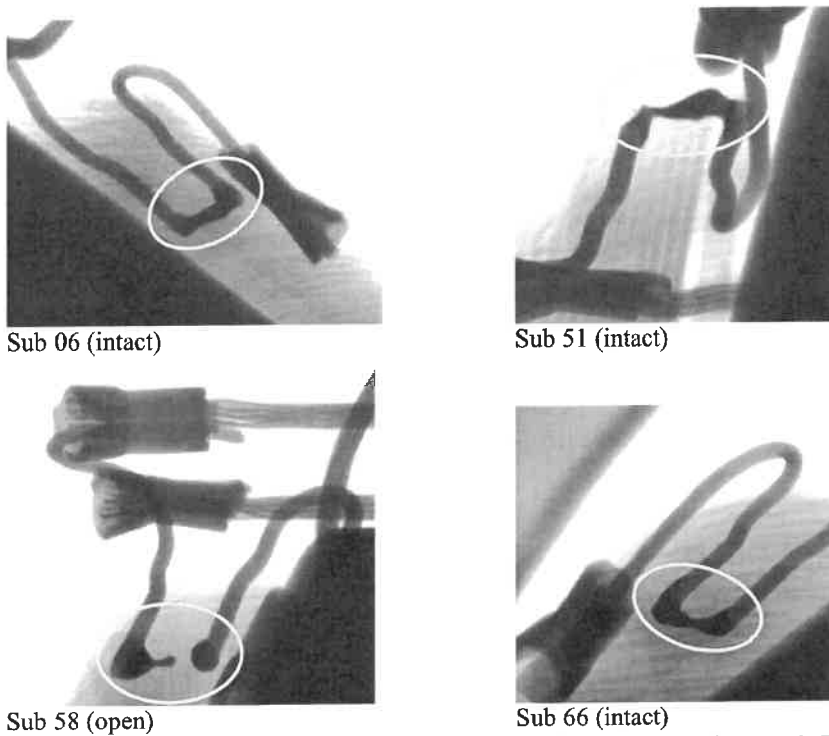
Figure 39. Radiograph of subs 6, 51, 58 and 66 after Lock-Rotor test

Figure 39 shows the TCO from sub 58, which tripped but took more than 2 hours. As seen in previous TCOs that had a long trip time, the melted linkage would bead to both wire leads; but in this case, the radiograph shows a thin portion of the fusible link still present.

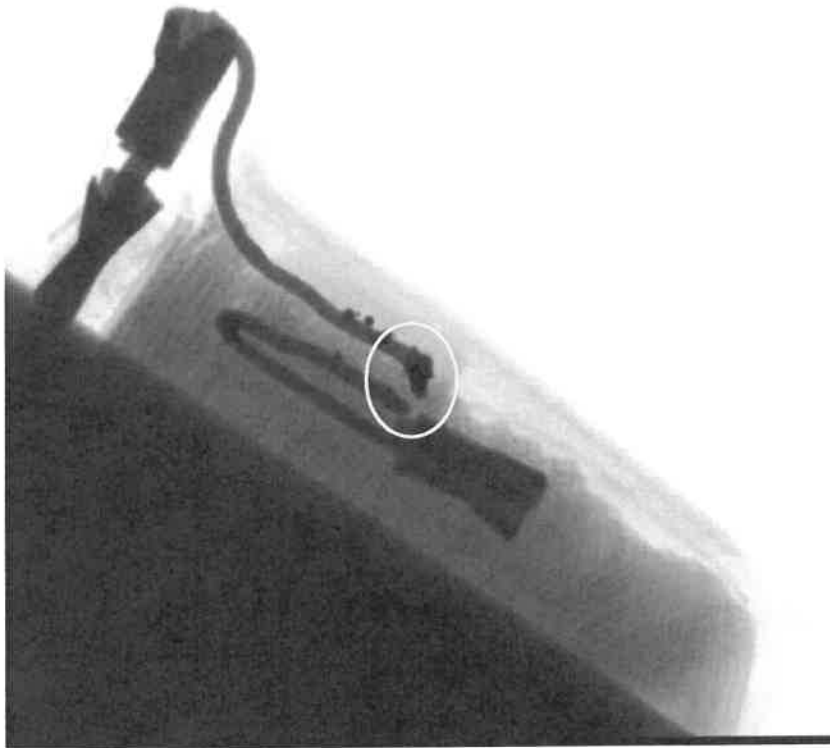
Figure 42. Radiograph of the TCO after the test (sub 73)

Figure 42 shows a radiograph of the TCO after the test. Post-test radiographs of the TCO show the TCO is open, which was caused by the intense heat from the flames. This would suggest that any analysis of a TCO after a fire incident does not necessarily indicate the status of the TCO during the incident.

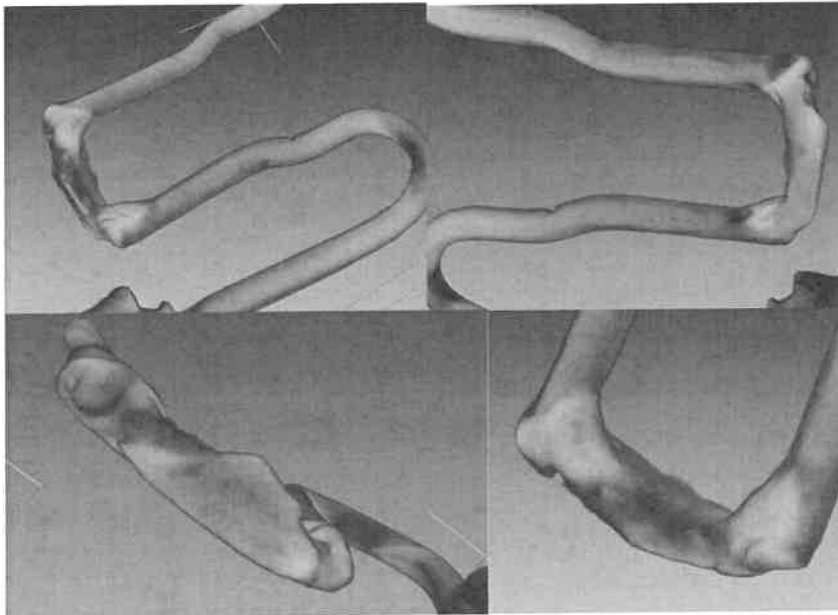
Figure 43. CT scans of the TCO before conditioning (sub 73)

CPSC staff reviewed the CT scans of the thermal linkage for fan sub 73. The thermal linkage shows abnormalities as shown in Figure 43. The CT scans appear to show the linkage to take partial form of the TCO case, such that a flat section had formed. In theory, temperatures below  $T_f$  may be causing the thermal linkage to soften. This may cause changes in the eutectic materials, where it may alter the eutectic temperature or  $T_f$ .

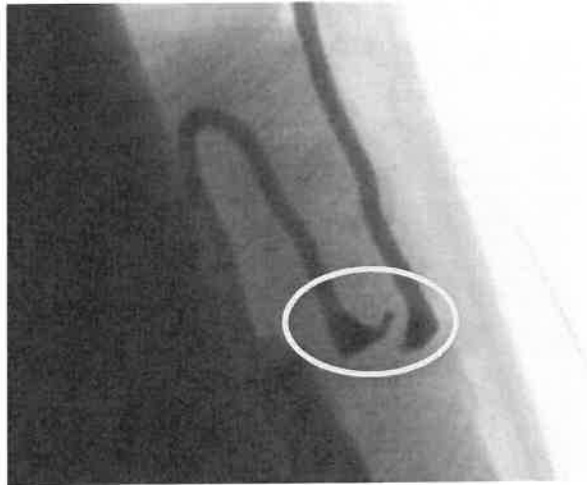
Figure 46. Radiograph of the TCO after the test (sub 23)

Figure 46 shows a radiograph of the TCO after the test. Post-test radiographs of the TCO show the TCO is open, which was caused by the intense heat from the flames. This would suggest that any analysis of a TCO after a fire incident does not necessarily indicate the status of the TCO during the incident. The radiograph shows a thin portion of the thermal linkage intact. It would appear even at the high temperatures when the motor ignited, portions of the eutectic material in the thermal linkage could not melt.

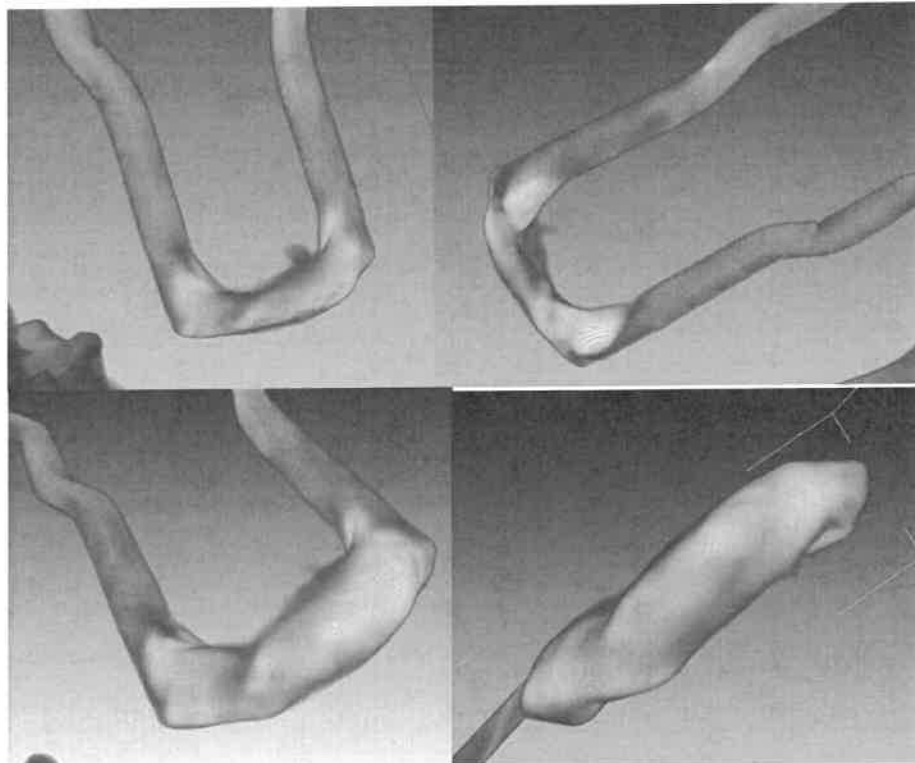
Figure 47. CT scans of the TCO before conditioning (sub 23)

The CT scans of the thermal linkage for fan sub 23 were reviewed. The thermal linkage shows some abnormalities, as shown in Figure 47. The CT scans appear to show the linkage uneven and bulging in some areas.

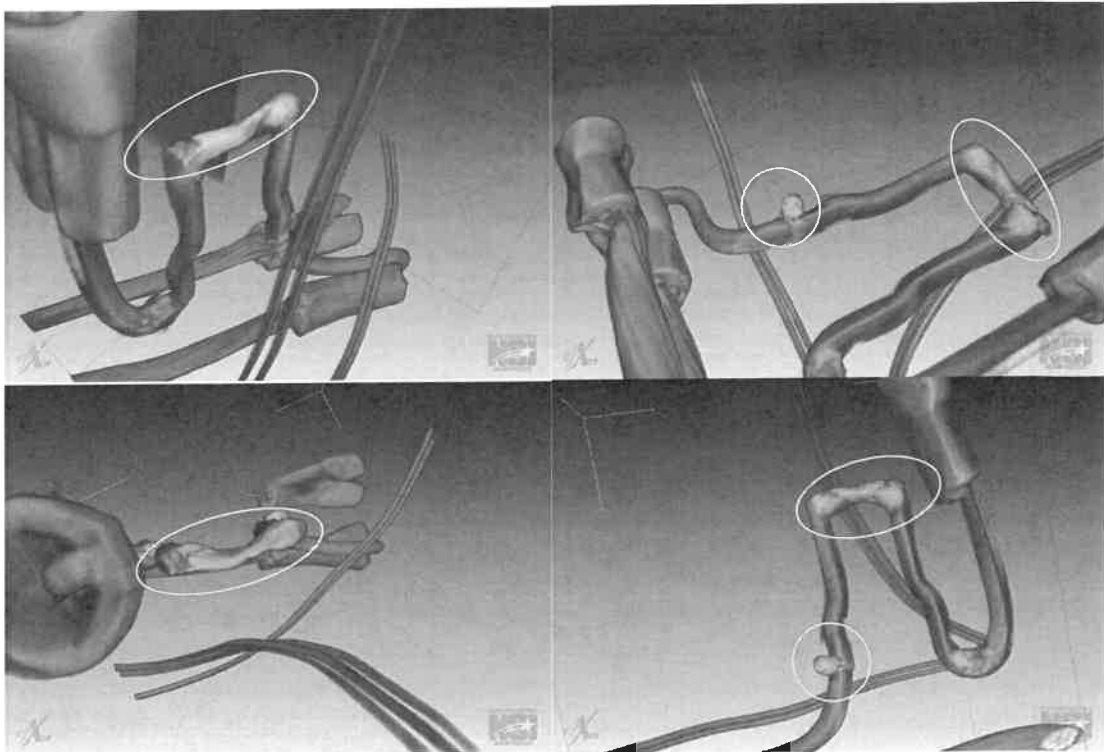
Figure 51. CT scans of the TCO after the test (sub 54)

Figure 51 shows CT scans of the TCO after the test. CT scans of the TCO confirm the solder link within the TCO is intact. The radiographs and CT scans show a solder bead has formed outside the TCO casing. This would suggest that the TCO is no longer hermetically sealed when thermally aged or placed under thermal stress. The reason that the windings were operating at such an elevated temperature for so long without eventually breaking down is not known, but it can be surmised that the winding coating would eventually deteriorate and cause shorts within the winding because the eureka temperature has changed from  $T_f$ .
