## Interim Report

# Survey and Investigation of Buildings Damaged by Category III, IV and V Hurricanes in FY 2022- 2023

## Hurricane Ian - 28 September 2022

Sponsor: Florida Building Codes and Standards (Florida  
DBPR)

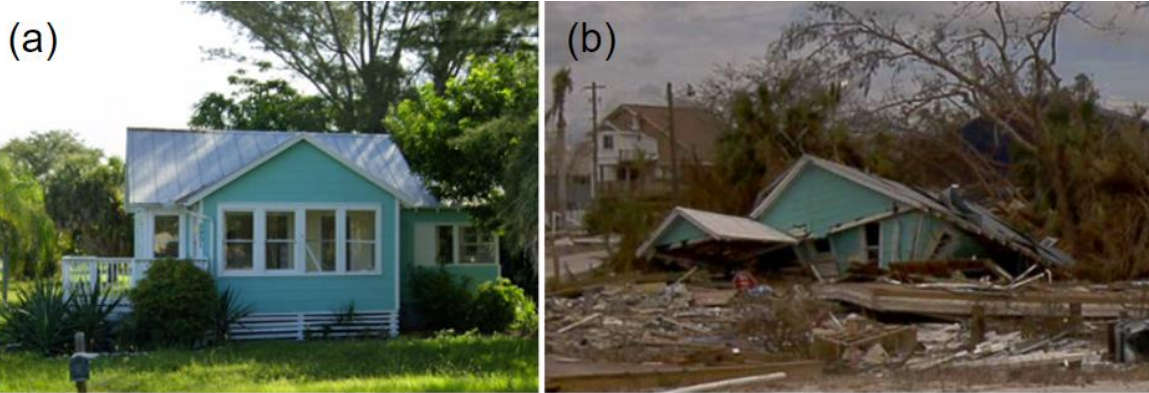
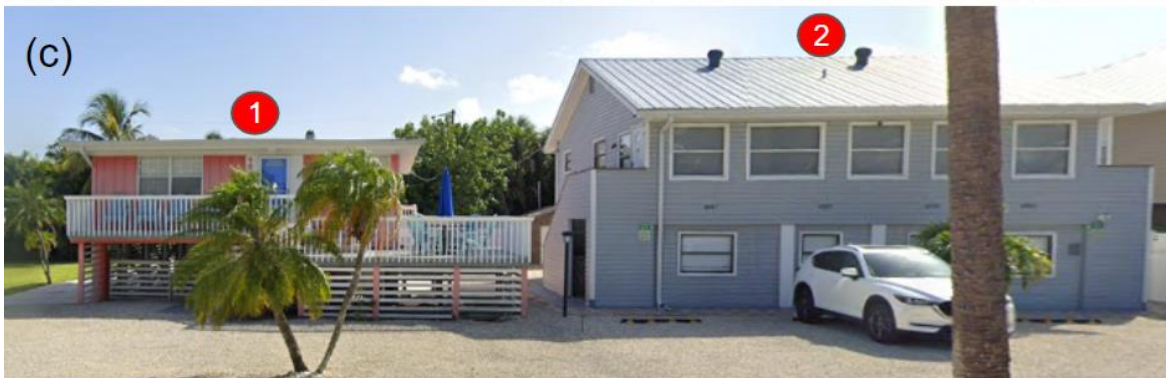
Importance of freeboard elevation to survivability, including (a) before and (b) after views of a single-family home on Estero Island constructed in 1950 that collapsed during Hurricane Ian; (c) before and (d) after views of two homes with disparate performance on Estero Island. Home (1) was constructed in 1956, while home (2) was constructed in 1950, but home (2) was elevated approximately 3 ft higher than home (1) and its breakaway walls performed as intended.

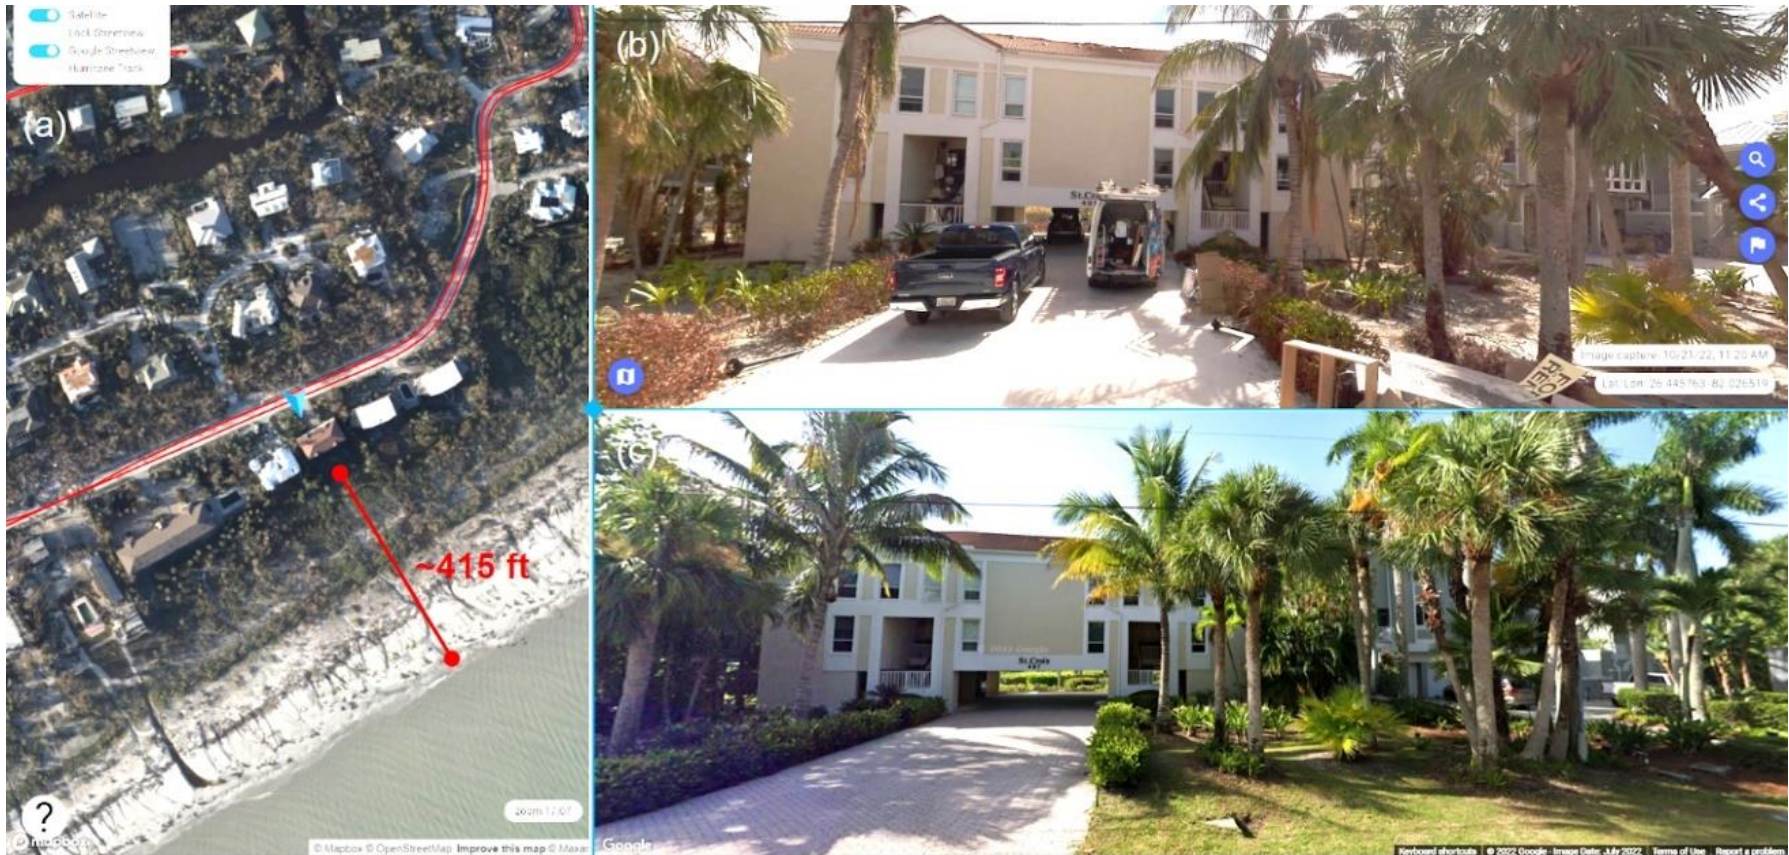
Illustrative effect of the vegetation and extended setback in Sanibel potentially mitigating surge impacts to structures. Subset (a) provides the post-storm aerial view showing a setback of approximately 415 ft from the shoreline, (b) the post-storm surface-level view, and (c) the pre-storm surface-level view.

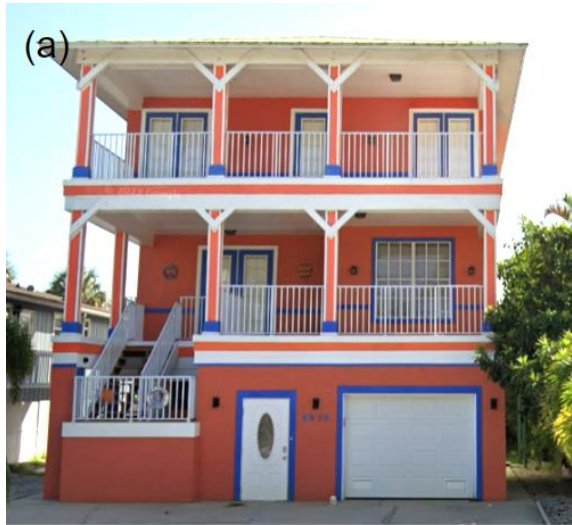
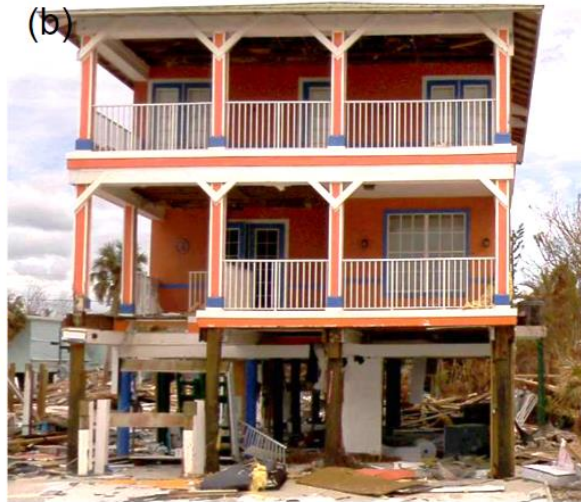
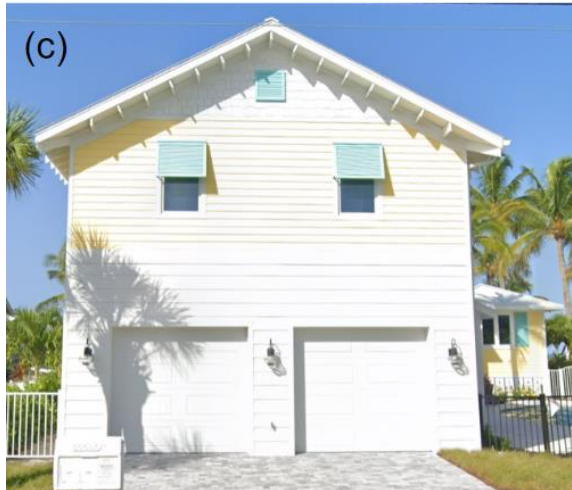
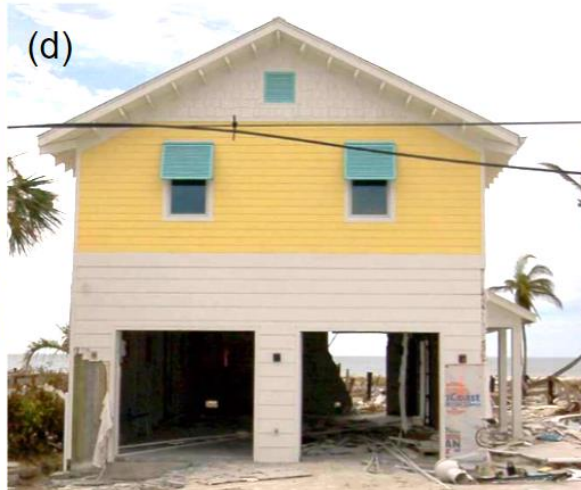
Examples of the performance of breakaway walls during Hurricane Ian, including (a) before and (b) after views of a home on Estero Island constructed in 2000 with acceptable performance of the breakaway walls; and (c) before and (d) after views of a two-story structure with garage at ground level constructed in 2020 in which the breakaway CMU walls on the back side of the structure only partially broke away.

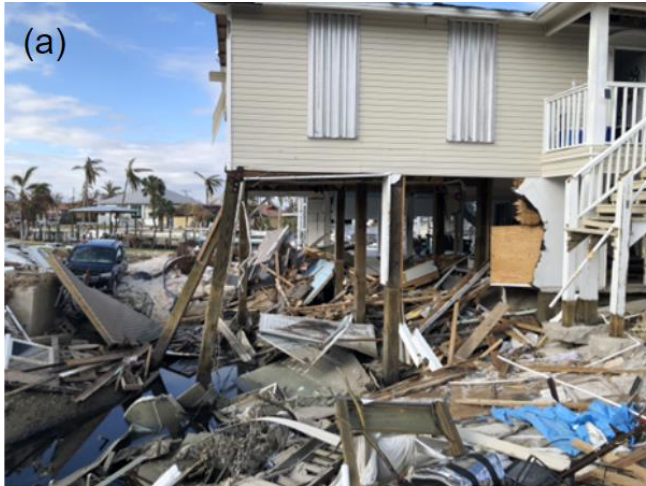
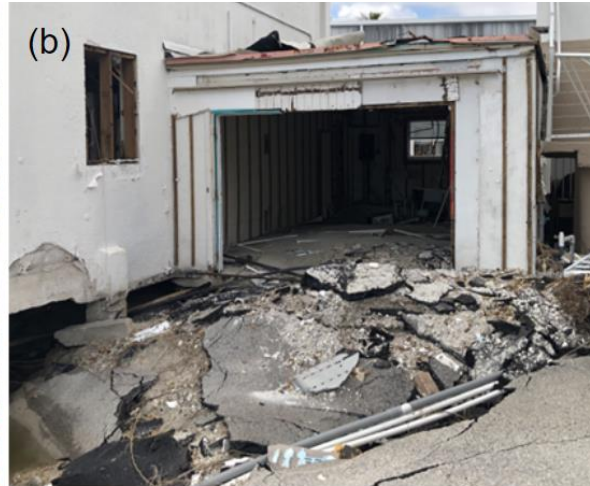
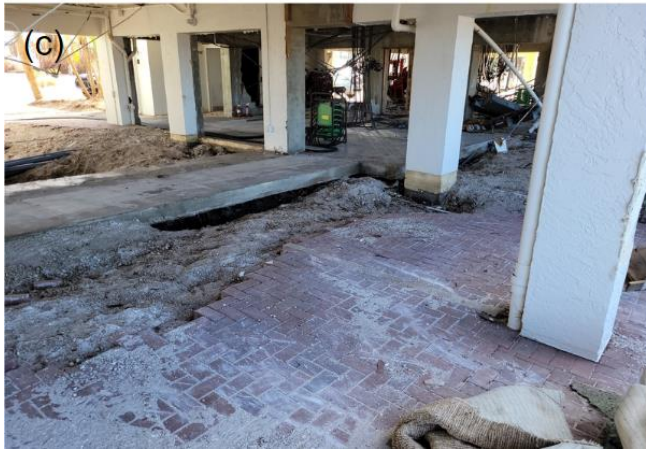
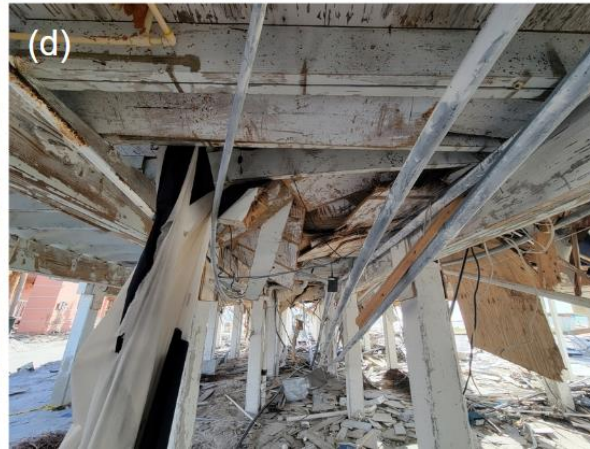
Examples of scour, uplift, and other surge effects on buildings during Hurricane Ian, including (a) debris transport and breakaway wall performance, (b) scouring and pavement washout, (c) scour around piers, and (d) effects of hydrodynamic uplift forces on a wood-framed floor system

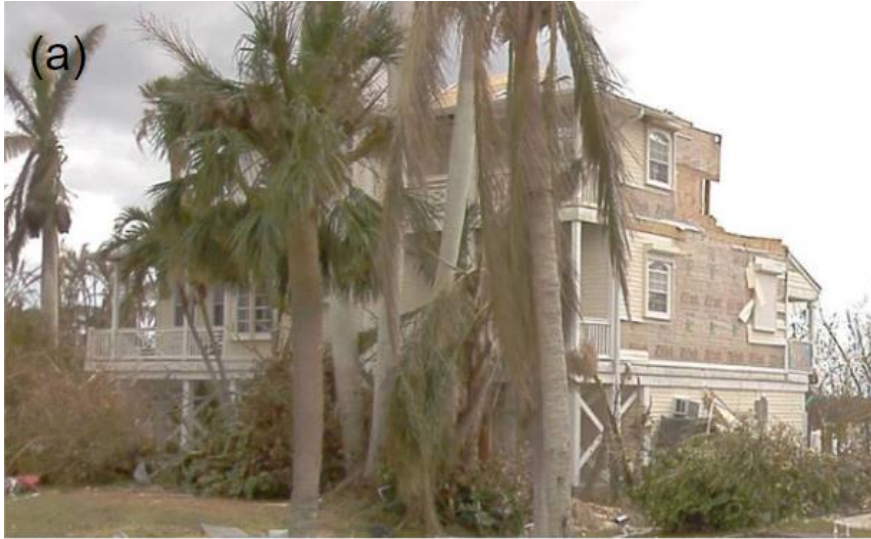
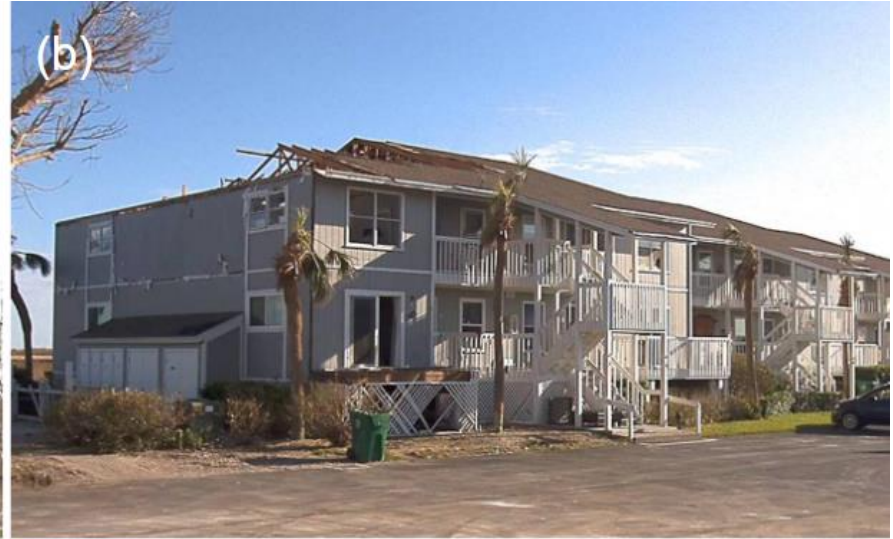
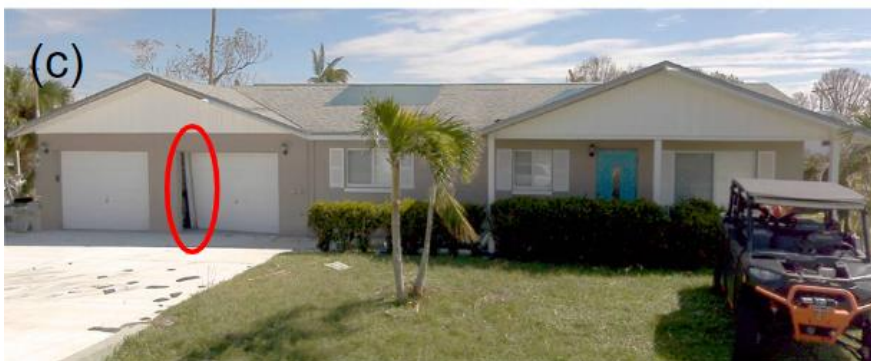
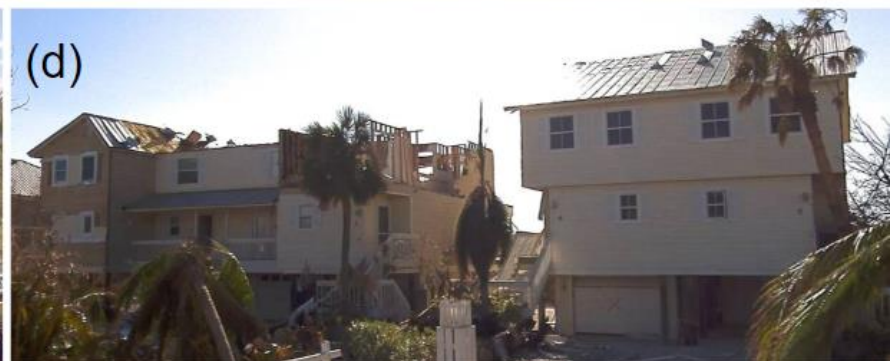
Examples of poor wind performance on the barrier islands, including (a) a 3-story home constructed in 1999 with partial roof structure removal and wall collapse in the top story, (b) gable end roof structure loss in apartment buildings constructed in 1986; (c) garage door framing blown inward in a home constructed in 1967; (d) roof structure failure in one home adjacent to loss of metal roof cover in another, both of which were constructed in 1978.

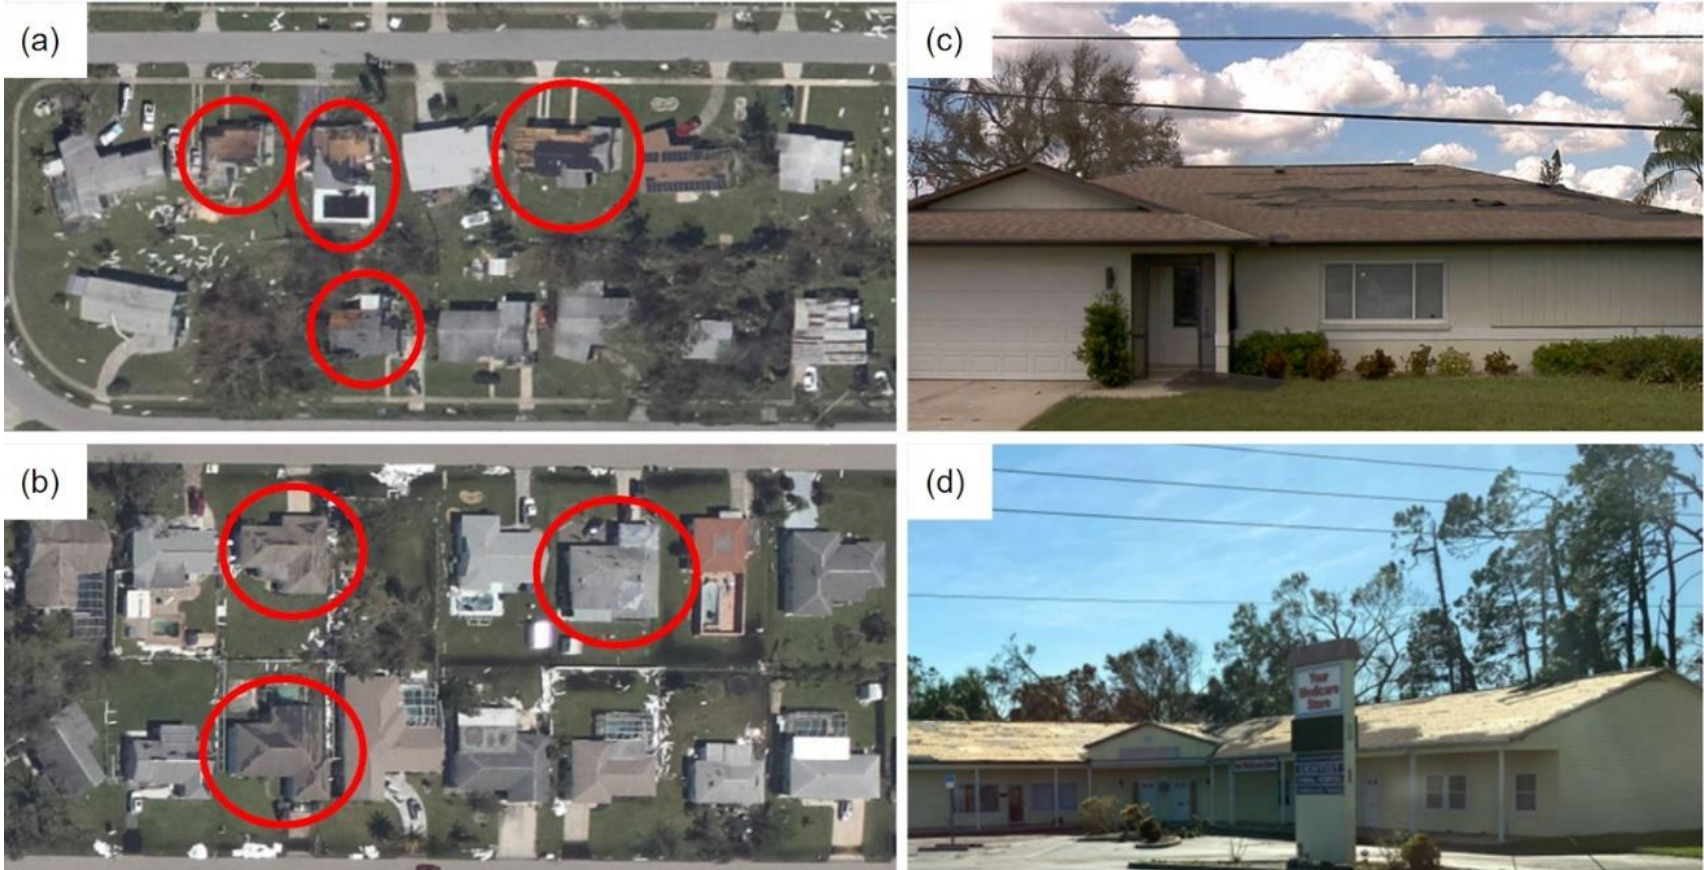
Illustrative performance of asphalt shingle and rolled membrane roofs in Port Charlotte consisting of homes constructed in the (a) 1960s with asphalt shingles and rolled roofs, (b) 1980s, (c) 1980s construction but asphalt shingle roof installed in 2005 but also (d) isolated commercial structures.

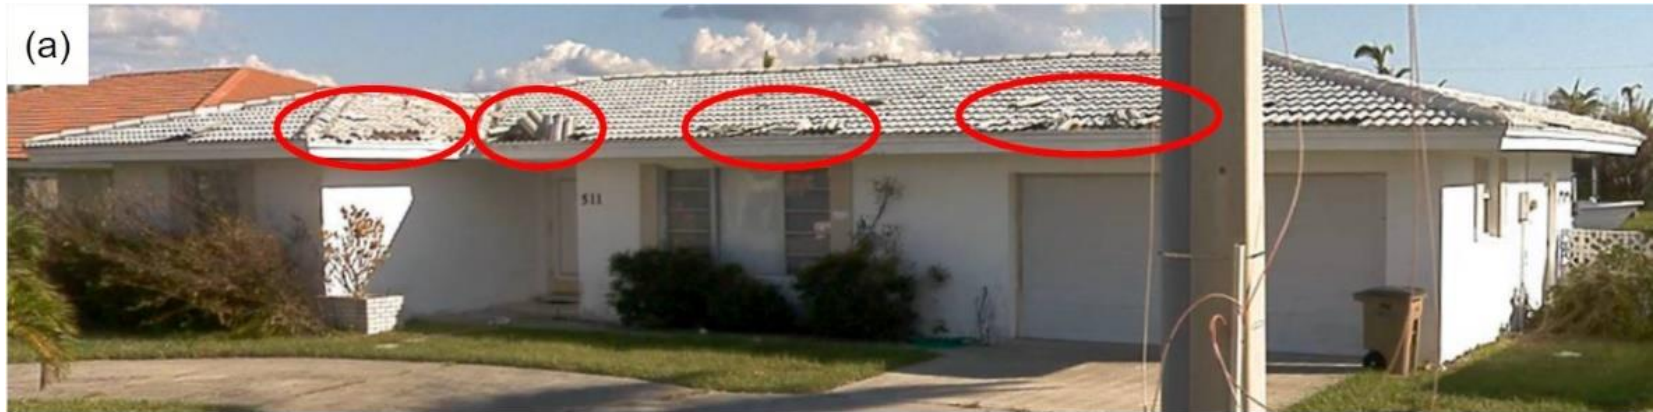
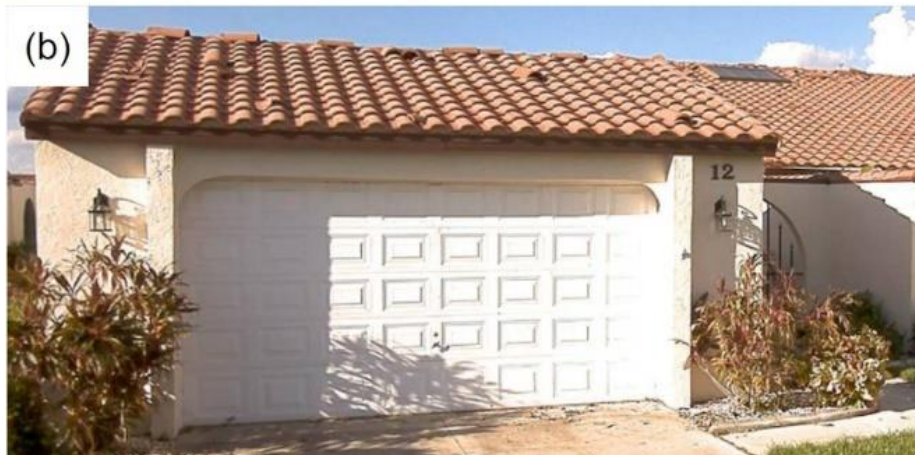
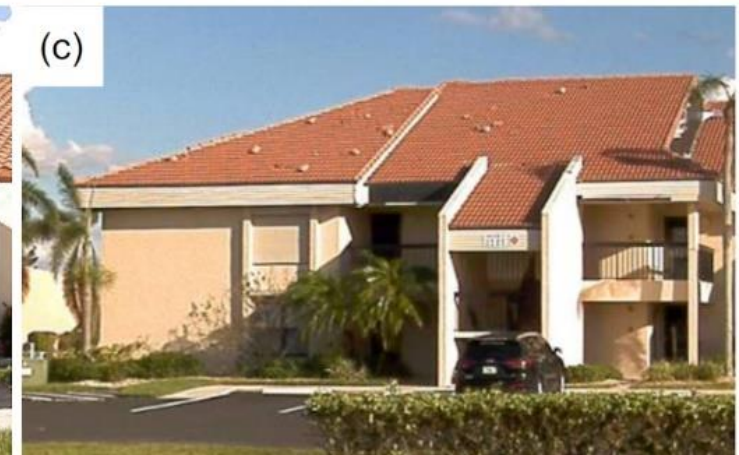
Illustrative examples of damage to tiled roofs, including (a) tile uplift (indicated by red ellipses) concentrated along the eaves of a single-family home in Punta Gorda constructed in 1969; (b) loose tiles in the field and ridge regions of the roof on a condominium in Punta Gorda, FL constructed in 1989; and (c) isolated loose tiles on a roof on a multi-family residential unit also in Punta Gorda, FL constructed in 1990.
