Interim Report:

Survey and Investigation of Buildings Damaged by Category III, IV and V Hurricanes in FY 2022-2023 - Hurricane Ian

Project #: P0266604

Report No. 01-23
17 April 2023

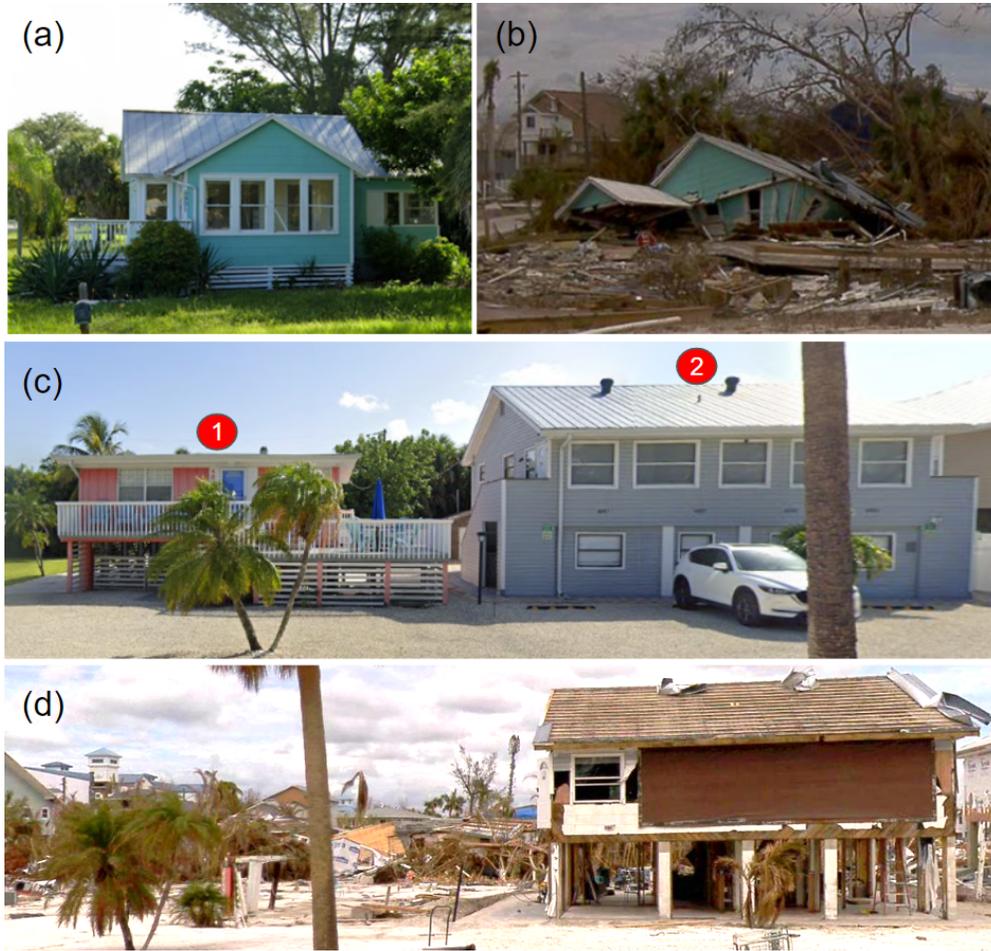
- **The most widespread damage by far occurred in Ft. Myers Beach and was primarily tied to storm surge and wave action.** A hazard gradient was obvious in the damage patterns, with the regions with the expected strongest wave impacts near and coastward of the Coastal Construction Control line (roughly aligned with Estero Blvd in Ft. Myers Beach) correlating with the highest frequency of complete destruction. Destruction appeared to be correlated with freeboard elevation, as illustrated in Figure 4.1.

Figure 4.1. Importance of freeboard elevation to survivability, including (a) before and (b) after views of a single-family home on Estero Island constructed in 1950 that collapsed during Hurricane Ian; (c) before and (d) after views of two homes with disparate performance on Estero Island. Home (1) was constructed in 1956, while home (2) was constructed in 1950, but home (2) was elevated approximately 3 ft higher than home (1) and its breakaway walls performed as intended.

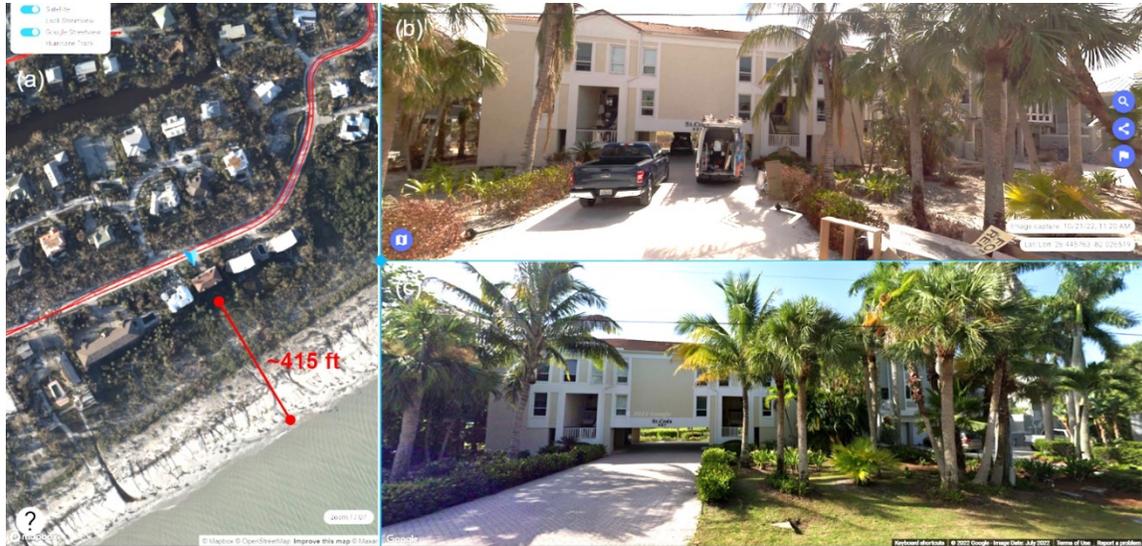
abundance of vegetative features between the buildings and the coast in Sanibel Island which could have resulted in dissipation of much of the wave energy. Figure 4.2 shows a typical coastal building on Sanibel. Differences in building stock or construction practices also could be a factor. The median year of construction was 1981 for both Sanibel Island and Ft. Myers Beach / Estero Island, but construction practices may still differ between what are two distinct communities.

Figure 4.2. Illustrative effect of the vegetation and extended setback in Sanibel potentially mitigating surge impacts to structures. Subset (a) provides the post-storm aerial view showing a setback of approximately 415 ft from the shoreline, (b) the post-storm surface-level view, and (c) the pre-storm surface-level view.

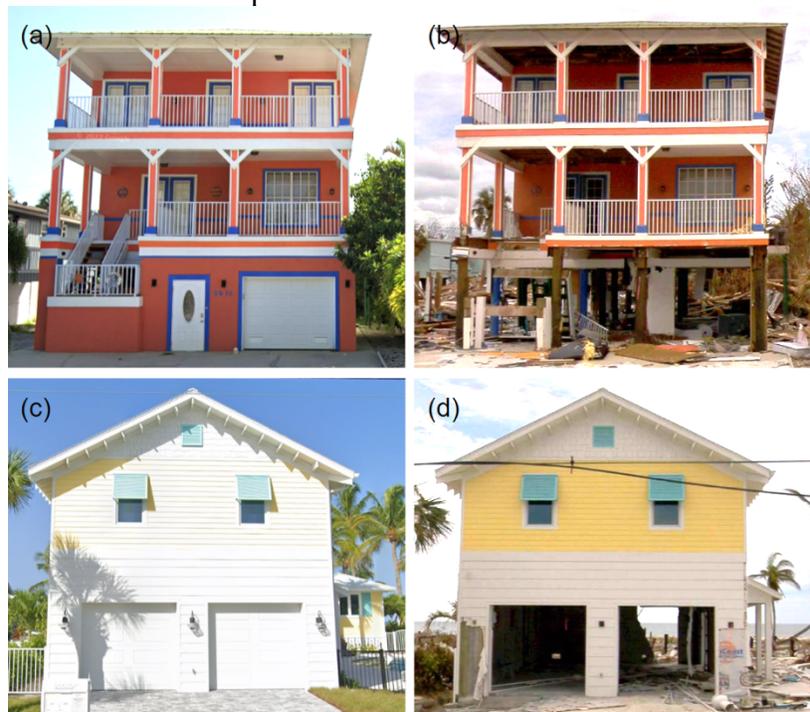
- **Breakaway walls appeared to perform as intended in most cases**, but it should be noted that a survivability bias is potentially present, since structures with breakaway walls that didn't perform as intended may have washed away, destroying evidence. Further study is needed. A couple examples of breakaway wall performance are illustrated in Figure 4.3.

Figure 4.3. Examples of the performance of breakaway walls during Hurricane Ian, including (a) before and (b) after views of a home on Estero Island constructed in 2000 with acceptable performance of the breakaway walls; and (c) before and (d) after views of a two-story structure with garage at ground level constructed in 2020 in which the breakaway CMU walls on the back side of the structure only partially broke away.

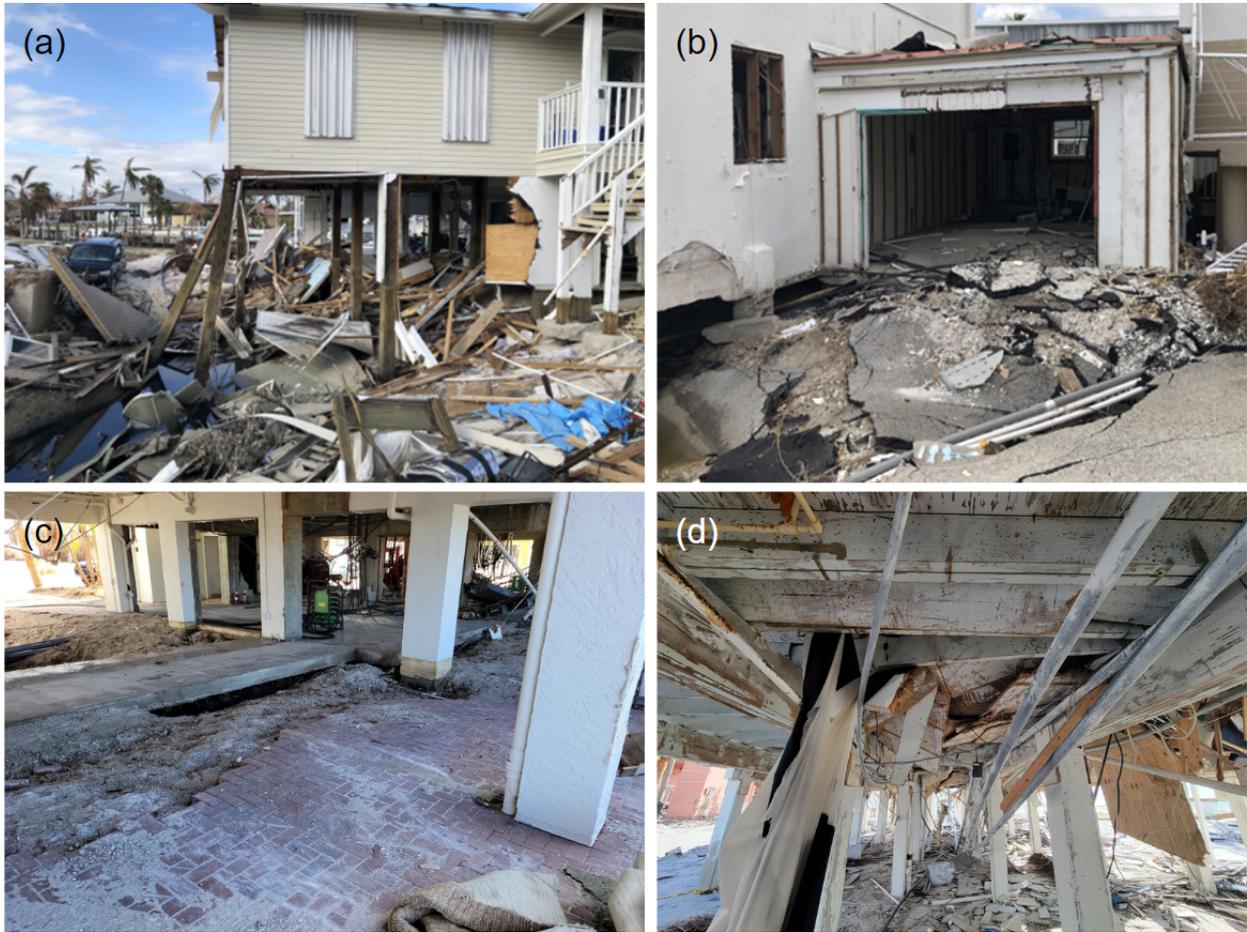
- **In addition to direct lateral hydrodynamic loading on structures the storm surge and waves in Ft. Myers Beach produced several other effects** including sinkhole formation, significant scouring around piles and other structural members, and uplift of slabs and floor systems. Figure 4.4 illustrates some of these effects.

Figure 4.4. Examples of scour, uplift, and other surge effects on buildings during Hurricane Ian, including (a) debris transport and breakaway wall performance, (b) scouring and pavement washout, (c) scour around piers, and (d) effects of hydrodynamic uplift forces on a wood-framed floor system.

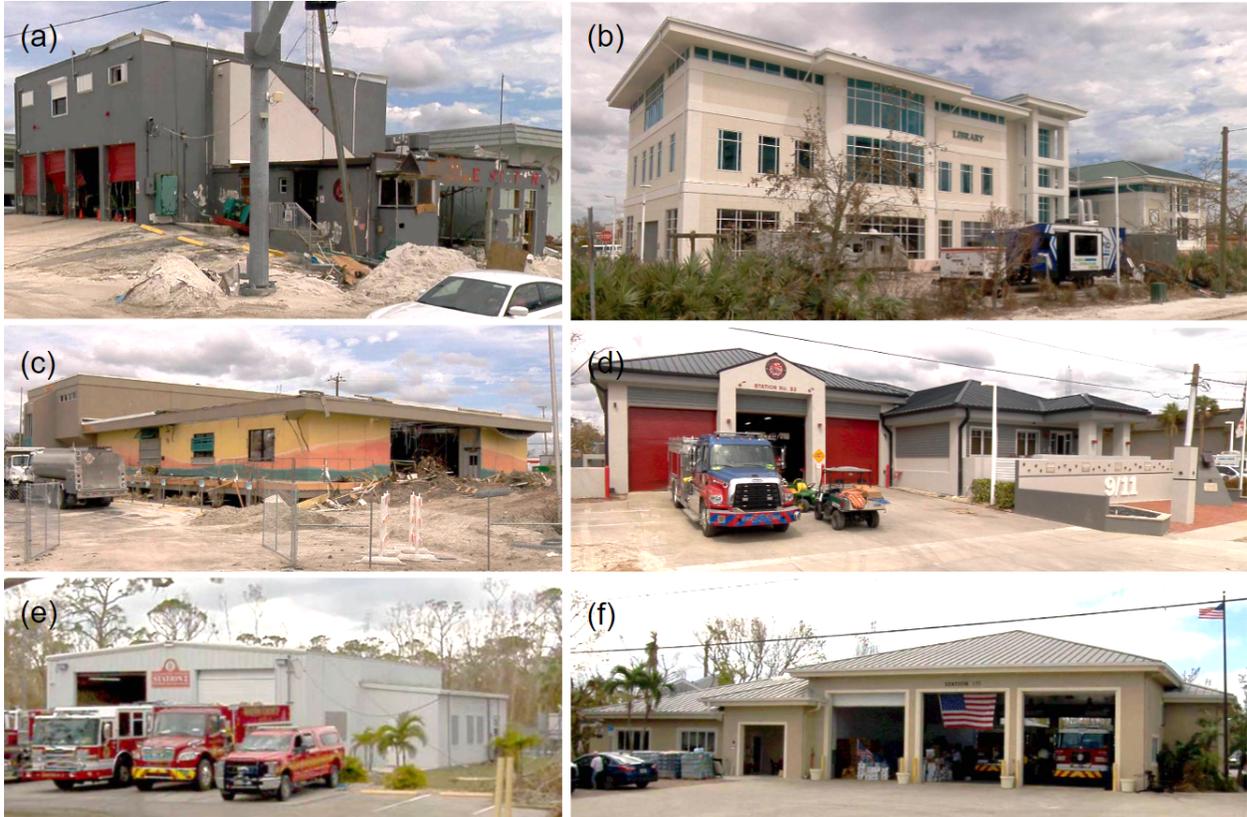
- **Critical facilities performed acceptably on the barrier islands**, based on what could be observed from the surface-level panoramas (illustrated in Fig. 4.5). One possible exception was the Ft. Myers Beach Fire Department District Station 31, which experienced partial wall collapse due to storm surge. This district station was constructed on grade, and approximately 500 ft from the coastline. Otherwise, from a structural perspective, both wind and storm surge performance appeared to be good., More in-depth assessments would be needed to evaluate functionality and other performance goals of these facilities.

Figure 4.5. Illustrative performance of critical or cultural facilities on the barrier islands, including (a) the Ft. Myers Beach Fire Department District Station 31, constructed in 1985 with partial collapse of some walls and breaching of roll-up doors; (b) the Ft. Myers Beach Library (portion shown added in 2011) with only minor loss of metal roof cover visible (not shown); (c) Ft. Myers Beach Town Hall (constructed in 1968) with surge damage to end wall and washout below foundation; (d) Ft. Myers Fire Station No. 33 (built in 2008) with no visible signs of exterior damage; (e) Pine Island Fire Station (built in 1975) with no signs of exterior damage; and (f) Sanibel Fire Department Station 171 (built in 2005) with no visible signs of exterior damage.

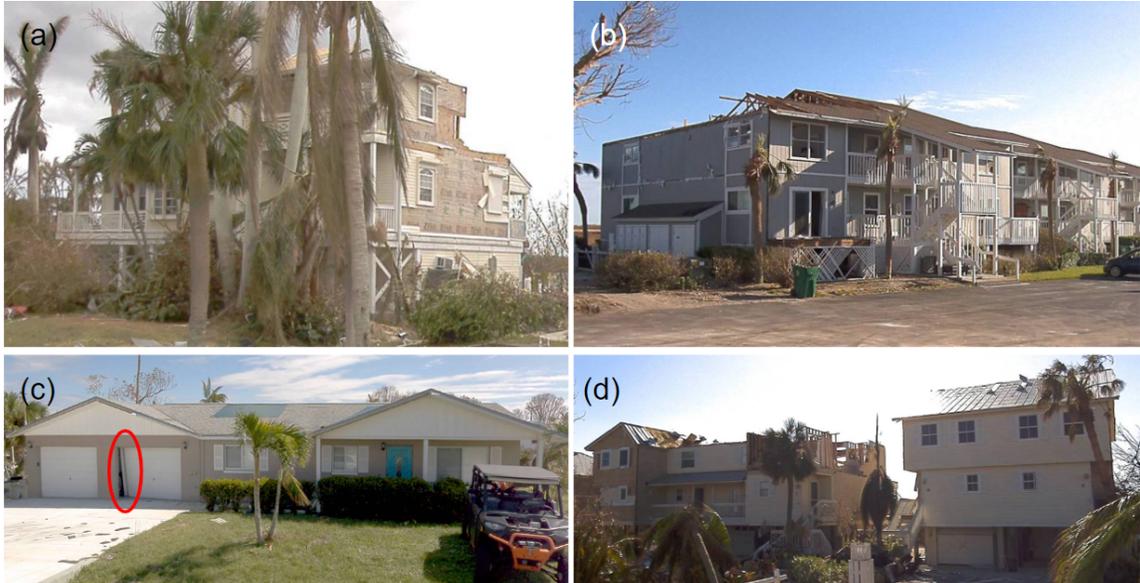
- **Structural wind damage was rare in site-built structures**, even north of the track where peak wind estimates were highest, but there were isolated examples of structural roof failures and partial wall collapses in older residential buildings built prior to the adoption of the Florida Building Code in 2002 (Fig. 4.6).

Figure 4.6. Examples of poor wind performance on the barrier islands, including (a) a 3-story home constructed in 1999 with partial roof structure removal and wall collapse in the top story, (b) gable end roof structure loss in apartment buildings constructed in 1986; (c) garage door framing blown inward in a home constructed in 1967; (d) roof structure failure in one home adjacent to loss of metal roof cover in another, both of which were constructed in 1978.

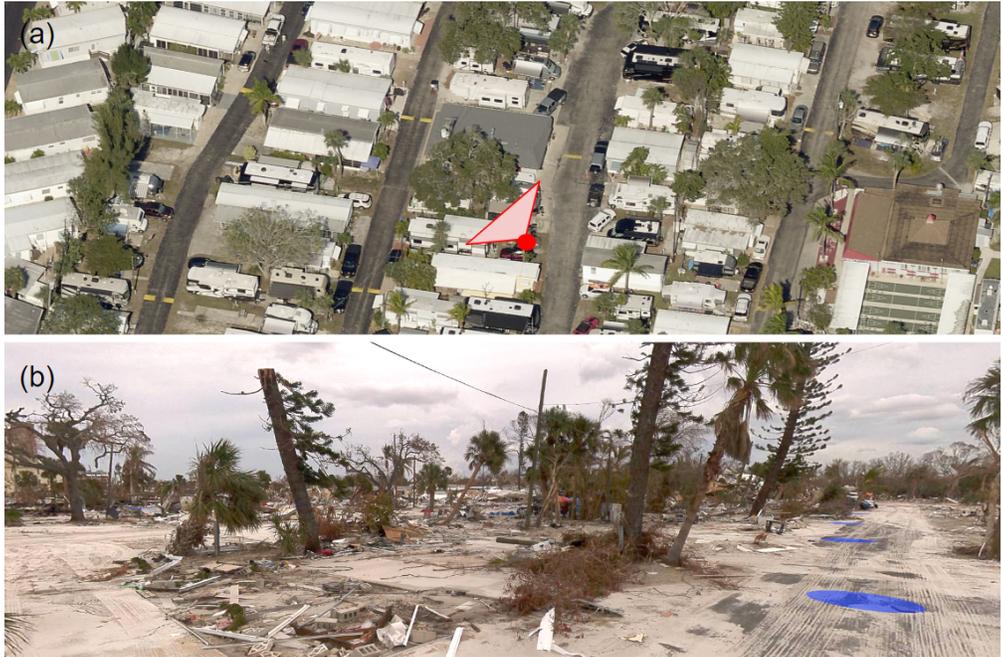
- **RV and mobile/manufactured home parks exhibited poor performance under direct wave action and were more likely to experience wind damage than site-built structures.** Under direct wave action, homes and parks were completely washed away (Fig. 4.7). Away from the coastline, several instances of homes pushed off their unreinforced masonry pier foundations were observed due to storm surge or inland flooding, and wind damage was frequently observed, up to and including loss of the roof structure. Most of the mobile/manufactured homes with wind damage observed in the preliminary review of the surface-level panoramas only experienced damage to the building envelope.

Figure 4.7. Example of surge impacts on RVs and manufactured homes on Ft. Myers Beach during Hurricane Ian: (a) before oblique view of the RV park, and (b) after view of the RV park shown in (a). The red triangle in (a) approximates the location and field of view in (b).

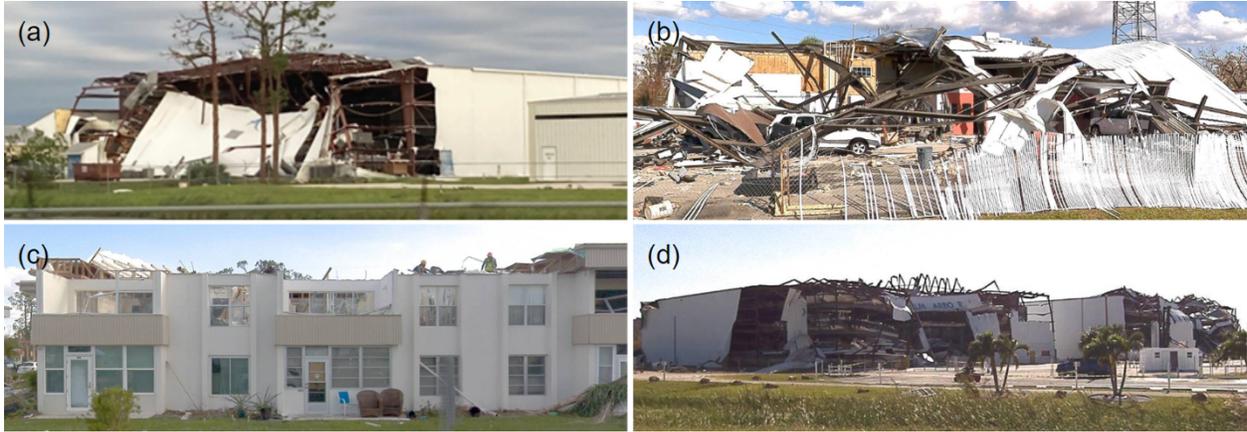
- **Isolated structural wind damage was observed in Punta Gorda, Port Charlotte and surrounding regions**, primarily consisting of the loss of structural roof framing (e.g., rafters, trusses, purlins) in older construction (pre-Florida Building Code) as illustrated in Figure 4.8. Structural damage to site-built single-family homes was isolated in these areas, as a preliminary review of the FAST-1 imagery did not reveal any examples of such failures.

Figure 4.8. Examples of significant structural damage from Hurricane Ian, including (a) end bay failure in a metal building aircraft hangar (year built: 1996) at Punta Gorda airport, (b) collapse of an automobile maintenance garage in Grove City constructed in 1986; (c) wood roof structure failure in two-story wood-frame condominiums in Port Charlotte constructed in 1973, and (d) end bay collapses and cladding loss of two marina buildings in Cape Haze constructed in 1999.

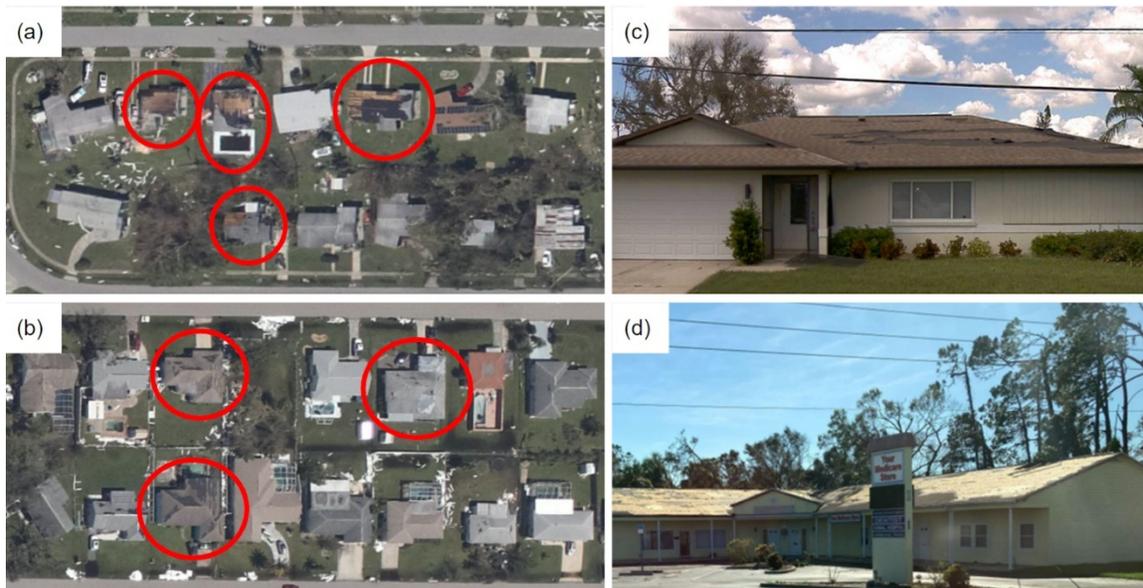
- **Roof cover damage was commonly observed but the extent of damage varied considerably.** The frequency and extent of damage by roof cover material type is beyond the focus of this EARR, but examples of damage were easily identified for asphalt shingle (Fig. 4.9) and clay/concrete tile (Fig. 4.10) roofs. Older asphalt shingle roofs tended to experience the most severe damage, while newer asphalt shingle roofs and tile roofs typically only exhibited the loss of a few shingles or tiles, respectively. Many non-residential buildings also showed signs of roof cover damage, including hospital facilities as highlighted in Cortes et al. (2022).

Figure 4.9. Illustrative performance of asphalt shingle and rolled membrane roofs in Port Charlotte consisting of homes constructed in the (a) 1960s with asphalt shingles and rolled roofs, (b) 1980s, (c) 1980s construction but asphalt shingle roof installed in 2005 but also (d) isolated commercial structures.

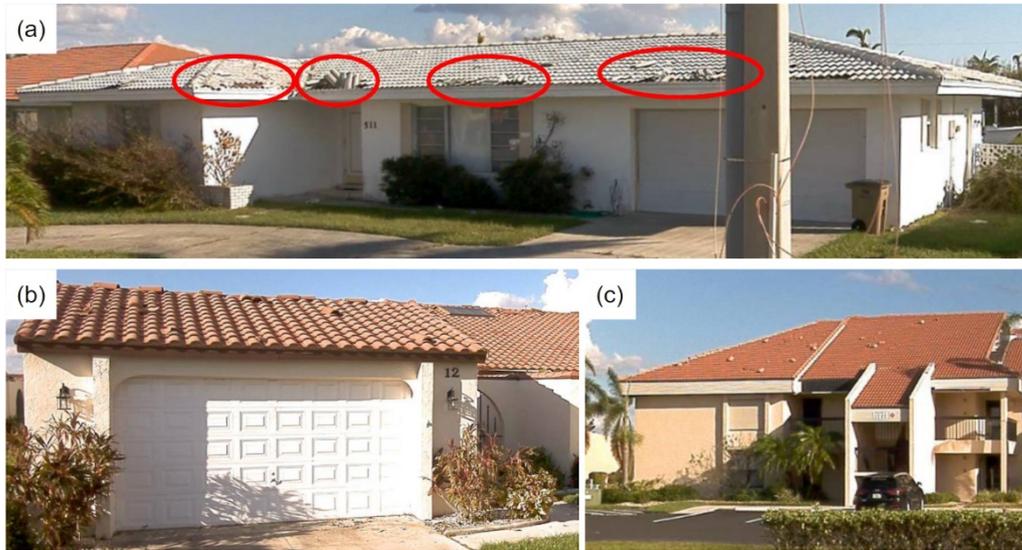
Figure 4.10. Illustrative examples of damage to tiled roofs, including (a) tile uplift (indicated by red ellipses) concentrated along the eaves of a single family home in Punta Gorda constructed in 1969; (b) loose tiles in the field and ridge regions of the roof on a condominium in Punta Gorda, FL constructed in 1989; and (c) isolated loose tiles on a roof on a multi-family residential unit also in Punta Gorda, FL constructed in 1990.

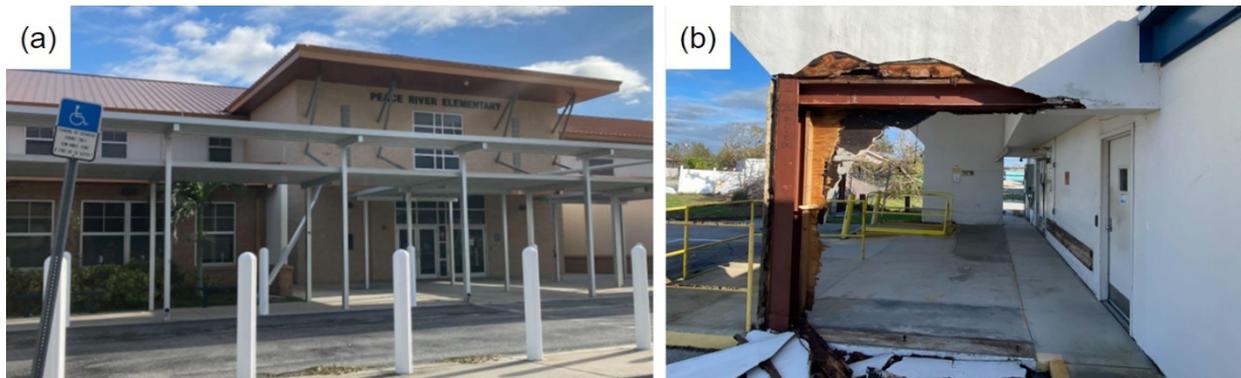
- **Municipal structures performed well, showing only minor damage to building envelope components (roofing, wall cladding)** (Fig. 4.11). For example, the Peace River Elementary School in Punta Gorda appeared essentially unscathed save for failure of metal trellis (Fig. 4.11a).

Figure 4.11. Isolated cladding loss in non-residential buildings, including (a) minor damage to flashing at Peace River Elementary School in Port Charlotte and (b) failure of exterior stucco-clad wall panel at USPS office in Port Charlotte.

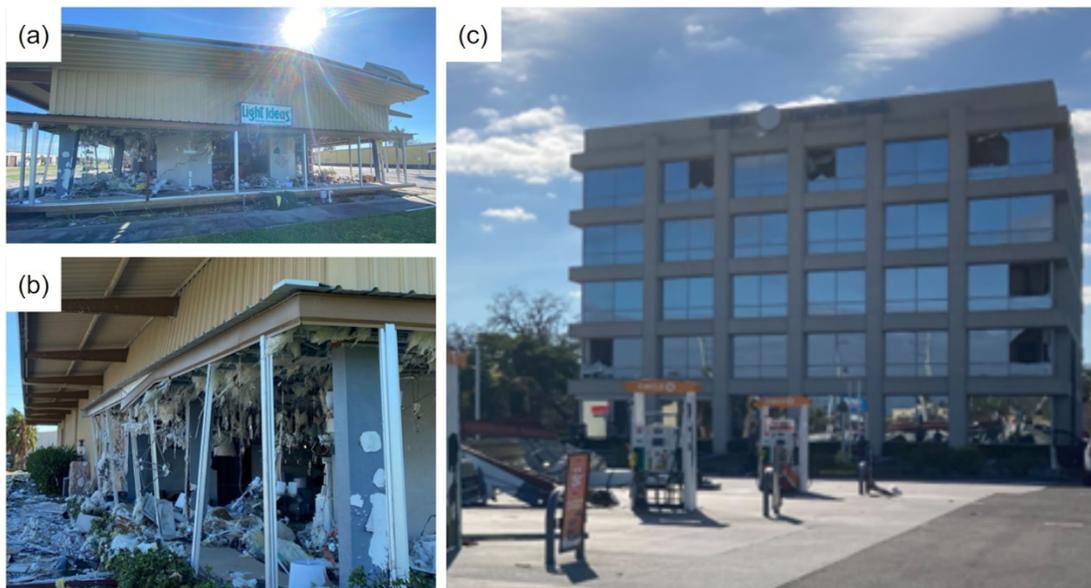
- **A few illustrative examples of significant fenestration damage were observed** (Fig. 4.12), but such damage also does not appear to be widespread.
- **Manufactured home communities' performance was generally worse than that of site-built construction, but structural damage was still not common in the coastal urban regions.** Damage primarily consisted of the loss of cladding elements, as illustrated in Figure 4.13, but structural damage was more frequently observed in some communities closer to the coast where the highest wind speeds would have been experienced (Fig. 4.13 a, b).

Figure 4.12. Examples of isolated fenestration damage observed in the Port Charlotte area, including (a) and (b) complete loss of glass storefront in a commercial building constructed in 1973, and (c) broken windows in a 5-story commercial building constructed in 1987.

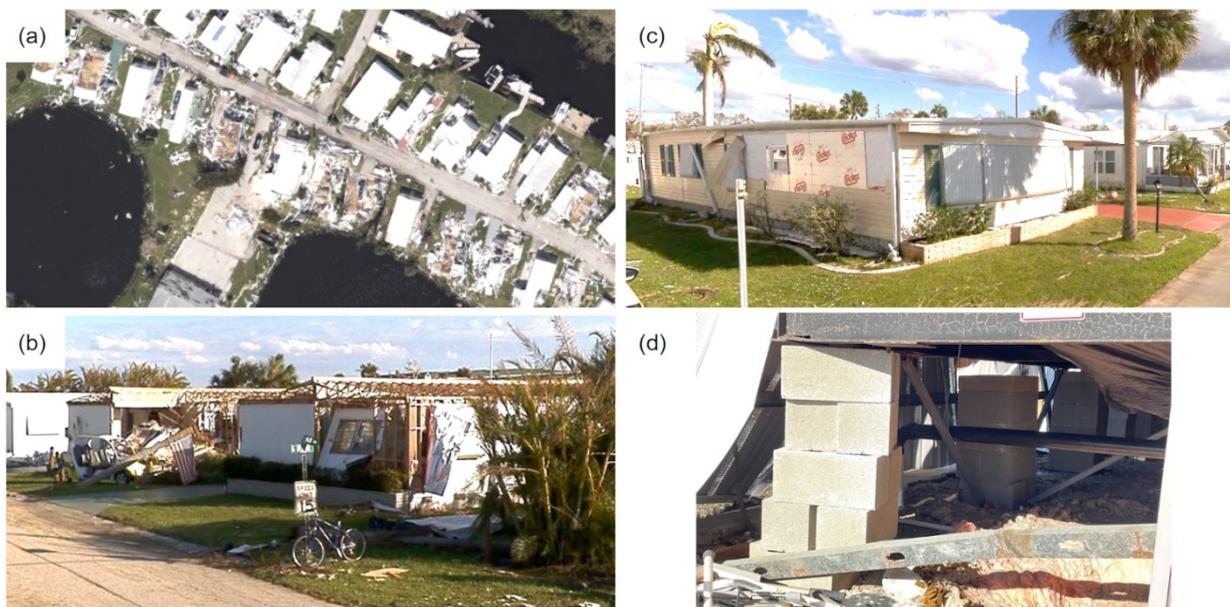
Figure 4.13. Illustrative damage to mobile/manufactured homes, including (a) aerial and (b) street-level views of structural damage to Gasparilla Mobile Estates in Placida (established in the 1970s), including loss of roof structure and wall collapses; (c) cladding damage to manufactured homes in Punta Gorda; and (d) shifted unreinforced masonry piers supporting a manufactured home subjected to storm surge on San Carlos Island.

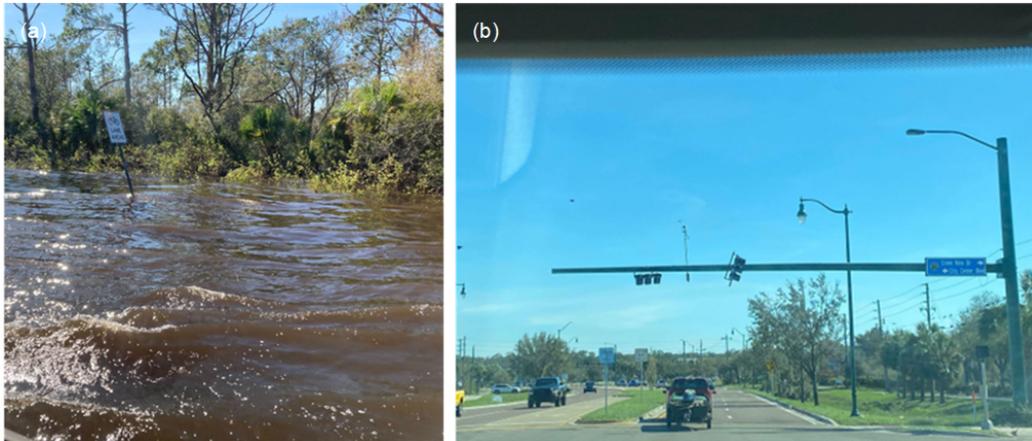
A few illustrative photos of inland flooding and damage to transportation infrastructure captured by FAST 1.1 are shown in Figure 4.14. While Hurricane Ian caused significant impacts in these inland areas due to flooding, treefalls, and other hazards, the impacts are likely outside of the purview of StEER and are not investigated further at this time.

Figure 4.14. Photos of damage to the road infrastructure in inland regions: (a) street flooding at Exit 182 in I-75 on route to Sumter Blvd. and (b) damaged traffic lights at the intersection of City Center and Sumter Blvd. in the city of North Port.
