Draft Final Report for Project Entitled:

Impact of Spray Foam Insulation on Durability of Plywood and OSB Roof Decks

Florida Building Commission
State of Florida Department of Business and Professional Regulation

Forrest J. Masters, Ph.D., P.E., masters@ce.ufl.edu, (352) 392-9537 x 1505, PI
Kurtis R. Gurley, Ph.D., kgurl@ce.ufl.edu, (352) 392-9537 x 1508
David O. Prevatt, Ph.D., P.E. (MA), dprev@ce.ufl.edu, (352) 392-9537 x 1498

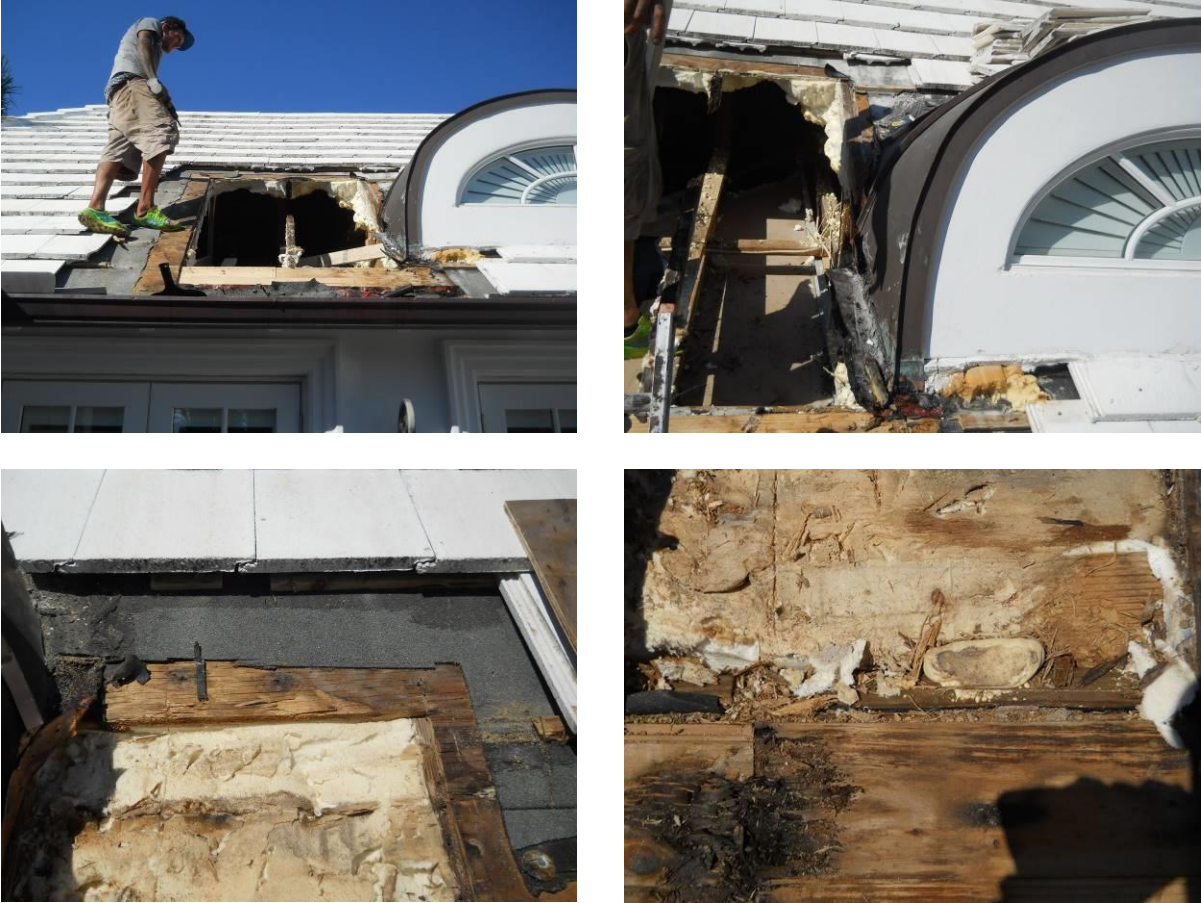
Mark Zehnal provided evidence of a damaged roof system in Palm Beach County that had closed cell spray foam insulation installed. We were told that the home was built in 2005 and was repaired in 2014. This series of photographs documents the extent of damage to the roof deck and wood framing adjacent to a large dormer. The photos show a rotted deck adjacent to a dormer. The photos did not identify the source of the water (although experience suggests failed flashing below the window sill and or failed base flashing along the dormer wall are potential sources).

Figure 7: Moisture damage in an unvented attic with ccSPF. Moisture was particularly event around the visible dormer (Courtesy of Mark Zehnal).

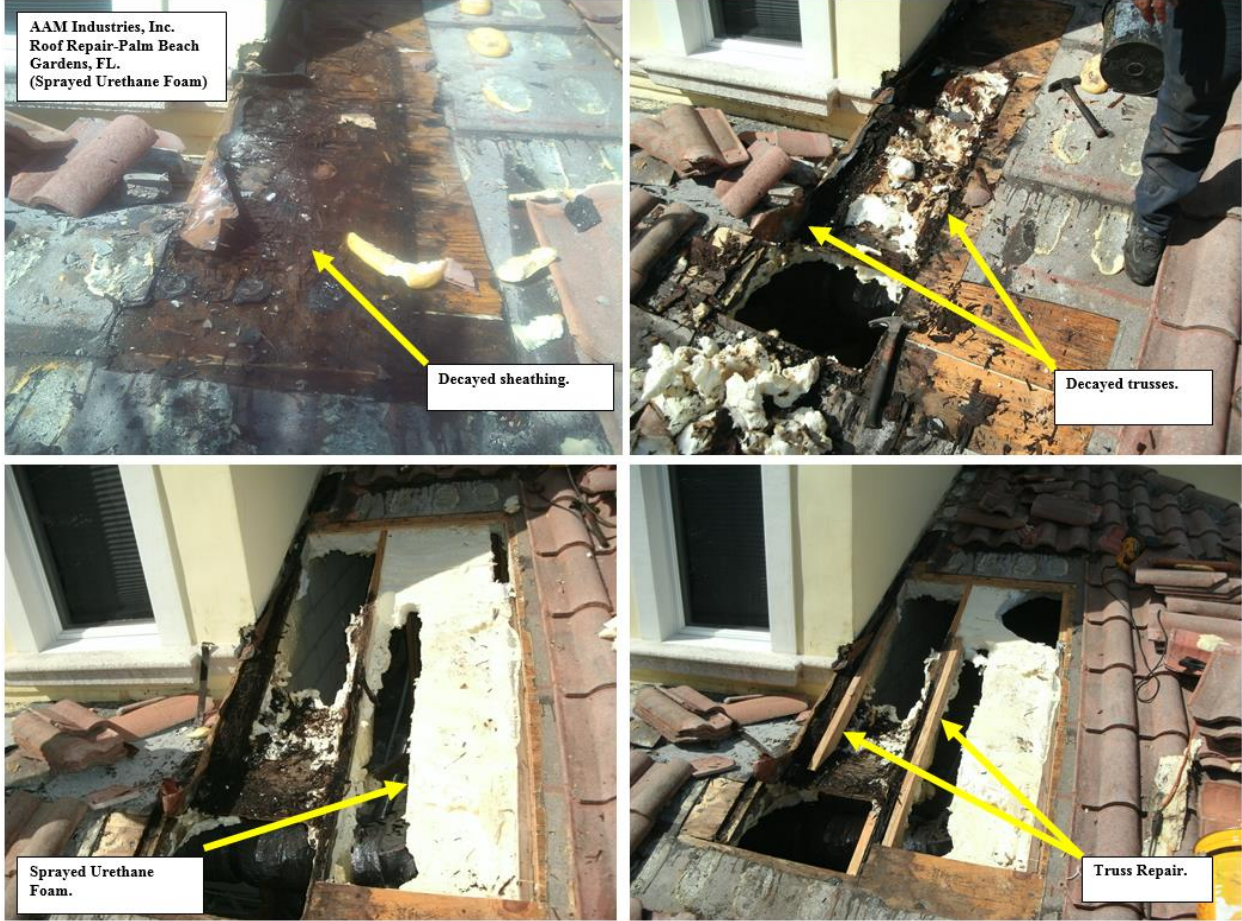
The roof system of a Palm Beach Gardens, FL house with spray applied insulation showed signs of water intrusion damage. As seen in the photo the sheathing and wood framing both began to rot and is speculated to be caused by the elevated moisture content of the sheathing due to a leak caused by roof defection. As was seen in the first case this damage occurred next to a window which suggests the moisture could have entered the system due to failed flashing at the window sill and been trapped between the spray foam and the sheathing. A forensic study was not conducted on this home so these photos are considered anecdotal and just an example of a home with spray foam and moisture damage.

Figure 8: Moisture damage around a gable dormer to an unvented attic with ccSPF.

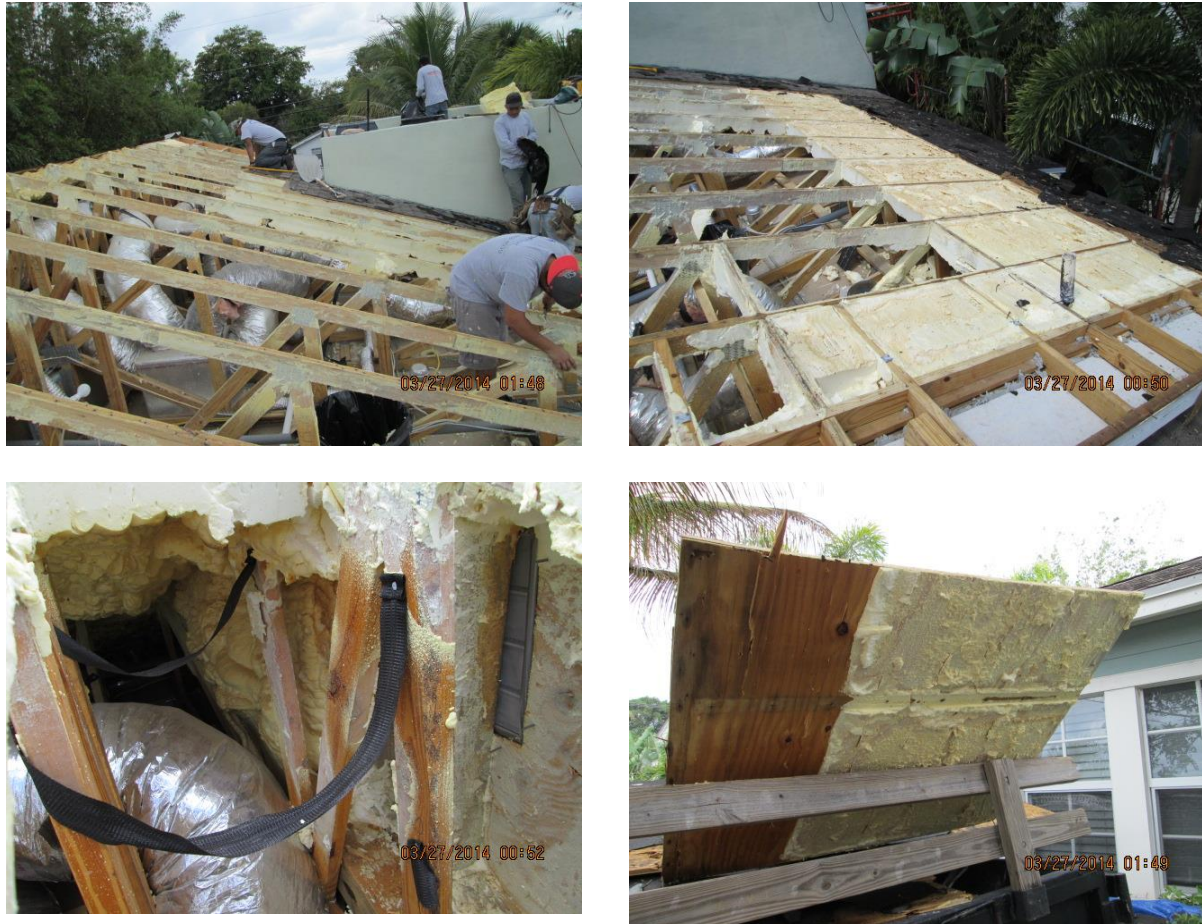
An additional home installed with ccSPF installed on the underside of the wooden roof sheathing was identified in which the foam had to be removed from the home as a result to a homeowner allergy to the spray foam insulation. As the foam was being stripped, a buildup of moisture was detected on the wood framing and underside of the wood sheathing. A forensic study of the home was then conducted in which a chemical ratio test of the spray foam was performed as this is the typical diagnosis of a moisture related spray foam issue. The ratio of the spray foam was confirmed to be correct and was identified as completely reacted (solid) and thus concluded this was not the cause of the moisture buildup, It is the motivation of this study to determine the effects of moisture buildup in wood sheathing in homes such as this to gain insight on how to prevent problems due to a building envelope moisture intrusion.

Figure 9: Evidence of moisture buildup in home installed with ccSPF. Note the moisture on both the sheathing and wood framing

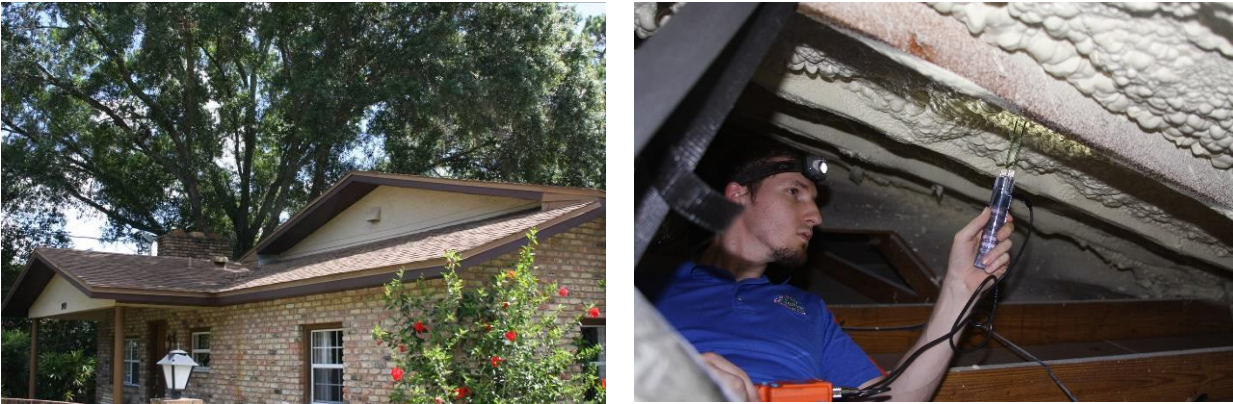
Figure 11: (Left) View of the front of the house from ground. (Right) View from inside the attic showing the ccSPF and a moisture content measurement being taken.

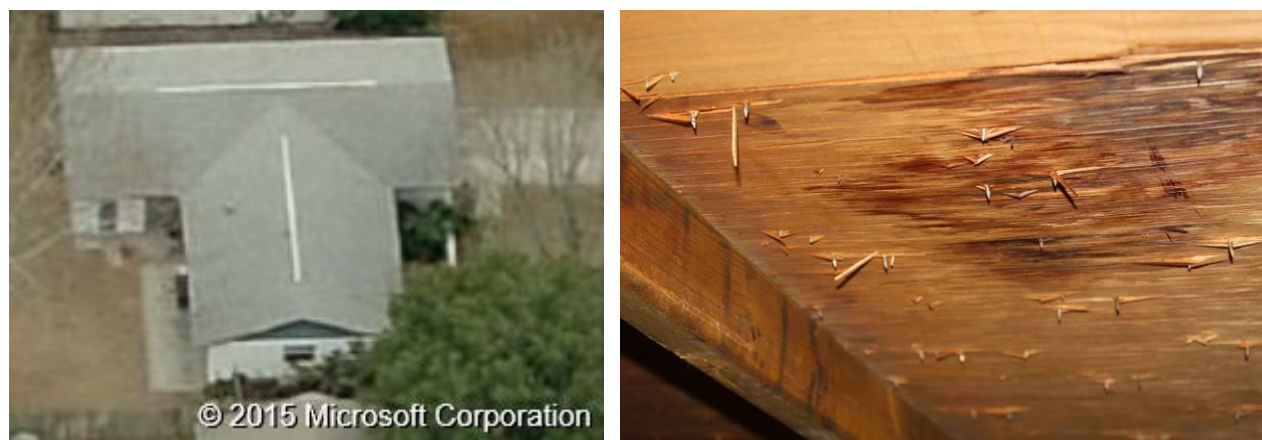
Figure 13: (Left) Aerial view of Home 3; (Right) Apparent water damage in the plywood sheathing. No moisture was present at the time of inspection, and no evidence of past moisture was evident in the insulation below.

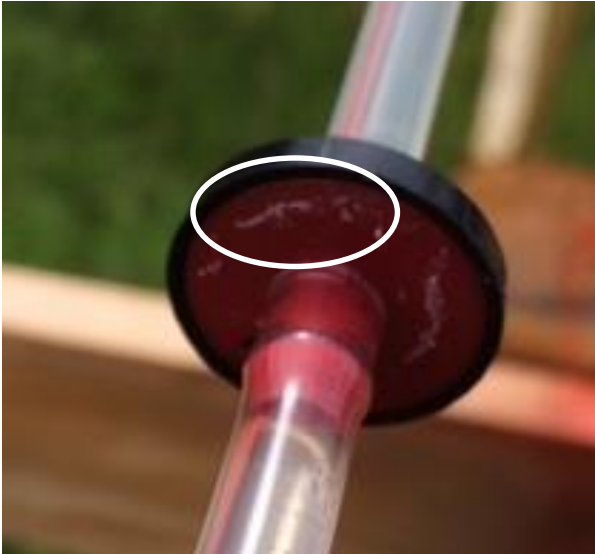
It should be noted that, as can be seen in Figure 35, mineral deposits from the water formed over time on the drippers and slowed the dripping rate below the desired 1-3 mL/min. This was unexpected and the differences in drip rate were not obvious until week 6. All of the drippers over the week 8 samples were replaced at week 6 and checked to ensure a consistent flow rate, but it is probable that Week 6 samples, and possibly even some Week 4 samples, experienced slower dripper flow rates than Week 1 and 2 samples.

Figure 35: Old dripper with mineral deposits indicated by white ellipse
