Final Report:

Survey and Investigation of Buildings Damaged by Category-III, IV & V Hurricanes in FY 2018-2019 – Hurricane Michael

Project #: P0091032

Report No. 01-19

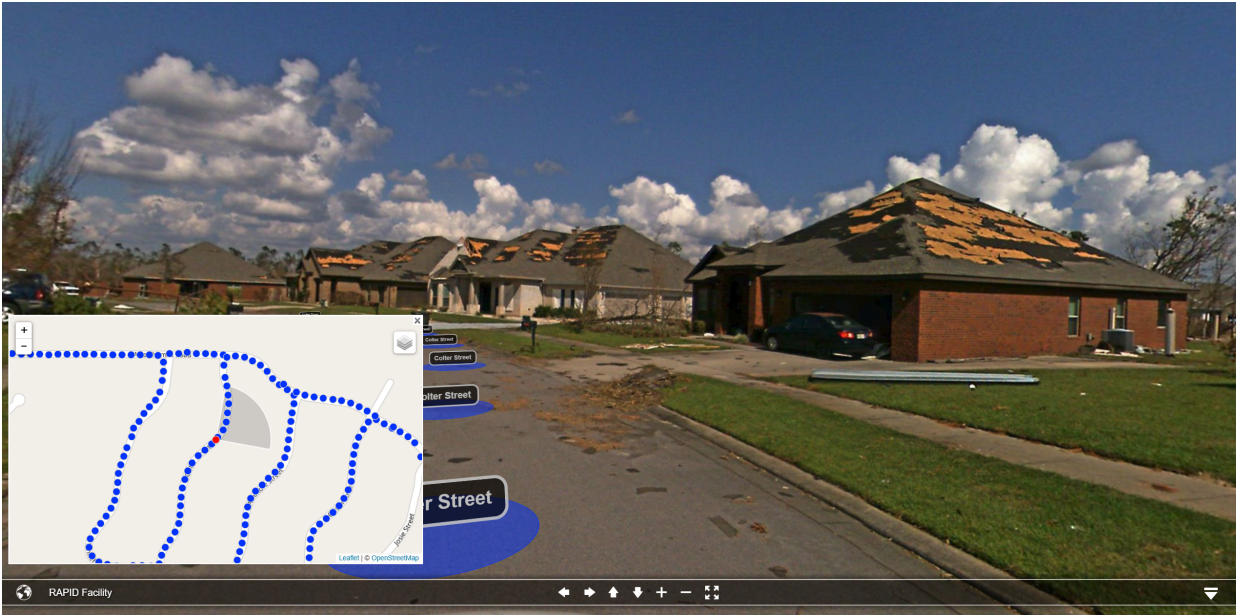
Figure 6. StreetView imagery of homes damaged by Hurricane Michael in Panama City, FL.

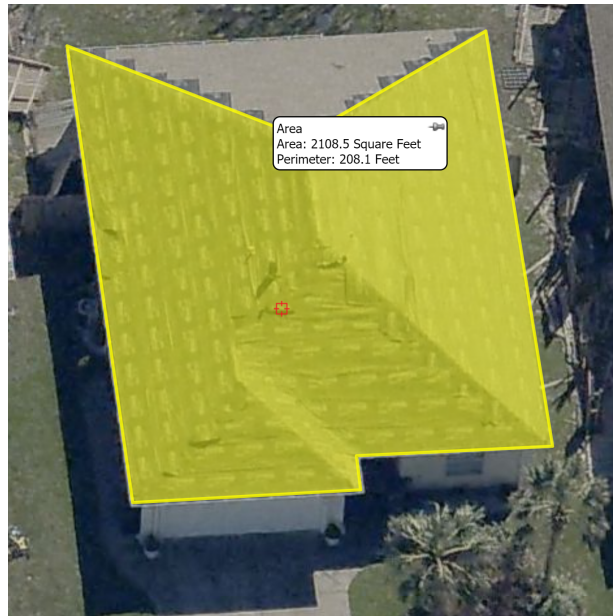
Figure 8. Example of estimated area of roof cover damage

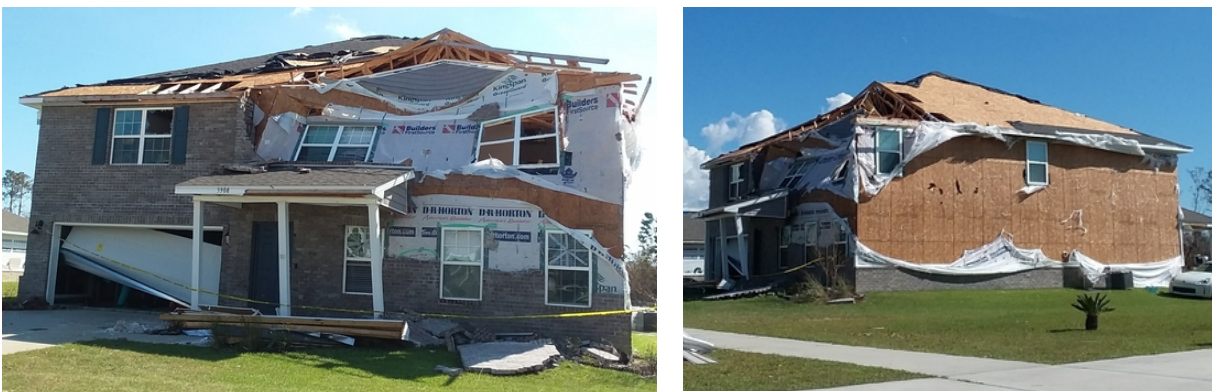
The lone structural roof failure in a post-FBC home occurred to a home built in 2016 located in the Magnolia Hills subdivision. As shown in Figure 22, the home experienced the collapse inward of the garage door, collapse of approximately 5-10% of the roof structure, removal of ~15% wood roof decking, and ~45% of the roof cover. Nearly 70% of the brick and vinyl wall cladding was lost. The research team was unable to access the roof structure to determine specifics of the load path, but building permit records can be pursued for further analysis.

Figure 22. Damage to a 2016 home in the Magnolia Hills subdivision in Panama City, FL. The estimated peak gust wind speed here was 57 m/s, with an ASCE 7-10 design wind speed of 59 m/s.

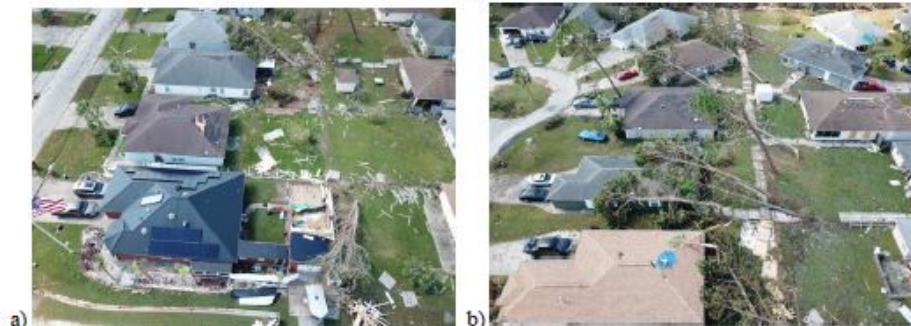
Figure 1: Post Hurricane Michael Damage to Residential Houses in Cedar's Crossing, Panama City, FL
