INDUSTRY UPDATE

Polymeric Cladding and Wind Performance 2020

Data, Observations and
Recommendations Moving Forward

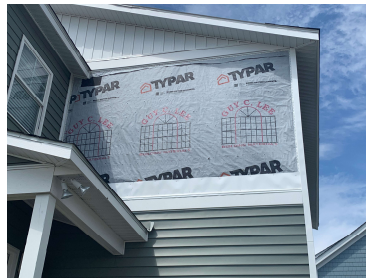
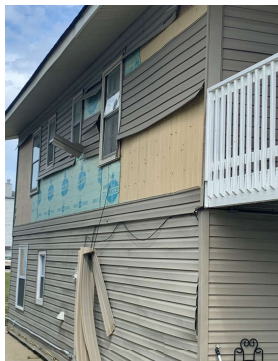
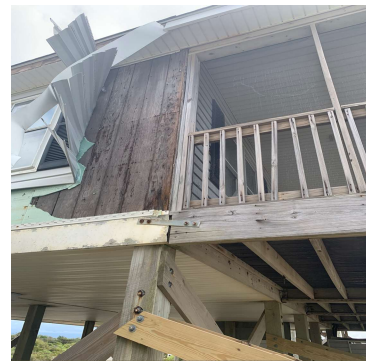
General observation: Properly specified product installed correctly performs in high-wind regions.

Observations when failure occurred:

- Most noted failures were fascia related
- Soffit failures were noted and were more vulnerable when used in large porch ceiling applications and as a ceiling application under homes (homes are built using piles)
- Siding failures occurred more in residing applications than new construction
- Fastener corrosion contributed factor to siding failure in a number of cases
- Gable ends have more noticeable failures
- Instances of using J-channel without utility trim/punch locks or as starter strip were noted
- Still noticeable nonhigh-wind single nail hem products used

- Highlight need for use corrosion resistant fasteners
- Consider broadening soffit instruction to include more specifics on porch ceiling installation and bottom of home ceiling application, new code changes address this issue
- Consider highlighting fasteners that can be used without hitting stud (e.g. ring shank or screws)
- Study and provide stronger direction on fascia installation
- Continue focus on coastal applications and education of installers, builders, code officials

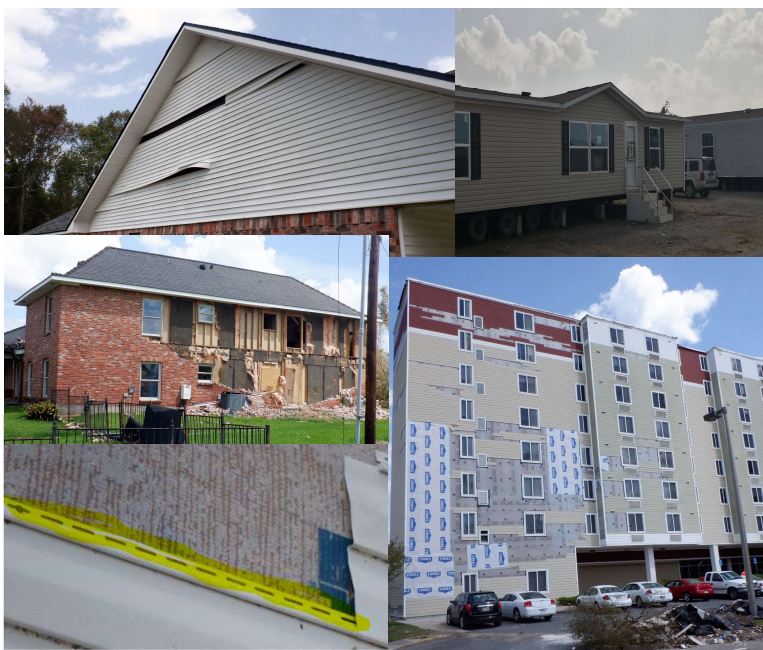
Improper Installation

- Siding failures are the result of improper nailing patterns, often wider than 16-inches on center
- Instances of improper use of J-channel were noted
- Lack of solid sheathing, especially at gable ends and chimneys, may have contributed to siding blow off, as without solid sheathing (and at gable ends, also drywall) the siding becomes subject to more severe wind pressure without equalization
- Soffit failures were noted, most in combination with fascia failure, code changes correct this issue
- Non-high wind related product, improper specification
- All materials impacted in Lake Charles region, note multifamily construction and brick construction with major damage

- Education On Proper Installation / Inspections
 - Installers, Building Officials, Architects, Designers
- Focus on siding installation performance at gable ends, chimneys and other locations without interior drywall
- Highlight fasteners that can be used without hitting stud, for example as allowed ring shank nails
- Study fascia installation
