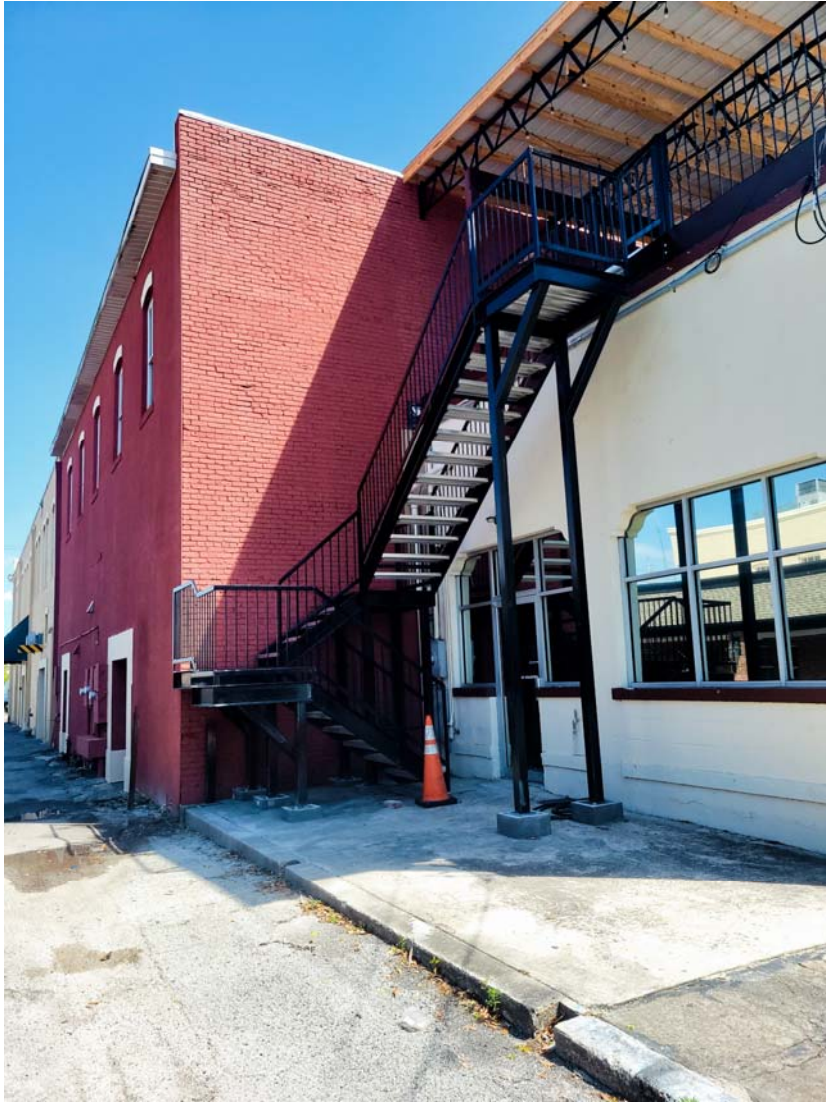
This is the north side of the building where we installed the emergency egress staircase. The front corner is where the electric power lines are attached to the building from the service pole.

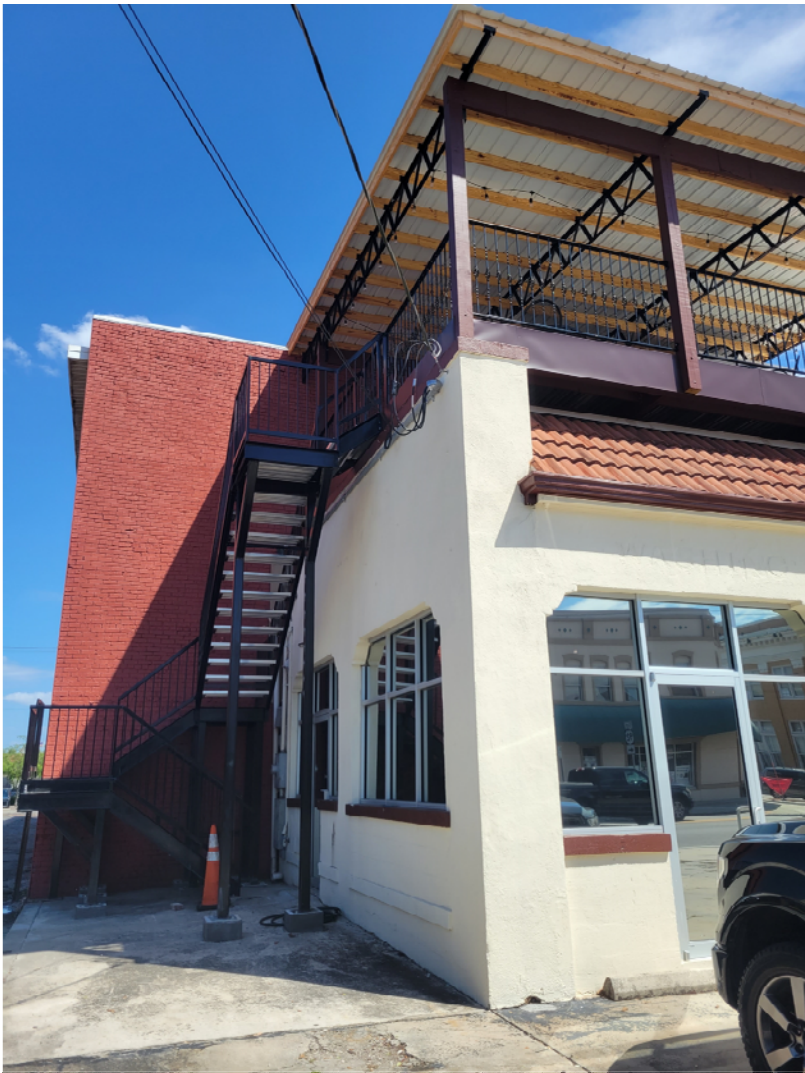
Power line connections to the building in the front corner.

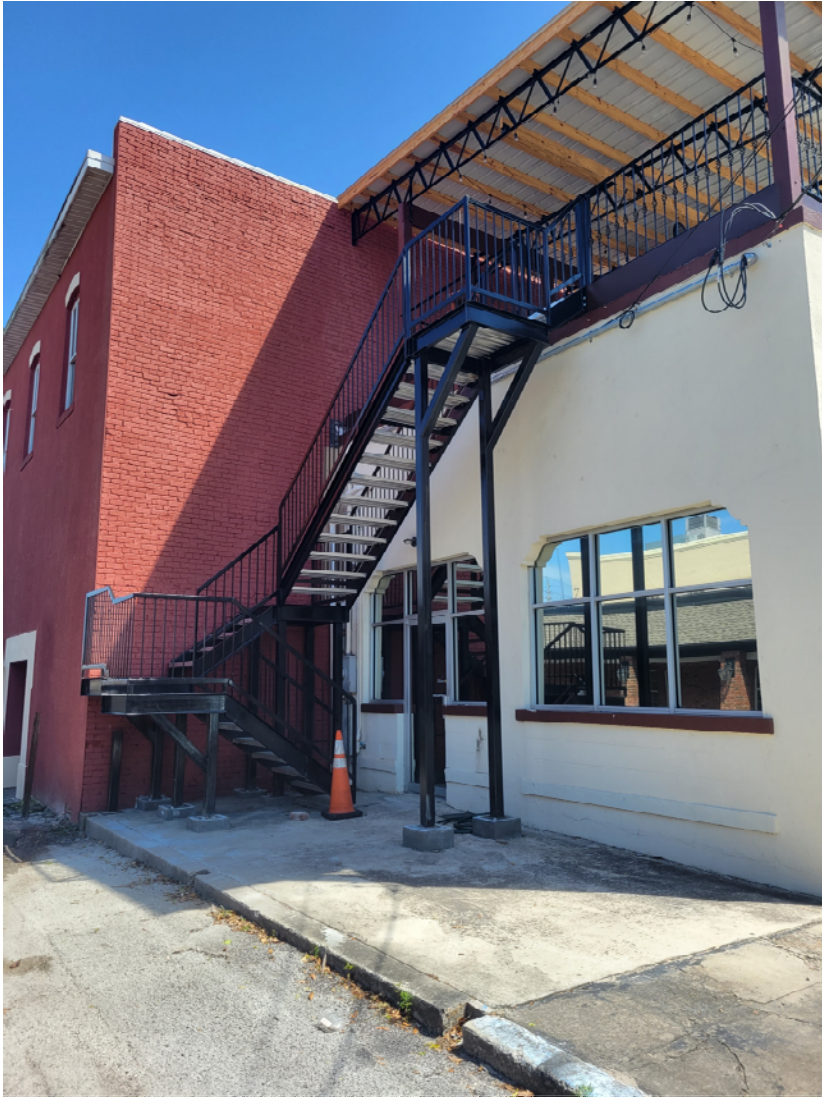
Better view of the power supply lines coming in and attaching to the building

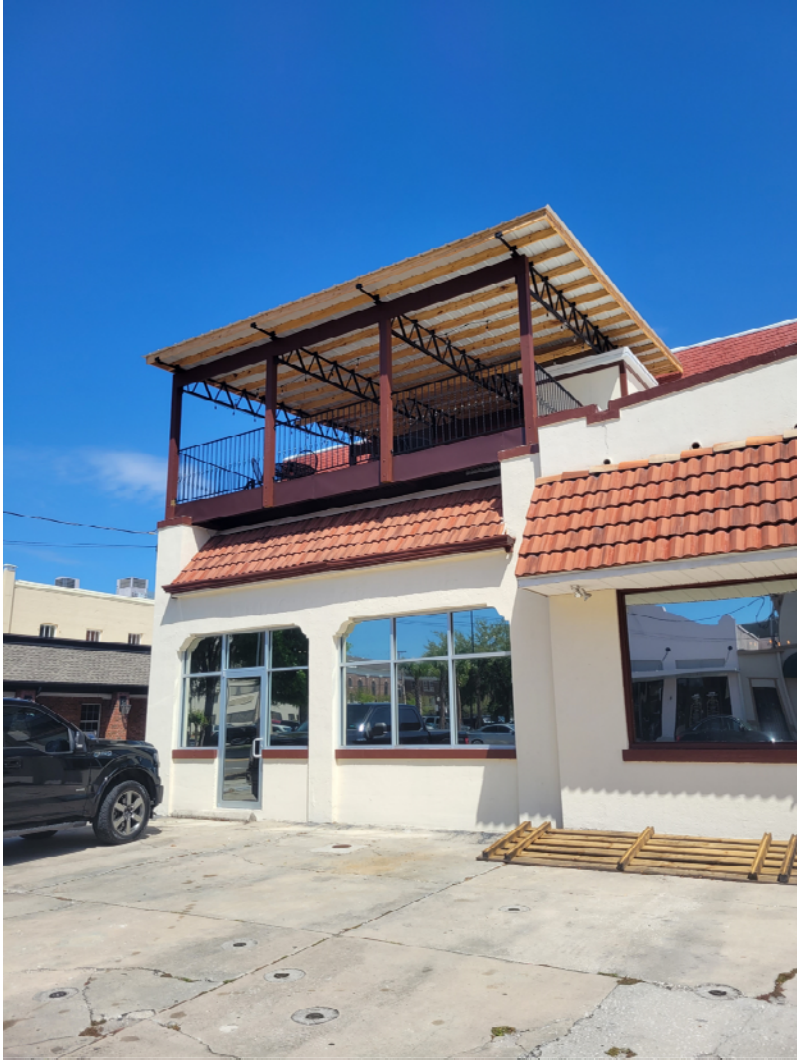
Northeast view of the roof top area and the recessed tile mansard that has been on the building prior to 1952.

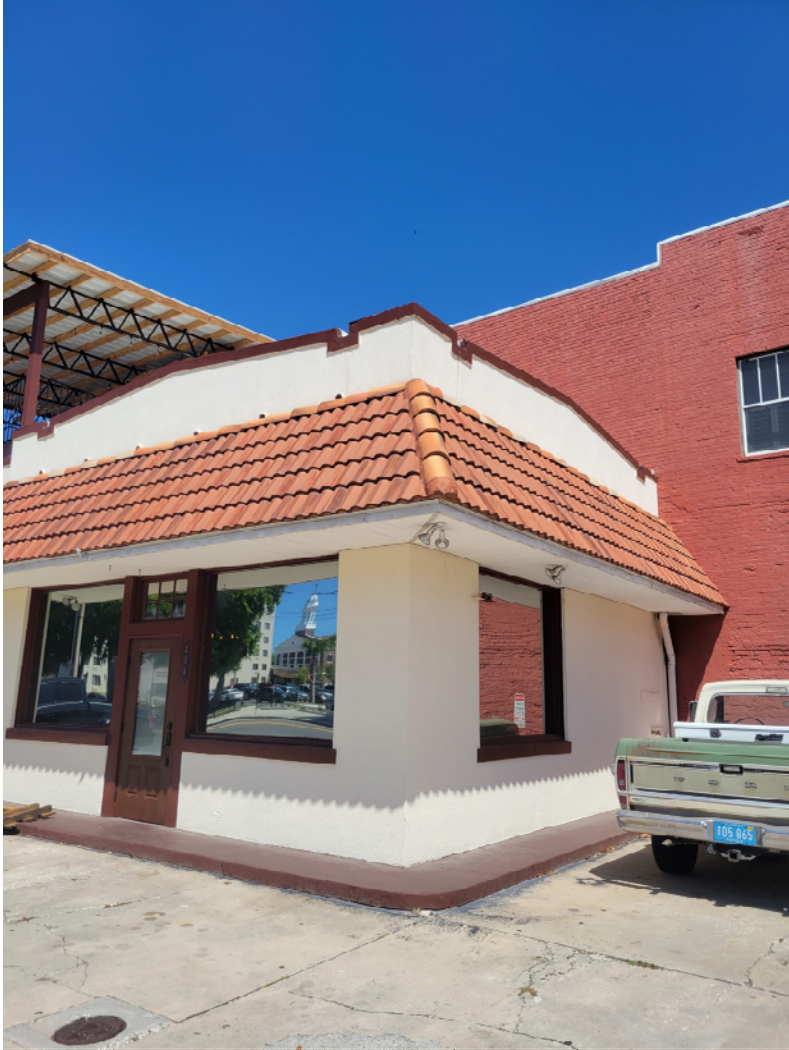
This is the south section of the building where there is a parapet wall on the roof that separates the two areas. So it would not be feasible to try to put the lift on this end as there is no access to that deck area.

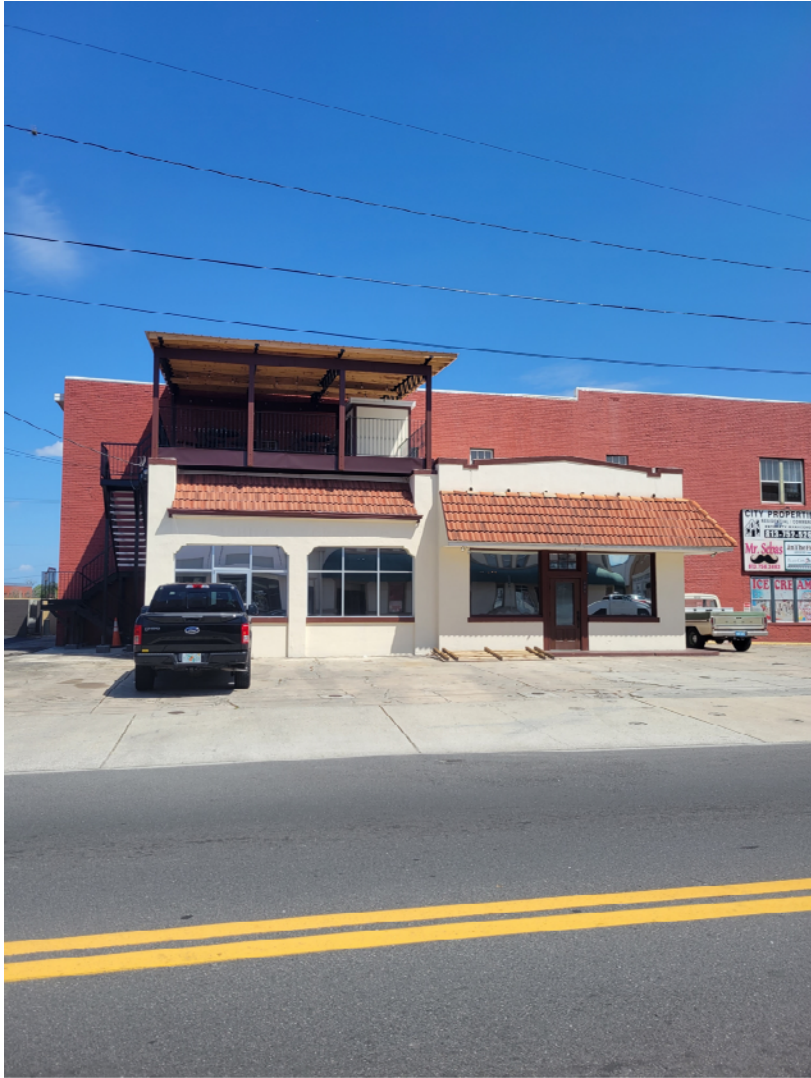
This currently is the front of the building showing the open air roof area. The railing has been added on the deck upstairs. The canvas awnings are under production and not installed yet but they are planned on the front as well.

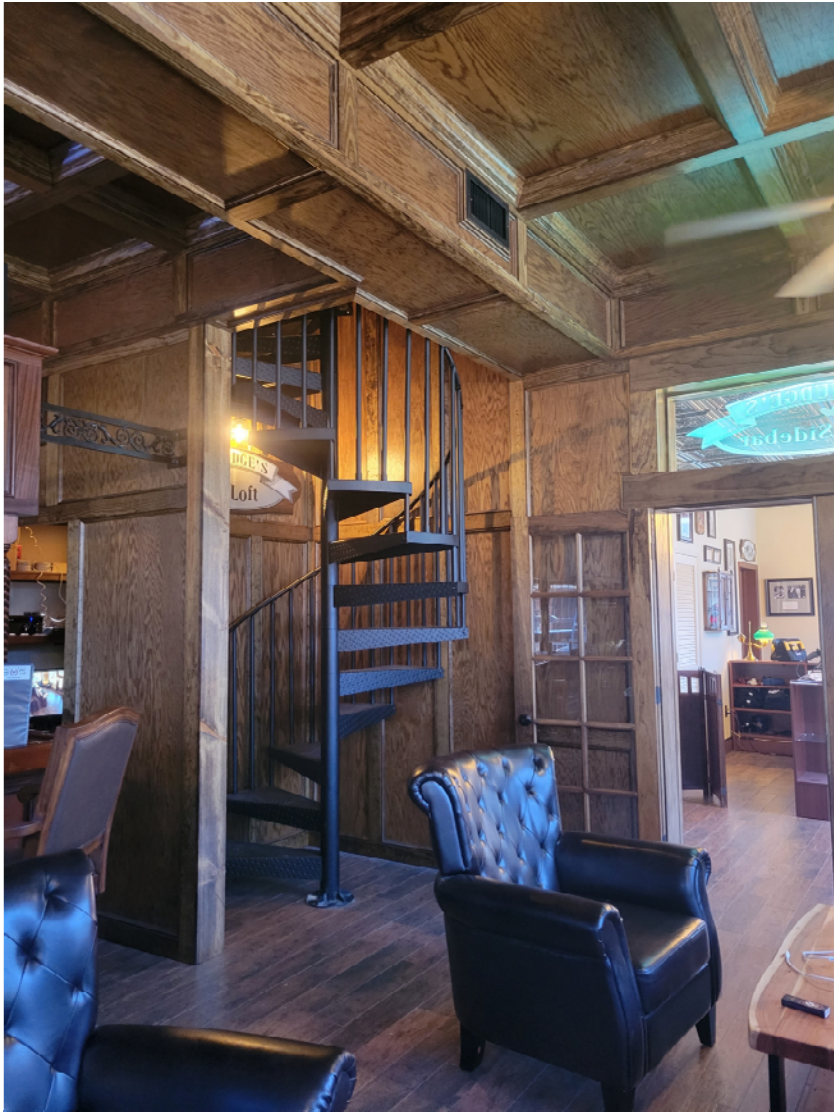
Interior spiral staircase which exits on the deck where there appears to be a small enclosure on the deck area.

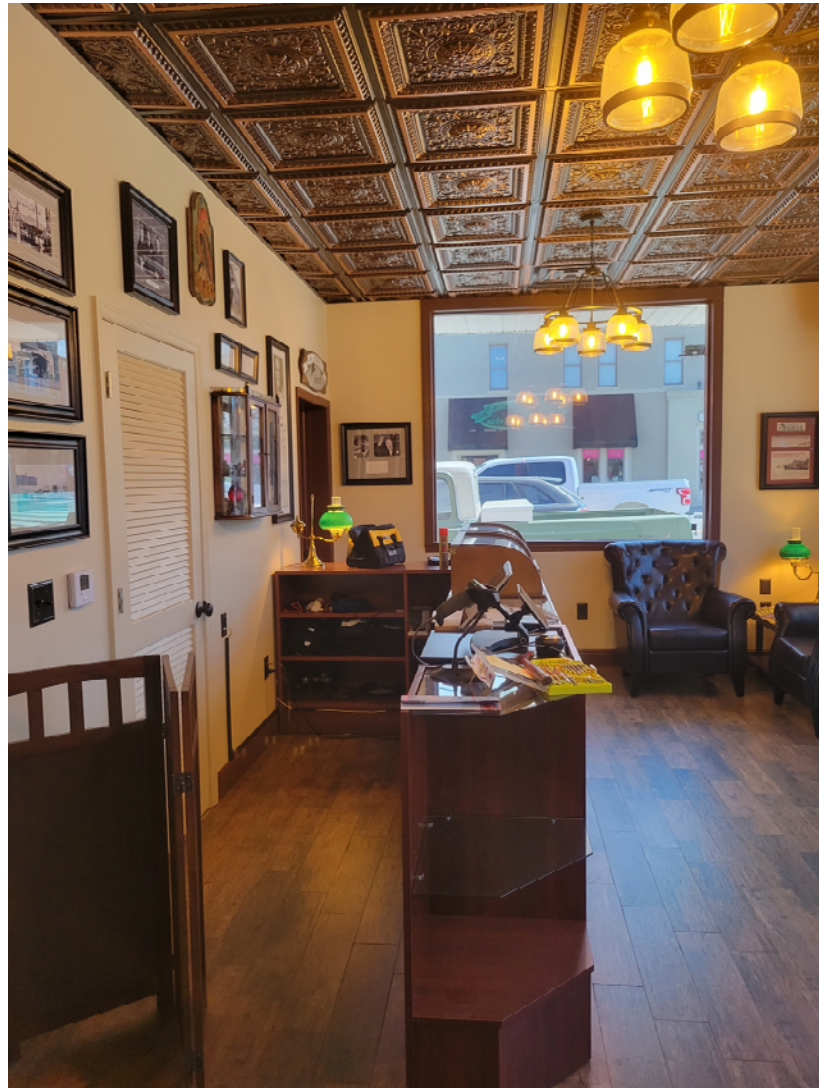
This is the retail section where the unisex restroom which services everywhere.
