# Final Report

## Survey and Investigation of Buildings Damaged by Category III, IV and V Hurricanes in FY 2024-2025 – Hurricanes Helene and Milton

Project #: P0362614

Report No. 02-25  
26 June 2025

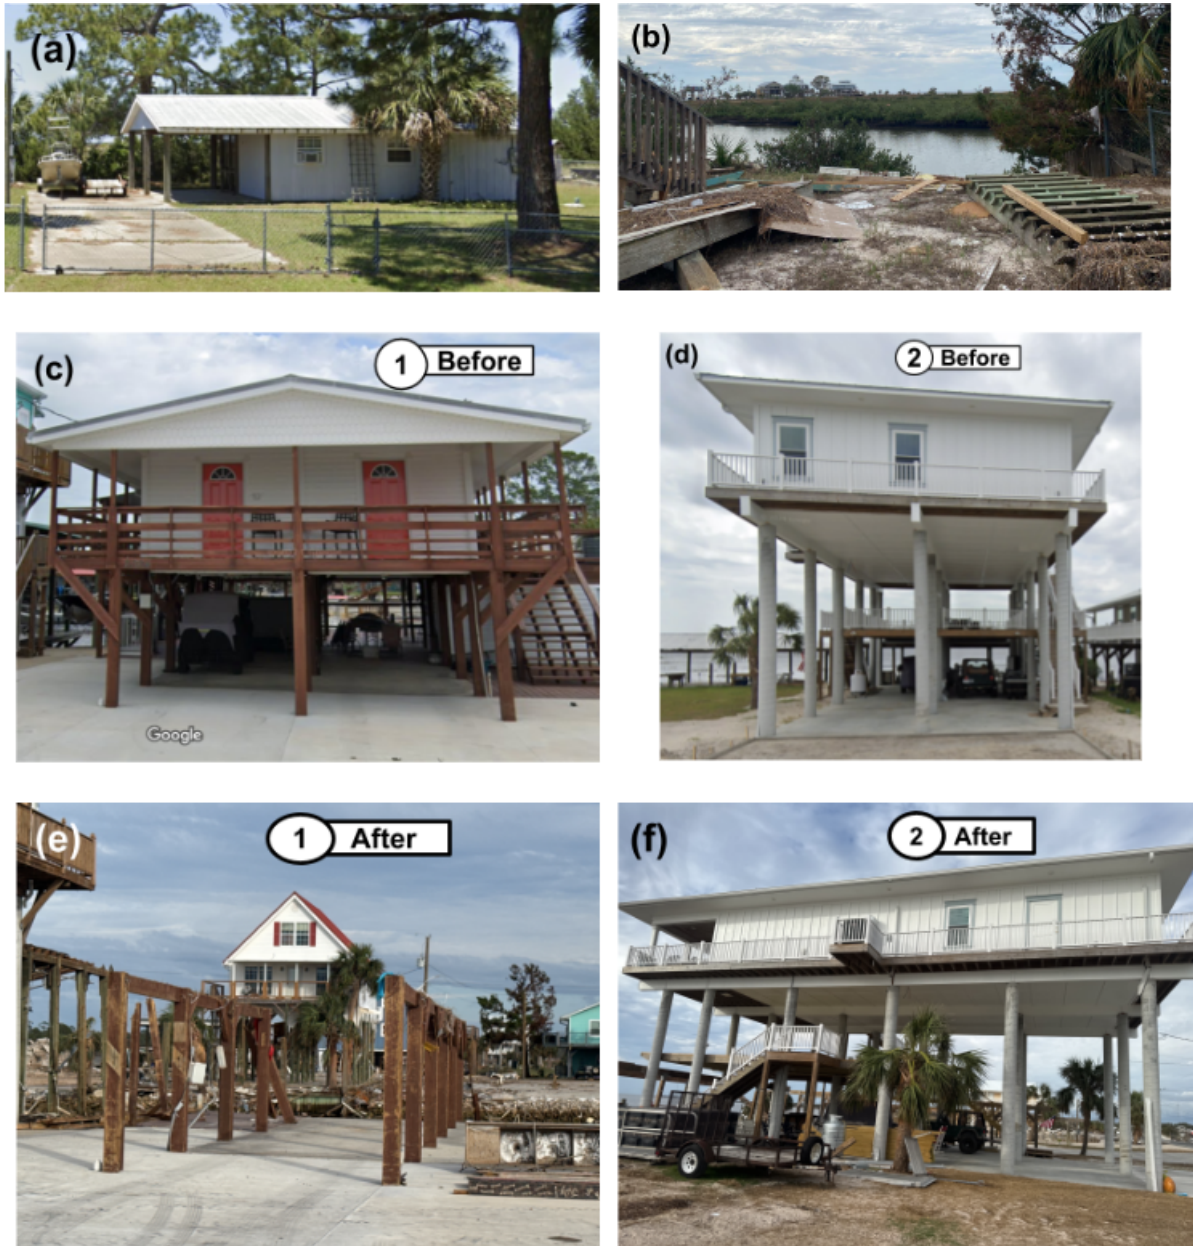
- In the affected communities, **the performance of single-family dwellings appeared to be closely linked to their freeboard elevation**, as shown in Figure 14. Homes built on slab-on-grade foundations or elevated up to 10 feet to the lowest horizontal structural member (LHSM) were either washed away or suffered significant damage. In contrast, many homes elevated to 16–20 feet on concrete piers experienced minimal damage to the livable floor, with impacts primarily limited to stairs and decks built at the 8–10 foot level. Conversations with residents and contractors indicated that many of these homes had their freeboard increased after the 1993 "Storm of the Century," which contributed to their improved performance during this event.

Figure 14. Impact of floor elevation on the survivability of coastal homes: (a) pre-storm and (b) post-storm views of a slab-on-grade single-family home on Dekle Beach Blvd, built in 1996, which was completely washed away during Hurricane Helene; (c, d) pre-storm and (e, f) post-storm views showing the contrasting performance of two elevated homes on Keaton Beach Rd, FL. Home (1), built in 2000, features wooden columns with a **7-foot elevation** to the lowest horizontal structural member (LHSM), whereas home (2), constructed in 1977, is supported by cast-in-place concrete columns with a **20-foot elevation** to the LHSM.

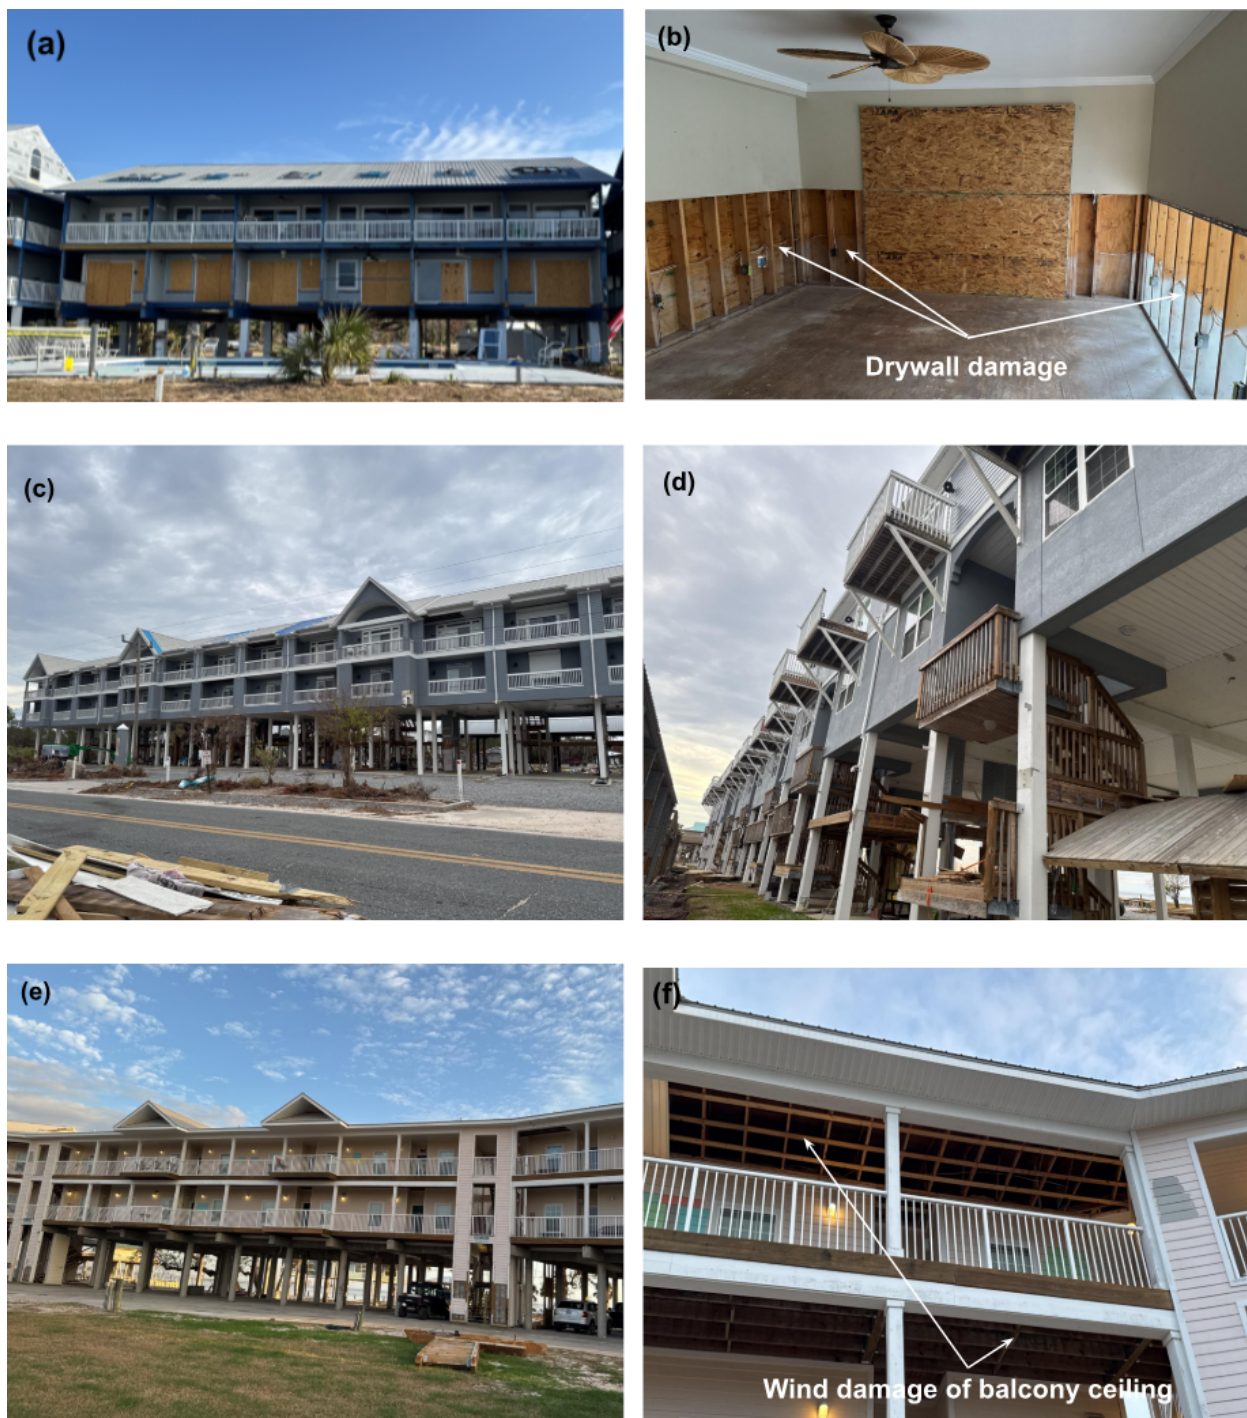
- **The performance of multi-story, multi-family condominiums varied across the surveyed communities.** Figure 15 shows some examples of multi-family building performance. While all structures experienced negligible to slight structural damage, many sustained substantial to heavy non-structural damage, significantly driving losses. Buildings with lower elevations of 8–10 feet to the LHSM were particularly affected, as surge levels exceeded these heights, resulting in the destruction of contents on the first livable floor. Additionally, some condominiums experienced wind damage to siding and balcony ceilings across multiple floors.

Figure 15. Performance of multi-family condos during Hurricane Helene: (a) substantial to heavy damage to a condo built in 2007 near the Steinhatchee Marina, elevated on an **8-foot wooden foundation** and (b) interior view of a second-story room showing water damage to the drywall of that condo; (c) minimal structural damage to a condo on Keaton Beach Rd, built in 2005 on **18-foot concrete columns** to the lowest horizontal structural member (LHSM); however, wave and surge damage primarily affected the (d) ground-floor utility enclosure and stairway decks; (e) a multi-family condo on Main Street in Horseshoe Beach, built in 2005 on **12-foot concrete piers**

along the shoreline, experienced minimal damage, with (f) the most notable impacts being damage to the enclosed breakaway space at the open ground level and the loss of balcony ceilings at multiple floor levels due to wind.

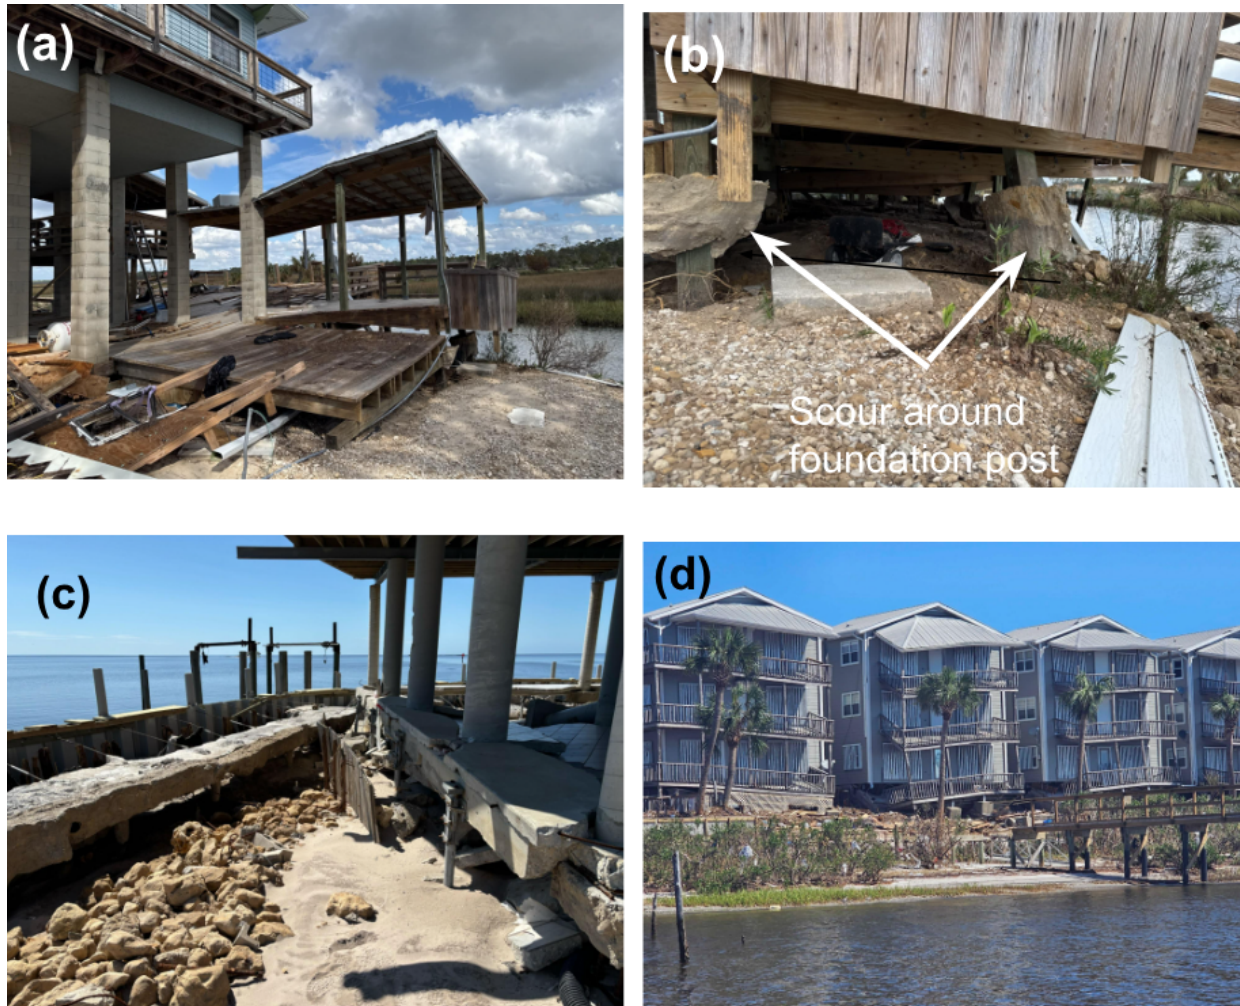
- **In addition to direct lateral hydrodynamic loading on structures, storm surge and waves caused several other impacts**, including the uplift of slabs and floor systems, as well as significant scouring around piles and other structural elements, compromising the stability of both single-family and multi-family homes. Figure 16 illustrates these effects.

Figure 16. Examples of uplift, scour, and erosion effects on coastal buildings during Hurricane Helene: (a) uplift of a slab-on-grade floor deck and (b) scour around the post foundation of a single-family home in Dekle Beach built in 1983; (c) erosion and scour affecting the open ground story floor slab and waterfront of a single-family home built in 1980 in Horseshoe Beach; and (d) scour and erosion around the foundation of multi-story Seashore Landing Condominiums in Cedar Key, constructed in 1995.

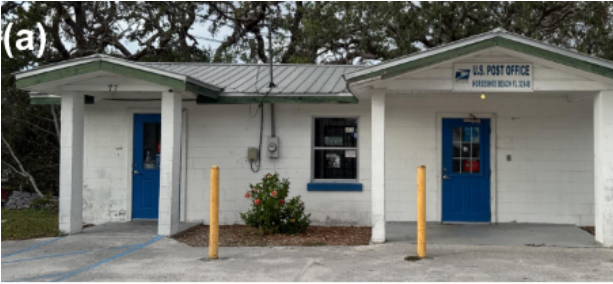
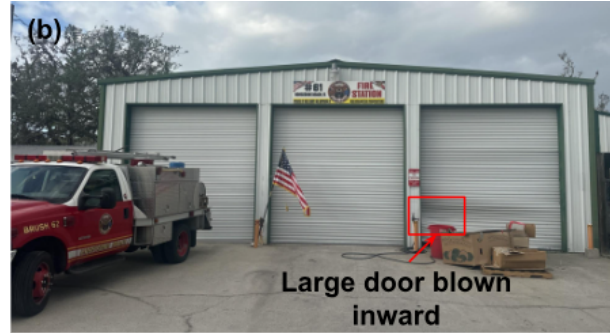
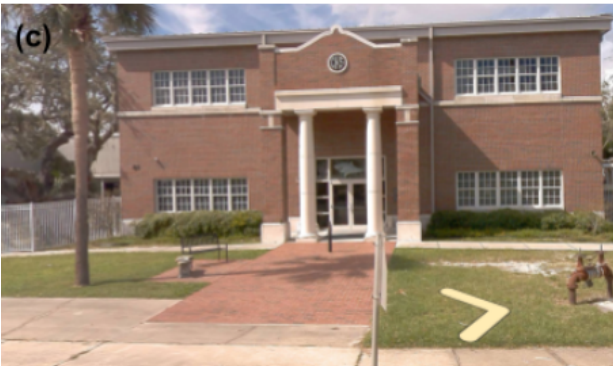
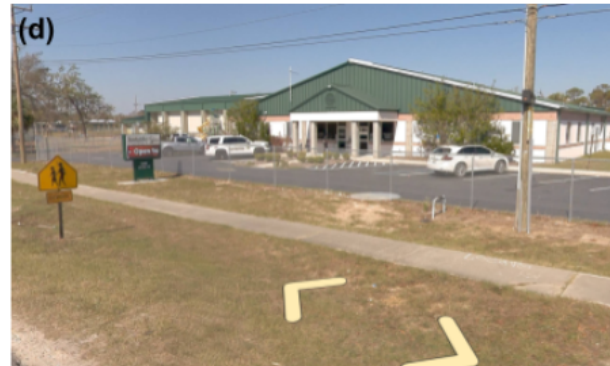
Figure 17. Performance of essential facilities in coastal areas affected by Hurricane Helene: (a) the Horseshoe Beach Post Office, built in 1948, sustained no damage; (b) the Horseshoe Beach Fire Station, constructed in 1935, exhibited visible damage, including a large door blown inward, likely due to debris impact and damming; (c) Cedar Key School, built in 2003, remained undamaged; and (d) the elementary school in Steinhatchee also showed no visible damage. All these facilities are located further inland within their respective communities, reducing their exposure to surge and wave impacts.

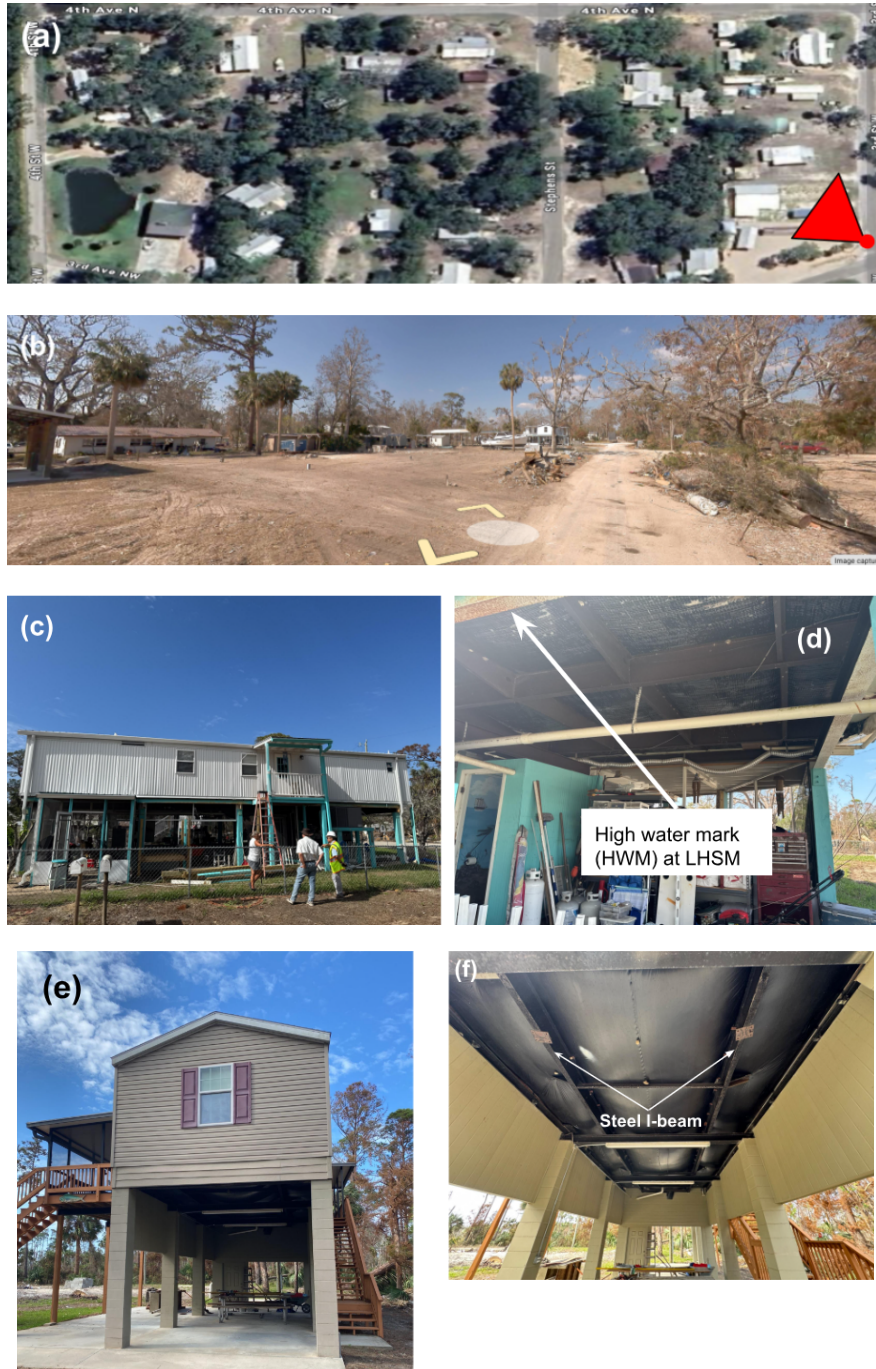
Figure 18. Performance of RVs and manufactured homes during Hurricane Helene in Steinhatchee, FL: (a) pre-storm and (b) post-storm views of a manufactured home park; The red triangle in (a) approximates the location of streetview in (b); (c) an elevated manufactured home built in 2001 with an 8-ft elevation to the LHSM survived, while neighboring slab-on-grade homes were washed away; (d) high water mark (HWM) reaching the LHSM, preserving the contents of the livable floor in the same home; (e) another elevated manufactured home, built in 2004 with an 11-ft elevation to the LHSM; and (f) the higher freeboard in this home prevented surge and wave exposure to the steel I-beam LHSM.

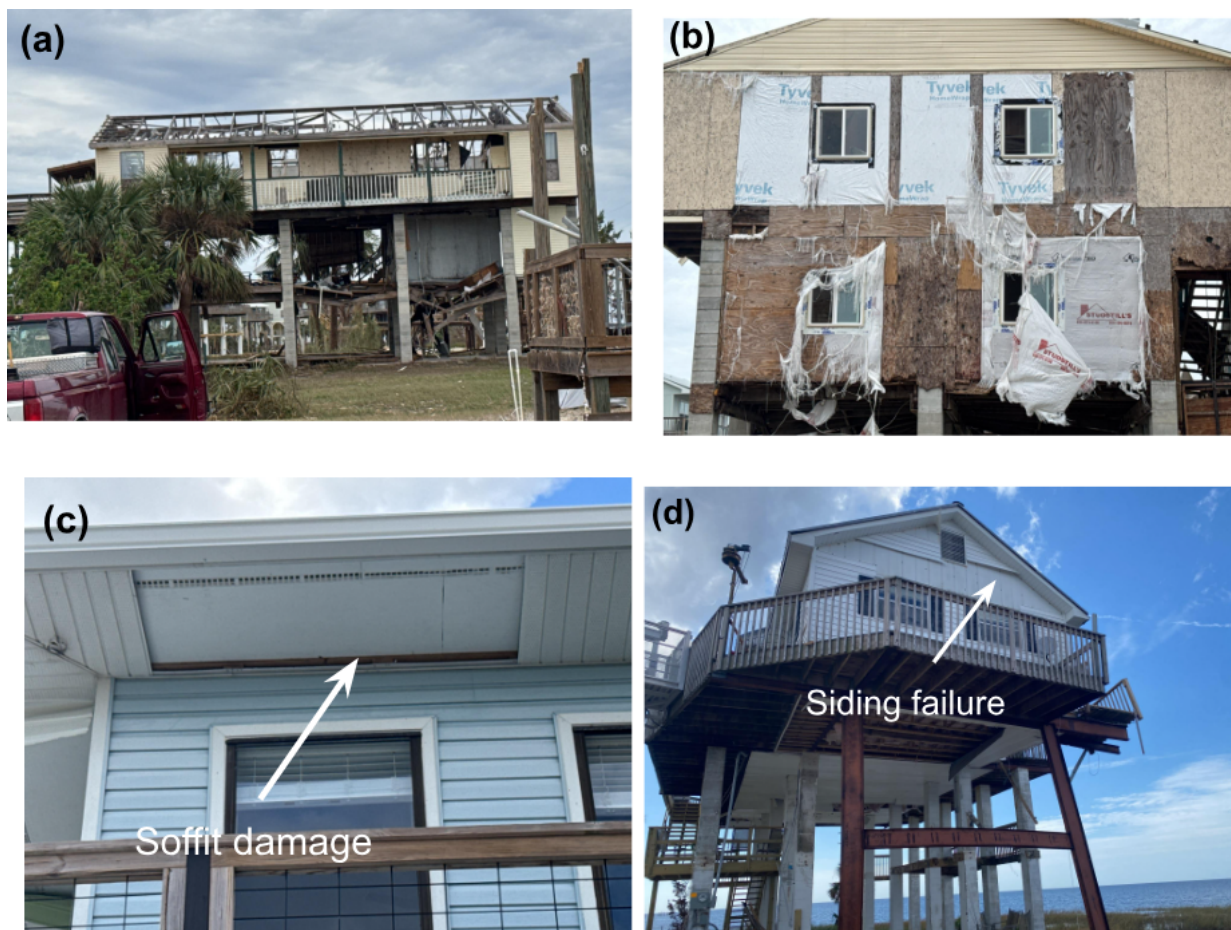
Figure 19. Examples of poor wind performance in buildings within the affected community: (a) a one-story home on Dekle Beach Blvd, built in 1998 on **16-foot elevated reinforced masonry piers**, experienced roof structure and sheathing failure. The home featured an **8-foot elevated deck** extending over the entire floor plan, which, along with part of it enclosed by wood framed walls the living area built on it, likely failed due to surge and wave loading; (b) siding damage observed on the same home; (c) soffit partially removed along the eave of a house constructed in 1983, Dekle Beach and (d) vinyl siding that was installed over existing wood siding system of house (originally constructed in 1945) was partially stripped from the northeast elevation (i.e., gable end) siding damage on elevated buildings located in Dekle Beach, constructed in **1983 and 1945**, respectively.

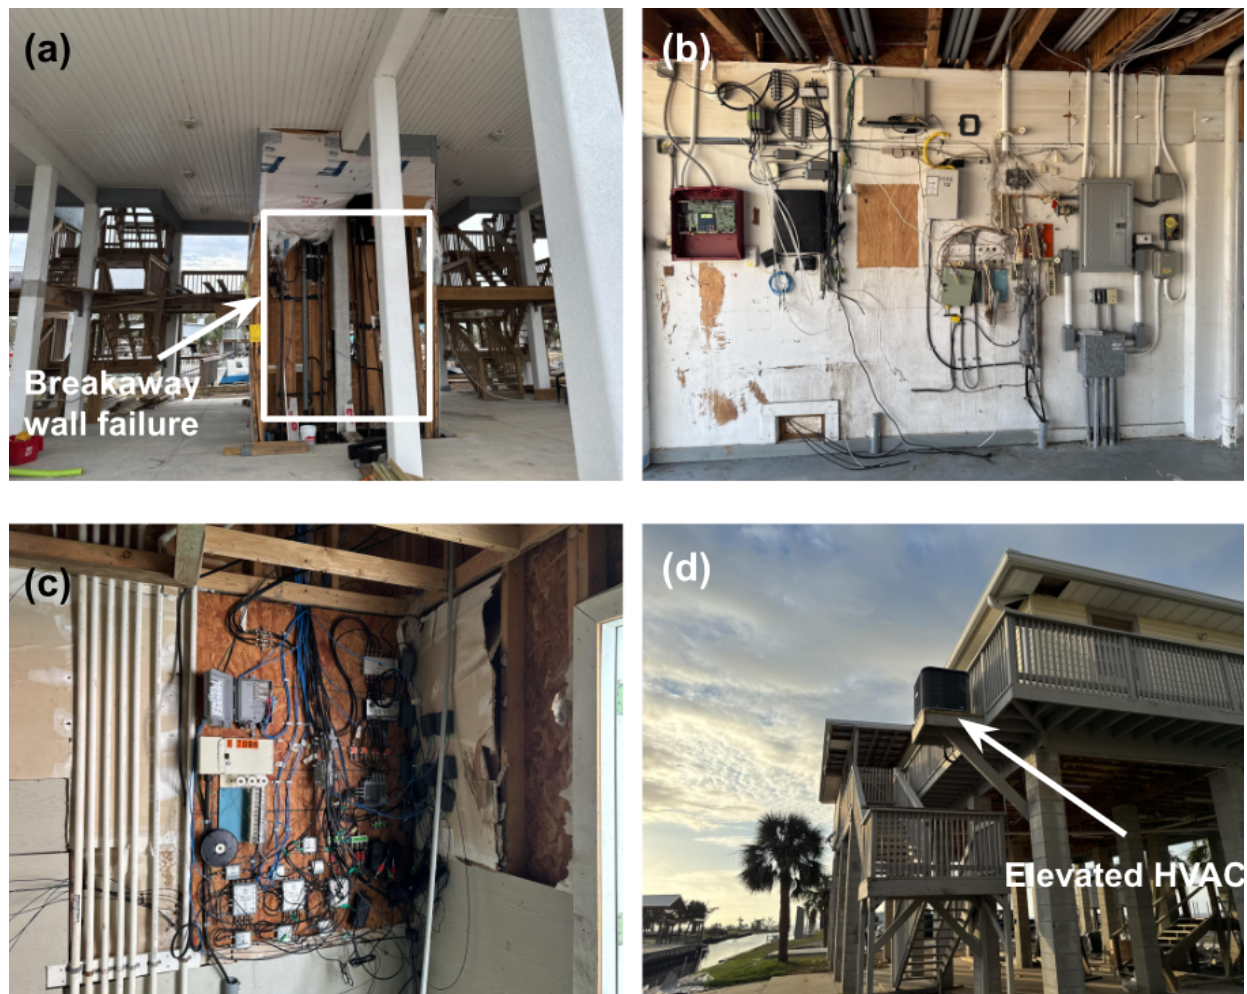
Figure 20. Performance of breakaway walls and utilities during Hurricane Helene: (a) designed failure of breakaway walls exposing the elevator shaft in a multi-story condominium on Keaton Beach Rd, built in 2005; (b) water damage to utilities in the open ground story of a multi-story condominium built in 2007, north of the Steinhatchee Marina; (c) enclosed utilities in the ground story of a multi-story condominium south of the Steinhatchee Marina; and (d) an elevated air-conditioning unit elevated to **13 ft above** ground in Horseshoe Beach home built in 1995 that remained undamaged.

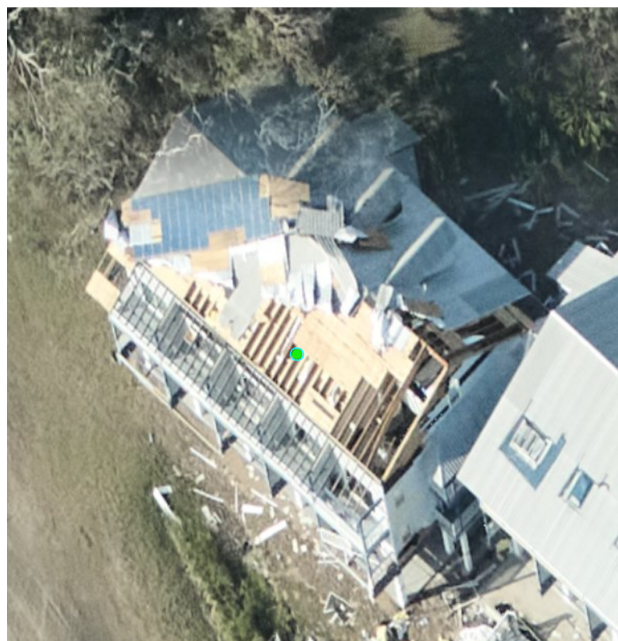
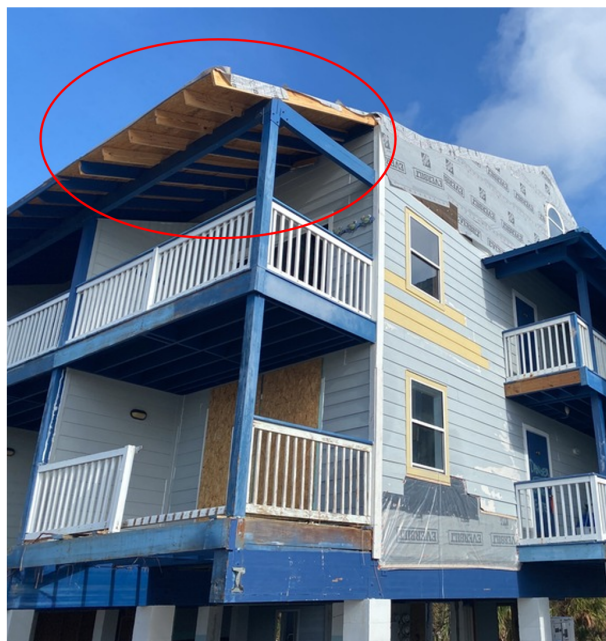
Figure 22. Wind damage to a multi-family residential structure in Steinhatchee, FL constructed in 2007. This was the only post-FBC structure with observed wind-induced structural damage. Left image shows an aerial view of the structure captured prior to repairs. The right image shows the structure with repairs at the time the field team was on site.

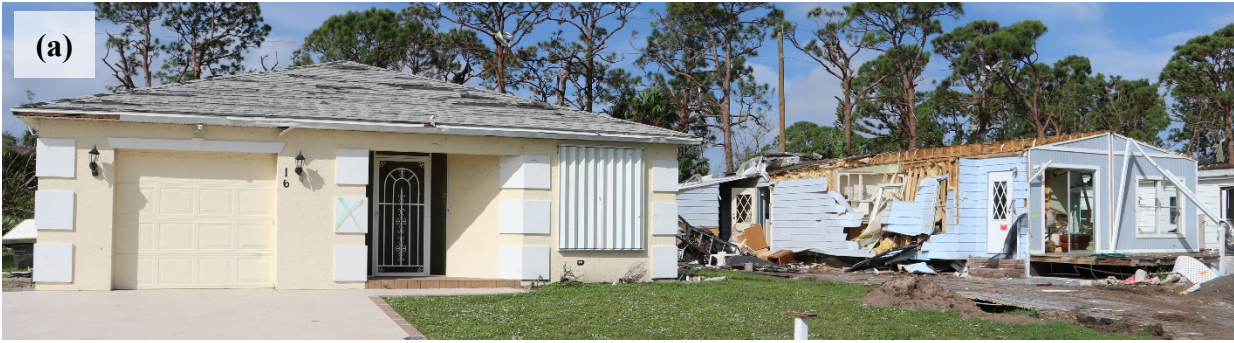
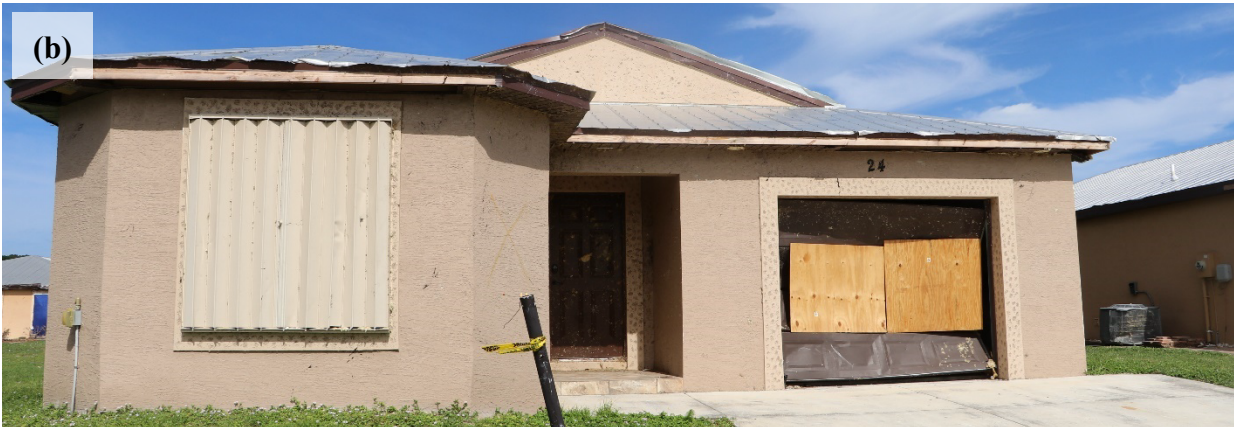
Figure 24. (a) Contrasting damage to site-built and manufactured homes in the Spanish Lakes community struck by an EF3 tornado (max wind speeds estimated at 134 mph by the NWS in this community). The left home is concrete masonry block site built (constructed in 2009) and suffered roof cover loss and minor soffit and flashing damage. The right home is a manufactured home (constructed in 1982) with major structural roof and wall damage. (b) Damage to a single-width garage door and metal roof suffered by a concrete masonry block home (constructed in 2020). The garage door was located on the primary windward wall relative to the tornado path. The damage appeared to be primarily caused by wind-borne debris.

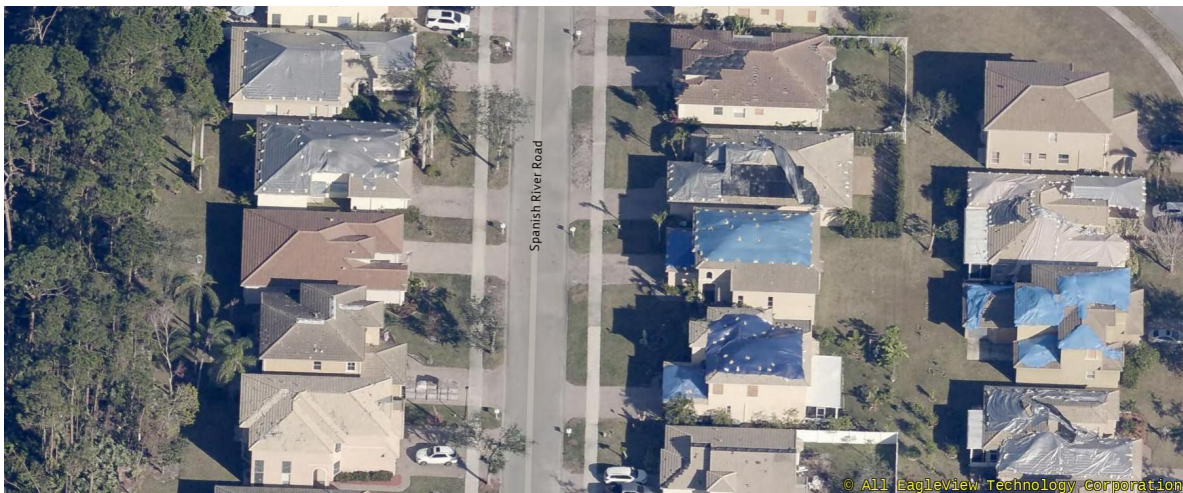
Figure 25. Significant roof cover loss to tile roofs on homes constructed in 2004-2005 in a gated community just south of the Spanish Lakes community. No structural damage was observed based on the available aerial imagery.

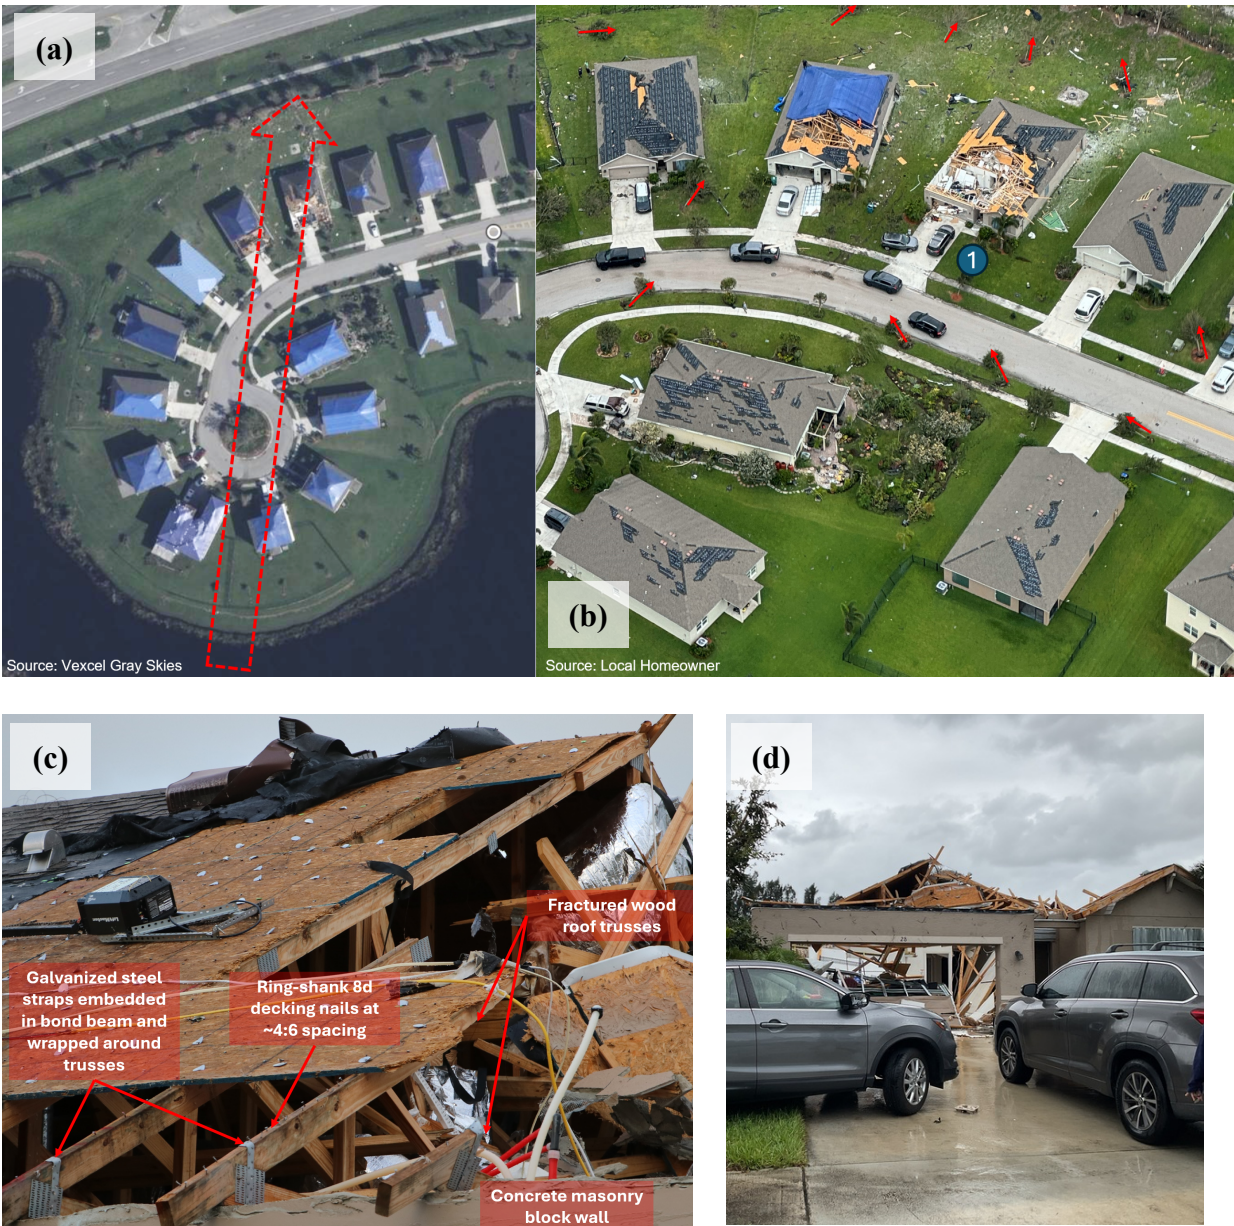
Figure 26. (a) Aerial view of observed damage to a collection of homes constructed in 2019 and later. The red dashed arrow indicates the approximate tornado path. (b) Oblique view of the damage with the red arrows in the right figure indicating approximate wind vectors based on observed tree-fall directions. All homes were constructed of concrete masonry block exterior walls with wood truss roofs and composite asphalt shingles. The two homes with structural roof damage were the only two homes with garage door failures. The garage doors were oriented on the primary windward wall as the tornado translated past. (c) Roof load path and other details for the home indicated by (1) in (a). (d) The garage door blown inward and subsequent roof structure damage (photo shared by the homeowner).

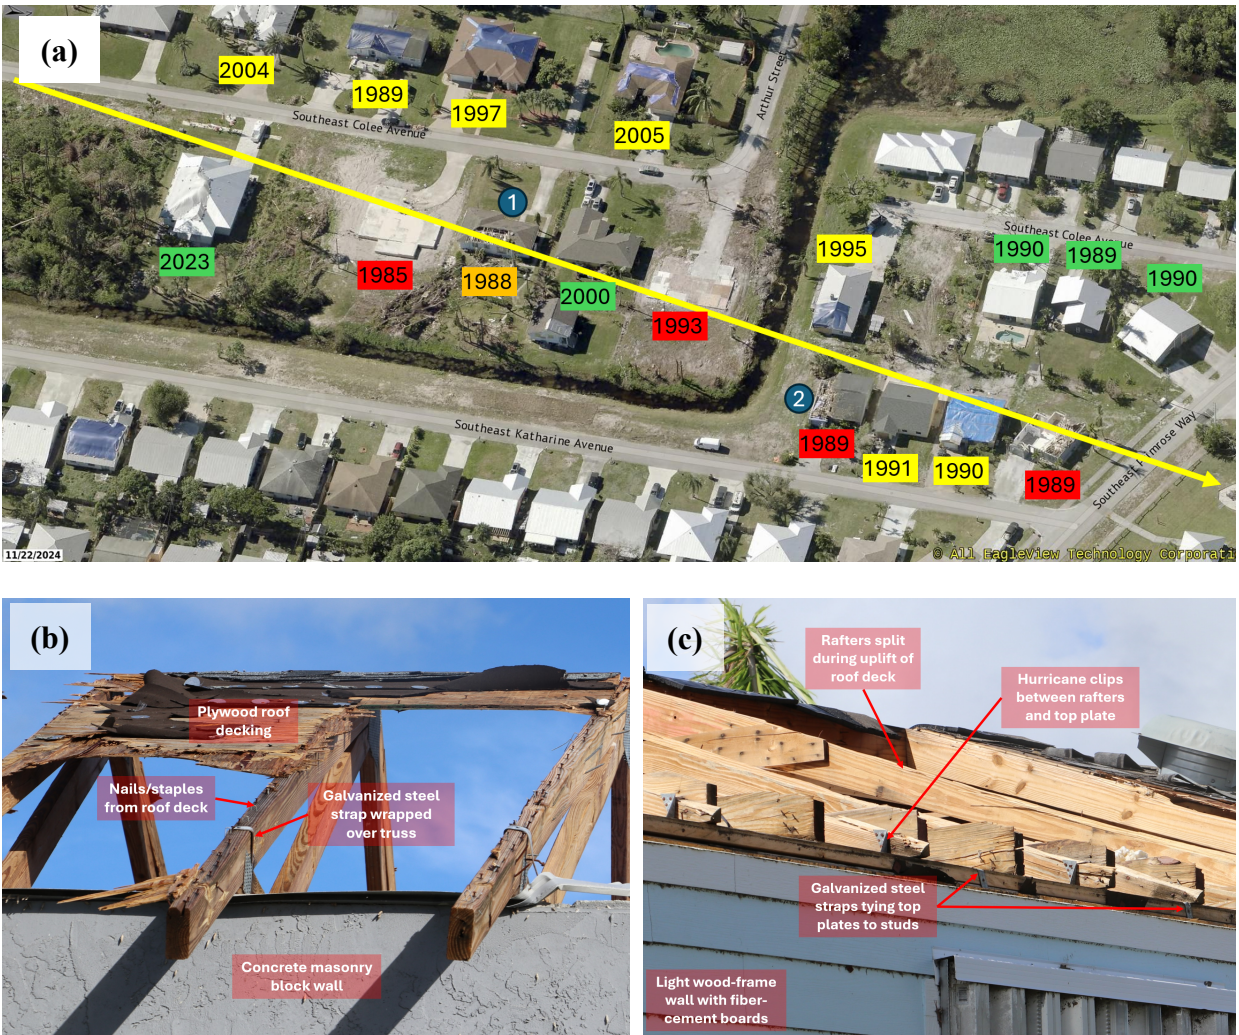
In Stuart, FL, the research team investigated damage caused by an EF2 tornado to both wood-frame and concrete masonry block homes (Figure 27(a)). Most of the homes in the community were pre-FBC, but the load path still included hurricane straps and clips. Plywood roof decking was fastened with nails and/or staples. Damage was somewhat sporadic and could not be clearly linked to any specific construction details. Not all pre-FBC homes in the direct tornado path were destroyed, but those that were destroyed (e.g., complete roof uplift, collapse of walls) were all pre-FBC. The few post-FBC homes in the community, including one home that appears to have been near the center of the tornado path, performed well outside of some minor flashing damage and tree-related damage to a corrugated metal roof. One home was constructed in 1977 but permit records indicate it was retrofitted in 2017 with impact resistant windows and doors, and in 2020 with a metal roof and re-nailing of the roof deck. Despite these retrofits, the roof deck was uplifted off about 40% of the roof, with the failures all appearing to have occurred due to fastener pull-through (Figure 27(b-c)). Fastener pull-through was the dominant failure mechanism for roof deck failures in the other homes inspected in Stuart, FL as well.

Figure 27. (a) EF2 tornado path through a community in Stuart, FL with damage ratings and year of construction overlaid. The two homes with bare slabs were wood-framed homes that lost their roofs and had most walls collapse. Debris had been cleaned up by the time the photograph was taken. Several post-FBC homes suffered roof cover damage that required re-roofing, but no structural damage was observed. (b) Roof load path details for a typical pre-FBC concrete masonry block home (indicated by (2) in (a)). (c) Roof load path details for a pre-FBC light wood-frame home (indicated by (1) in (a)).

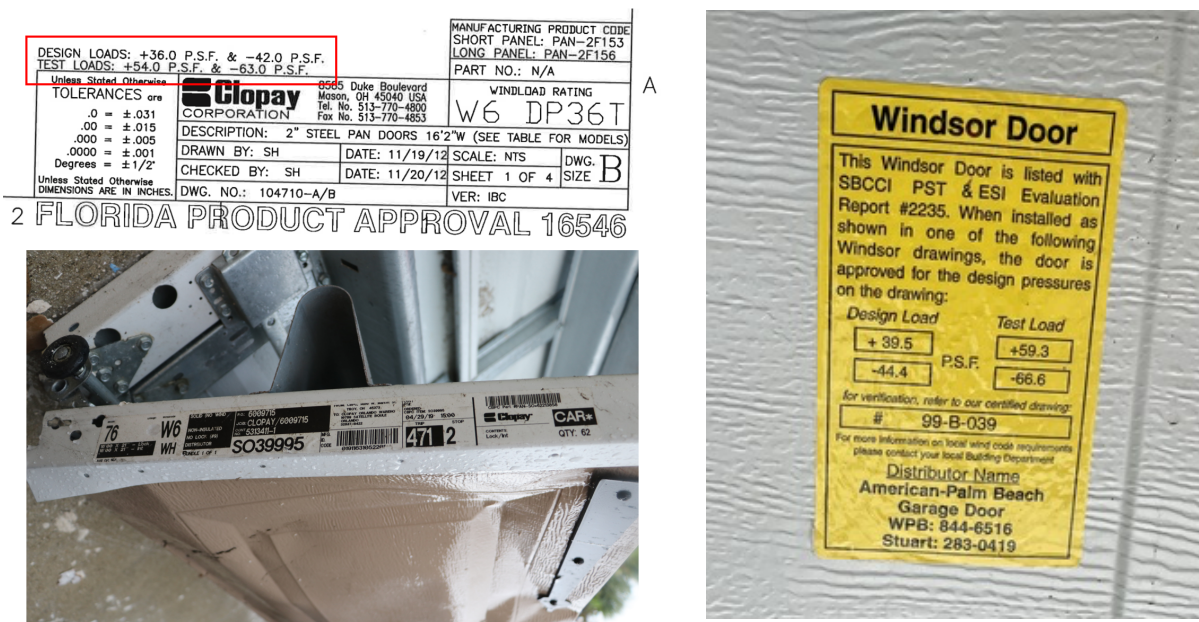
Figure 28. Garage door labels and design pressures observed in the field study. The left figure shows the label and associated Florida Product Approval for a failed garage door in the Cobblestone community. The right figure shows the label for a non-impact rated garage door installed in a 2007 home in the Spanish Lakes community that was not damaged.

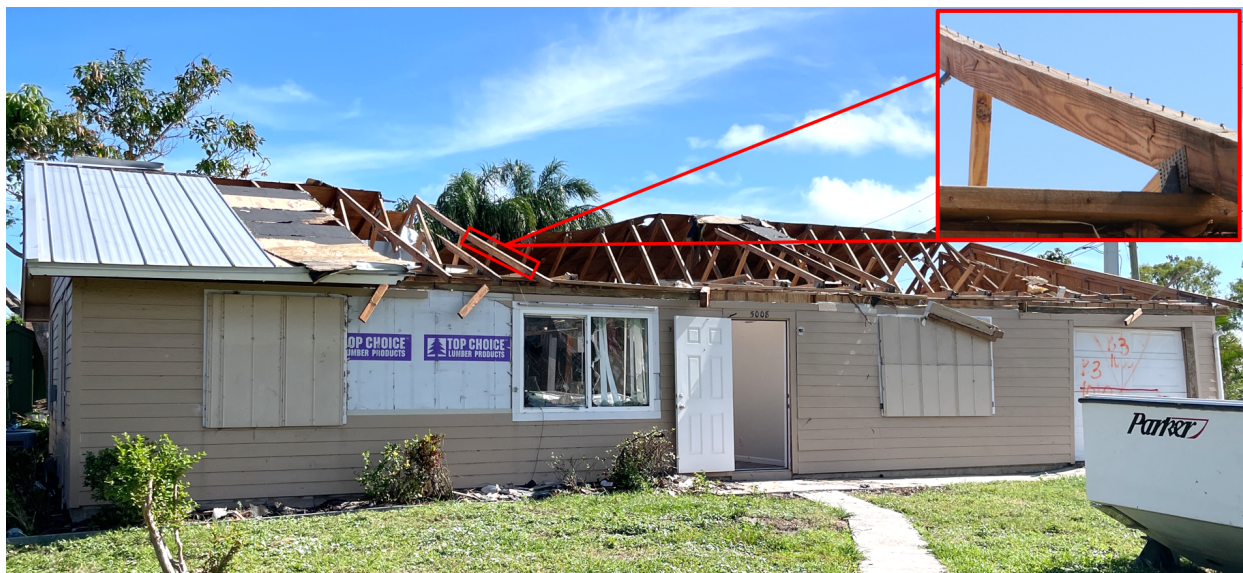
Figure 32. Severe structural roof damage to a wood-frame home constructed in 1977 that was retrofitted in 2017 and 2020 to install impact-rated windows, re-nail plywood roof deck, and install a metal roof. The inset shows a typical roof truss top chord with fasteners all remaining embedded in the truss, with failure of the roof deck due to fastener pull-through.
