# HURRICANE ENGINEERING & TESTING INC.

**Uniform Static Air Pressure Test, Air Infiltration Tests,  
Large Missile Impact & Cyclic Wind Pressure Test**  
(FBC TAS 202 & AAMA/WDMA/CSA 101/I.S.2/A440-22, AAMA 501-24)  
**(Failed to meet water infiltration requirement for both standards listed above)**  
(FBC TAS 201/203 & ASTM E1886-19/E1996-23)

REPORT NUMBER: **HETI-24-8199**  
MANUFACTURER: Handcrafted Iron Doors LLC.  
8260 Consumer Ct, Sarasota, FL 34240.  
TEST LOCATION: Hurricane Engineering & Testing Inc.  
6120 NW 97<sup>th</sup> Avenue, Doral, Florida, 33178  
NOTIFICATION NUMBER: HETI24012 (MIAMI-DADE COUNTY, FLORIDA)  
LAB. CERTIFICATION No.: 21-0413.01 (MIAMI-DADE COUNTY, FLORIDA)  
IAS. CERTIFICATION No.: TL-296 (ISO 17025-17)  
FBC ORGANIZATION No: TST1691  
FBPE Registration #: 6905  
PRODUCT: Outswing Entry door  
MATERIAL: Steel  
PRODUCT SIZE: 72 1/4" wide x 127 high (without Anchor plates)  
MODEL COLOR: CS007  
TEST No. **3**  
DESIGN LOADS (PSF): **+60, -70** (failed to meet water infiltration requirement)

DRAWING NUMBER: Test Door #3 by Handcraft Iron Doors LLC, dated 03/09/2026  
consisting of 6 pages, Revision 0.  
TEST WITNESSED BY: Syed Waqar Ali, Ph.D. (

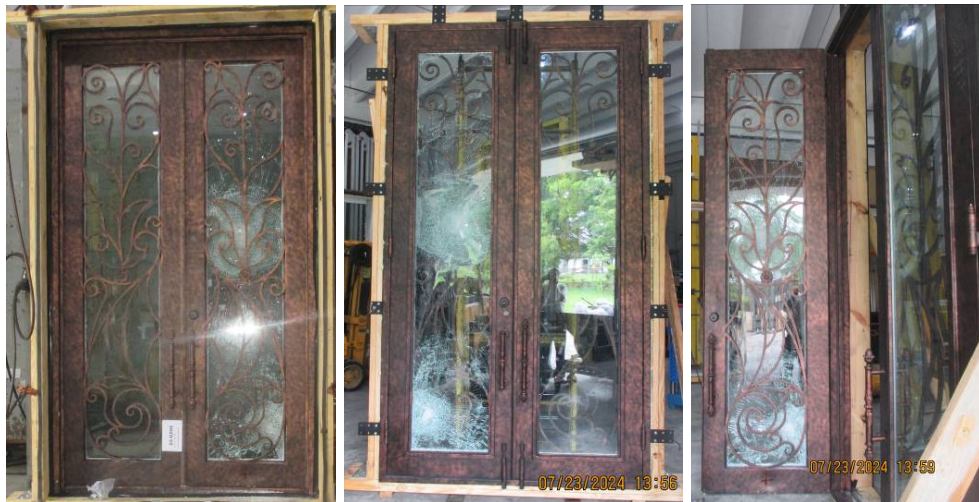
**Exterior & Interior View**

Uniform Load Test was performed with ASTM E330-14(2021) test method. See Figure on page 1 for gage locations.
