# HURRICANE ENGINEERING & TESTING INC.

## Uniform Static Air Pressure, Air and Water Infiltration Test, Large Missile and Cyclic Wind Pressure Test (Reference Standards FBC TAS 202, TAS201/203, ASTM E1886/E1996)

REPORT NUMBER: **HETI-25-8263**

PRODUCT: Outswing Entry Door

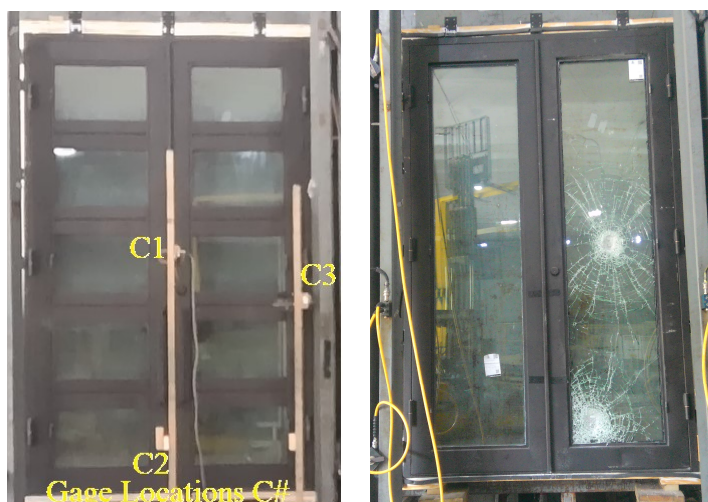
Test Samples

Uniform Load Test was performed with ASTM E330-14(2021) test method. See Figure on page 1 for gage locations.
