**TAS 100 PERFORMANCE TEST REPORT**

**TEMO, INC.**

**PRODUCT TYPE: Sunroom Roof Panel**

**Report No: 64395.01-122-44**  
**Test Completion Date: 05/17/06**  
**Report Date: 06/05/06**  
**Expiration Date: 05/17/10**

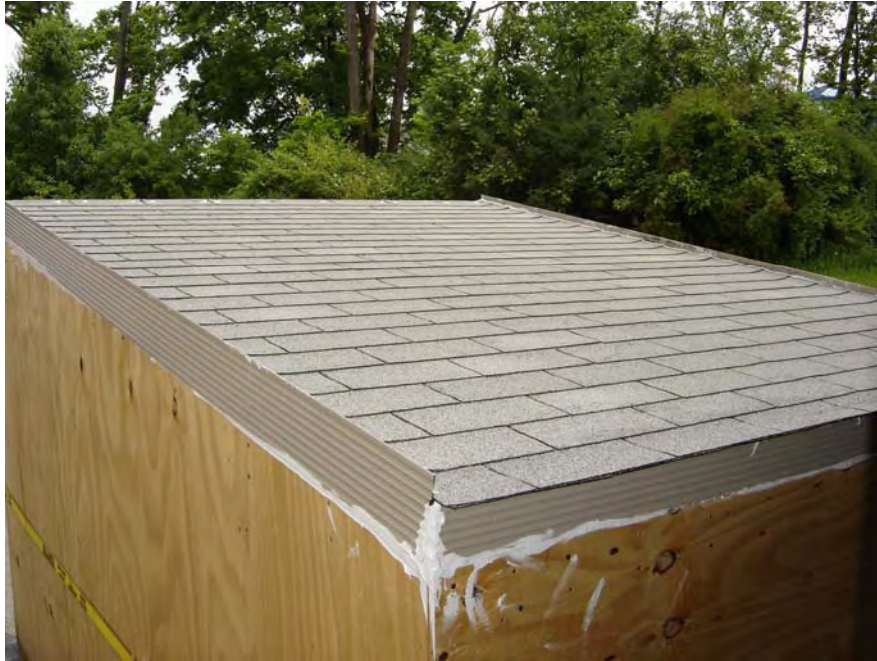
**Photo No. 1**  
**Roof System Prior to Test**

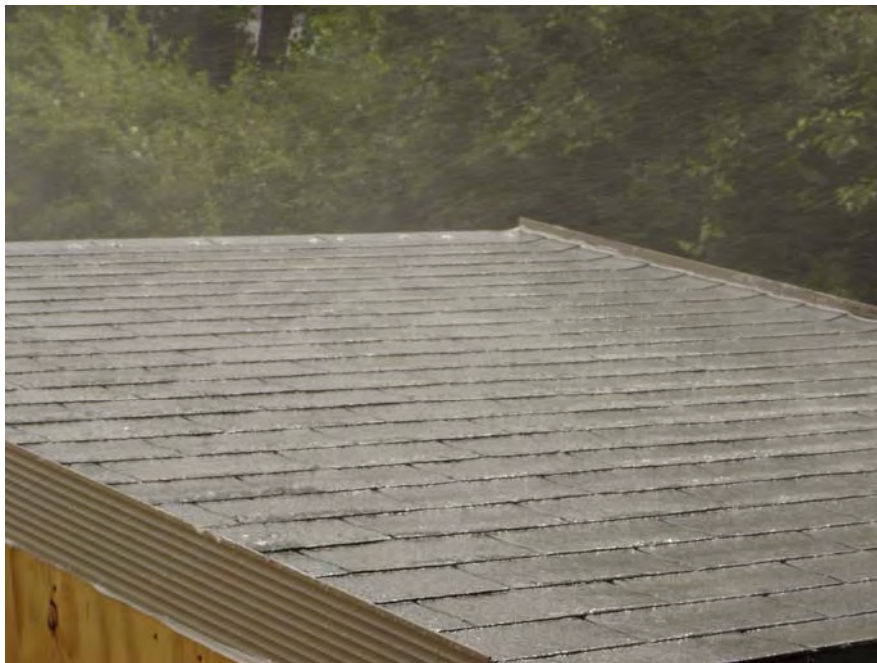
| <u>Wind Speed</u> | <u>Observations</u> |
|---|---|
| 35 mph | No damage |

**Photo No. 2**  
**Roof System During 35 MPH Phase**

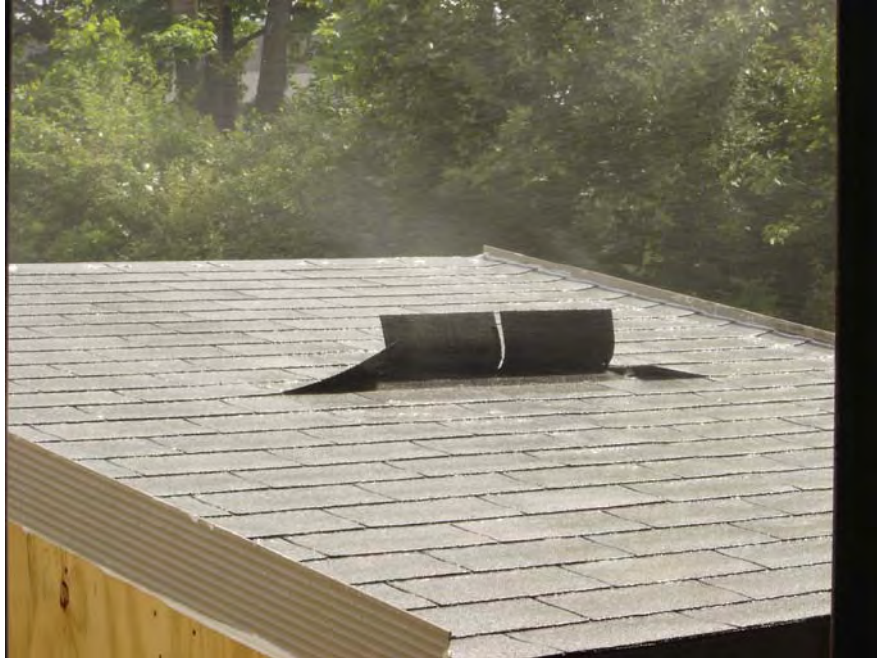
| <u>Wind Speed</u> | <u>Observations</u> |
|---|---|
| 70 mph | Two shingles in the middle of 13th course lifted up off of the roof. The shingles remained attached to the roof and laid flat on the roof after the completion of the test. |

**Photo No. 3**  
**Roof System During 70 MPH Phase**

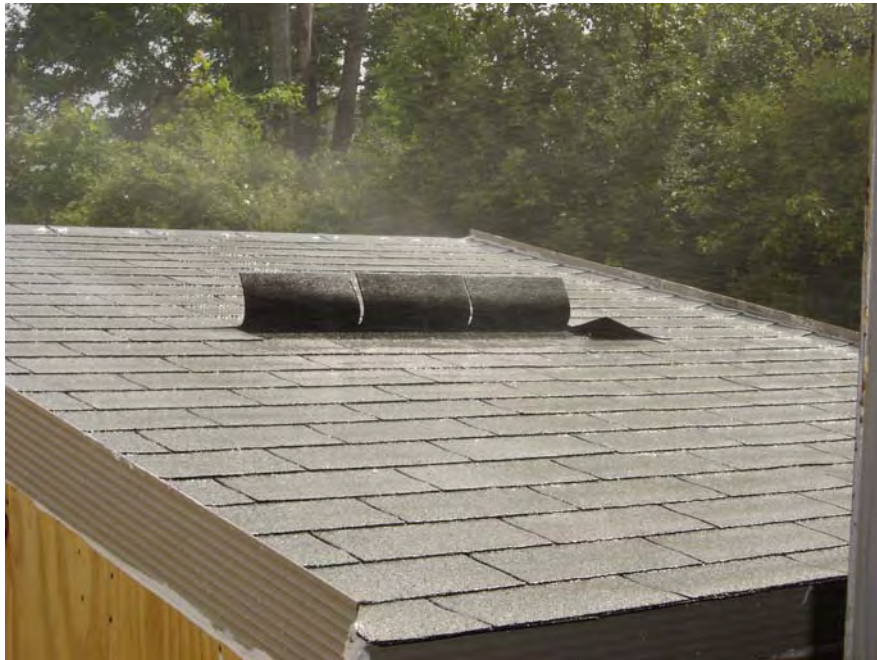
| <u>Wind Speed</u> | <u>Observations</u> |
|---|---|
| 90 mph | Three shingles in the middle of 13th course lifted up off of the roof. The shingles remained attached to the roof and laid flat on the roof after the completion of the test. |

**Photo No. 4**  
**Roof System During 90 MPH Phase**

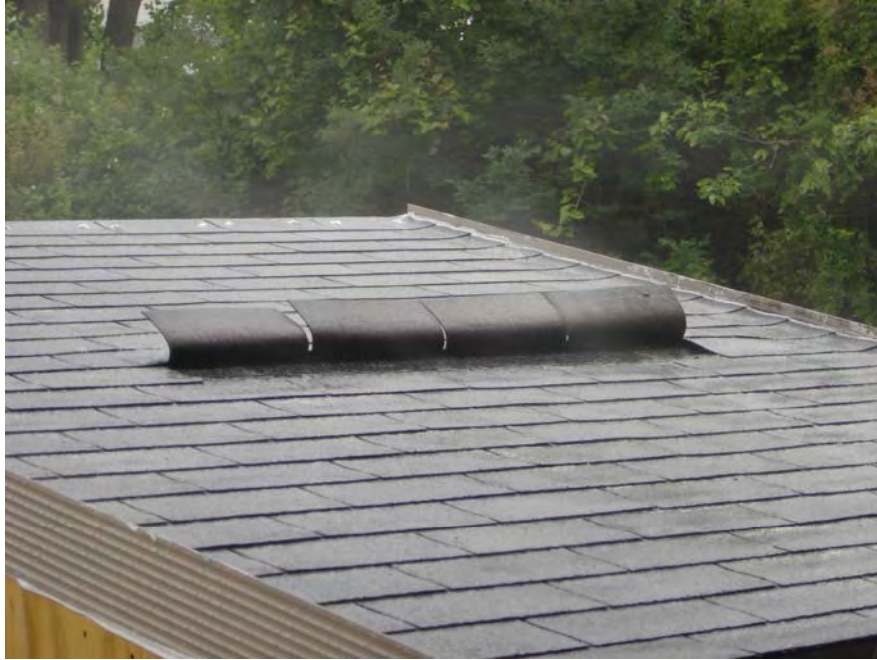
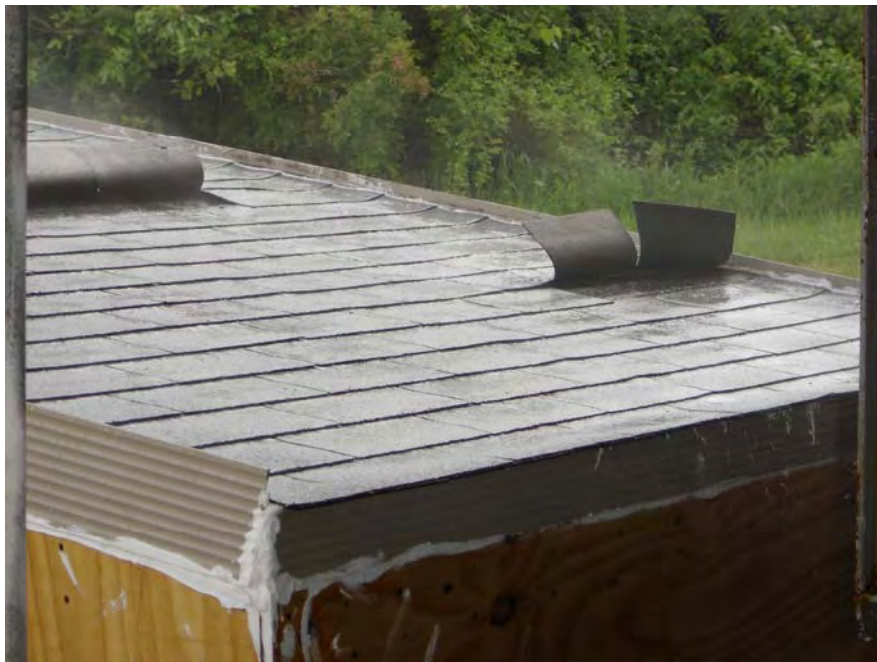
| <u>Wind Speed</u> | <u>Observations</u> |
|---|---|
| 110 mph | Four shingles in the middle of 13th course and two shingles on the right side of the 6th course lifted up off of the roof. The shingles remained attached to the roof and laid flat on the roof after the completion of the test. |

**Photo No. 5**  
**Roof System During 110 MPH Phase**

**Photo No. 6**  
**Roof System During 110 MPH Phase**
