## Repairing Aluminum Wiring

CPSC #516

U S Consumer Product  
Safety Commission  
Washington, D C 20207

## ALUMINUM WIRING

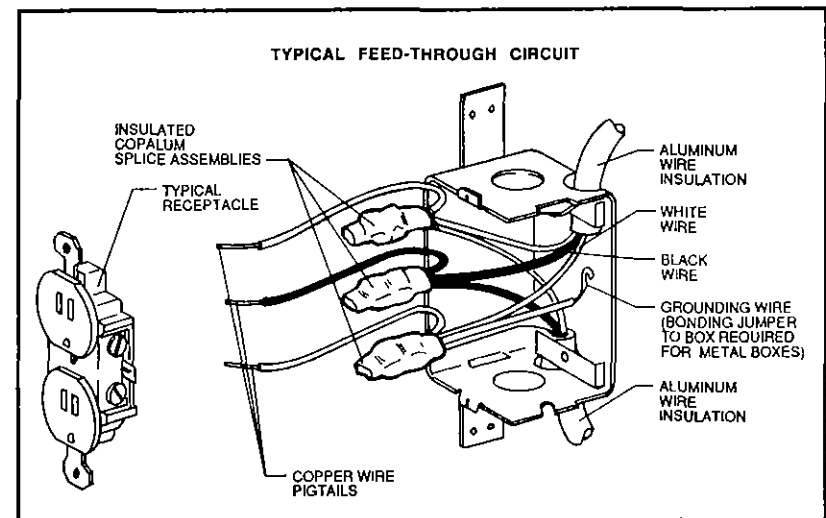
## Recommended COPALUM Crimp Connector Repair

- ◆ The crimp connector repair consists of attaching a piece of copper wire to the existing aluminum wire branch circuit with a specially designed metal sleeve and powered crimping tool. The metal sleeve is called a COPALUM parallel splice connector and is manufactured only by AMP Incorporated. This special connector can be properly installed only with the matching AMP tool. This tool makes a permanent connection that is, in effect, a cold weld. An insulating sleeve is placed around the crimp connector to complete the repair.

- ◆ The CPSC-sponsored research, laboratory tests, and demonstration projects identified only one method of repairing existing aluminum wire circuits which meet these criteria. That repair is known as the crimp connector repair.

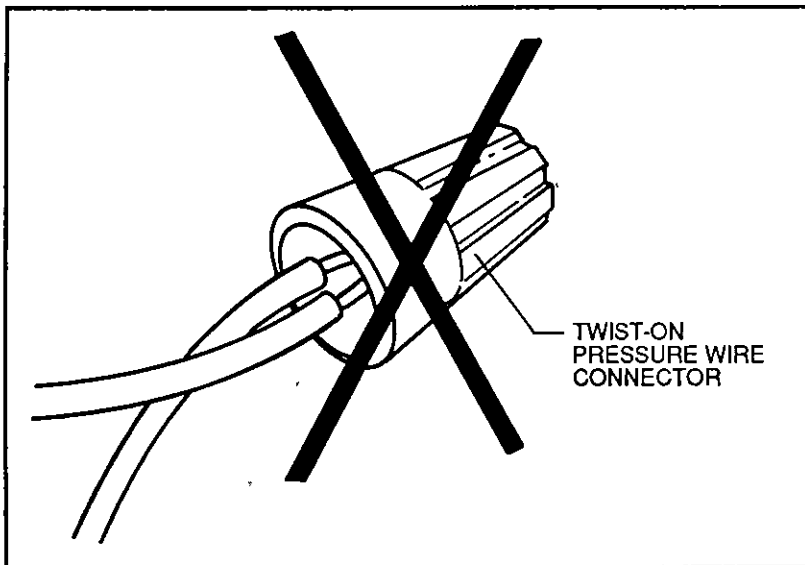
### "Pigtailing" Is Not a Recommended Repair

◆ The first repair ("pigtail") involves attaching a short piece of copper wire to the aluminum wire with a twist-on connector sometimes called a wire nut, the copper wire is connected to the switch, wall outlet or other termination device. The Commission staff has evaluated the effectiveness of "pigtail" as a repair. In CPSC-sponsored laboratory testing some brands of twist-on connectors have performed very poorly. Over time, substantial numbers of these connectors have overheated in laboratory tests. Surveys of and statements made by electricians and electrical inspectors confirm the highly variable and often poor performance of these connectors when used with old technology aluminum wire. It is possible that some pigtail "repairs" made with twist-on connectors may be even more prone to failure than the original aluminum wire connections. Accordingly, the Commission staff believes that this method of repair does not solve the problem of overheating present in aluminum branch circuits.

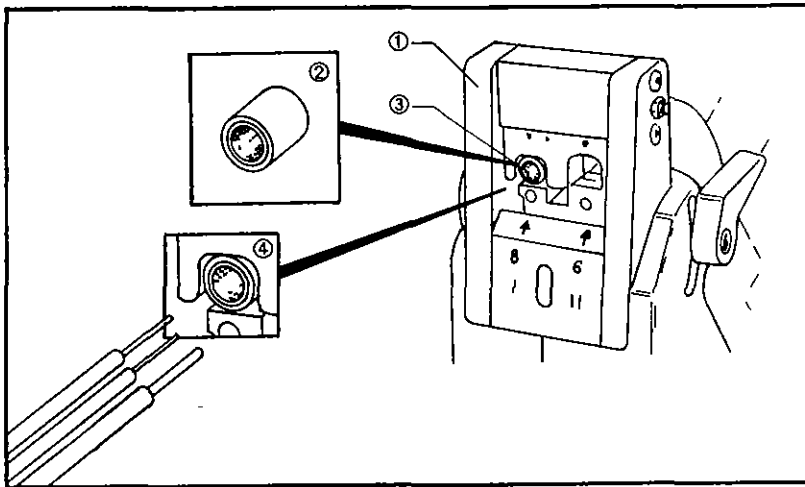
### How the COPALUM Crimp Method Works

◆ The precision dies in the COPALUM tool squeeze the connector and wires into a particular shape which was determined during the design of the COPALUM wire connector. Both the final shape of the connection and the amount that it is squeezed (deformed during crimping) are critical in making a reliable crimp connection. Upwards of 10,000 pounds of force is necessary to obtain the amount of deformation for which the connector is designed.

- (1) Use the correct tool and dies (recommended by the AMP field representative) for the splice being crimped. Ensure that the color coding and marking designation on the splice correspond to the color coding and marking designation on the tool.
- (2) Be sure the perforated liner is inside the splice. The ends of the liner are flared to prevent removal.
- (3) Load the splice into the dies of the tool.
- (4) Insert stripped wires into the splice until the ends of wires extend beyond end of the splice. Wires should be parallel in the splice. Insulation of the wire **MUST NOT ENTER** the splice.
