Final Report:

Evaluation of Wind Resistance of Vinyl Siding and Soffit Systems, and Performance during the 2017 Hurricane Irma

Project #: P0103255

Report No. 01-19 6 June 2019

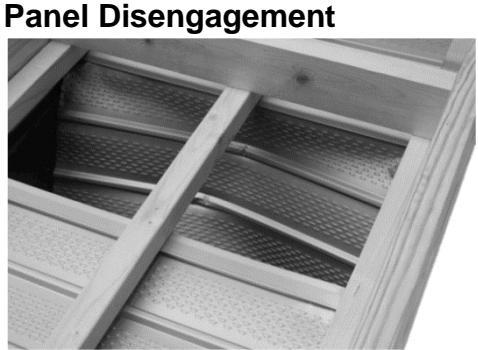
Observed Failure Modes Vinyl and Aluminum Soffits

- Dominant failure mode
- The aluminum sections failed in the middle from panel disengagement.
- The vinyl sections failed in the end from panel disengagement.

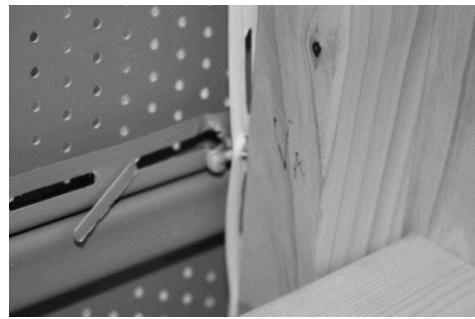
Nail Pullover

- Dominant failure mode
- Nail pullover of the J-channel can cause the panels to disengage
- The sequence of nail pullover and panel unlocking could not easily be distinguished visually

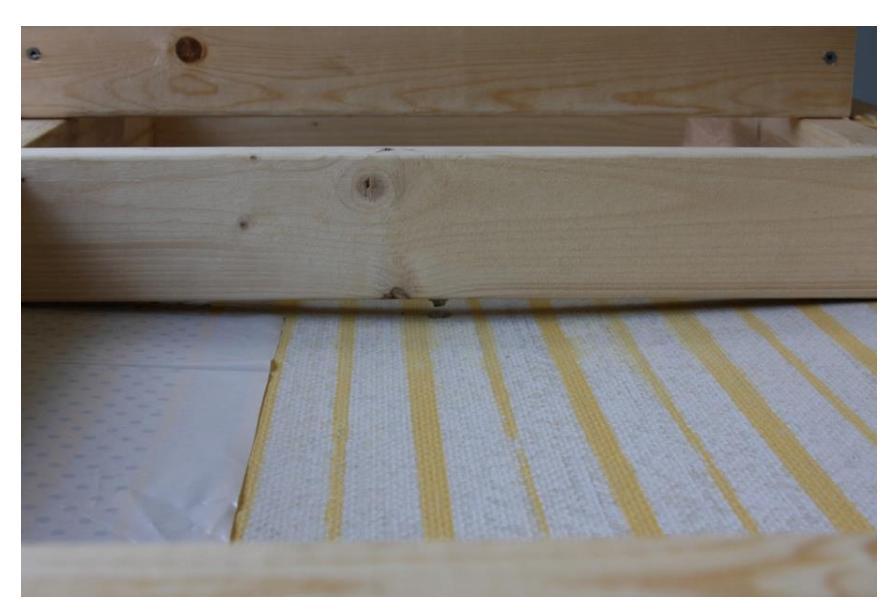
Figure 4. Predominant Failure Mode (Masters and Kiesling 2011)

Observed Failure Modes Stucco, Fiber Cement Board and OSB Soffits

- The most common mode of failure was pullout of the soffit around the fasteners in the intermediate nailing member (as the picture show)
- This failure was seen in each of the 610 mm (2 ft) fiber cement board soffit during both loading.
- The middle fastener should receive nominally twice the load the edge fasteners receive due to the difference in tributary area.

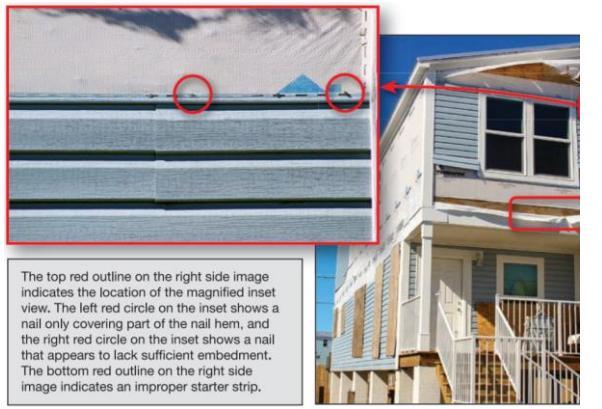
Failure of vinyl siding failure due to nail covering only part of the nail hem, and lack of nail embedment (Fema 2018)

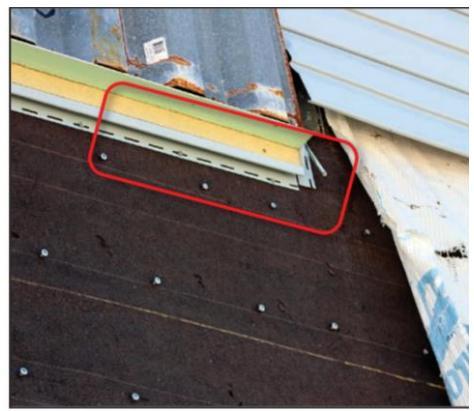
Vinyl siding failure because to lack utility trim under the windows (Fema 2018)

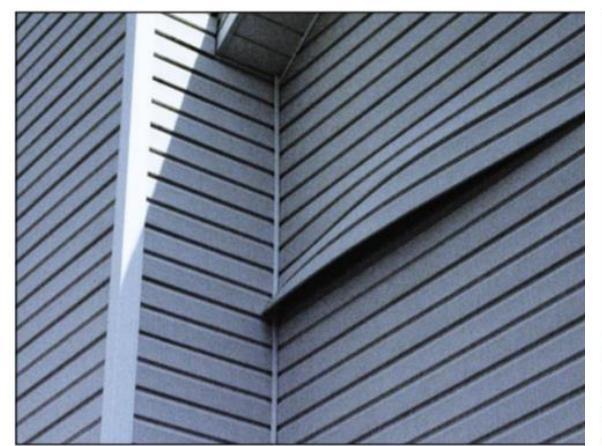
Unlatched vinyl siding panel susceptible to blow (FEMA 2005)

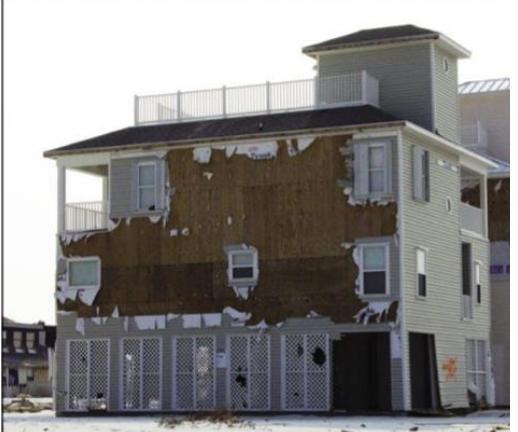
Extensive lost of vinyl siding and housewrap event though high wind panel was used (FEMA 2005)

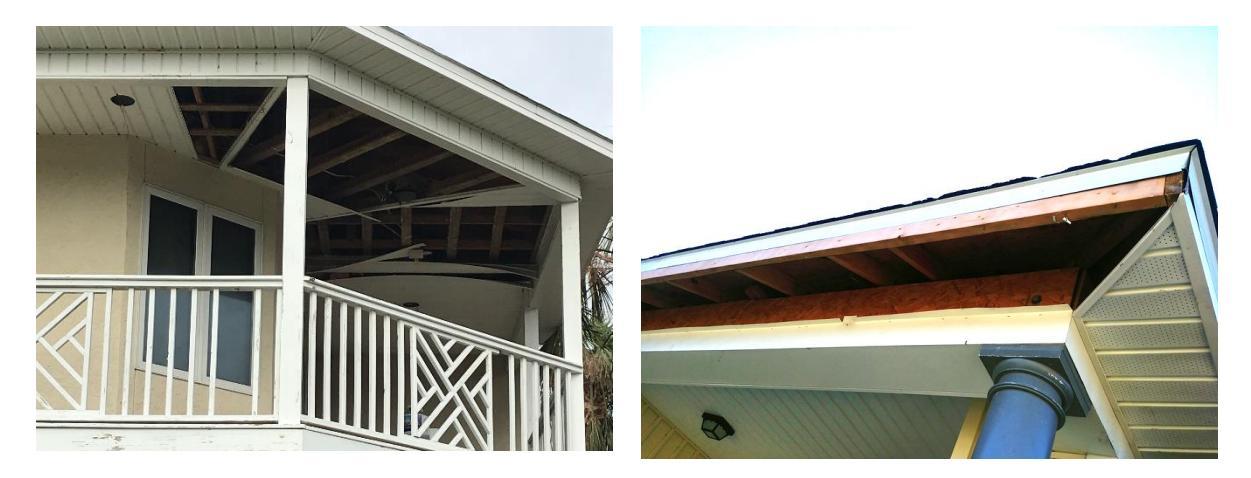
Figure 15. (Left) Failed vinyl soffit on the second story of a 1998 home in the Gulf Aire neighborhood due to Hurricane Michael; and (right) Failed fascia on a 2015 home in the Cedar's Crossing neighborhood due to Hurricane Michael.

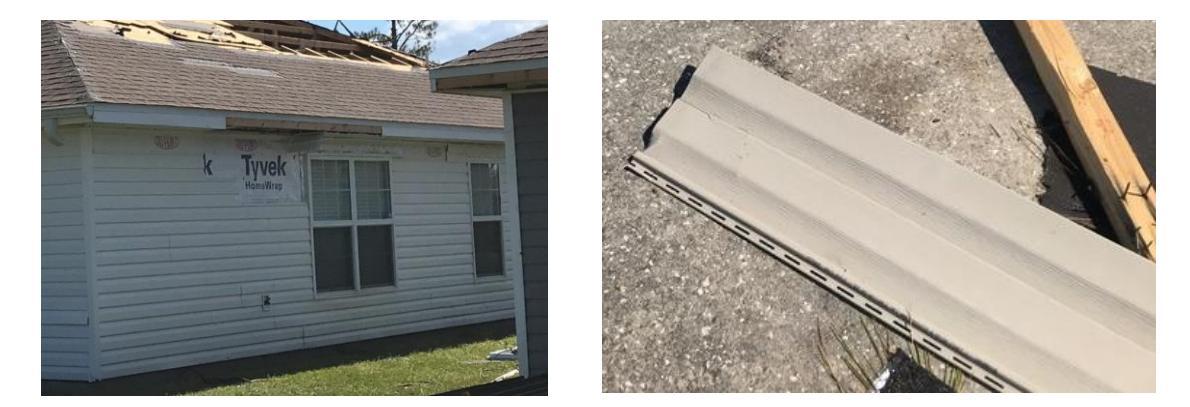
where $K_z = 0.57$, $K_{zt} = 1$, $\hat{V}_{est} = 50$ m/s, and $C_{p,ext} = -1.4$, resulting in $\hat{p}_{est} = -1.22$ kPa. The estimated wind loads were therefore nominally 55% of design, not accounting for any pressure equalization factors that are likely present with permeable cladding systems. The observed failure in this case was minor, and the reconnaissance team was unable to determine whether any deficiencies in installation were present. Given the similar layout and products used elsewhere in this subdivision, it is likely the same manufacturer and material that was used in all 2006/2007 homes in this same neighborhood, some of which had more significant vinyl siding failures.

Figure 20. Case Study #1: Minor failure of a vinyl siding system on a 2006 home in the Cedar's Crossing neighborhood for which the siding manufacturer and Miami-Dade Notice of Approval were able to be traced.

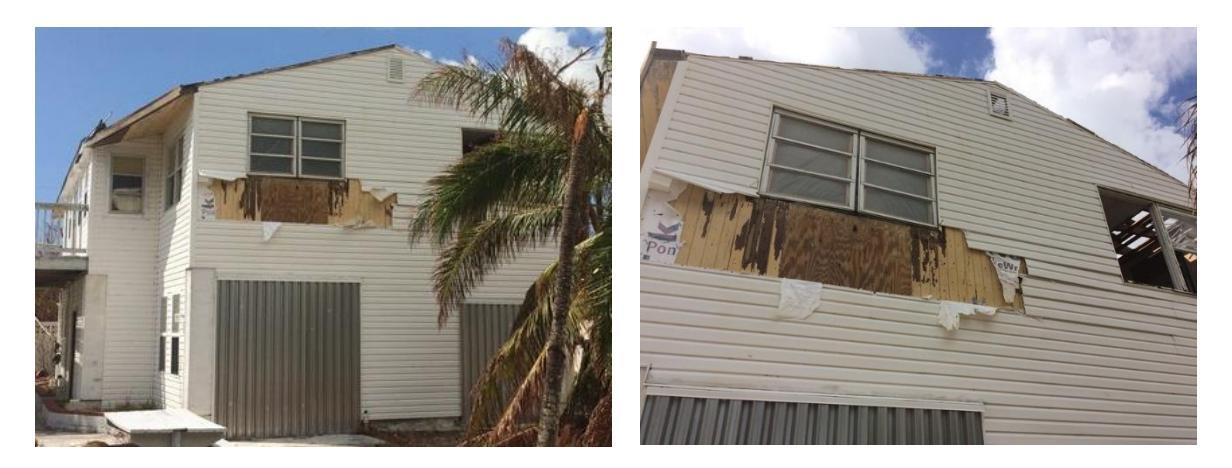
Case Study #2 is a single story, elevated, site-built home originally constructed in 1958. The original wall cladding system was replaced in 2004 with PVC vinyl siding (different manufacturer than that of Case Study #1). Per the Notice of Acceptance included in the permit file, the siding had a thickness of approximately 1 mm (0.04 inches), a single nailing hem, and a rated design pressure of +/-1.91 kPa (40 psf). The vinyl siding looks to have been installed directly atop the original exterior wood paneling. Approximately 40% of the siding was detached on the entire home. The failure of the vinyl siding in this home may have been exacerbated by the installation over existing cladding surface. The Structural Extreme Events Reconnaissance (StEER) Early Access Reconnaissance Report following Hurricane Florence also noted frequent vinyl siding failures when installed over existing cladding systems (Kijewski-Correa et al. 2018).

Figure 21. Case Study #2: Failure of a vinyl siding system on a 1958 home on Sugarloaf Key. The vinyl siding was installed in 2004 per the county permit records.

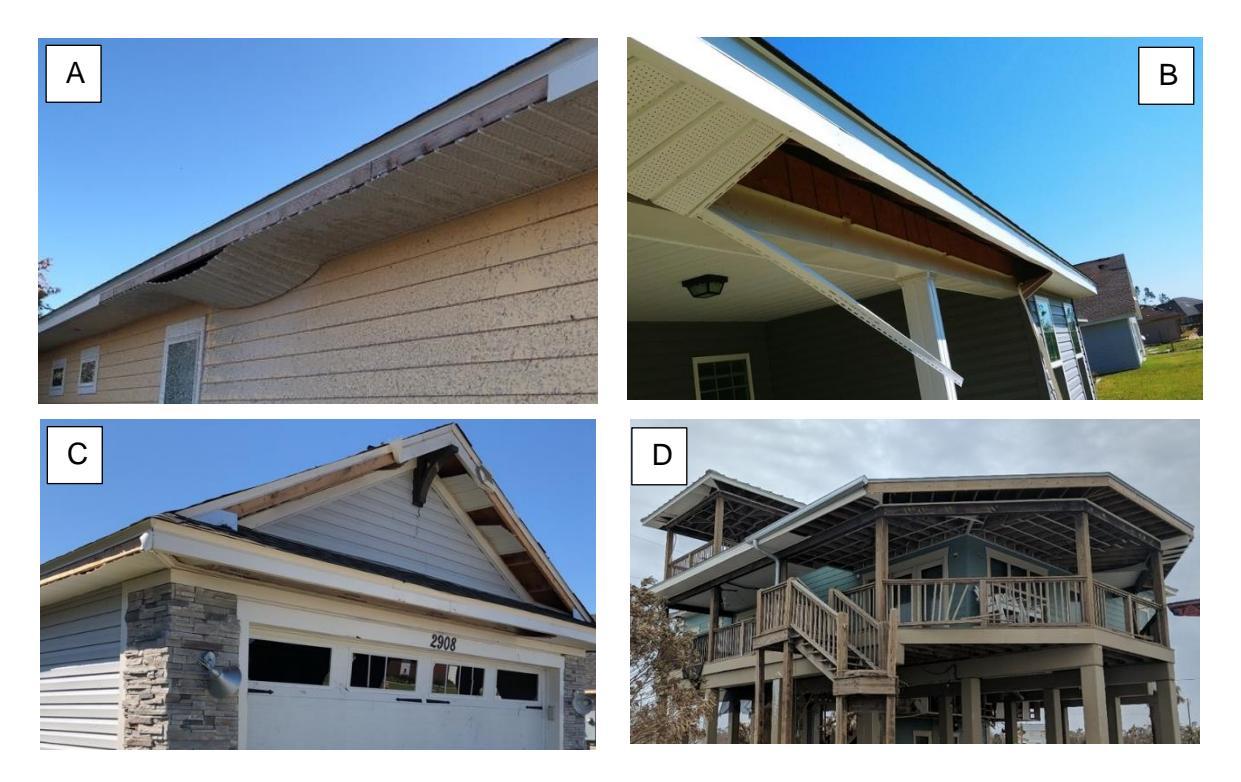
at the same locations. Anecdotally, the presence of gutters prevented fascia loss, which in turn mitigated soffit loss.

Figure 25. Soffit and fascia damage. (A) a 2017 home in Beacon Hill subdivision; (B) soffit damage without corresponding fascia damage to a 2015 home in Cedar's Crossing neighborhood; (C) extensive soffit and fascia damage to a 2016 home in Cedar's Crossing neighborhood; (D) extensive soffit and fascia damage to a 2012 home seaward of the Coastal Construction Control line in Mexico Beach, FL. Note the lack of fascia failure where the gutter is installed.
