Final Report:

Survey and Investigation of Buildings Damaged by Category III, IV & V Hurricanes in FY 2022-2023 - Hurricane Ian

Project #: P0091032

Report No. 02-23 13 June 2023

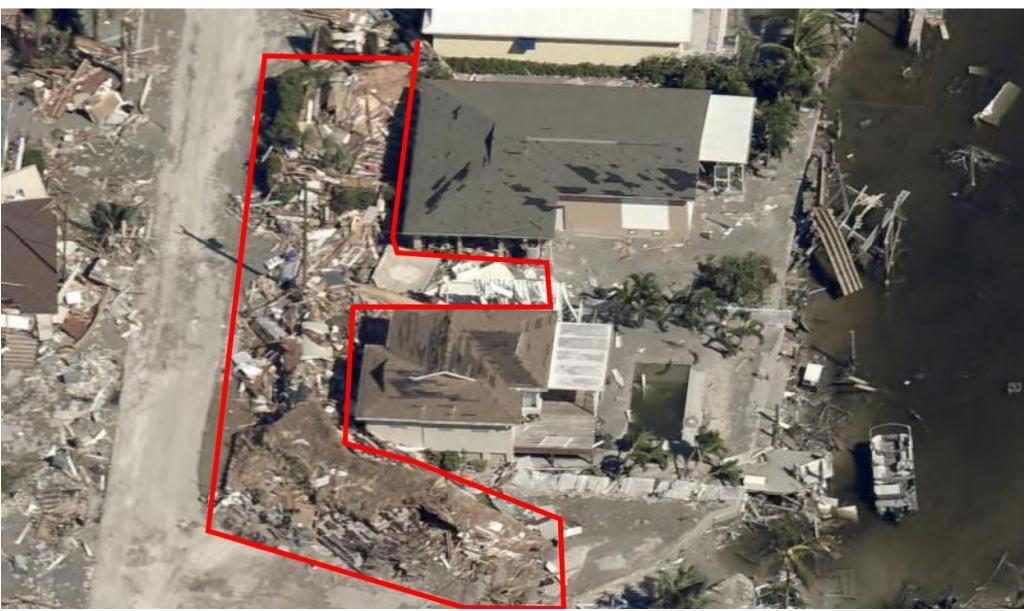
Figure 7. Debris damming against homes.

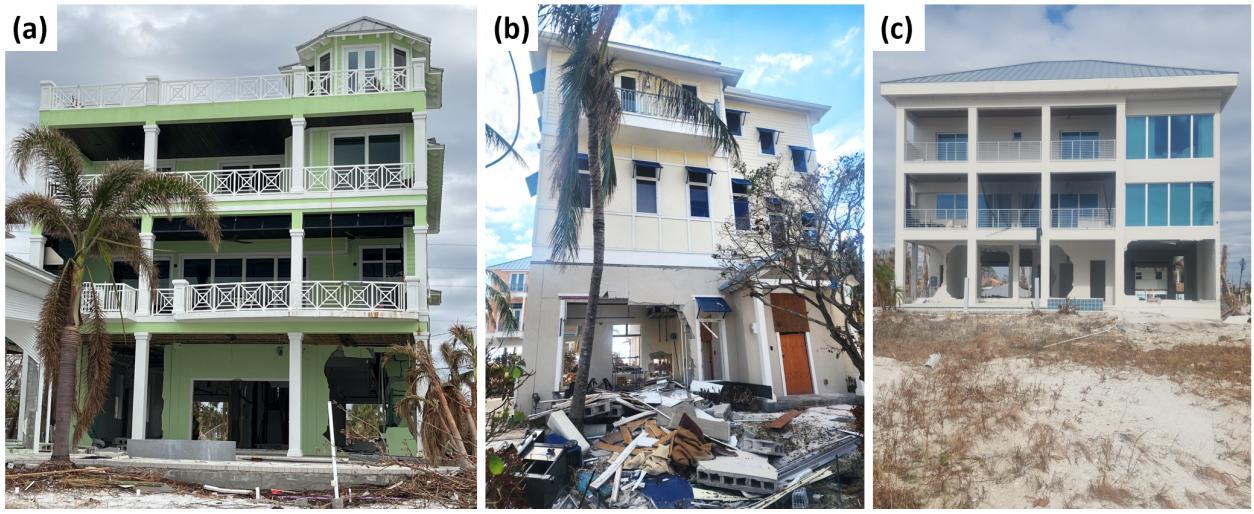
Figure 21. Examples of partial breakaway wall failures, including (a) a home on Ft. Myers Beach with CMU breakaway walls constructed in 2015; (b) a home on Ft. Myers Beach with CMU

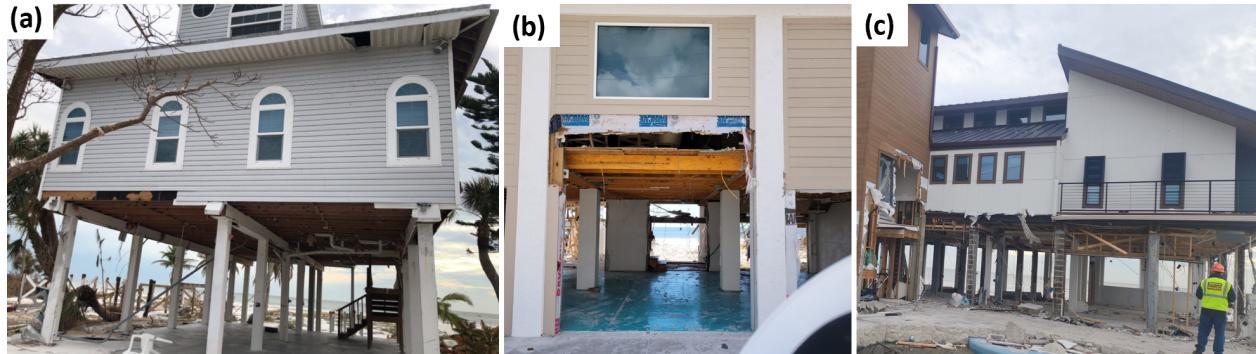
Figure 22. Examples of breakaway wall failure damaging wall cladding. (a) a home in Ft. Myers Beach constructed in 1991 with vinyl siding cladding; (b) a home in Ft. Myers Beach constructed in 1950 with fiber cement cladding; (c) a home in Ft. Myers Beach constructed in 1990 with composite wall panel cladding.

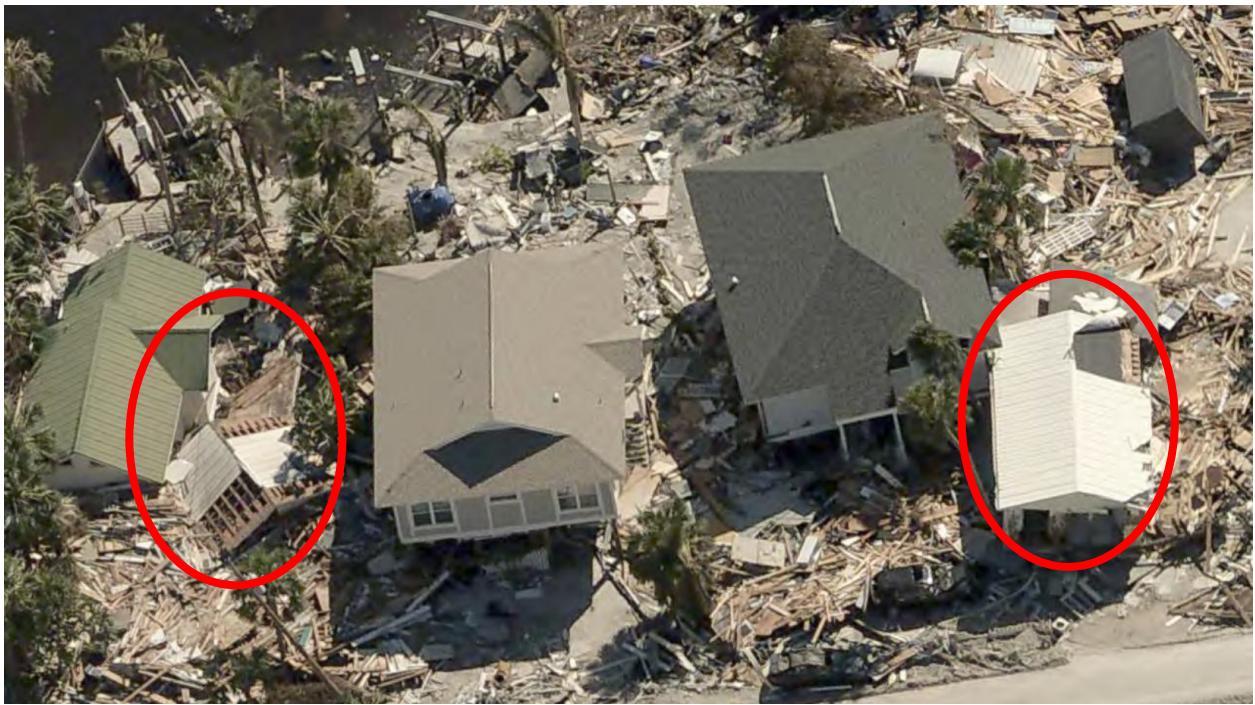
Figure 24. Examples of debris impact damming on Fort Myers Beach that did not result in collapse of the impacted structures (GPS Location: 26.452799°, -81.952546°).

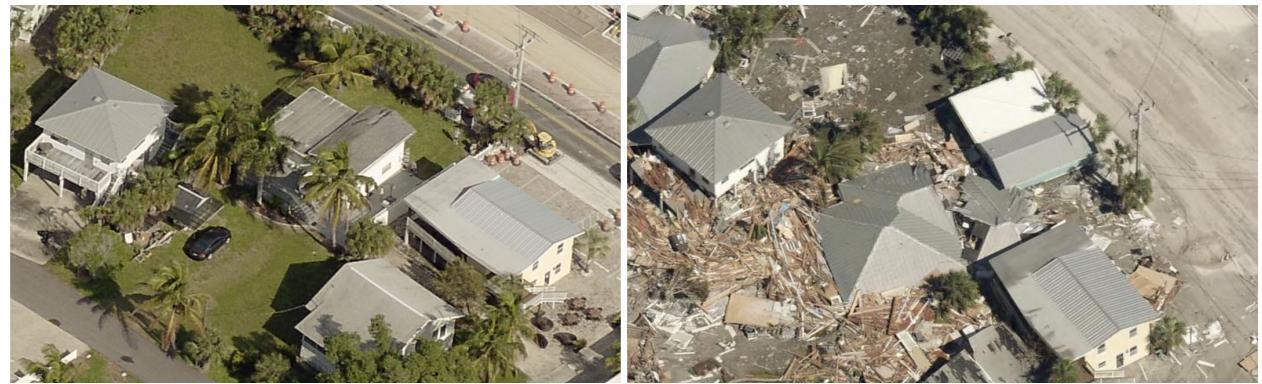
Figure 25. Before (left) and after (right) views of a cluster of homes affected by the impact of storm surge debris. To what extent debris damming contributed to the failures as opposed to the impact of moving debris could not be ascertained (GPS Location: 26.424844°, -81.906611°).

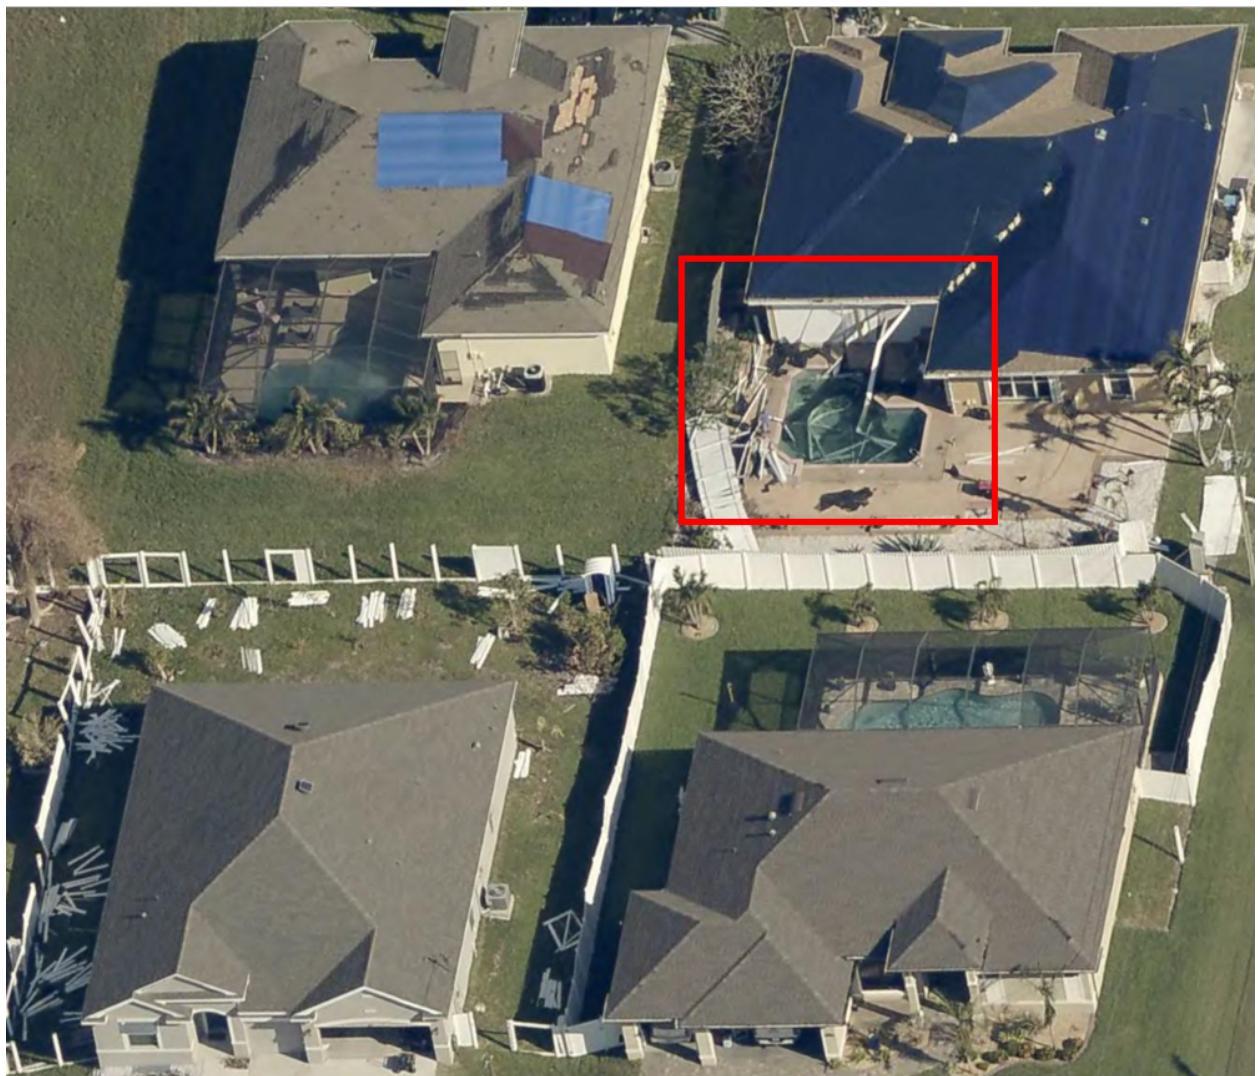
Figure 33. Illustrative post-Ian view of sunroom performance in Cape Coral, FL. Out of the three visible sunrooms, one collapsed. The collapsed sunroom was built in 1999, while the other two were constructed in 2007 and 2018.

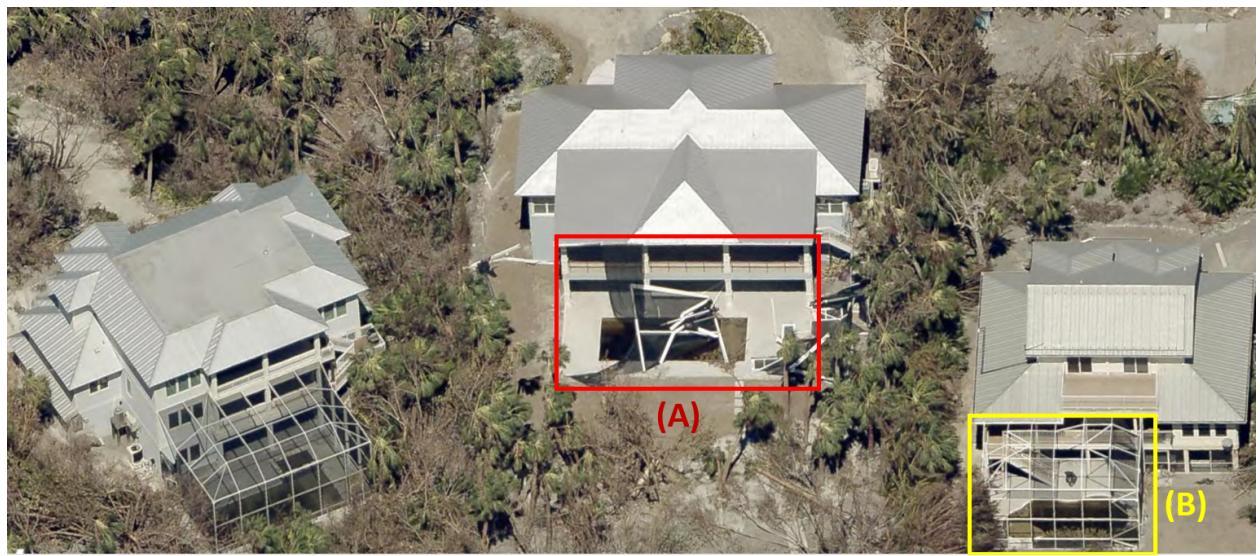
Figure 34. Examples of sunroom performance on Sanibel Island, including (A) collapse of a sunroom constructed in 2007, and (B) partial removal of the screen panels in a sunroom constructed in 2007. Sunrooms on the barrier islands would have been subjected to both high winds and storm surge in most locations.

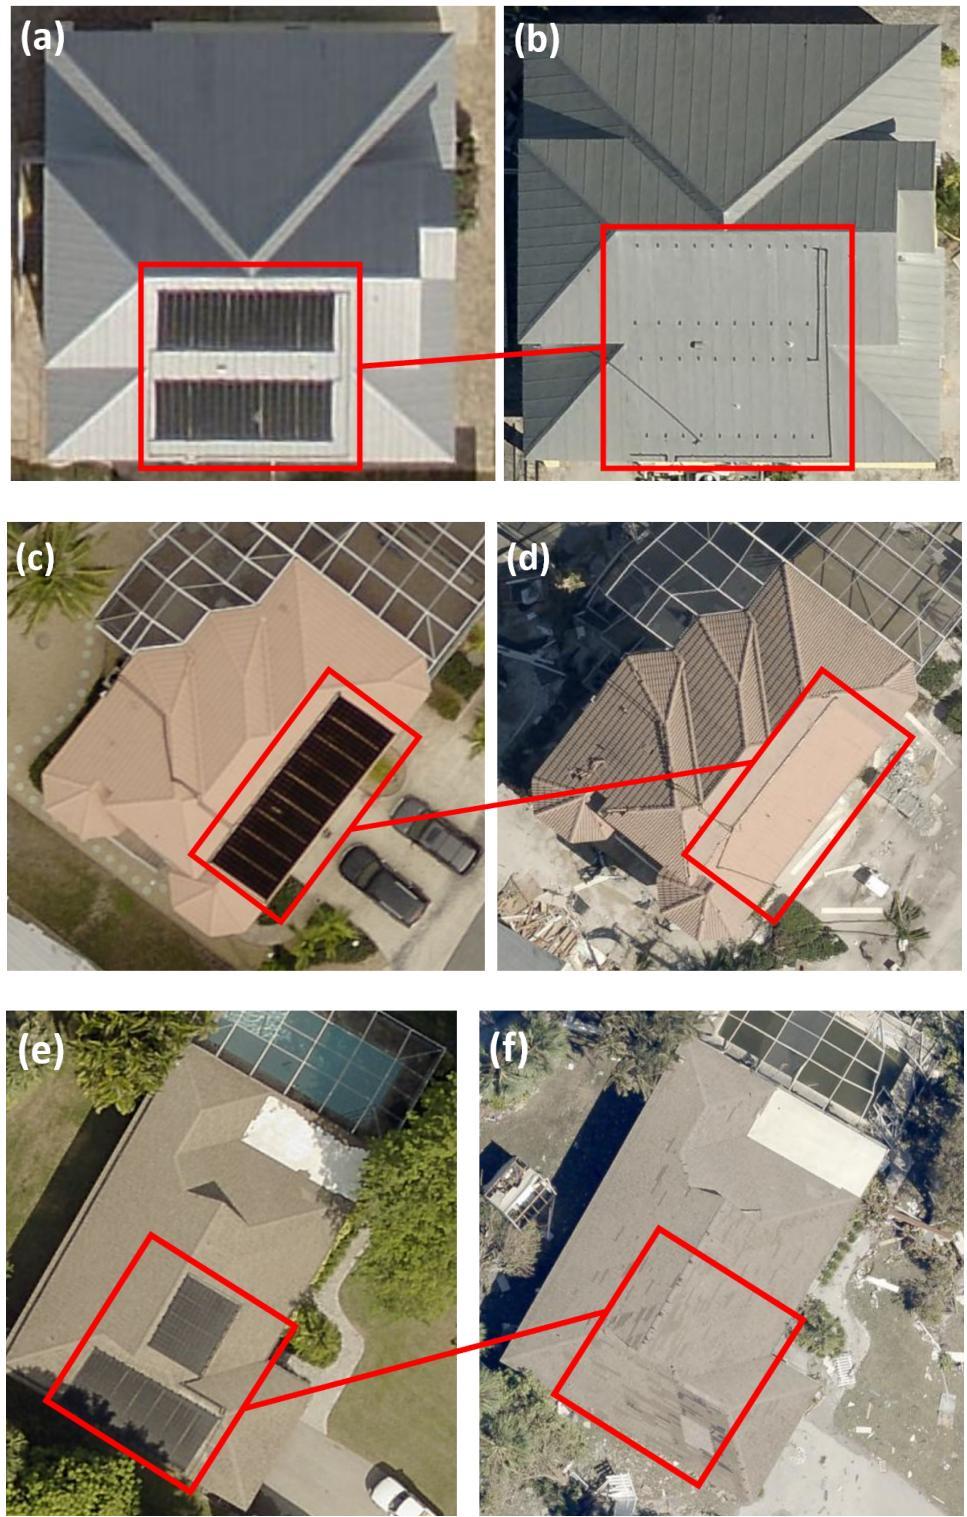
Figure 35. Examples of rooftop solar system performance, each including pre- and post-Ian aerial views sourced from Pictometry EagleView; (a,b) two-story home on Ft. Myers Beach with a rooftop solar system installed in 2012; (c,d) one-story home on Ft. Myers Beach with a rooftop solar system installed in 1997; and (e,f) one-story home on Ft. Myers Beach with a rooftop solar system installed in 2020.

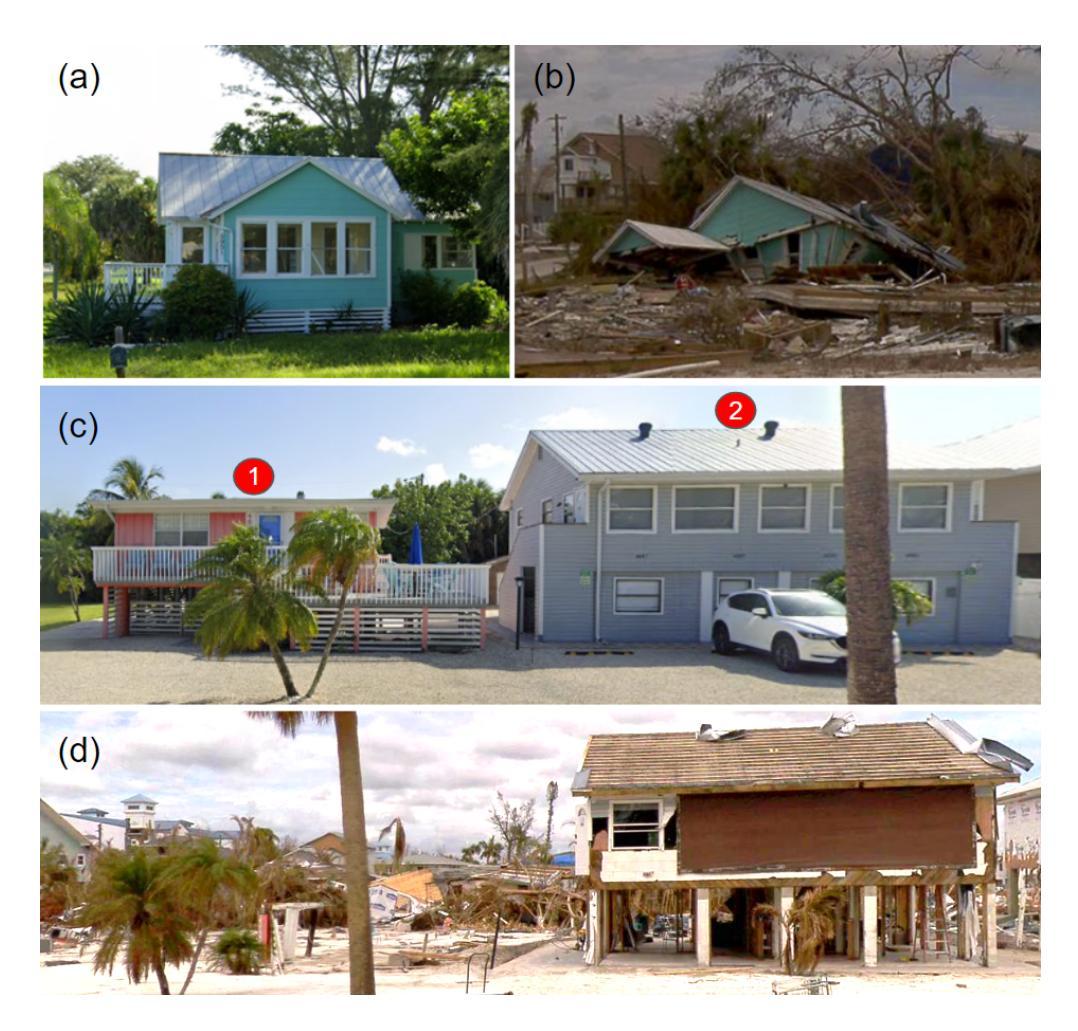
Figure 4.1. Importance of freeboard elevation to survivability, including (a) before and (b) after views of a single family home on Fort Myers Beach constructed in 1950 that collapsed during Hurricane Ian; (c) before and (d) after views of two homes with disparate performance on Fort Myers Beach. Home (1) was constructed in 1956, while home (2) was constructed in 1950, but home (2) was elevated approximately 3 ft higher than home (1) and its breakaway walls performed as intended.

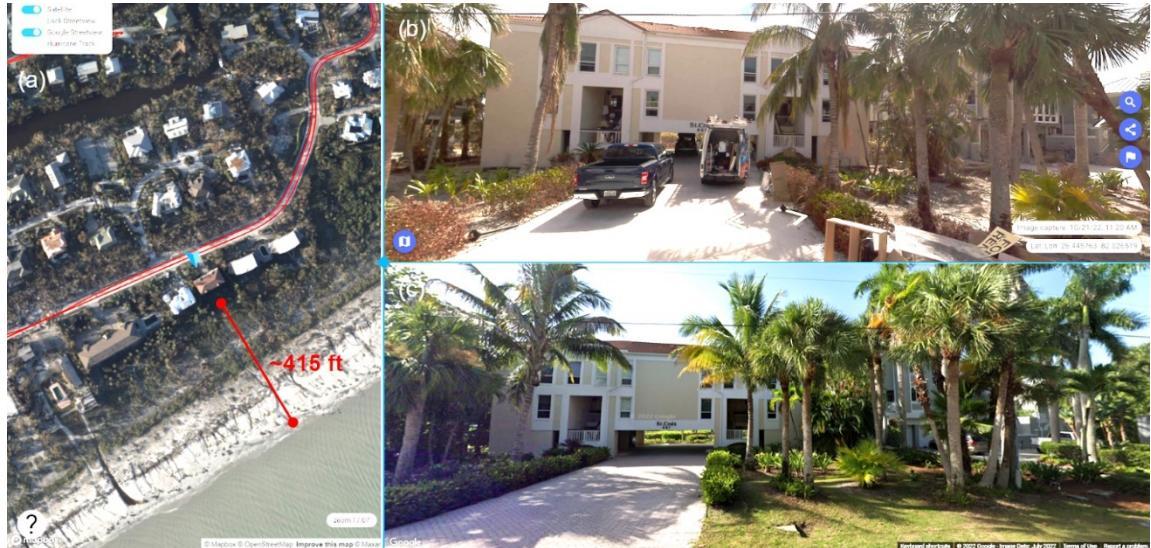
Figure 4.2. Illustrative effect of the vegetation and extended setback in Sanibel potentially mitigating surge impacts to structures. Subset (a) provides the post-storm aerial view showing a setback of approximately 415 ft from the shoreline, (b) the post-storm surface-level view, and (c) the pre-storm surface-level view.

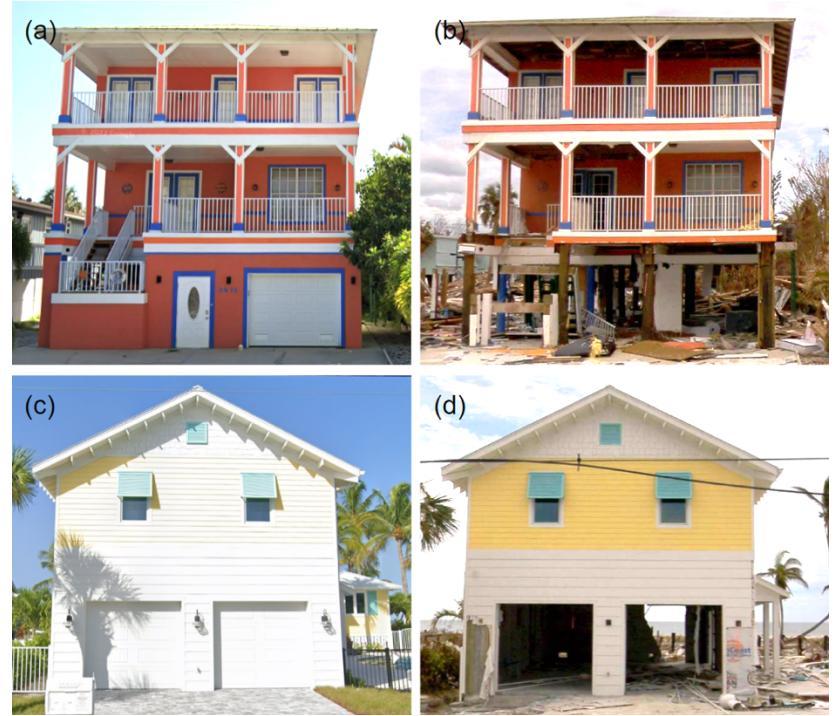
Figure 4.3. Examples of the performance of breakaway walls during Hurricane Ian, including (a) before and (b) after views of a home on Fort Myers Beach constructed in 2000 with acceptable performance of the breakaway walls; and (c) before and (d) after views of a two-story structure with garage at ground level constructed in 2020 in which the breakaway CMU walls on the back side of the structure only partially broke away.

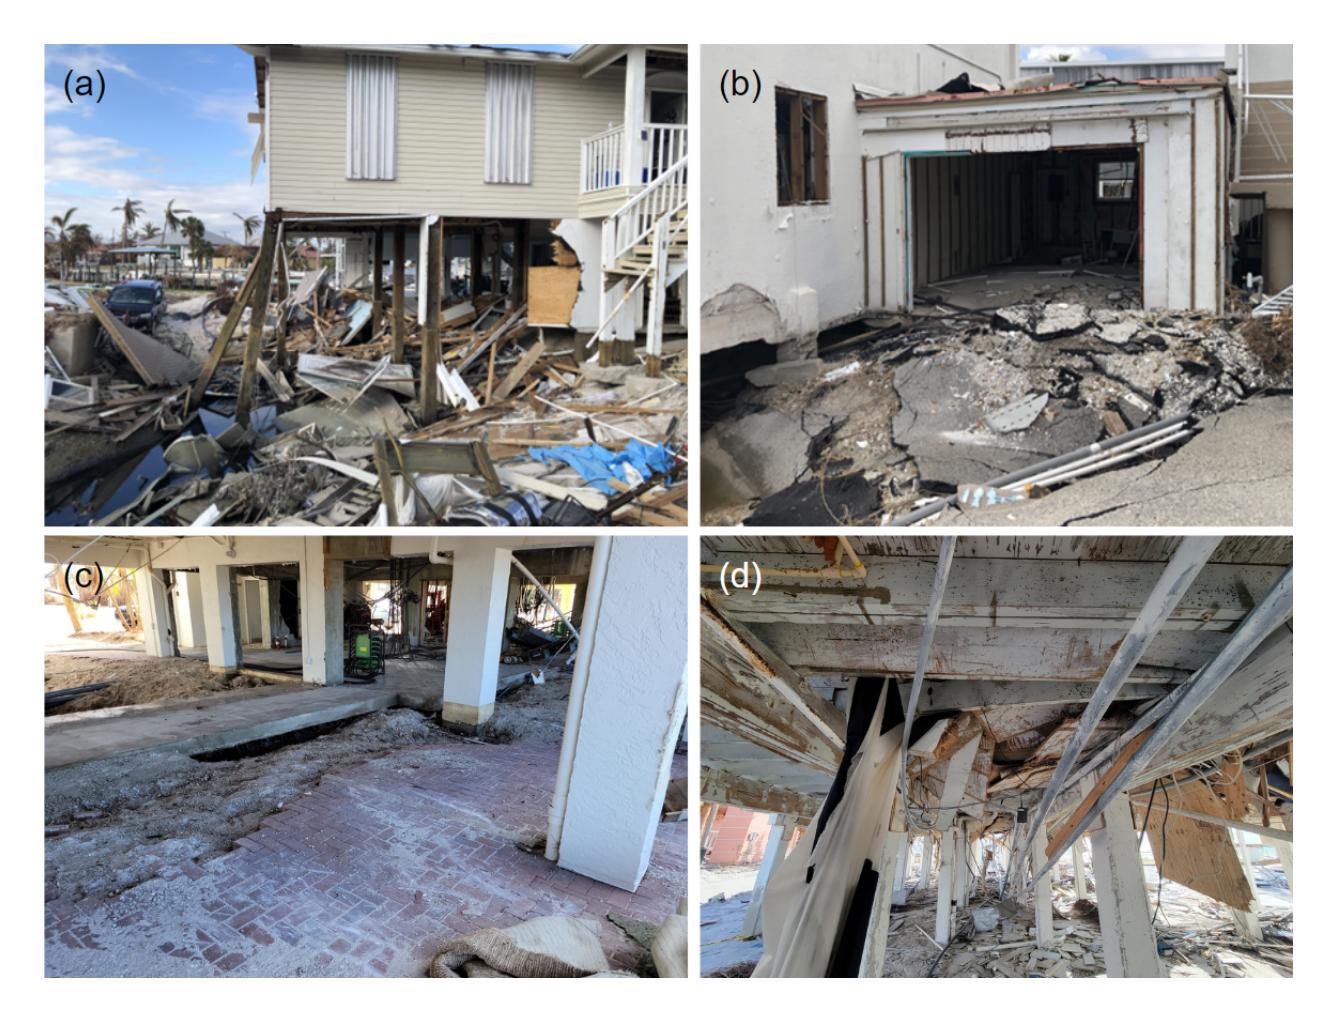
Figure 4.4. Examples of scour, uplift, and other surge effects on buildings during Hurricane Ian, including (a) debris transport and breakaway wall performance, (b) scouring and pavement washout, (c) scour around piers, and (d) effects of hydrodynamic uplift forces on a wood-framed floor system.

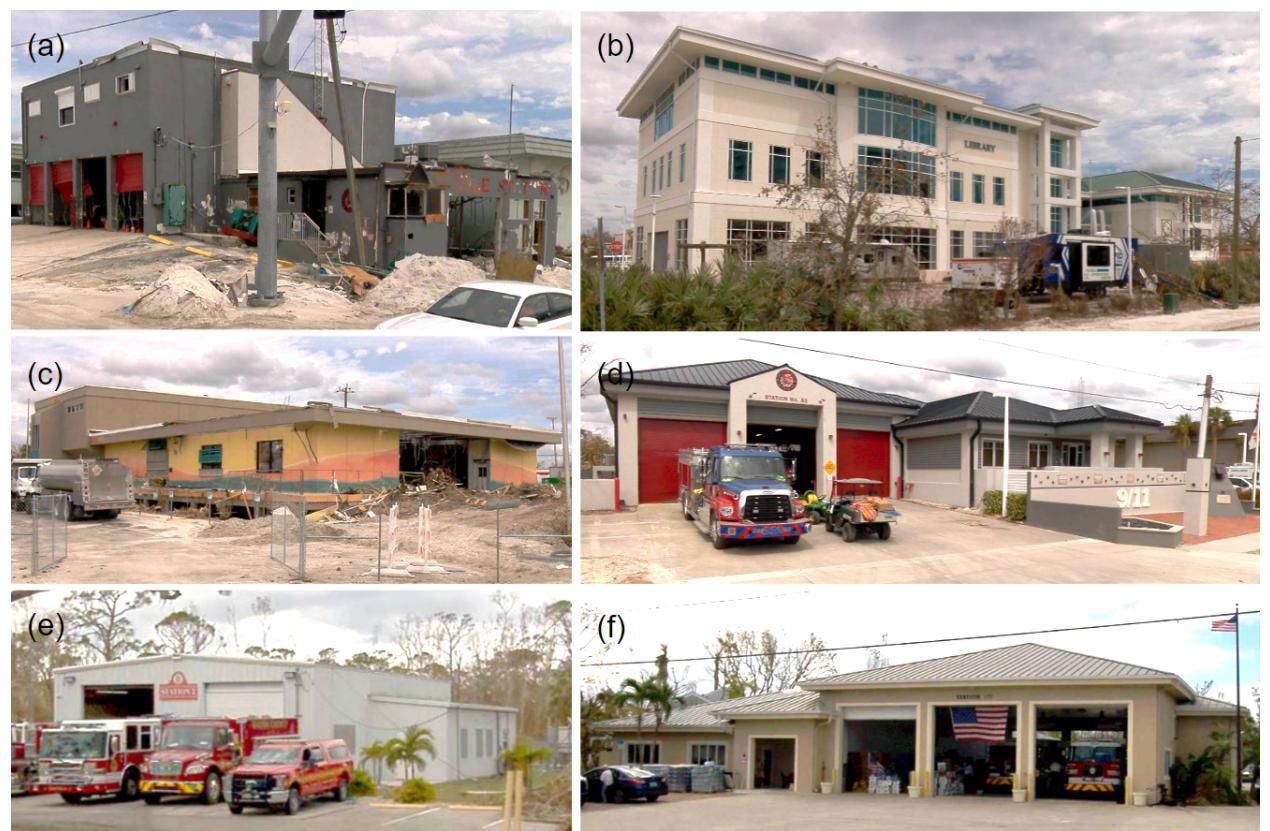
Figure 4.5. Illustrative performance of critical or cultural facilities on the barrier islands, including (a) the Ft. Myers Beach Fire Department District Station 31, constructed in 1985 with partial collapse of some walls and breaching of roll-up doors; (b) the Ft. Myers Beach Library (portion shown added in 2011) with only minor loss of metal roof cover visible (not shown); (c) Ft. Myers Beach Town Hall (constructed in 1968) with surge damage to end wall and washout below foundation; (d) Ft. Myers Fire Station No. 33 (built in 2008) with no visible signs of exterior damage; (e) Pine Island Fire Station (built in 1975) with no signs of exterior damage; and (f) Sanibel Fire Department Station 171 (built in 2005) with no visible signs of exterior damage.

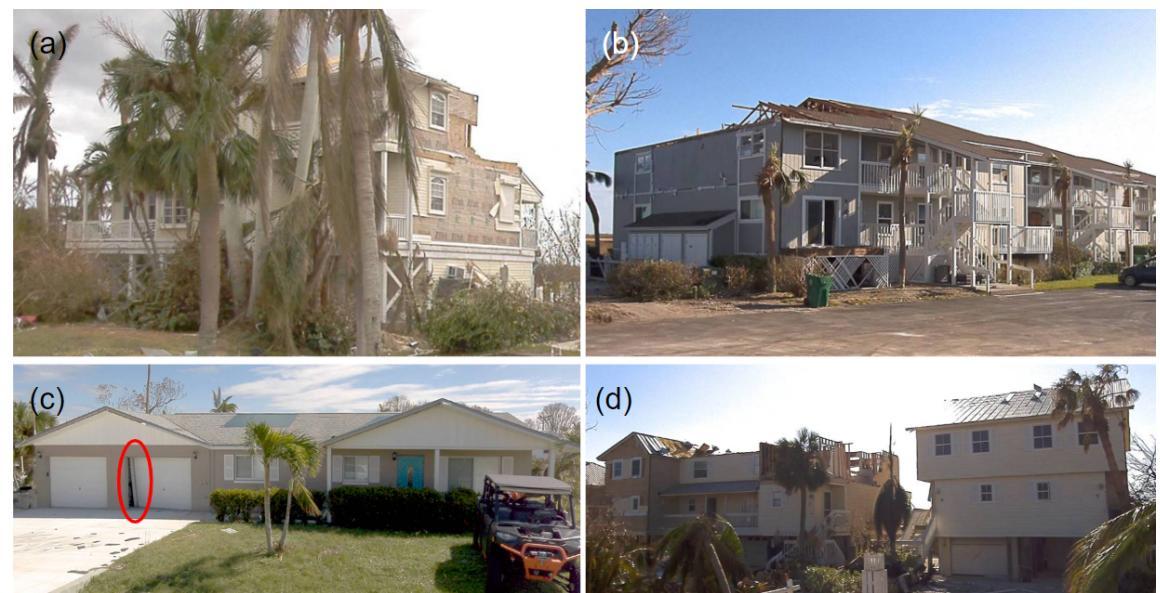
Figure 4.6. Examples of poor wind performance on the barrier islands, including (a) a 3-story home constructed in 1999 with partial roof structure removal and wall collapse in the top story, (b) gable end roof structure loss in apartment buildings constructed in 1986; (c) garage door framing blown inward in a home constructed in 1967; (d) roof structure failure in one home adjacent to loss of metal roof cover in another, both of which were constructed in 1978.

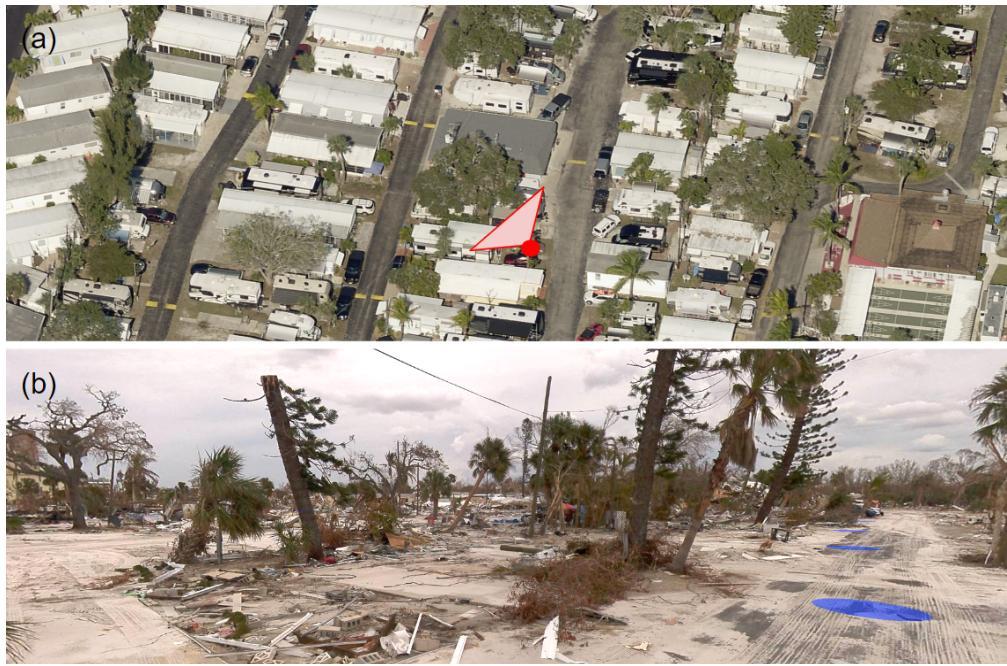
Figure 4.7. Example of surge impacts on RVs and manufactured homes on Ft. Myers Beach during Hurricane Ian: (a) before oblique view of the RV park, and (b) after view of the RV park shown in (a). The red triangle in (a) approximates the location and field of view in (b).

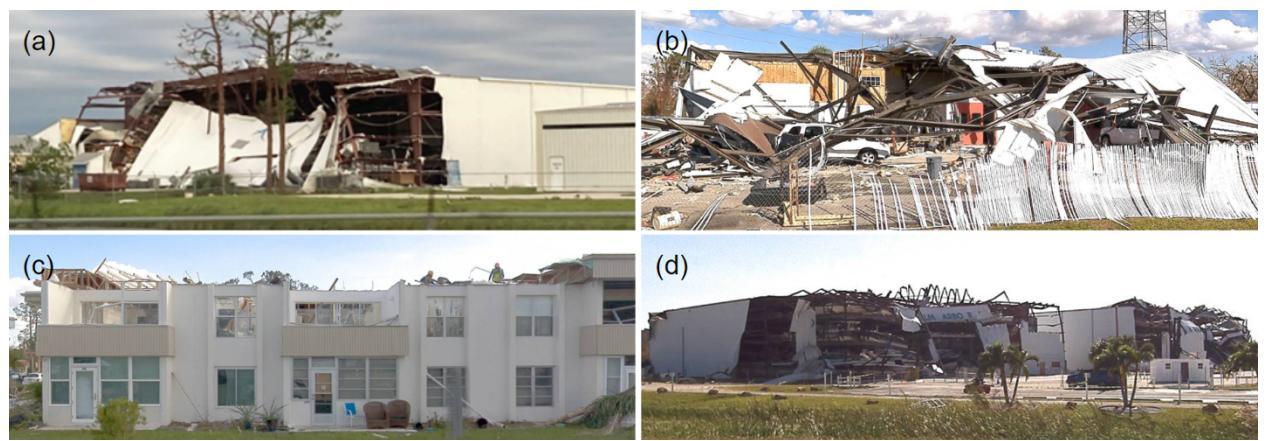
Figure 4.8. Examples of significant structural damage from Hurricane Ian, including (a) end bay failure in a metal building aircraft hangar (year built: 1996) at Punta Gorda airport, (b) collapse of an automobile maintenance garage in Grove City constructed in 1986; (c) wood roof structure failure in two-story wood-frame condominiums in Port Charlotte constructed in 1973, and (d) end bay collapses and cladding loss of two marina buildings in Cape Haze constructed in 1999.

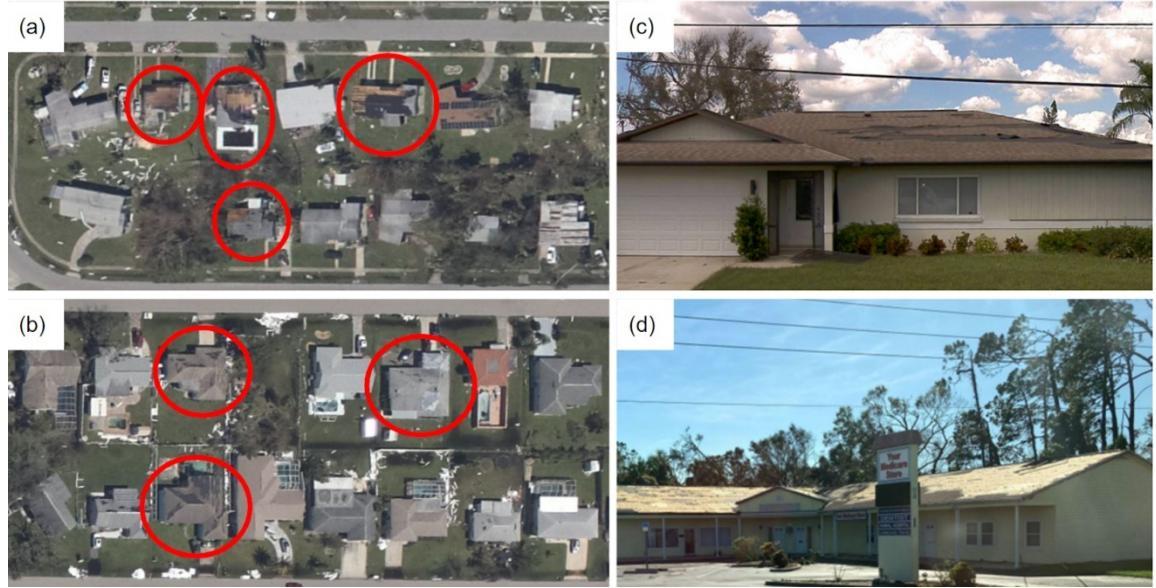
Figure 4.9. Illustrative performance of asphalt shingle and rolled membrane roofs in Port Charlotte consisting of homes constructed in the (a) 1960s with asphalt shingles and rolled roofs, (b) 1980s, (c) 1980s construction but asphalt shingle roof installed in 2005 but also (d) isolated commercial structures.

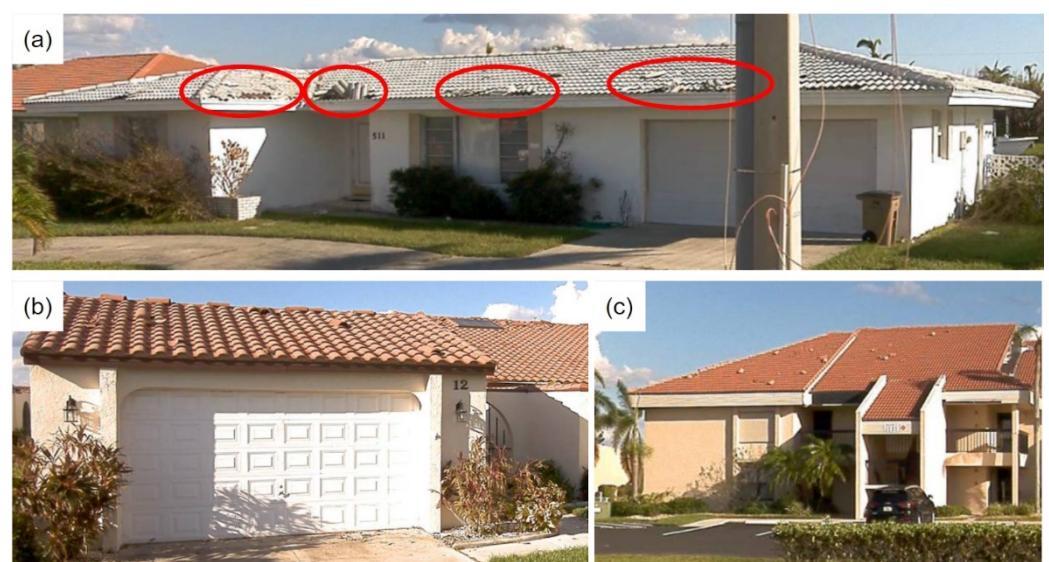
Figure 4.10. Illustrative examples of damage to tiled roofs, including (a) tile uplift (indicated by red ellipses) concentrated along the eaves of a single family home in Punta Gorda constructed in 1969; (b) loose tiles in the field and ridge regions of the roof on a condominium in Punta Gorda, FL constructed in 1989; and (c) isolated loose tiles on a roof on a multi-family residential unit also in Punta Gorda, FL constructed in 1990.

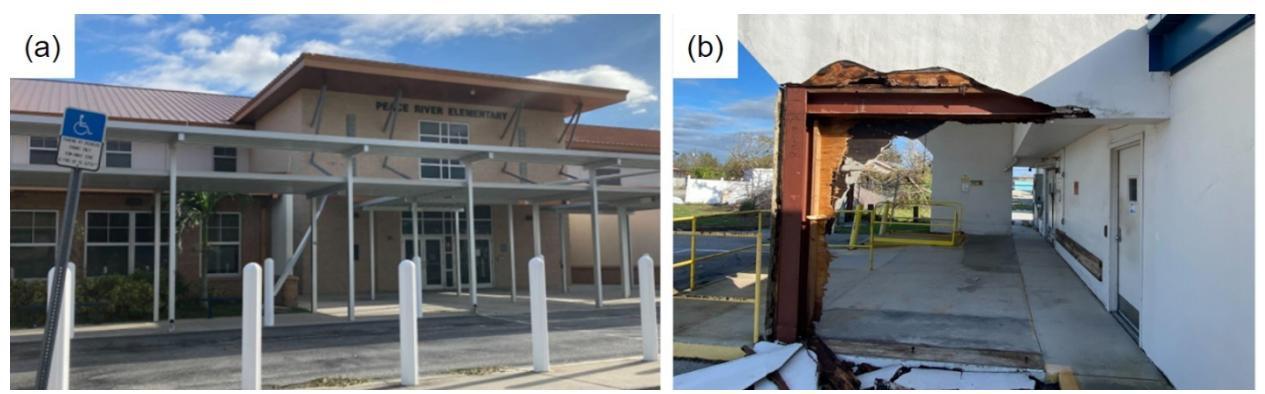
Figure 4.11. Isolated cladding loss in non-residential buildings, including (a) minor damage to flashing at Peace River Elementary School in Port Charlotte and (b) failure of exterior stuccoclad wall panel at USPS office in Port Charlotte.

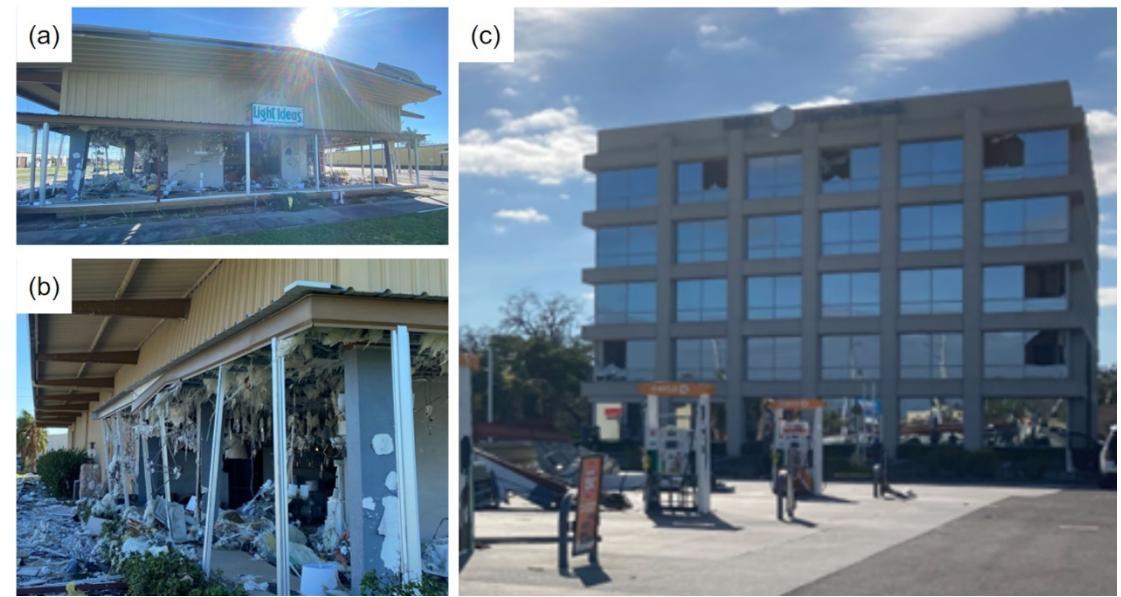
Figure 4.12. Examples of isolated fenestration damage observed in the Port Charlotte area, including (a) and (b) complete loss of glass storefront in a commercial building constructed in 1973, and (c) broken windows in a 5-story commercial building constructed in 1987.

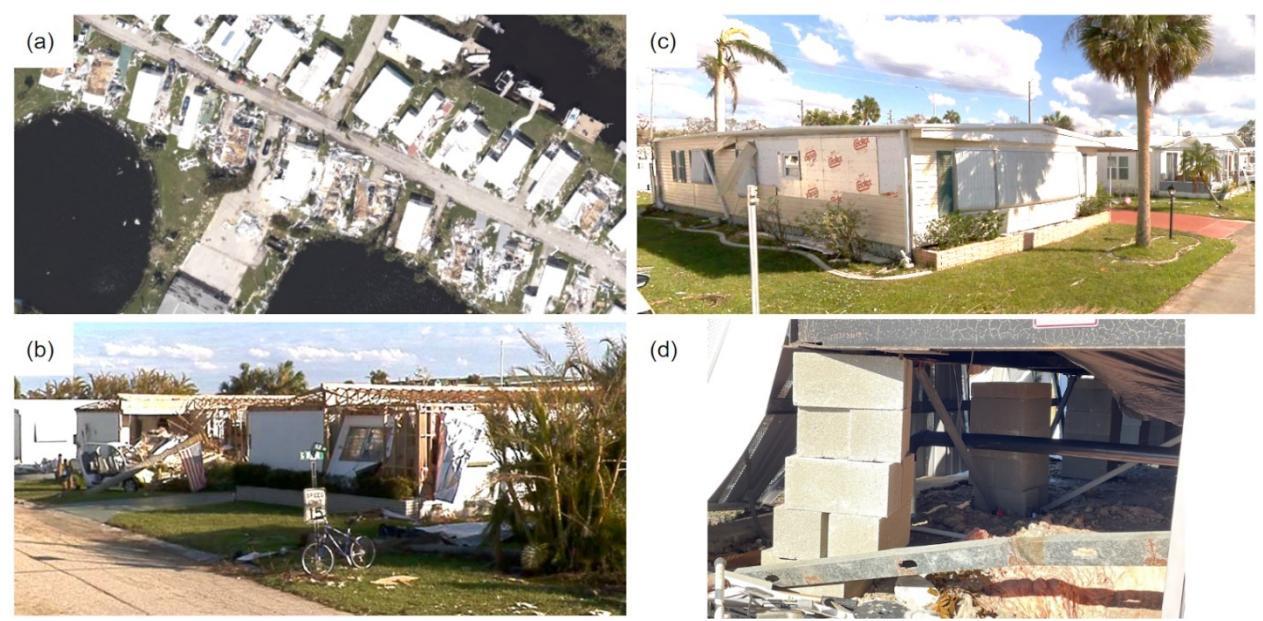
Figure 4.13. Illustrative damage to mobile/manufactured homes, including (a) aerial and (b) street-level views of structural damage to Gasparilla Mobile Estates in Placida (established in the 1970s), including loss of roof structure and wall collapses; (c) cladding damage to manufactured homes in Punta Gorda; and (d) shifted unreinforced masonry piers supporting a manufactured home subjected to storm surge on San Carlos Island.

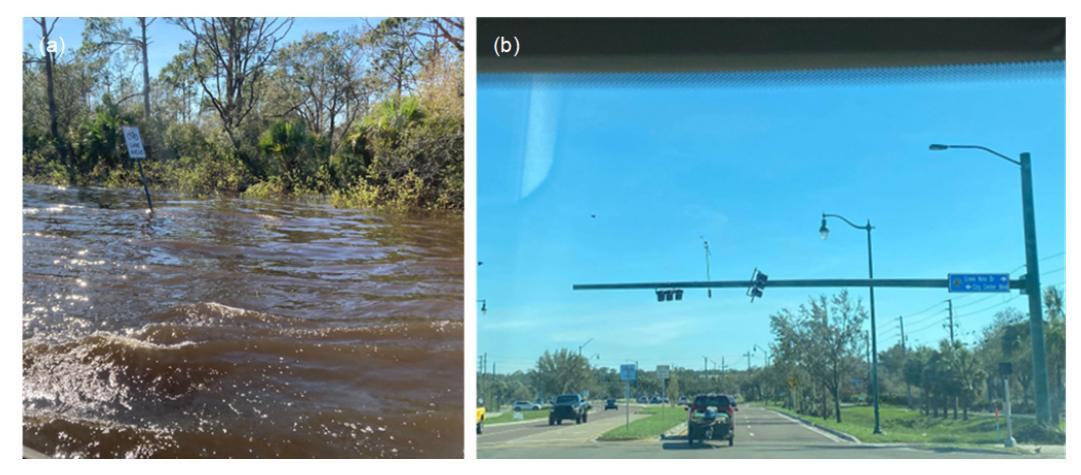
Figure 4.14. Photos of damage to the road infrastructure in inland regions: (a) street flooding at Exit 182 in I-75 on route to Sumter Blvd. and (b) damaged traffic lights at the intersection of City Center and Sumter Blvd. in the city of North Port.
