## FIRE TEST REPORT

ASTM E108/UL 790 CLASS A TESTING ON ROOF ASSEMBLY CONTAINING PHOTOVOLTAIC  
AND ACM PANELS WITH FIRE RESISTENT WOOD SUB-FRAMING

M9823.02-121-24 R0

## TEST REPORT FOR CERTAINTEED LLC

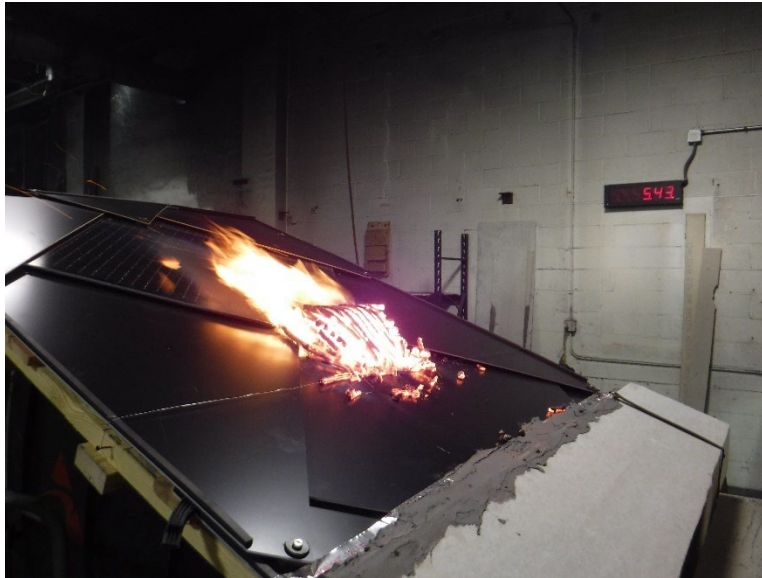
**Photo No. 3**  
**Test #1 During Test**

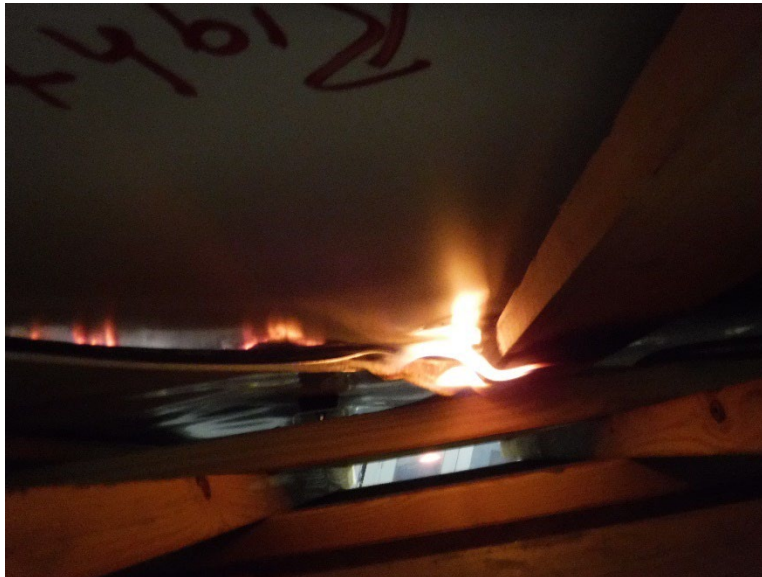
| TIME (min:sec) | OBSERVATIONS |
|---|---|
| 05:21 | Ignition of 1" x4" wood batten |

**Photo No. 4**  
**Test #1 Flaming of 1 x 4 Batten**

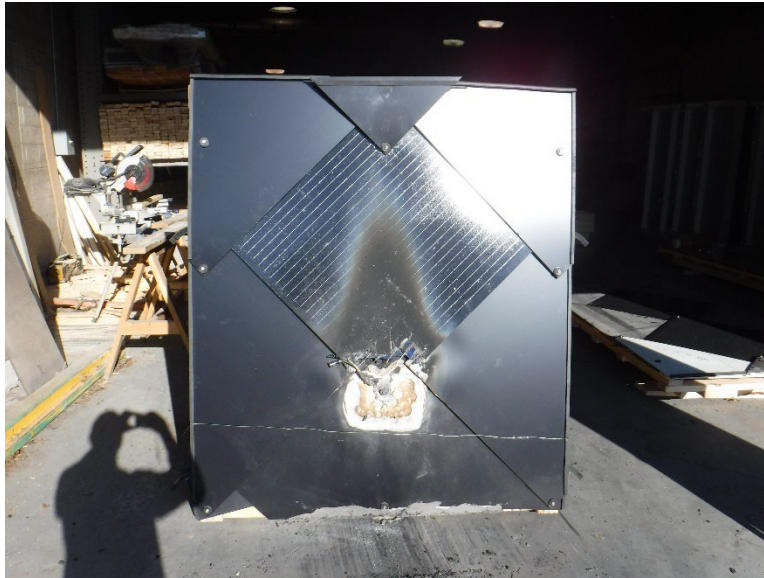
**Photo No. 5**  
**Test #1 Post Test**

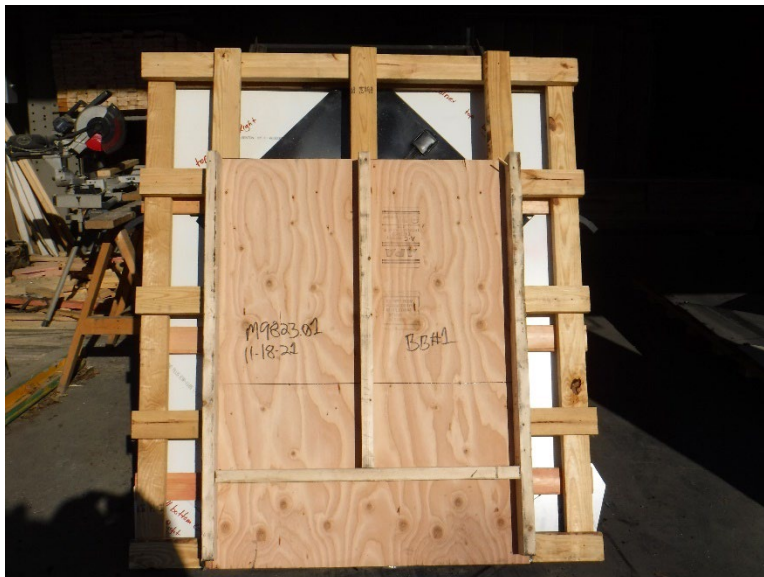
**Photo No. 6**  
**Test #1 Underdeck Post Test**

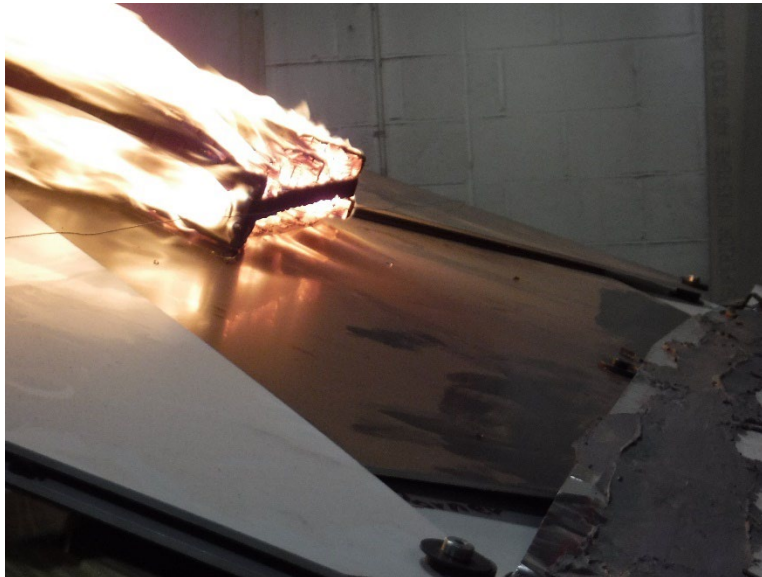
| TIME (min:sec) | OBSERVATIONS |
|---|---|
| 01:36 | Warping of ACM panel at leading edge of brand |

**Photo No. 10**  
**Test #2 Warping of Center ACM at Leading Edge**

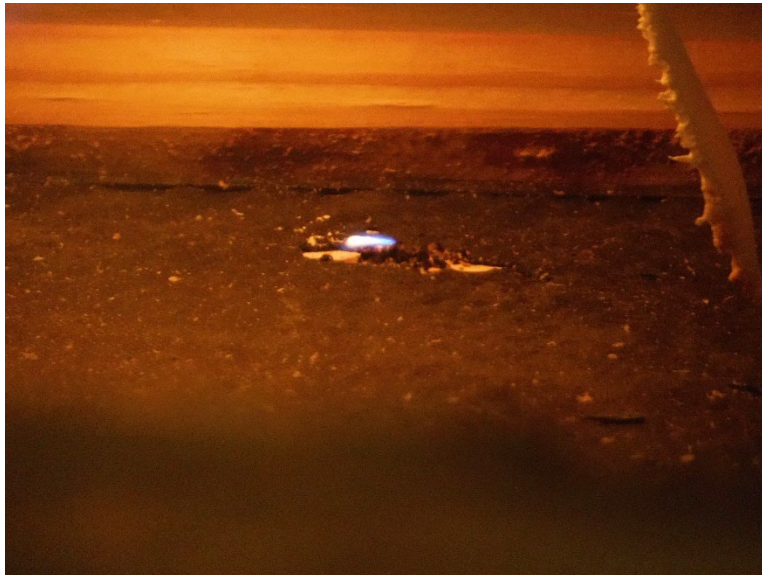
| TIME (min:sec) | OBSERVATIONS |
|---|---|
| 18:57 | Dripping of ACM panel onto roof deck |

**Photo No. 16**  
**Test #3 Flaming Droplets from ACM onto Roof Deck**

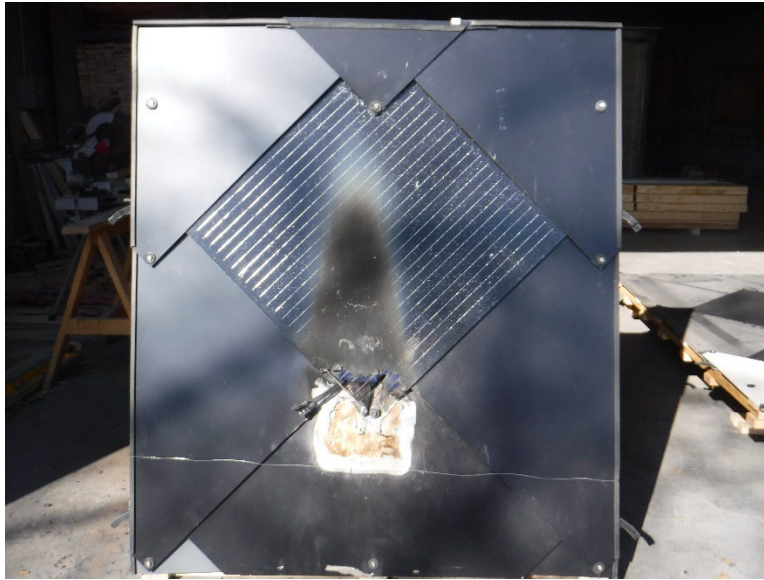
**Photo No. 17**  
**Test #3 Post Test**

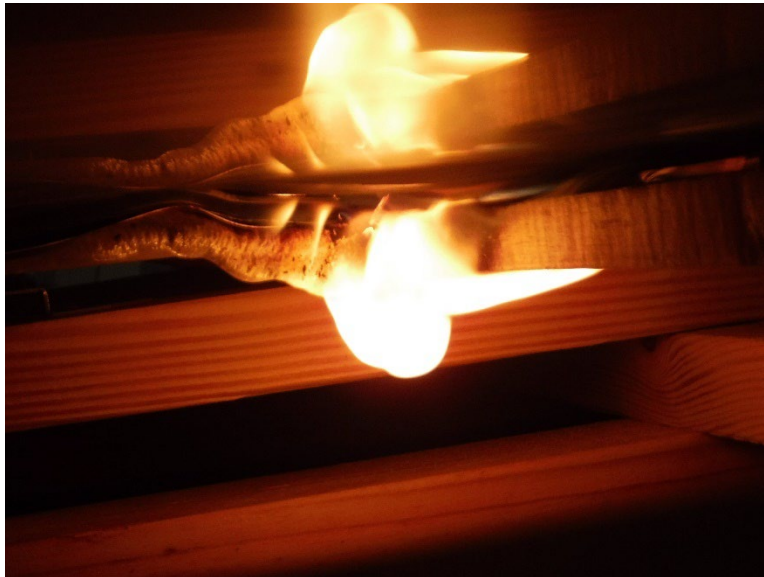
| TIME (min:sec) | OBSERVATIONS |
|---|---|
| 09:54 | Ignition of 1" x 4" wood batten |
| 13:20 | Ignition of underside of ACM panel at 1" x 4" wood batten |

**Photo No. 22**  
**Test #4 Flaming of 1 x 4 Batten at Edge of ACM Underside of Panel**

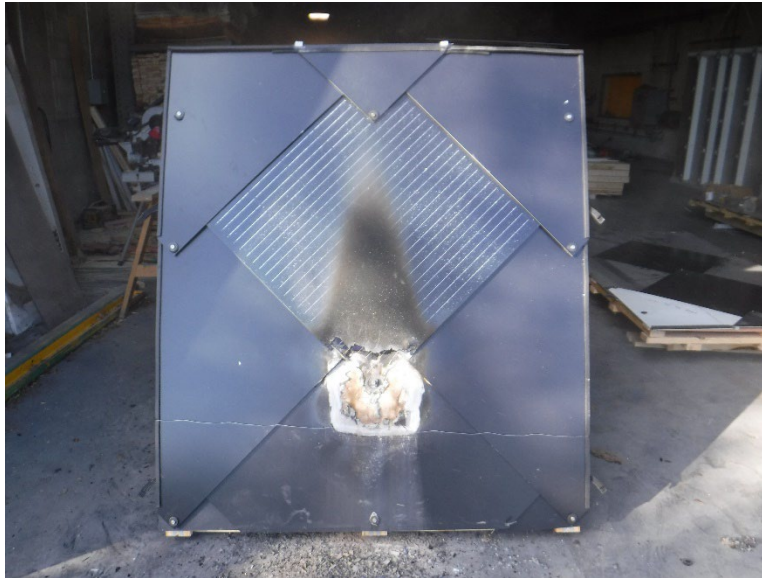
**Photo No. 23**  
**Test #4 Post Test**

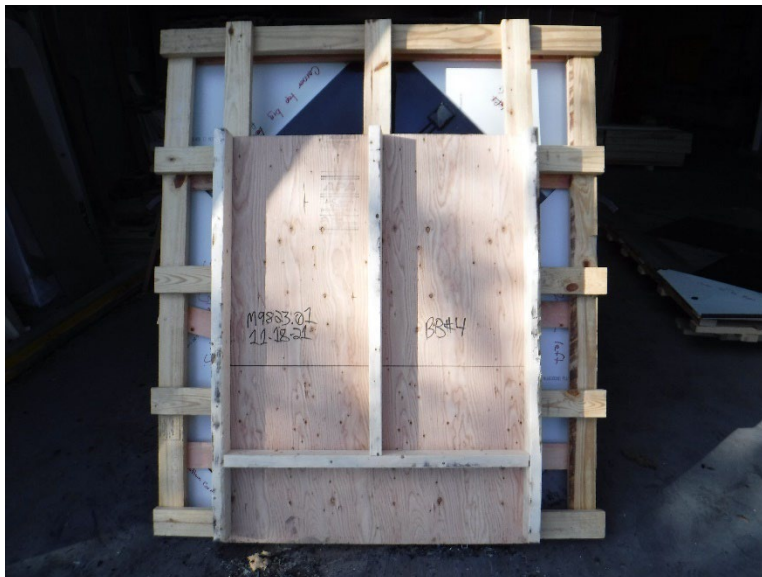
**Photo No. 24**  
**Test #4 Underdeck Post Test**

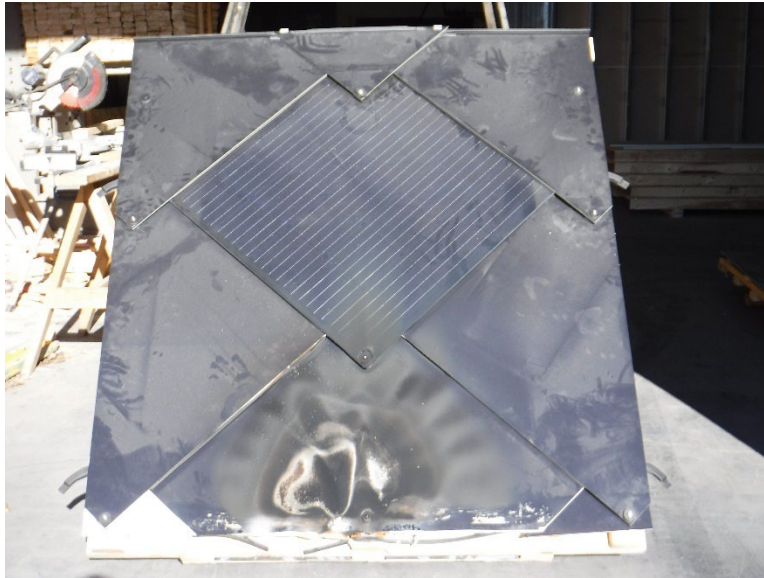
**Photo No. 29**  
**Test #5 Post Test**

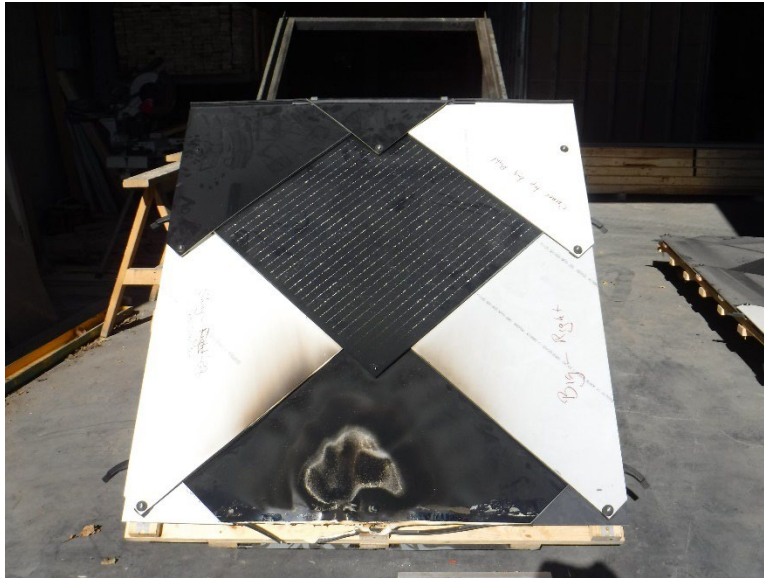
**Photo No. 35**  
**Test #6 Post Test**

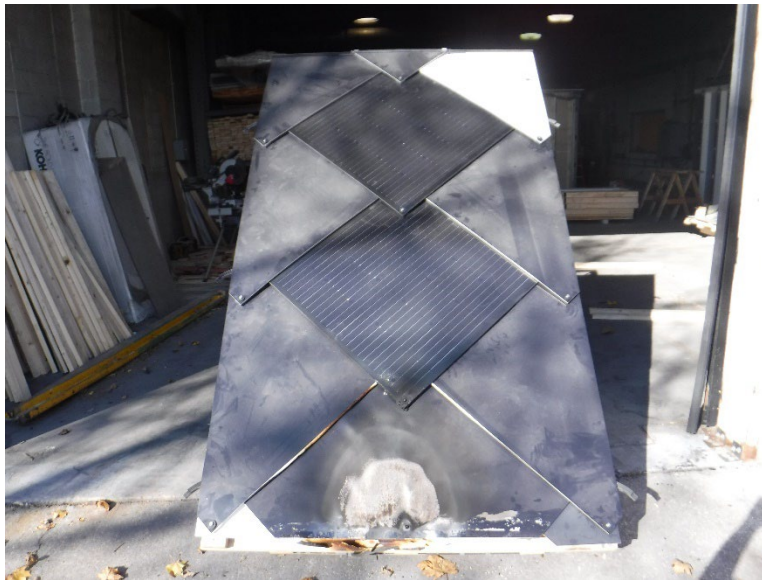
**Photo No. 39**  
**Test #7 Post Test**

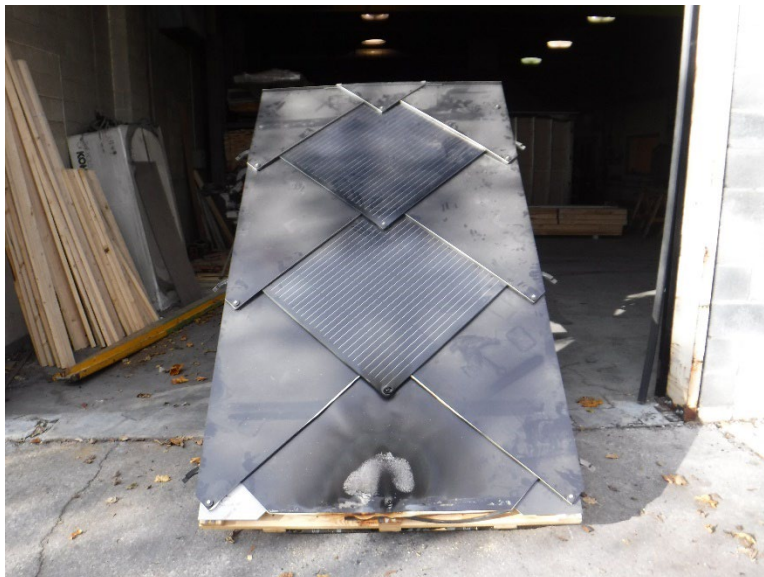
**Photo No. 42**  
**Test #8 Post Test**
