### **TEST REPORT:**

**AAMA 501-05 Curtain Wall Mock-Up Testing  
EFCO Corporation, a Pella Company  
SERIES 5600 System Curtain Wall  
Exterior/Interior Glazed Mock-Up  
REPORT #CCLI 12-051**

**March 29, 2012**

AAMA 501-05 CURTAIN WALL MOCK-UP TESTING  
**EFCO CORPORATION, A PELLA COMPANY**  
SERIES 5600 SYSTEM CURTAIN WALL  
EXTERIOR/INTERIOR GLAZED MOCK UP  
REPORT CCLI #12-051

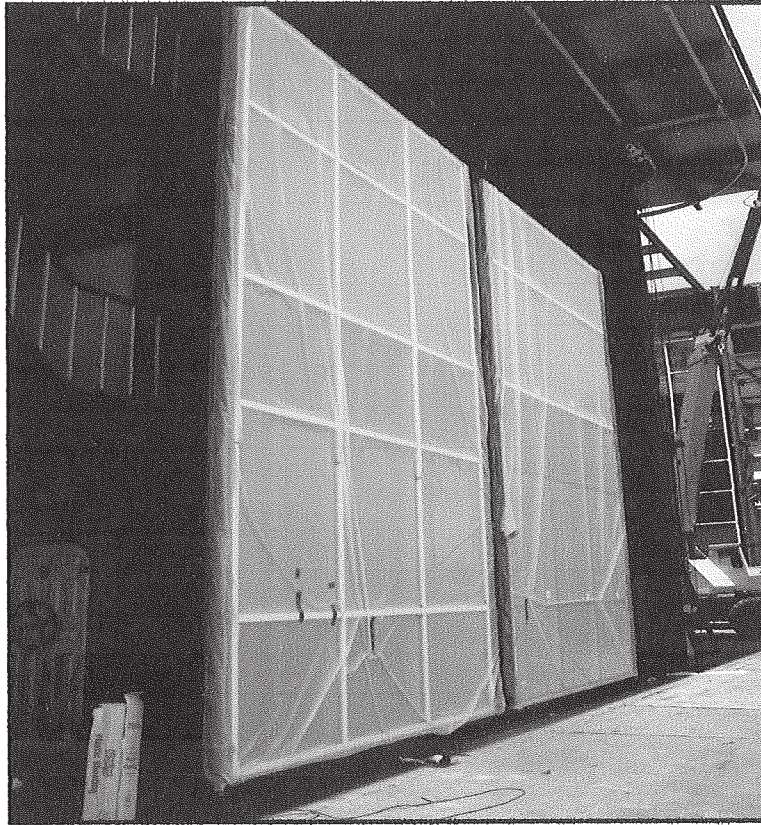
**PHOTOGRAPH 1**

**Static Pressure Air Infiltration Test @ 6.24 psf per ASTM E 283-04**

The specimen and perimeter sealant joints were completely covered with an impervious 4 mm plastic material and duct tape, thus allowing no movement of air through the specimen. The exterior face of the specimen was subjected to a positive pressure differential of 6.24 psf to obtain a leakage rate for the test chamber. The plastic bag was removed and the chamber infiltration was subtracted from the total air infiltration resulting in the infiltration rate of the test specimen.

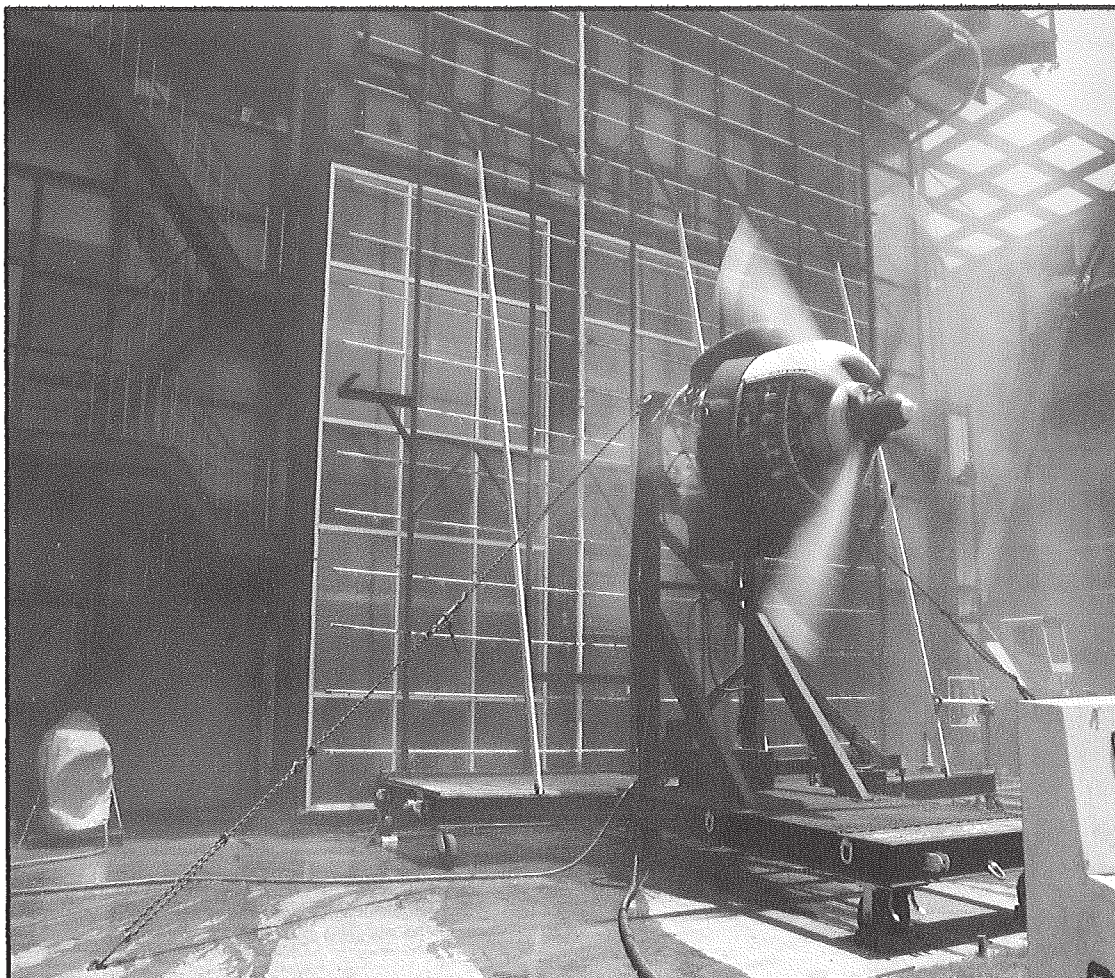
**PHOTOGRAPH 2**

**Dynamic Water Penetration @ 76 mph Slipstream Velocity per AAMA 501.1-05**

**Results:** Passed with no water penetration observed.

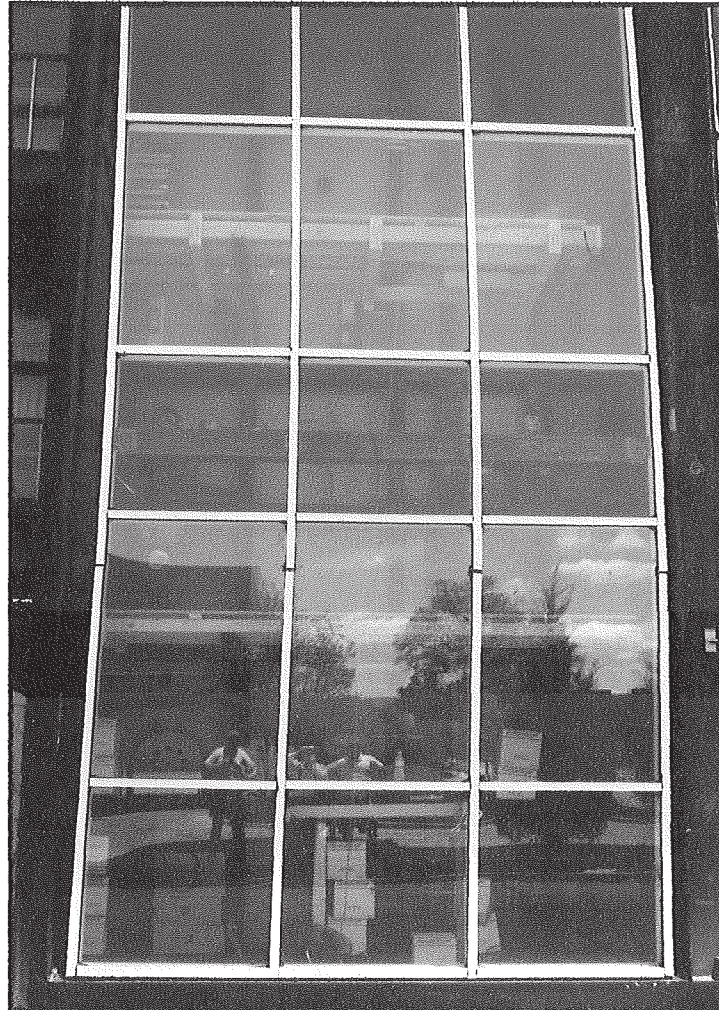
**PHOTOGRAPH 3**

**Seismic Induced Interstory Drift Test Design Displacement @ 0.015 x Story Height per AAMA 501.4-00**
