CONSTRUCTION CONSULTING LABORATORY, *INTERNATIONAL*

**AAMA 501-05 Curtain Wall Mock-Up Testing  
EFCO Corporation, a Pella Company  
SERIES 5600 System 2 and 4 Sided  
Structural Glazed Curtain Wall Mock-Up  
REPORT #CCLI 12-052**

**March 29, 2012**

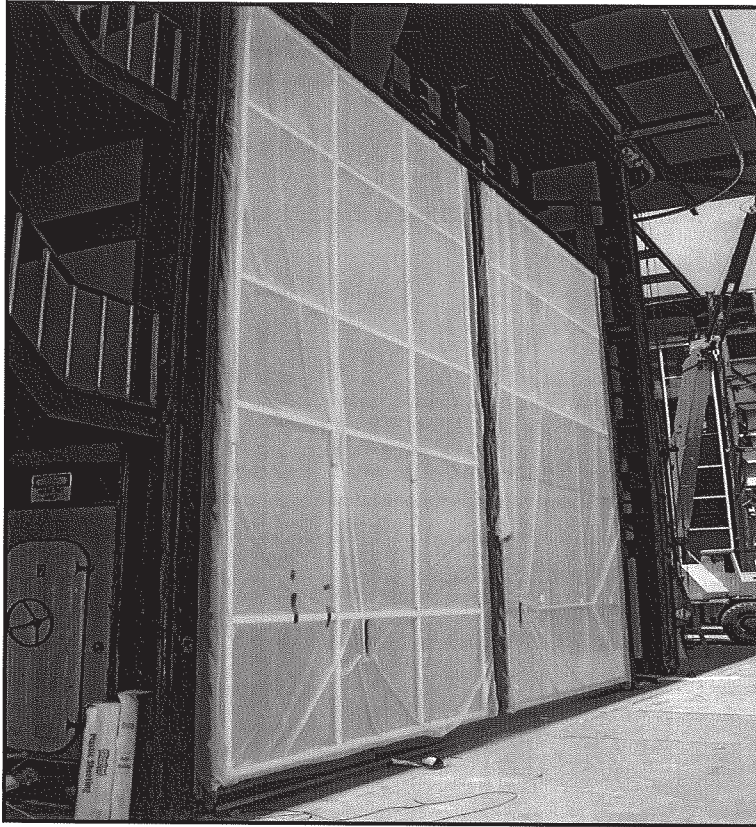
**PHOTOGRAPH 1**

**Results:** Passed

**Static Pressure Air Infiltration Test @ 6.24 psf per ASTM E 283-04**

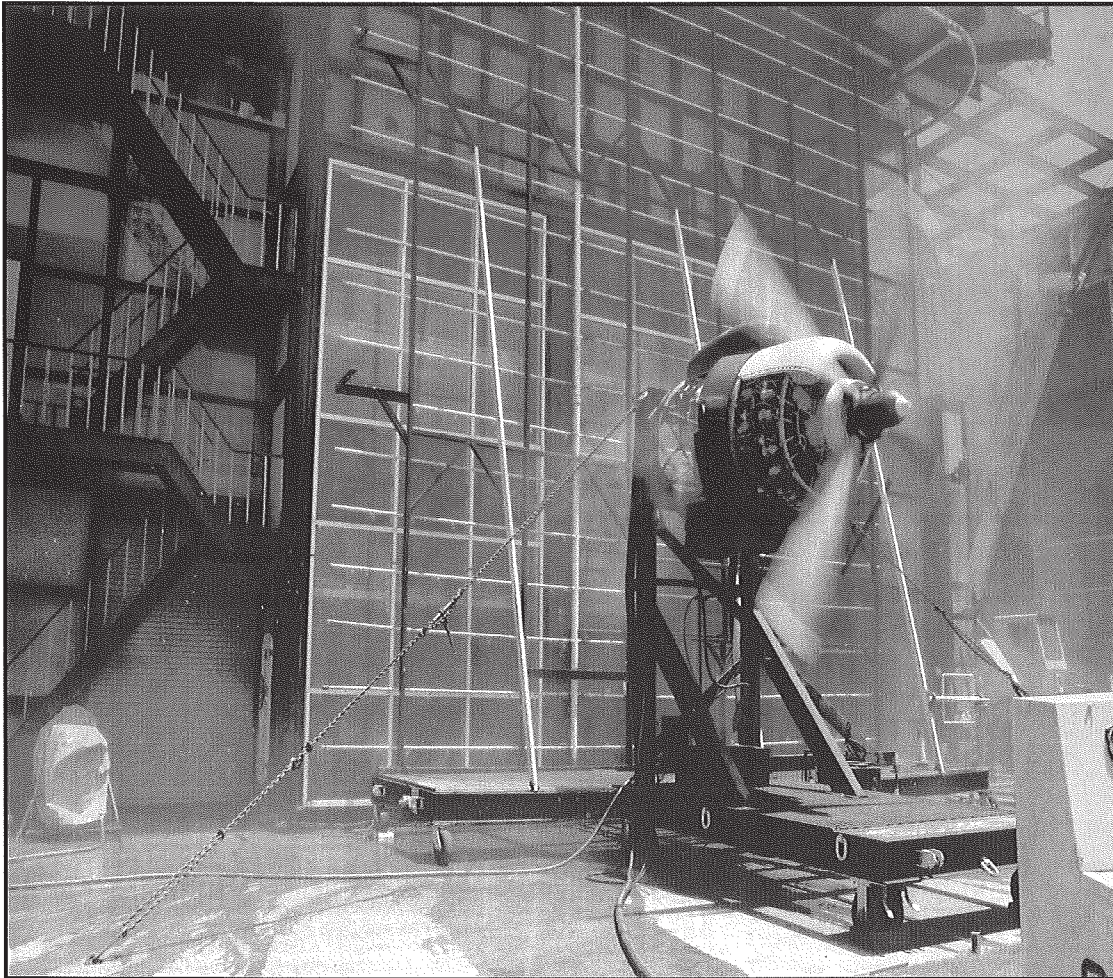
**PHOTOGRAPH 2**

**Dynamic Water Penetration @ 76 mph Slipstream Velocity per AAMA 501.1-05**

**Results:** Passed with no water penetration observed.

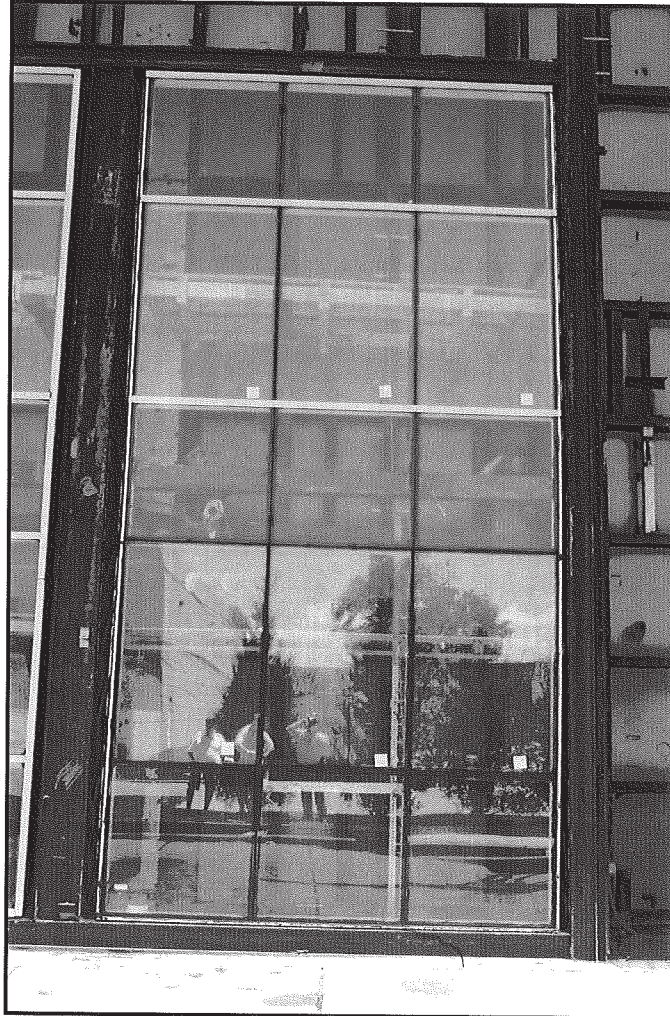
**PHOTOGRAPH 3**

**Results:** Passed with no glass breakage.

**Seismic Induced Interstory Drift Test Design Displacement @  $0.015 \times$  Story Height per AAMA 501.4-00**
