## MIAMI-DADE COUNTY PERFORMANCE TEST REPORT

AMARR GARAGE DOORS

PRODUCT: Coated Steel Door Skin Panels

Report No: C5463.01-106-18

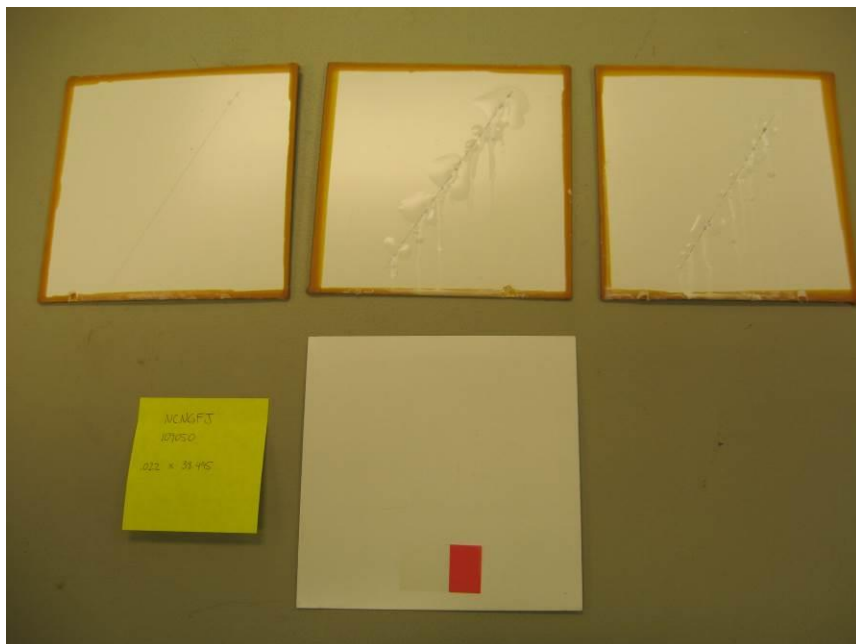
**Photo No. 6**  
**Sample Group A (G-40 [NCNGFJ]) - After 1000 Hours Exposure**

| Specimen Details | | Scribe Creepage | | Unscribed Area Blister Rating and Observations |
|---|---|---|---|---|
| <b>G-40<br/>Galvanized with Polyester Topcoat (NCNGFJ: white coat backing)</b> | <b>A-1</b> | Coating blistered away from scribe<br>no red rust present | <b>7</b><br>1/32" to 1/16" | Coating blistered away from scribe, no other blisters present |
| | <b>A-2</b> | | <b>0</b><br>5/8" or more | Coating blistered away from scribe, one other blister present |
| | <b>A-3</b> | | <b>3</b><br>1/4" to 3/8" | Coating blistered away from scribe, few other blisters present |

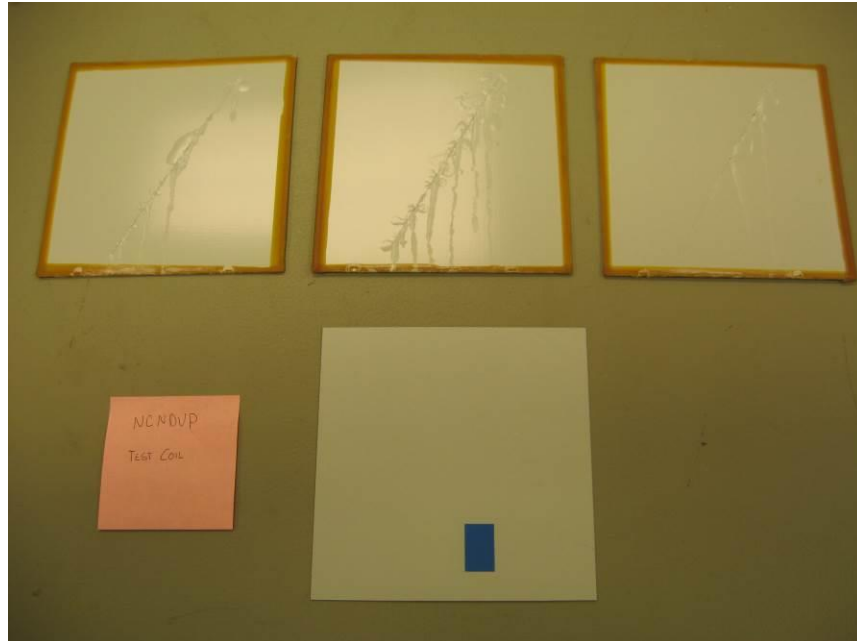
**Photo No. 7**  
**Sample Group B (G-30 [NCNDVP]) - After 1000 Hours Exposure**

| Specimen Details | | Scribe Creepage | | Unscribed Area Blister Rating and Observations |
|---|---|---|---|---|
| <b>G-30<br/>Galvanized with Polyester Topcoat (NCNDVP: green coat backing)</b> | <b>B-1</b> | Coating blistered away from scribe,<br>no red rust present | <b>0</b><br>5/8" or more | Coating blistered away from scribe, few other blisters present |
| | <b>B-2</b> | | <b>1</b><br>1/2" to 5/8" | Coating blistered away from scribe, no other blisters present |
| | <b>B-3</b> | | <b>2</b><br>3/8" to 1/2" | Coating blistered away from scribe, one other blister present |

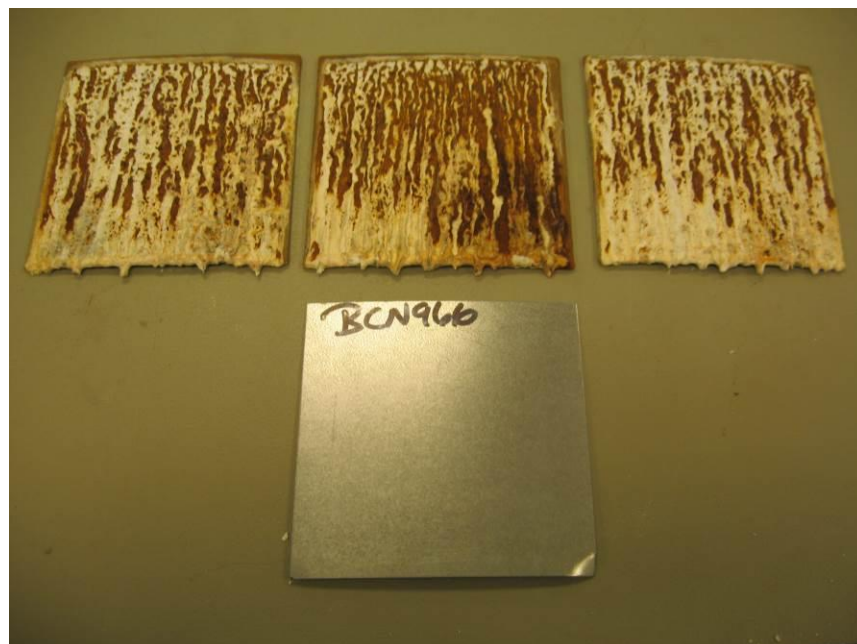
**Photo No. 8**  
**G90 Control Group Samples - After 1000 Hours Exposure**

| Specimen Details | | Scribe Creepage | | Unscribed Area Blister Rating and Observations |
|---|---|---|---|---|
| <b>G-90<br/>Galvanized Control Samples</b> | <b>C-1</b> | Heavy corrosion over entire specimen face (Scribe no longer visible) | <b>0</b><br>5/8" or more | No top coat to evaluate |
| | <b>C-2</b> | | <b>0</b><br>5/8" or more | |
| | <b>C-3</b> | | <b>0</b><br>5/8" or more | |
