Project No. T313-19LT

### PERFORMANCE TEST REPORT

TAS 100-95  
TEST PROCEDURE FOR WIND AND WIND DRIVEN RAIN  
RESISTANCE OF DISCONTINUOUS ROOF SYSTEMS  
PERFORMANCE TEST REPORT

LIFETIME TOOL B.D. VENT

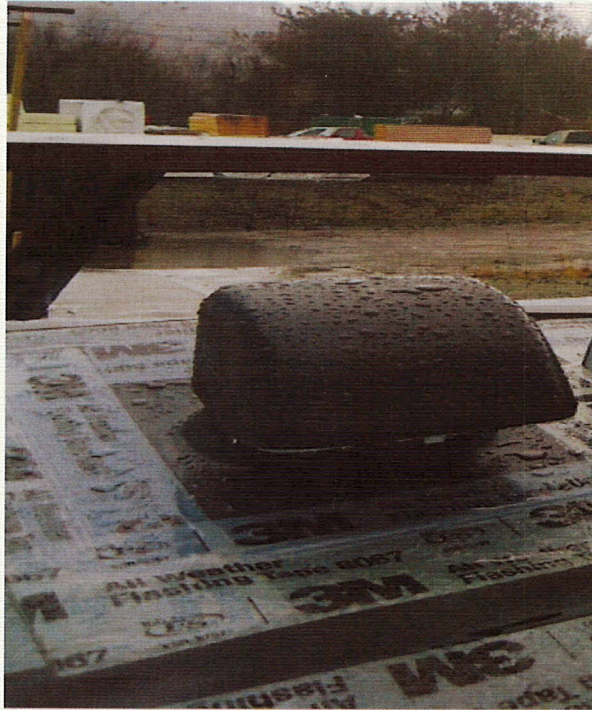
**TOP OF DECKING**

Upon completion of the test wind speeds, visual observation indicated that there was no damage to the exposed roof vents system. See Test Data for indication of leakage thru exposed 4” diameter extended pipe on underneath of specimen.

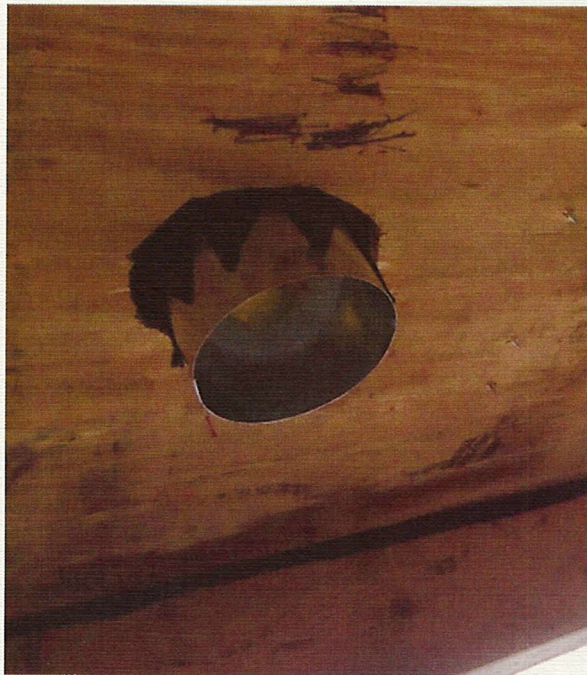
**BELOW DECKING WITH 4" DIAMETER EXTENDED PIPING**

Note: No Leak – No water coming thru 4” extended pipe on underneath of specimen

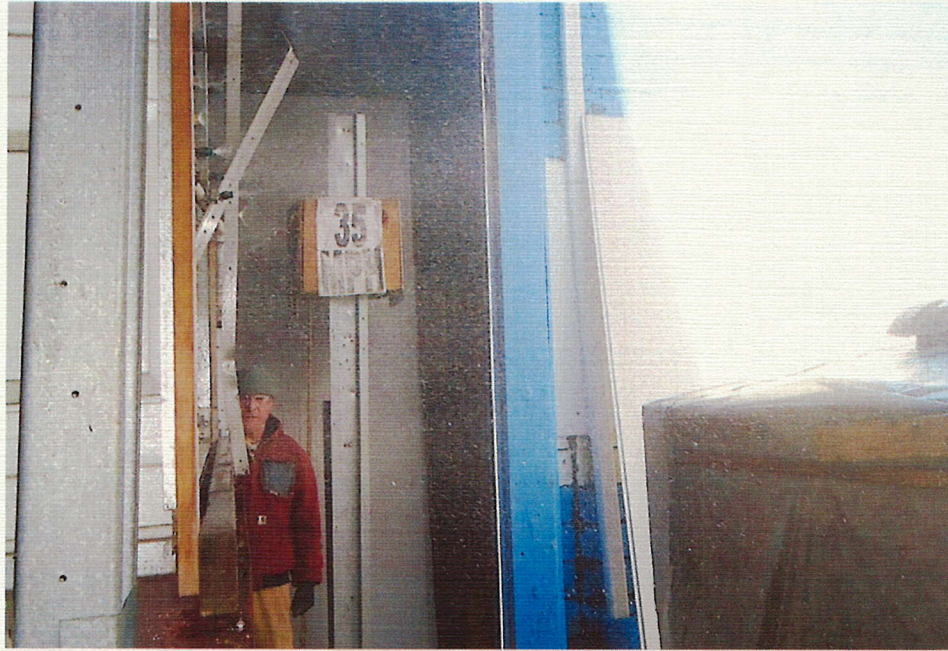
**WIND SPEED @ 35 MPH**

| SPECIMEN | WIND<br>SPEED | WIND<br>SPEED | WIND<br>SPEED | WIND<br>SPEED | COMMENTS |
|---|---|---|---|---|---|
| (LIFETIME TOOL<br>B. D. VENT) | No Leaks | No Leak | No Leak | No Leak | No leakage thru all wind<br>speeds. |
