Best Practices for Minimizing Wind and Water Infiltration Damage

HURRICANE MICHAEL IN FLORIDA

Recovery Advisory 2, June 2019

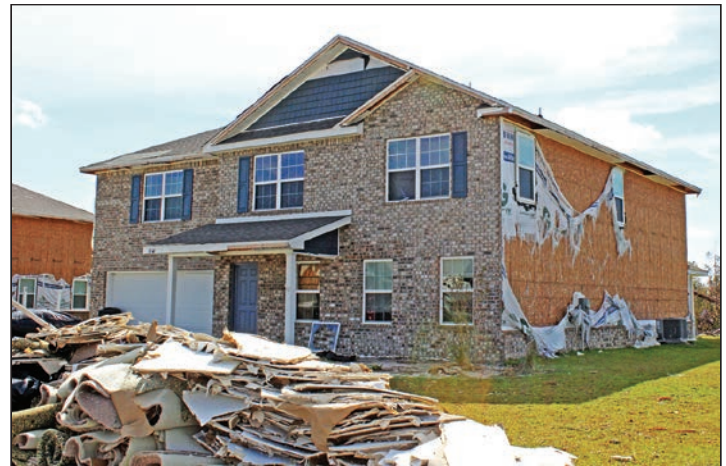
Note that roof covering damage is not visible in the photograph. The resulting interior water damage is indicated by the debris pile near the curb.

Figure 1: House with typical envelope damage (siding, soffit, and fascia cover) observed on newer buildings after Hurricane Michael (Panama City area)

This Recovery Advisory presents important recommendations to reduce wind and water infiltration damage to new and existing residential buildings. The recommendations discussed are from existing Federal Emergency Management Agency (FEMA) Building Science resources, including recovery advisories published after Hurricane Irma, and also include new recommendations and best practices based on observations made by the Mitigation Assessment Team (MAT) after Hurricane Michael struck in 2018 (Figure 1 shows an example of observed damage).

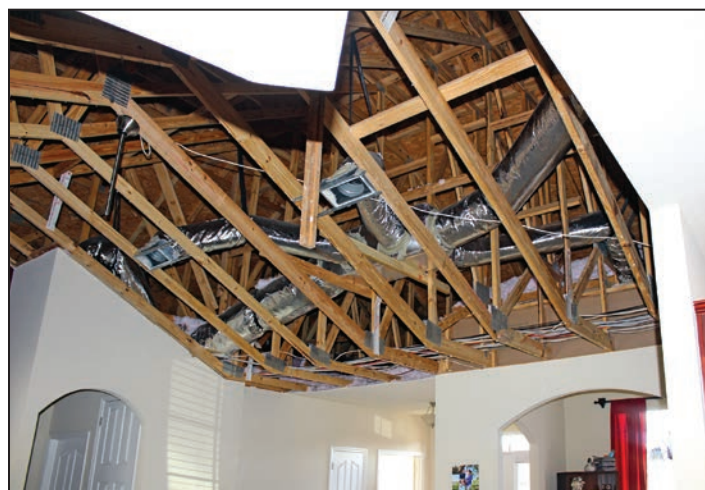
Figure 4: House with significant interior damage from water intrusion (Panama City area)

Interior damage occurred when ridge shingles and the ridge vent were blown off; the drywall on the ceiling collapsed and was removed.

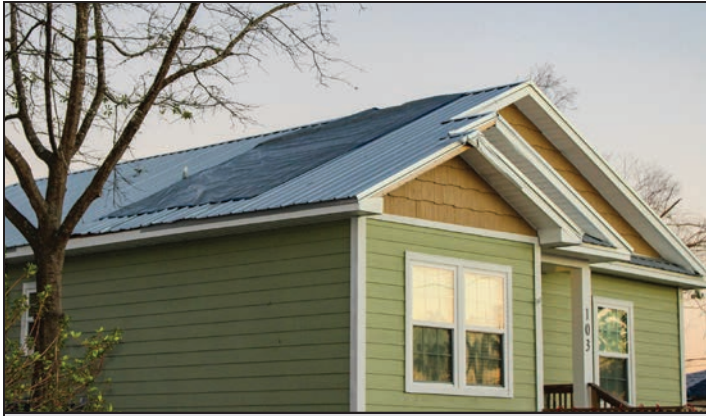
Figure 8:
Successful sealed roof deck (Panama City area)

Example of a sealed roof deck that successfully protected a home during Hurricane Michael after wind-borne debris punctured the metal roof covering.

The benefits of a sealed roof deck were demonstrated in the residence shown in Figure 8. The metal roof covering of the home in the Panama City area was punctured by asphalt shingles that blew off an adjacent building during Hurricane Michael. Although the metal roof was damaged, the home had a sealed roof deck constructed in accordance with Option 1 shown in Figure 5 and did not suffer any interior water damage.
