EVALUATION OF DRAFTSTOPPING WITHIN TYPE V COMBUSTIBLE CONCEALED ATTIC SPACES

**Florida Building Commission
and
The University of Florida**

**Koffel Associates, Inc.
8815 Centre Park Drive, Suite 200
Columbia, MD 21045-2107**

Final Report – July 10, 2014

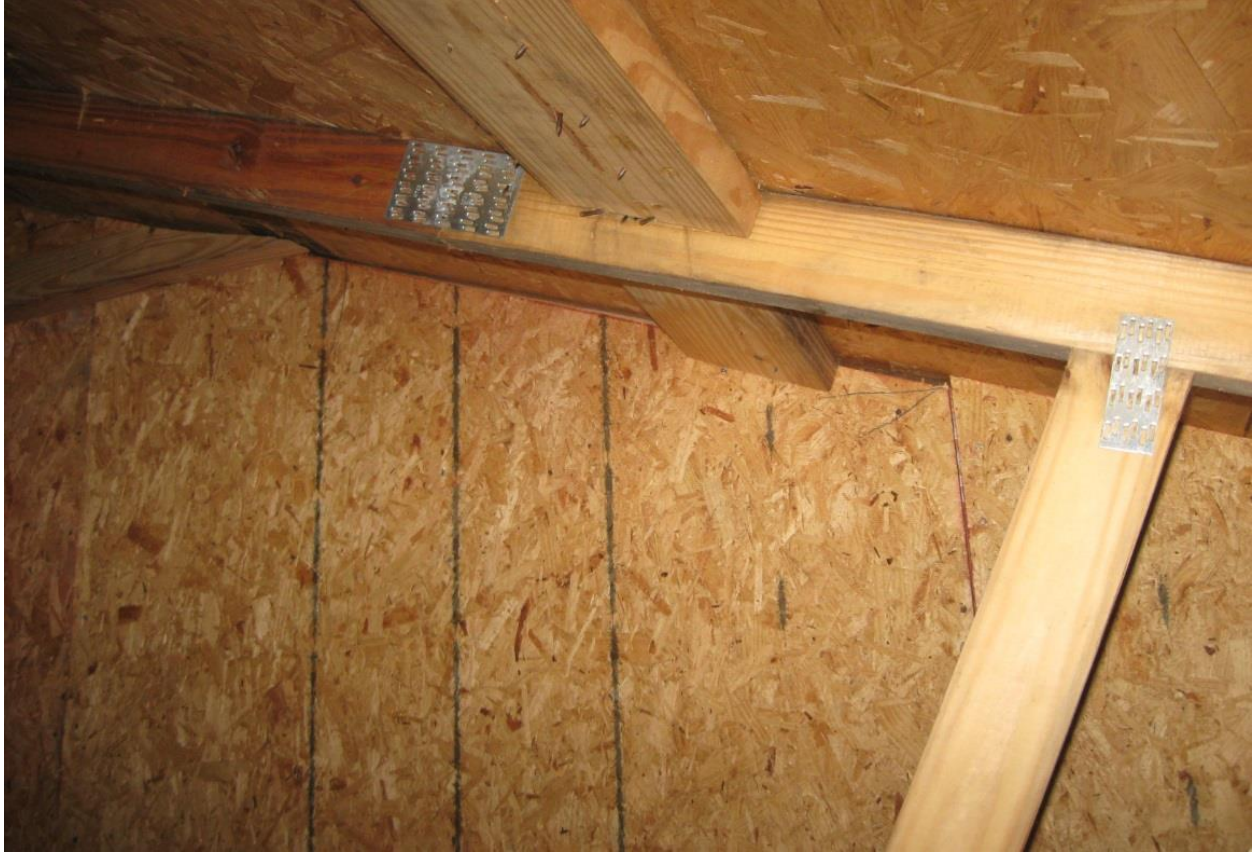
Picture 01 – Typical Plywood Draftstopping

- 1) Plywood (wood structural panel) is the most common draftstopping material (See Pictures 01 through 03).
- 2) The only other draftstopping material observed was gypsum (See Pictures 04 and 05).
- 3) Very few of the buildings had any type of penetration or joint protection.
- 4) Most draftstopping was installed parallel to the trusses. The only case where it was more efficient to install perpendicular to the trusses was where each truss was installed in two sections (due to size and site constraints) and a corridor ran the entire length of the building perpendicular to the trusses (See Pictures 06 and 07).

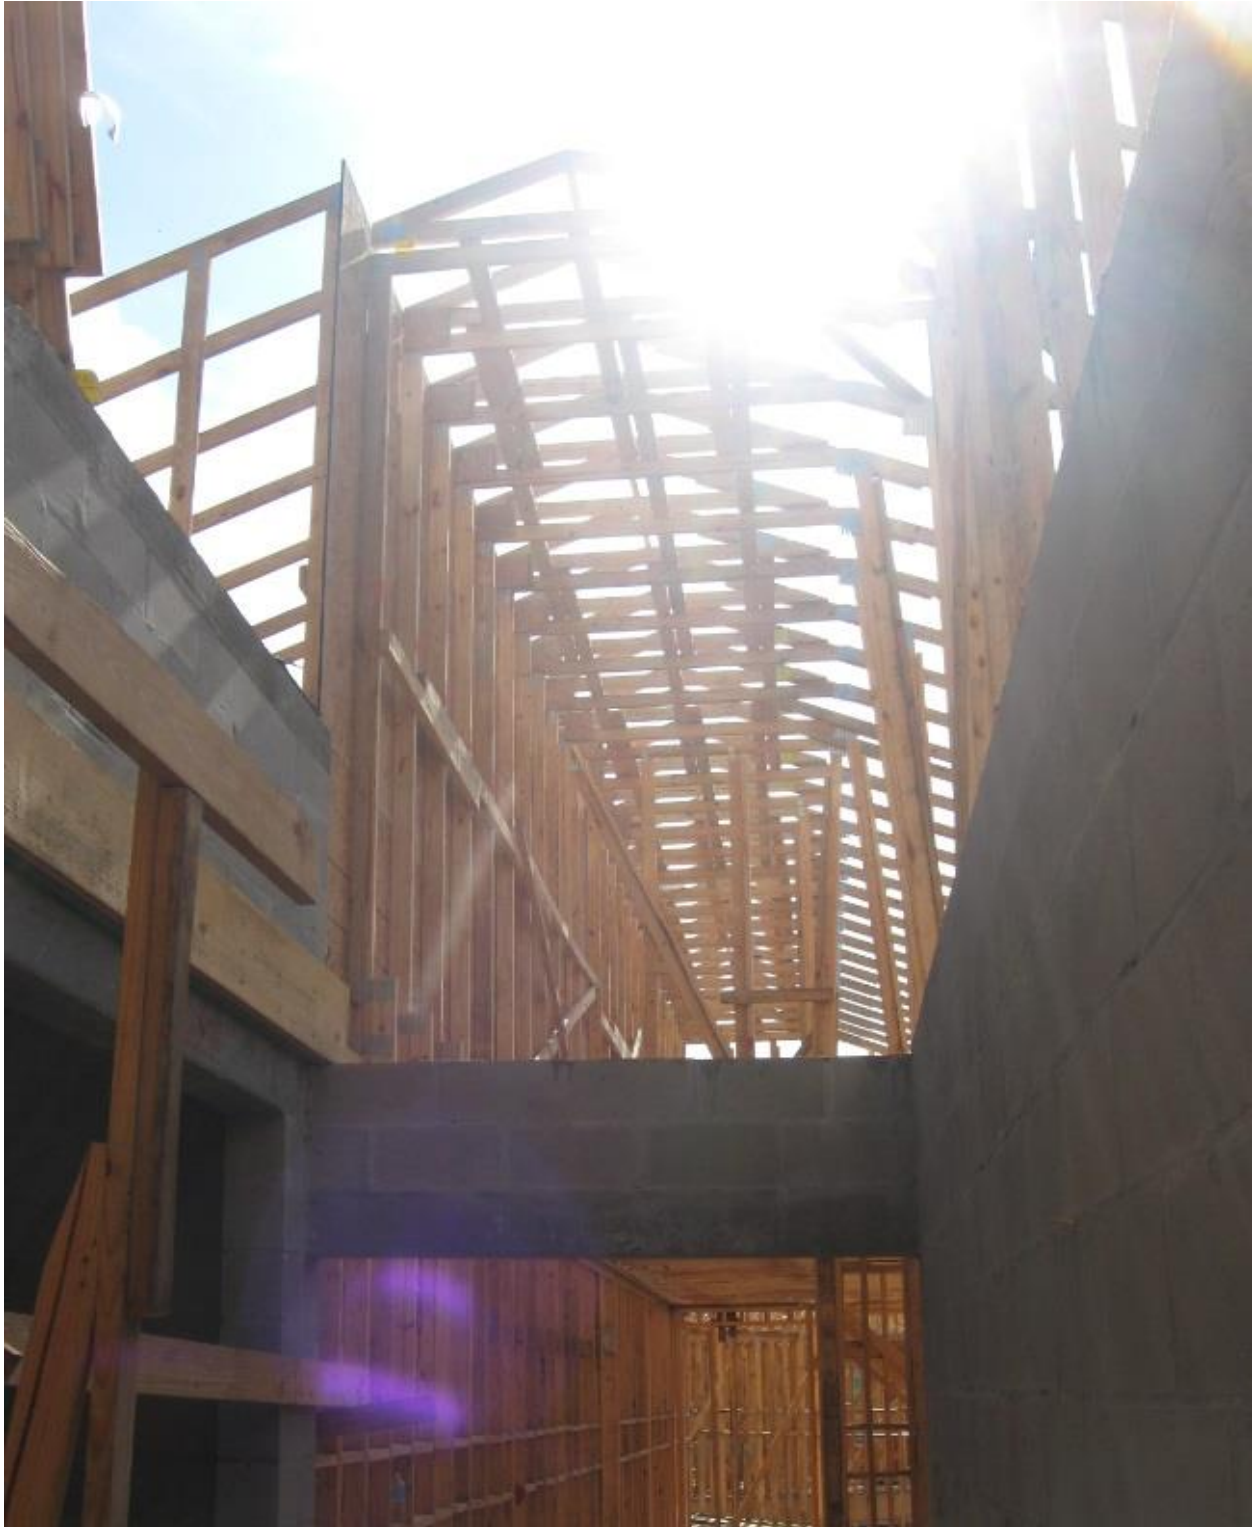
Picture 06 – Draftstopping Installed Perpendicular to the Trusses

Note how the trusses are in two sections.

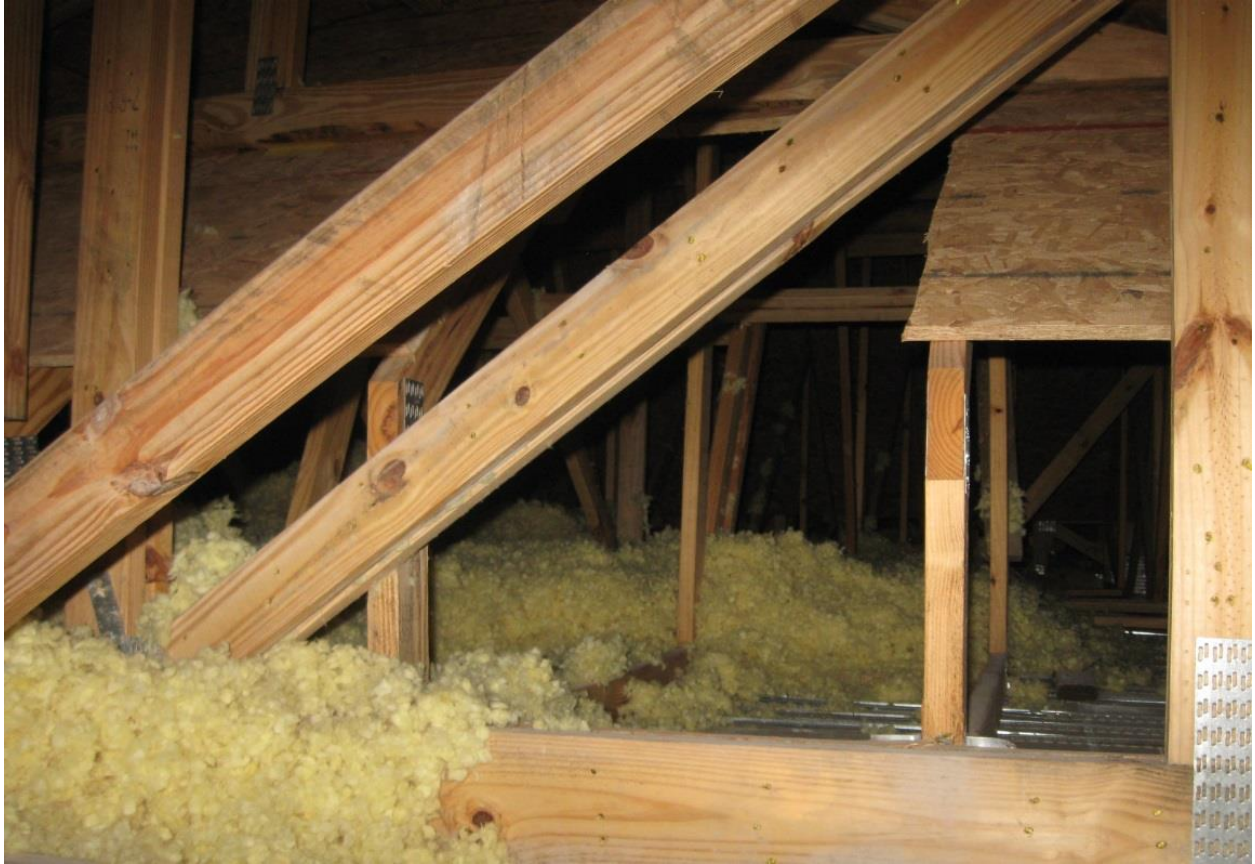
Picture 08 – Building 6 Deficiency.

- 1) Only 1 of the 7 buildings under construction had draftstopping that was deficient. This deficiency appeared to be from lack of details provided on the permit drawings (See Picture 08).

Note that the draftstopping stops about 2 ft from the attic floor and the access opening is not provided with a self-closing door.

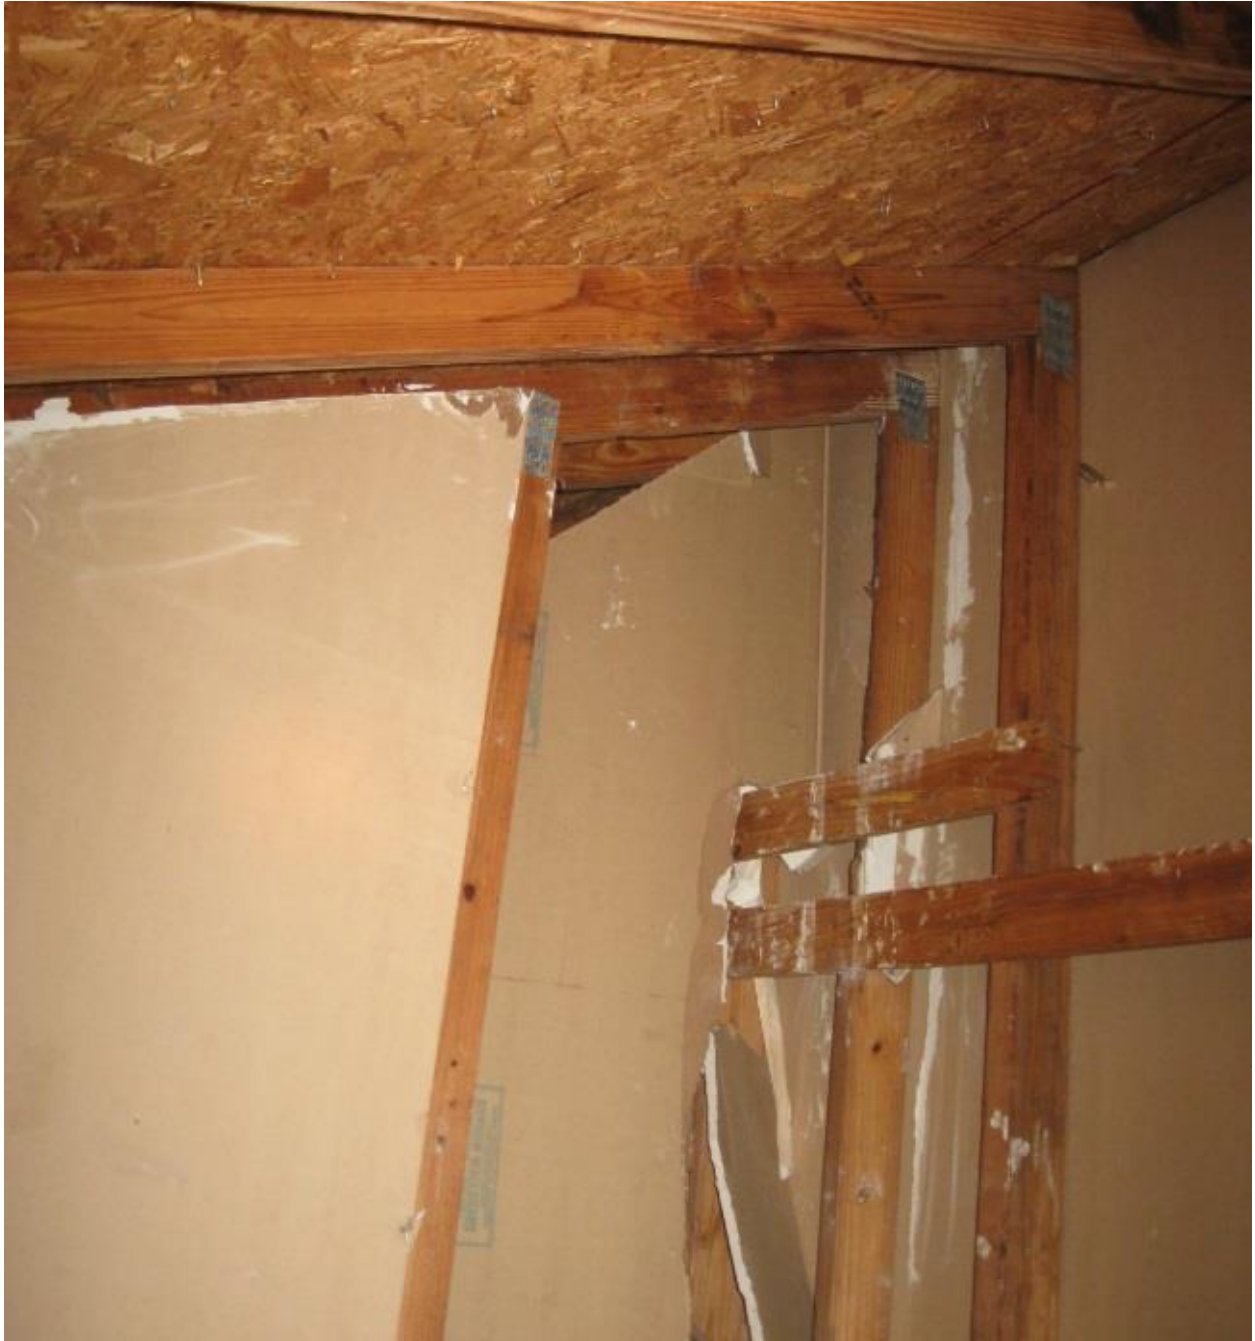
Picture 09 – Building 11 Deficiency.

Note that the draftstopping has partially fallen out of place.

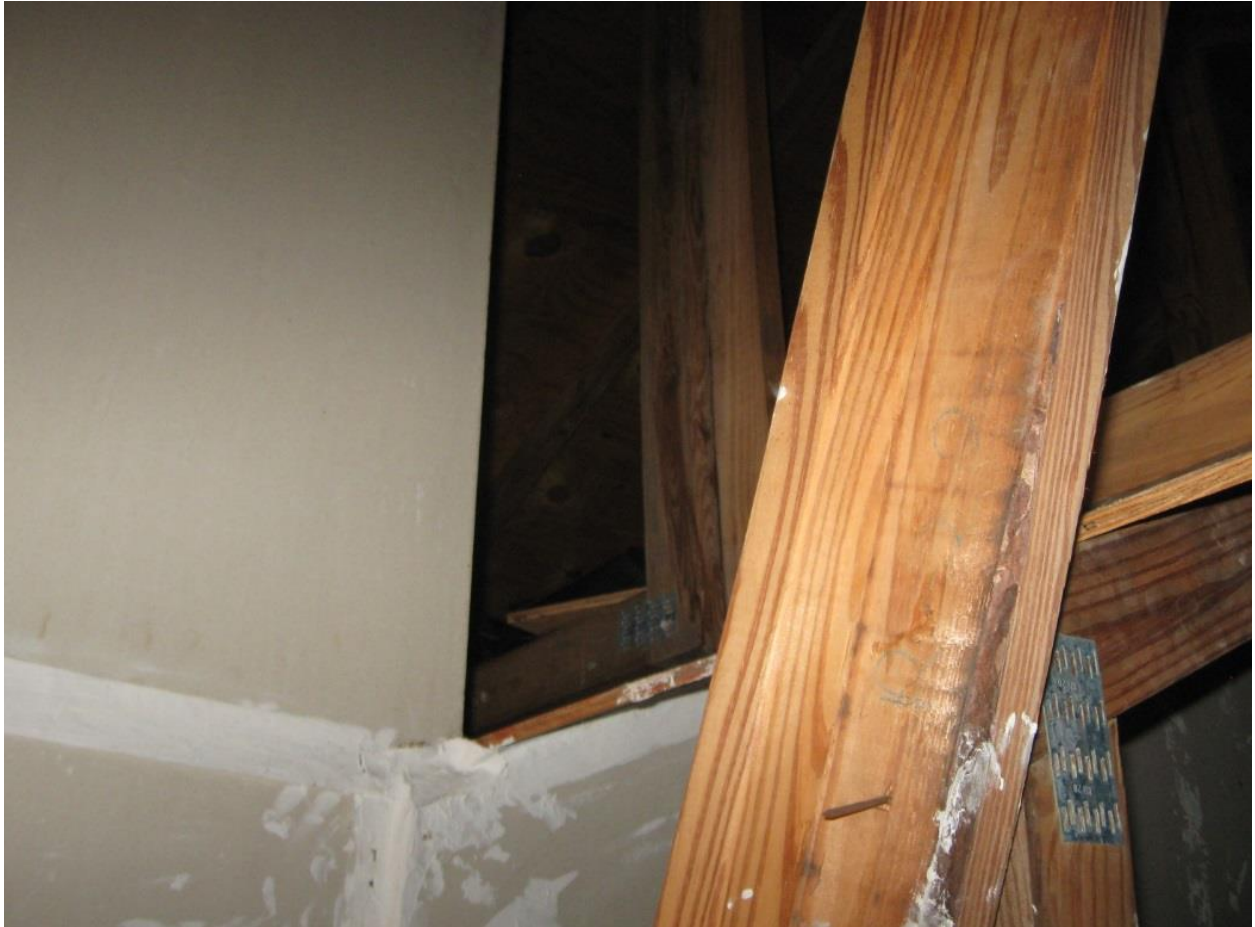
Picture 10 – Building 12 Deficiency.

- 4) All of the existing buildings were draftstopped along every unit separation, even though this was historically not required.
- 5) Two of the 5 existing buildings had minor deficiencies (See Pictures 10 through 12). However, these could be compensated by the fact the draftstopping was over-designed.

Note that the draftstopping is not continuous around part of the roof.

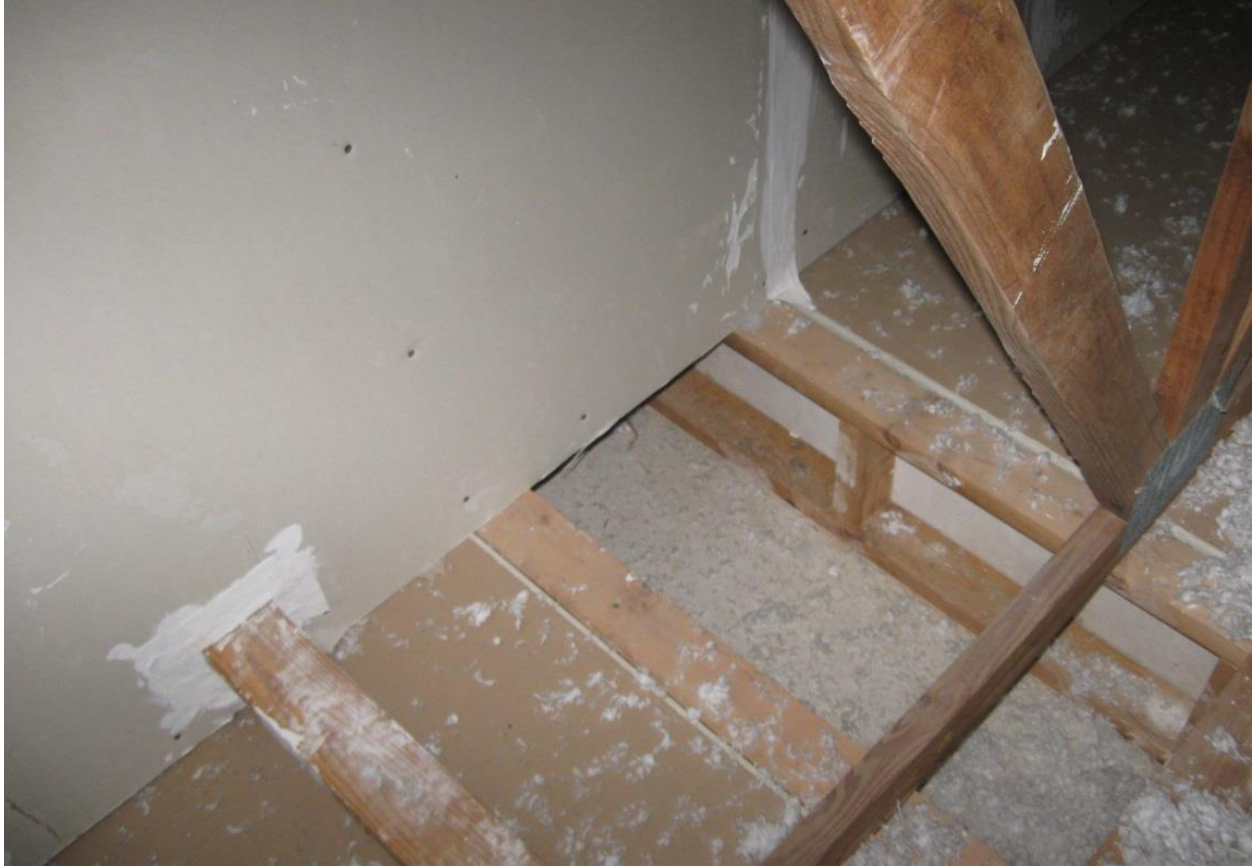
Picture 11 – Building 12 Deficiency.

Note that the draftstopping is not installed down into a ceiling soffit.

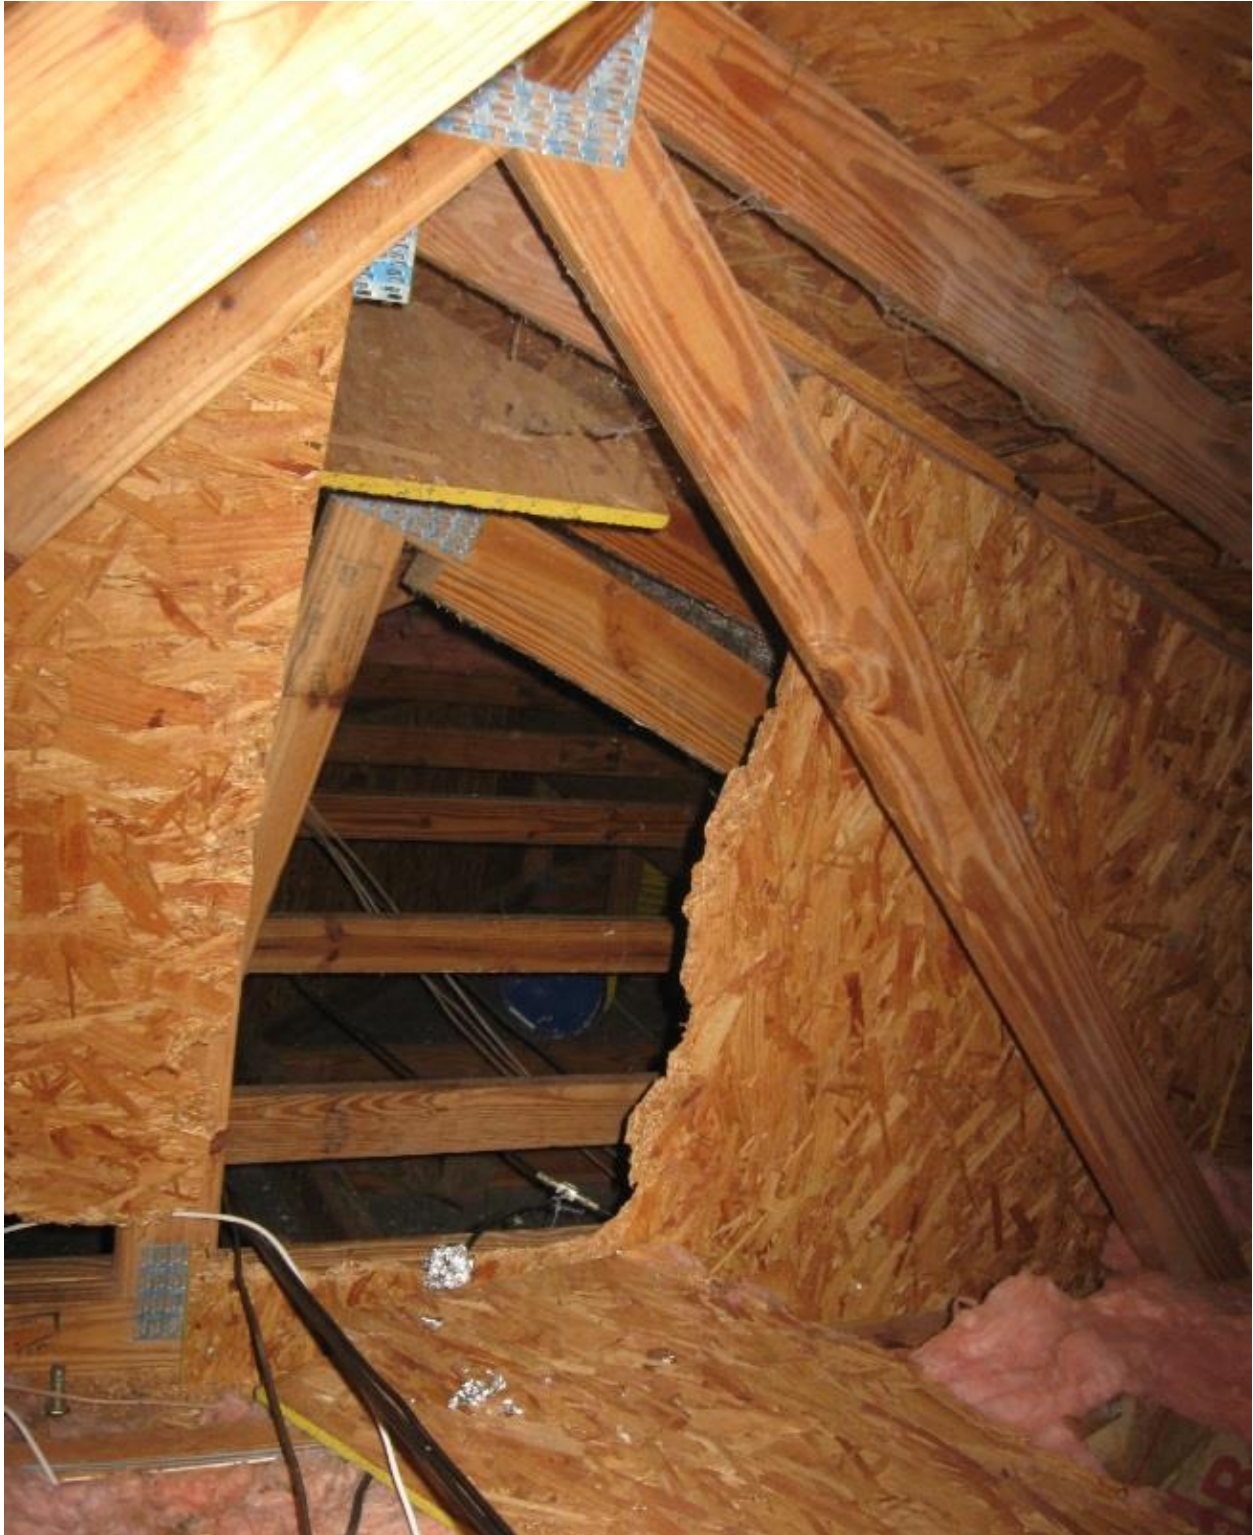
Picture 13 – Building 15 Deficiency.

- 1) The two existing R-2 Hotels were both sprinkler protected in the attics, though this is not required.
- 2) The two existing R-2 Hotels had draftstopping in the attics, though this was not required due to the sprinkler protection. However, it was not maintained in one of the properties.
- 3) One of 2 Business buildings was observed without draftstopping.
- 4) The Business building with draftstopping had major deficiencies (See Picture 13).

Note the hole cut for access and penetrations.

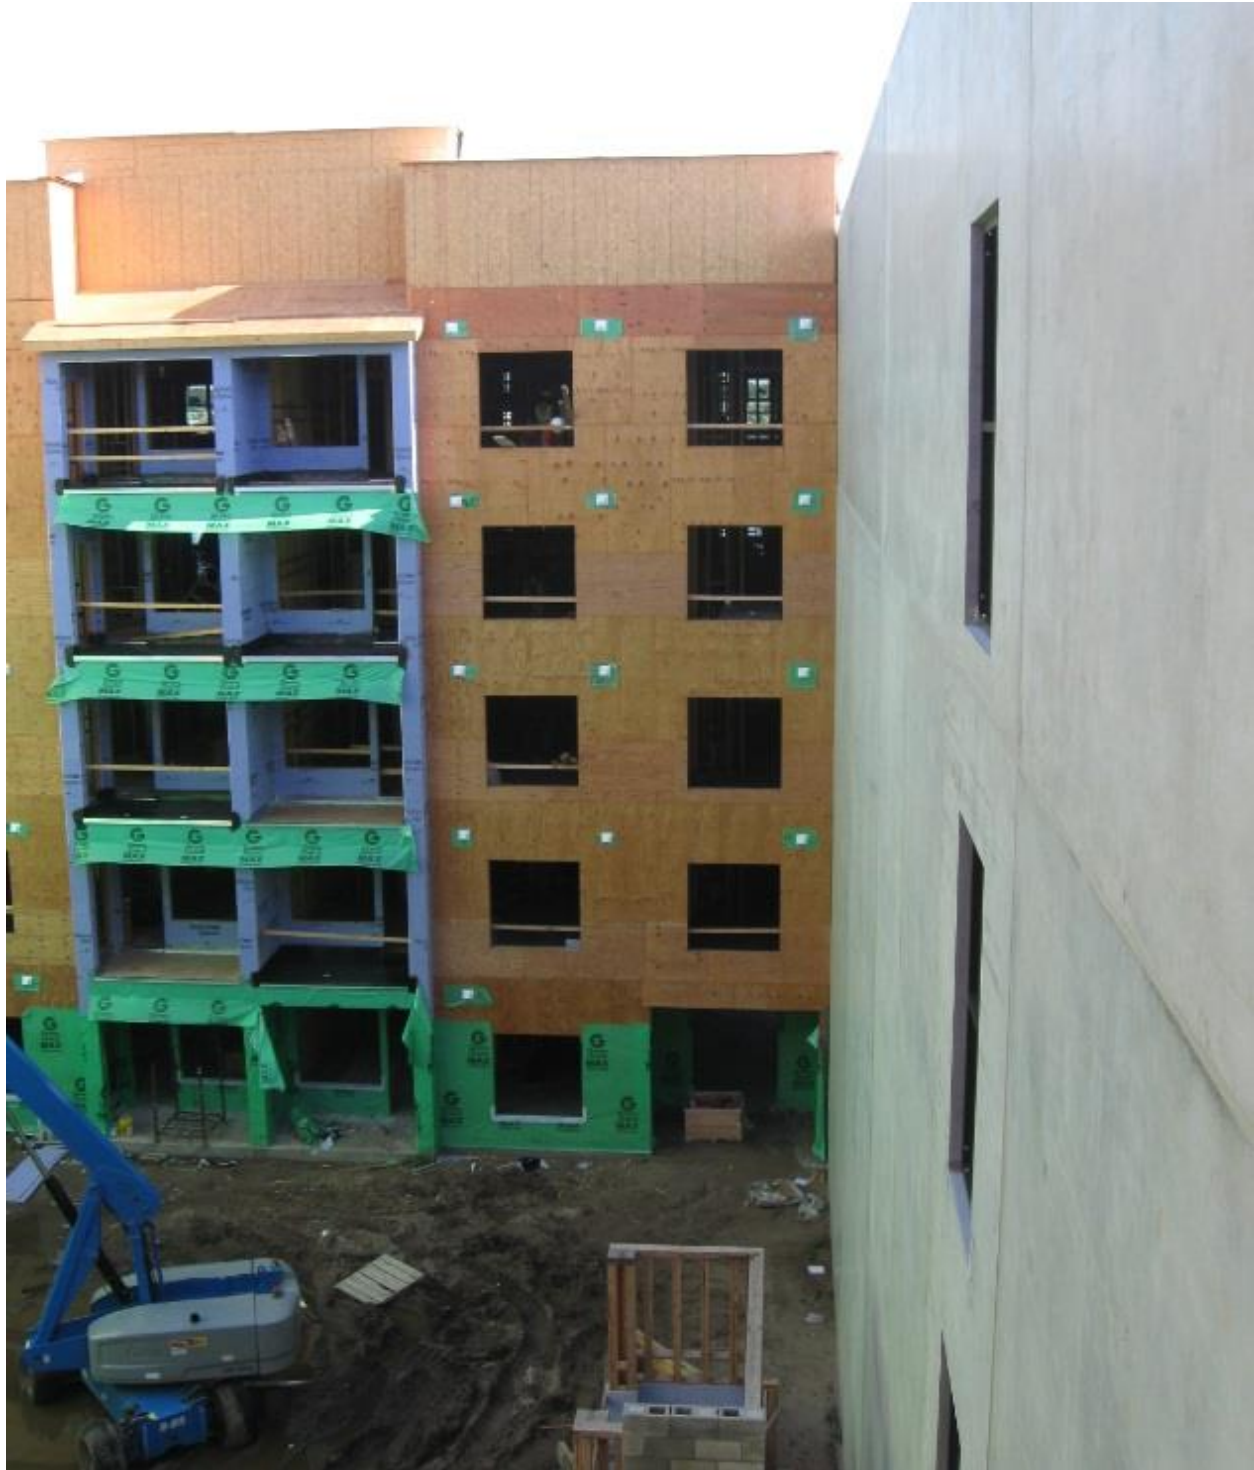
Picture 14 – Type III Construction with Exterior Walls of Fire-Retardant-Treated Wood Adjacent to Concrete Parking Garage

The R-2 Apartment under construction is of Type III construction with exterior walls of fire-retardant-treated wood (See Picture 14). This arrangement is allowed by IBC Section 602.3. Normally, Type III buildings have non-combustible exterior walls. Type III construction with exterior walls of fire-retardant-treated wood is difficult to construct as the exterior wall must be load bearing and cannot be tied into any of the studwork internal to the building. This arrangement appeared to be constructed correctly at the property observed except for at a concrete fire wall, which would create an exterior wall (See Picture 15). The fire wall also appeared to be constructed incorrectly as it was not independent of the attached concrete parking garage.

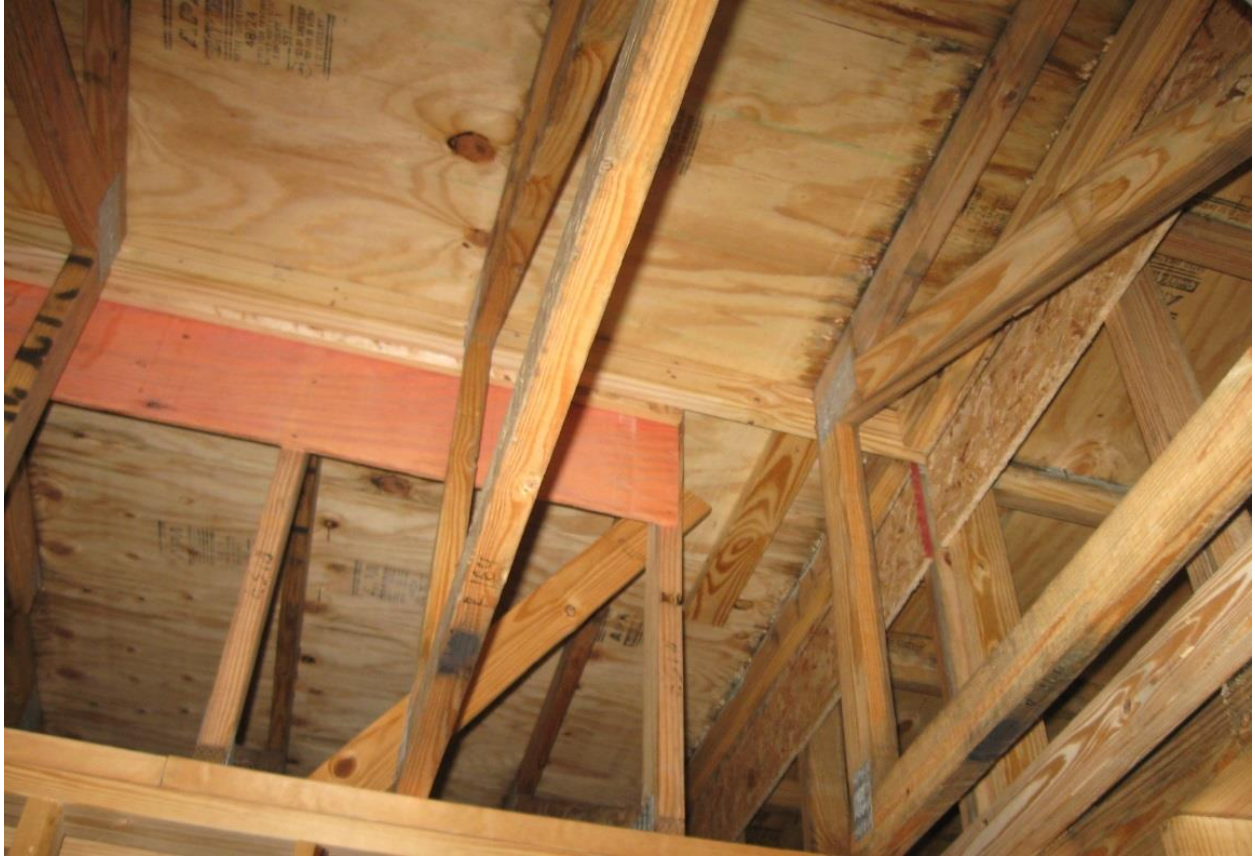
Picture 16 – Draftstopping for Interstitial Sprinklers.

The R-2 Apartment under construction of Type III construction also used interstitial sprinklers. This specialty type of sprinkler requires draftstopping to 1,000 sq ft per the listing of the sprinkler (See Picture 16). However, this draftstopping was deficient as it was not continuous.

Note that the two sections stop short.

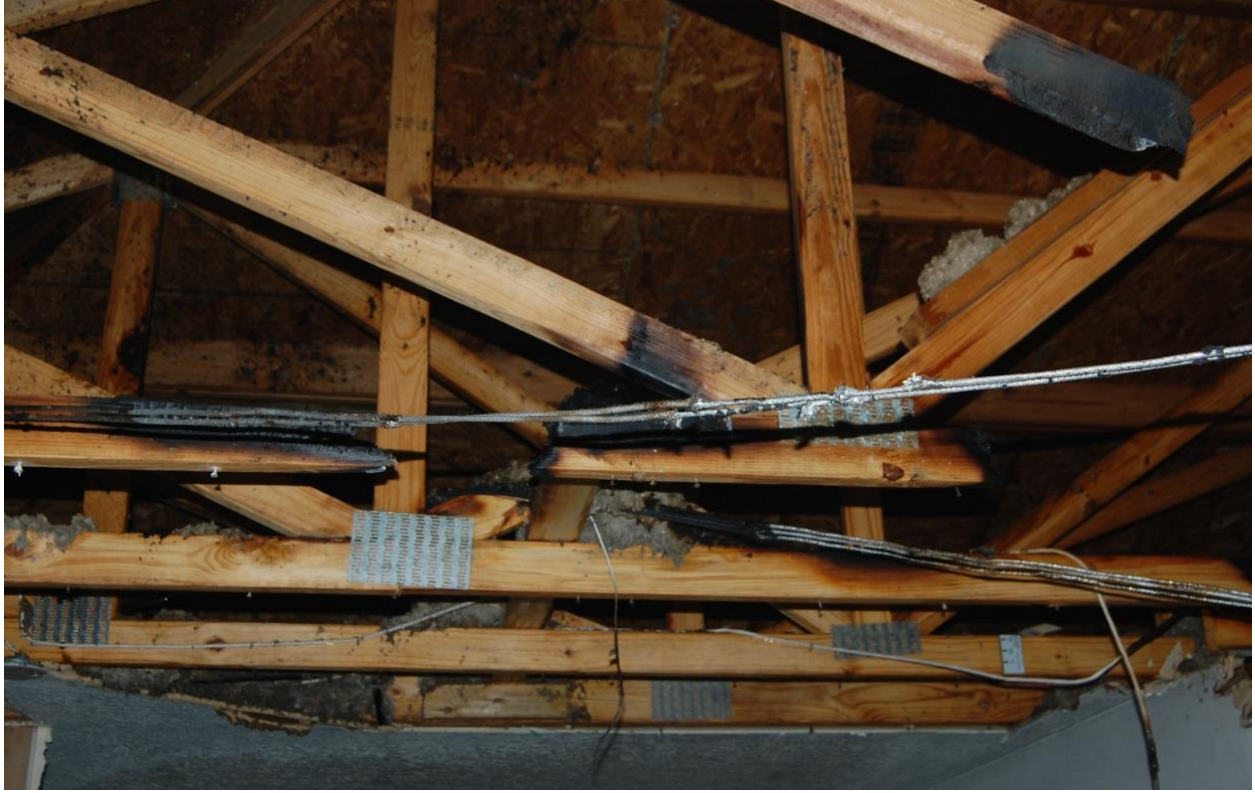
Picture 18 – Lightning Strike in Wood Attic.

Note that this is post-fire with minor damage.
