Final Report for Project Entitled:
Corrosion of Roofing and Screen Enclosure Fasteners Systems

Performance Period: 10/10/2014 – 6/30/2015

Florida Building Commission
State of Florida Department of Business and Professional Regulation

Designated Project Leader: Kurtis R. Gurley

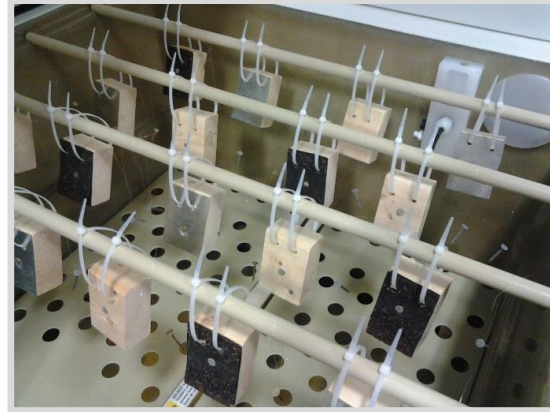
The test chamber accommodated all of the 88 specimens. Figure 1 presents images of the specimens placed in the test chamber prior to testing. Each specimen was suspended from a rod by either zip-ties (installed specimens) or fishing line (bare specimens). No specimen was in contact with any other, and all suspension rods were in the same horizontal plane.

Figure 1: Images of the prepared roof fastener specimens within the test chamber

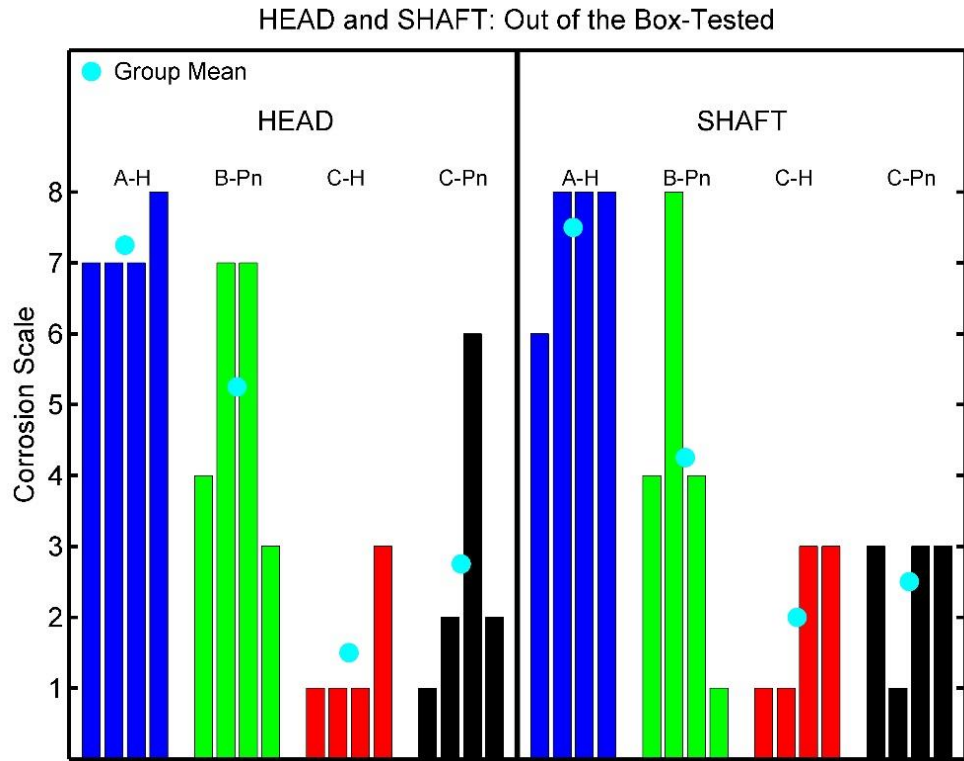
The tabular corrosion scale results in Tables 3 – 5 are presented in graphical form in figures 2 - 5. Figure 2 presents the out of box test results (configuration OB) as documented in Table 3. The vertical axis denotes the corrosion scale presented in Table 2. The colors delineate the manufacturer-install method combinations as labeled on the plot (A-H, B-Pn, C-H, C-Pn), the clusters with four bars each correspond to the four specimens tested in identical conditions, and head and shaft results are presented separately on the left and right half, respectively. The light blue circle associated with each four bar cluster shows the mean score among those four identically tested specimens.

Figure 2: Corrosion scale results for 16 roof fasteners tested out of the box (configuration OB)

Figure 2 demonstrates that the manufacturer C products (red and black bars) performed substantially better than manufacturer A (blue bars) and B (green bars) products when tested out of the box. This is apparent when comparing either the individual bars or the mean corrosion scores (light blue dots) among manufacturers. This is significant in that TAS 114 Appendix E is applied only to out of the box specimens. The difference in performance among manufacturers is not as clear when viewing performance in terms of the pass/fail criterion in Table 9. This suggests that a grading scale may be worth pursuing as a replacement for the current pass/fail requirement.

Interpretation of results in Figures 3 and 4 is best conducted in contrast with the Figure 2 out of the box configuration results. Consider the head results in Figure 2 with the head results in Figure 3. The poor performance of the manufacturer A product is not degraded further by installation, because the out of the box performance is initially so poor. For manufacturer B, the scatter among the four green bars in Figure 2 is reflected in the scatter among the nine green bars in Figure 3. No clear degradation of performance can be observed due to installation. Although the installation through flashing into wood has a slightly higher mean score than the out of the box mean score, the corresponding shingle and bare wood installation results have the counter result, indicating the cause is due to experimental scatter rather than a clear influence of flashing. These head observations also apply when comparing the shaft results in Figures 2 and 4. Conclusions based on manufacturer A and B comparisons are constrained (hindered) by the poor baseline performance in the out of the box results.

- Section 6.6.2 presents the visual analysis of corrosion scale results for out of the box testing. Figure 2 and Table 6 clearly show that manufacturer C performs significantly better than manufacturers A and B. This is significant in that TAS 114 Appendix E is applied only to out of the box specimens in practice. All tested products are electrogalvanized fasteners of identical dimensions

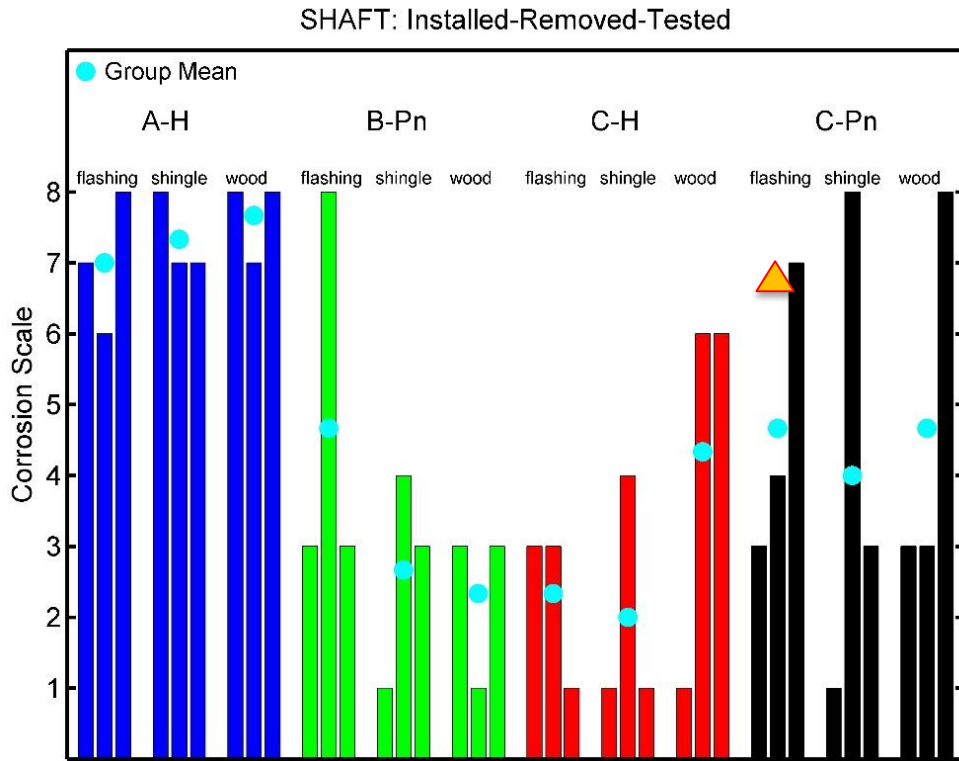
Figures 3 and 4 present the tested after installation and removal results (configuration II), for head and shaft, respectively, as documented in Table 4. The colors delineate manufacturer-install method as labeled (A-H, B-Pn, C-H, C-Pn). The substrate labels (flashing, shingle, wood) delineate the substrate corresponding to the clusters of three specimens tested in identical conditions. The light blue circle associated with each three bar cluster shows the mean score among those three identically tested specimens. The colored triangular icons will be explained in Section 6.6.4.

Figure 4: SHAFT: Corrosion scale results for 36 roof fasteners tested after installation and removal (configuration II)

Figures 3 and 4 present the installed – removed – tested results (configuration II). The purpose for this configuration is to detect any influence the process of installation may have on corrosion resistance due to damage caused by the driver or friction with the substrate, or due to contact with the substrate. This configuration is worst case, or conservative scenario for the shaft resistance, as any damage incurred during installation is then exposed directly to the corrosive environment, in contrast with field conditions.

A single case of manufacturer C product (Figure 4, shaft, pneumatic driver - installed through flashing, removed and tested) indicates a modest ($P = 0.205$) likelihood that the installation process reduced corrosion performance compared to the out of the box results. This evidence is not sufficiently substantial, and the difference is again attributed to experimental scatter.

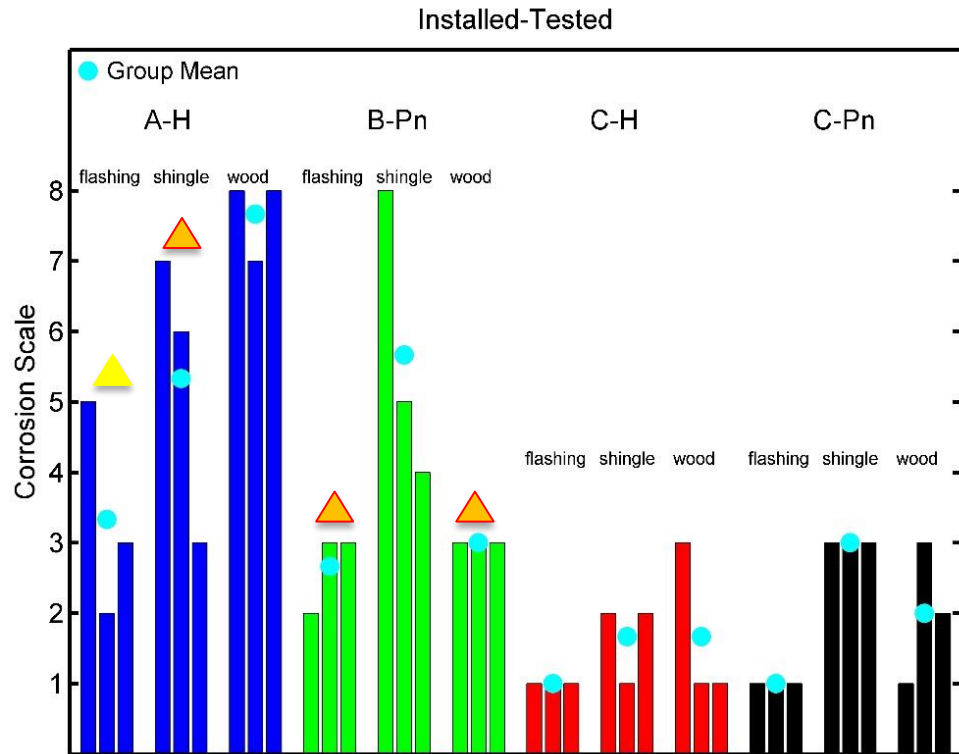
Figure 5 presents the tested as-installed results (configuration I) as documented in Table 5. These results are head-only, as the shaft was within the substrate during testing, and post-test removal showed no corrosion in any specimen that was within a substrate during testing. The colors delineate manufacturer-install method as labeled (A-H, B-Pn, C-H, C-Pn). The substrate labels (flashing, shingle, wood) delineate the substrate corresponding to the clusters of three specimens tested in identical conditions. The light blue circle associated with each three bar cluster shows the mean score among those three identically tested specimens. The colored triangular icons will be explained in Section 6.6.4.

Figure 5: Corrosion scale results for 36 roof fasteners tested as-installed (configuration I)

Figure 5 interpretation is also best conducted in contrast with the Figure 2 out of the box configuration results. Manufacturers A and B show mixed results compared with Figure 2, where performance improves in some cases and remains poor in other cases. This is attributable to experimental scatter. Manufacturer C tested as installed performance is consistent with the out of the box results, with very little corrosion observed on the installed heads.

In Table 10 only a single test indicates statistically significant differences. This test is located in row 5, and highlighted in yellow. This is the comparison between the out of the box (OB) - manufacturer A - hand driven nails - head corrosion results and the tested as installed (I) - manufacturer A - hand driven nails - through flashing into wood substrate. This rejection of the null hypothesis is also indicated in Figure 5 as the yellow triangle above the appropriate grouping.

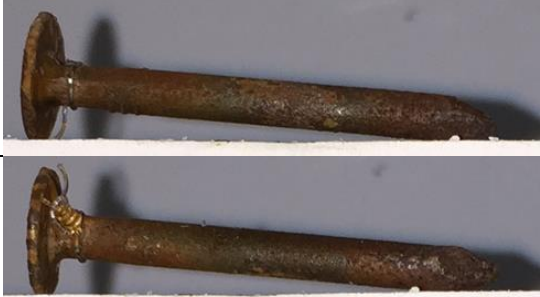
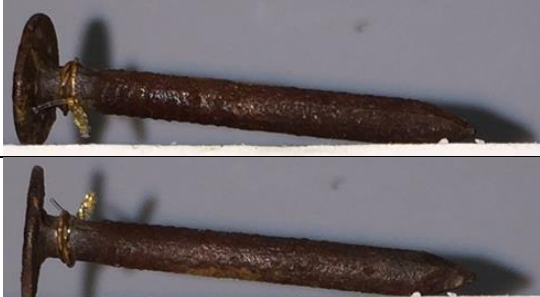
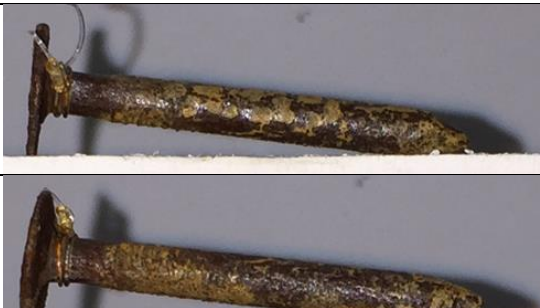
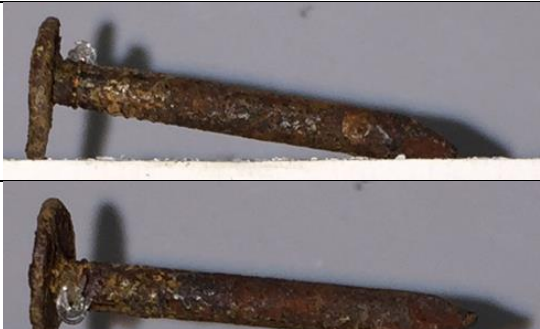
CODE: OB-A-H

Sample 1 Head classification: 7	Sample 1 Shaft classification: 6

Sample 2 Head classification: 7	Sample 2 Shaft classification: 8

Sample 3 Head classification: 7	Sample 3 Shaft classification: 8

Sample 4 Head classification: 8	Sample 4 Shaft classification: 8

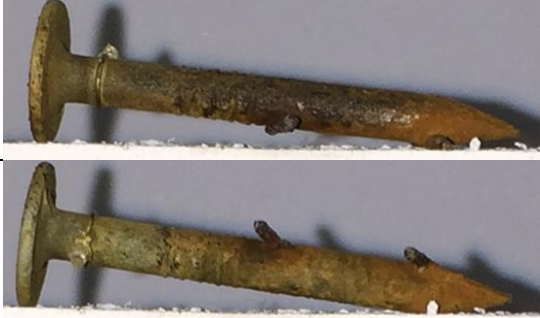
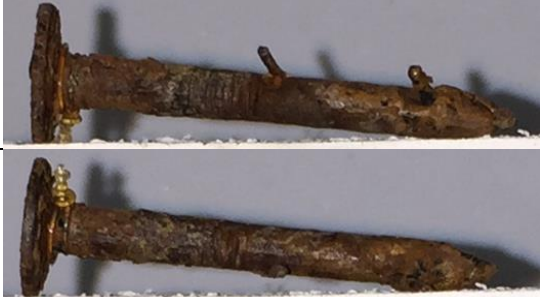
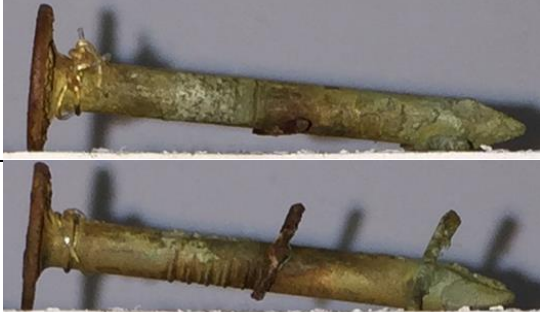
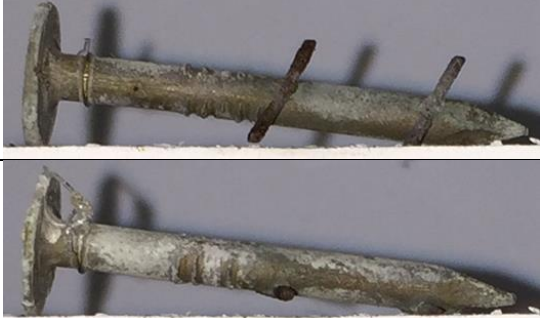
CODE: OB-B-Pn

Sample 1 Head classification: 4	Sample 1 Shaft classification: 4

Sample 2 Head classification: 7	Sample 2 Shaft classification: 8

Sample 3 Head classification: 7	Sample 3 Shaft classification: 4

Sample 4 Head classification: 3	Sample 4 Shaft classification: 1

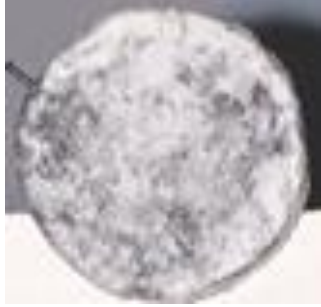
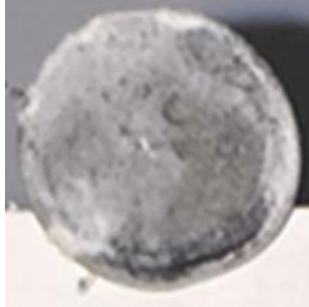
CODE: OB-C-H

Sample 2 Head classification: 1	Sample 2 Shaft classification: 1

Sample 3 Head classification: 1	Sample 3 Shaft classification: 3

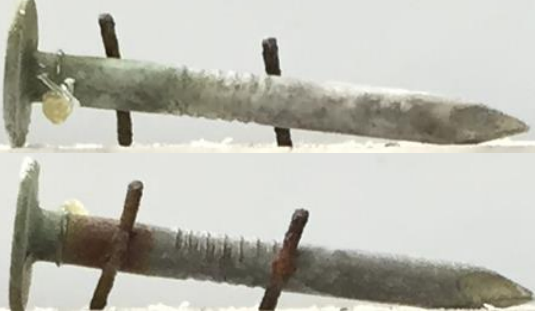
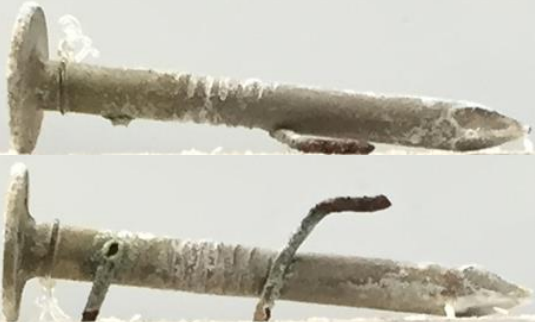
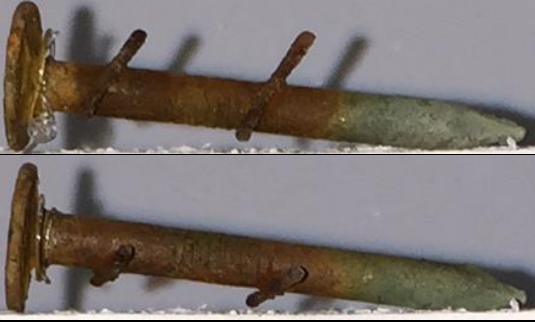
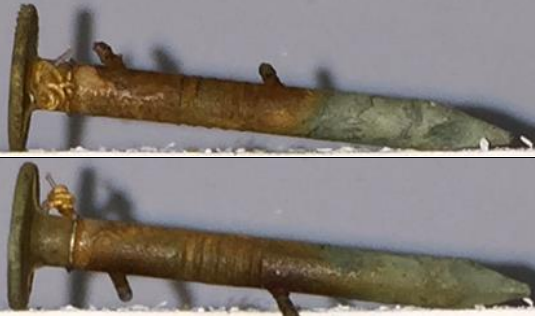
CODE: OB-C-Pn

Sample 1 Head classification: 1	Sample 1 Shaft classification: 3

Sample 2 Head classification: 2	Sample 2 Shaft classification: 1

Sample 3 Head classification: 6	Sample 3 Shaft classification: 3

Sample 4 Head classification: 2	Sample 4 Shaft classification: 3

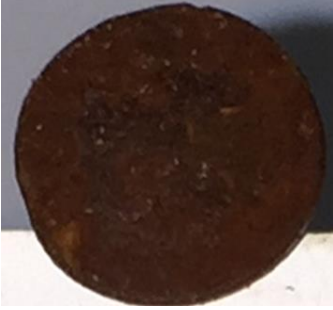
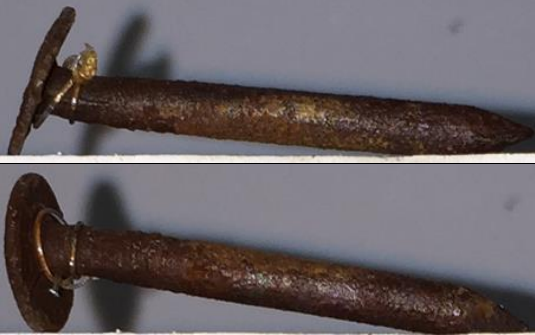
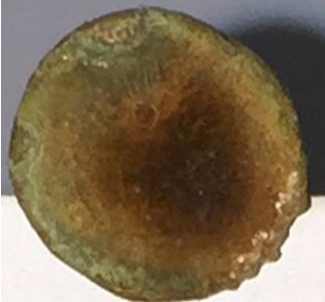
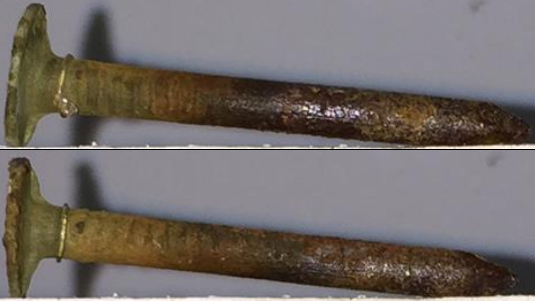
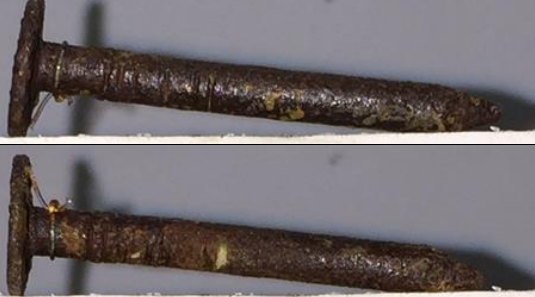
CODE: II-A-H-F

Sample 1 Head classification: 8	Sample 1 Shaft classification: 7

Sample 2 Head classification: 6	Sample 2 Shaft classification: 6

Sample 3 Head classification: 8	Sample 3 Shaft classification: 8

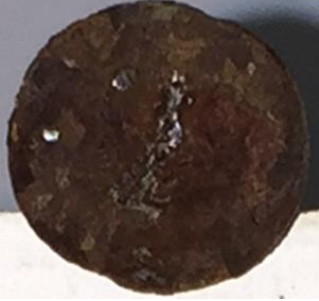
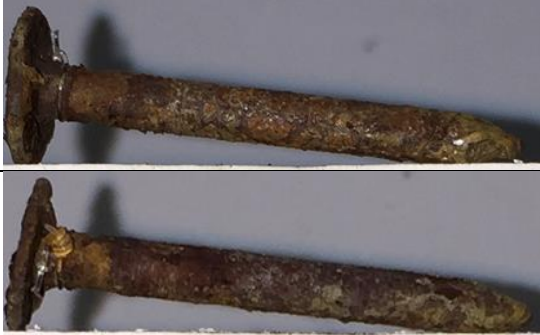
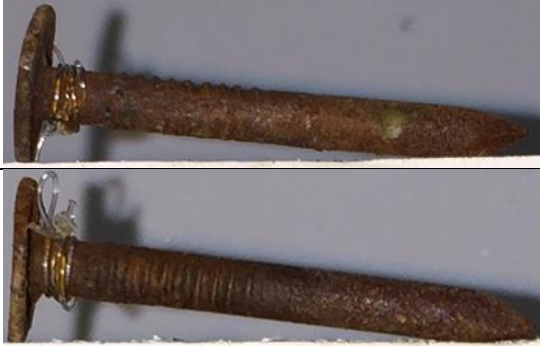
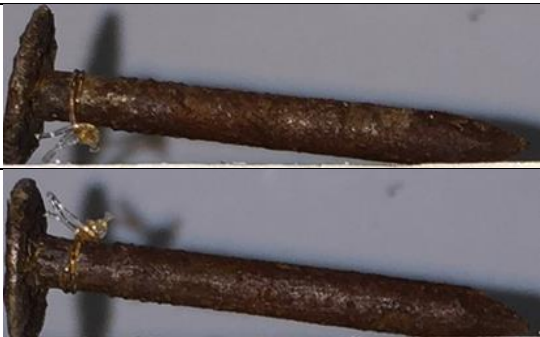
CODE: II-A-H-W

Sample 1 Head classification: 8	Sample 1 Shaft classification: 8

Sample 2 Head classification: 6	Sample 2 Shaft classification: 7

Sample 3 Head classification: 8	Sample 3 Shaft classification: 8

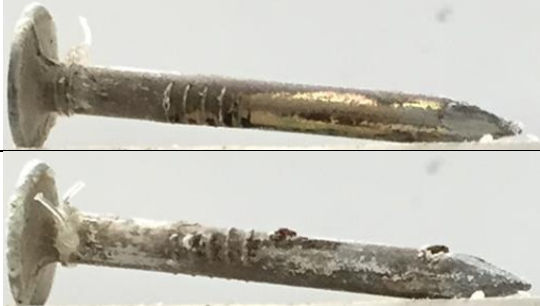
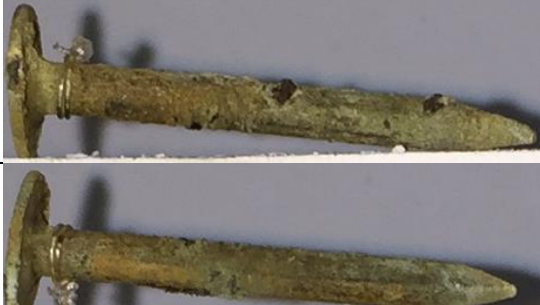
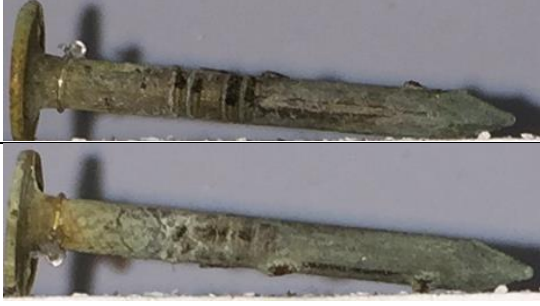
CODE: II-B-Pn-S

Sample 1 Head classification: 1		Sample 1 Shaft classification: 1

Sample 2 Head classification: 4		Sample 2 Shaft classification: 4

Sample 3 Head classification: 3		Sample 3 Shaft classification: 3

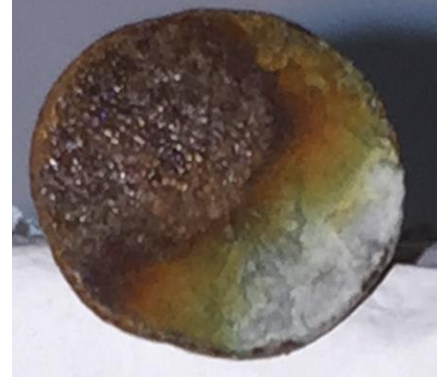
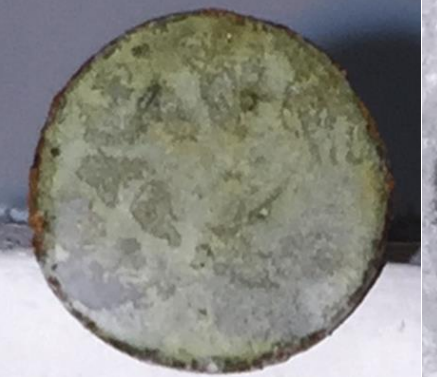
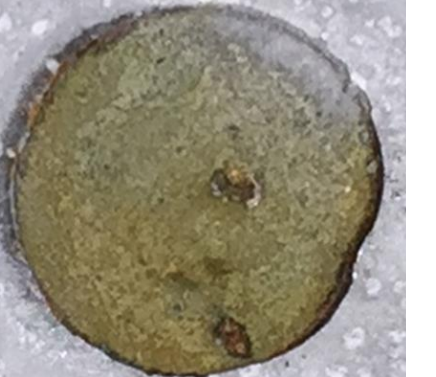
CODE: I-A-H-F		
Sample 1 Classification: 5	Sample 2 Classification: 2	Sample 3 Classification: 3

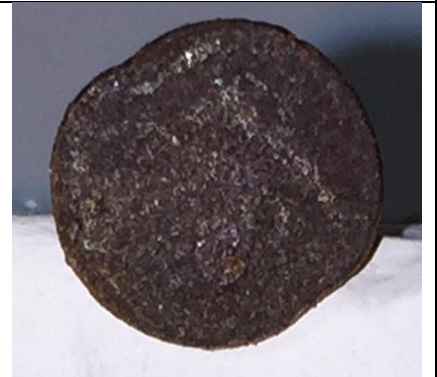
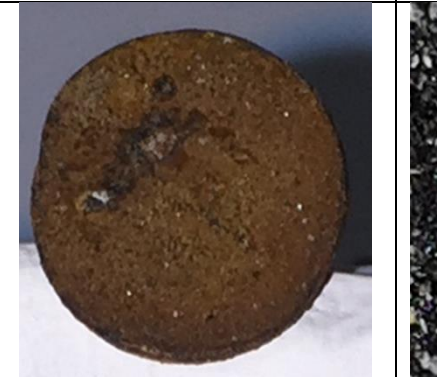
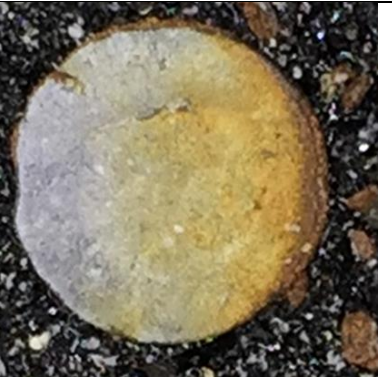
CODE: I-A-H-S		
Sample 1 Classification: 7	Sample 2 Classification: 6	Sample 3 Classification: 3

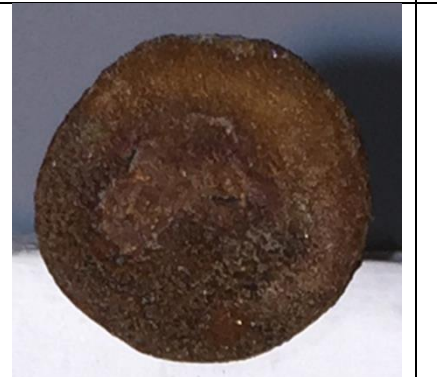
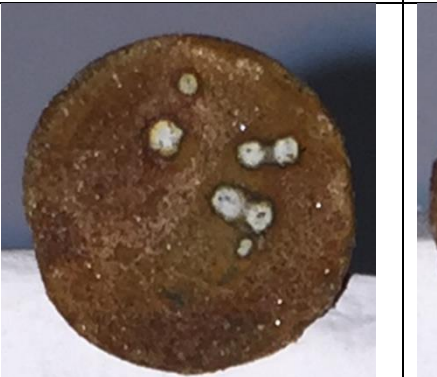
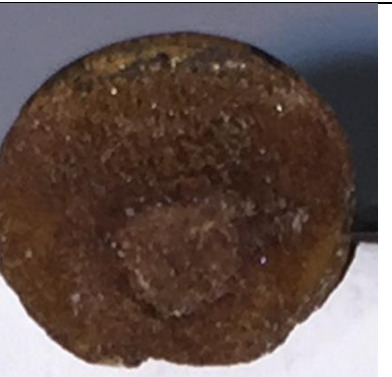
CODE: I-A-H-W		
Sample 1 Classification: 8	Sample 2 Classification: 7	Sample 3 Classification: 8

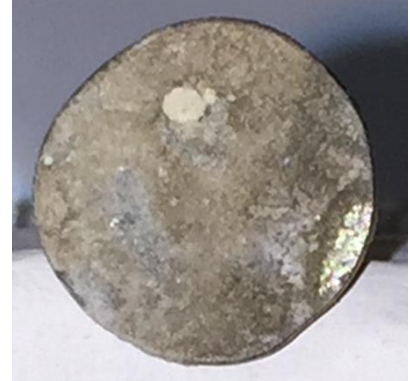
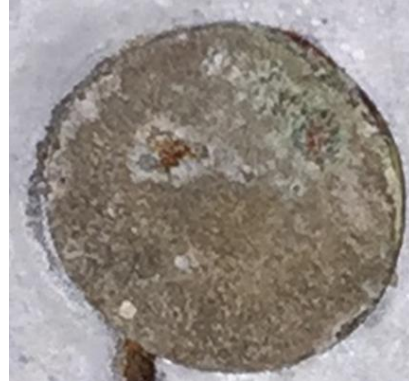
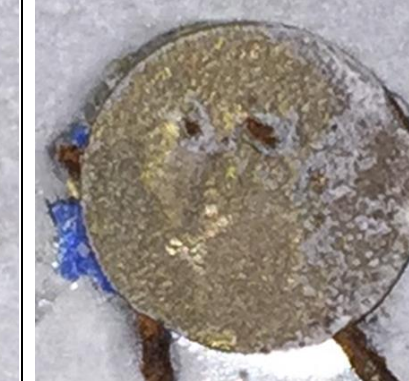
CODE: I-B-Pn-F		
Sample 1 Classification: 2	Sample 2 Classification: 3	Sample 3 Classification: 3

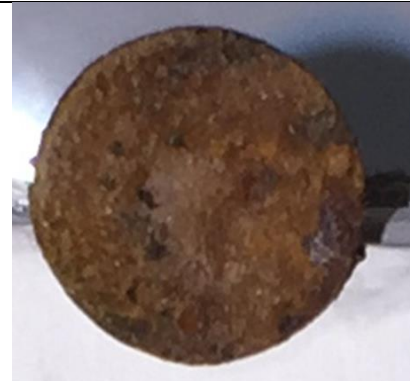
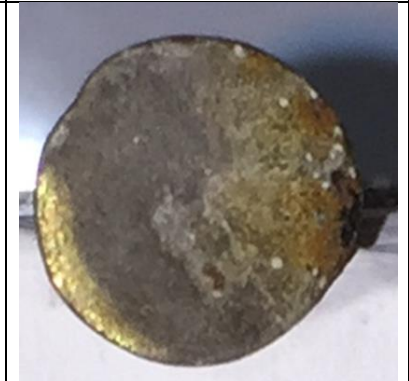
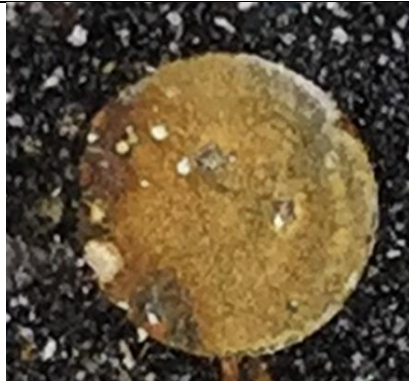
CODE: I-B-Pn-S		
Sample 1 Classification: 8	Sample 2 Classification: 5	Sample 3 Classification: 4

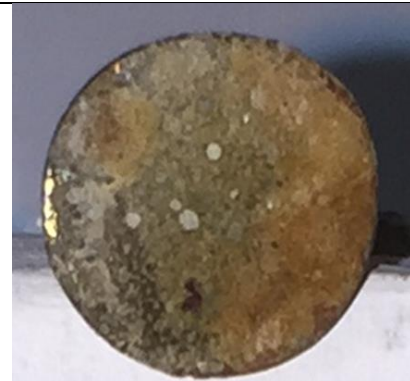
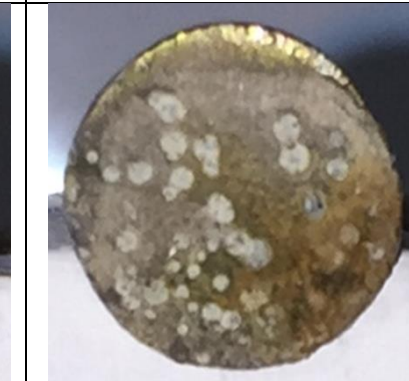
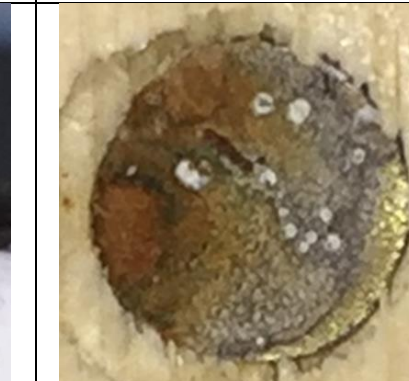
CODE: I-B-Pn-W		
Sample 1 Classification: 3	Sample 2 Classification: 3	Sample 3 Classification: 3

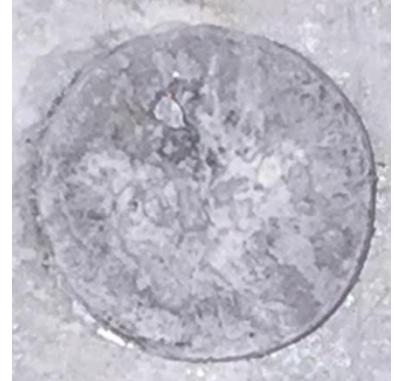
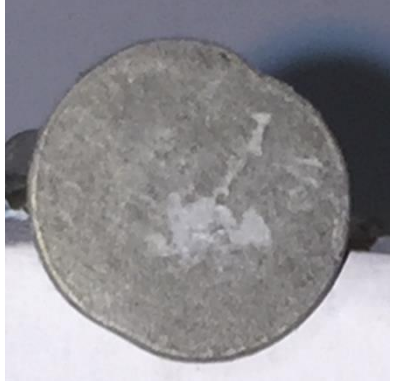
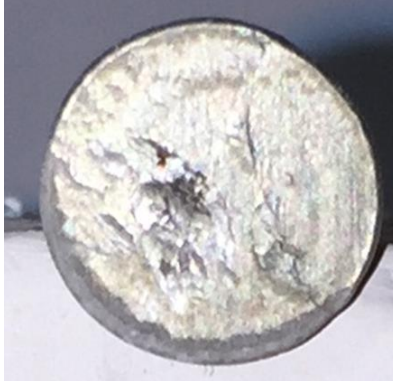
CODE: I-C-H-F		
Sample 1 Classification: 1	Sample 2 Classification: 1	Sample 3 Classification: 1

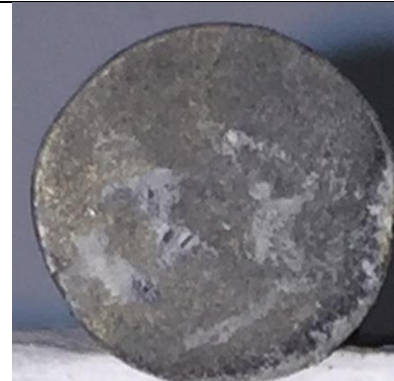
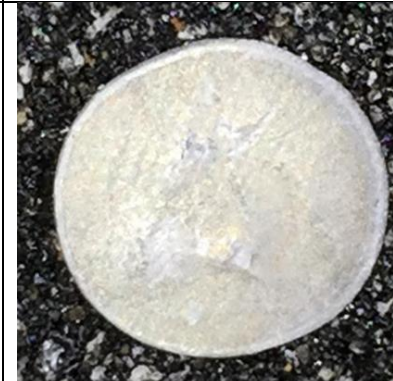
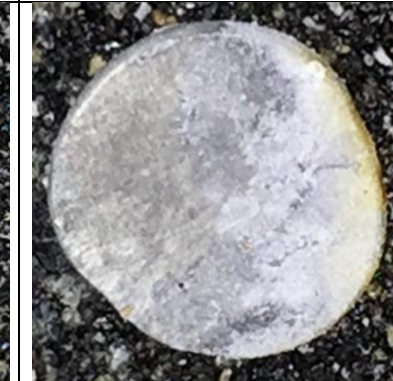
CODE: I-C-H-S		
Sample 1 Classification: 2	Sample 2 Classification: 1	Sample 3 Classification: 2

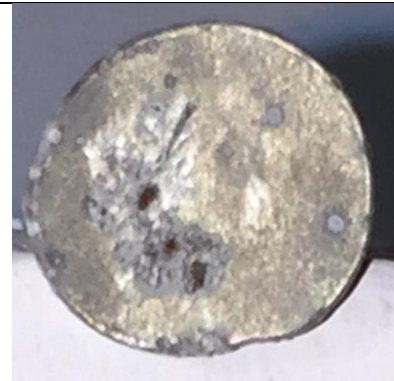
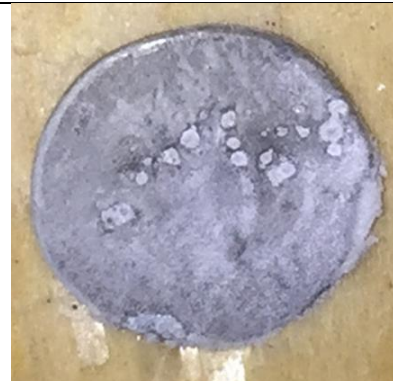
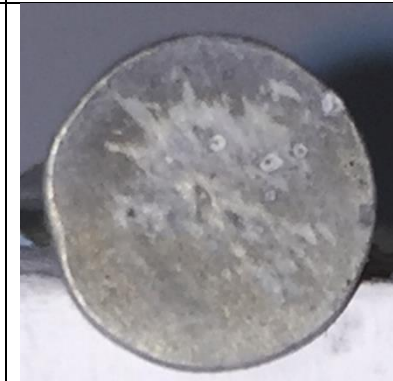
CODE: I-C-H-W		
Sample 1 Classification: 3	Sample 2 Classification: 1	Sample 3 Classification: 1

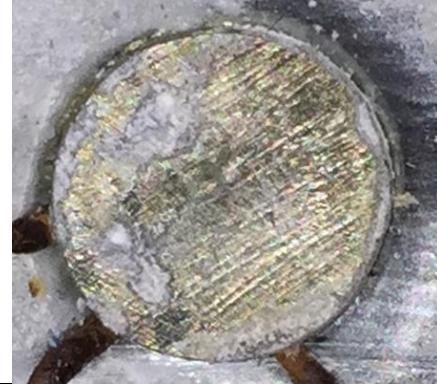
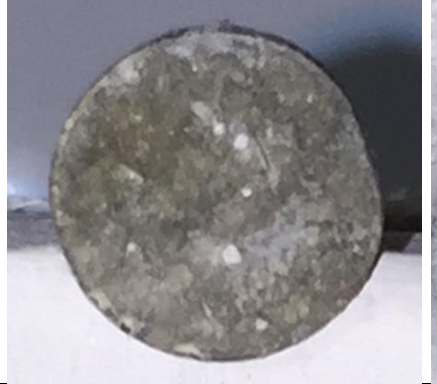
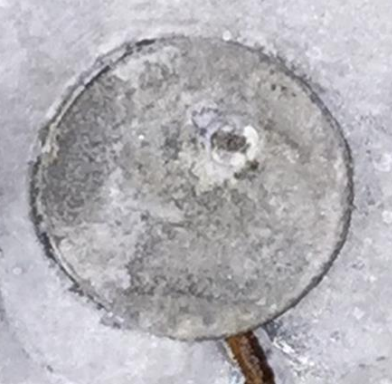
CODE: I-C-Pn-F		
Sample 1 Classification: 1	Sample 2 Classification: 1	Sample 3 Classification: 1

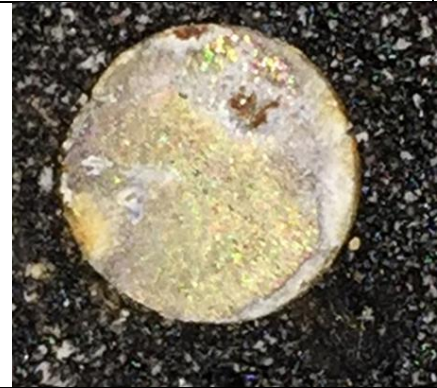
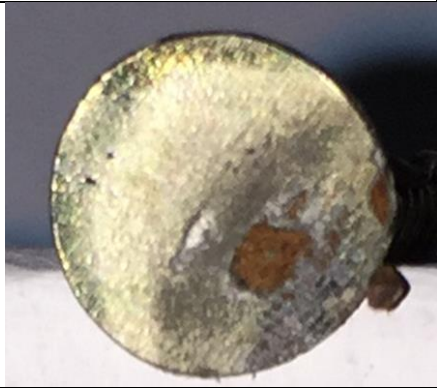
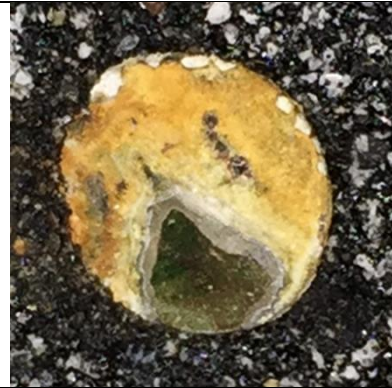
CODE: I-C-Pn-S		
Sample 1 Classification: 3	Sample 2 Classification: 3	Sample 3 Classification: 3
