**Final Report for Project Entitled:**  
**Impact of Spray Foam Insulation on Durability of Plywood and OSB Roof Decks**

Florida Building Commission  
State of Florida Department of Business and Professional Regulation

The project goal is to develop better understanding of the impact of spray foam insulation on the water retaining behavior of wood roof decks. The work includes preparation of a state-of-the-art literature review on wood roof decks insulated with spray-applied foam, experimental evaluation of the relative drying characteristics of various wood roof deck configurations and inspections of existing Florida homes with installed spray-foam insulated wood roof decks.

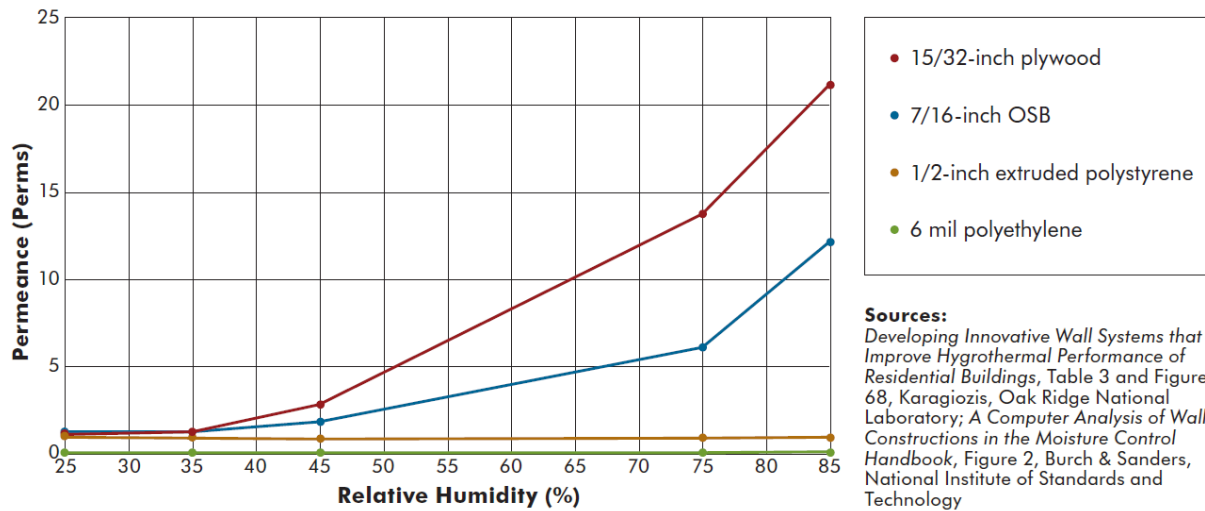
Figure 5: Water vapor permeance for building materials as a function of relative humidity (APA, 2009).

Of particular importance to this project is the moisture performance of plywood and OSB sheathing, which account for the vast majority of all structural wood panels in the US. Figure 5e shows the vapor permeance (a measure of a material's ability to permit moisture transport through the material) for plywood and OSB as compared to two common vapor retarders. While the water vapor permeance for both plywood and OSB increase with relative humidity, the permeance of plywood is higher than OSB, particularly at higher relative humidities. This would suggest that plywood is able to dry more quickly than OSB, a finding also noted by other studies (Ojanen and Ahonen 2005; Wu et al. 2008)). With respect to surface moisture absorption, plywood tends to absorb more moisture than OSB under equivalent circumstances. Ojanen and Ahonen (2001) found that plywood products absorbed water faster than OSB during the first four days of exposure, but slowed after this initial period. Water absorption into OSB started slow but increased significantly after 1-2 weeks, and moisture levels in OSB exceeded those of plywood after 2-3 weeks. The likely cause of these results is the differences in water repellence of the two materials. OSB typically has water-repellant surface coatings that limit the absorption and drying efficiency initially. Timusk (2008) found that cyclic wetting/drying had a large effect on permeability of OSB, with permeability doubling after just one cycle. This was also noted by (Nofal and Kumaran 2003). Wu and Ren (2000) however, noted that under long-term RH cycles (12 month initial cycle followed by two 6 month cycles), the actual equilibrium moisture content did not change significantly from one cycle to another.

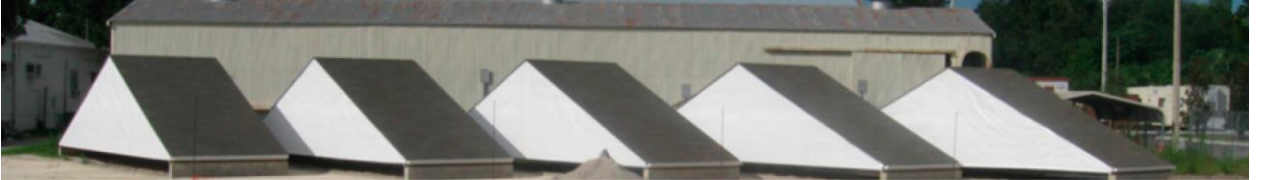
Table 2: Test matrix for full-scale roof specimens in McBride (2011).

Roof 1	Roof 2	Roof 3	Roof 4	Roof 5
No ccSPF	25 mm continuous layer ccSPF + 75 mm fillet	25 mm continuous layer ccSPF + 75 mm fillet	75 mm continuous layer ccSPF	75 mm continuous layer ccSPF
(104) 13-mm leak gaps	(104) 13-mm leak gaps	No Leaks	(104) 13-mm leak gaps	No Leaks

McBride (2011) exposed five full-scale wood roof specimens to 90 days of simulated and natural rainfall in a Florida climate to evaluate moisture accumulation in closed cell spray-applied polyurethane roofs. Test specimens consisted of 9.1 m (30 ft) by 3 m (10 ft) gable roof “attics” with a roof slope of 26° (6 in 12), oriented north-south. All specimens were constructed using wood trusses and 11.1 mm (7/16 inch) thick OSB decking. The roof system consisted of 30# felt and asphalt shingles, as shown in Table 2. Moisture contents in the wood trusses, temperature and relative humidity were monitored throughout the duration of the exposure period using sensors and proprietary software from SMT Research.

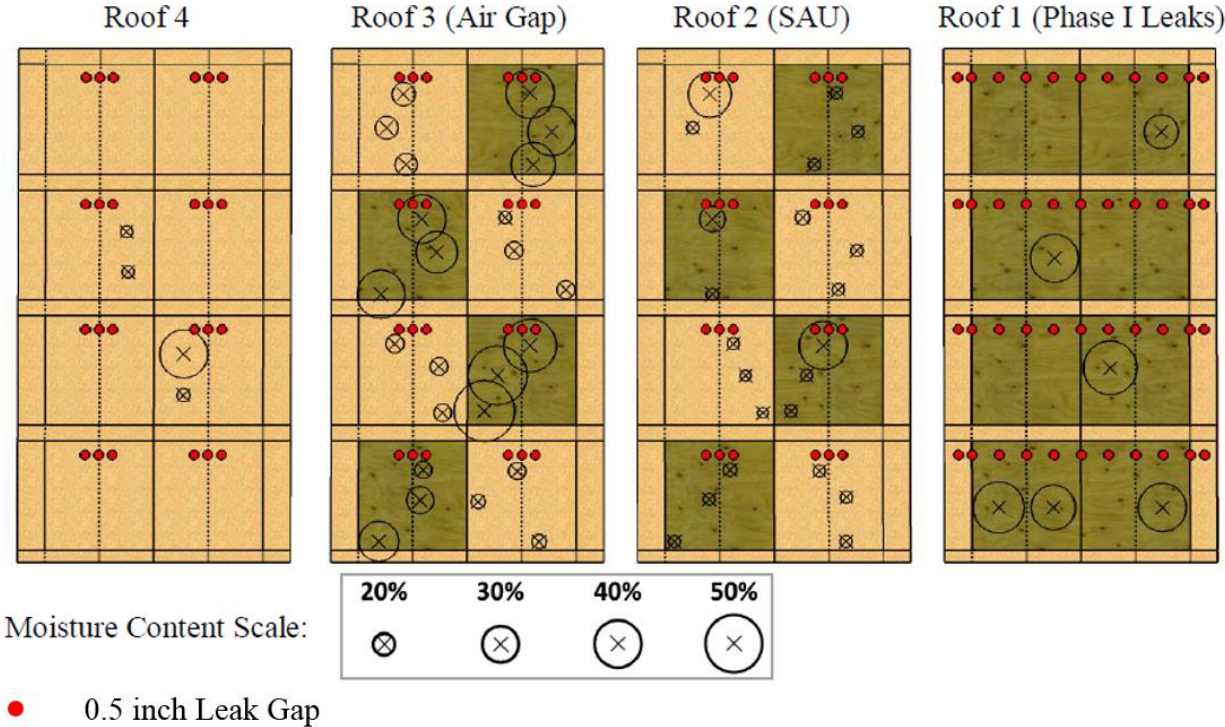
Figure 6: Moisture contents observed in roofs with plywood and OSB (figure from Prevatt et al 2013). Roof 2, 3 and 4 contained 24 leak gaps and were exposed to 15 minutes of simulated rainfall every fourth day. Roof 1 contained 48 leak gaps and was exposed to 15 minutes of simulated rainfall every other day.

A subsequent study by Prevatt et al. (2013), built on the results from the McBride (2011) study to evaluate potential differences between OSB and plywood on moisture accumulation and retention in ccSPF-retrofitted wood roofs. The study also evaluated the performance of two moisture mitigation methods – (1) the use of a self-adhered membrane on the top surface of the sheathing, taking the moisture control approach laid out by Lstiburek (2002); and (2) the presence of an air gap between the ccSPF and the sheathing for 2/3rds of the capacity width, leaving the full fillet to retain the structural benefits. This approach follows the recommendation of Rose (1996). Four full-scale monoslope attic specimens were constructed and oriented so that the slope faced south, based on the findings from McBride (2011) that moisture accumulation was significantly higher on the south slope. Specimens were exposed to natural and simulated rainfall for approximately 9 months, and leaks were deliberately cut into the roof covering to allow moisture intrusion into the roof sheathing. Results demonstrated that self-adhered underlayment on the top surface of the roof sheathing was effective at limiting moisture accumulation in both OSB and plywood panels, with moisture contents greater than 20% only observed locally at the locations of leak gaps as shown in Figure 6. The air gap allowed the sheathing to dry approximately twice as fast as sheathing without the air gap. The authors also noted that moisture was absorbed more readily into the plywood panels, in agreement with previous research (Ojanen and Ahonen, 2005; Wu et al, 2008).

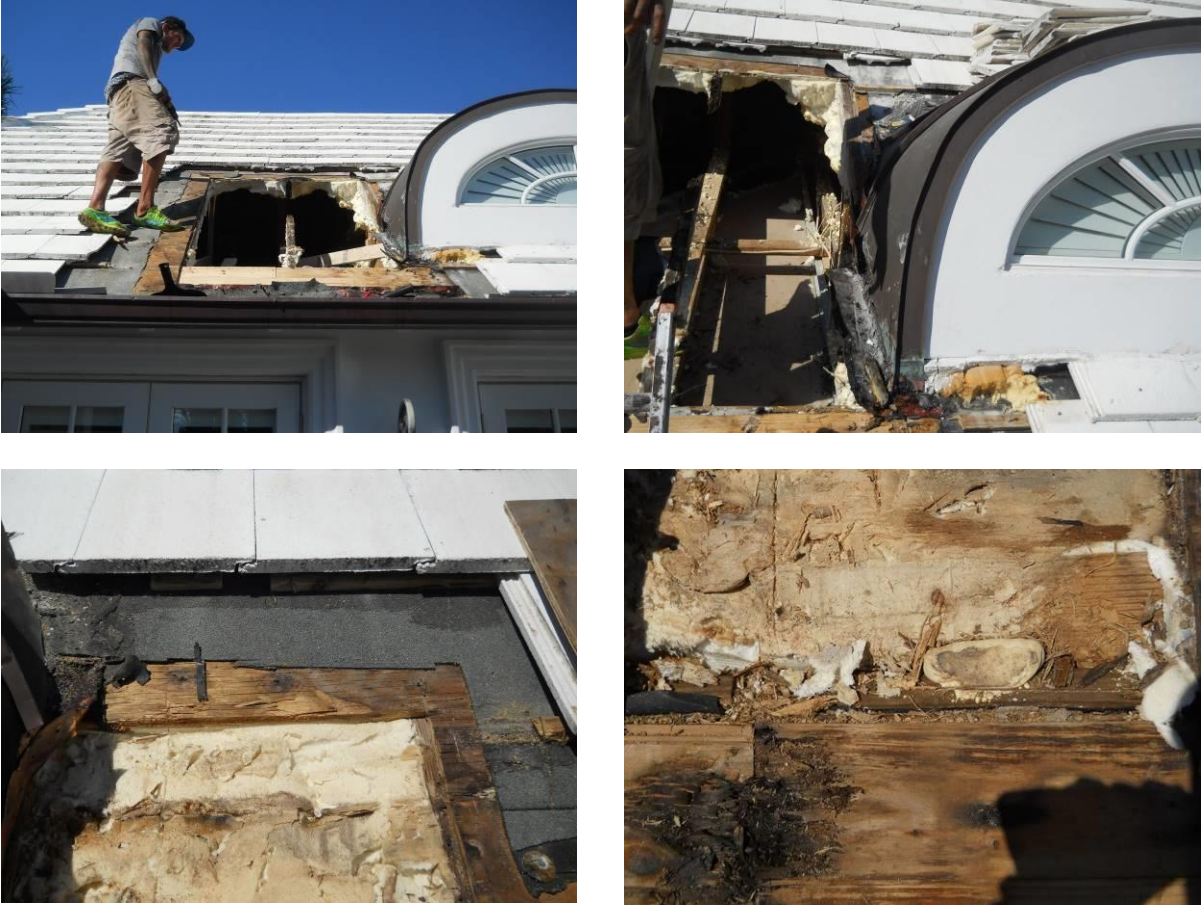
Figure 8: Moisture damage in an unvented attic with ccSPF. Moisture was particularly event around the visible dormer (Courtesy of Mark Zehnal).

Mark Zehnal provided evidence of a damaged roof system in Palm Beach County that had closed cell spray foam insulation installed. We were told that the home was built in 2005 and was repaired in 2014. This series of photographs documents the extent of damage to the roof deck and wood framing adjacent to a large dormer. The photos show a rotted deck adjacent to a dormer. The photos did not identify the source of the water (although experience suggests failed flashing below the window sill and or failed base flashing along the dormer wall are potential sources).

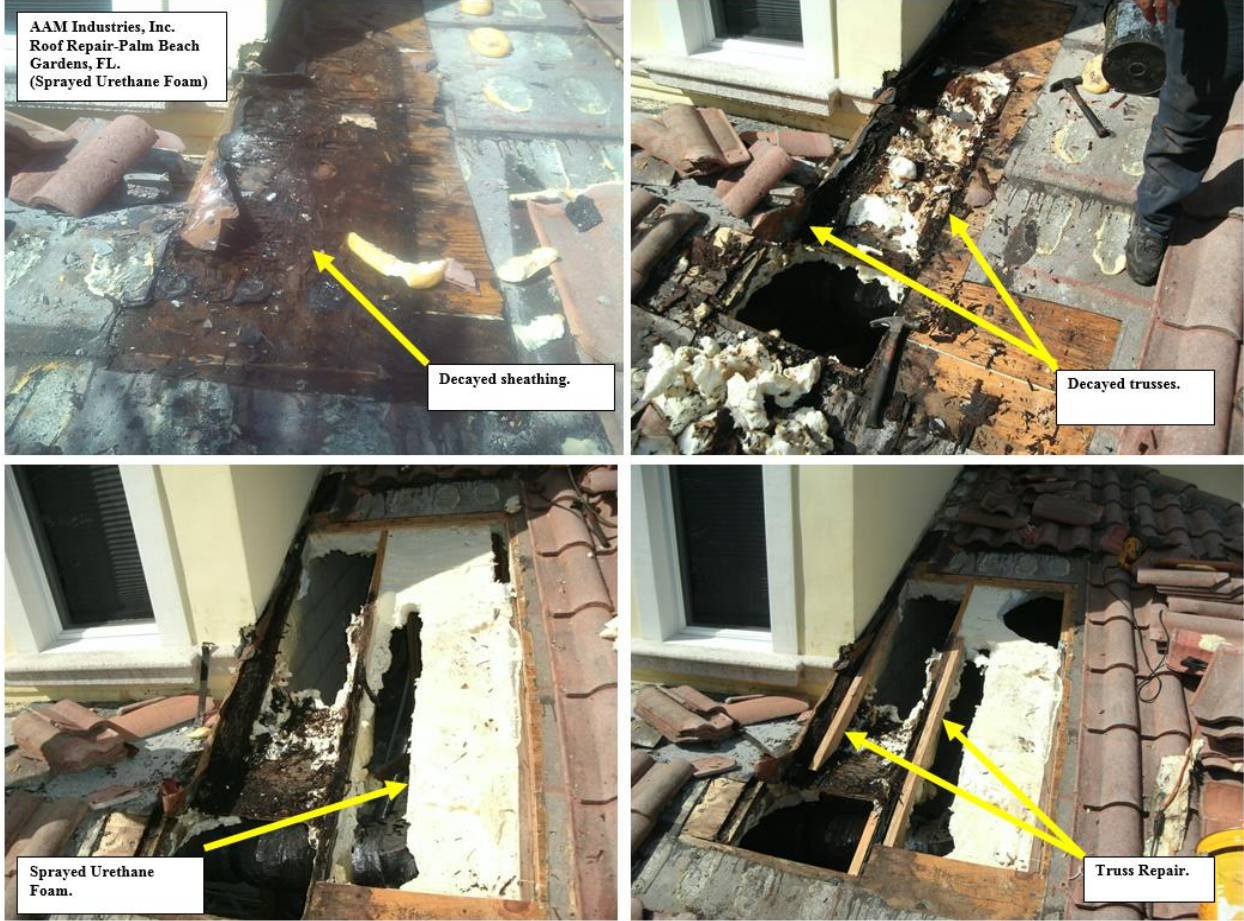
Figure 9: Moisture damage around a gable dormer to an unvented attic with ccSPF.

The roof system of a Palm Beach Gardens, FL house with spray applied insulation showed signs of water intrusion damage. As seen in the photo the sheathing and wood framing both began to rot and is speculated to be caused by the elevated moisture content of the sheathing due to a leak caused by roof defection. As was seen in the first case this damage occurred next to a window which suggests the moisture could have entered the system due to failed flashing at the window sill and been trapped between the spray foam and the sheathing. A forensic study was not conducted on this home so these photos are considered anecdotal and just an example of a home with spray foam and moisture damage.

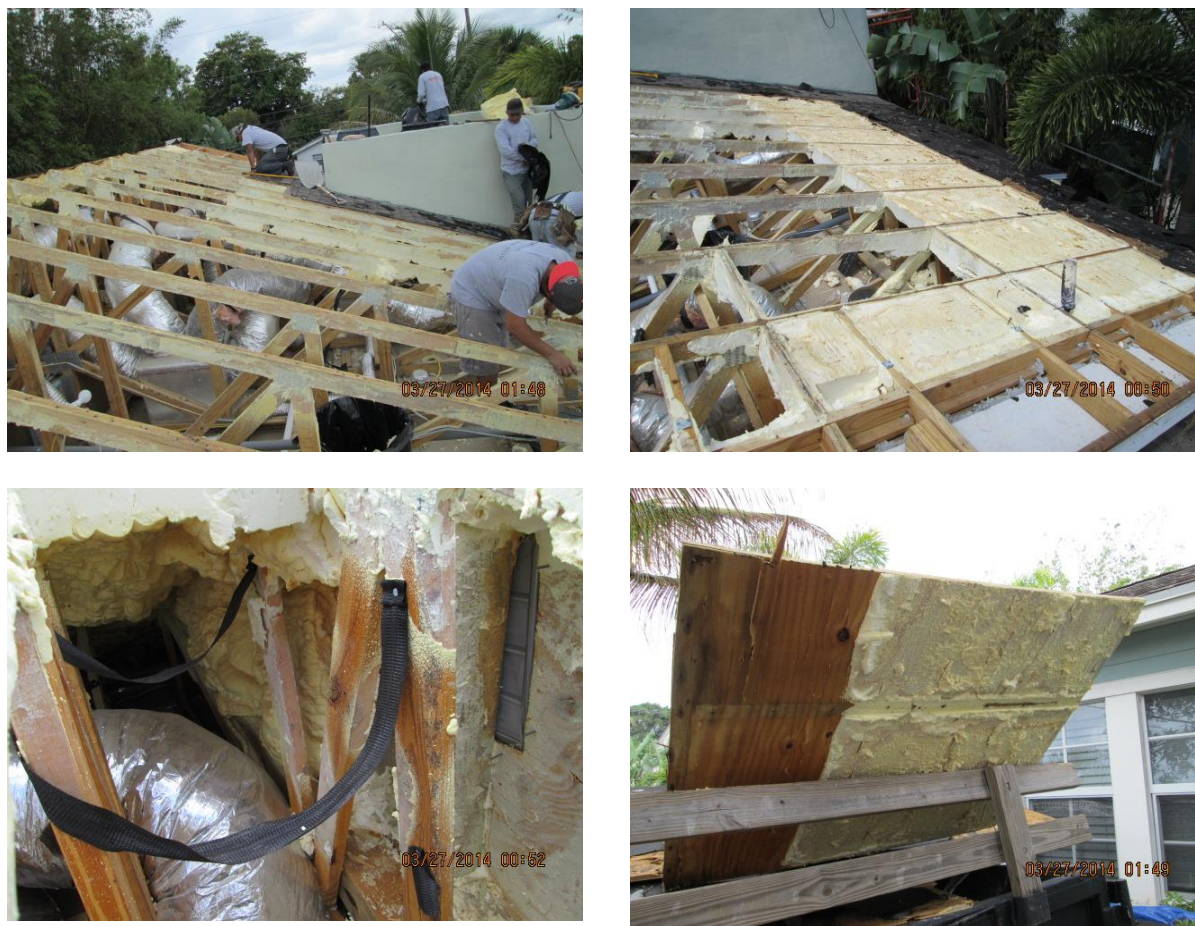
Figure 10: Evidence of moisture buildup in home installed with ccSPF. Note the moisture on both the sheathing and wood framing

An additional home installed with ccSPF installed on the underside of the wooden roof sheathing was identified in which the foam had to be removed from the home as a result to a homeowner allergy to the spray foam insulation. As the foam was being stripped, a buildup of moisture was detected on the wood framing and underside of the wood sheathing. A forensic study of the home was then conducted in which a chemical ratio test of the spray foam was performed as this is the typical diagnosis of a moisture related spray foam issue. The ratio of the spray foam was confirmed to be correct and was identified as completely reacted (solid) and thus concluded this was not the cause of the moisture buildup, It is the motivation of this study to determine the effects of moisture buildup in wood sheathing in homes such as this to gain insight on how to prevent problems due to a building envelope moisture intrusion.

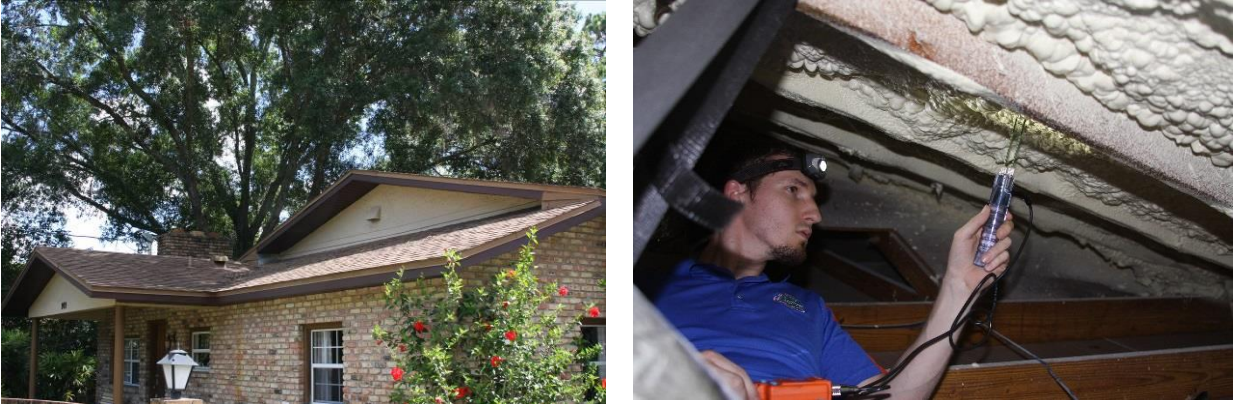
Figure 12: (Left) View of the front of the house from ground. (Right) View from inside the attic showing the ccSPF and a moisture content measurement being taken.

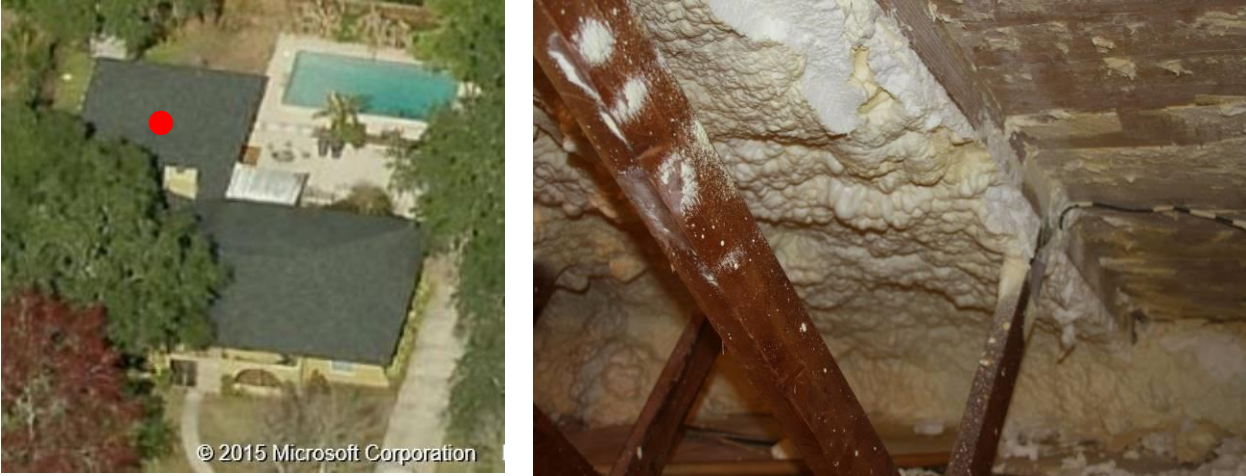
Figure 13: (Left) Aerial view of Home 2. The red dot indicates the approximate location of the photo to the right. (Right) ocSPF installed in the attic space. The truss shown is directly over the garage wall. SPF to the right of the truss, over the garage, has been removed by the homeowner.

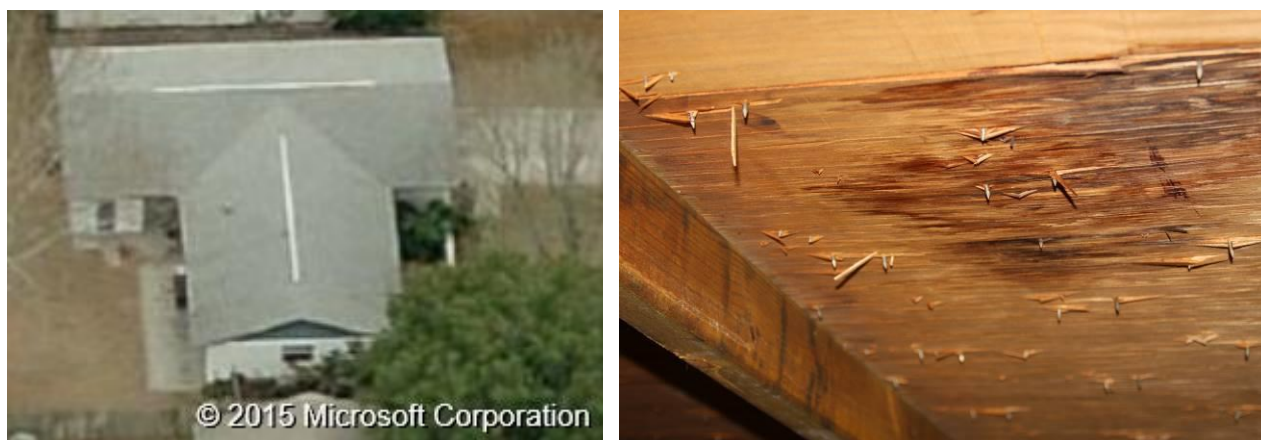
Figure 14: (Left) Aerial view of Home 3; (Right) Apparent water damage in the plywood sheathing. No moisture was present at the time of inspection, and no evidence of past moisture was evident in the insulation below.

Home 3 is a concrete block home located also located in Altamonte Springs, FL. The home has a T-shaped floor plan (shown in Figure 14) with a gable roof at a 4 in 12 roof slope. The roof structure consists of wood trusses with plywood sheathing, which is overlaid with an unknown underlayment and asphalt shingles. The attic is insulated at the ceiling level with blown-in insulation. Attic vents are present at the gable ends. Moisture contents and interior attic temperatures were taken at a few points within the attic, and shingle surface temperatures were measured at 5:00 pm. The observed data is summarized in Table 9. A weather station 3.5 miles away recorded an ambient temperature of 92°F and relative humidity of 43%. The sky was partly cloudy. During inspection of the roof sheathing, discoloration of the plywood was noted (Figure 14) in several locations, and the wood seemed brittle as the moisture meter pins were stuck in the wood. The areas were dry to the touch however and the moisture meter did not measure elevated moisture contents. It appears there may have been roof leaks there in the past that had subsequently dried out. The homeowner was not aware of any roof leaks. One LogTag was installed inside the attic, near the center of the roof, and another was placed outside to capture ambient conditions.

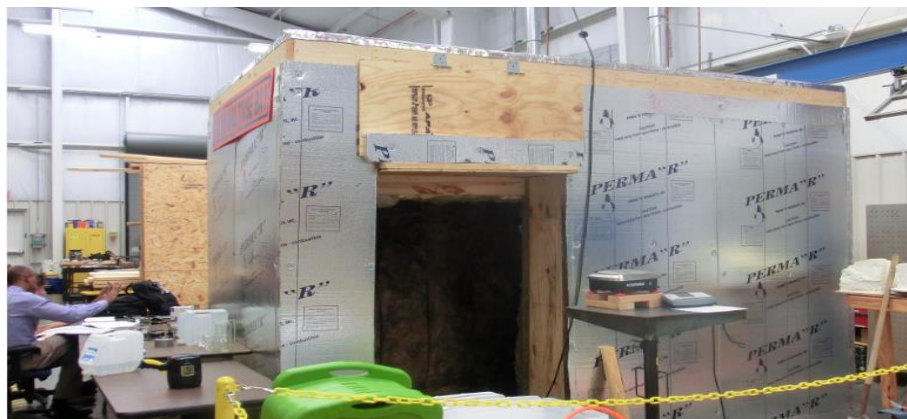
Figure 15: Insulated Thermal Chamber

The Insulated Thermal Chamber is 11 ft by 5 ft by 6.5 ft tall (interior dimensions) (Figure 15). The insulation consists of R19 Batten Insulation and 2 in. thick Perma “R” polystyrene rigid insulation board. The chamber consists of a thermally controlled portion housed above the roof specimens and an ambient condition of the lab below subjected the specimens to an approximate 70F thermal variance (Figure 16). Thermal control is provided by two Radiant Electric Heat 1445CL surface mounted heaters that produce 5150 BTU of energy each. Each heater measures 46 in. by 15 in. by 1-1/8 in. and it is centered on the 1/3 points on the roof deck. The roof deck temperature is thermostat controlled by two Johnson Control A419 thermostats to a set temperature of 150F. Log Tag data loggers have been placed in 4 locations inside the “Top” of the thermal chamber and 1 in the bottom ambient condition to capture the relative humidity and temperature at various points in the structure. The roof deck supports the 36 specimens that are approximately 22 in. below the heaters (Figure 16). The interior condition below the roof deck is open to the laboratory – a semi-controlled space with average temperature 65.7 °F and relative humidity of 48%.

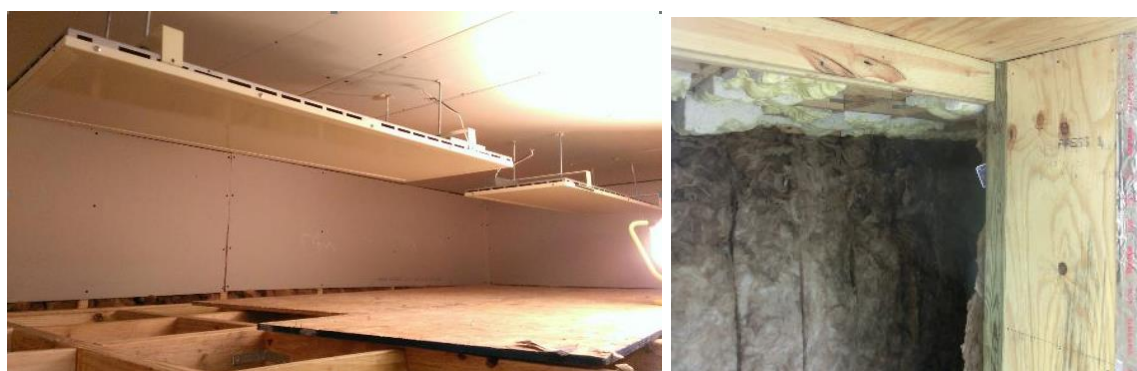
Figure 16: Thermally controlled top portion (Left) lower interior chamber open to ambient Temperature (Right).

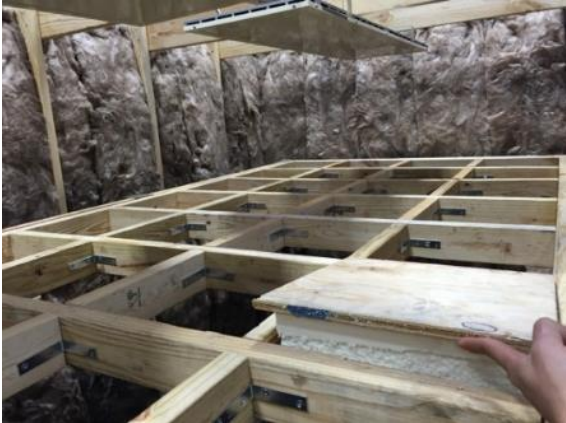
Figure 17: Chamber Test Deck

The roof specimens are 12 in. by 12 in. cross-sections of a typical roof system. Each specimen (Plywood or OSB) has asphalt shingles and roofing underlayment (30# or Grace Ice & Water Shield) installed (Figure 19). Table 12 provides the system matrix of the number of samples with or without spray foam insulation (closed cell (ccSPF) or open cell (ocSPF)). Wood roof sheathing was purchased from traditional hardware stores. The thicknesses of the sheathing were 15/32" for plywood and 7/16" for OSB which represents the most commonly used properties in Florida construction as noted by the Advisory Panel. Sheathing acclimated in the lab for approximately 14 days. Moisture content was measured using a handheld DelmHorst Instrument point moisture meter – Model BD-2100. Average moisture values for the sheathing were 7.24% and 6.94% for plywood and OSB sheathing, respectively. All of the roof specimen constructed can be seen in Table 12.

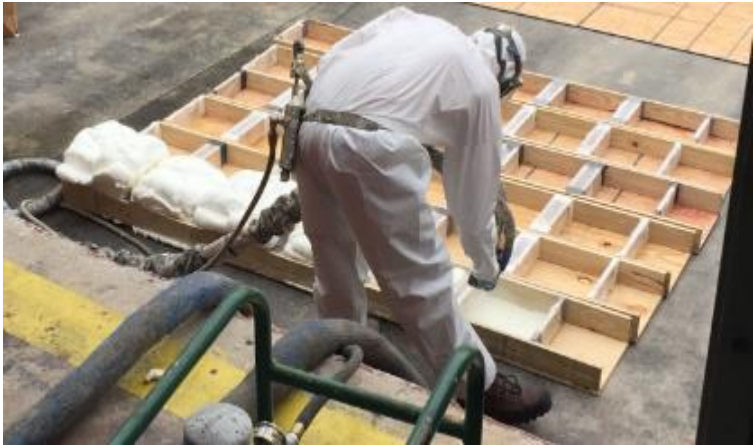
Figure 18: Installation of open-celled SPF insulation

Spray foam insulation was installed by Gale Insulation in Alachua, FL on 03/27/15 beginning at 8:30am. A grid system pre-fastened to the sheathing provided a 12 in. x 12 in x 3 in. opening for insulation. A single-pass foam was used for the open cell spray foam application (ocSPF) (Figure 2), and two passes used for the closed cell spray foam (ccSPF) application. For the ocSPF the foam expansion was quite large, exceeding the depth of the samples. These samples will maintain the “as sprayed” surface and form a “skin” which is representative of spray foam insulation in practice.

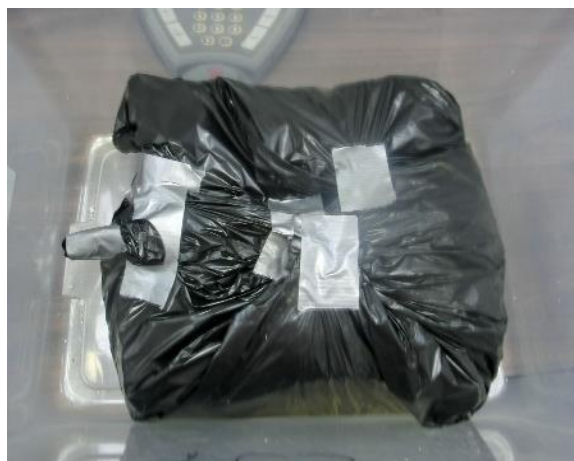
Figure 20: Wrapped sample being saturated

Each sample of wood sheathing (and insulation, if any) was placed into plastic bags (double wrapped) and the measured volume of water (calculated above) was added to the bag (Figure 20). The weight of water was standardized to 180 grams per sample in order to expedite process based on preliminary testing of water absorption. The samples were weighed over a 48 hour period – (at 24, 36 and 48 hour) until saturated equilibrium weight was achieved. Once the saturated weight was achieved in all 36 samples, they were weighed to obtain the initial saturated weight. The samples were then installed with the appropriate roofing material (pre-cut) which consisted of 3-tab asphalt shingle and underlayment (#30 building felt and Self Adhering roof membrane), cut to just fit the individual roofing sample. These roofing coverings are fastened to the roof deck using roofing nails tacked along the perimeter of each sample at 6 in. o.c. To minimize systematic (epistemic) measurement errors, the roofing sample locations within the roof grid were randomized and sample were weighed in random order. The change in weight in each sample will be monitored throughout the testing period using an Ohaus Ranger 7000 scale (Figure 21). The weight change will be monitored regularly, (twice daily in initial weeks and recorded).

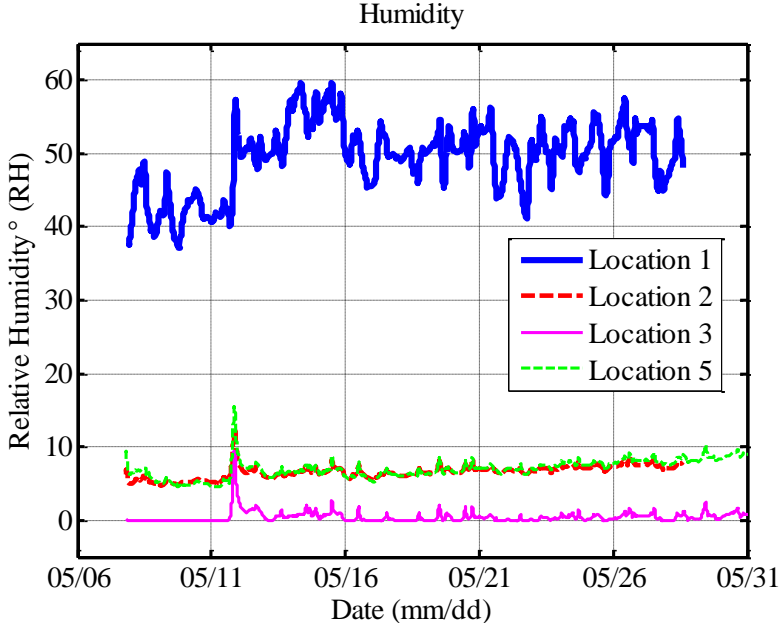
Figure 24: Log Tag Humidity Data

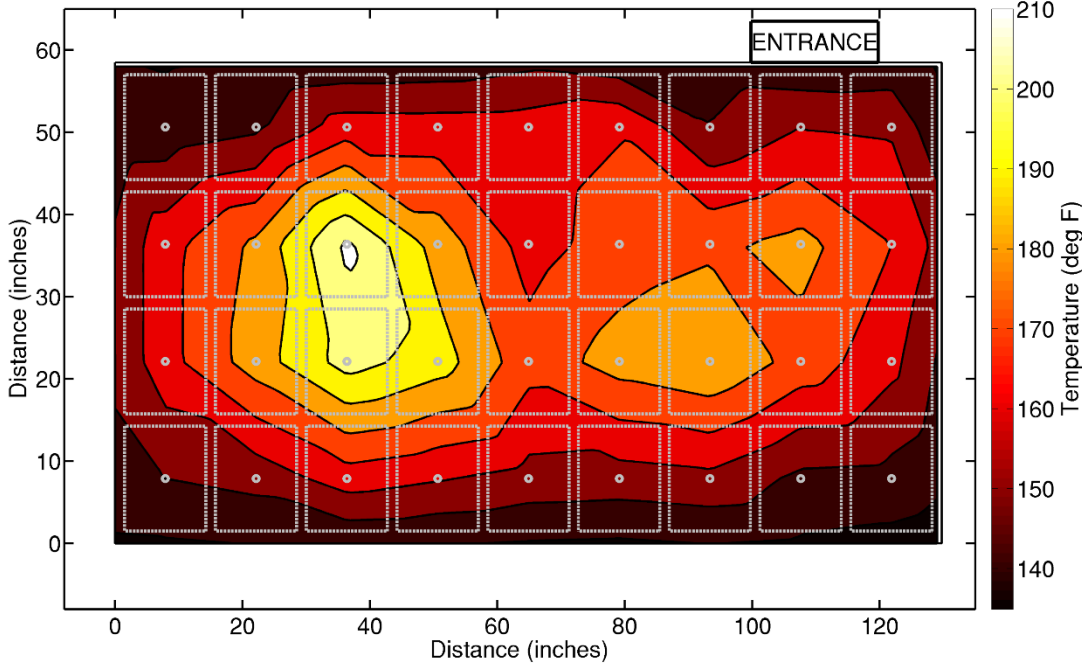
Figure 25: Temperature contours within the thermal chamber. Temperatures were determined using infrared camera.

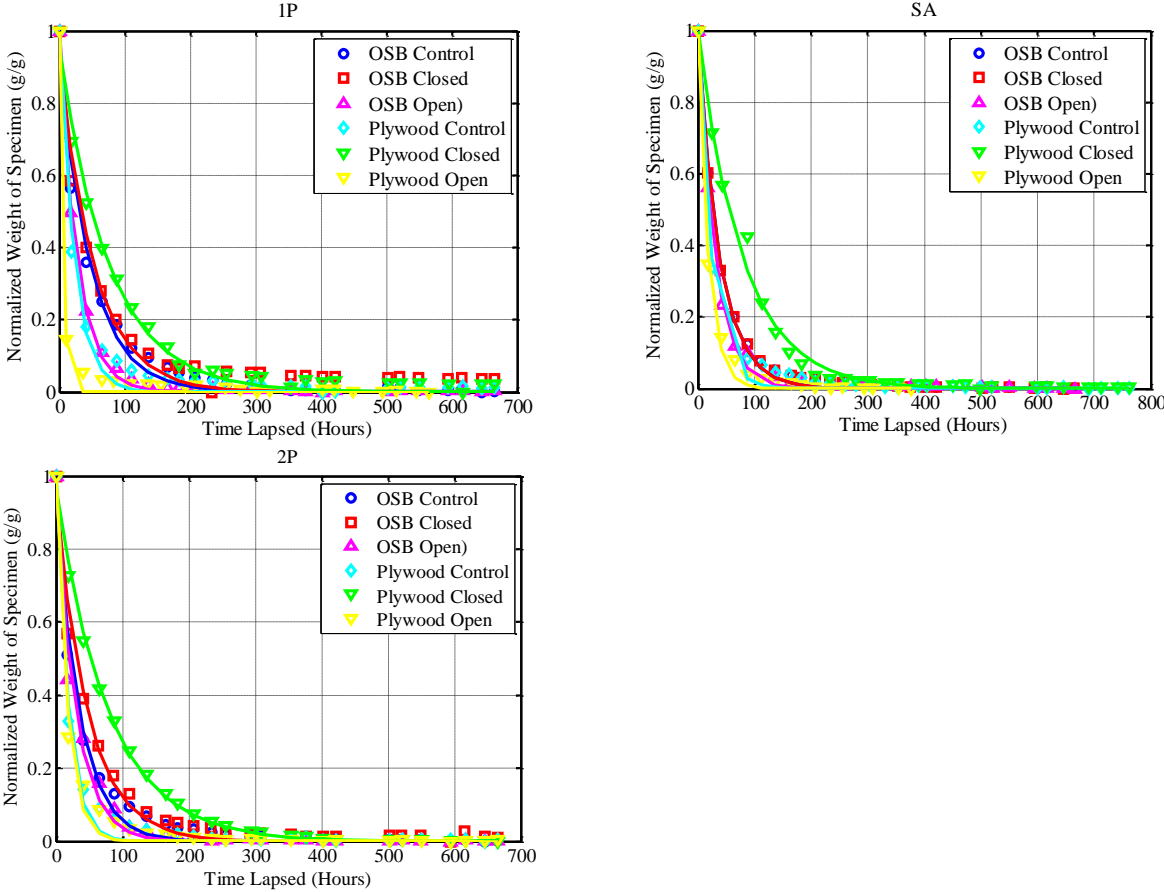
Figure 27: Drying data for ERP 3a

and Figure 27. We obtained the half-life of 36 samples by interpolating their individual weight variation curves. Figure 28 presents the 36 half-life times, along with the mean and standard deviation of each group of data. Results showed that the mean of the half-life for the plywood specimen with ccSPF installed is the highest among six groups. As compared with the plywood specimen with ccSPF, the ccSPF OSB roof panels have a shorter half-life time, but still exceed the others. As a whole, the installation of ccSPF slows down the drying process of roof panels, regardless of the types of underlayment and roof panel materials. Multiple underlayment plies did not affect drying rates. Self-adhered membrane slowed the drying rate compared to 30# felt underlayments in five of the six specimens.

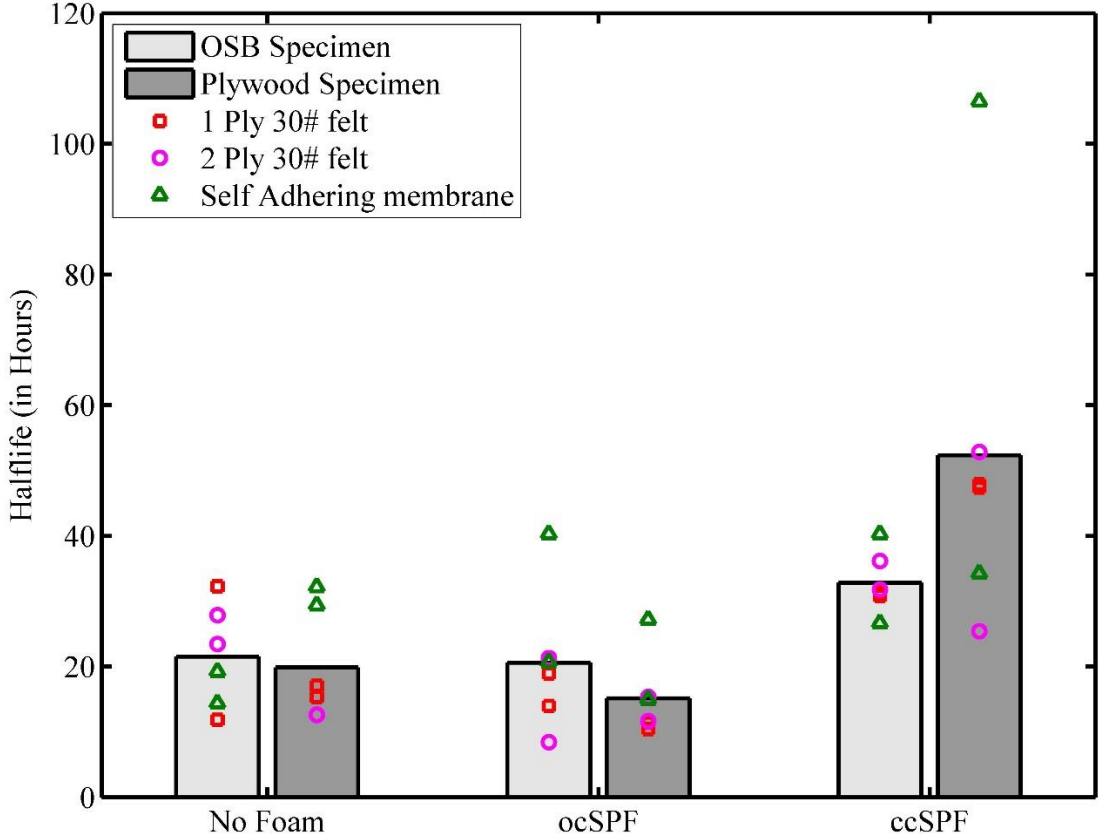
Figure 28: Half-life for all specimens

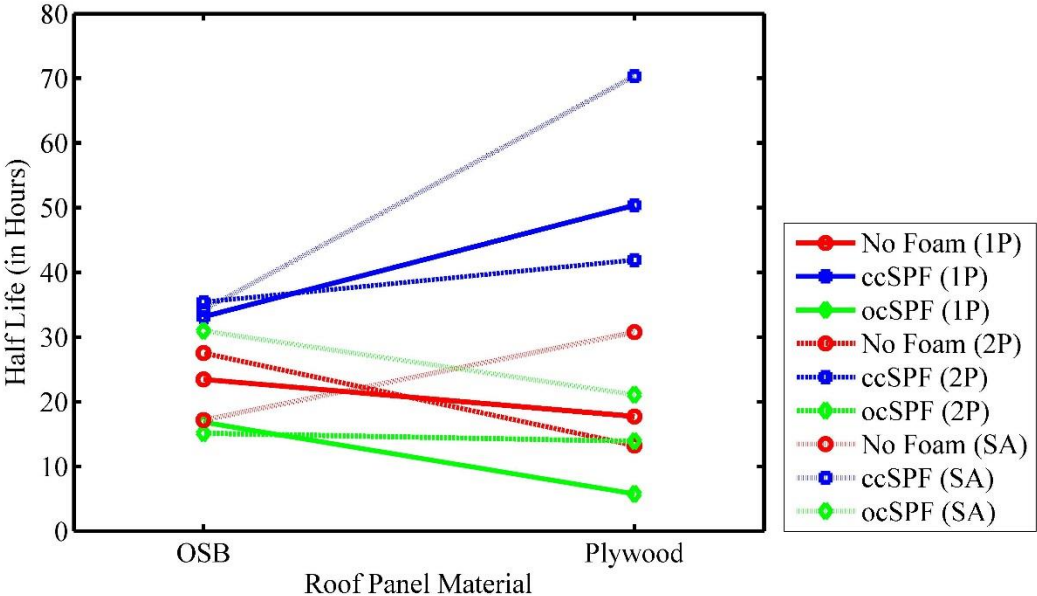
Figure 29: Interaction plot for different roof panel materials

As mentioned earlier, two random samples were measured in this study for each roof panel material, each type of underlayment and each foam installation. We took the average of the two repetitions and plotted them in Figure 29. It was observed that OSB samples have a larger half time than plywood samples, except in the case of specimen with ccSPF installed. It indicates that there is an interaction between the foam installation and roof panel materials.

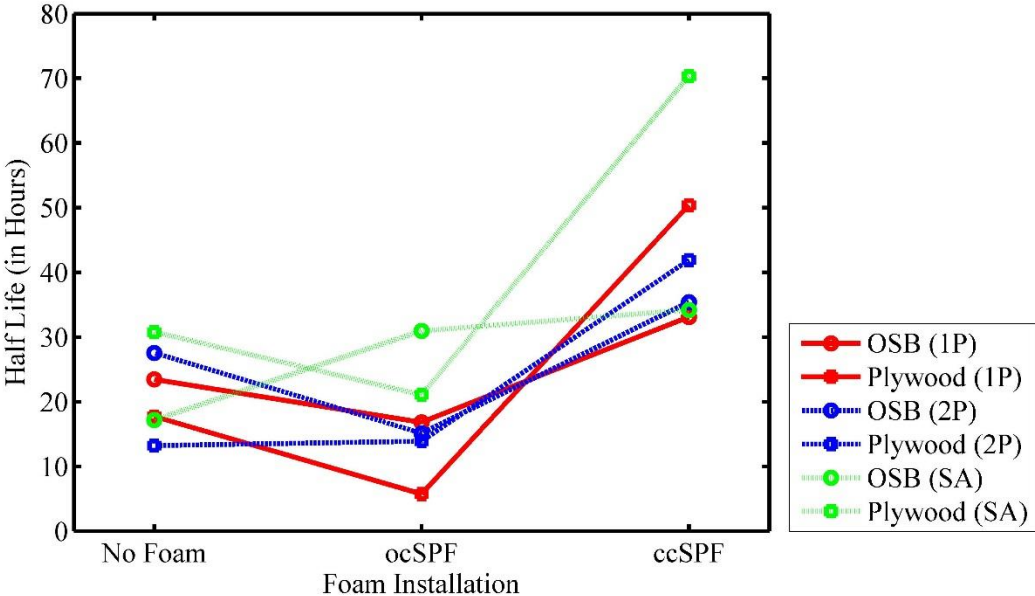
Figure 30: Interaction plot for different foam installations

Figure 30 presents the interaction plot of the samples with various foam installations. The half-life of ccSPF samples is the highest, whereas ocSPF samples have the lowest half-life, except for plywood sample with self-adhering underlayment.

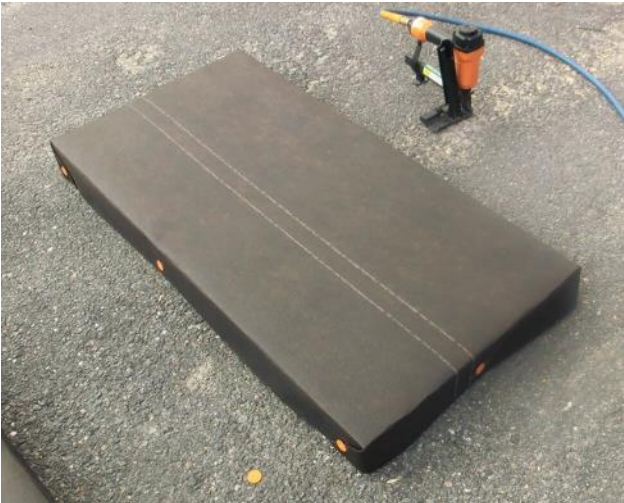
Figure 32: Membrane installed on all edges to prevent uncontrolled moisture travel

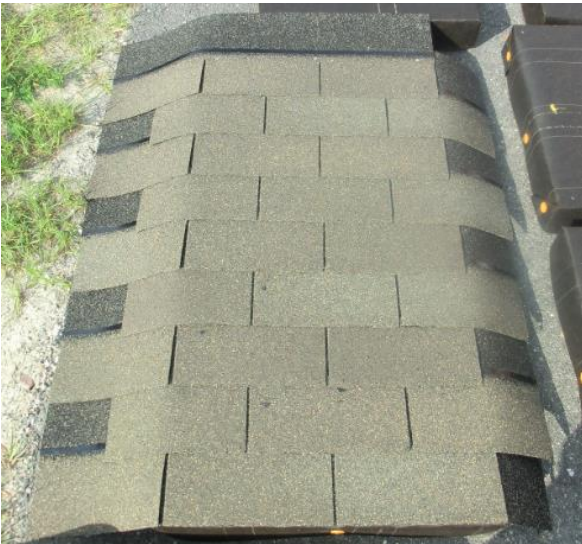
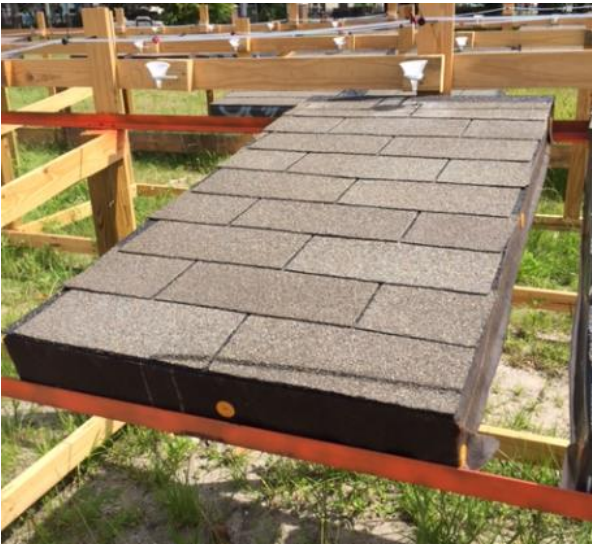
Figure 33: Asphalt Shingle Installation (Left) and Sample Placement (Right)

64 wood deck test samples (each sample measures 4 ft long x 2 ft wide) were fabricated with 3-tab asphalt shingle roofing and one of two underlayment materials (#30 felt or Grace Ice & Water Shield). Additional membrane flashing was installed along top and sloping edges to minimize potential for incidental water entry from sources other than the leak point source (Figure 32). All samples were installed on a 3 ft tall frame (low side) with a 2 in 12 roof slope (minimum permitted roof slope for steep-sloped roofing per FL Building Code (1507.2 - Asphalt shingles)) (Figure 33)..

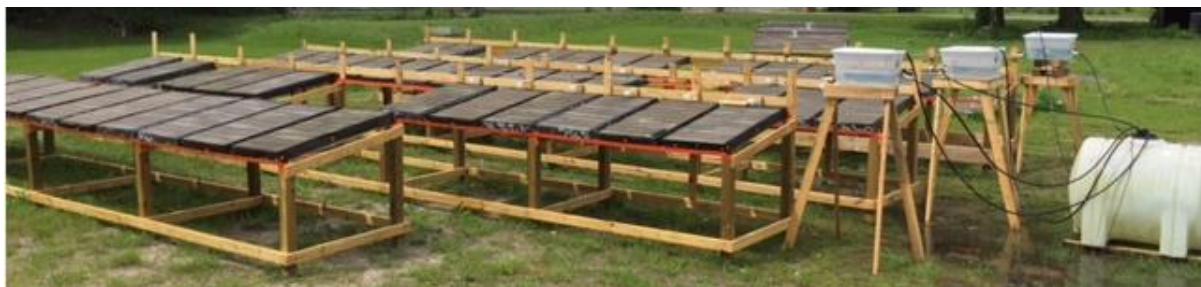
Figure 36: Photograph of Complete Test Configuration of all samples

An in-line non pressure actuating drip emitter attached to 1/4 inch tubing at a slope of 1/4 inch per foot point was installed at the center of each sample 4 inches from the high side (Figure 34). A calibrated, consistent rate of water of 1-3 mL/min will pass directly to the roof deck through a 5/8" diameter hole in the roofing and underlayment. A 4-inch pressure head is maintained by supply reservoirs which have intake and outflow valves to keep the pressure head constant (Figure 36). The experiment was constructed outside of the Powell Lab and exposed to existing Gainesville weather, including natural thermal cycling, in addition to the point-source water leak during the 8-week exposure period. Ambient temperature and relative humidity conditions were taken from NWS weather station located at the Gainesville Regional Airport that is 1.65 miles due north-east of the test site. The precipitation records for the entire testing period can be seen in Figure 35. The no leak samples as seen in Table 13 were constructed the same as other samples with the 5/8" diameter hole cut through the shingles and underlayment, but no drip emitter was installed on top. The only moisture source introduced to these samples was natural rainfall over the samples. The precipitation records for the testing period can be found in Figure 35.

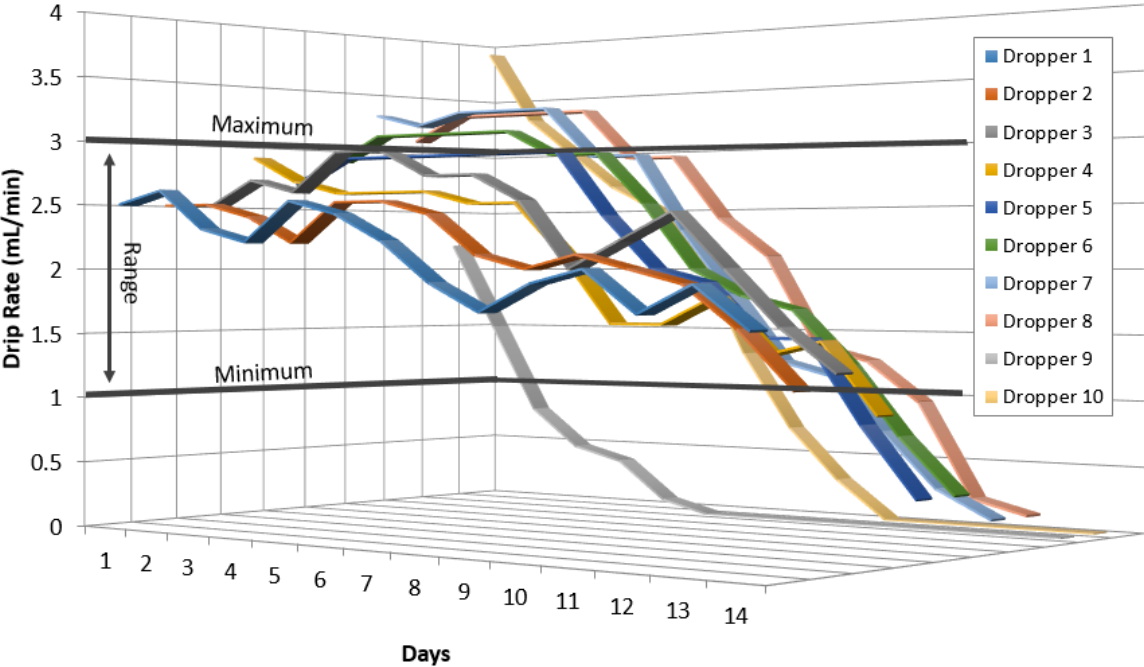
Figure 38: Dropper degradation rates. Maximum and minimum refer to the desired upper and lower limits of 3 mL/min and 1 mL/min flow rates respectively.

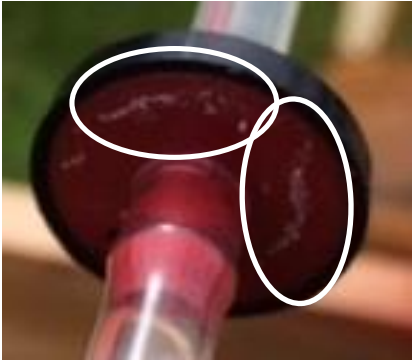
Figure 39: Whitish deposits observed on drippers after 6-weeks in use.
