**Final Report for Project Entitled:**

**Corrosion of Roofing Fasteners**

Florida Building Commission  
State of Florida Department of Business and Professional Regulation

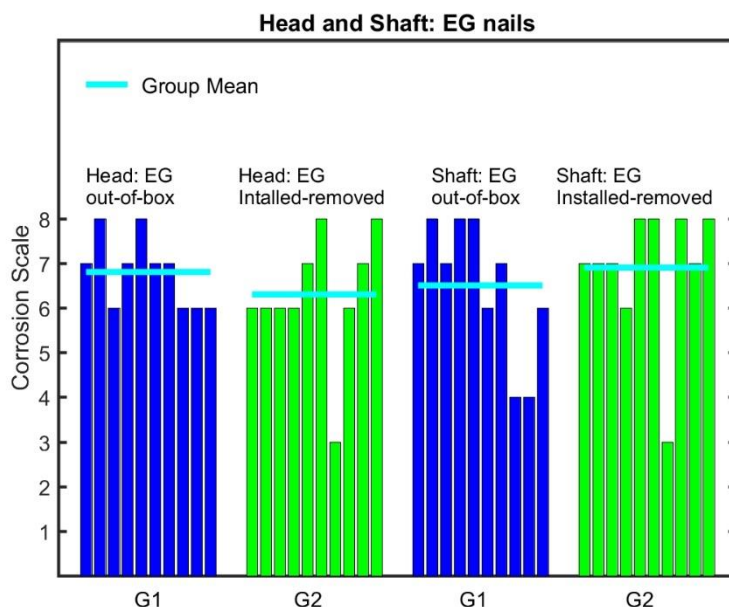
Figure 5: Test-2 Corrosion scale results for 1 ¼" EG nails, no certification marking. Blue: tested out-of-the-box. Green: installed-removed prior to testing

- Figure 5: Results are consistent with those of test-1 EG nails, demonstrating a high level of head and shaft corrosion. The process of installing and removing the fasteners did not improve or worsen the corrosion performance.

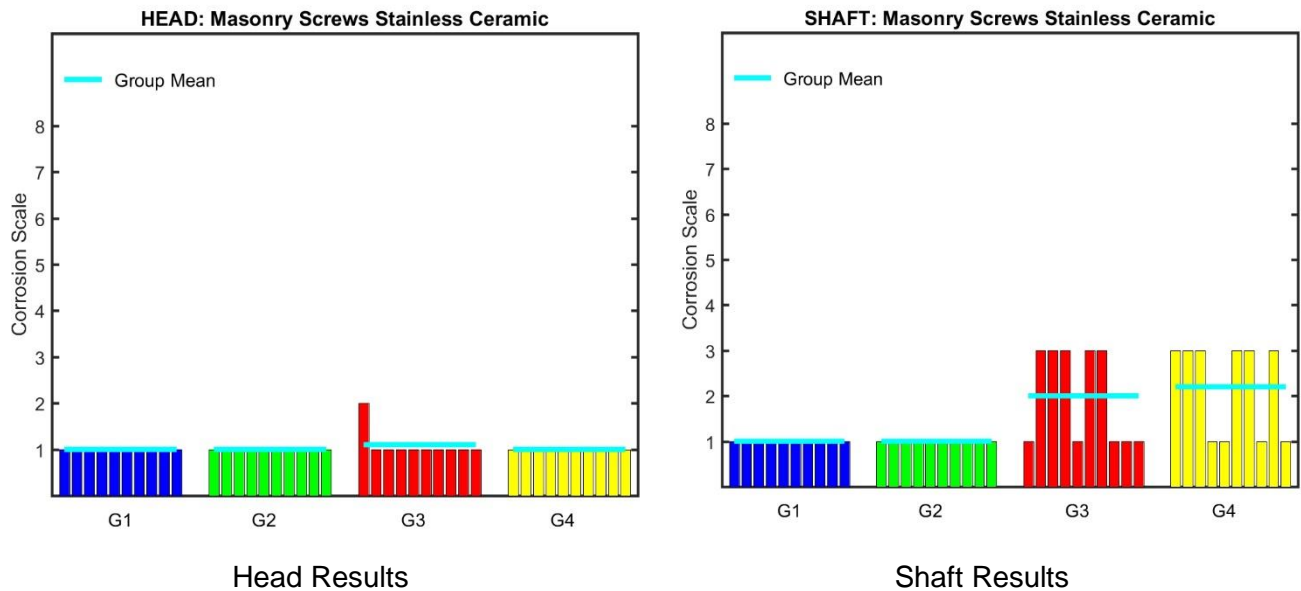
Figure 7: Test-3 Corrosion scale results for stainless steel ceramic coated masonry screws. Ten samples of each.

- Figure 7: All of the 304 stainless steel ceramic coated masonry screws (G1 – G4, pages 38 through 41) exhibited similar corrosion resistance. As seen in the Appendix C photos taken post-test before and after wire brushing, the ceramic coating peeled from the head and shaft, exposing the steel. A minor amount (a few spots) of corrosion was observed in several samples (scores of 2 and 3), less than the 5% surface corrosion TAS 114 pass/fail standard. The ceramic coating is intended to provide a barrier between the stainless steel and the metal being driven through in order to prevent unlike metal reactions. These samples were not tested as-installed through unlike metal, where degradation of the coating may initiate corrosion.

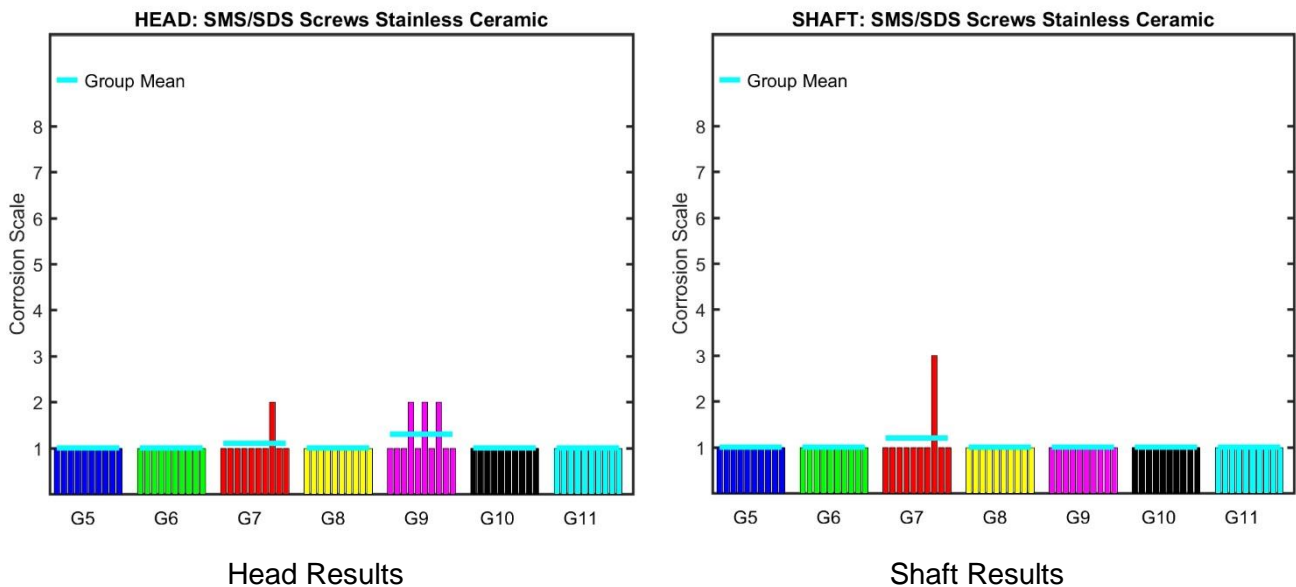
Figure 8: Test-3 Corrosion scale results for stainless steel ceramic coated self-driving and sheet metal screws. Ten samples of each.

- Figure 8: All of the 316 stainless steel ceramic coated sheet metal and self-driving screws (G5 – G11) exhibited similar corrosion resistance. As seen in the Appendix C photos taken post-test before and after wire brushing, the ceramic coating peeled from the head and shaft in G5 – G9 (pages 42 through 46), exposing the steel. However, the ceramic coating for G10 and G11 (pages 47 and 48) remained intact. A minor amount (a few spots) of corrosion was observed in several samples (scores of 2 and 3), less than the 5% surface corrosion TAS 114 pass/fail standard. These samples were not tested as-installed through unlike metal, where degradation of the coating may initiate corrosion.

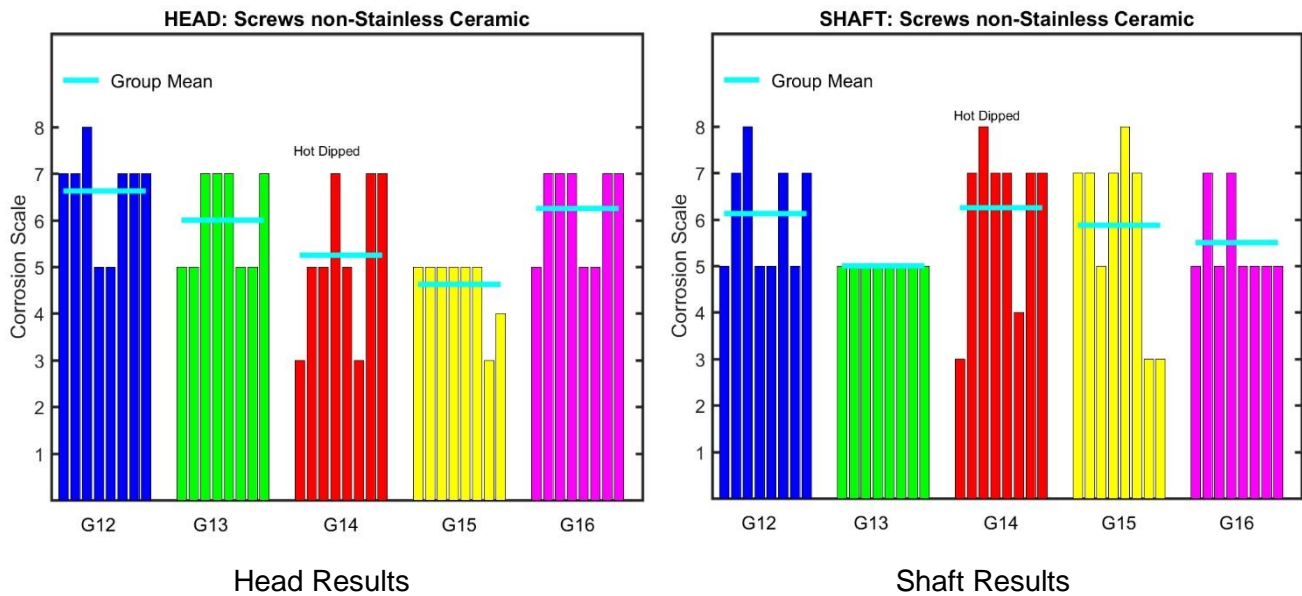
Figure 9: Test-3 Corrosion scale results for non-stainless steel masonry, self-driving and sheet metal screws. Eight samples of each.

- Figure 9: The non-stainless steel sheet metal and self-driving screws (G12 – G16, pages 49 through 53) exhibited extensive corrosion in most samples, coupled with loss of the ceramic coating.

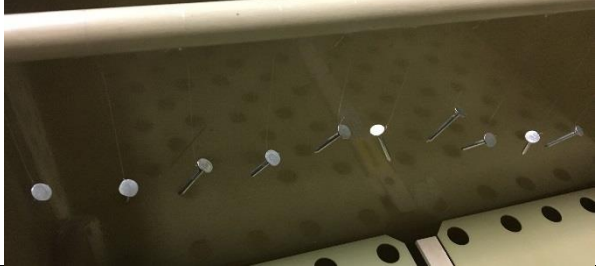
Test-1 Group 1: Set up and two of ten samples 1 1/4" EG, ASTM A641, non-HVHZ	
Sample pre-testing	Group pre-testing

Sample 3 Head classification: 6	Sample 3 Shaft classification: 6

Sample 10 Head classification: 8	Sample 10 Shaft classification: 8

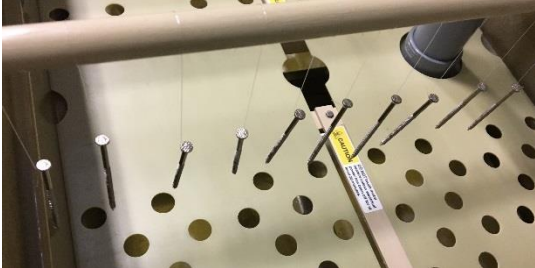
Test-1 Group 11: Set up and one of ten samples 10d 3" ring shank Stainless Steel, patio/deck nails, HVHZ	
Sample pre-testing	Group pre-testing

Sample 8 Head classification: 1	Sample 8 Shaft classification: 3

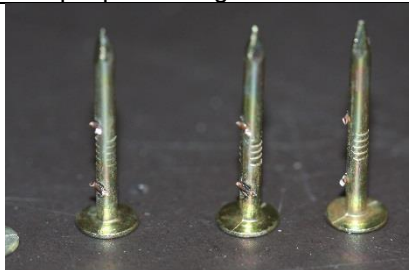
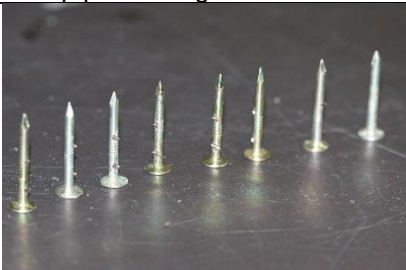
Test-2 Group 1: Pre-test and two of ten samples 1 ¼" EG unrated: out-of-the-box	
Sample pre-testing	Group pre-testing

Sample 3 Head classification: 6	Sample 3 Shaft classification: 7
