**Re: ES-SGD2020, FLORIDA PRODUCT APPROVAL NO. 22267 COMPLAINT
ES-8000T, FLORIDA PRODUCT APPROVAL NO. 17897.5 COMPLAINT**

An independent third-party testing entity tested the subject SGD Product, which resulted in a sudden and catastrophic failure of the system

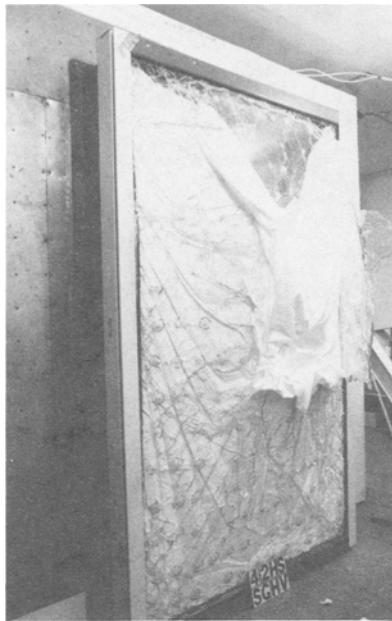
FIG. 8. Tearing of Laminate for Heat-Strengthened Laminated Glass

Laminate tearing was one of the forerunners of specimen failure. Tears were measured relative to the total number of cycles that had been completed, during the experiments in the course of the pressure/vacuum cycling. It was concluded that tears in the PVB interlayer propagated quicker than tears in the PVB/PET/PVB interlayer. Table 4 shows the extent to which laminate tears propagated during the testing of the specimens.

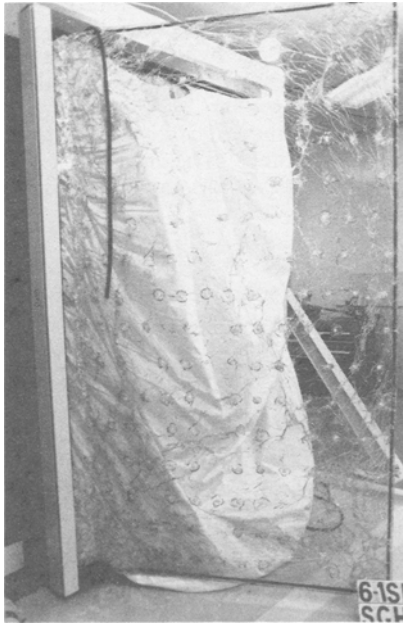
FIG. 9. Failure of Silicone Anchor Bead for Unconventionally Glazed System

and anchored with the silicone seal subjected to the high-velocity missiles (series 4 and 8), all seemed to fail in one of two modes, or a combination of the two modes. The first mode, laminate tearing, was a common phenomenon and often resulted in tears several feet long. These laminate tears opened as much as 0.61 m (2 ft) in one pressure cycle, as shown in Fig. 8. Eventually, these tears would result in failure of the specimen. The second mode of failure was the failure of the silicone anchor bead, as shown in Fig. 9. Once an anchor bead failure occurred on one of the sides, it normally propagated quickly resulting in failure of the system. Clearly, the 19-mm ($\frac{3}{4}$ -in.) anchor bead performed better than the 9-mm ($\frac{3}{8}$ -in.) anchor bead.

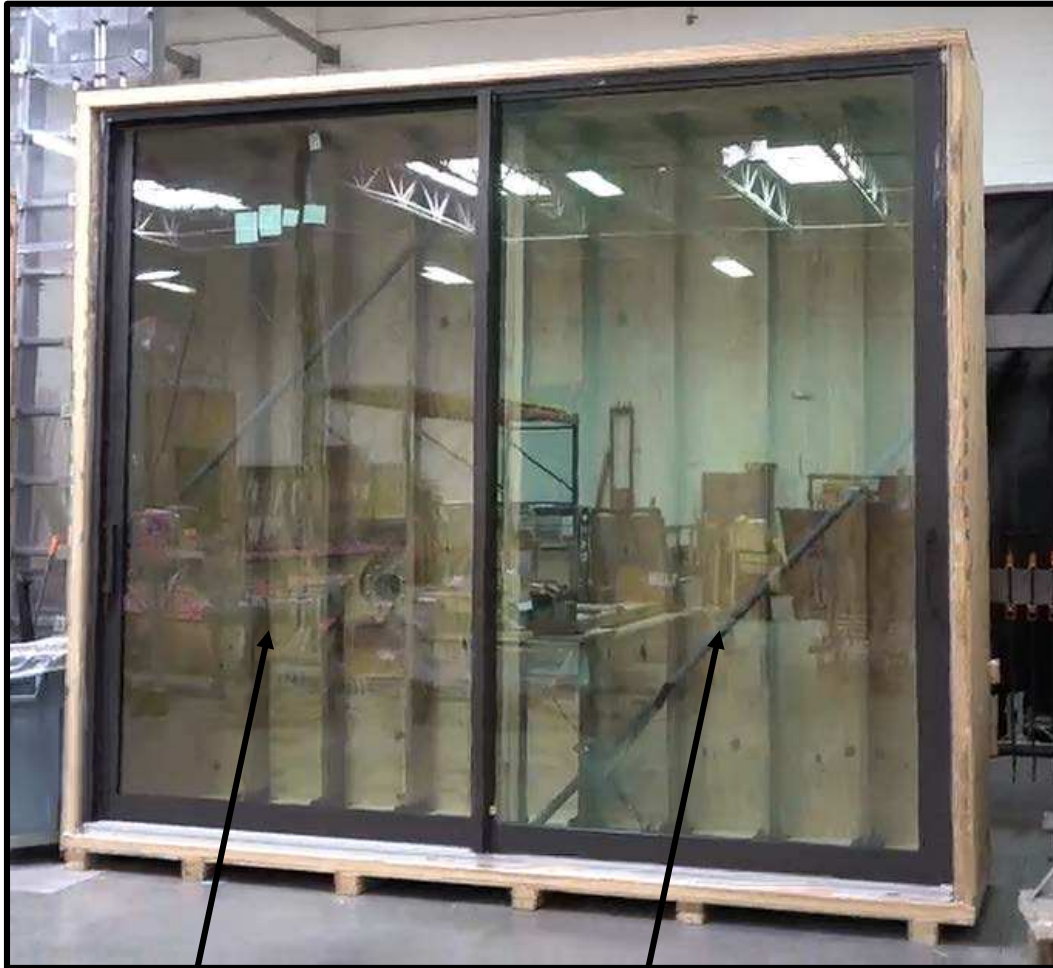
Test Assembly Prior to Testing

Left Panel (OSLI) - IGU

Right Panel (OSLI) – Monolithic Laminate

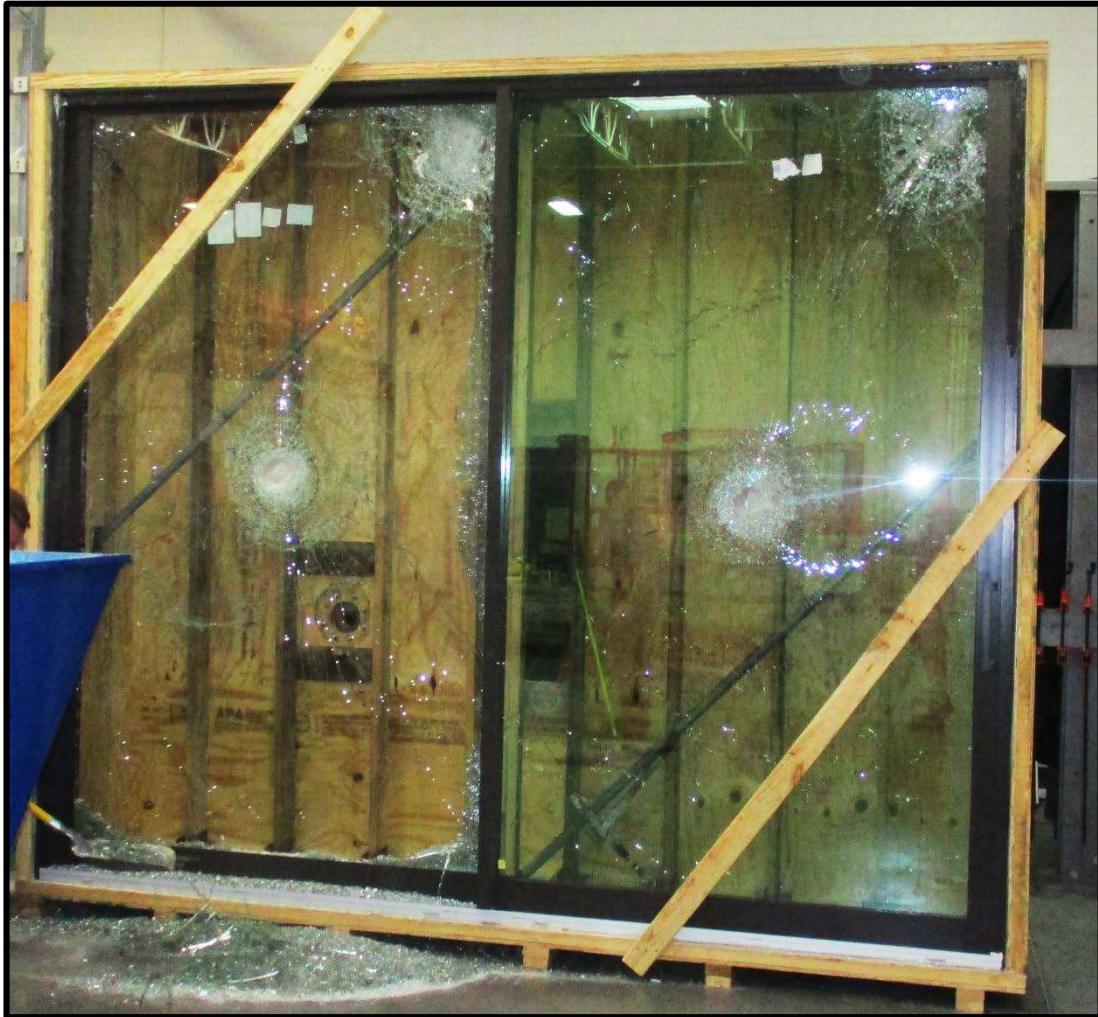
Test Assembly After Impacts

Impact ¹	Missile Weight	Missile Length	Missile Velocity	Location of Impact ²	Observation	Result ³
1	8.8lbs	102"	49.1 fps	Left Operable Panel Center of Infill	Shattered exterior lite, Fractured interior laminate	Pass
2	8.8lbs	102"	49.7 fps	Left Operable Panel Upper Right Corner of Infill	Refractured interior laminate	Pass
3	8.8lbs	102"	49.6 fps	Right Operable Panel Center of Infill	Fractured laminate lite	Pass
4	8.8lbs	102"	49.4 fps	Right Operable Panel Upper Right Corner of Infill	Refractured laminate lite	Pass

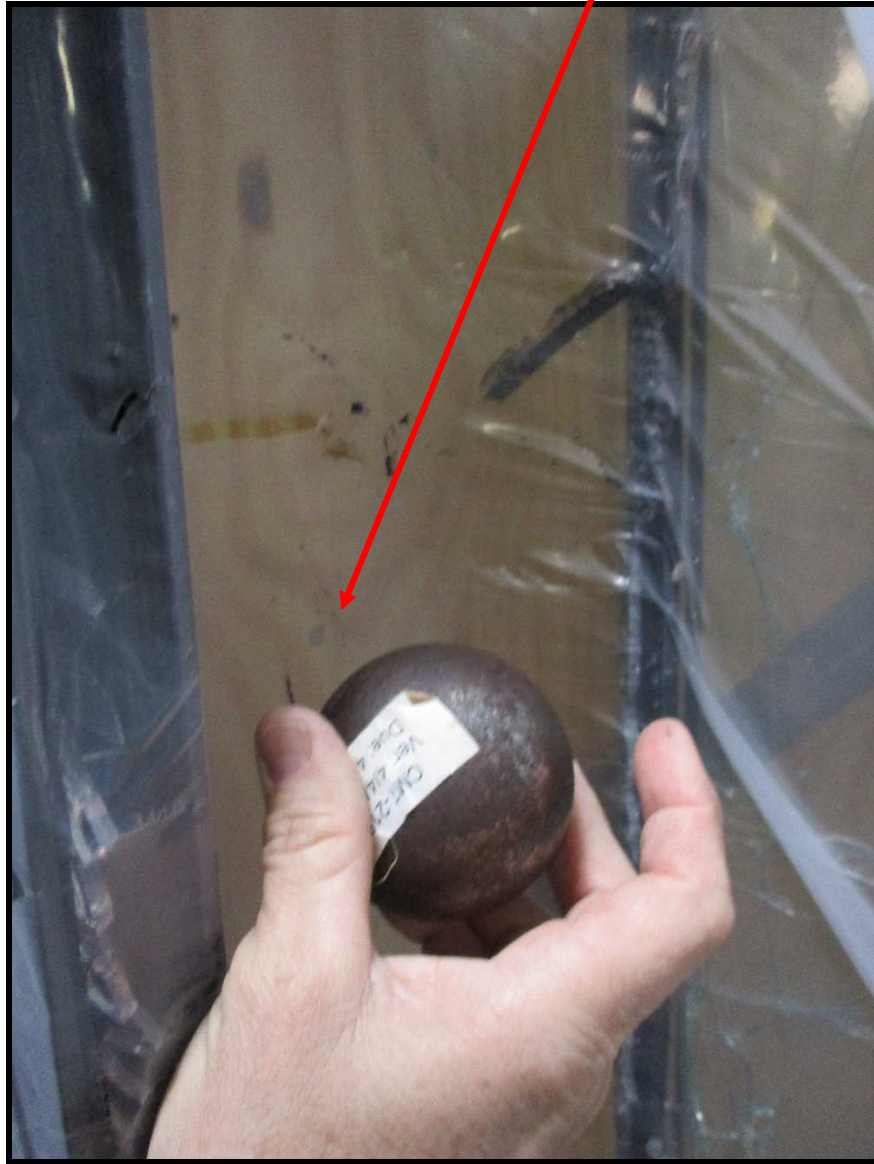
Test Assembly (Left Panel – IGU) After 450 Cycles FAILURE DUE TO DEGLAZING

Therein, PRI noted, in reference to the dry glazed 57x102 systems, that the “samples provided did not achieve the desired performance for basic protection per TAS 201 at the desired differentials per TAS 203 due to deglazing during cyclic wind loading.” *See* Exh. B. In reference to the wet glazed 142x120 system PRI noted, “the sample provided did not achieve the desired performance for basic protection per TAS 201 at +80/-85 psf pressure differentials per TAS 203 due to deglazing during positive cyclic wind loading.” *See id.*

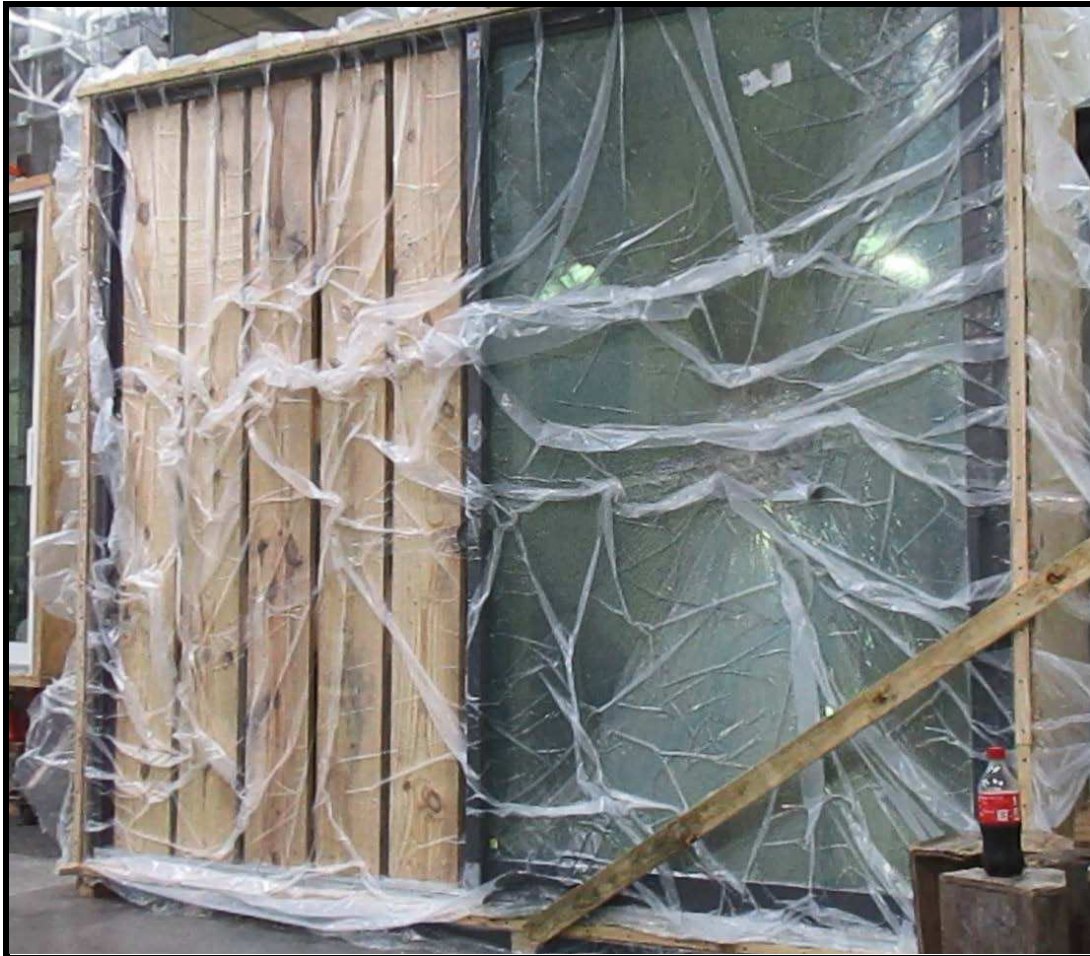
Test Assembly Isolation of Failed Panel

Table 3: TAS 203 / E1886 Results (Client Request to Isolate Failed Panel and Continue with Cycling)

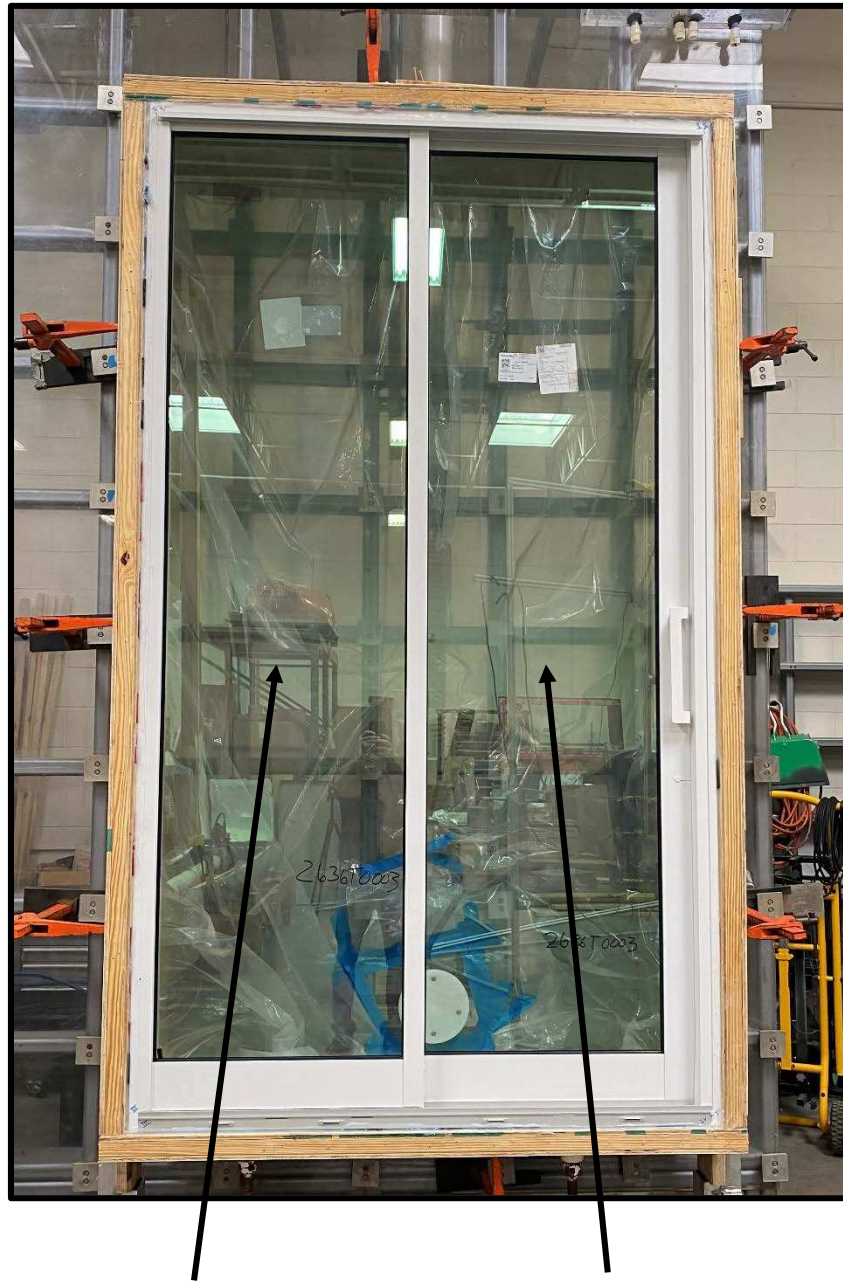
Test Assembly Prior to Testing (Typical Level 1 & 2)

Left Panel - Fixed

Right Panel Operable

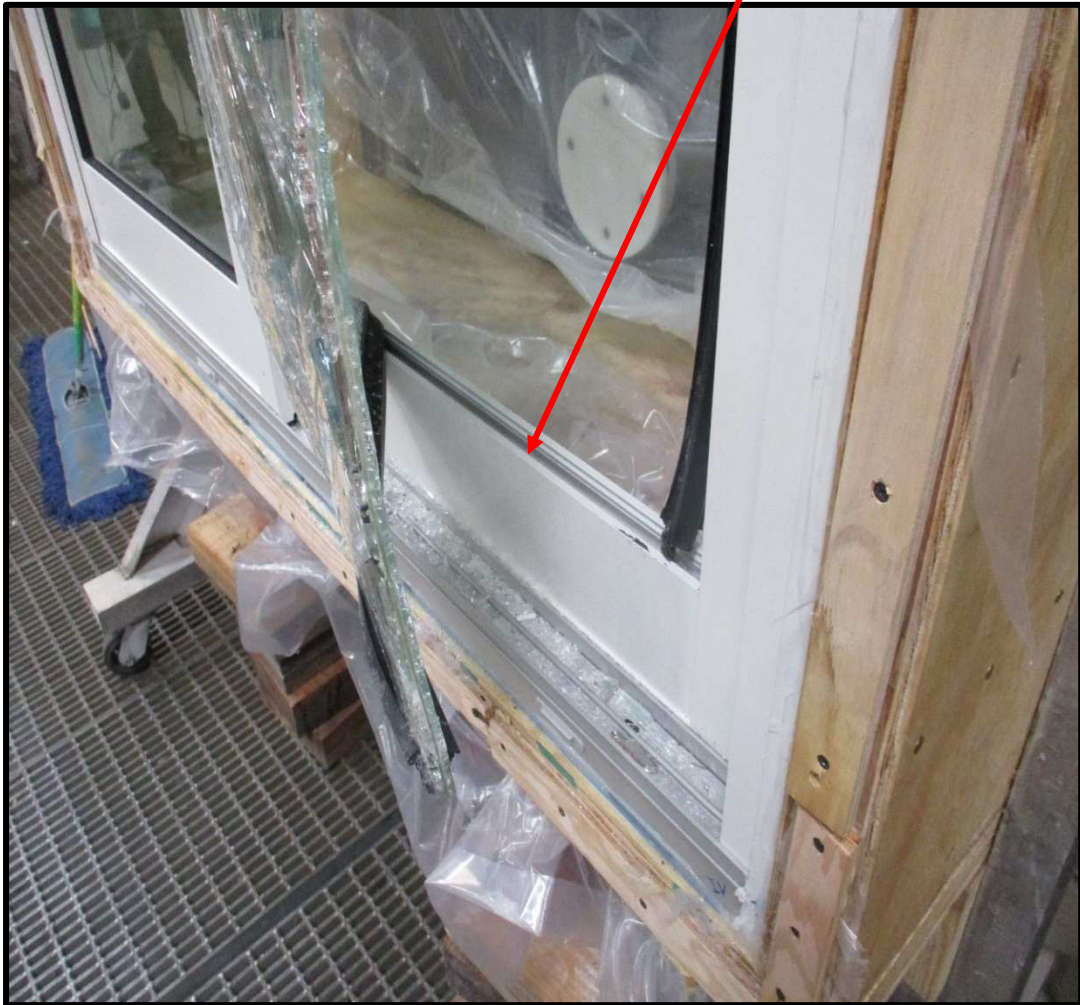
Test Specimen 1: After 26 Cycles 1st Sequence Negative Loading FAILURE DUE TO DEGLAZING

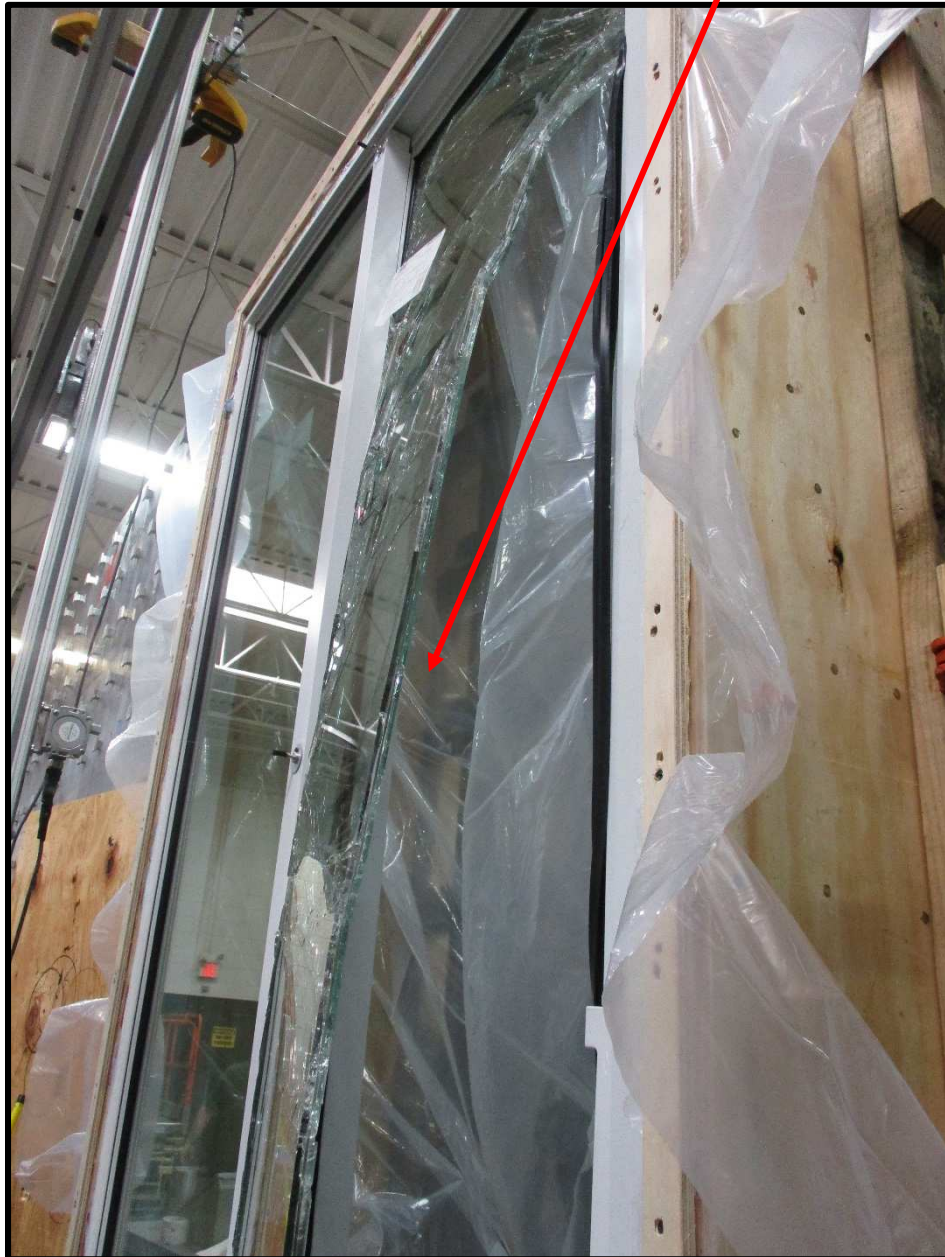
Test Specimen 2: After 228 Cycles 2nd Sequence Negative Loading FAILURE DUE TO DEGLAZING
