Draft Interim Report for Project Entitled:

Corrosion of Residential Fasteners

February 15, 2017

Florida Building Commission
State of Florida Department of Business and Professional Regulation

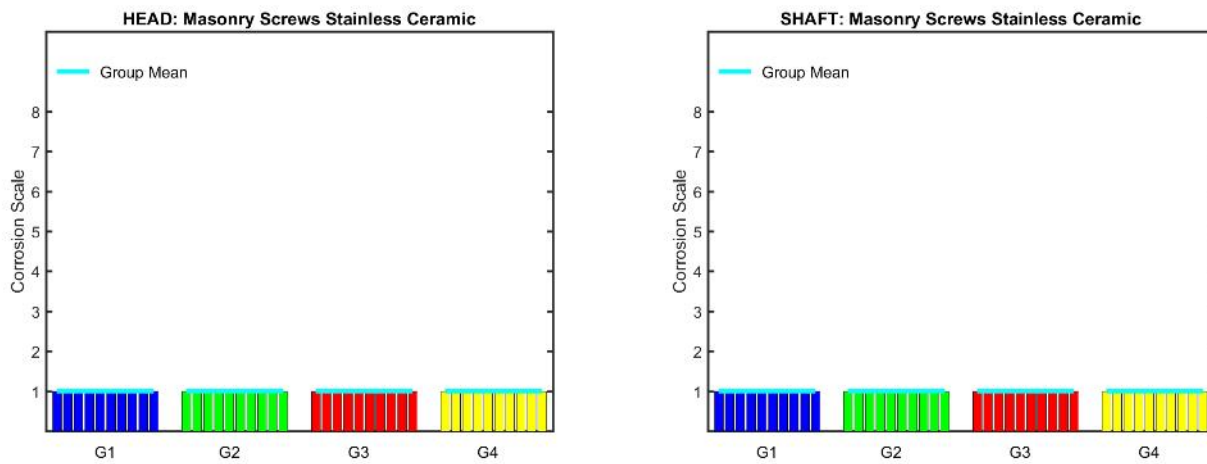
Figure 1: Test-1 Corrosion scale results for stainless steel ceramic coated masonry screws. Ten samples of each. Five out-of-the-box, five installed in aluminum. Per color grouping: left five are installed, right five are out-of-the-box.

- Figures 1 & 2: Consistent with the findings from the 2015 – 2016 study, the performance of ceramic coated stainless steel masonry screws, SDS and SMS was excellent. There was no observed difference in corrosion resistance when comparing out-of-the-box samples with samples that were installed in aluminum. The loss of the ceramic coating was very common. Most samples had significant coating peeling after testing, and most samples that were installed in aluminum showed visible ceramic coating scratching prior to testing. However, this did not compromise the underlying stainless steel. The contact of unlike metals (stainless steel and aluminum) resulting from the loss of ceramic coating did not produce any observed corrosion.

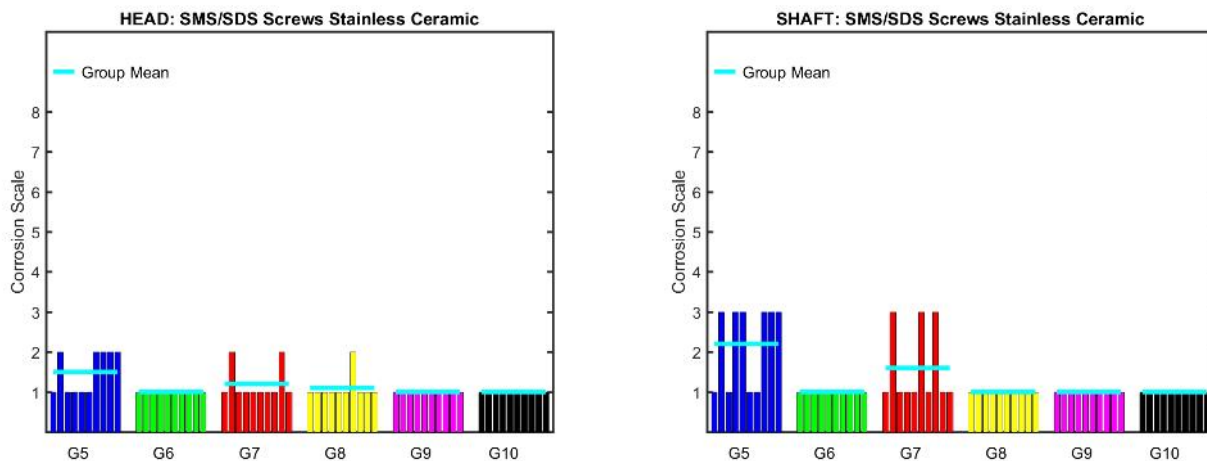
Figure 2: Test-1 Corrosion scale results for stainless steel ceramic coated self-driving and sheet metal screws. Ten samples of each. Five out-of-the-box, five installed in aluminum. Per color grouping: left five are installed, right five are out-of-the-box.

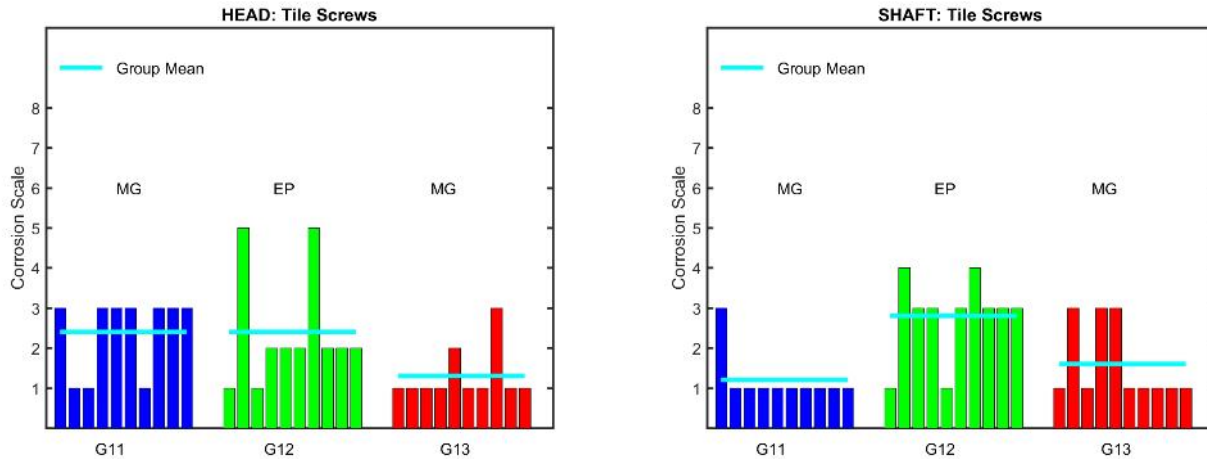
Figure 3: Test-1 Corrosion scale results for tile screws, mechanically galvanized and electroplated. Ten samples of each. Five out-of-the-box, five installed in tile and removed. Per color grouping: left five are installed, right five are out-of-the-box.

- Figure 3: The performance of mechanically galvanized and electroplated roof tile screws was consistent with the findings from the 2015 – 2016 study. In the previous study the tests were not run to the full duration of 500 cycles. The current test was run for the complete 500 cycles. Spots of light corrosion were observed on many samples, and others showed no signs of corrosion. The samples installed into tile and removed prior to testing showed no difference in performance compared to the samples tested out-of-the-box. Electroplated samples showed slightly more corrosion than mechanically galvanized samples

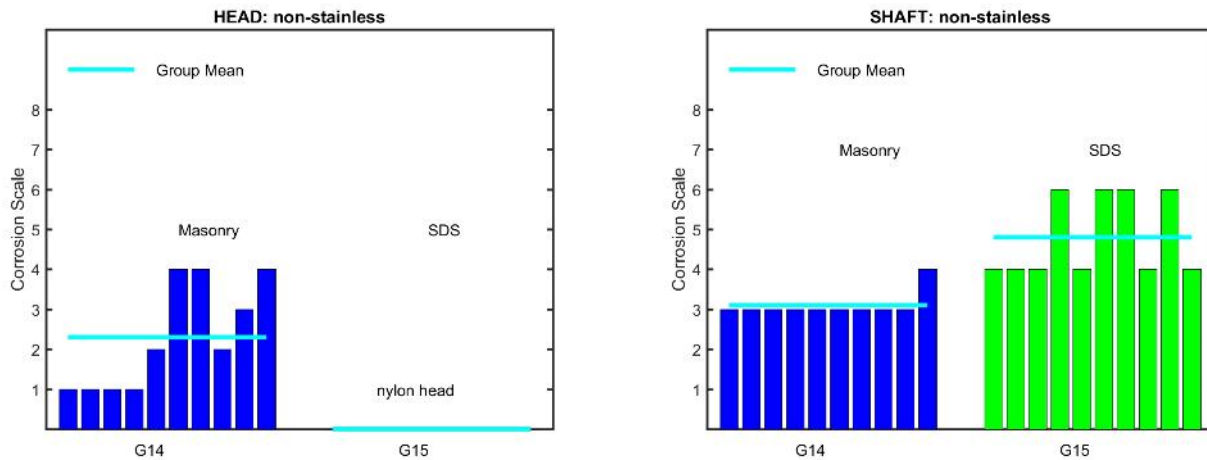
Figure 4: Test-1 Corrosion scale results for case hardened carbon steel masonry and SDS screws, ceramic coated. Ten samples of each. Five out-of-the-box, five installed in aluminum. Per color grouping: left five are installed, right five are out-of-the-box.

- Figure 4: Ceramic coated case hardened carbon steel masonry screws and SDS exhibit significant corrosion on the shaft on most samples, and corrosion on the head on the masonry screws (the SDS had a nylon head). Installation in aluminum did not influence the onset of corrosion on the shaft.

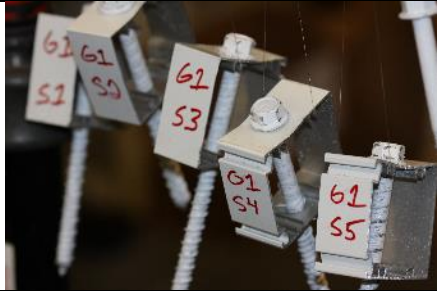
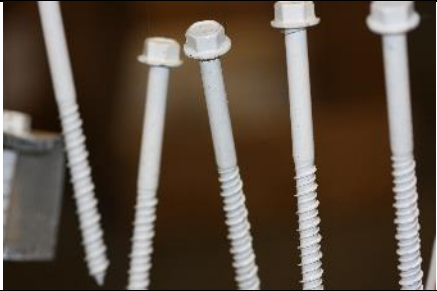
Group 1: Ceramic coated Hex 3/8 x 5 304 Stainless white	
Sample pre-testing installed	Sample pre-testing out-of-the-box

A collection of ceramic-coated hex bolts of various sizes, some with small white labels attached. The labels have handwritten numbers in red ink, including '61 S1', '61 S3', '61 S4', and '61 S5'.

A close-up view of several ceramic-coated hex bolts standing upright, showing their white finish and hexagonal heads.
Sample 1	Sample 1

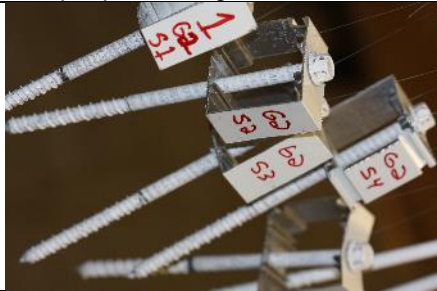
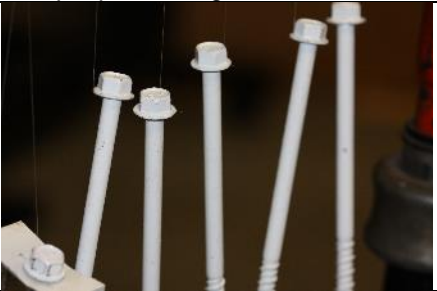
Group 2: Ceramic coated Hex 3/8 x 7 304 Stainless white	
Sample pre-testing installed	Sample pre-testing out-of-the-box

A collection of ceramic-coated hex bolts of various sizes, some with small white labels attached. The labels have handwritten numbers in red ink, including '61 S1', '61 S3', '61 S4', and '61 S5'.

A close-up view of several ceramic-coated hex bolts standing upright, showing their white finish and hexagonal heads.
Sample 1	Sample 1

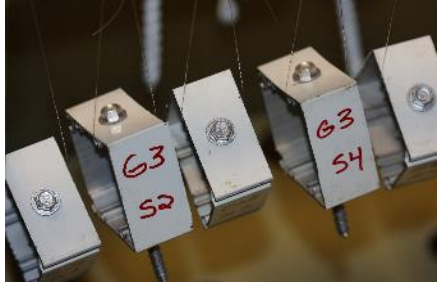
Group 3: Ceramic coated Hex 1/4 x 3 1/4 304 Stainless silver	
Sample pre-testing installed	Sample pre-testing out-of-the-box

A photograph showing several ceramic-coated hex bolts installed in a metal plate. The bolts are secured with nuts. Handwritten labels in red ink are attached to the bolts, with 'G3' and 'S2' visible on the left and 'G3' and 'S4' on the right.

A photograph showing several ceramic-coated hex bolts hanging vertically from a yellow surface. The bolts are clean and appear to be in their original packaging.
Sample 1	Sample 1

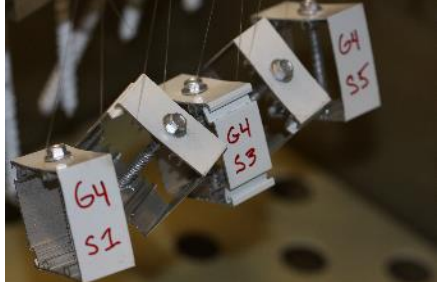
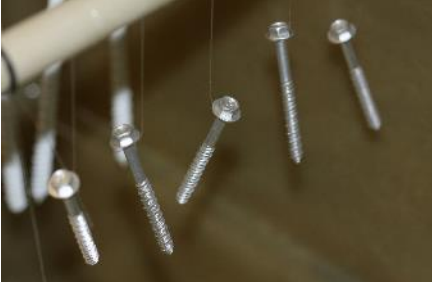
Group 4: Ceramic coated Hex 1/4 x 2 1/4 304 Stainless silver	
Sample pre-testing installed	Sample pre-testing out-of-the-box

A photograph showing several ceramic-coated hex bolts installed in a metal plate. The bolts are secured with nuts. Handwritten labels in red ink are attached to the bolts, with 'G4' and 'S1' visible on the left and 'G4' and 'S5' on the right.

A photograph showing several ceramic-coated hex bolts hanging vertically from a yellow surface. The bolts are clean and appear to be in their original packaging.
Sample 1	Sample 1

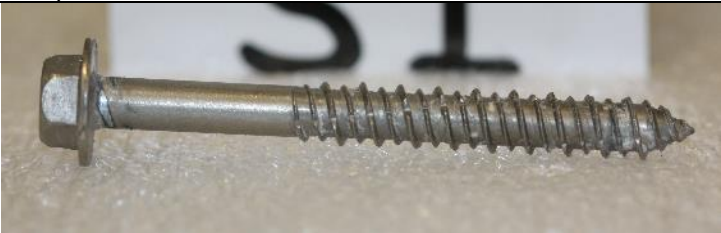
A close-up photograph of the head of a ceramic-coated hex bolt installed in a metal plate. The bolt is secured with a nut.

A close-up photograph of a single ceramic-coated hex bolt lying horizontally on a light-colored surface. The bolt is clean and shows the hexagonal head and threaded shaft.

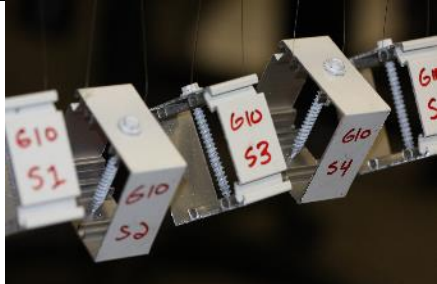
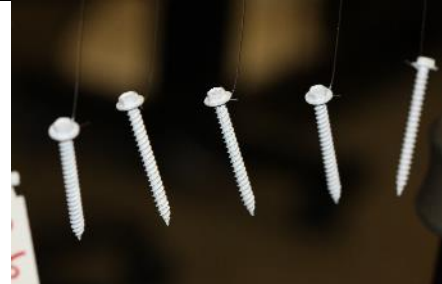
Group 10: Ceramic coated Hex 1/4 10 x 2 SDS Stainless white	
Sample pre-testing installed	Sample pre-testing out-of-the-box

<p>Group 10 installed samples in a testing rig. Labels include 610 S1, 610 S2, 610 S3, and 610 S4.</p>

<p>Group 10 samples out-of-the-box, showing the hex head and threaded shaft.</p>
Sample 1	Sample 1
