Draft Final Report for Project Entitled:
Corrosion of Roofing and Screen Enclosure Fasteners Systems

Performance Period: 10/10/2014 – 6/30/2015

Florida Building Commission
State of Florida Department of Business and Professional Regulation

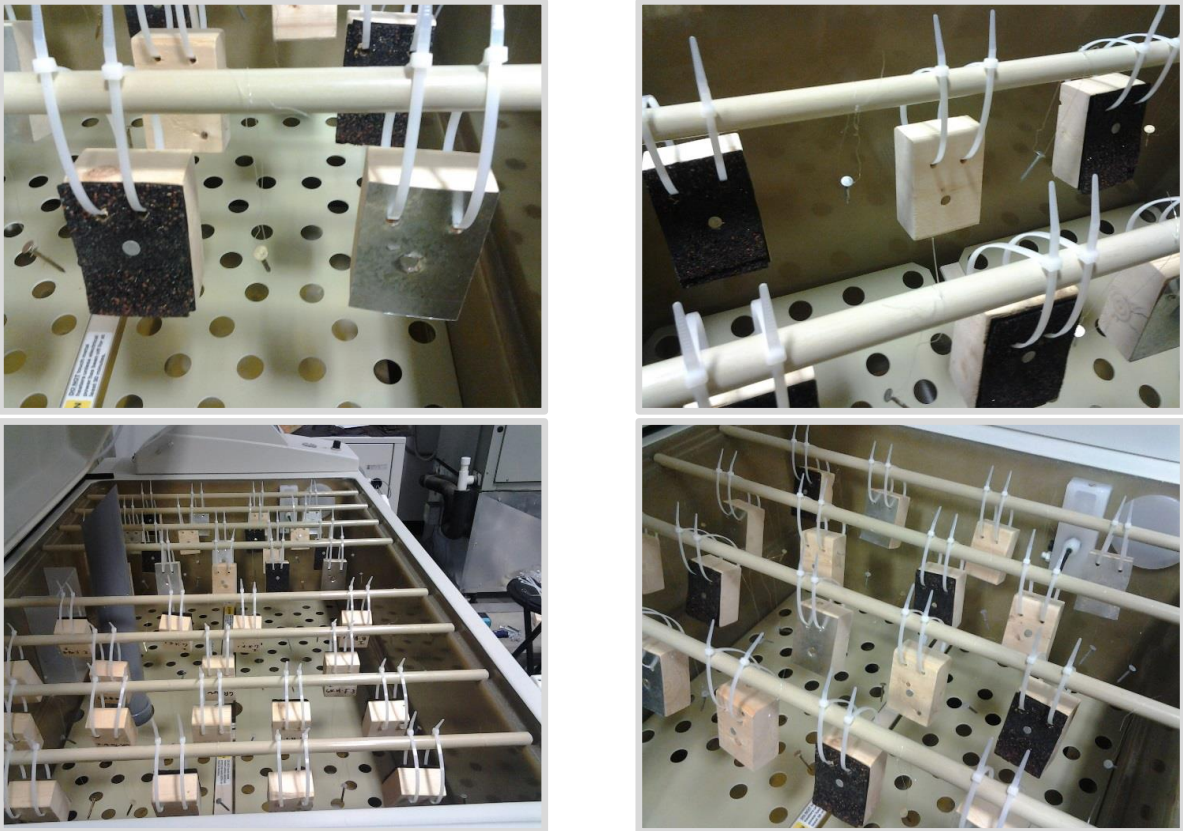
Figure 1: Images of the prepared roof fastener specimens within the test chamber

The test chamber accommodated all of the 88 specimens. Figure 1 presents images of the specimens placed in the test chamber prior to testing. Each specimen was suspended from a rod by either zip-ties (installed specimens) or fishing line (bare specimens). No specimen was in contact with any other, and all suspension rods were in the same horizontal plane.

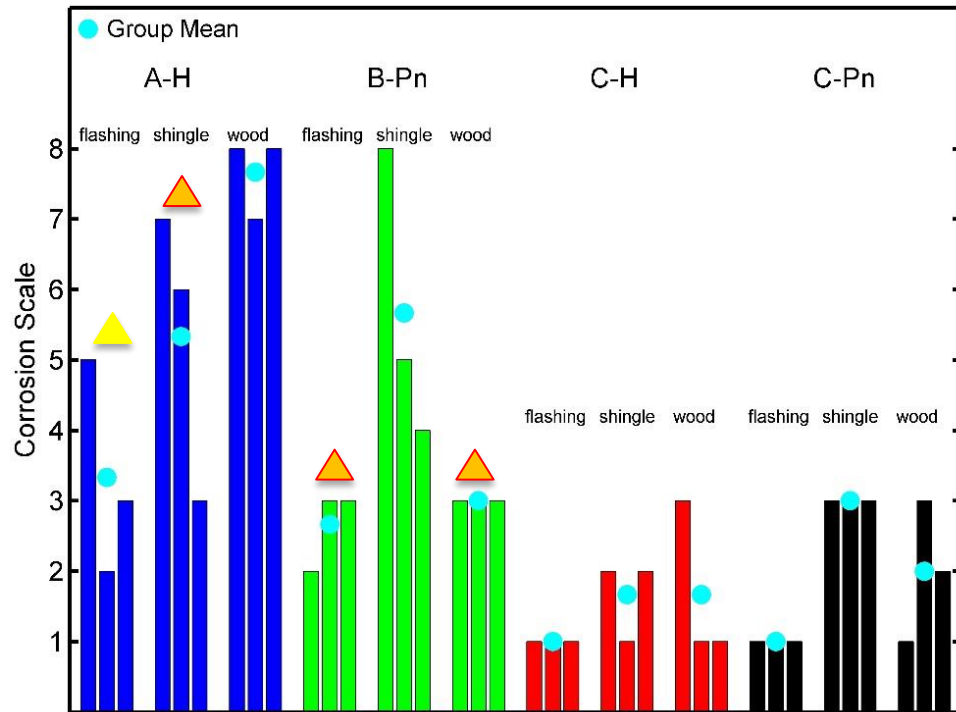
Figure 5: Corrosion scale results for 36 roof fasteners tested as-installed (configuration I)

Figure 5 presents the tested as-installed results (configuration I) as documented in Table 5. These results are head-only, as the shaft was within the substrate during testing, and post-test removal showed no corrosion in any specimen that was within a substrate during testing. The colors delineate manufacturer-install method as labeled (A-H, B-Pn, C-H, C-Pn). The substrate labels (flashing, shingle, wood) delineate the substrate corresponding to the clusters of three specimens tested in identical conditions. The light blue circle associated with each three bar cluster shows the mean score among those three identically tested specimens. The colored triangular icons will be explained in Section 6.6.4.

Figure 5 interpretation is also best conducted in contrast with the Figure 2 out of the box configuration results. Manufacturers A and B show mixed results compared with Figure 2, where performance improves in some cases and remains poor in other cases. This is attributable to experimental scatter. Manufacturer C tested as installed performance is consistent with the out of the box results, with very little corrosion observed on the installed heads.

In Table 10 only a single test indicates statistically significant differences. This test is located in row 5, and highlighted in yellow. This is the comparison between the out of the box (OB) - manufacturer A - hand driven nails - head corrosion results and the tested as installed (I) - manufacturer A - hand driven nails - through flashing into wood substrate. This rejection of the null hypothesis is also indicated in Figure 5 as the yellow triangle above the appropriate grouping.

Among the 48 total comparison tests, only one rejected the null hypothesis, and an additional eight accepted with relatively low confidence. Viewing these results as the colored triangles in Figures 3-5, it is striking that all but one of these cases indicate an increase in corrosion

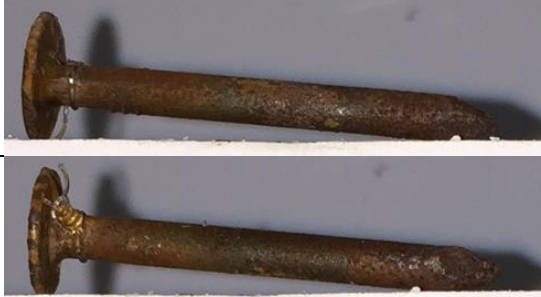
CODE: OB-A-H

Sample 1 Head classification: 7	Sample 1 Shaft classification: 6

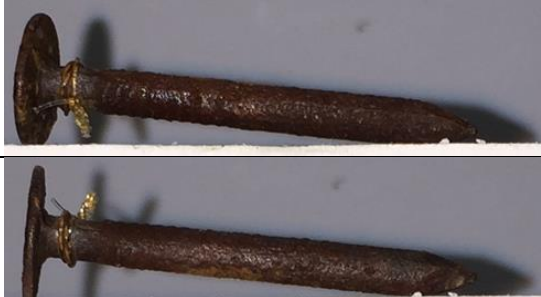
Sample 2 Head classification: 7	Sample 2 Shaft classification: 8

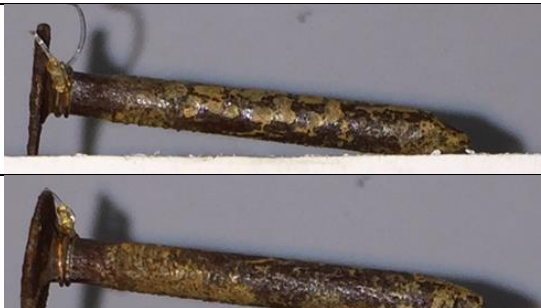
Sample 3 Head classification: 7	Sample 3 Shaft classification: 8

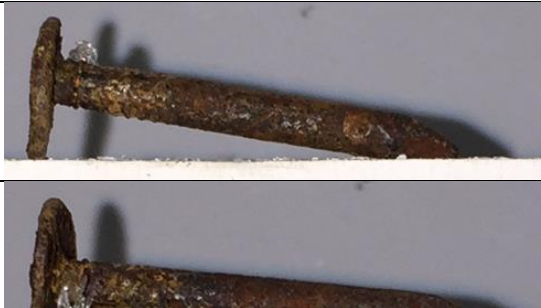
Sample 4 Head classification: 8	Sample 4 Shaft classification: 8

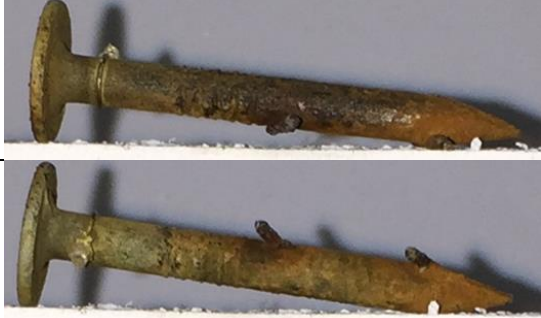
CODE: OB-B-Pn

Sample 1 Head classification: 4	Sample 1 Shaft classification: 4

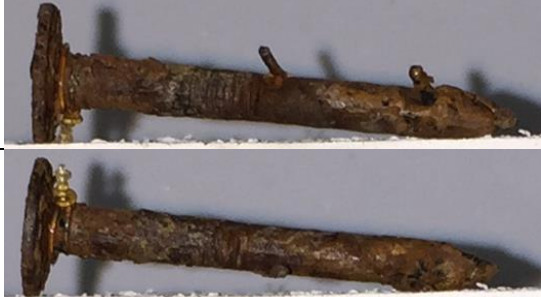
Sample 2 Head classification: 7	Sample 2 Shaft classification: 8

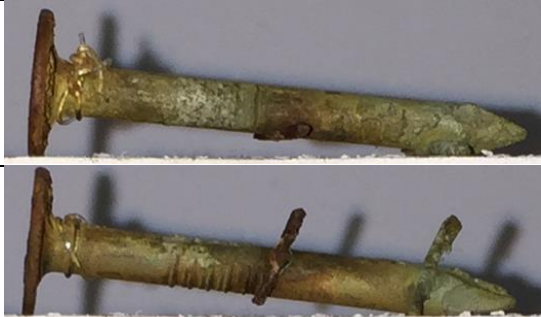
Sample 3 Head classification: 7	Sample 3 Shaft classification: 4

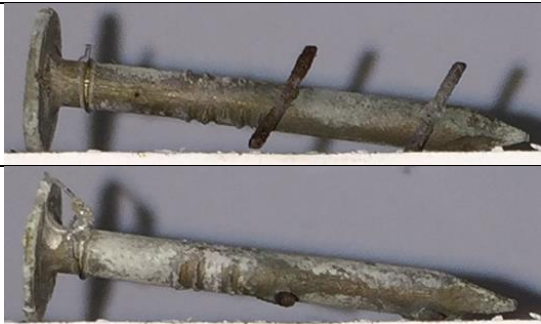
Sample 4 Head classification: 3	Sample 4 Shaft classification: 1

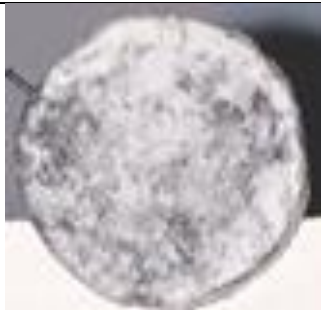
Sample 2 Head classification: 1	Sample 2 Shaft classification: 1

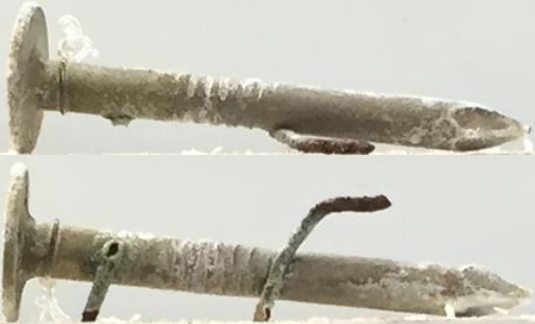
Sample 2 Head classification: 2	Sample 2 Shaft classification: 1

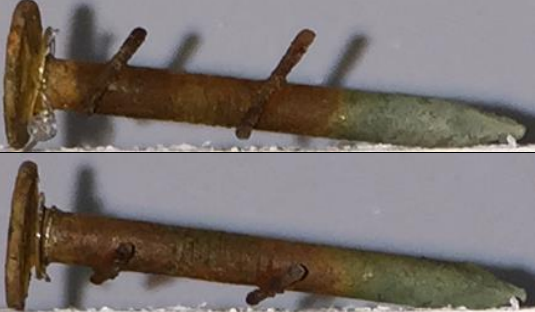
Sample 3 Head classification: 6	Sample 3 Shaft classification: 3

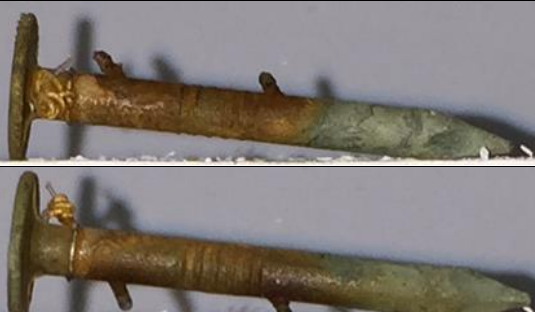
Sample 4 Head classification: 2	Sample 4 Shaft classification: 3

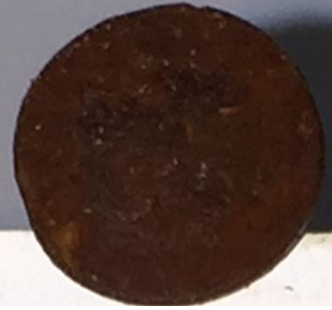
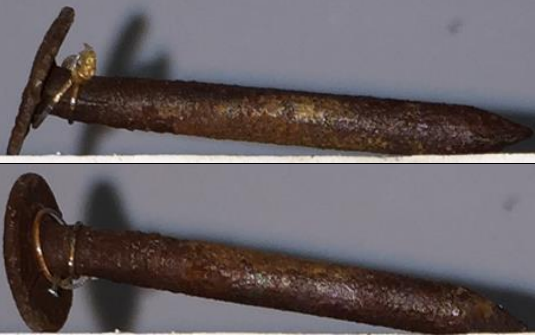
CODE: II-A-H-F

Sample 1 Head classification: 8	Sample 1 Shaft classification: 7

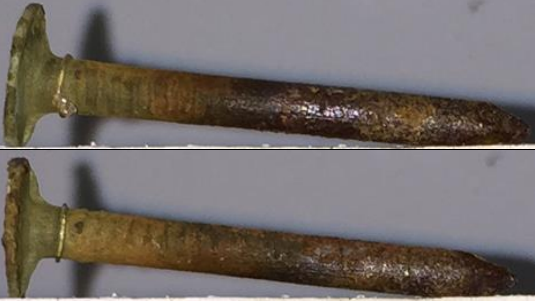
Sample 2 Head classification: 6	Sample 2 Shaft classification: 6

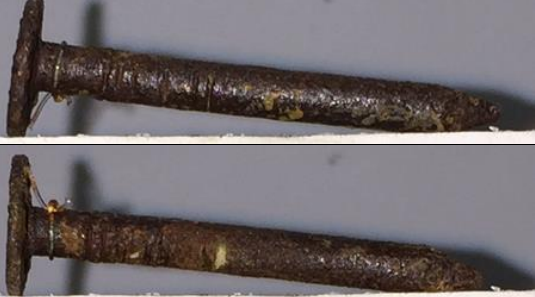
Sample 3 Head classification: 8	Sample 3 Shaft classification: 8

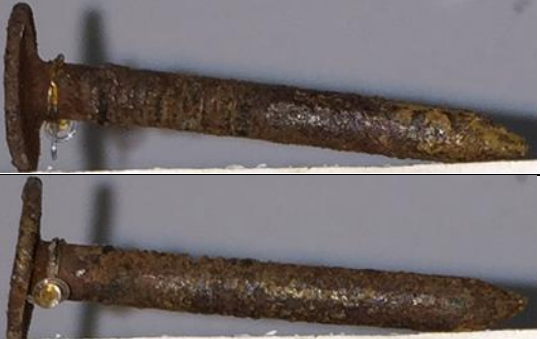
CODE: II-A-H-S

Sample 1 Head classification: 8	Sample 1 Shaft classification: 8

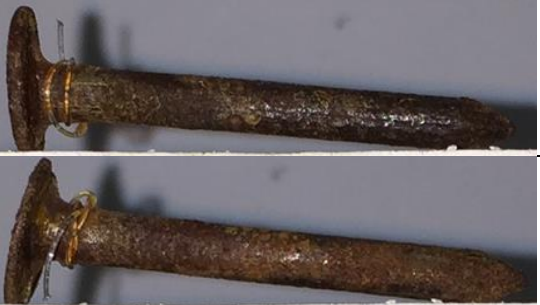
Sample 2 Head classification: 7	Sample 2 Shaft classification: 7

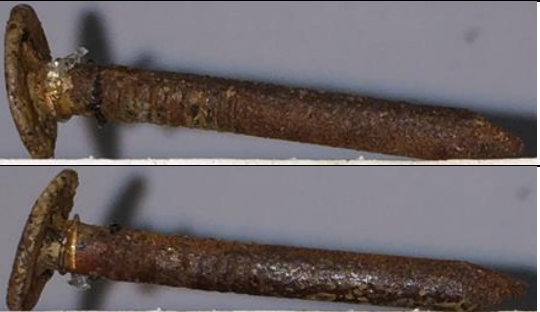
Sample 3 Head classification: 8	Sample 3 Shaft classification: 7

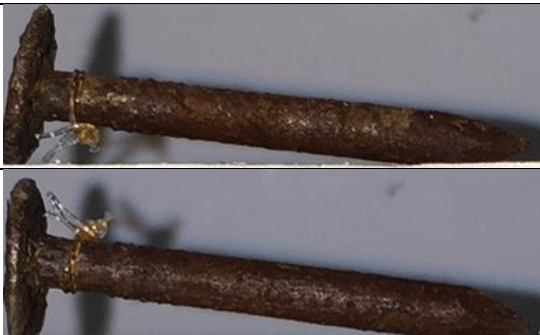
Sample 3 Head classification: 8	Sample 3 Shaft classification: 8

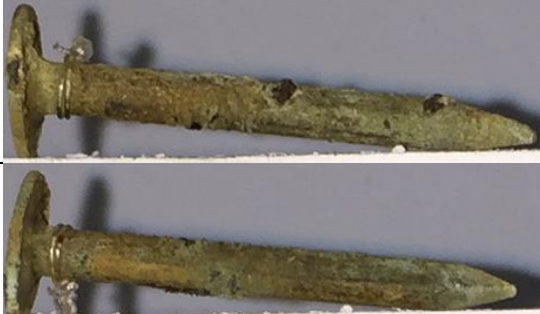
Sample 2 Head classification: 4		Sample 2 Shaft classification: 4

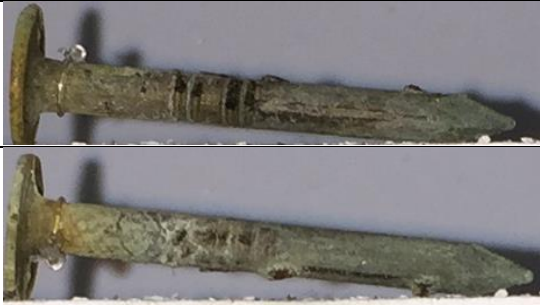
Sample 3 Head classification: 3		Sample 3 Shaft classification: 3

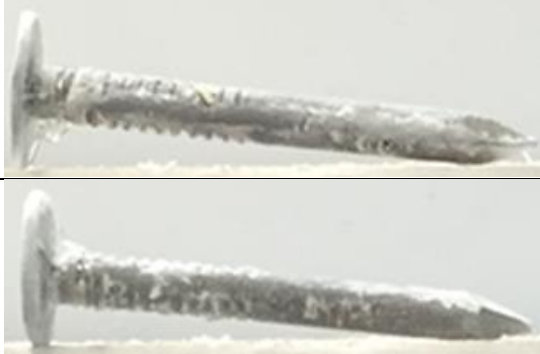
CODE: II-C-H-W	
Sample 1 Head classification: 1	Sample 1 Shaft classification: 1

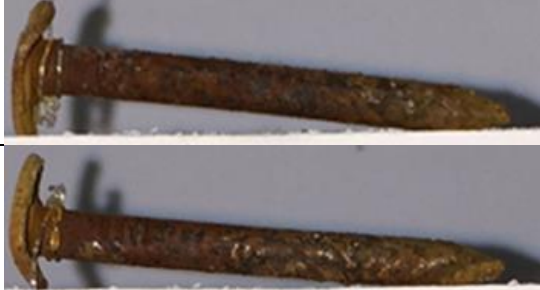
Sample 2 Head classification: 4	Sample 2 Shaft classification: 6

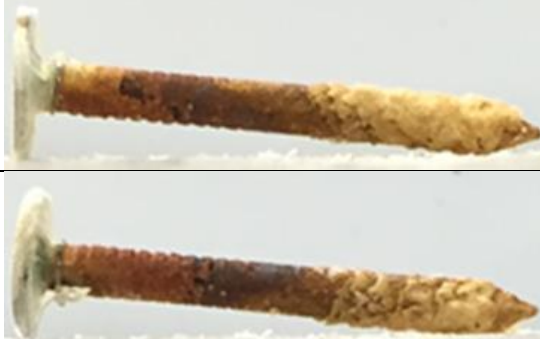
Sample 3 Head classification: 2	Sample 3 Shaft classification: 6

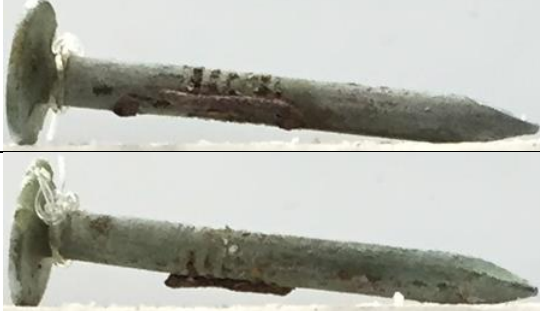
CODE: II-C-Pn-S

Sample 1 Head classification: 1	Sample 1 Shaft classification: 1

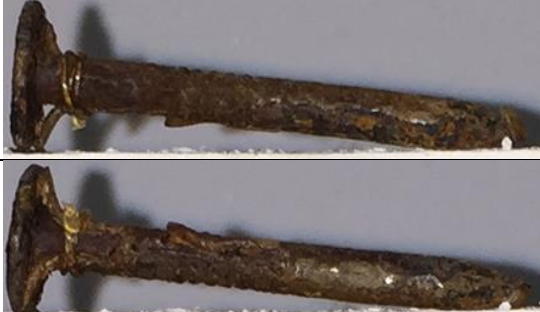
Sample 2 Head classification: 8	Sample 2 Shaft classification: 8

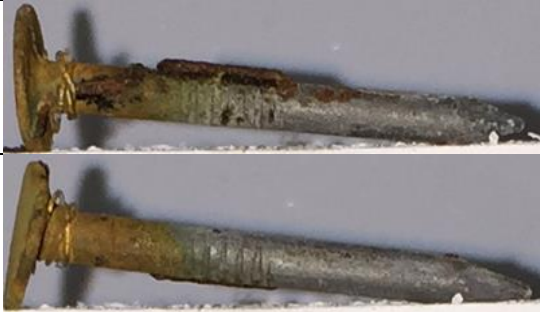
Sample 3 Head classification: 4	Sample 3 Shaft classification: 3
