Draft Final Report for Project Entitled:

Corrosion of Residential Fasteners

Florida Building Commission
State of Florida Department of Business and Professional Regulation

Kurtis R. Gurley, Ph.D., kgurl@ce.ufl.edu, (352) 294-7795

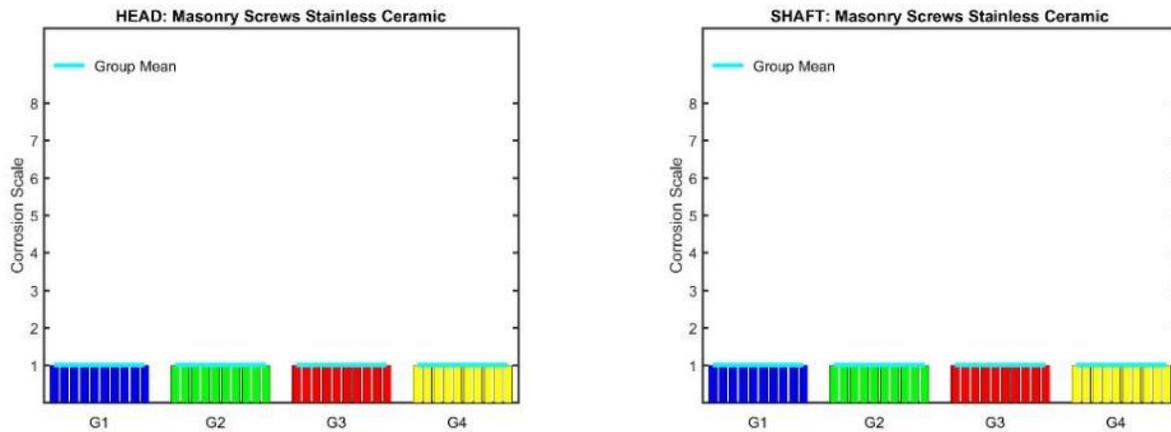
Figure 1: Test-1 Corrosion scale results for stainless steel ceramic coated masonry screws. Ten samples of each. Five out-of-the-box, five installed in aluminum. Per color grouping: left five are installed, right five are out-of-the-box.

- Figures 1 & 2: Consistent with the findings from the 2015 – 2016 study, the performance of ceramic coated stainless steel masonry screws, SDS and SMS was excellent. There was no observed difference in corrosion resistance when comparing out-of-the-box samples with samples that were installed in aluminum. The loss of the ceramic coating was very common. Most samples had significant coating peeling after testing, and most samples that were installed in aluminum showed visible ceramic coating scratching prior to testing. However, this did not compromise the underlying stainless steel. The contact of unlike metals (stainless steel and aluminum) resulting from the loss of ceramic coating did not produce any observed corrosion.

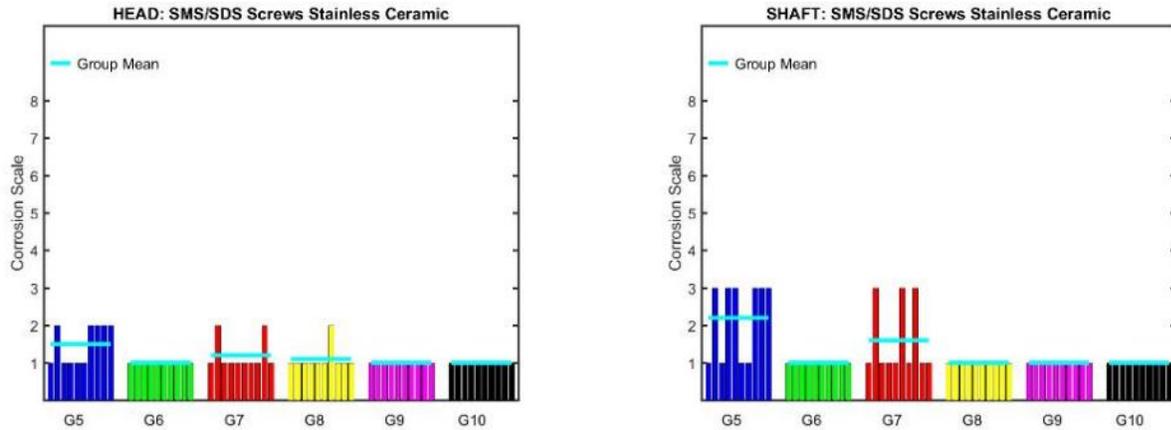
Figure 2: Test-1 Corrosion scale results for stainless steel ceramic coated self-driving and sheet metal screws. Ten samples of each. Five out-of-the-box, five installed in aluminum. Per color grouping: left five are installed, right five are out-of-the-box.

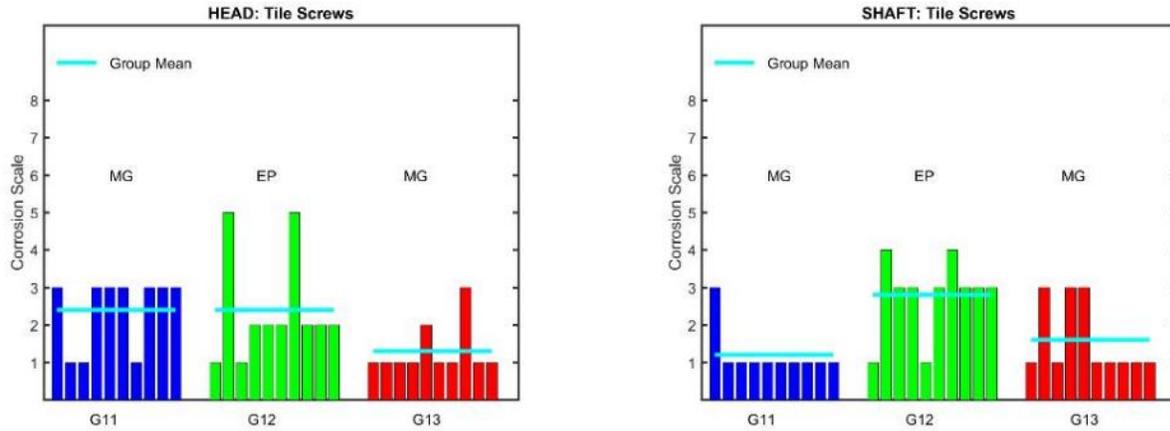
Figure 3: Test-1 Corrosion scale results for tile screws, mechanically galvanized and electroplated. Ten samples of each. Five out-of-the-box, five installed in tile and removed. Per color grouping: left five are installed, right five are out-of-the-box.

- Figure 3: The performance of mechanically galvanized and electroplated roof tile screws was consistent with the findings from the 2015 – 2016 study. In the previous study the tests were not run to the full duration of 500 cycles. The current test was run for the

complete 500 cycles. Spots of light corrosion were observed on many samples, and others showed no signs of corrosion. The samples installed into tile and removed prior to testing showed no difference in performance compared to the samples tested out-of-the-box. Electroplated samples showed slightly more corrosion than mechanically galvanized samples

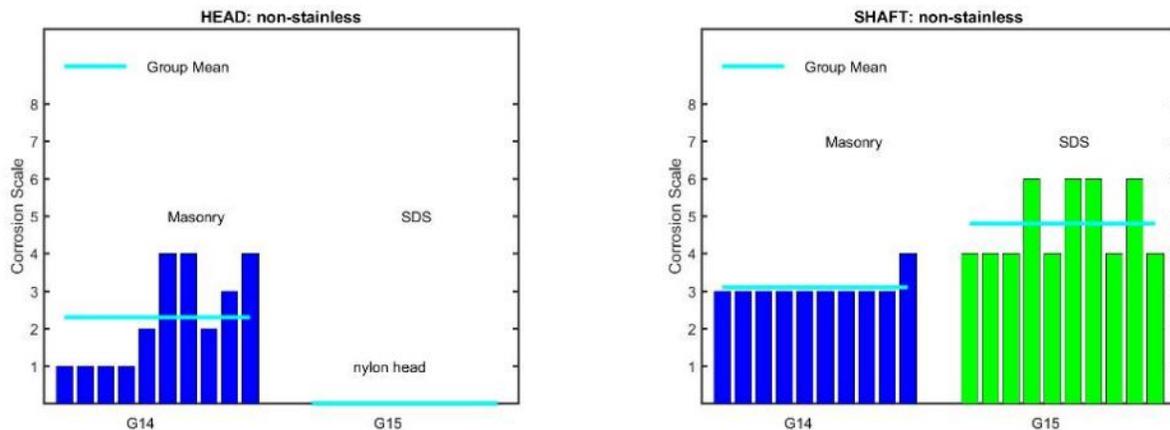
Figure 4: Test-1 Corrosion scale results for case hardened carbon steel masonry and SDS screws, ceramic coated. Ten samples of each. Five out-of-the-box, five installed in aluminum. Per color grouping: left five are installed, right five are out-of-the-box.

- Figure 4: Ceramic coated case hardened carbon steel masonry screws and SDS exhibit significant corrosion on the shaft on most samples, and corrosion on the head on the masonry screws (the SDS had a nylon head). Installation in aluminum did not influence the onset of corrosion on the shaft.

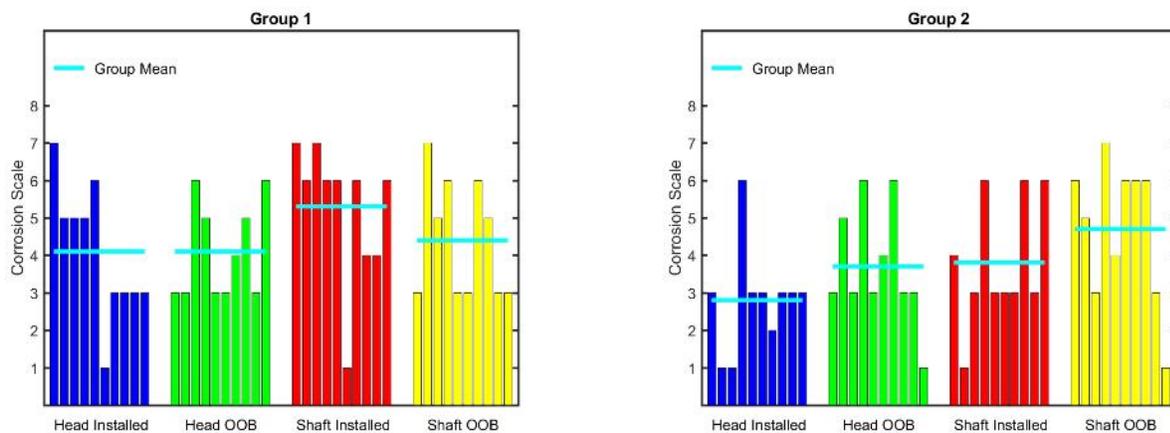
Figure 5: Test-2 Corrosion scale results for Group 1 and Group 2. Twenty samples of each. Ten out-of-the-box, ten installed and removed from wood.

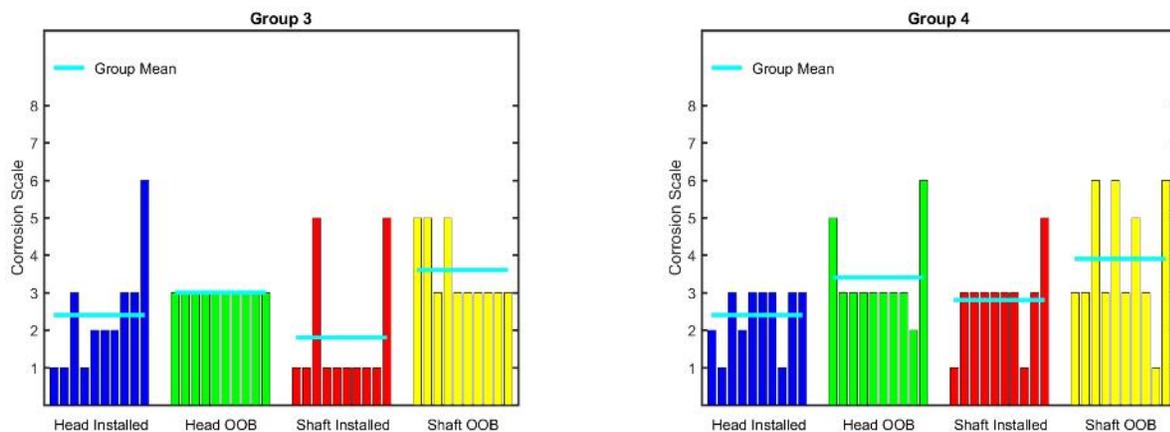
Figure 6: Test-2 Corrosion scale results for Group 3 and Group 4. Twenty samples of each. Ten out-of-the-box, ten installed and removed from wood.

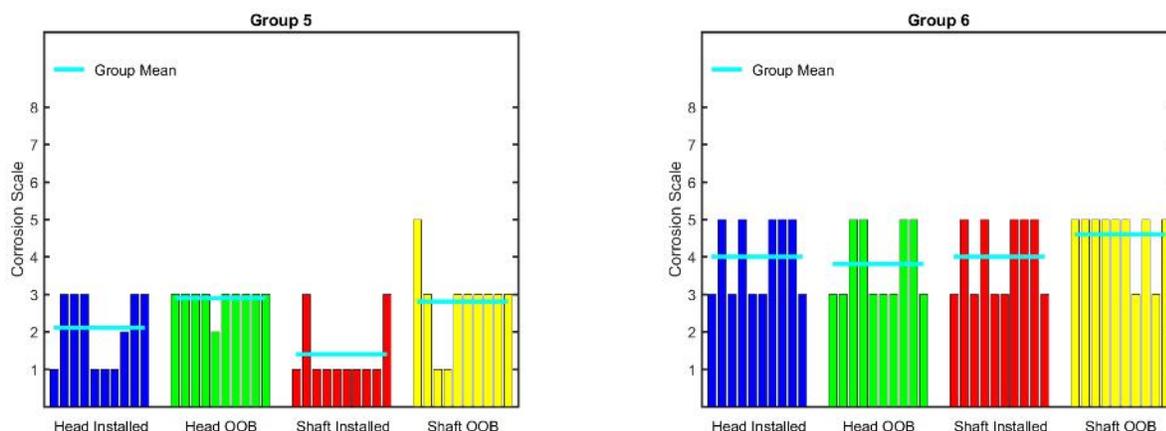
Figure 7: Test-2 Corrosion scale results for Group 5 and Group 6. Twenty samples of each. Ten out-of-the-box, ten installed and removed from wood.

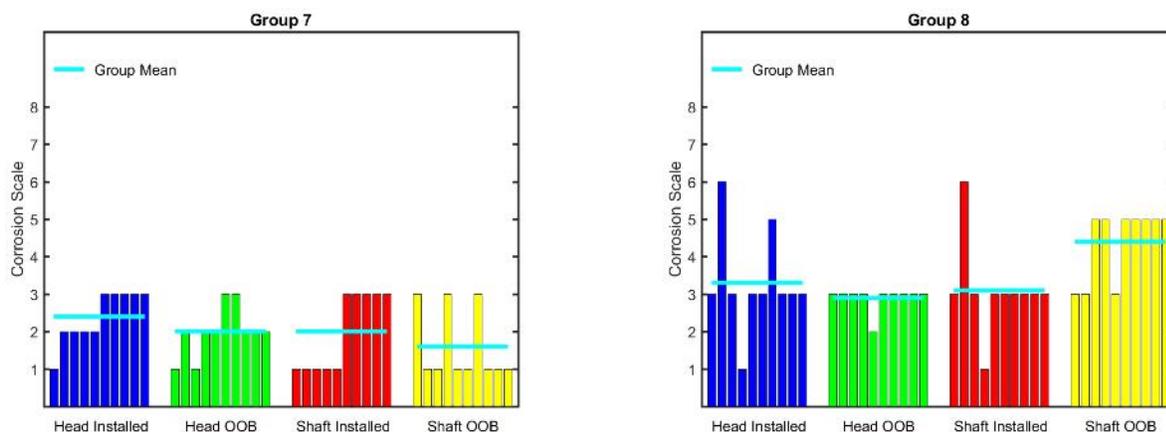
Figure 8: Test-2 Corrosion scale results for Group 7 and Group 8. Twenty samples of each. Ten out-of-the-box, ten installed and removed from wood.

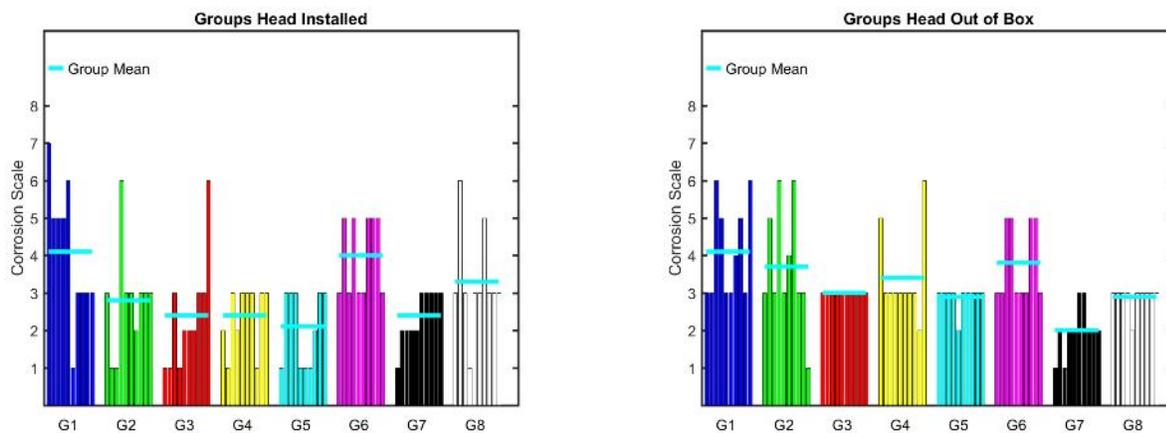
Figure 9: Test-2 Corrosion scale results, all 8 groups. Nail head for installed and removed samples (left), Nail head for out of the box (right). Combined head results from Figures 5-8.

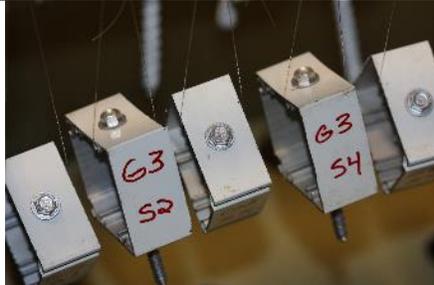
Test-1 Group 3: Ceramic coated Hex 1/4 x 3 1/4 304 Stainless silver	
Sample pre-testing installed	Sample pre-testing out-of-the-box

A photograph showing four ceramic-coated hex bolts installed in a metal plate. Each bolt has a small white tag attached to its head with red handwritten markings. The first two bolts have tags labeled 'G3' and 'S2', and the last two have tags labeled 'G3' and 'S4'.

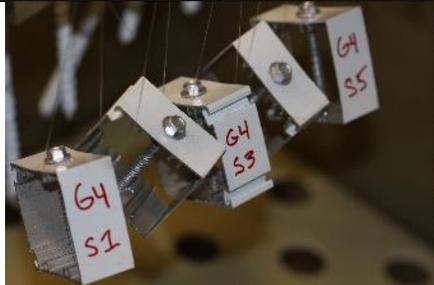
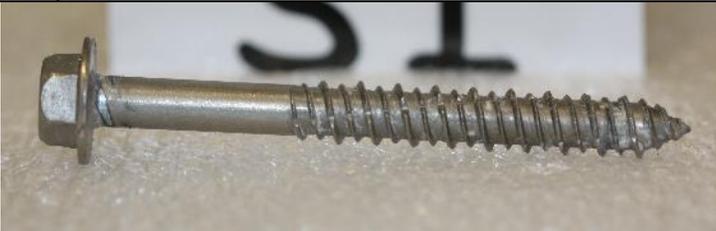
Test-1 Group 4: Ceramic coated Hex 1/4 x 2 1/4 304 Stainless silver	
Sample pre-testing installed	Sample pre-testing out-of-the-box

A photograph showing four ceramic-coated hex bolts installed in a metal plate. Each bolt has a small white tag attached to its head with red handwritten markings. The first two bolts have tags labeled 'G4' and 'S1', and the last two have tags labeled 'G4' and 'S3'.

A close-up photograph of a single ceramic-coated hex bolt lying horizontally on a light-colored surface.

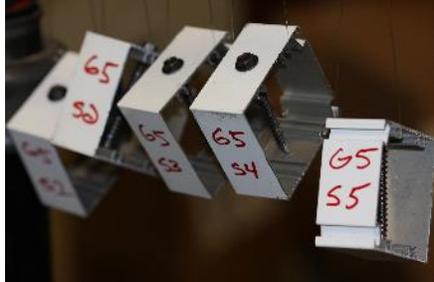
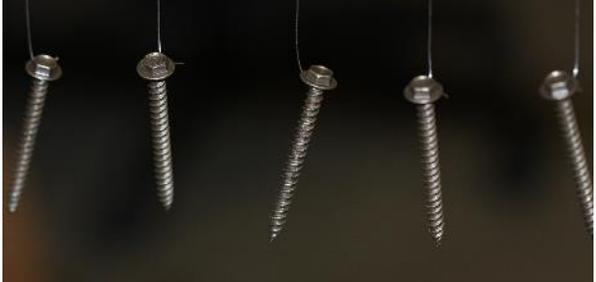
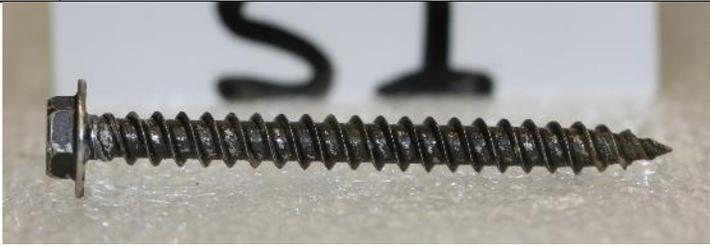
Test-1 Group 5: Ceramic coated Hex 1/4 10 x 2 SMS 316 Stainless bronze	
Sample pre-testing installed	Sample pre-testing out-of-the-box

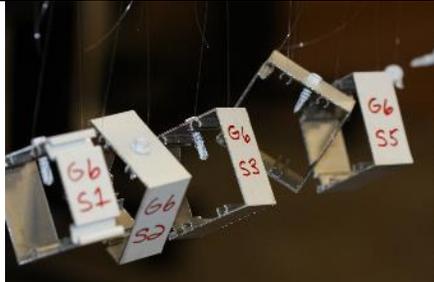
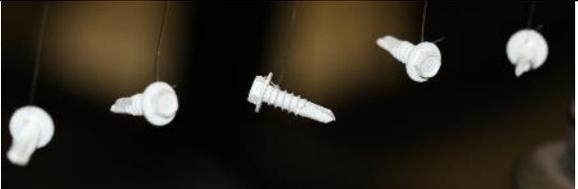
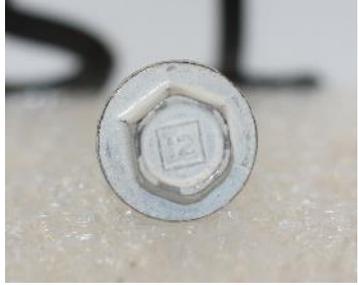
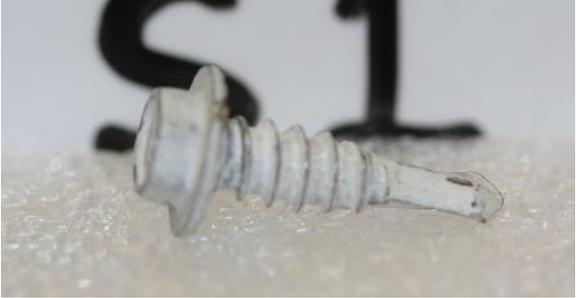
Test-1 Group 6: Ceramic coated Hex 1/4 12 x 3/4 SDS 316 Stainless white	
Sample pre-testing installed	Sample pre-testing out-of-the-box

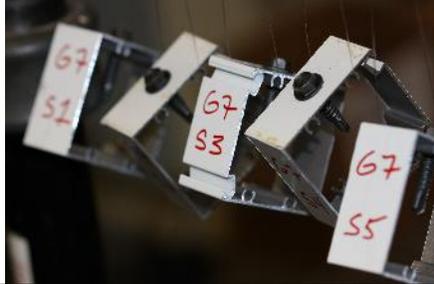
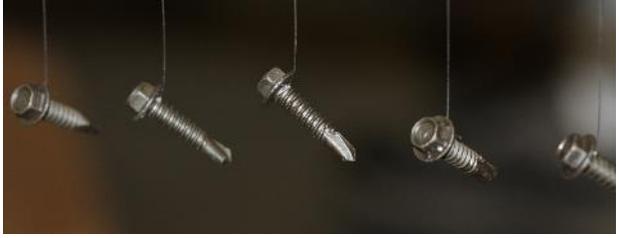
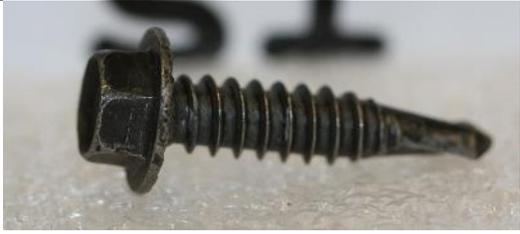
Test-1 Group 7: Ceramic coated Hex 5/16 14 x 1 SDS 316 Stainless bronze	
Sample pre-testing installed	Sample pre-testing out-of-the-box

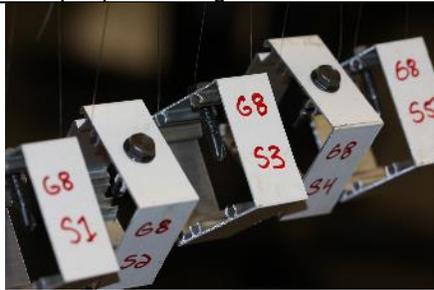
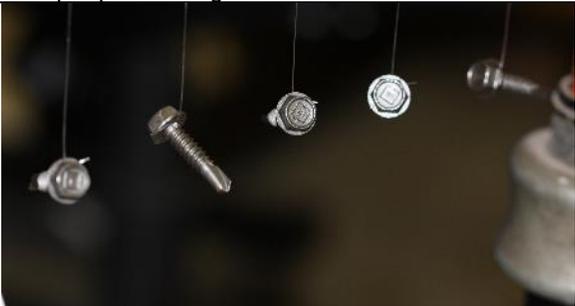
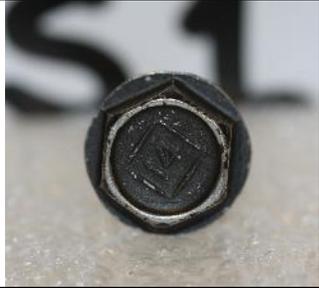
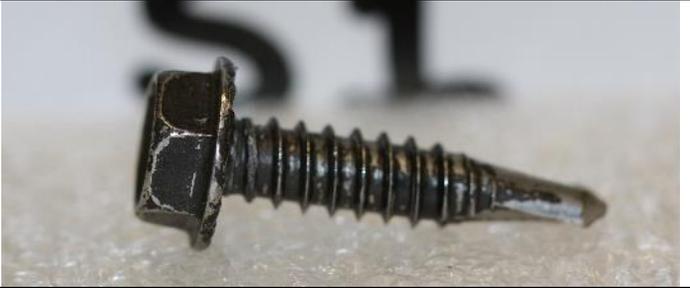
Test-1 Group 8: Ceramic coated Hex 3/8 14 x 1 SDS 316 Stainless bronze	
Sample pre-testing installed	Sample pre-testing out-of-the-box

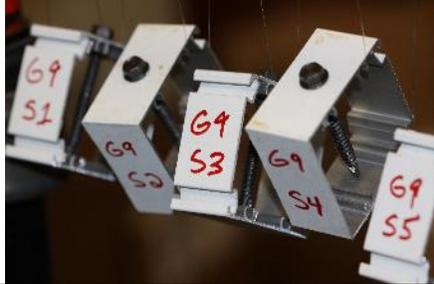
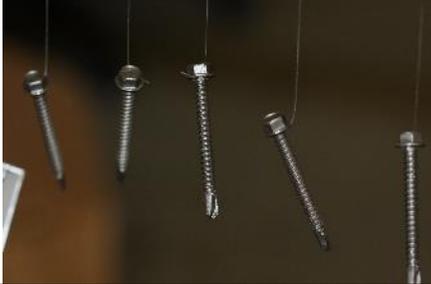
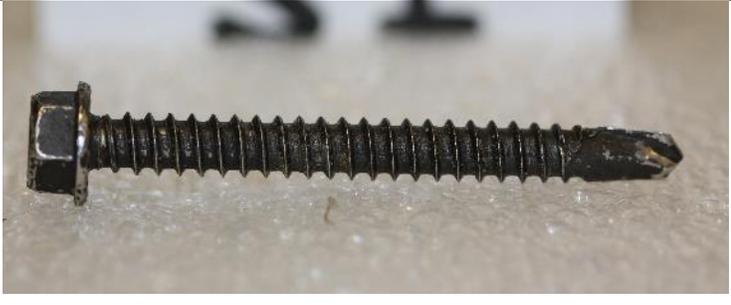
Test-1 Group 9: Ceramic coated Hex 5/16 12 x 2 SDS 316 Stainless bronze	
Sample pre-testing installed	Sample pre-testing out-of-the-box

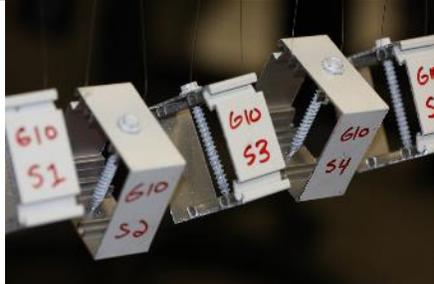
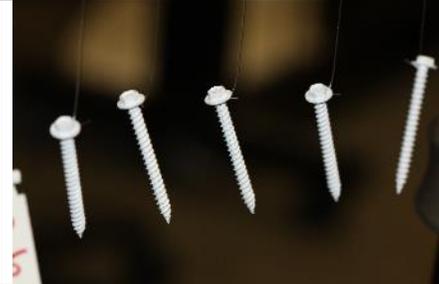
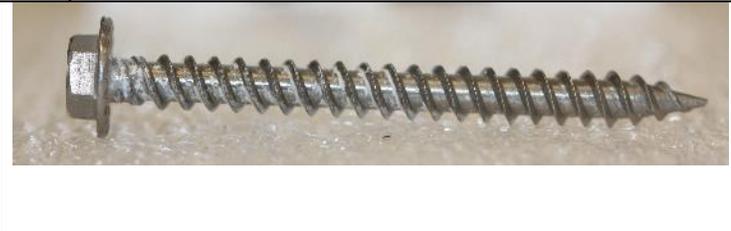
Test-1 Group 10: Ceramic coated Hex 1/4 10 x 2 SDS Stainless white	
Sample pre-testing installed	Sample pre-testing out-of-the-box

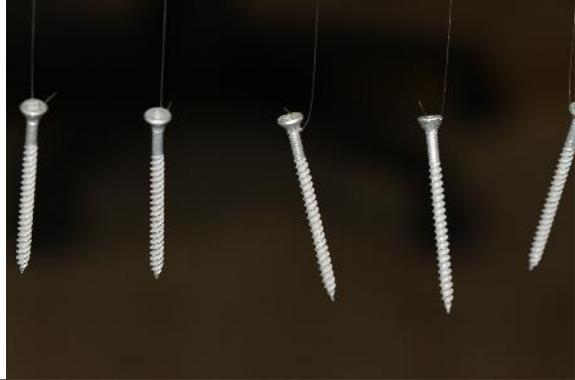
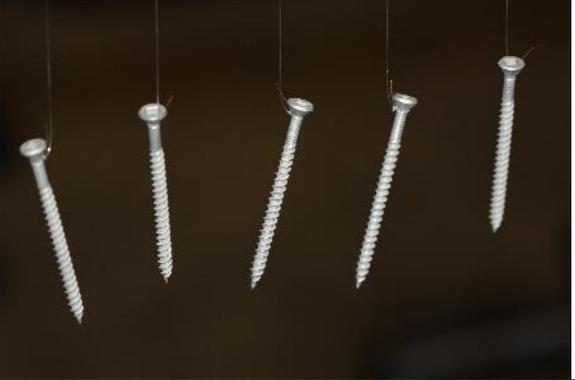
Test-1 Group 11: Tile screw mechanically galvanized	
Sample pre-testing installed	Sample pre-testing out-of-the-box

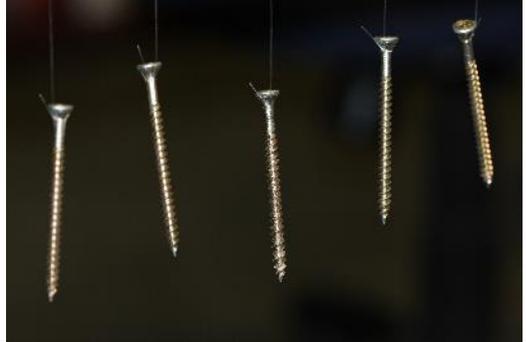
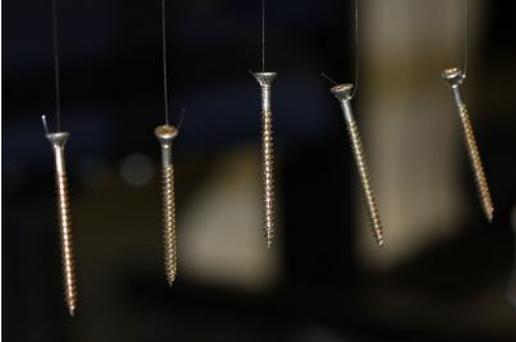
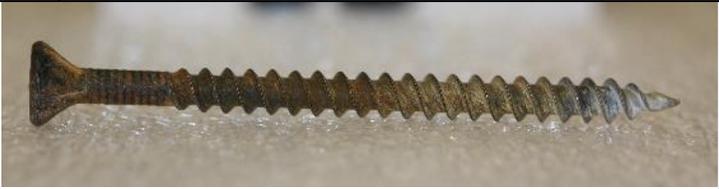
Test-1 Group 12: Tile screw electroplated	
Sample pre-testing installed	Sample pre-testing out-of-the-box

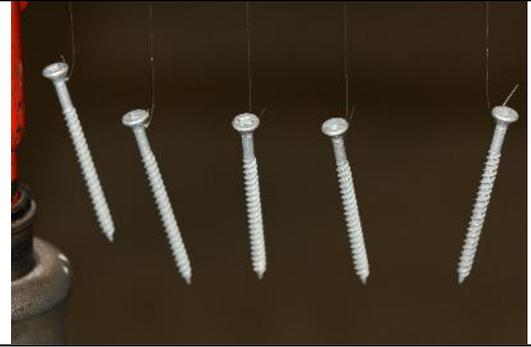
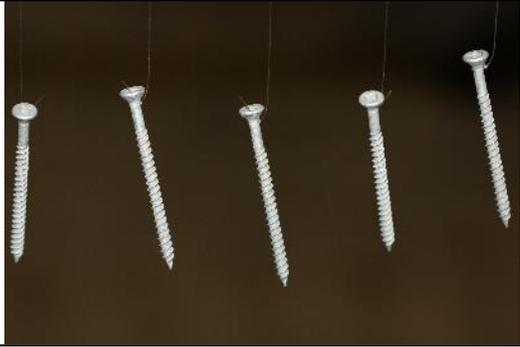
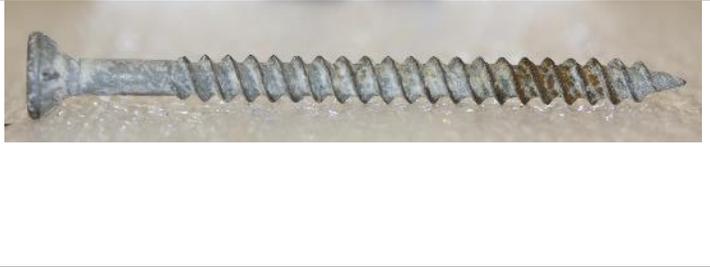
Test-1 Group 13: Tile screw mechanically galvanized	
Sample pre-testing installed	Sample pre-testing out-of-the-box

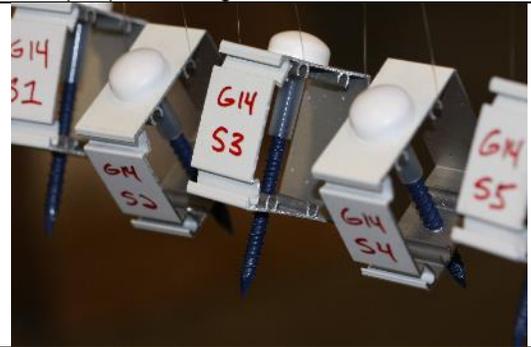
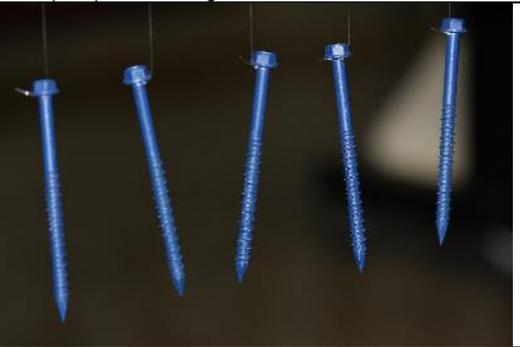
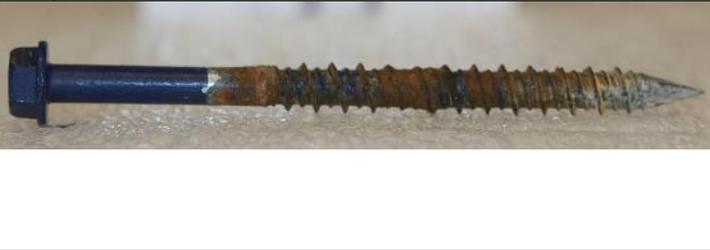
Test-1 Group 14: Ceramic coated case hardened carbon steel masonry screw	
Sample pre-testing installed	Sample pre-testing out-of-the-box

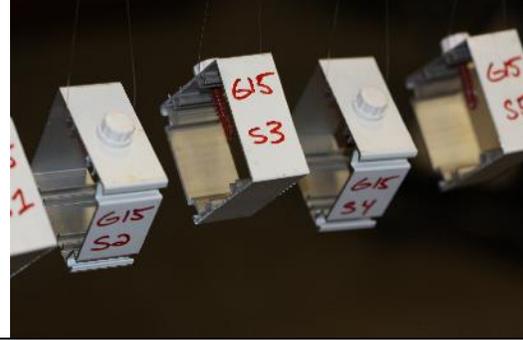
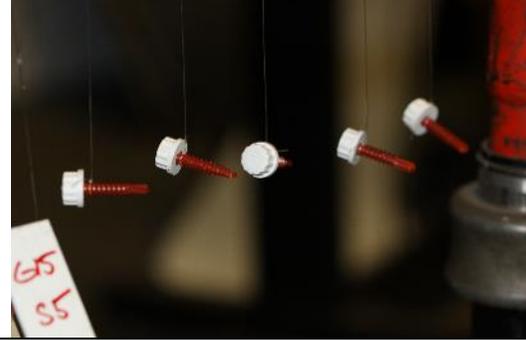
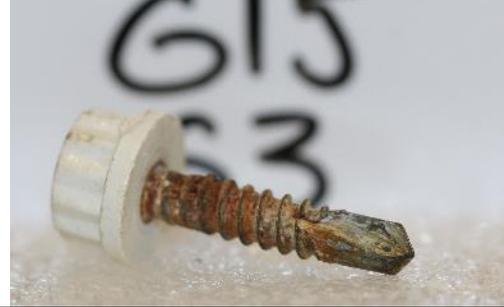
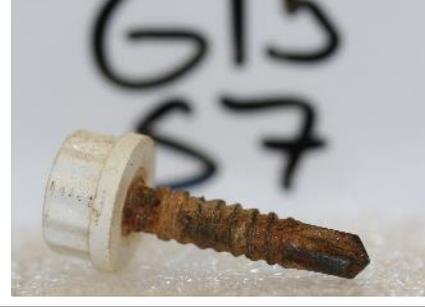
Test-1 Group 15: Ceramic coated case hardened carbon steel SDS

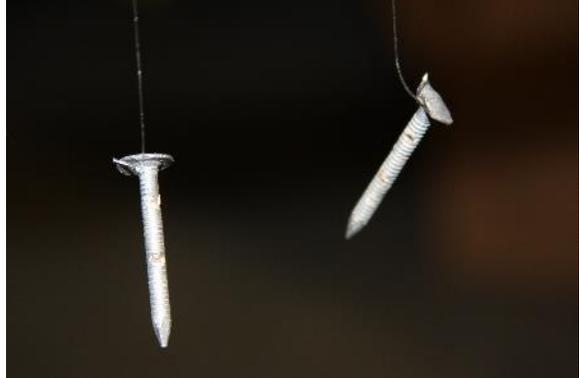
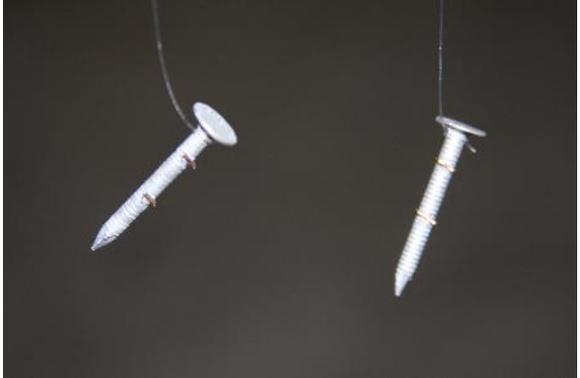
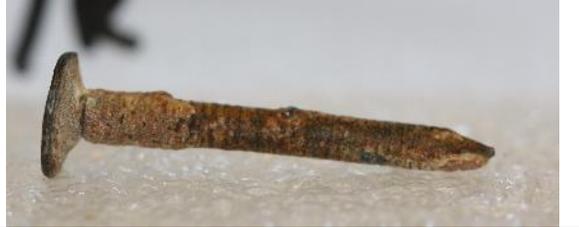
Test-2 Group 1: Hot Dipped 1-1/4" ring shank, coil gun ASTM F1667 (ASTM A641)	
Sample pre-testing installed removed	Sample pre-testing out-of-the-box

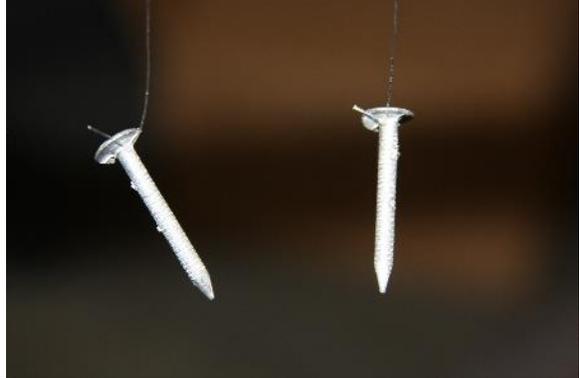
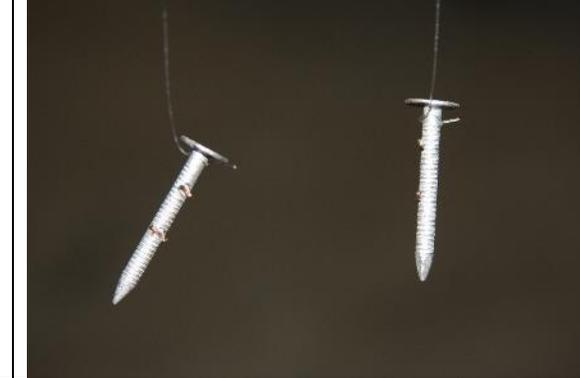
Test-2 Group 2: Hot Dipped 1-1/4" ring shank, coil gun ASTM F1667 (ASTM A641)	
Sample pre-testing installed removed	Sample pre-testing out-of-the-box

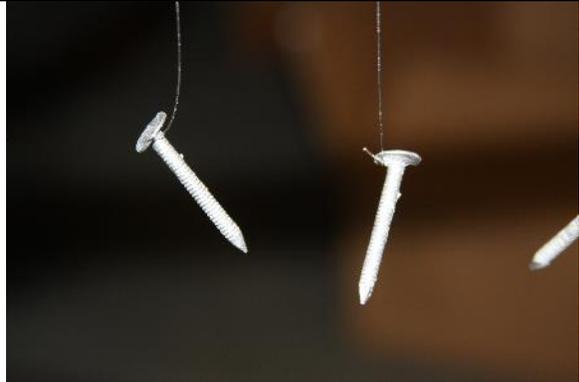
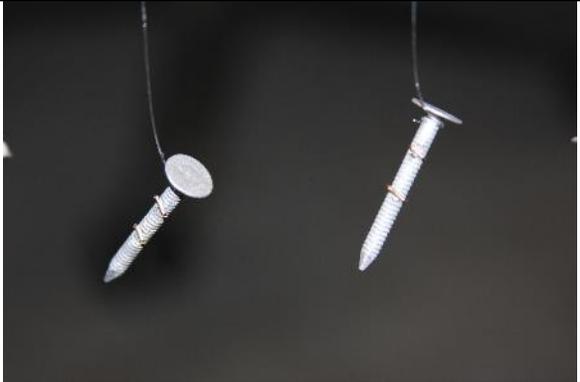
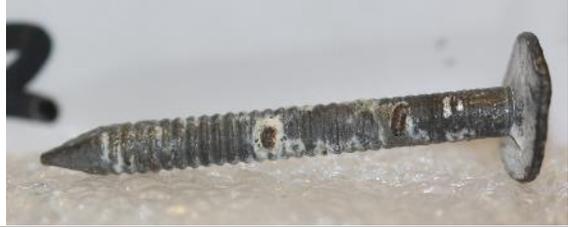
Test-2 Group 3: Hot Dipped 1-1/4" ring shank, coil gun ASTM F1667 (ASTM A641)	
Sample pre-testing installed removed	Sample pre-testing out-of-the-box

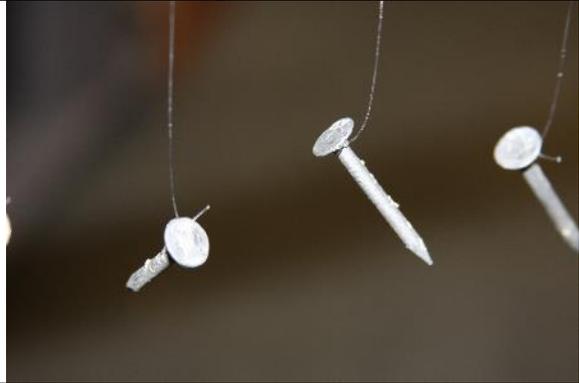
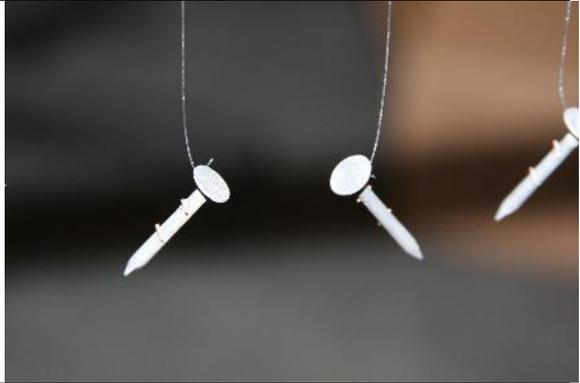
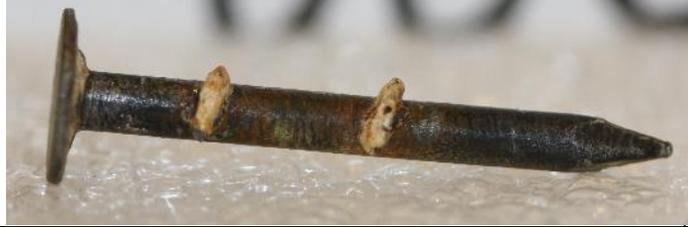
Test-2 Group 4: Hot Dipped 1-1/4" smooth shank, coil gun ASTM F1667, ASTM A153 Class D	
Sample pre-testing installed removed	Sample pre-testing out-of-the-box

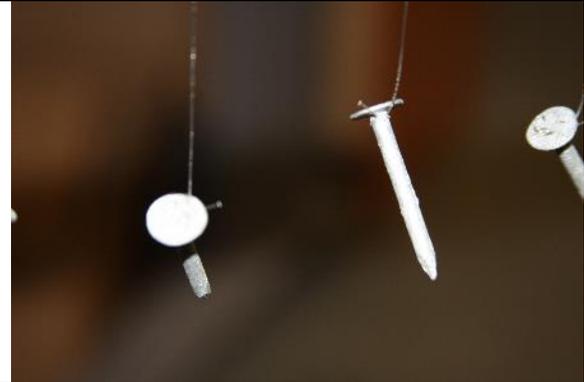
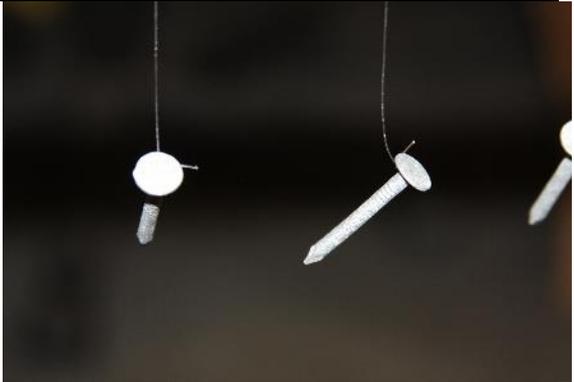
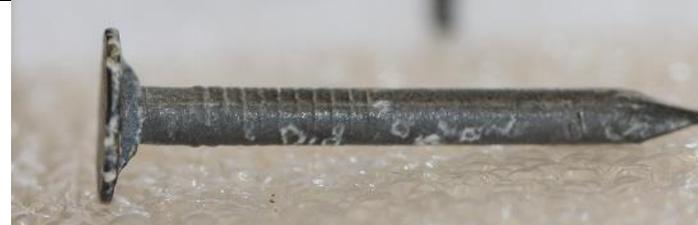
Test-2 Group 5: Hot Dipped 1-1/4" ring shank, hand driven Compliance unknown	
Sample pre-testing installed removed	Sample pre-testing out-of-the-box

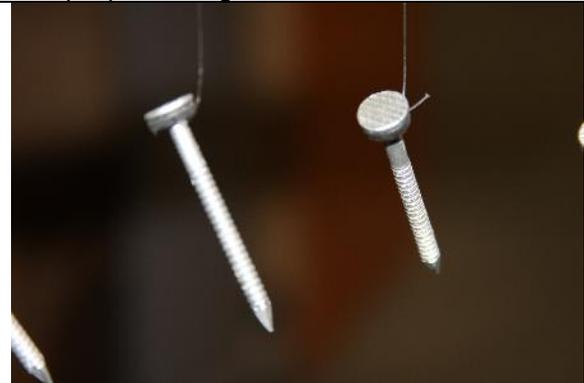
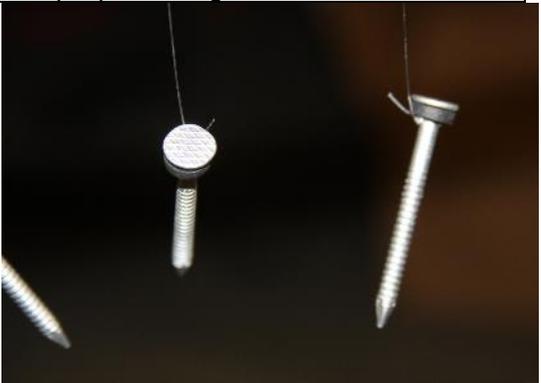
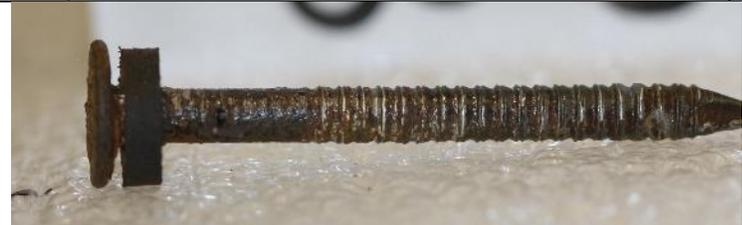
Test-2 Group 6: Hot Dipped 1-3/4" ring shank, hand driven ASTM F1667, ASTM A153 Class D	
Sample pre-testing installed removed	Sample pre-testing out-of-the-box

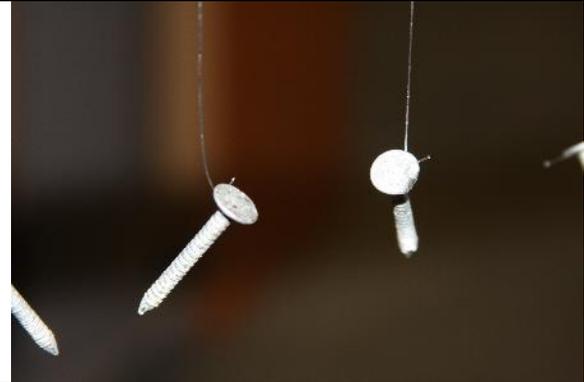
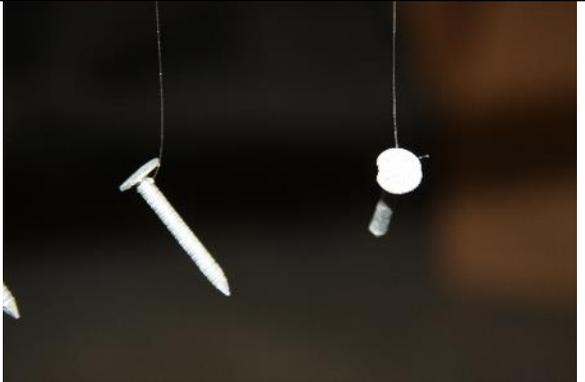
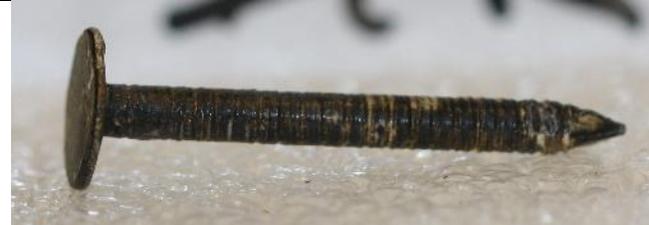
Test-2 Group 7: Hot Dipped 1-1/4" ring shank, hand driven ASTM F1667, ASTM A153 Class D	
Sample pre-testing installed removed	Sample pre-testing out-of-the-box

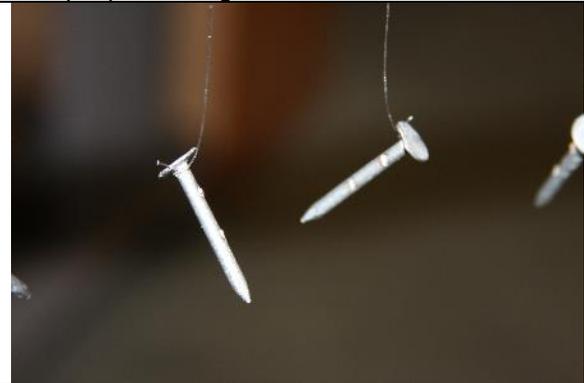
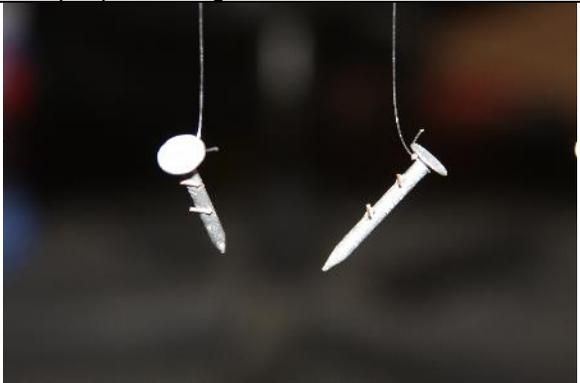
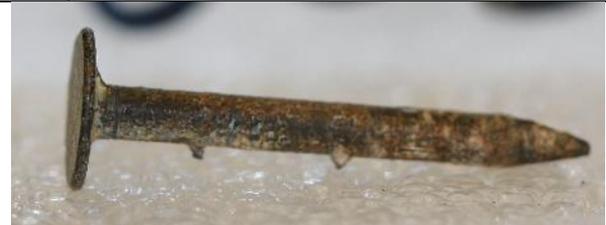
Test-2 Group 8: Hot Dipped 1-1/4" ring shank, coil gun Compliance unknown	
Sample pre-testing installed removed	Sample pre-testing out-of-the-box
