## Scope of Work

### ***An Investigation of the Factors Leading to Ridge Vent Failure and Possible Mitigation Solutions***

Proposal to Florida Department of Business and Professional Regulation  
Florida Building Commission

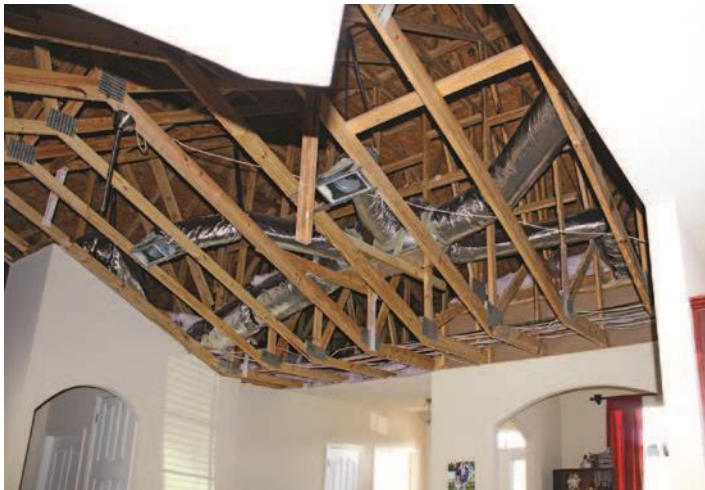
*Figure 1: House with significant interior damage from water intrusion (FEMA, 2019)*

Wind-driven water intrusion can cause catastrophic damage to the walls, ceilings, interiors, and possessions of homes, leading to significant disruption. The main sources of water intrusion into houses (aside from floods) arise from windows and doors, attic vents (including the ones on the roof, vents on gable end walls and soffits (eave and gable end), wall penetrations for utilities, cracks in wall siding. Especially, the loss of ridge vent can expose large openings in the roof deck to water infiltration. Therefore, it is important to understand to causes of ridge vent failure. *Figure 1* shows the interior of a home that suffered extensive interior water damage due to the failure of ridge shingles and the ridge vent.

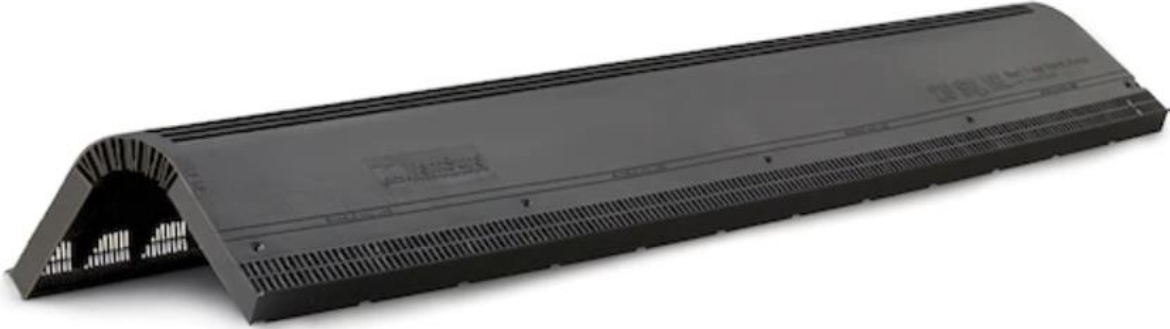
For the ridge design, standard ridge vent specifications will be used. For example, Figure 3 below shows a ridge vent available at Lowe’s [4]. These specifications could be used to model the ridge vent in the numerical

Figure 3: Example of an actual ridge vent [4].
