EXTERIOR STUCCO EVALUATION OBSERVATION REPORT

SITE: Delgado House, 18508 NW 138 Avenue, Alachua, Florida

Dates: 24 & 28 June 2021.

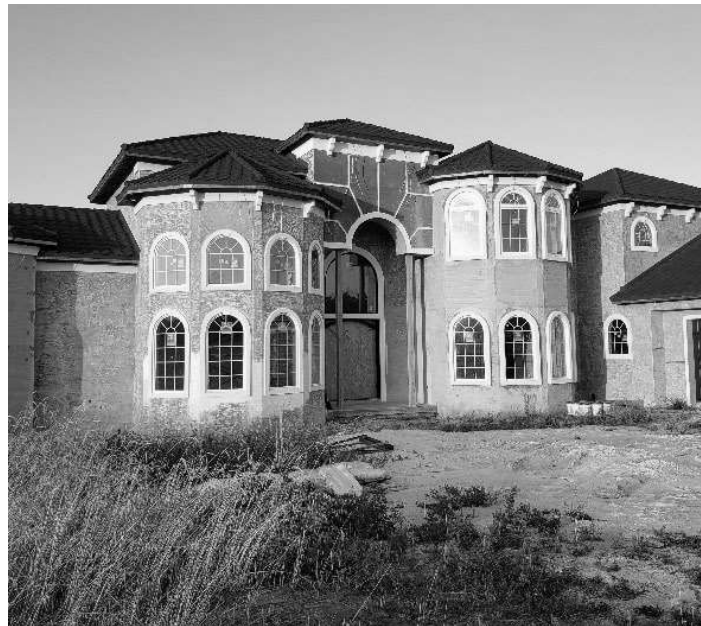
Figure 1. Front View

The following are our observations and preliminary opinions from our visits to the Delgado home shown below and our opinion on the proposed remedies by R&M Construction and Development LLC. Figures 1-3 show the Delgado's multi-story home under construction. Figure 1 is worth a thousand words. The house is littered with hairline cracks particularly on the west, southwest, east (Figure 2) and southeast (Figure 3) sides of the house. A majority of the cracks have been caulked. Unfortunately, many more exist in the brown coat around the entire house. This extensive cracking is most likely a result of:

1. Insufficient Sand.
2. Inconsistent Coat Thickness.
3. Insufficient Hydration due to inadequate curing.

Based on our field observations including the stucco thickness measurements shown in Table 1, we recommend complete removal of all stucco down to the sheathing and re-stuccoing as per the recommended stucco procedures outlined above with a proper inspection protocol in place to measure code compliance.

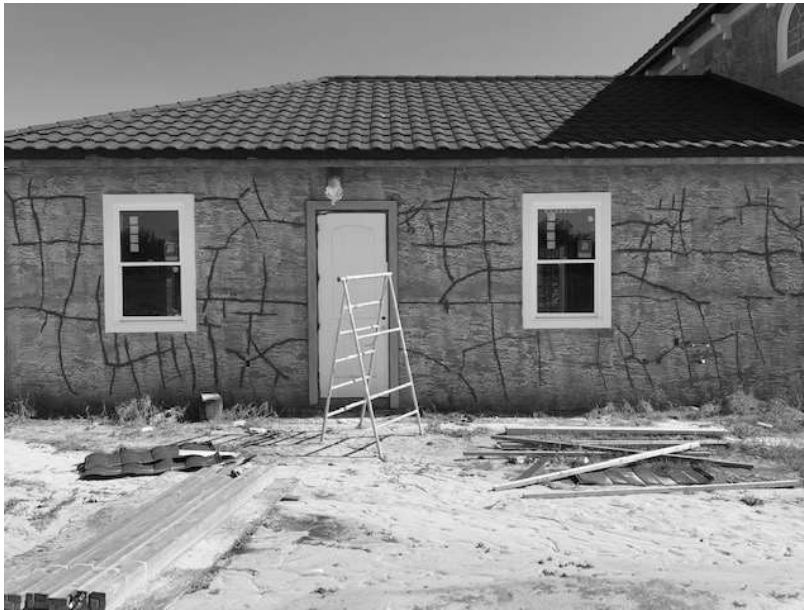
Figure 2: West Wall

1/2 inch which again is less than the required 3/4 inch for scratch plus brown coat. The extensive cracking of the west wall (Figure 2) in particular and to a certain extent even the east wall indicates that the scratch coat and/or base coat were not only **not thick enough** but were most likely **not cured properly** and therefore was subjected to extensive shrinkage cracking. Proof of this lies in the pictures of the west wall showing extensive cracking and patching. Patching of the cracks has failed to correct this since many more are observed and are likely to continue for some time.
