Interim Report:

Survey and Investigation of Buildings Damaged by Category III Hurricanes in FY 2016-17 – Hurricane Mathew 2016

Report No. UF01-17
11 April 2017

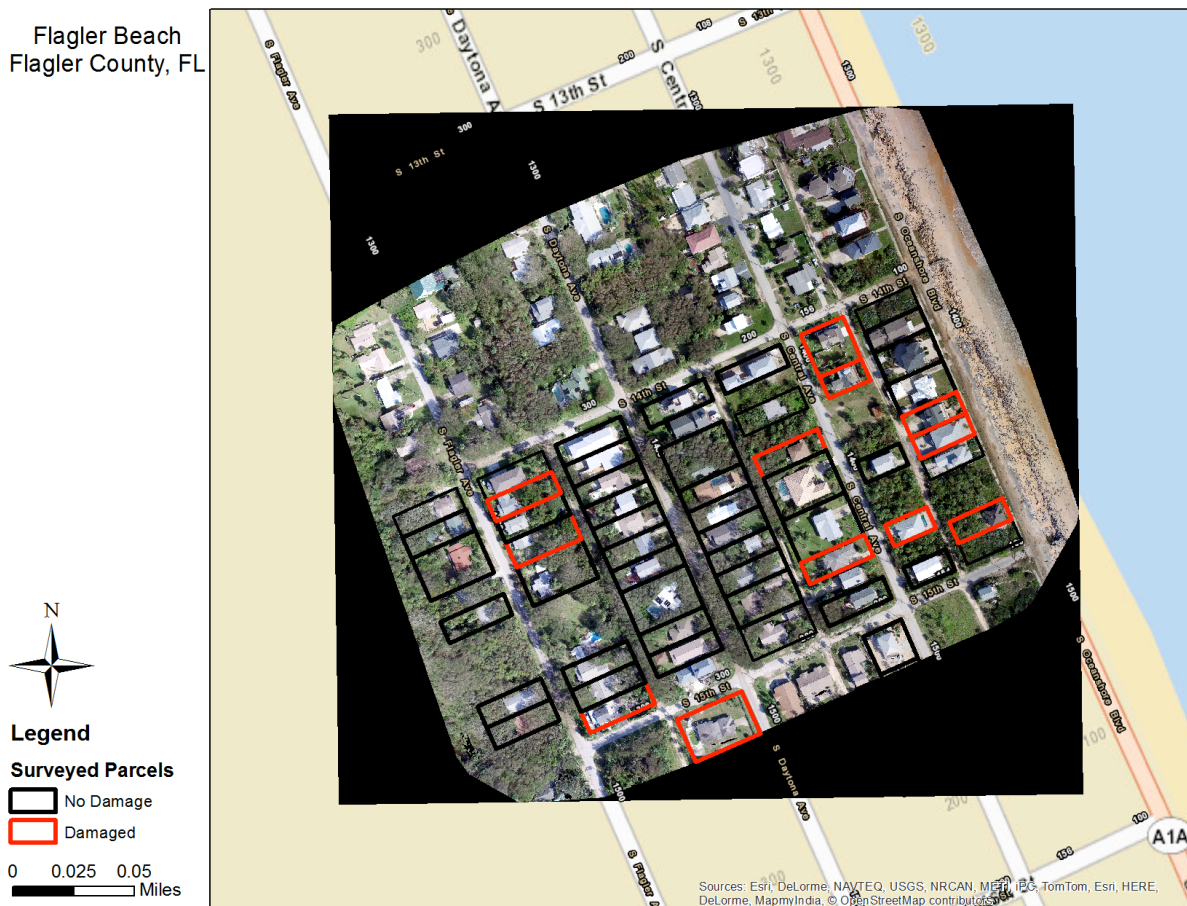
Figure 1: Aerial imagery of surveyed homes in Flagler Beach, FL obtained using the UAV.

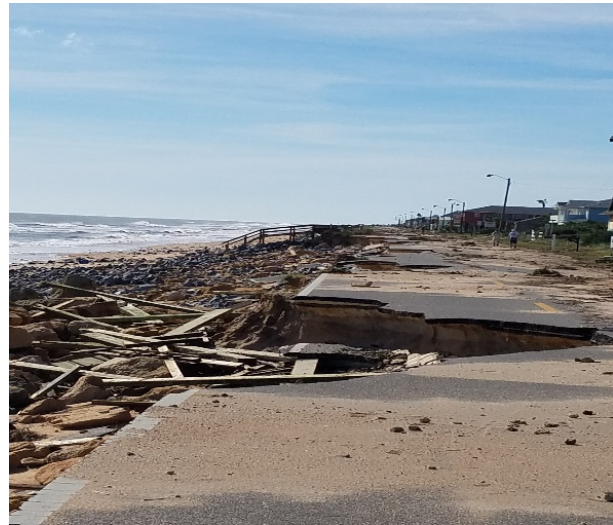
Figure A-2: Damage to A1A in Flagler Beach, FL

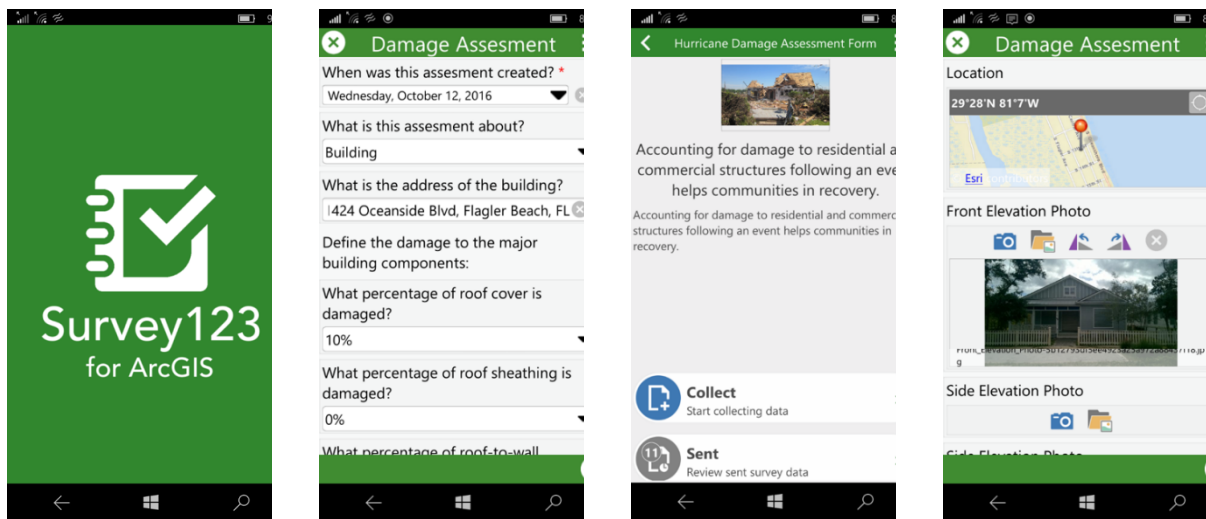
As shown in the screenshots in Figures A-4, the team deployed a survey form on the app to have 13 fields to input damages, 7 spots for photos from street level, and built in location redundancy where you can input both the street address and geotag each photo using the location feature on the smartphone.

Figures A-4: From left to right: a) Load screen b) Damage Assessment c) Survey Page d) Location/Images

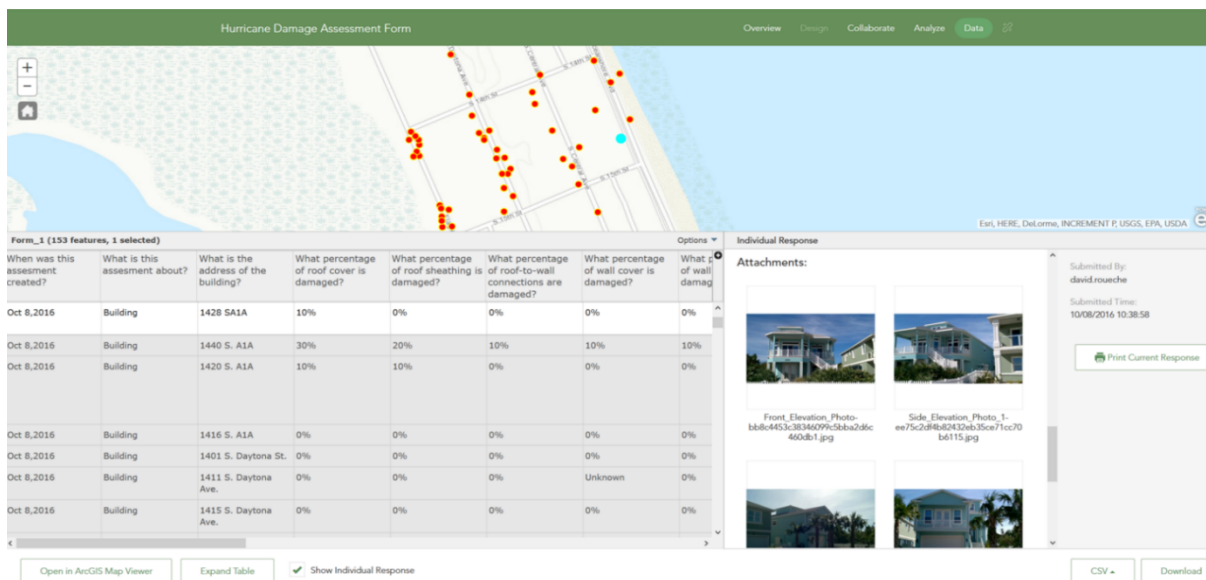
For each home assessed, the user input values for damages of varying degrees to the different components of the roof and walls of the home. At the same time, the user used the camera built into the phone to snap pictures of the house from every possible elevation, and at the end was able to save the survey so it could be uploaded to a central database after the collection had ended. As seen in Figure A-5, after all the data for one site had been uploaded the user can see on a map where the geotagged locations are, and in the table in the bottom of the

image, characteristics of each individual survey. Finally, in the bottom right images of the specific house the user is interested in are shown so that the physical damage, if any, can be shown visually.

Figure A-5: ESRI Survey123 online portal for viewing and editing damage survey submissions

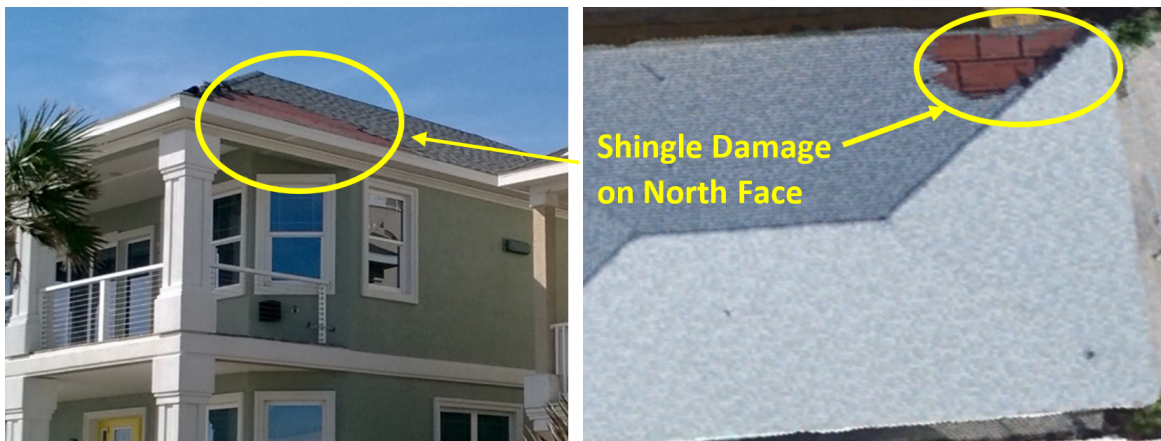
Figure 8: Home at 1424 S. Oceanshore Drive built in 2015. a) Photo from ground survey
b) UAV aerial imagery

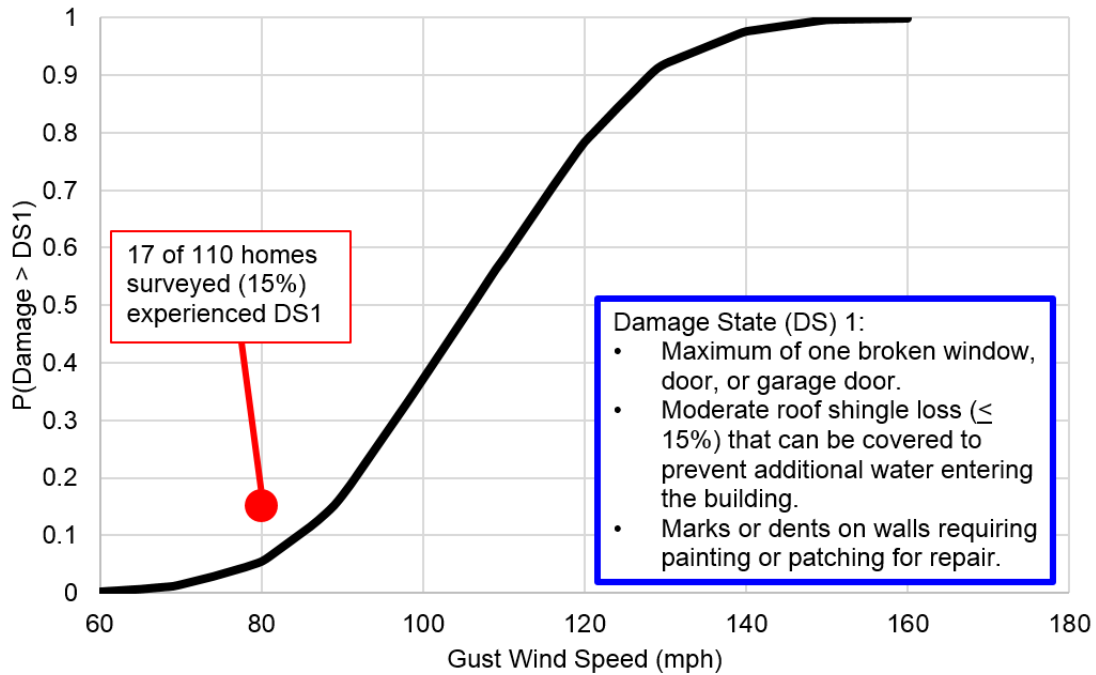
Figure A-9 shows the resulting fragility curve along with the proportion of damage observed in both sites combined. The proportion of observed damage is about 10% higher than would have been expected. The proportion of homes damaged in Marineland, 9%, would be closer to the expected amounts from HAZUS. The higher proportion of damage than predicted could be attributable to any one of the following factors:

- Some of the newest homes appeared to have been just finished, and the asphalt shingles may not have had the opportunity to fully seal by the time the hurricane struck.
- The HAZUS fragility curves may not be well-suited to a large proportion of old structures, where roofs may have been in need of replacing prior to the storm.
- This area of the coast has not had a hurricane strike in decades, and any vulnerabilities in existing structures would have remained unnoticed and uncorrected until this hurricane.

Figure A-9: Fragility curve from HAZUS-MH Hurricane for light damage (DS1)

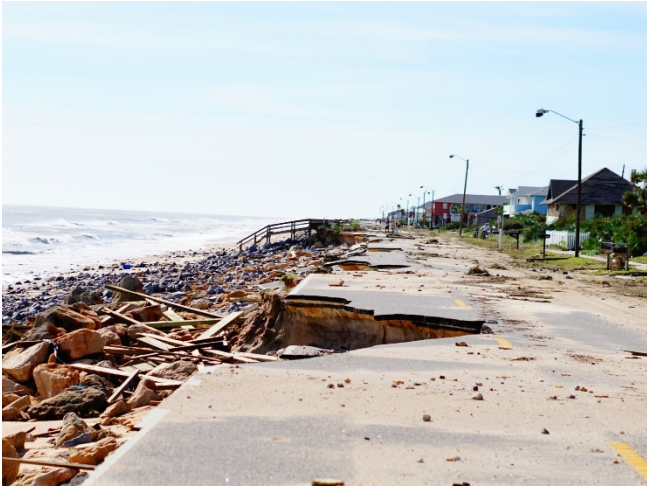
Furthermore, while damage to homes in the area was relatively minimal, the impact of Hurricane Matthew was felt fully by a large portion of A1A in Flagler Beach. Storm surges decimated long stretches of the road, with huge chunks of asphalt dumped onto the beaches, showing the innards of the road and the barriers underneath that were constructed to support the road and to help prevent damage. When cost estimates of the impact of storms such as Hurricane Matthew are calculated, damage to infrastructure such as that shown in the image below factors in a large portion.

Figure A-10: Damage to A1A along Flagler Beach

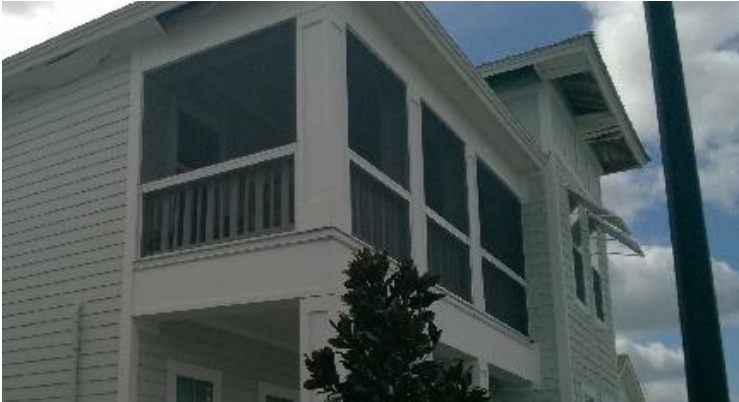
Figure A-12: 13 Smiling Fish Lane Damaged Soffits (Site 2)
