**Final Report for Project Entitled:**  
**Corrosion of Residential Fasteners**  
**Performance Period: 10/7/2016 – 6/30/2017**

Presented to the  
Florida Building Commission  
State of Florida Department of Business and Professional Regulation

Kurtis R. Gurley, Ph.D., kgurl@ce.ufl.edu, (352) 294-7795

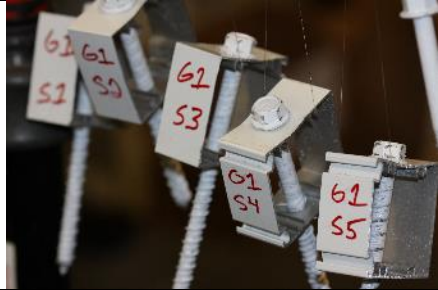
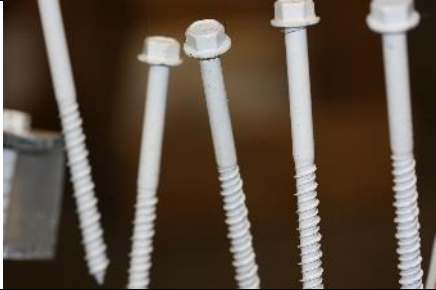
| Test-1 Group 1: Ceramic coated Hex 3/8 x 5 304 Stainless white | |
| Sample pre-testing installed | Sample pre-testing out-of-the-box |

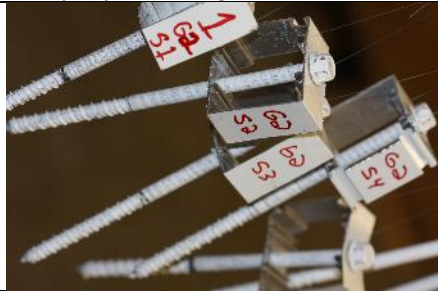
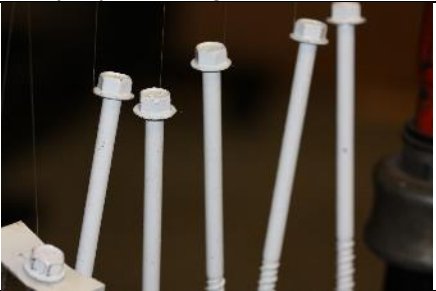
| Test-1 Group 2: Ceramic coated Hex 3/8 x 7 304 Stainless white | |

| Test-1 Group 2: Ceramic coated Hex 3/8 x 7 304 Stainless white | |
|---|---|
| Sample pre-testing installed | Sample pre-testing out-of-the-box |

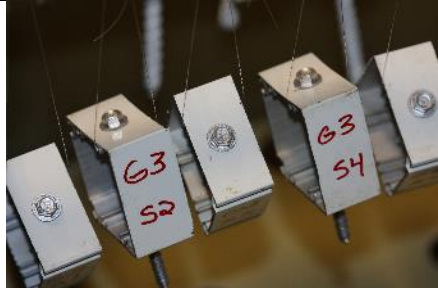
| Test-1 Group 3: Ceramic coated Hex 1/4 x 3 1/4 304 Stainless silver | |

| Test-1 Group 3: Ceramic coated Hex 1/4 x 3 1/4 304 Stainless silver | |
|---|---|
| Sample pre-testing installed | Sample pre-testing out-of-the-box |

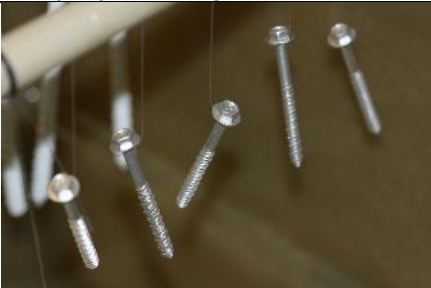
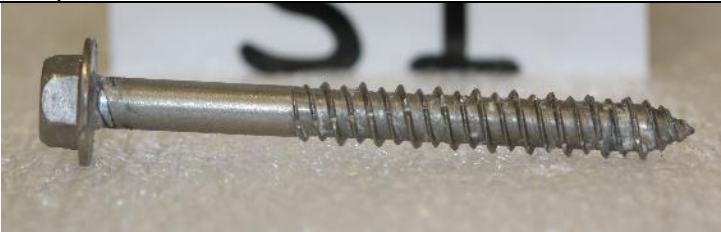
| Test-1 Group 4: Ceramic coated Hex 1/4 x 2 1/4 304 Stainless silver | |

| Test-1 Group 4: Ceramic coated Hex 1/4 x 2 1/4 304 Stainless silver | |
|---|---|
| Sample pre-testing installed | Sample pre-testing out-of-the-box |

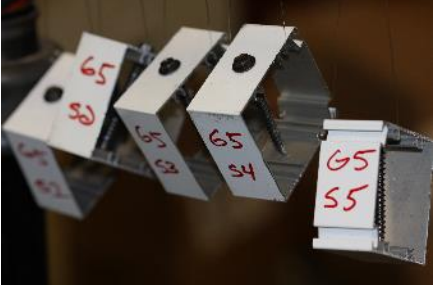
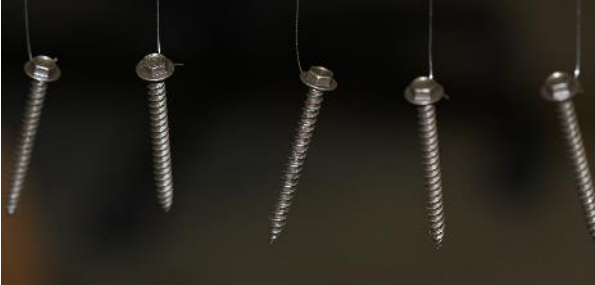
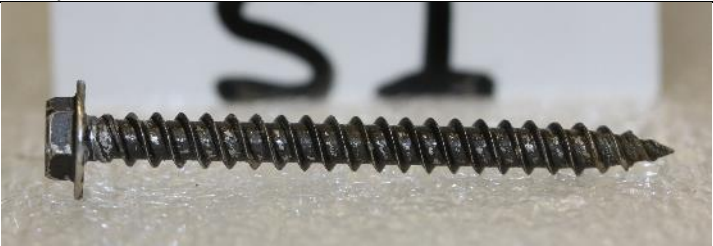
| Test-1 Group 5: Ceramic coated Hex 1/4 10 x 2 SMS 316 Stainless bronze | |

| Test-1 Group 5: Ceramic coated Hex 1/4 10 x 2 SMS 316 Stainless bronze | |
|---|---|
| Sample pre-testing installed | Sample pre-testing out-of-the-box |

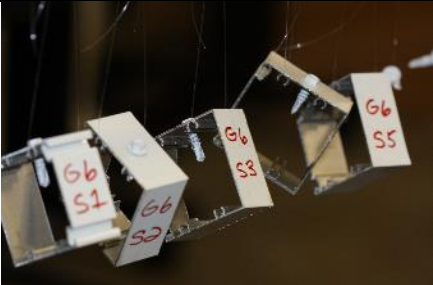
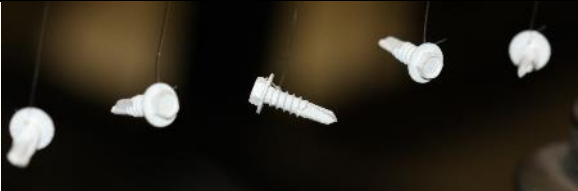
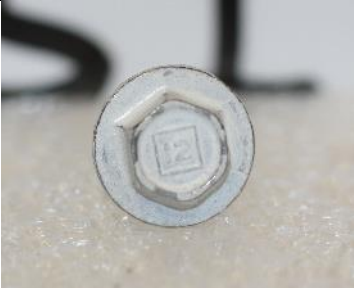
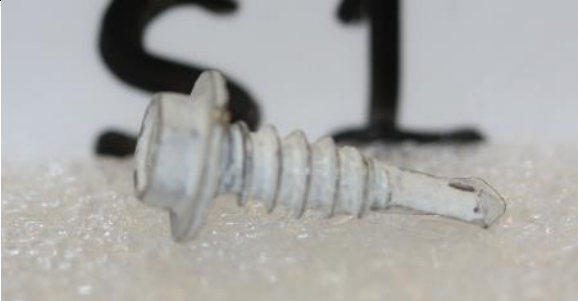
| Test-1 Group 6: Ceramic coated Hex 1/4 12 x 3/4 SDS 316 Stainless white | |

| Test-1 Group 6: Ceramic coated Hex 1/4 12 x 3/4 SDS 316 Stainless white | |
|---|---|
| Sample pre-testing installed | Sample pre-testing out-of-the-box |

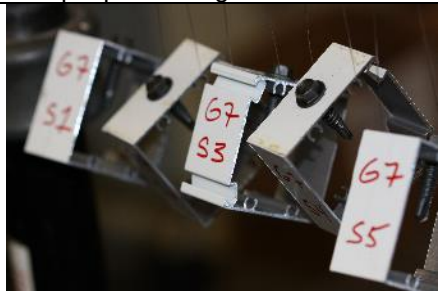
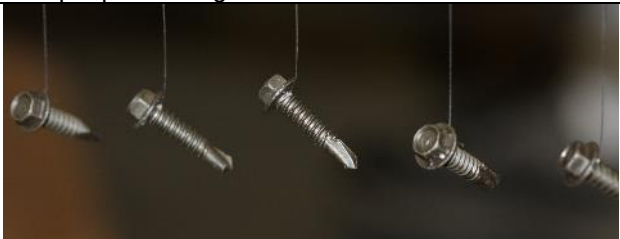
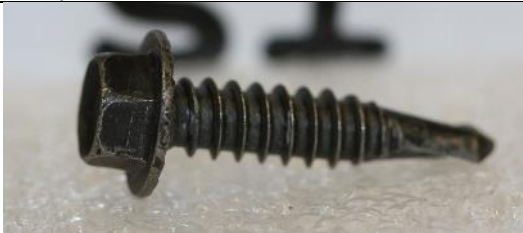
| Test-1 Group 7: Ceramic coated Hex 5/16 14 x 1 SDS 316 Stainless bronze | |

| Test-1 Group 7: Ceramic coated Hex 5/16 14 x 1 SDS 316 Stainless bronze | |
|---|---|
| Sample pre-testing installed | Sample pre-testing out-of-the-box |

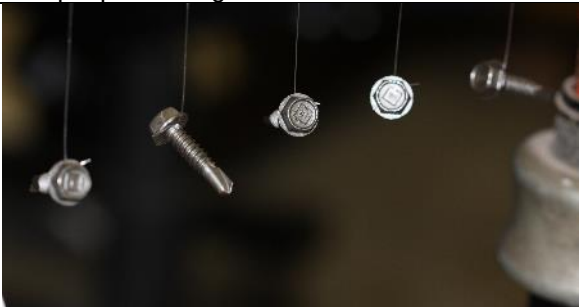
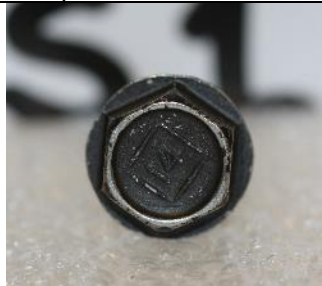
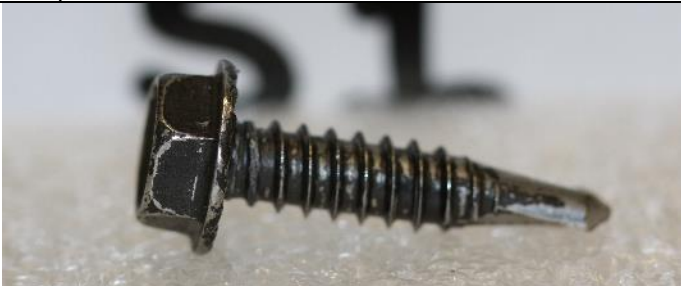
| Test-1 Group 8: Ceramic coated Hex 3/8 14 x 1 SDS 316 Stainless bronze | |

| Test-1 Group 8: Ceramic coated Hex 3/8 14 x 1 SDS 316 Stainless bronze | |
|---|---|
| Sample pre-testing installed | Sample pre-testing out-of-the-box |

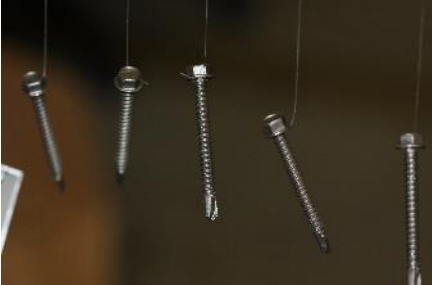
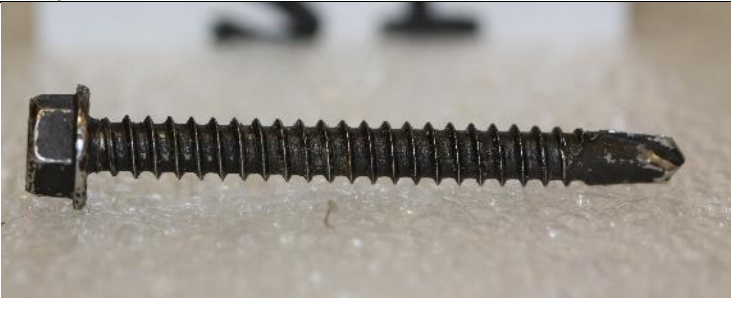
| Test-1 Group 9: Ceramic coated Hex 5/16 12 x 2 SDS 316 Stainless bronze | |

| Test-1 Group 9: Ceramic coated Hex 5/16 12 x 2 SDS 316 Stainless bronze | |
|---|---|
| Sample pre-testing installed | Sample pre-testing out-of-the-box |

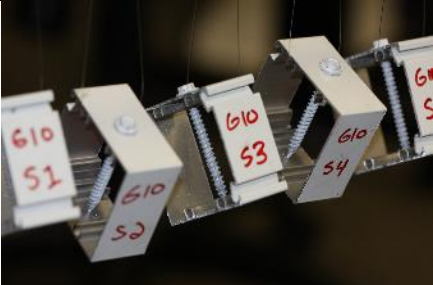
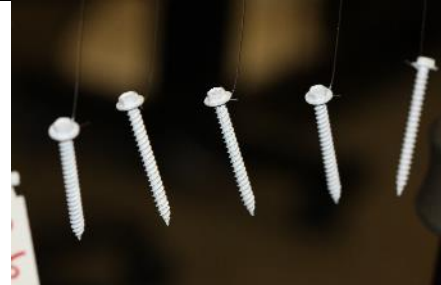
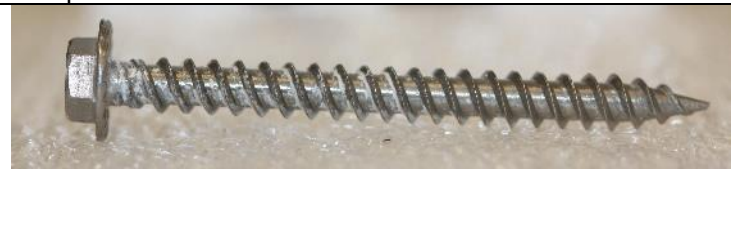
| Test-1 Group 10: Ceramic coated Hex 1/4 10 x 2 SDS Stainless white | |

| Test-1 Group 10: Ceramic coated Hex 1/4 10 x 2 SDS Stainless white | |
|---|---|
| Sample pre-testing installed | Sample pre-testing out-of-the-box |

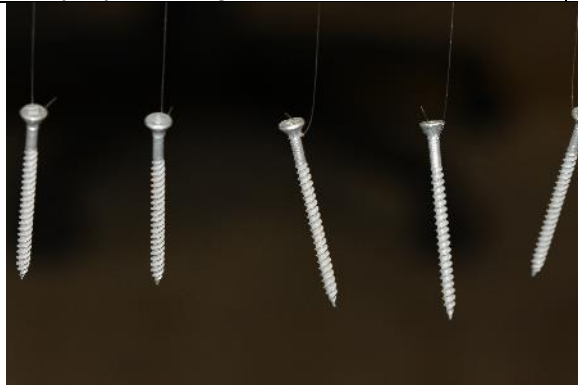
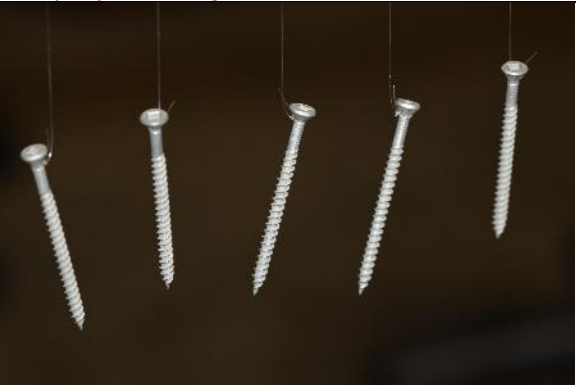
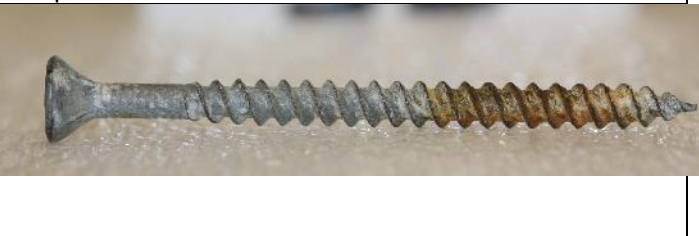
| Test-1 Group 11: Tile screw mechanically galvanized | |

| Test-1 Group 11: Tile screw mechanically galvanized | |
|---|---|
| Sample pre-testing installed | Sample pre-testing out-of-the-box |

complete 500 cycles. Spots of light corrosion were observed on many samples, and others showed no signs of corrosion. The samples installed into tile and removed prior to testing showed no difference in performance compared to the samples tested out-of-the-box. Electroplated samples showed slightly more corrosion than mechanically galvanized samples

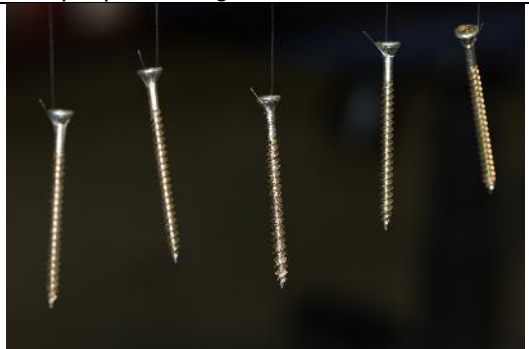
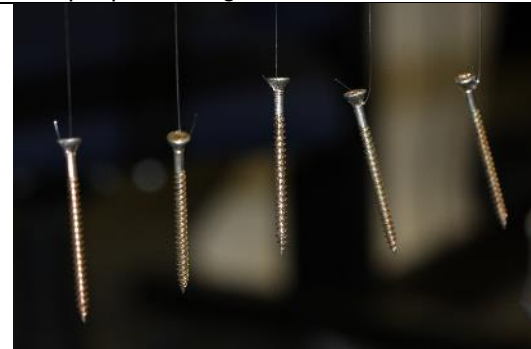
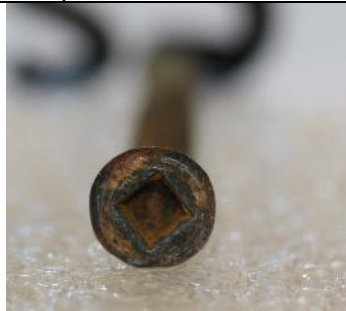
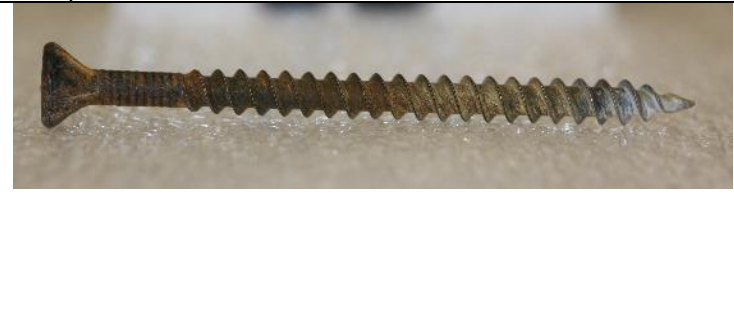
| Test-1 Group 12: Tile screw electroplated | |

| Test-1 Group 12: Tile screw electroplated | |
|---|---|
| Sample pre-testing installed | Sample pre-testing out-of-the-box |

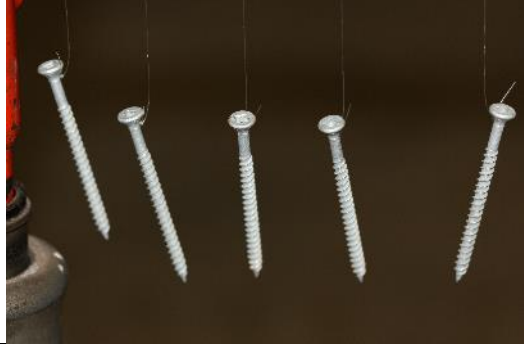
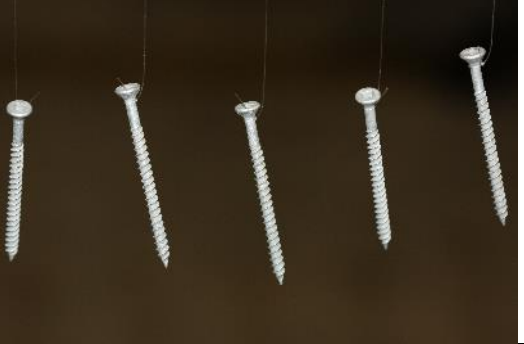
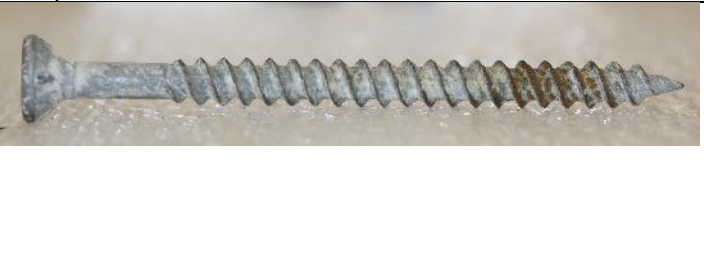
| Test-1 Group 13: Tile screw mechanically galvanized | |

| Test-1 Group 13: Tile screw mechanically galvanized | |
|---|---|
| Sample pre-testing installed | Sample pre-testing out-of-the-box |

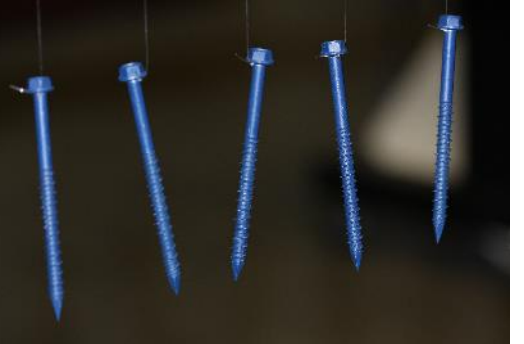
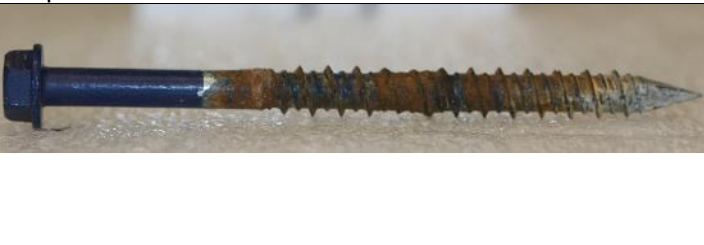
| Test-1 Group 14: Ceramic coated case hardened carbon steel masonry screw | |
| Sample pre-testing installed | Sample pre-testing out-of-the-box |

- Figure 4: Ceramic coated case hardened carbon steel masonry screws and SDS exhibit significant corrosion on the shaft on most samples, and corrosion on the head on the masonry screws (the SDS had a nylon head). Installation in aluminum did not influence the onset of corrosion on the shaft.

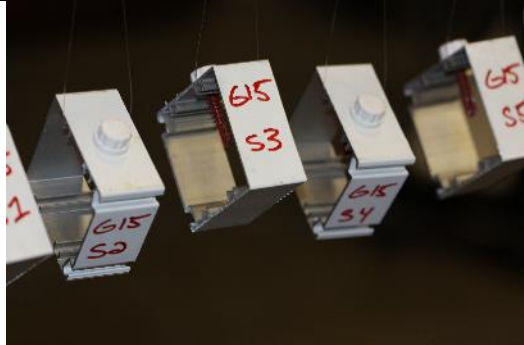
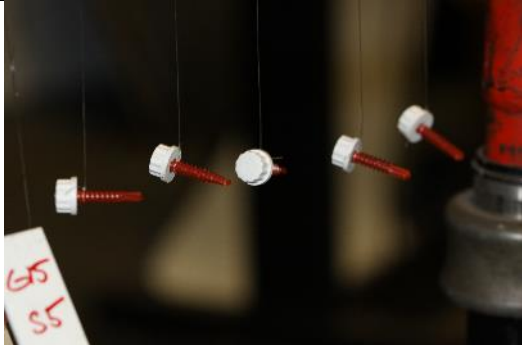
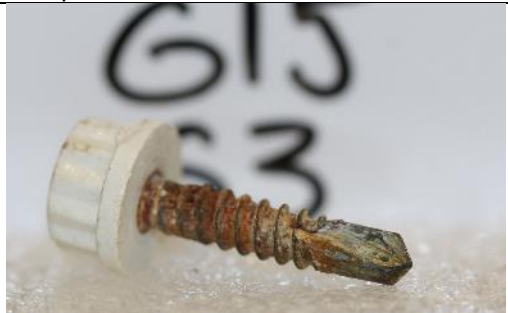
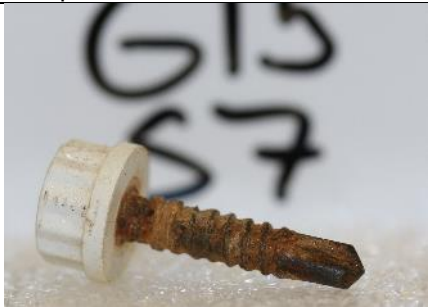
| Test-1 Group 15: Ceramic coated case hardened carbon steel SDS | |
| Sample pre-testing installed | Sample pre-testing out-of-the-box |

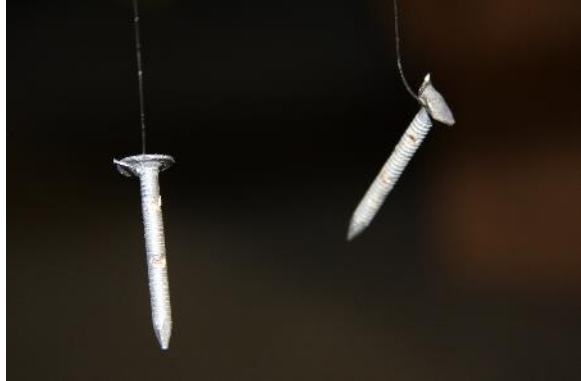
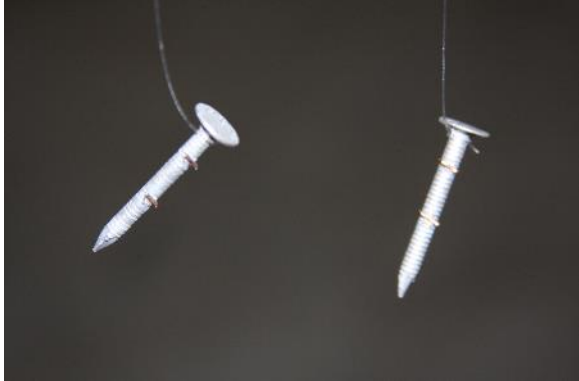
| Test-2 Group 1: Hot Dipped 1-1/4" ring shank, coil gun<br>ASTM F1667 (ASTM A641) | |
| Sample pre-testing installed removed | Sample pre-testing out-of-the-box |

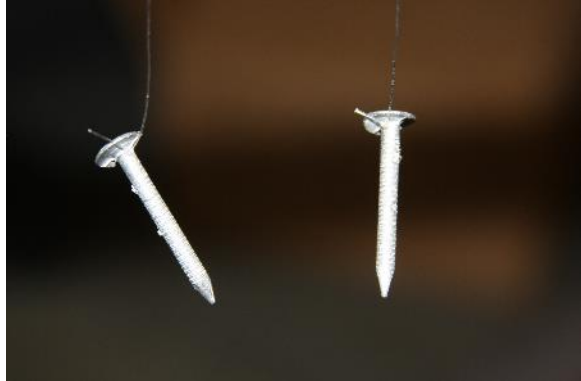
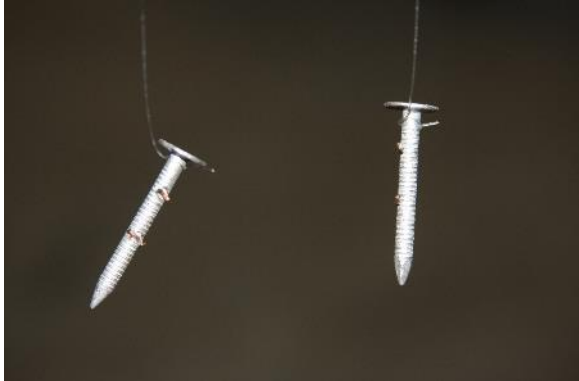
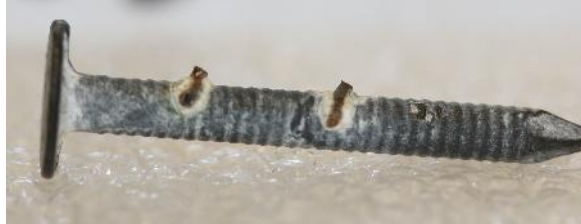
| Test-2 Group 2: Hot Dipped 1-1/4" ring shank, coil gun<br>ASTM F1667 (ASTM A641) | |

| Test-2 Group 2: Hot Dipped 1-1/4" ring shank, coil gun<br>ASTM F1667 (ASTM A641) | |
|---|---|
| Sample pre-testing installed removed | Sample pre-testing out-of-the-box |

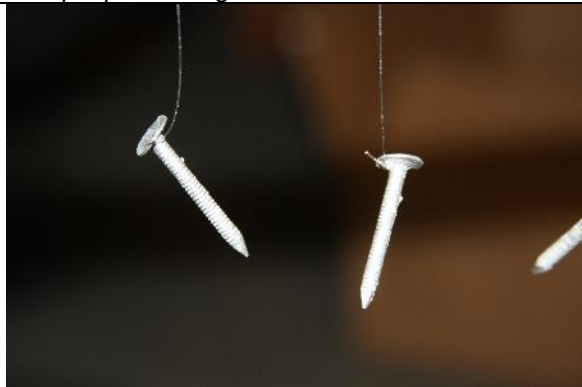
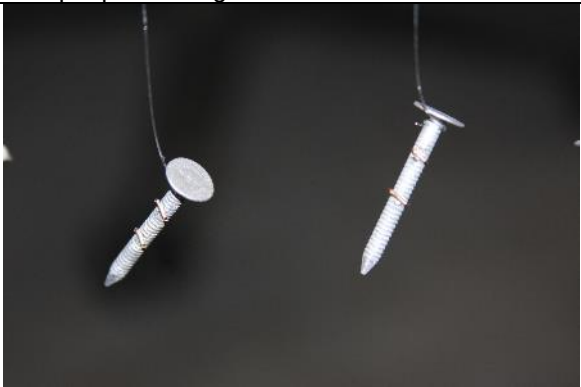
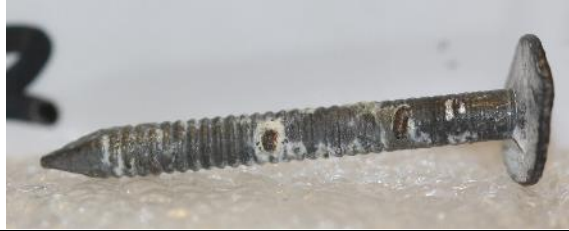
| Test-2 Group 3: Hot Dipped 1-1/4" ring shank, coil gun<br>ASTM F1667 (ASTM A641) | |

| Test-2 Group 3: Hot Dipped 1-1/4" ring shank, coil gun<br>ASTM F1667 (ASTM A641) | |
|---|---|
| Sample pre-testing installed removed | Sample pre-testing out-of-the-box |

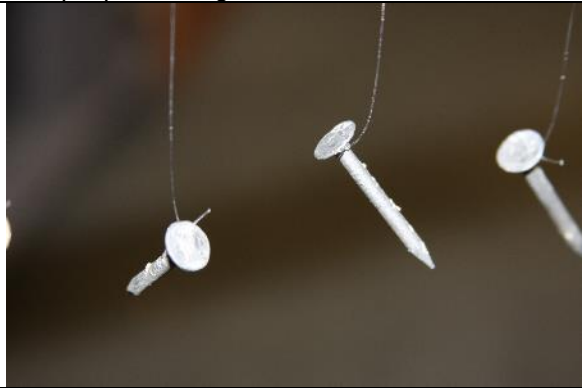
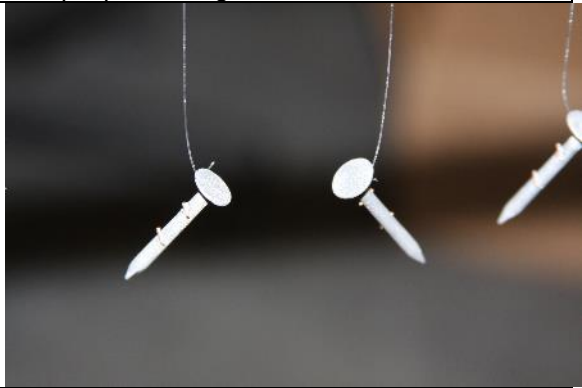
| Test-2 Group 4: Hot Dipped 1-1/4" smooth shank, coil gun<br>ASTM F1667, ASTM A153 Class D | |
| Sample pre-testing installed removed | Sample pre-testing out-of-the-box |

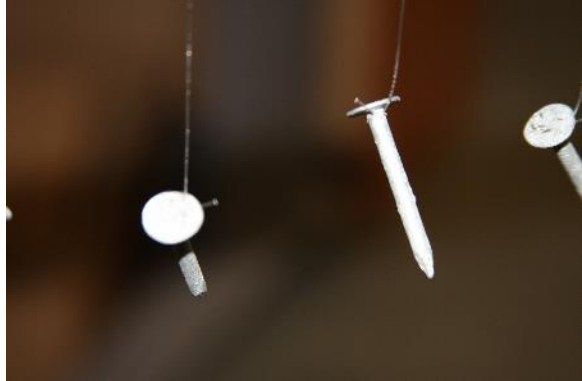
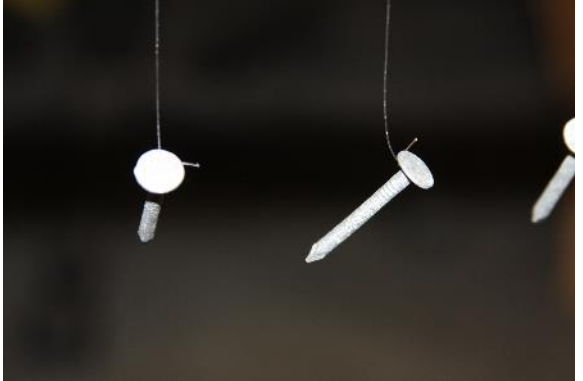
| Test-2 Group 5: Hot Dipped 1-1/4" ring shank, hand driven<br>Compliance unknown | |
| Sample pre-testing installed removed | Sample pre-testing out-of-the-box |

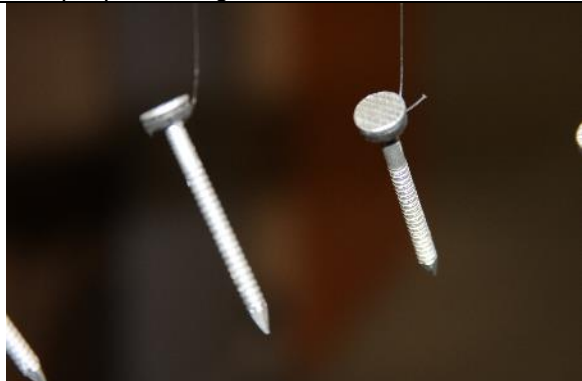
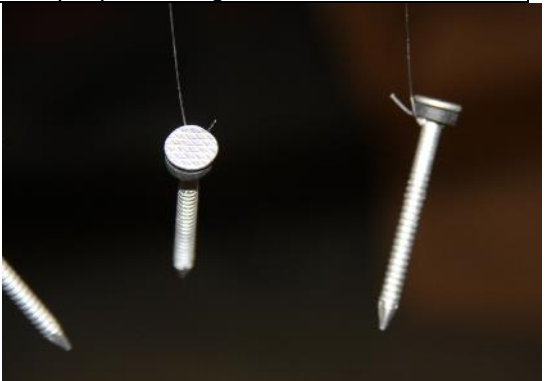
| Test-2 Group 6: Hot Dipped 1-3/4" ring shank, hand driven<br>ASTM F1667, ASTM A153 Class D | |
| Sample pre-testing installed removed | Sample pre-testing out-of-the-box |

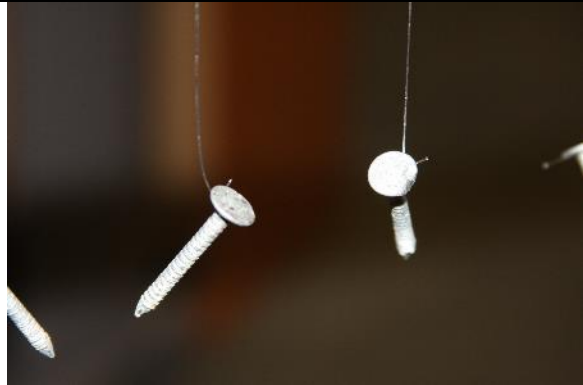
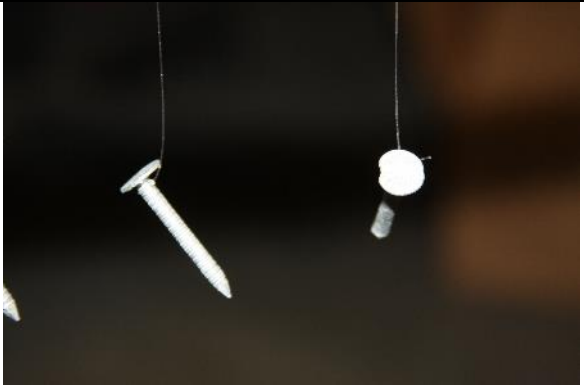
| Test-2 Group 7: Hot Dipped 1-1/4" ring shank, hand driven<br>ASTM F1667, ASTM A153 Class D | |
| Sample pre-testing installed removed | Sample pre-testing out-of-the-box |

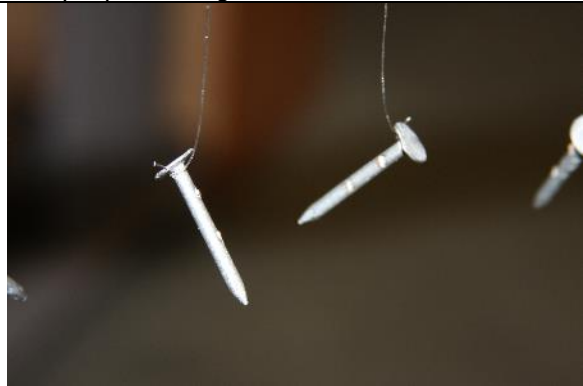
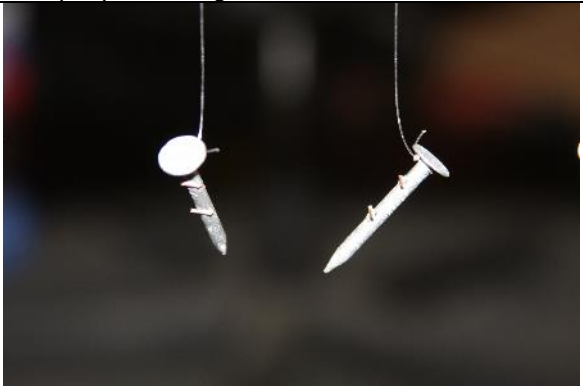
| Test-2 Group 8: Hot Dipped 1-1/4" ring shank, coil gun<br>Compliance unknown | |
| Sample pre-testing installed removed | Sample pre-testing out-of-the-box |
